BERRY POMEROY CASTLE
ARCHAEOLOGICAL EXCAVATION AND RECORDING
DURING CONDITION SURVEY WORK

STEWART BROWN ASSOCIATES FEBRUARY 2008

BERRY POMEROY CASTLE, DEVON
ARCHAEOLOGICAL EXCAVATION AND RECORDING IN ASSOCIATION WITH
CONDITION SURVEY WORK

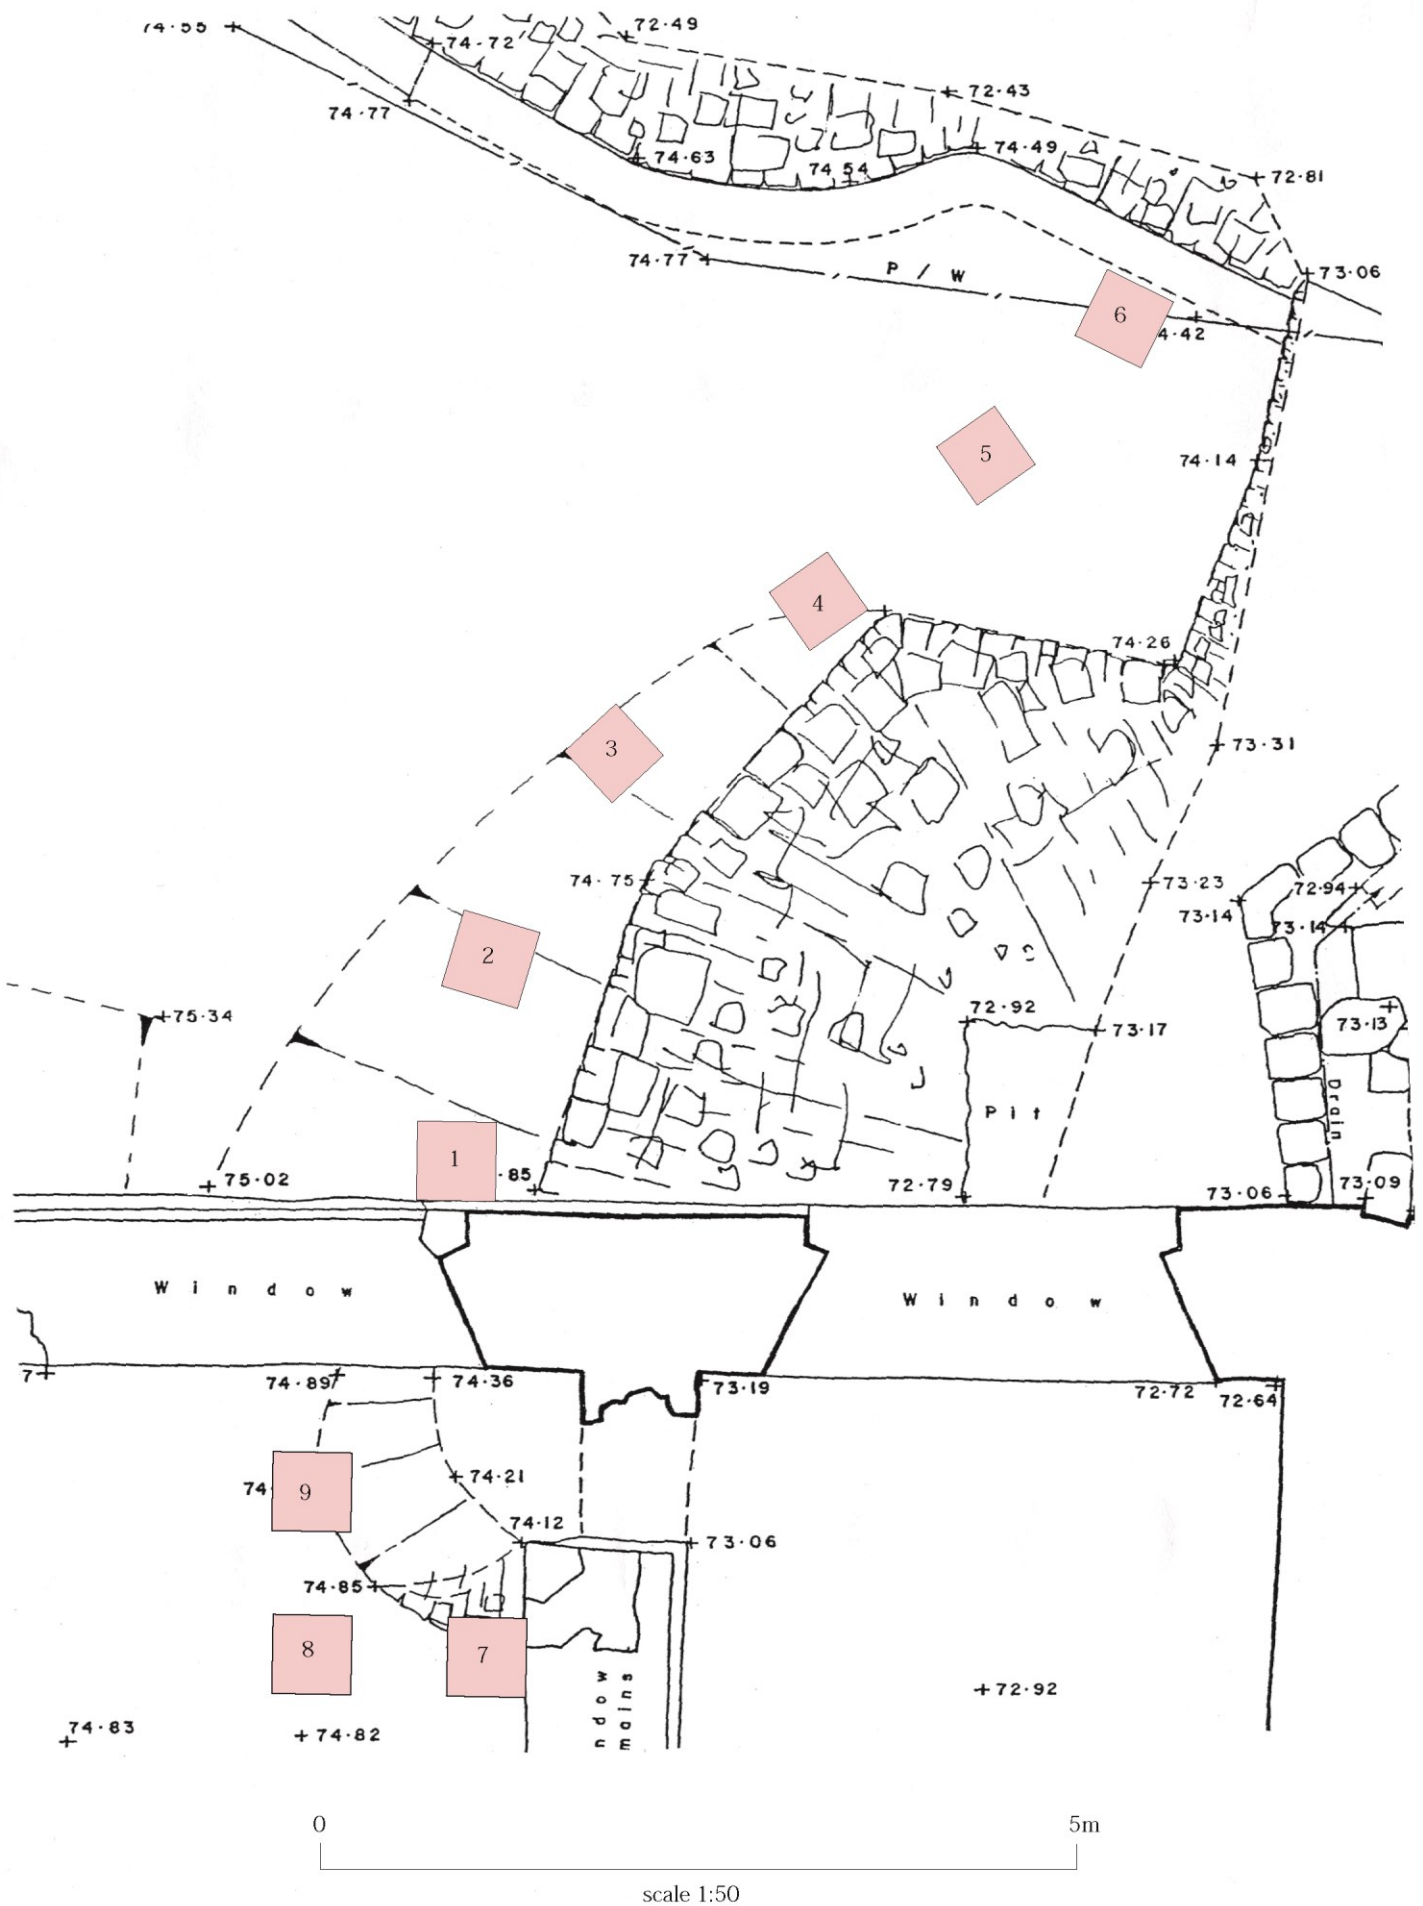
Fig. 2 Location plan of post-holes for new railings on North Terrace (using survey by Simmons Survey Partnership).

Plate 18 shows the archaeological excavation of three post-holes for new timber railings at the northern angle of the former kitchen. Fig. 2 shows the location of the post-holes (post-holes 7-9). Section drawings of the post-holes are shown in Fig. 3.

Six post-holes were archaeologically excavated on the north terrace for a new handrail/barrier (Figs. 2 and 3, post-holes 1-6; Plate 20).

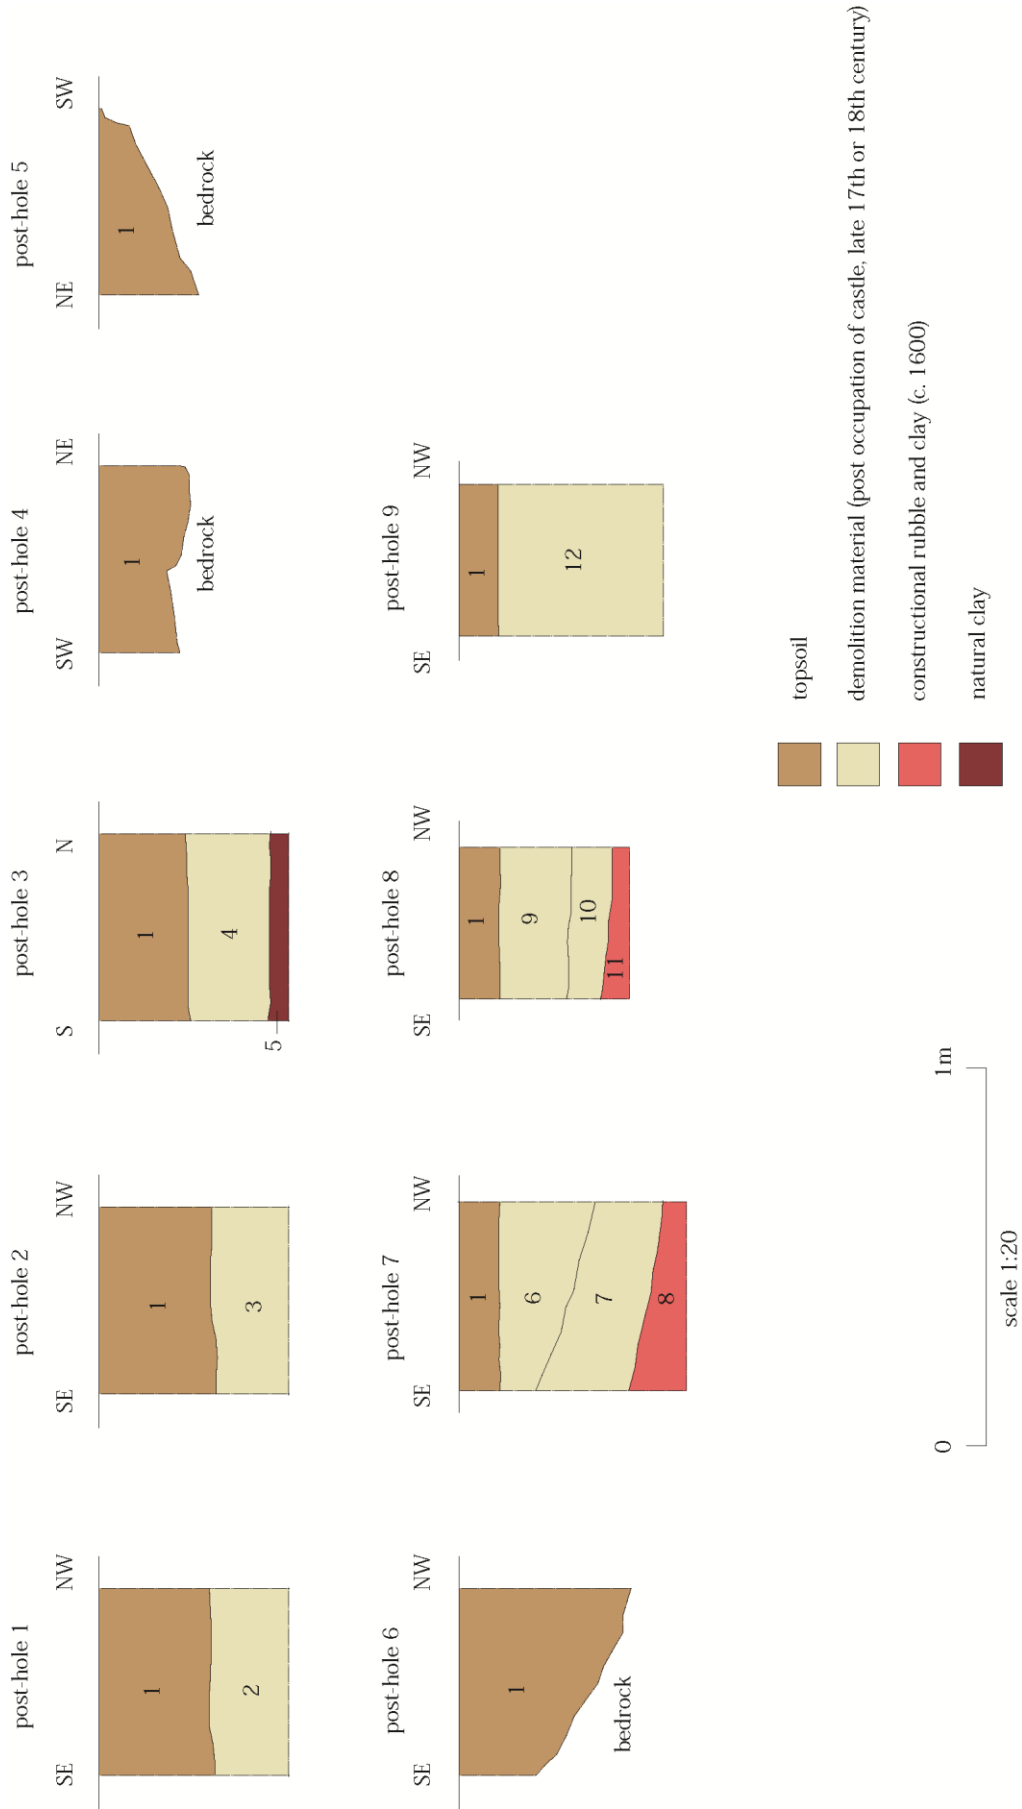
Fig. 3 Section drawings of post-holes excavated for new railings.

Post-hole 7 uncovered a layer of red/brown clay containing limestone and slate fragments with mortar (6) and a deposit of broken roofing slates up to 0.25m deep with some mortar (7). Both these are clearly demolition deposits dating from after the abandonment of the castle in the late 17th century. Beneath layer 7 was a deposit of clean red/brown clay containing limestone fragments which probably represents a leveling dump dating from the construction of the north range c. 1600.

Post-hole 8 uncovered a similar series of deposits (9-11) interpreted as equivalent to that in post-hole 7.

Post-hole 9 revealed only a single deposit of loose limestone and slate rubble with mortar and red/brown clay. This is interpreted as a demolition deposit equivalent to layers 6 and 9. The

Post-holes 1 and 2 revealed only demolition deposits (2, 3) comparable in composition to layers 6, 9, and 12 above. Post-hole 3 uncovered another similar demolition layer (4) overlying a clean red clay which is probably a natural weathering deposit overlying the limestone bedrock.

Post-holes 4 and 5 located limestone bedrock at depths of less than 0.24m, covered by only modern topsoil.

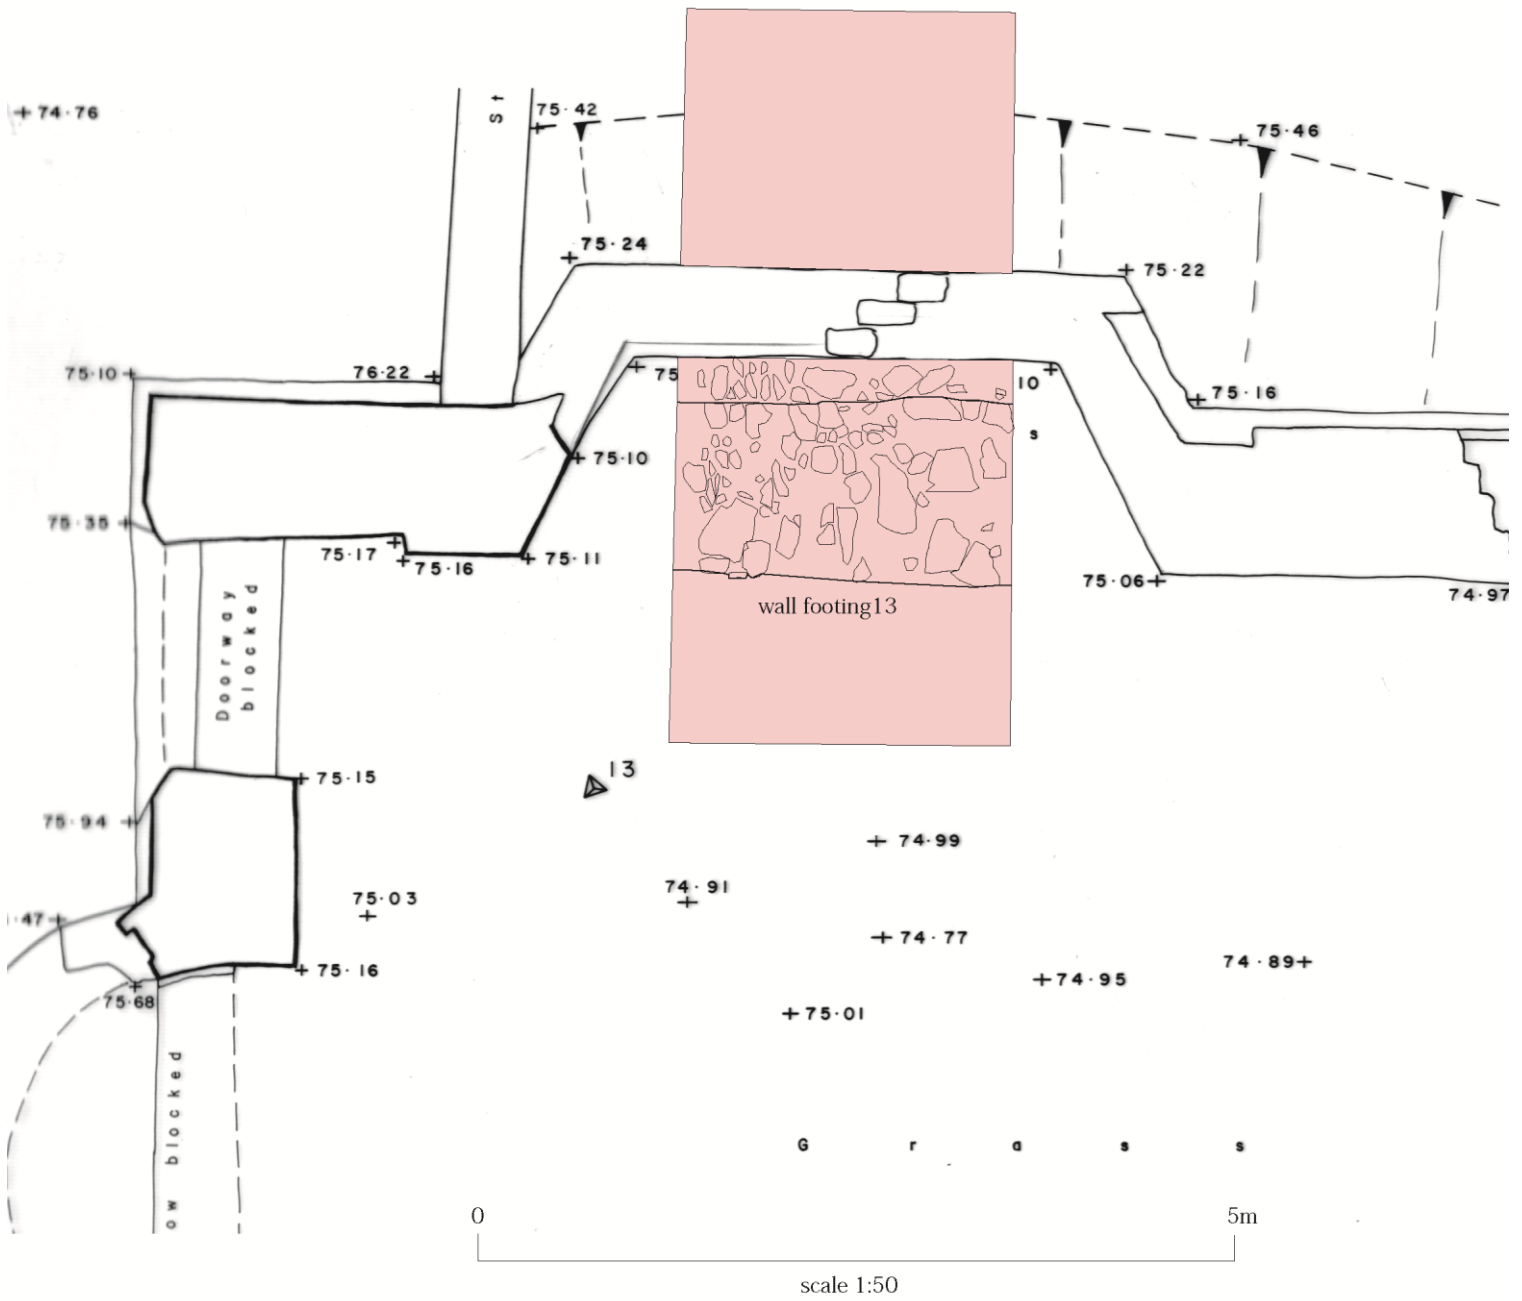
Fig. 4 Location plan showing excavations for new ramp on North Terrace (using survey by Simmons Survey Partnership)

Excavation of the area inside the window bay uncovered a mortared stone wall footing 1m wide (Fig. 4, 13; Plate 24). This follows the line of the north wall of the north range to each side of the window bay, strongly suggesting that the wall foundations of the north range were laid out initially in simple rectangular form, and that the projecting window bays were set out subsequently. This method of construction, in which the footings are continuous across architectural openings such as window bays and doorways, is commonly found in all periods of building, even though the footings beneath the openings have no structural purpose. At large building projects such as the north range at Berry Pomeroy Castle, it may have been rough masons who laid out the primary footings whilst skilled masons set out architectural features as a separate, secondary stage in the construction.

The wall footings were built of limestone and slate rubble set in white lime mortar with gravel aggregate, mixed with red/brown clay. They clearly date from the construction of the north range c. 1600. The footings directly underlie modern topsoil 0.1m deep. The footings were left intact beneath the stone chippings used to form the new ramp.

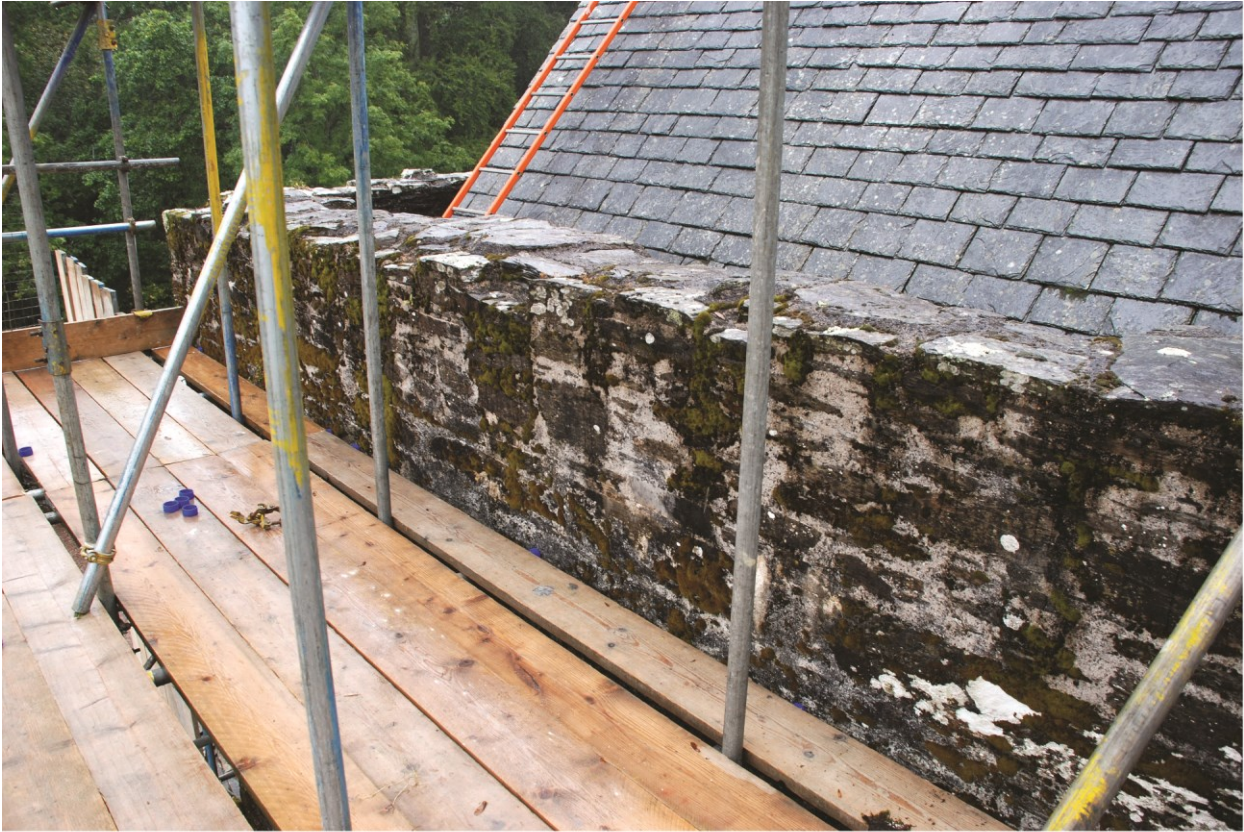
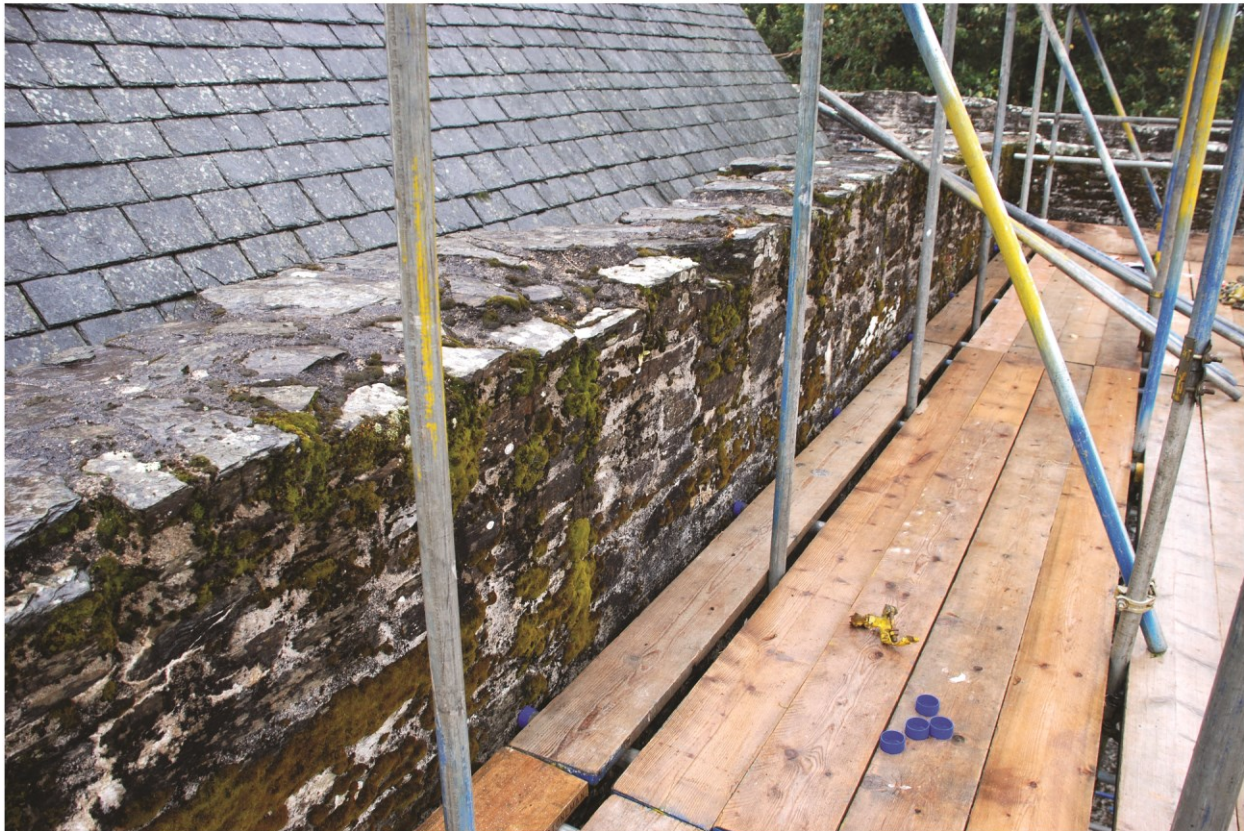
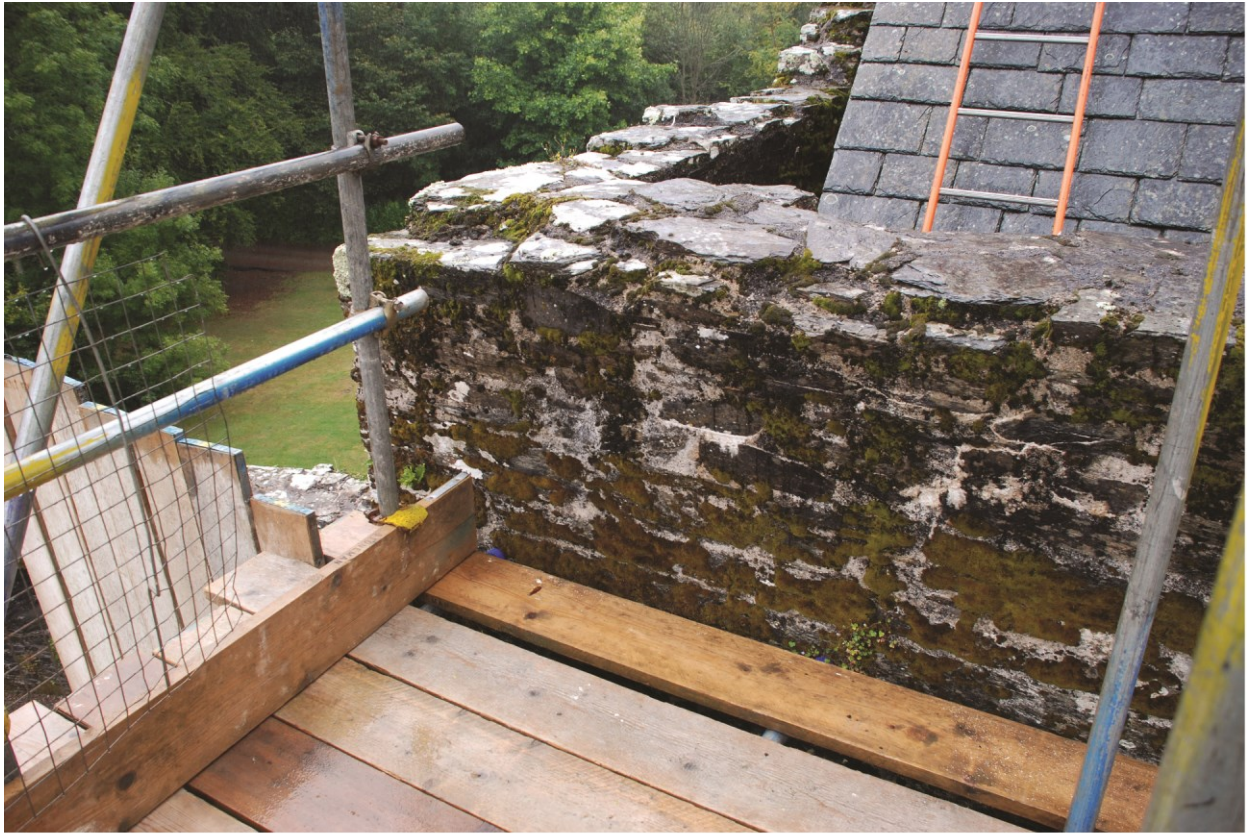
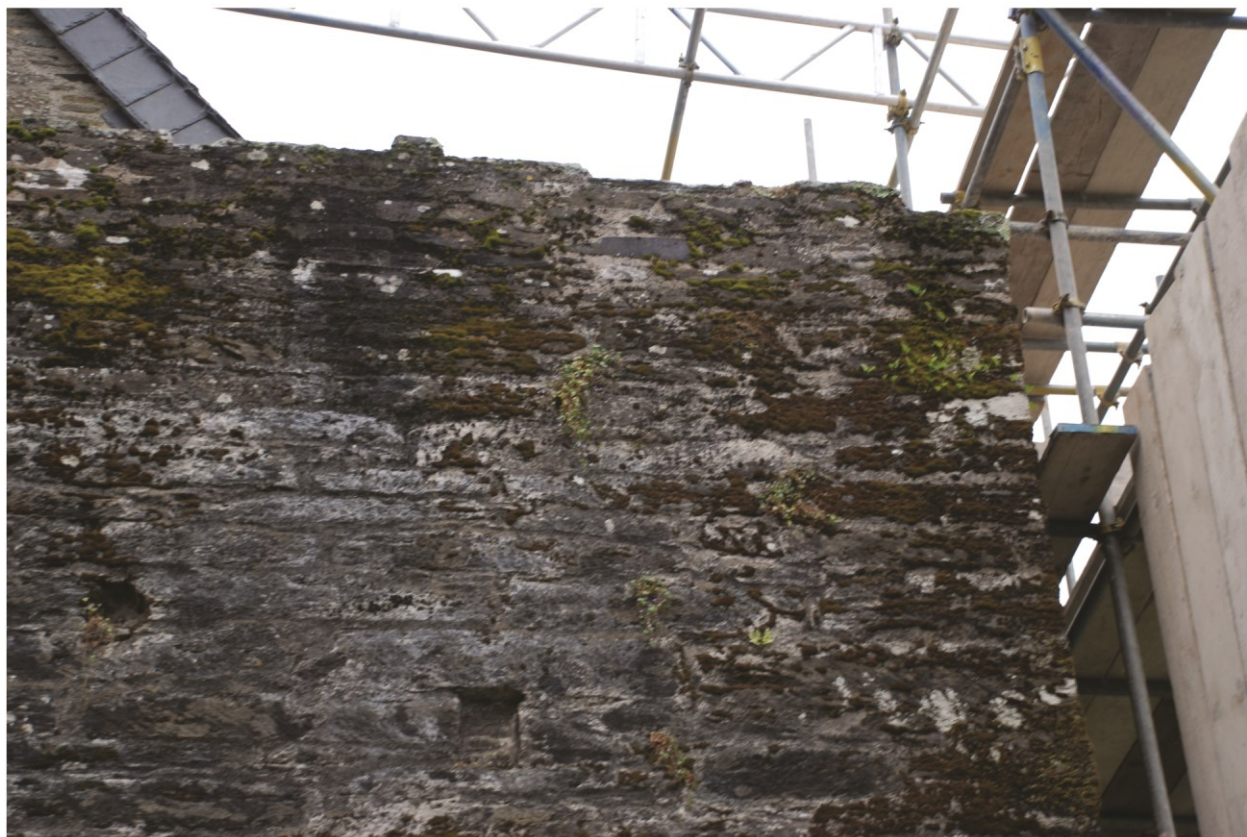
The parts of the parapet and adjoining areas affected by the condition survey work date from the above two phases of repair (1982 and 1998), so the rebuilding did not encroach on original fabric. No archaeological features were exposed by the work. The parapet wall before conservation work is shown in plates 1-4. Plates 5 and 6 show the parapet wall after conservation work.

Plate 1 The Gatehouse parapet wall before conservation work, looking east.

Plate 2 The gatehouse parapet wall before conservation work, looking south.

Plate 3 The gatehouse parapet wall, NE corner, before conservation work, looking east.

Plate 4 The gatehouse parapet wall, NE corner, before conservation work, looking southwest.

Taking down and rebuilding rear parapet wall and return to east elevation

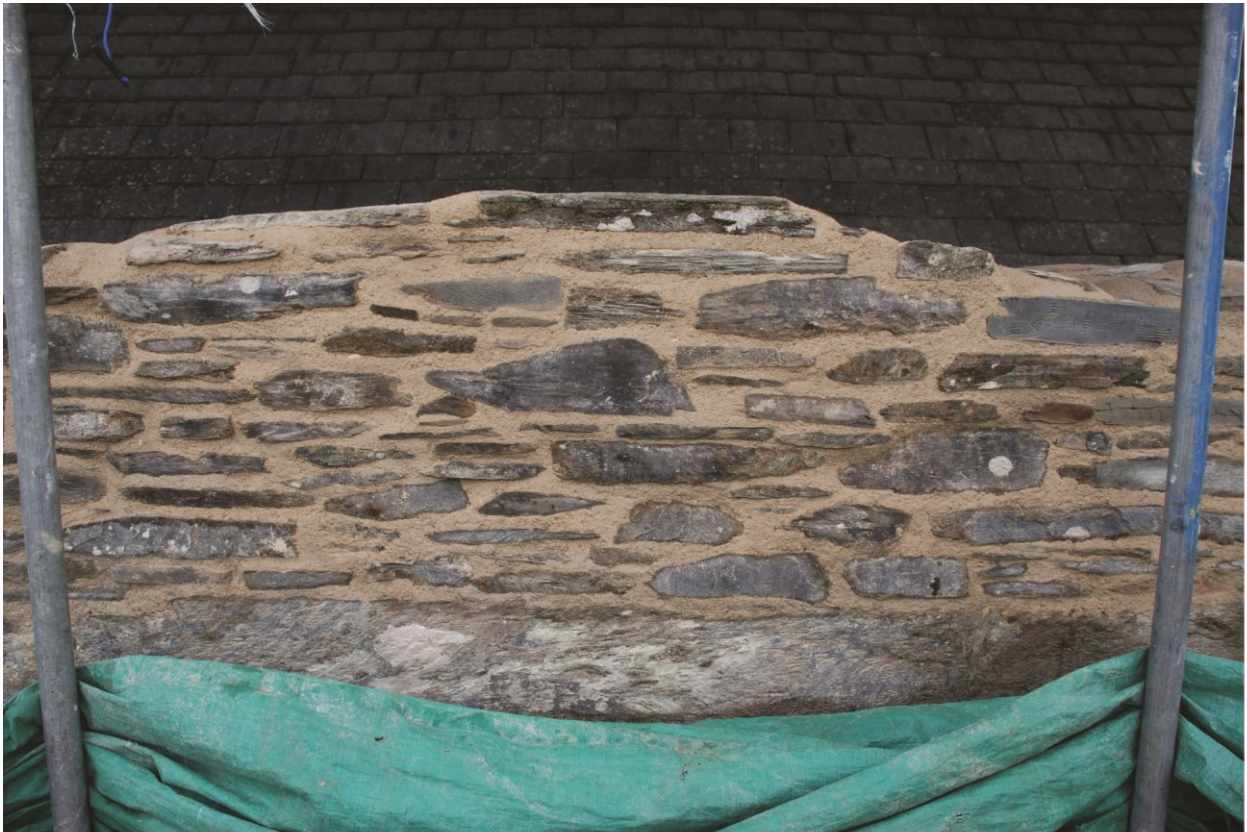
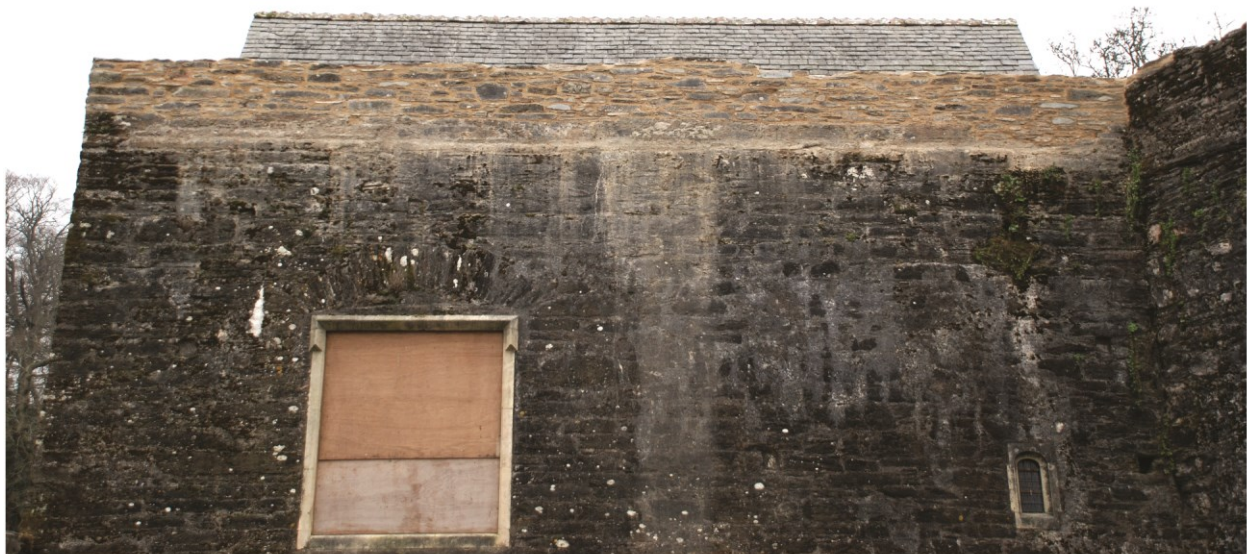
Plate 5 Detail of the gatehouse parapet wall after conservation work, looking southeast.

Plate 6 The gatehouse parapet wall after conservation work, looking southeast.

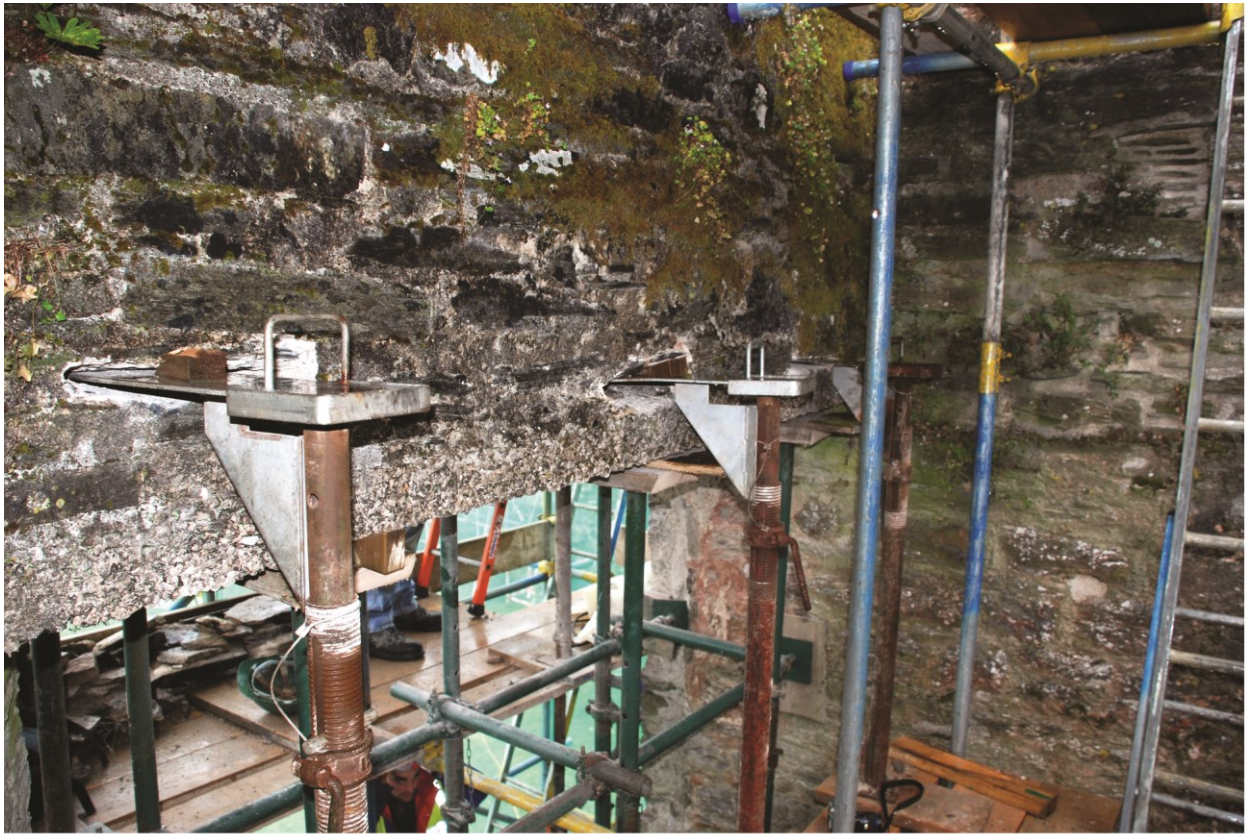
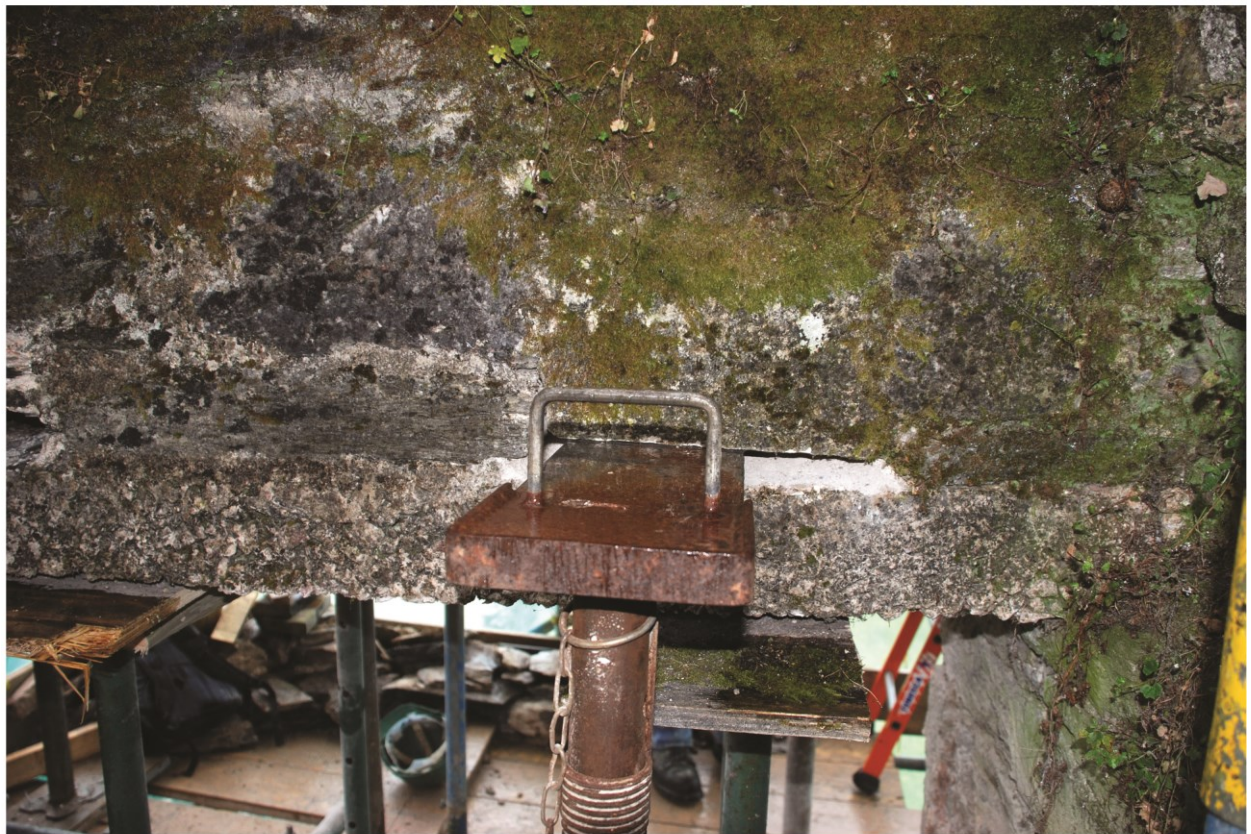
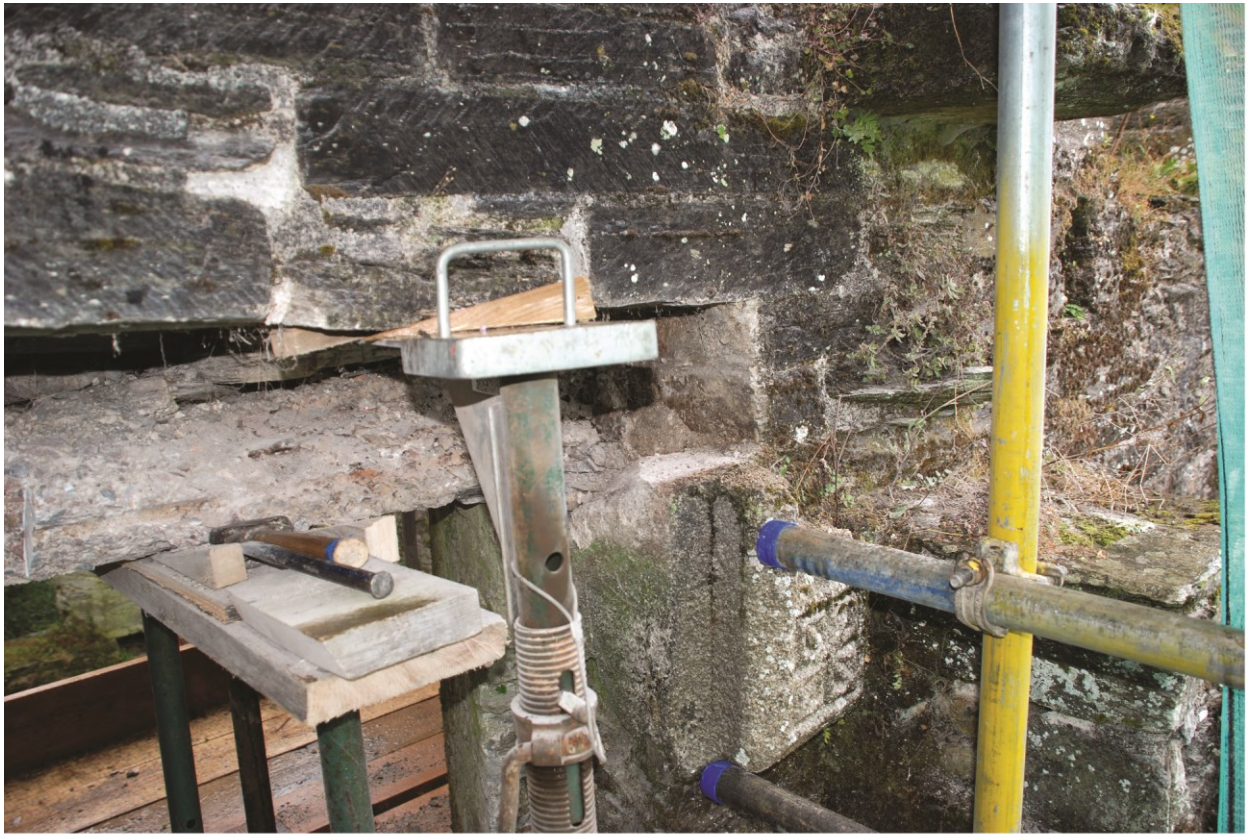
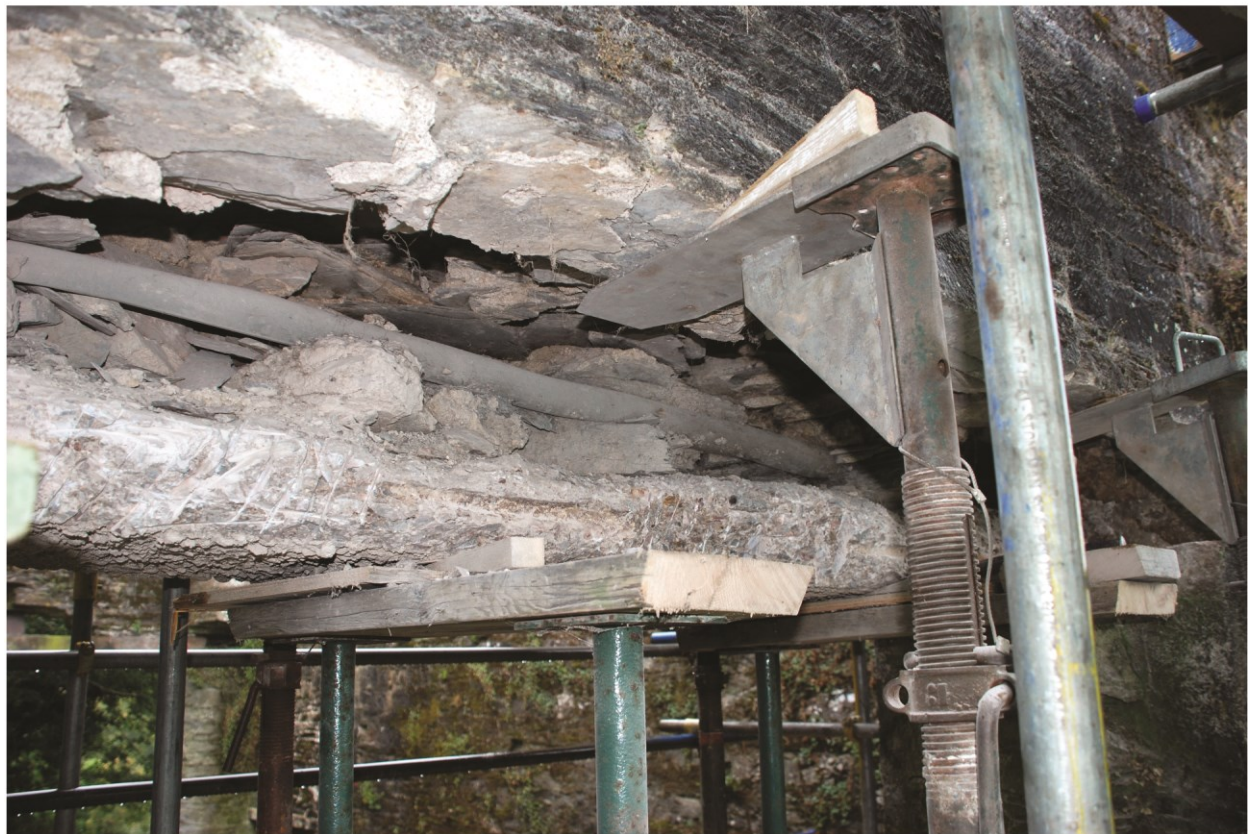
Plates 7-10 show the existing 20th-century concrete lintels before their replacement. The window openings originally contained windows with stone surrounds similar to those surviving in the remains of the house on the opposite side of the courtyard. Behind the stone window head were timber lintels supporting the wall above. The new oak lintels were inserted into the sockets for the original lintels, with an additional one replacing the lost original stone window head at the front. No archaeological features were uncovered during the works apart from the sockets for the original lintels. Plates 11 and 12 show the new lintels after conservation work.

Plate 7 The kitchen quarter, first-floor concrete lintel before conservation work, looking east.

Plate 8 The kitchen quarter, first-floor concrete lintel before conservation work, looking northeast.

Plate 9 The kitchen quarter, first-floor concrete lintel before conservation work, looking west.

Plate 10 The kitchen quarter, second-floor concrete lintel before conservation work, showing previously inserted tie, looking west.

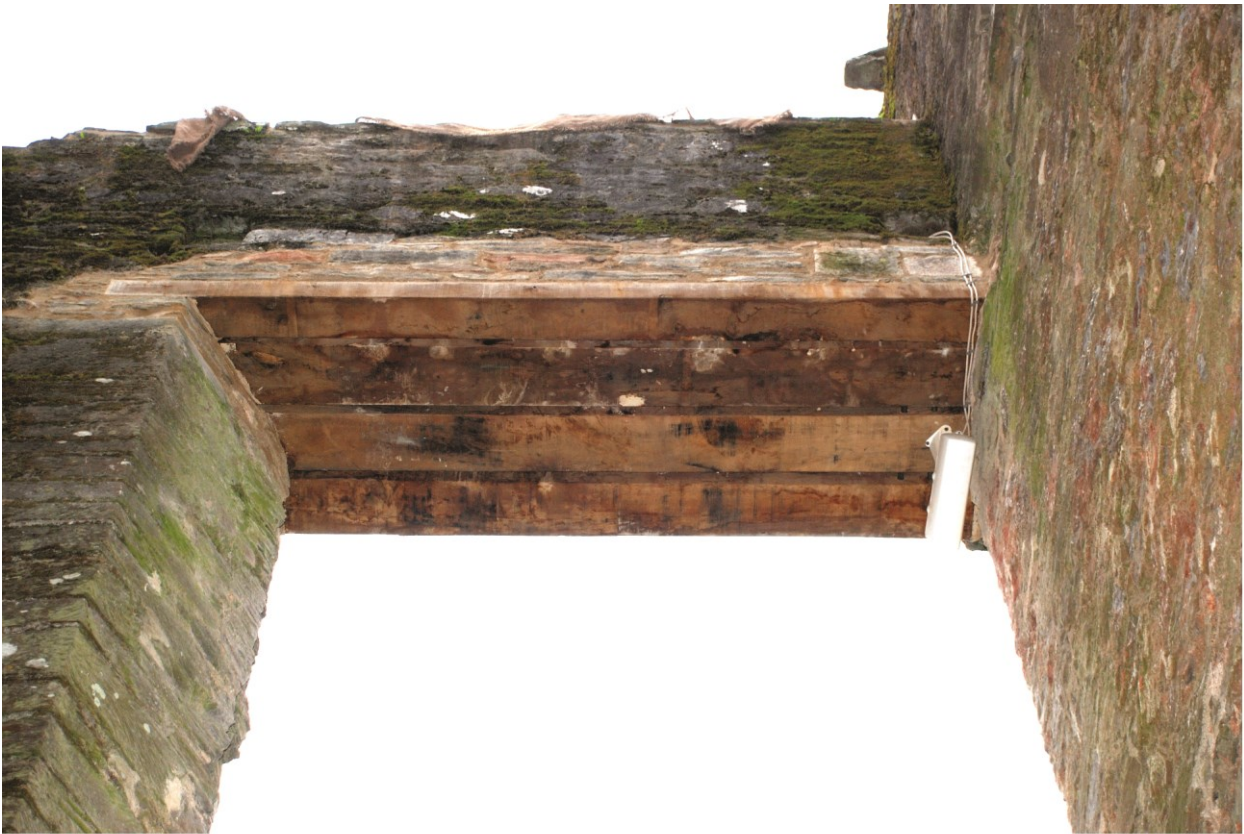
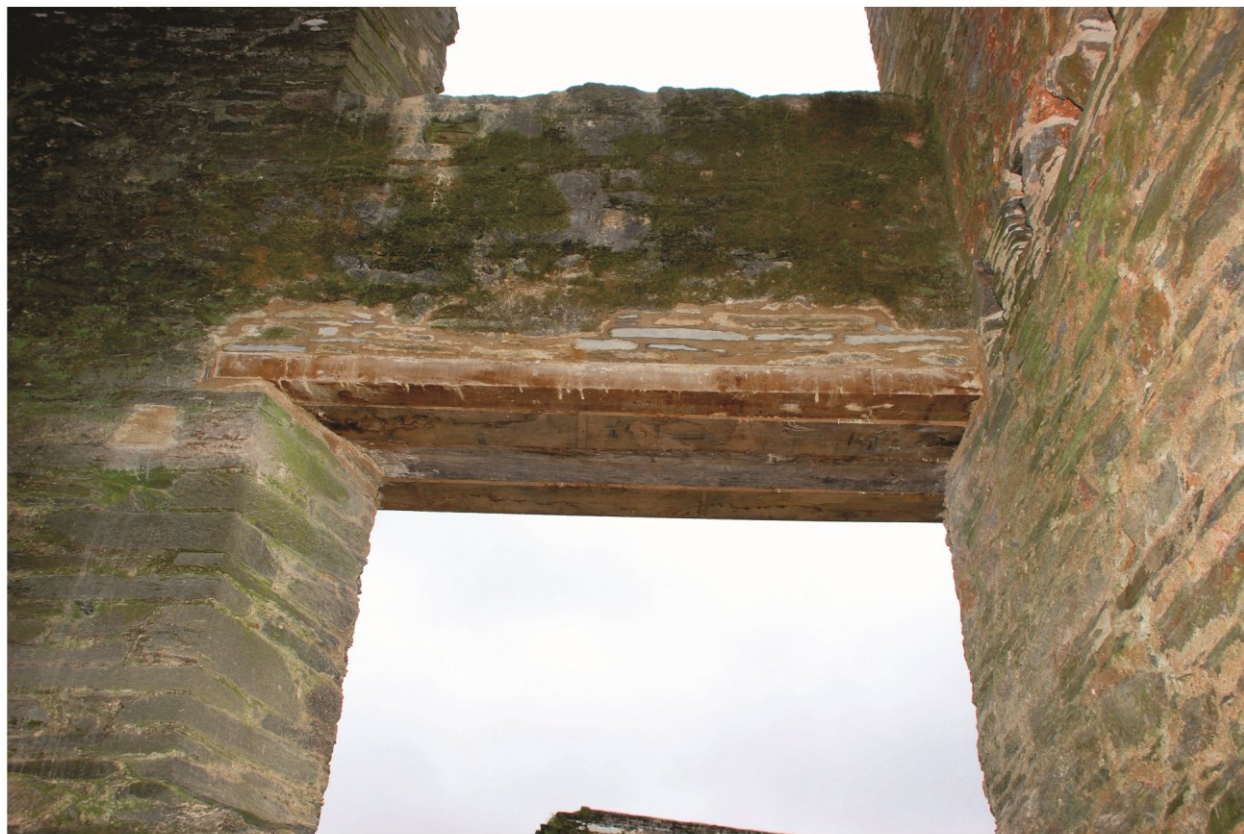
Plate 11 The kitchen quarter after conservation work, new second-floor lintels, looking northeast.

Plate 12 The kitchen quarter after conservation work, new first-floor lintels, looking northeast.

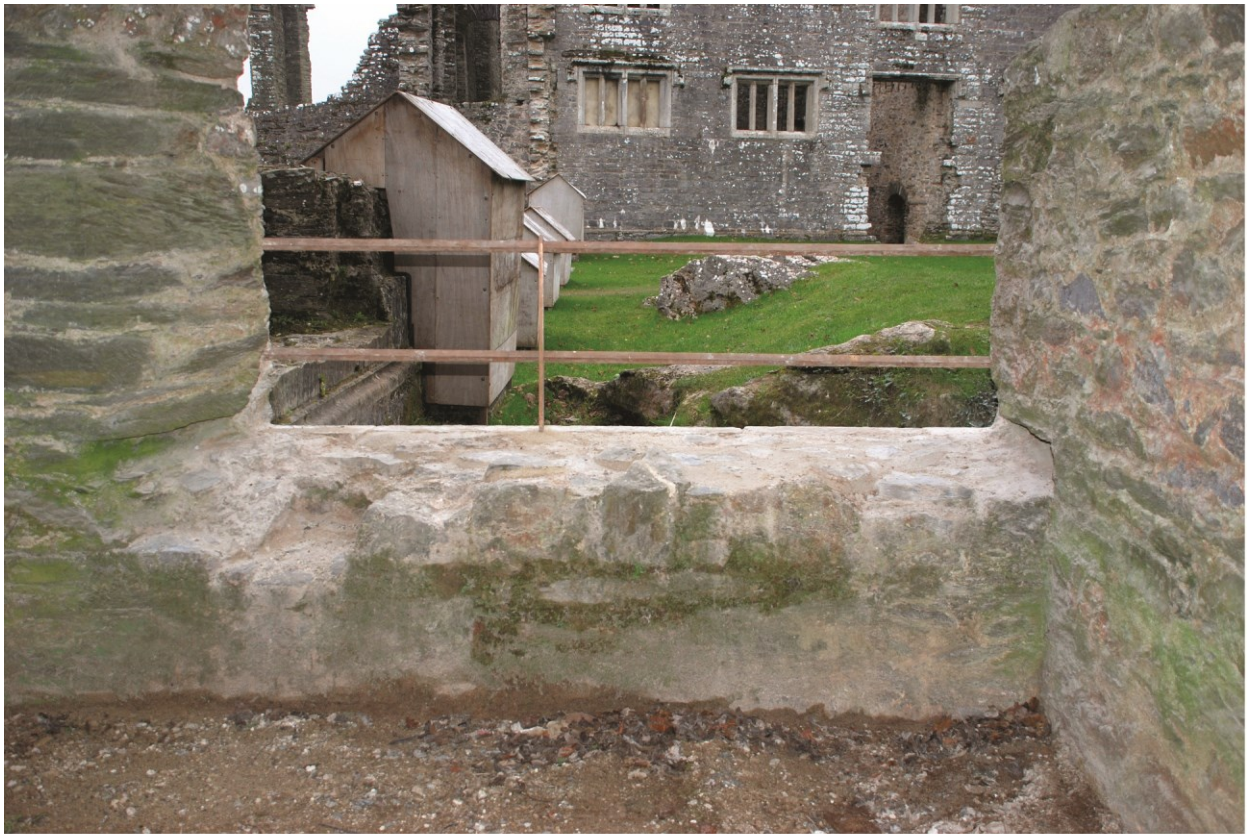
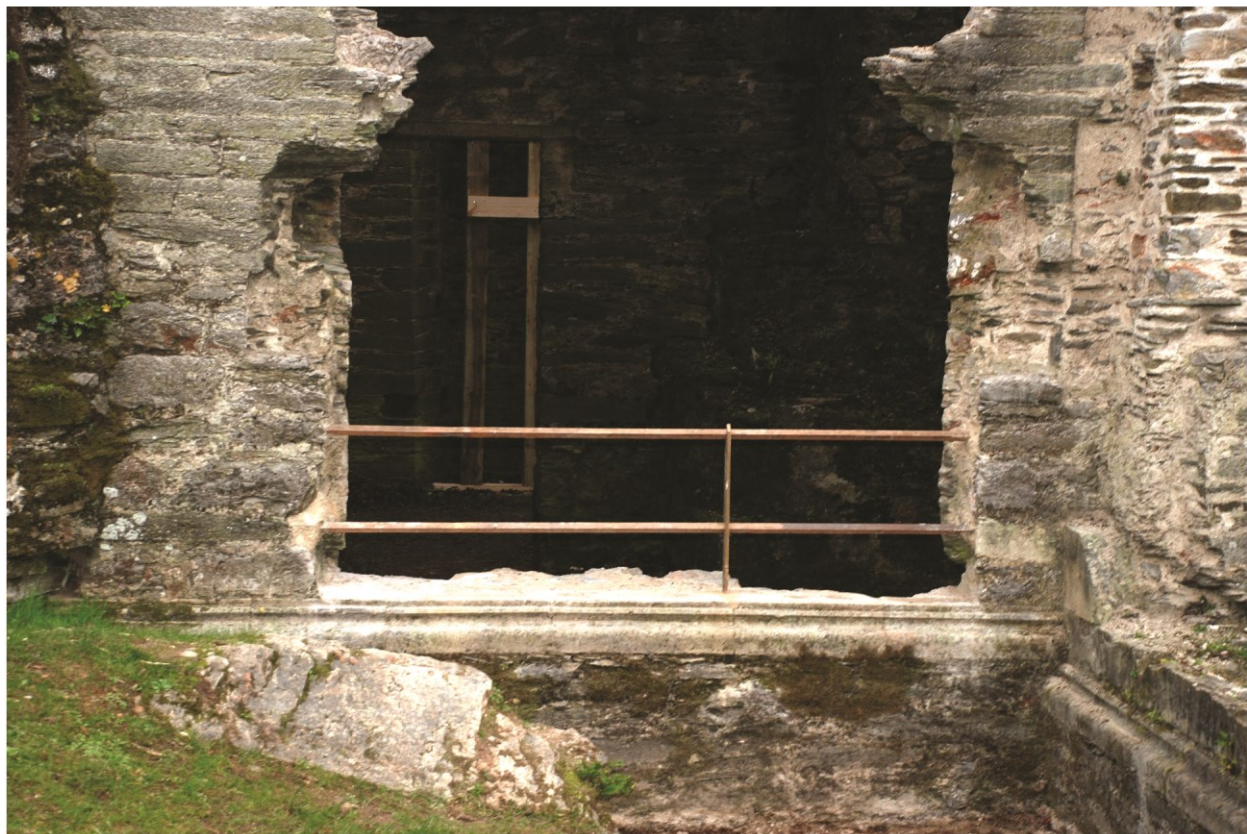
Consolidation of the window sill and wall capping uncovered no previously unrecorded archaeological features. The new railing was inserted into existing masonry joints so none of the original stonework was disturbed. Plates 13 and 14 show the window sill after conservation work and the new railing. Plate 15 shows the northeast elevation of the kitchen quarter after conservation work.

Plate 13 The kitchen quarter after conservation work, new railing and consolidation of the window sill, looking northeast.

Plate 14 The kitchen quarter after conservation work, new railing and consolidation of the window sill, looking southwest.
