BERRY POMEROY CASTLE
ARCHAEOLOGICAL EXCAVATION AND RECORDING
DURING CONDITION SURVEY WORK

STEWART BROWN ASSOCIATES FEBRUARY 2008

BERRY POMEROY CASTLE, DEVON
ARCHAEOLOGICAL EXCAVATION AND RECORDING IN ASSOCIATION WITH
CONDITION SURVEY WORK

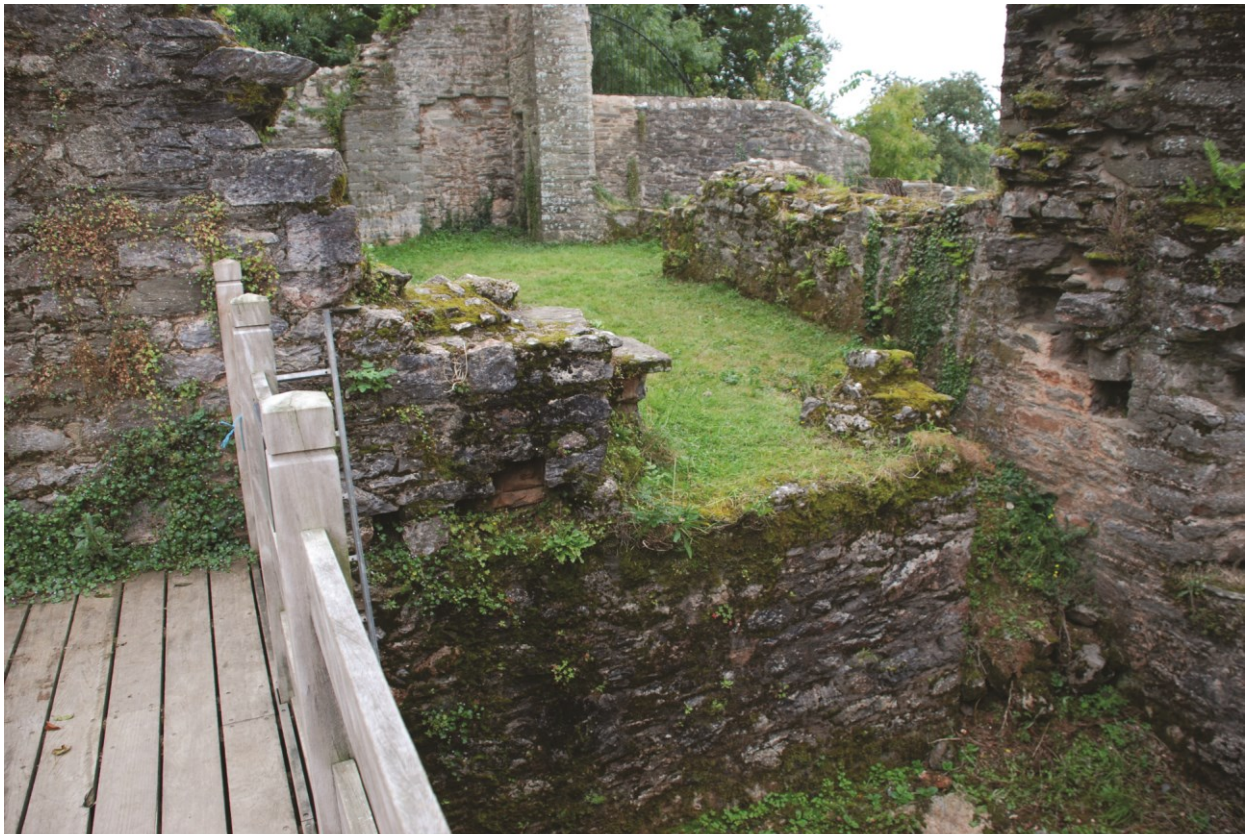
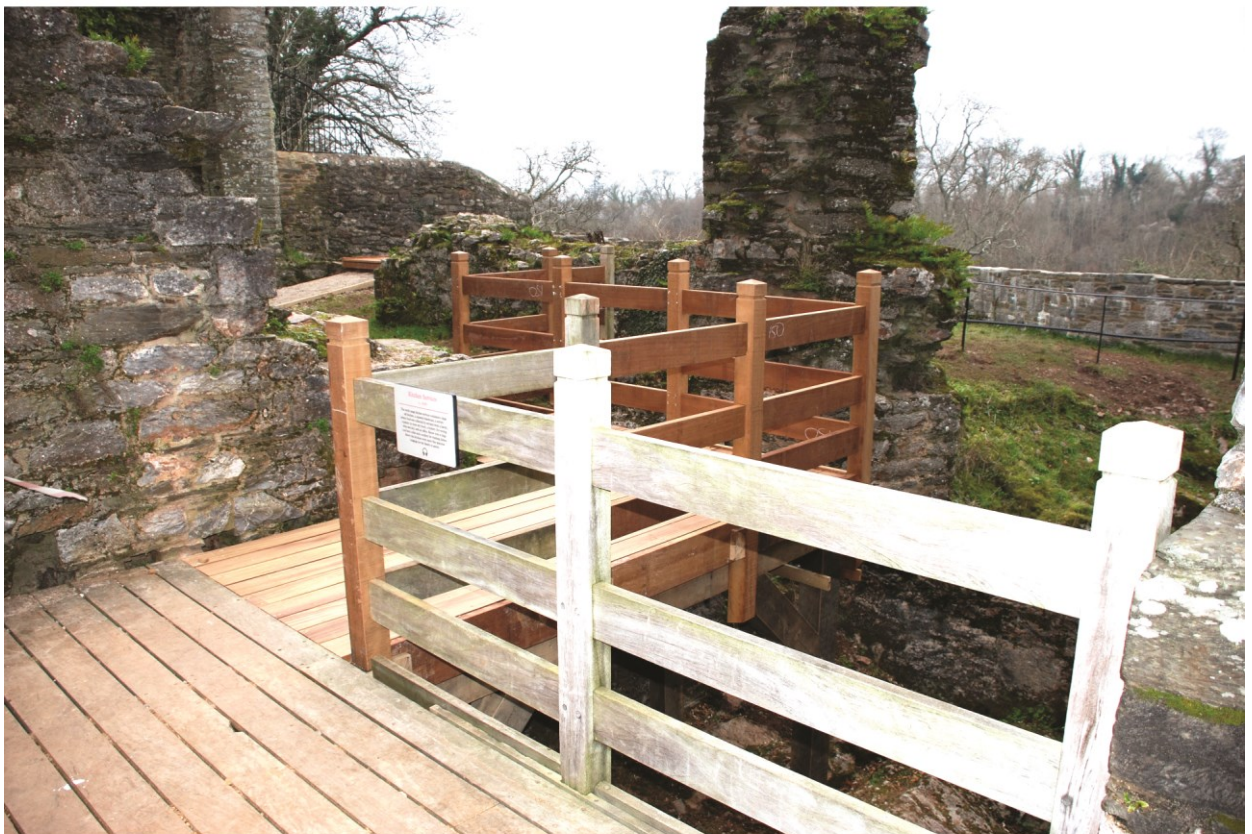
Plates 16 and 17 show the northeast wall of the former kitchen before and after extension of the decking. No archaeological features were uncovered during the work.

Plate 16 The northeast wall of the kitchen before extension of decking, looking west.

Plate 17 The northeast wall of the kitchen after extension of decking, looking west.

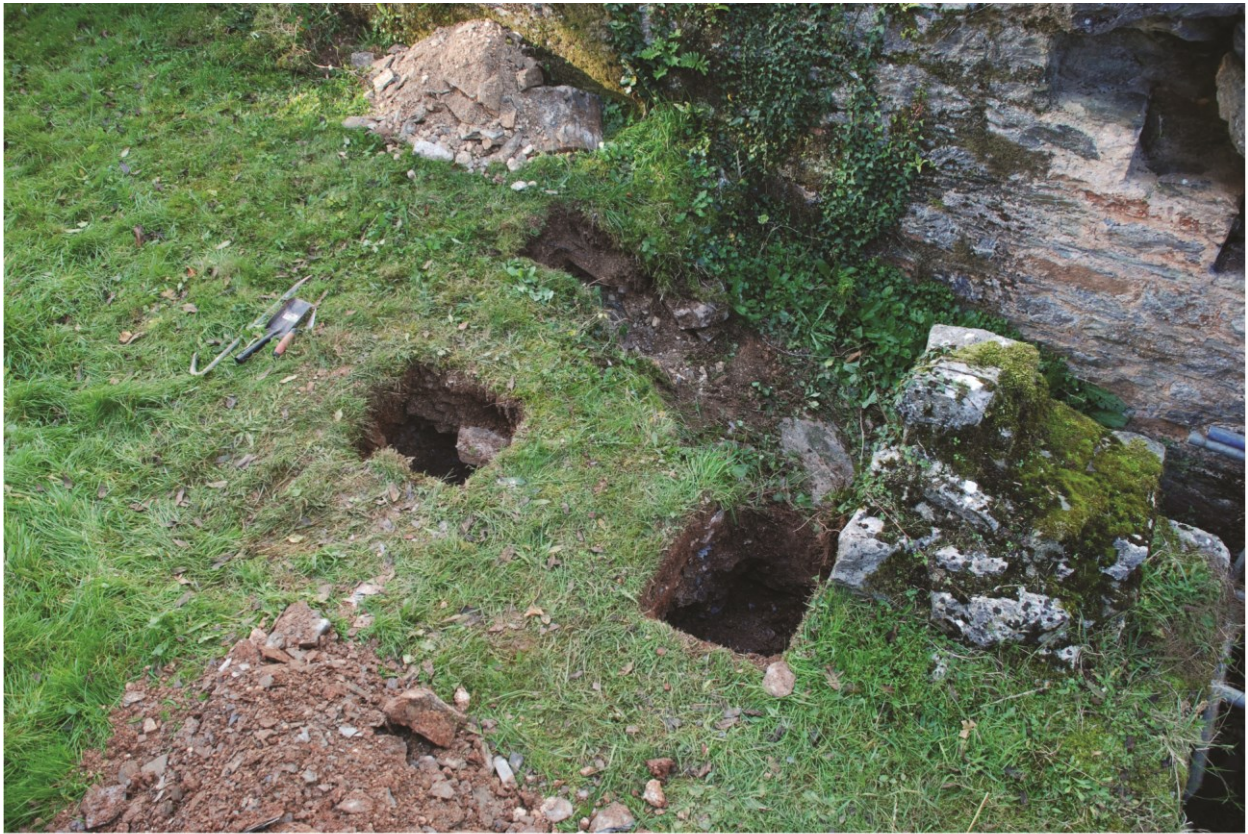
Plate 18 shows the archaeological excavation of three post-holes for new timber railings at the northern angle of the former kitchen. Fig. 2 shows the location of the post-holes (post-holes 7-9). Section drawings of the post-holes are shown in Fig. 3.

Post-hole 7 uncovered a layer of red/brown clay containing limestone and slate fragments with mortar (6) and a deposit of broken roofing slates up to 0.25m deep with some mortar (7). Both these are clearly demolition deposits dating from after the abandonment of the castle in the late 17th century. Beneath layer 7 was a deposit of clean red/brown clay containing limestone fragments which probably represents a leveling dump dating from the construction of the north range c. 1600.

Post-hole 8 uncovered a similar series of deposits (9-11) interpreted as equivalent to that in post-hole 7.

Post-hole 9 revealed only a single deposit of loose limestone and slate rubble with mortar and red/brown clay. This is interpreted as a demolition deposit equivalent to layers 6 and 9. The

deposit is deeper in this area since it infills the remains of a stairway which once descended to a basement scullery adjoining the kitchen to the northeast.

Plate 18 Excavation of post-holes for new timber railings at the northern angle of the kitchen, looking northwest.

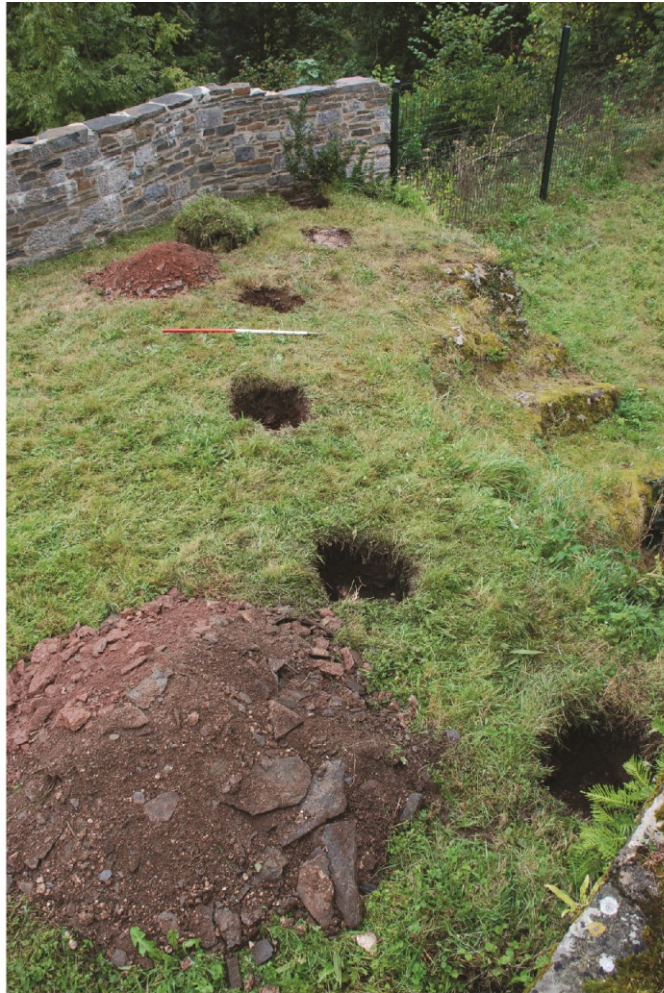
Six post-holes were archaeologically excavated on the north terrace for a new handrail/barrier (Figs. 2 and 3, post-holes 1-6; Plate 20).

Post-holes 1 and 2 revealed only demolition deposits (2, 3) comparable in composition to layers 6, 9, and 12 above. Post-hole 3 uncovered another similar demolition layer (4) overlying a clean red clay which is probably a natural weathering deposit overlying the limestone bedrock.

Post-holes 4 and 5 located limestone bedrock at depths of less than 0.24m, covered by only modern topsoil.

Plate 20 Excavation of post-holes for new rail across the north terrace, looking north.

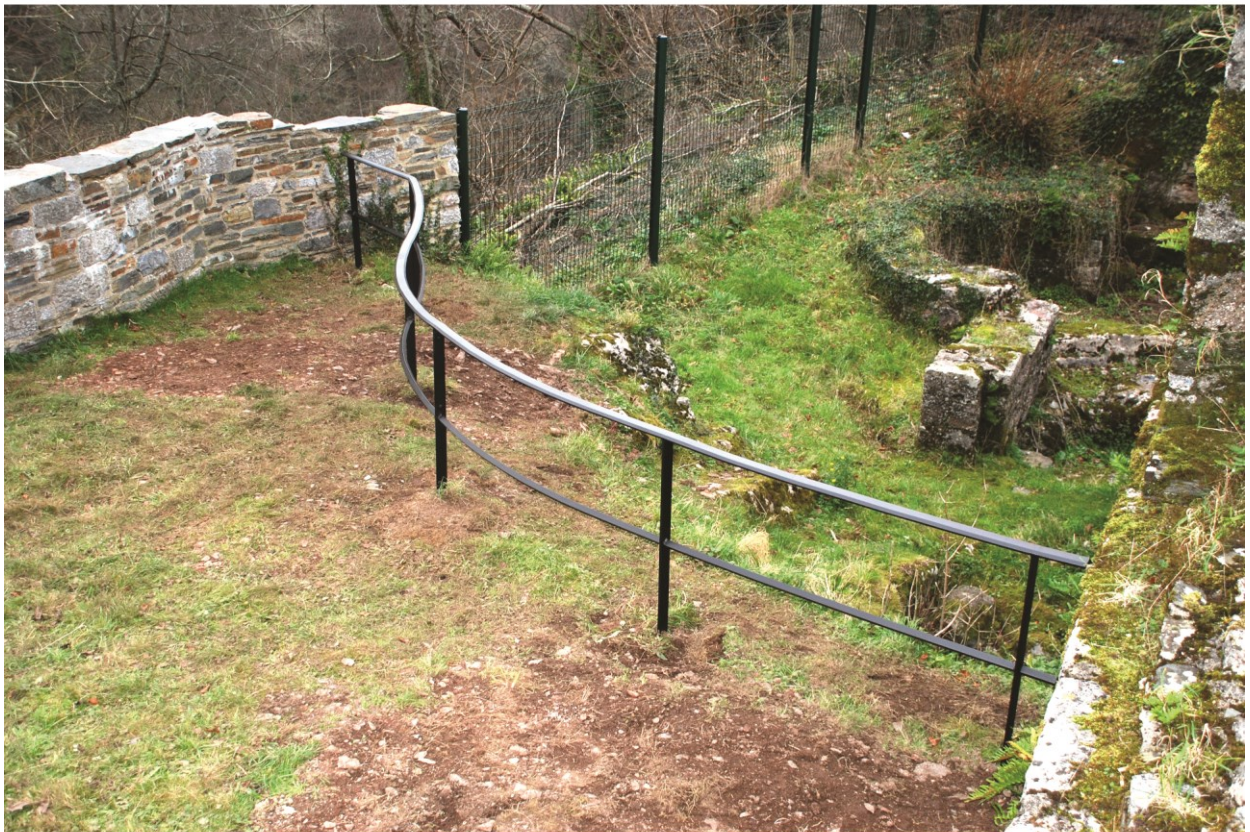
Plate 21 shows the new rail/barrier.

Plate 21 The new rail across the north terrace, looking north.

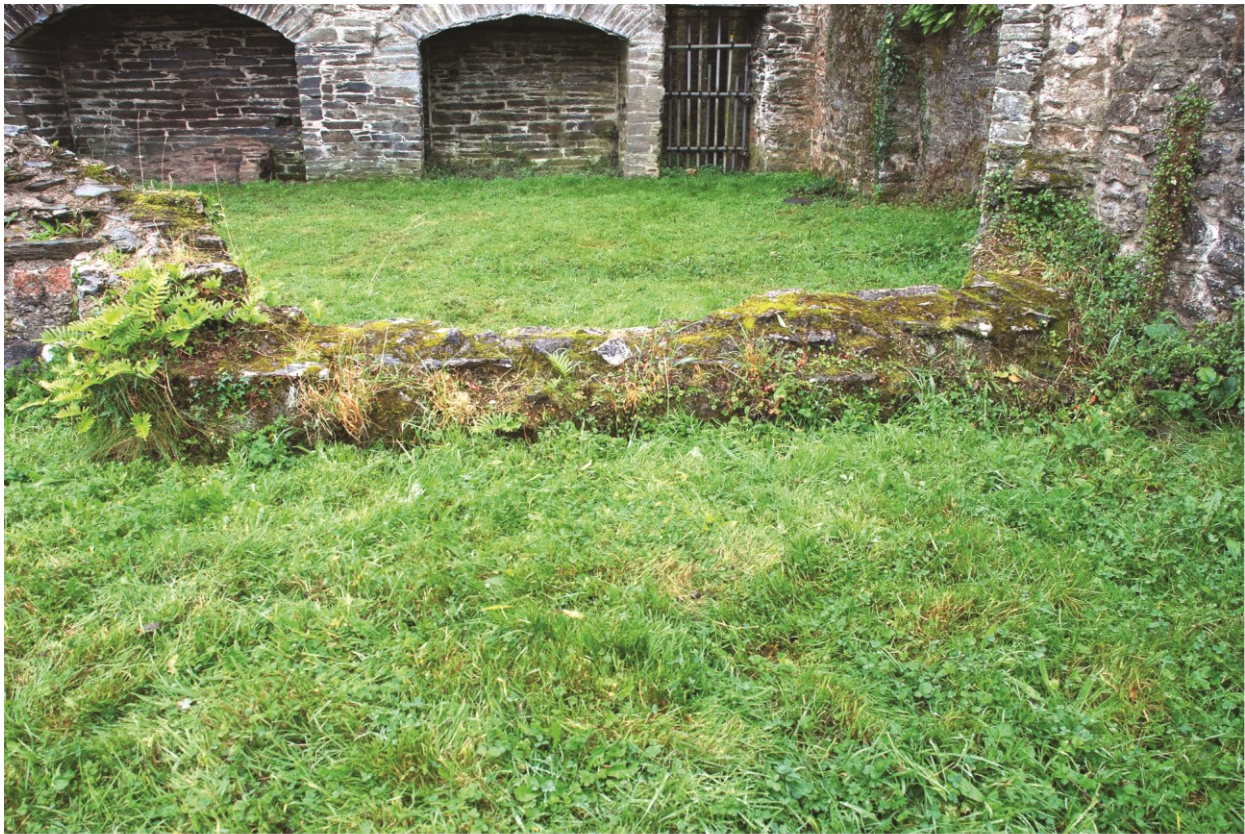
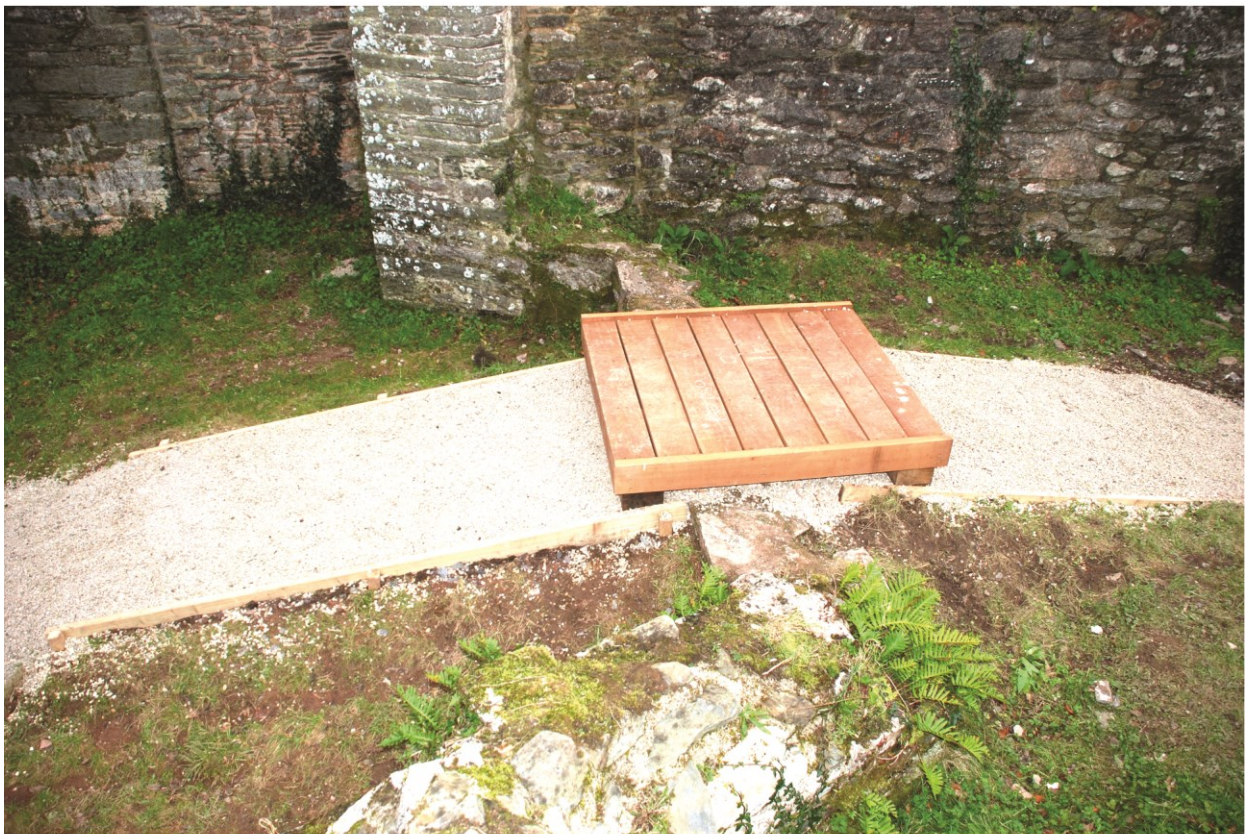
Plates 22 and 23 show the site of the new access ramp before and after the ramp was constructed. The ramp crosses the wall at a point where there was formerly a projecting window bay. Construction of the ramp required that the topsoil be removed to provide better drainage, so the site of the ramp extending to each side of the window bay was excavated archaeologically.

Plate 22 The north terrace and former kitchen area before construction of new access ramp, looking southeast.

Plate 23 The new access ramp leading to the north terrace, looking west.

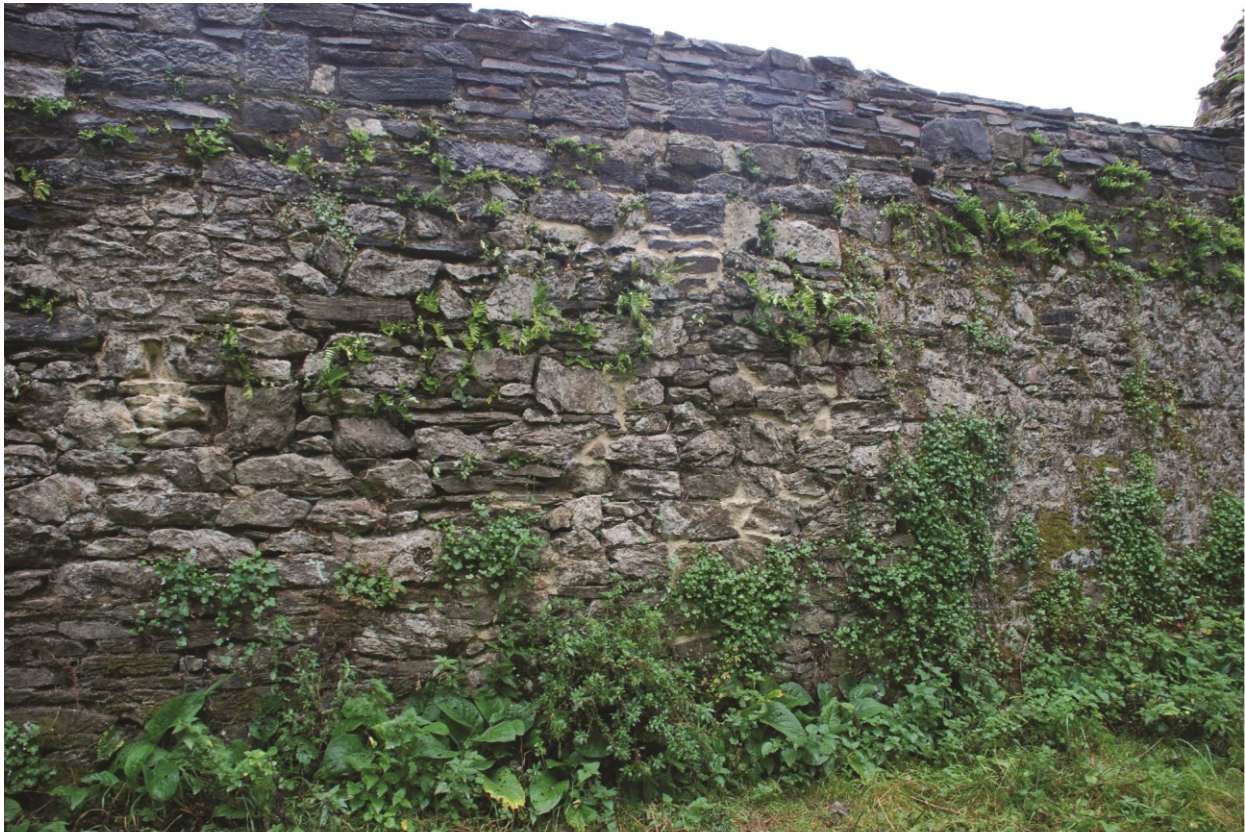
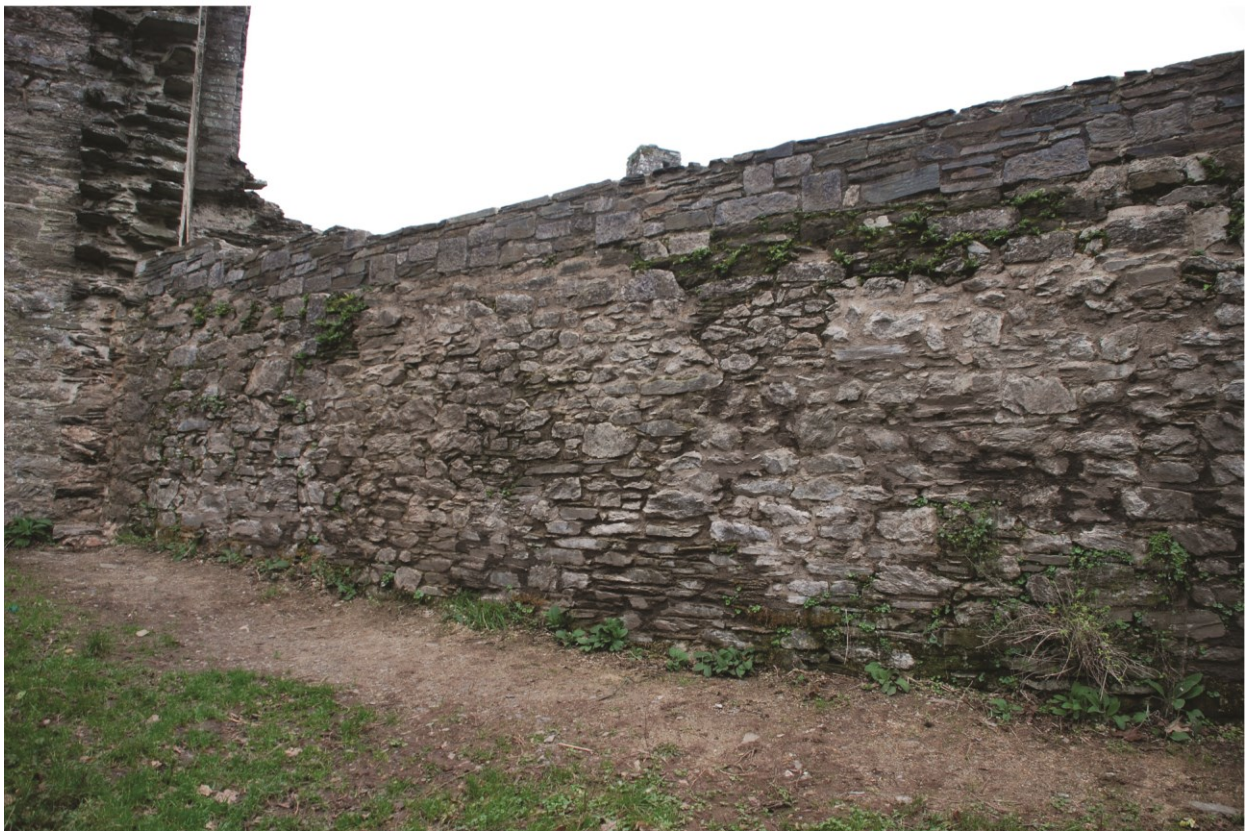
The boundary wall marking the southwest side of the outer courtyard of the castle is one of the latest walls to have been erected at the site and dates either from the late 17th century, or possibly the late 18th or 19th century when the castle was managed as a Romantic Ruin. The condition survey work included re-pointing of part of its exterior. No archaeological features were observed during the work. Plates 25 and 26 show the wall face before and after re-pointing.

Plate 25 The boundary wall before re-pointing, looking east.

Plate 26 The boundary wall after re-pointing, looking north.
