**Archaeological watching
brief at
Compasses Bridge,
Alfold,
Surrey**

Martin Cook BA MCIfA

30th May 2016
Revised 1st August 2016

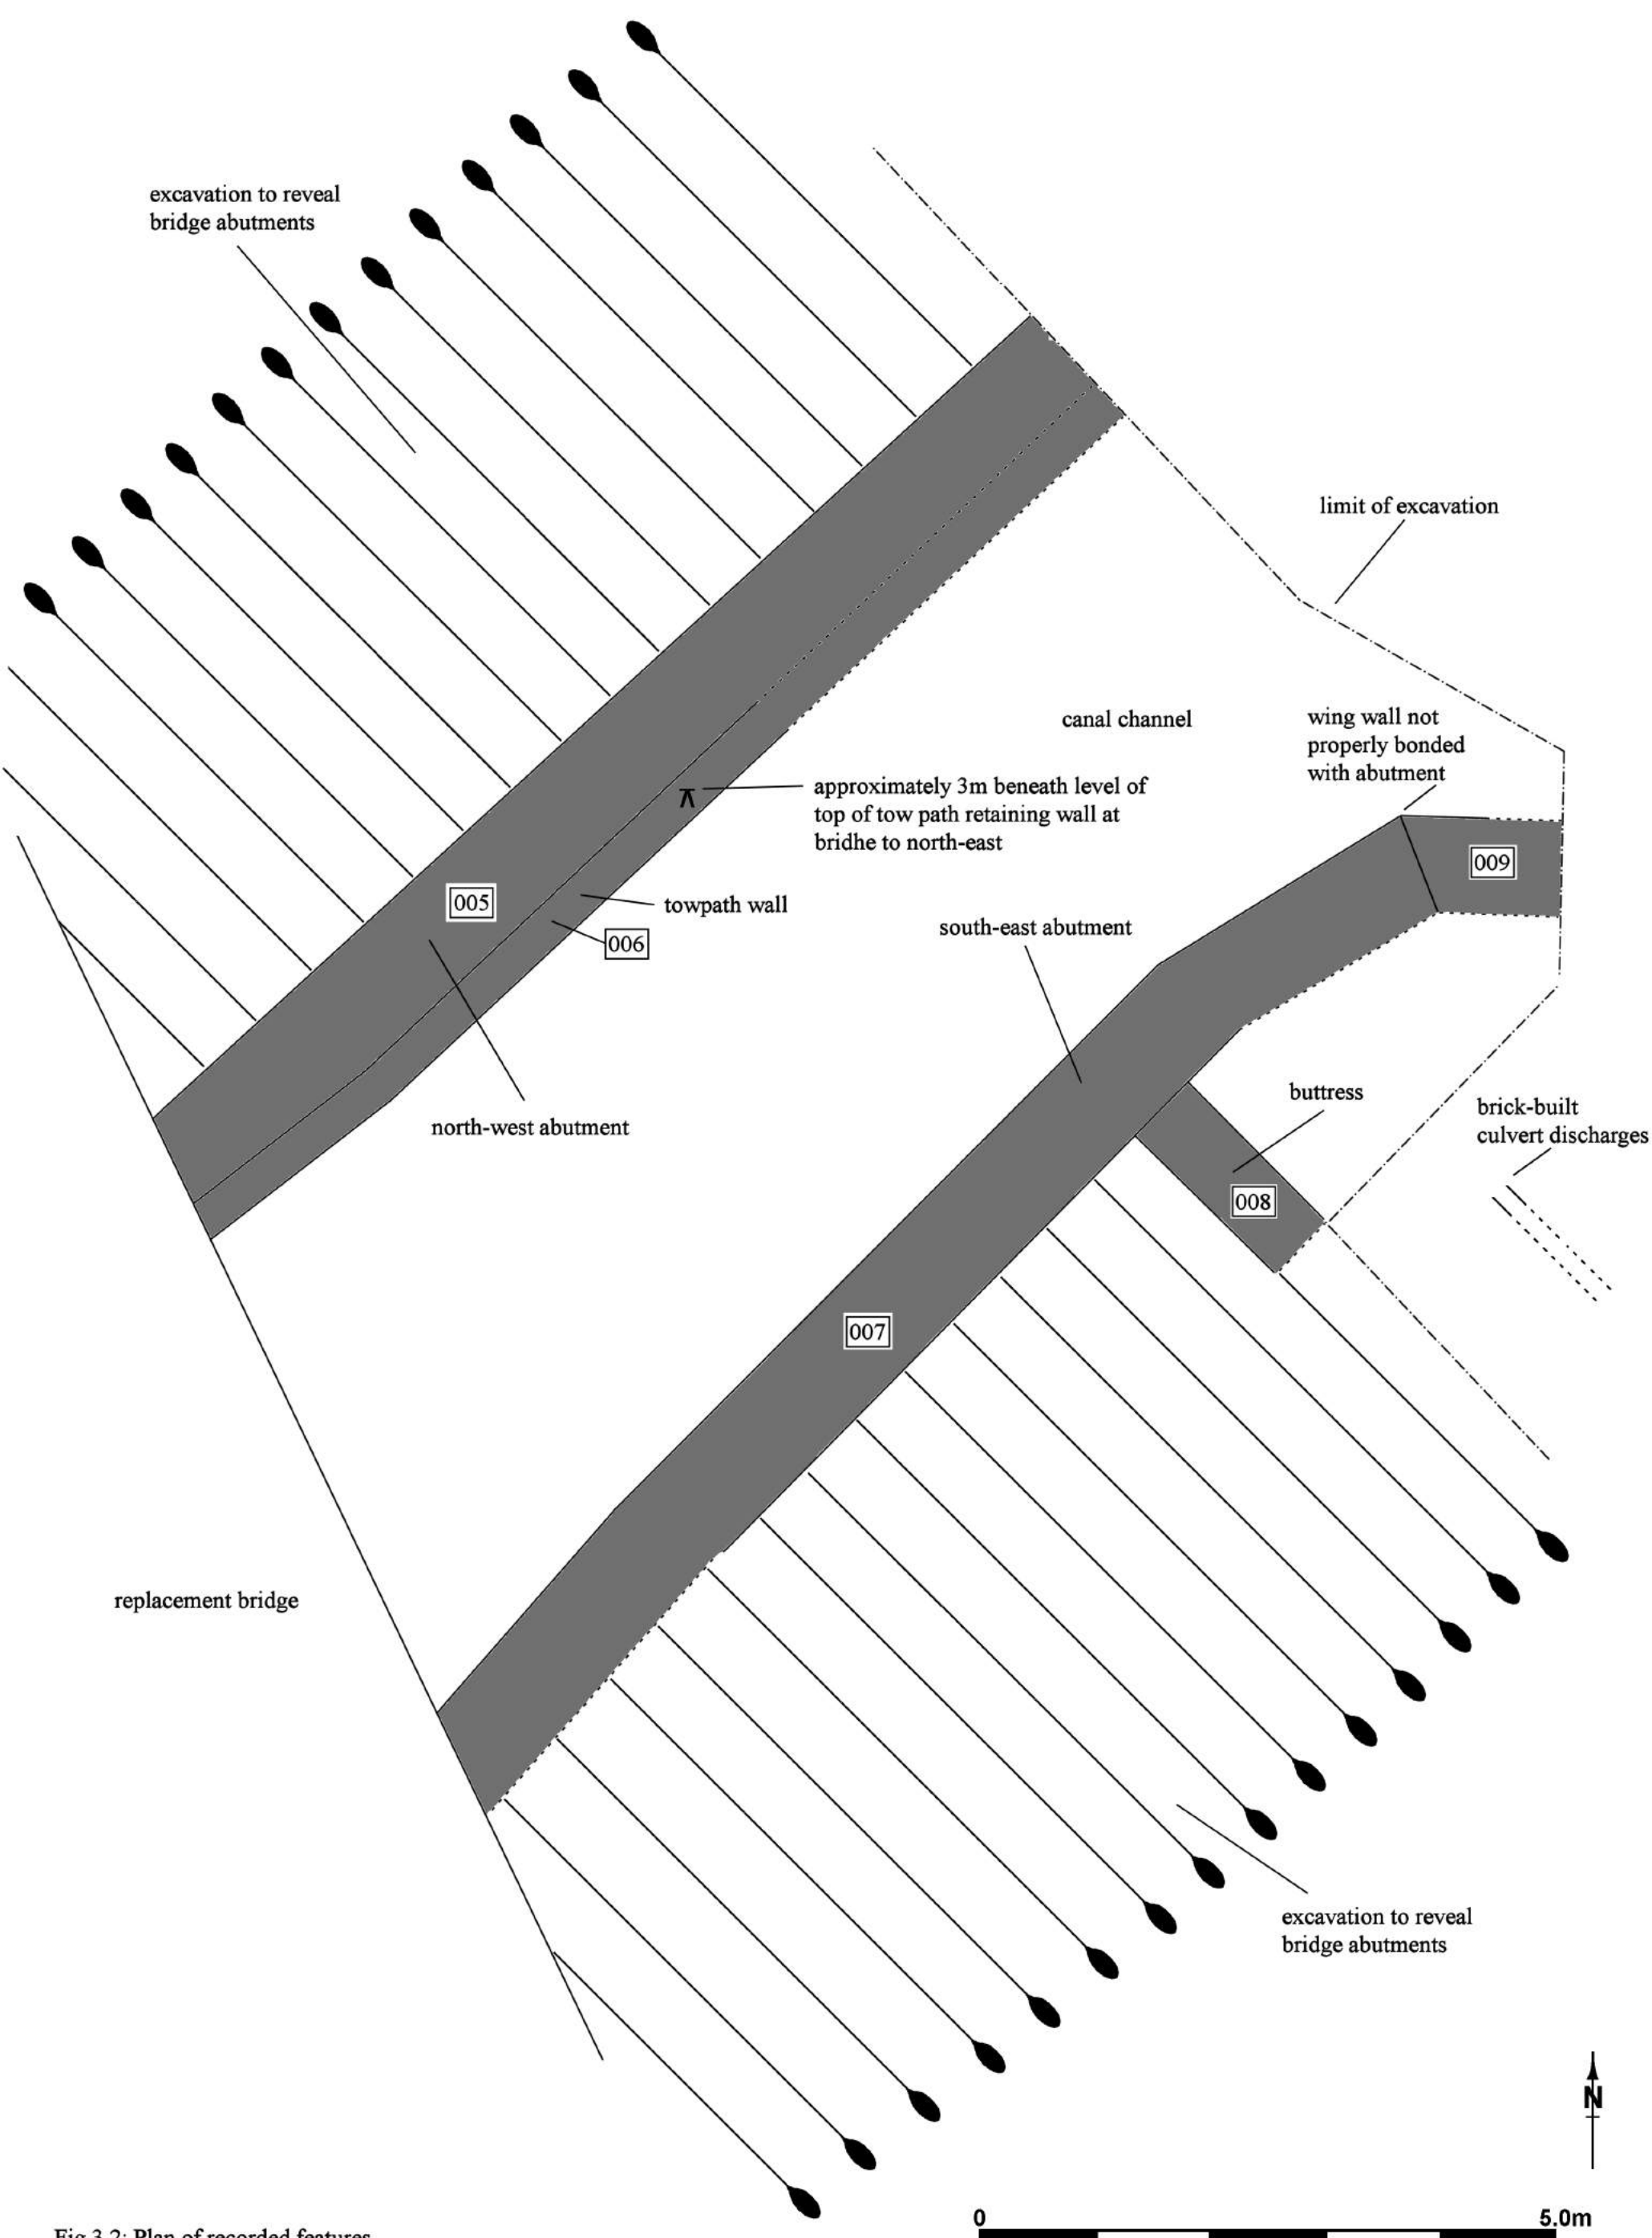
Fig 3.2: Plan of recorded features

The bridge abutments and the buttress (contexts 005, 007 and 008) were of solid masonry construction in English bond. It became apparent that the south-eastern wing wall of the north-east fore bay (context 009) was not properly bonded with the rest of the abutment (Fig 3.2). Within the limits of the excavation, it could not be determined if this was due to a repair, a subsequent modification or just a simple mistake in the original build.

The tow path retaining wall (context 006; Fig 3.2) was of slighter construction, comprising a brick-built wall with rubble infill. Only one course of this wall was exposed and it was not possible to determine its bond. Comparison of levels of the top of the tow path retaining wall beneath the bridge to the north-east (which has been rebuilt to its original height) and the top of the surviving tow path retaining wall at Compasses Bridge suggest that approximately three metres of construction has been lost.

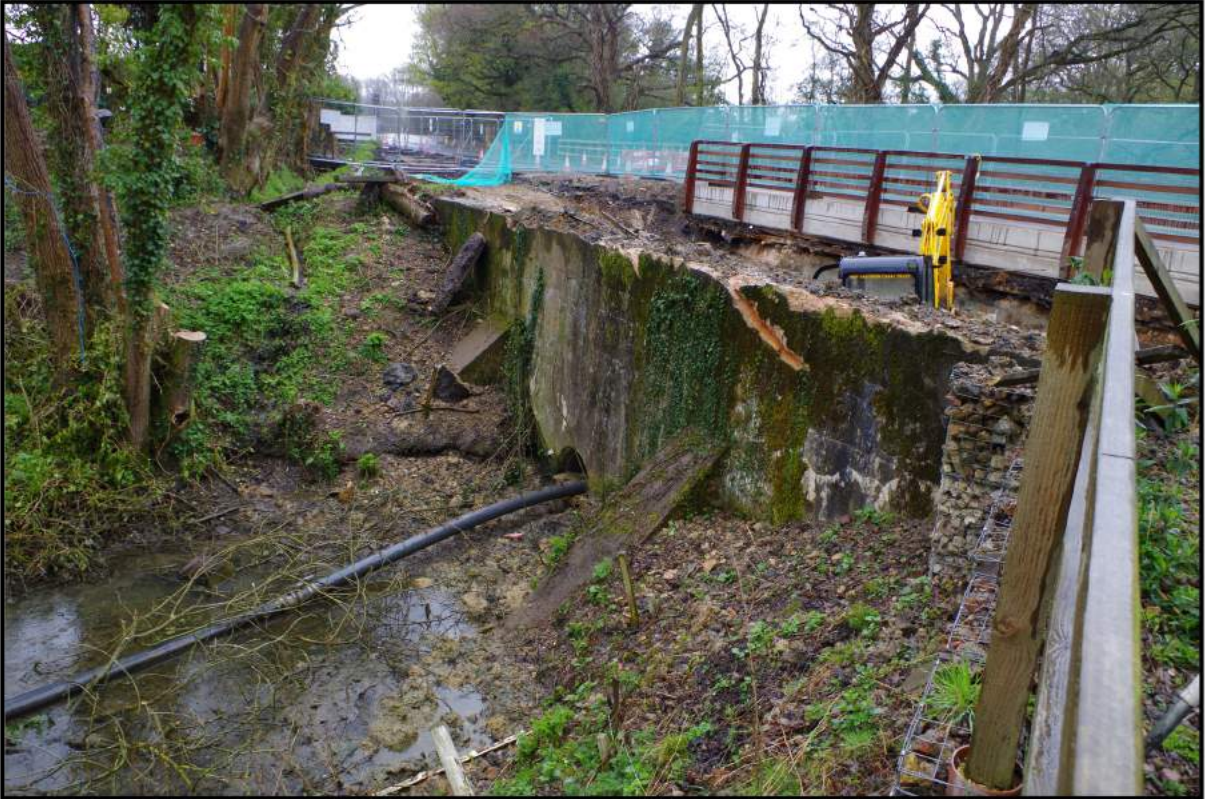
The causeway (Figs 4 and 5) comprised two reinforced concrete retaining walls (contexts 001 and 002), a concrete culvert (context 003) running approximately on the centre-line of the canal channel in order to maintain the flow along the watercourse and the bulk fill of the causeway (context 004). These modern deposits were not recorded in detail.

Fig 4: General view of north-east side of causeway showing culvert

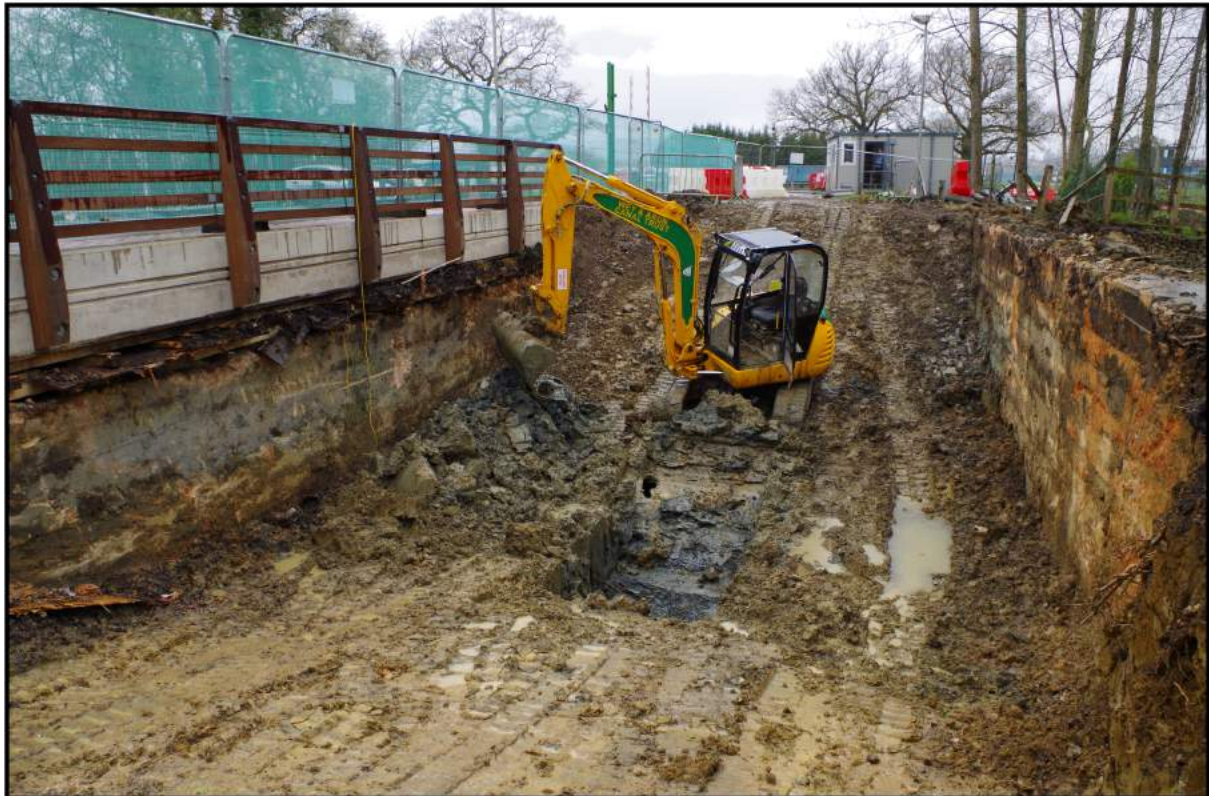
Fig 5: General view of excavation of causeway from south-east

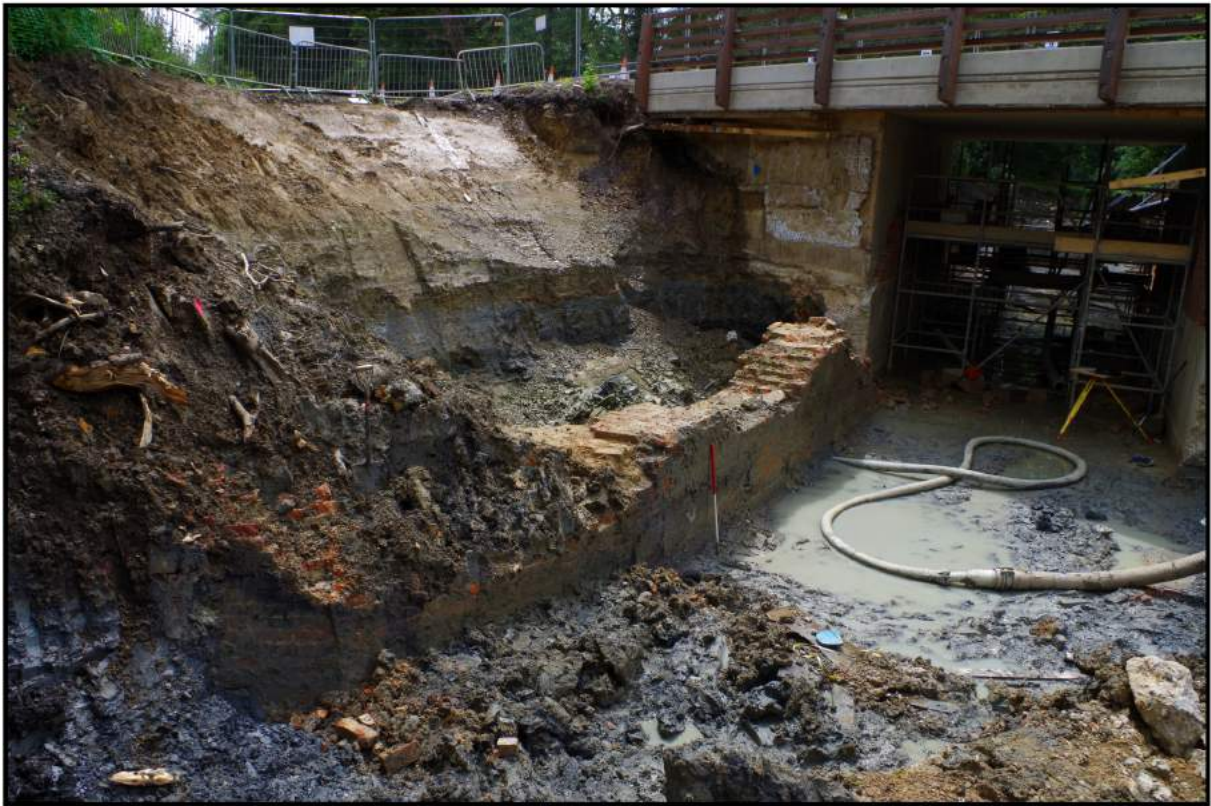
Fig 6: South-east abutment wall

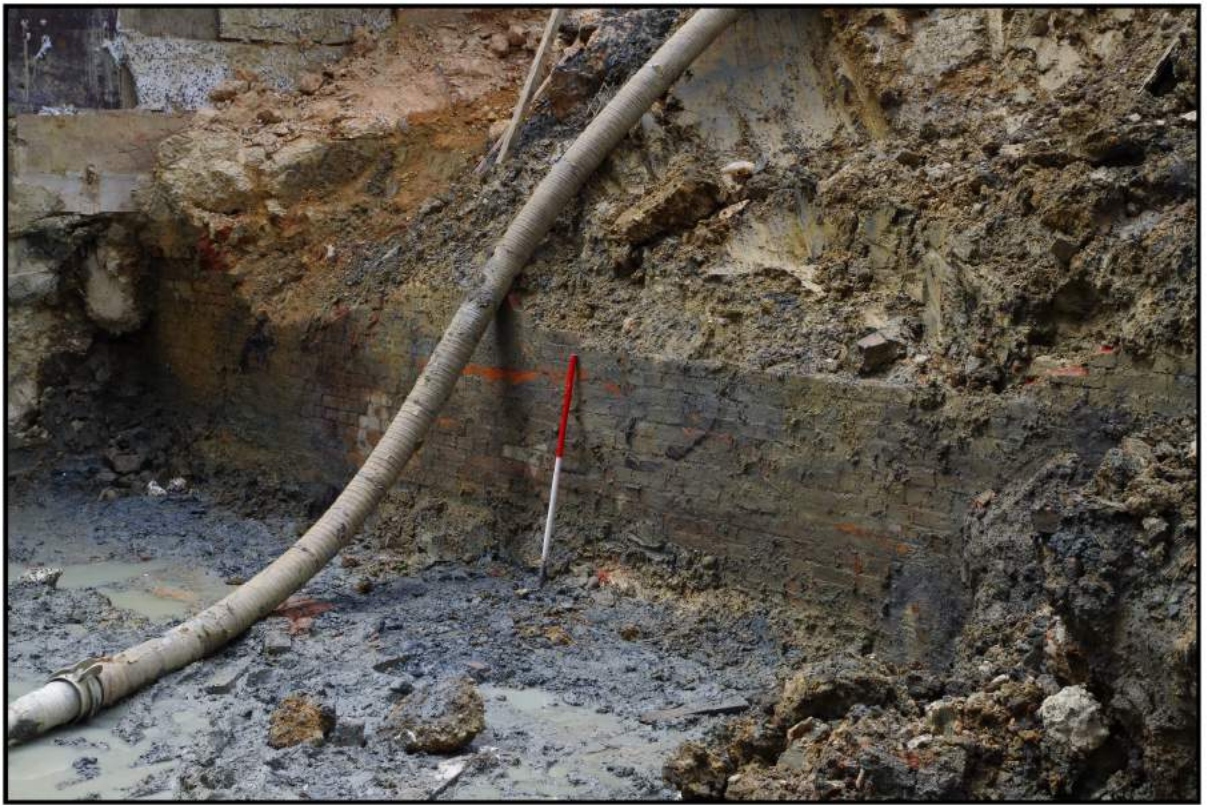
Fig 7: North-west abutment wall

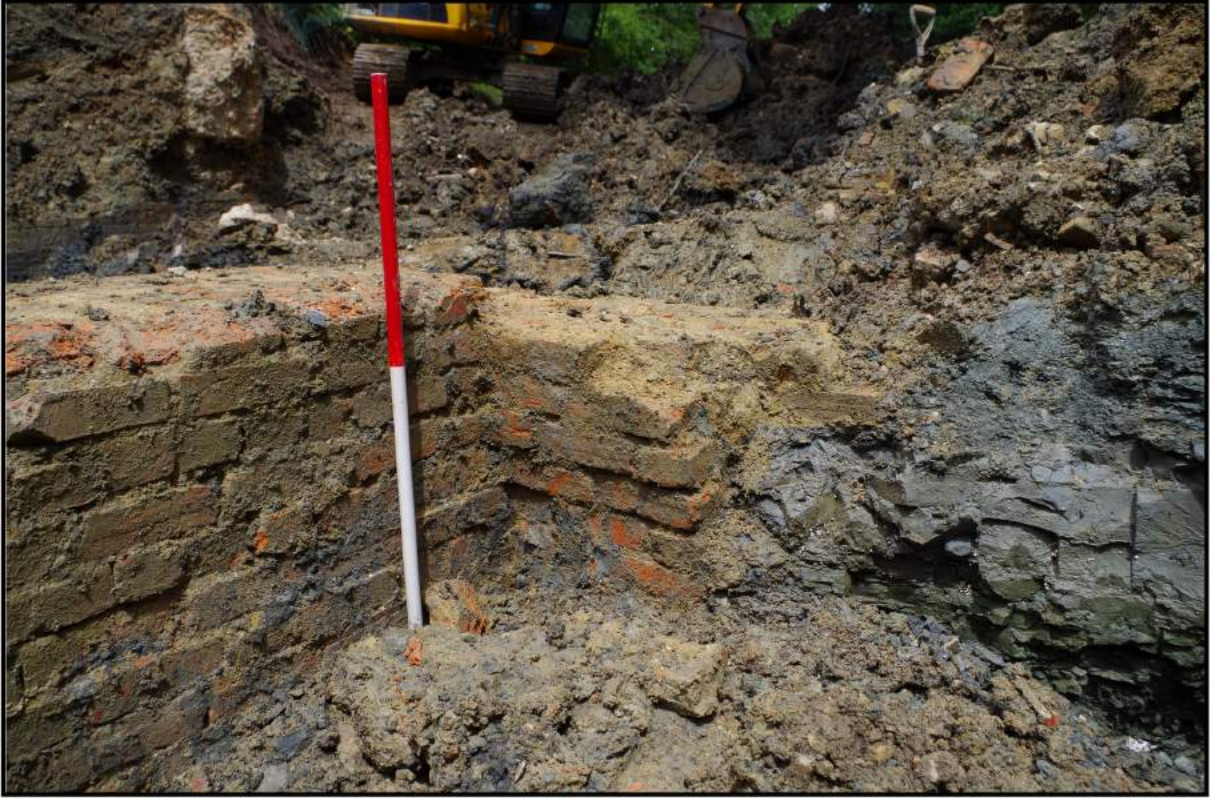
The purpose of the buttress is somewhat perplexing. Possible explanations include:

Fig 8: South-east abutment wall showing buttress

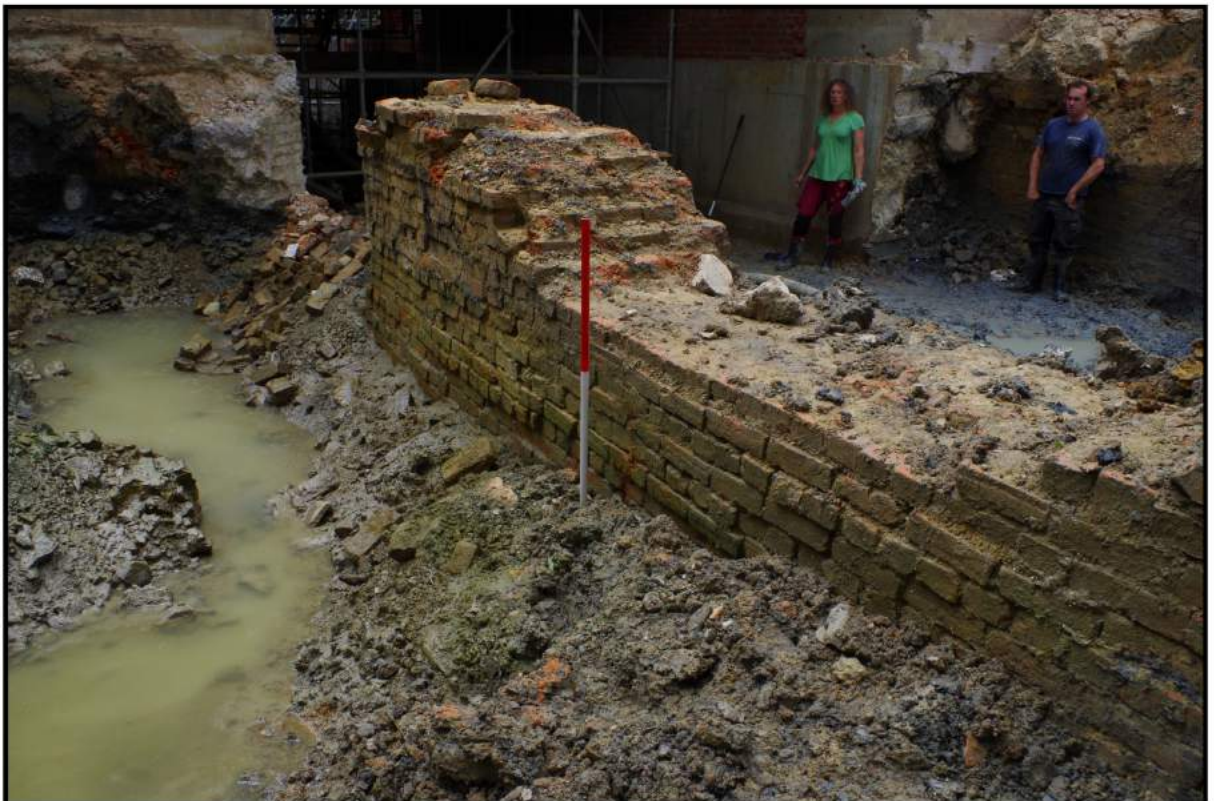
Fig 9: Rear of south-east abutment wall showing English bond brickwork

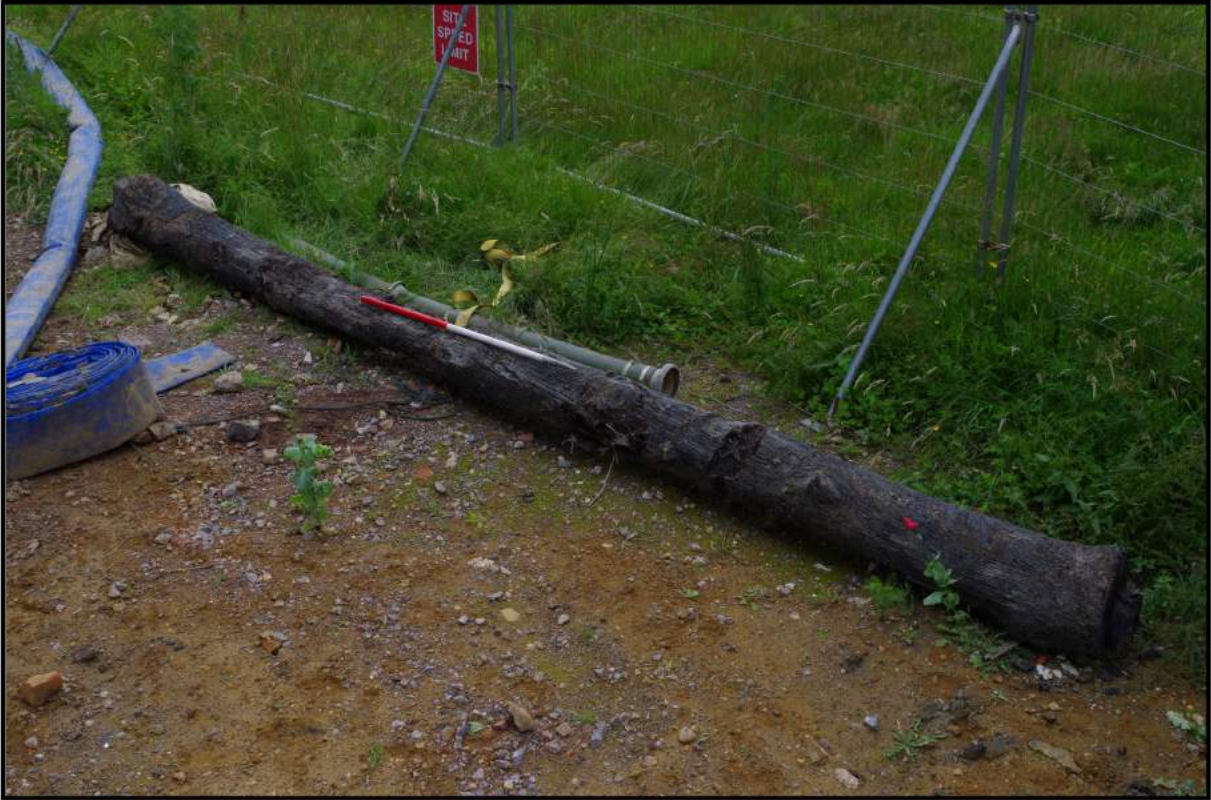
The only find from the excavation was a substantial timber which was found lying across the line of the canal, between the abutments (Context 010; Figs 10, 11 and 12). This was about four metres long, had a tenon at one end (Fig 11) with its other end formed into a spade-like profile (Fig 12). It was not seen *in situ* but it seems unlikely that it formed part of the original bridge construction. Its original function, and/or its function with respect to Compasses Bridge, is unknown.

Fig 10: Timber found between abutment walls

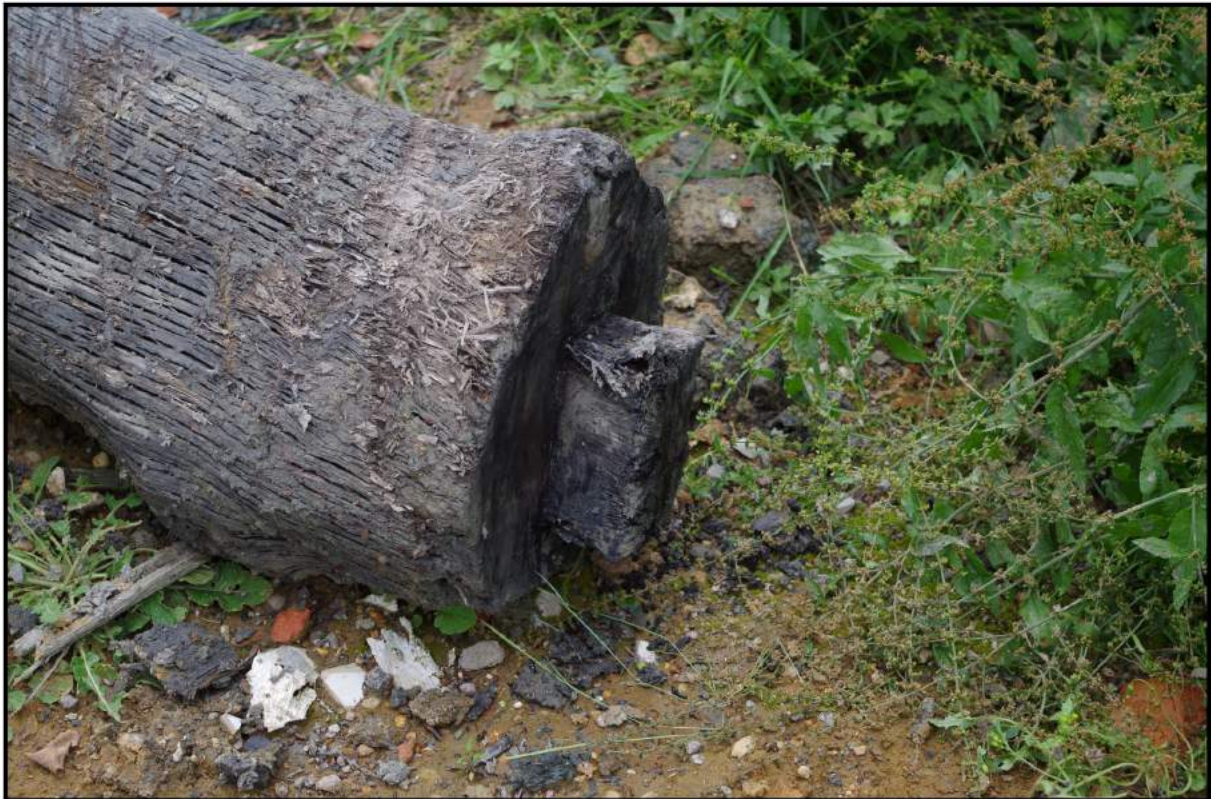
Fig 11: Timber found between abutment walls showing detail of tenon

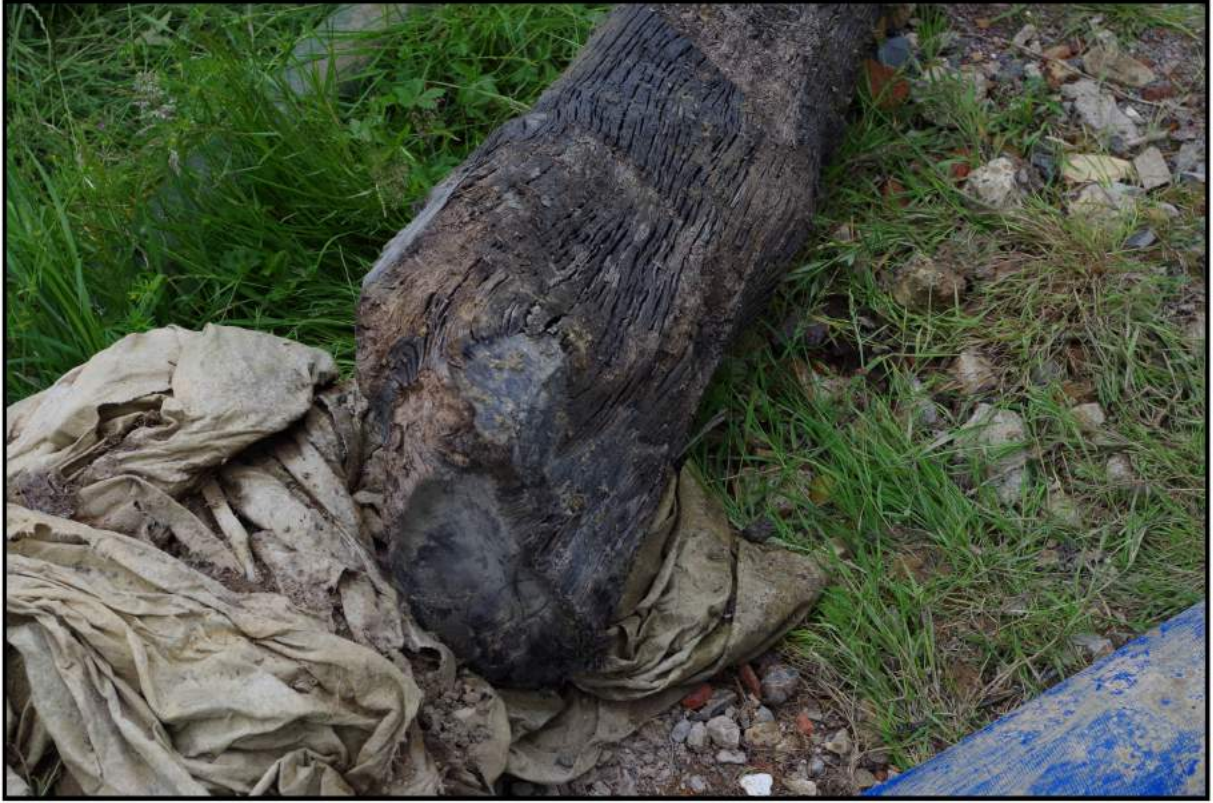
Fig 12: Timber found between abutment walls showing detail of 'spade' end
