Programme of archaeological work at Sheffield Lock, Burghfield, Kennet and Avon Canal, West Berkshire

17th June 2016 Revised 20th July 2016 Revised 24th August 2016

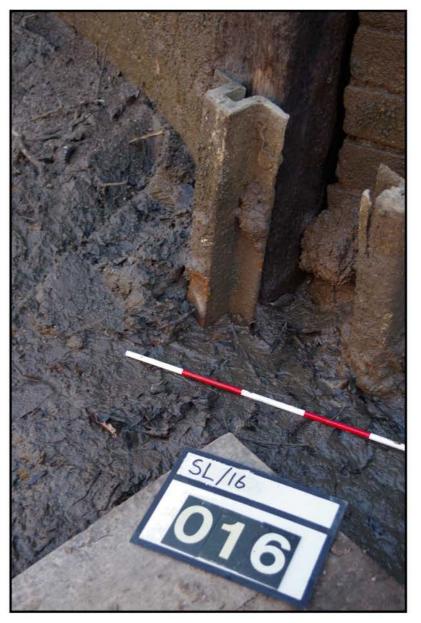
In three locations it is clear that the mortice and tenon joint between the king posts and the transverse beams must have failed. The foot of the king posts (contexts 053, 056 and 058; Fig 3.1) were retained using the same early pattern railway line that had formerly been used for training piles (contexts 016, 021 and 038; Figs 3.1, 9, 14 and 31).

Fig 9: Context 016; early pattern rail, repair to king post/transverse beam

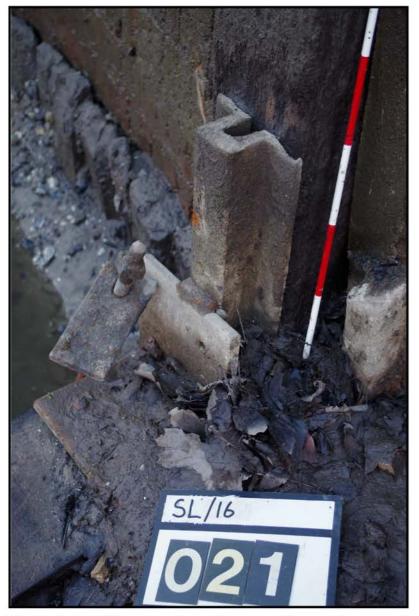
Fig 14: Context 021; early pattern rail, repair to king post/transverse beam

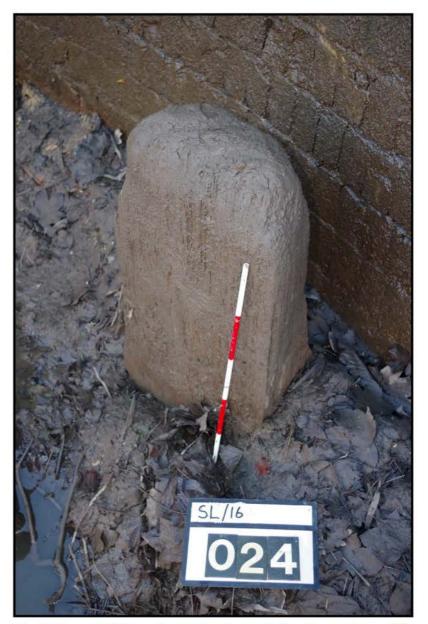
• timbers of various dimensions also protruded from the lock invert; (contexts 014, 019, 024, 027 and 028; Figs 7, 12, 17, 20 and 21).

These relict timbers tended to occur at the eastern end of the lock. There are too few of them to make any pattern analysis feasible but it is practically certain that they relate to an earlier configuration of the lock and it is felt likely that they are the remains of the turf-sided lock. The lock at Garston was shortened by abandoning part of the upstream structure. It is possible that the distribution of surviving timbers within the chamber at Sheffield Lock relates to a similar circumstance.

Fig 17: Context 024; vertical timber forward of scallop wall, possible remains of turf lock

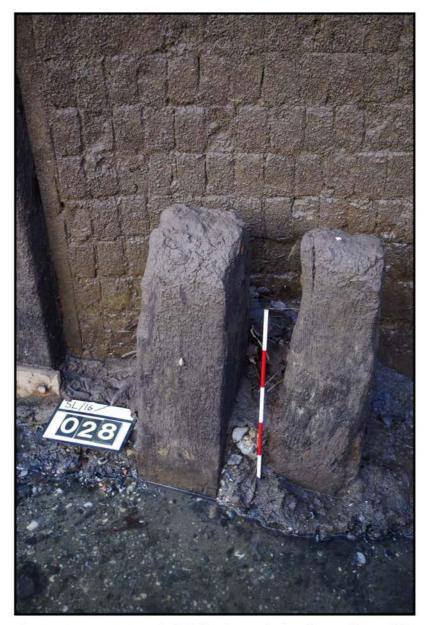
Fig 21: Context 028; vertical timber forward of scallop wall, possible part of turf lock

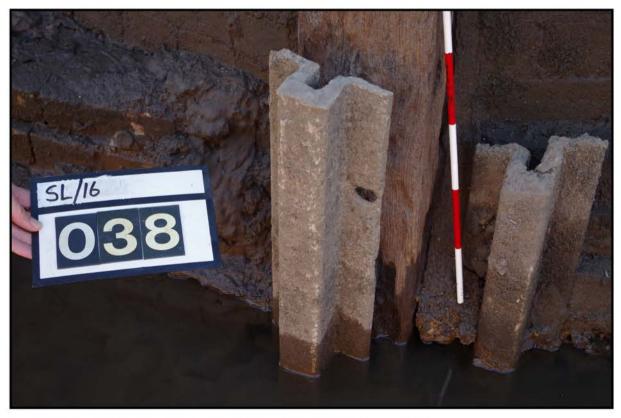
Fig 31: Context 038: early pattern rail, repair to king post/transverse beam

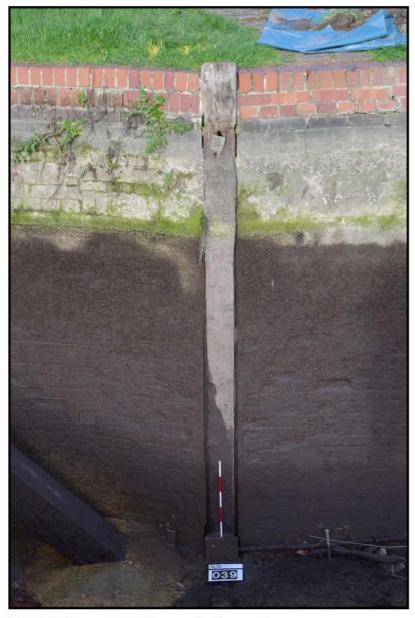
Fig 32.1: Context 039; king post before repair

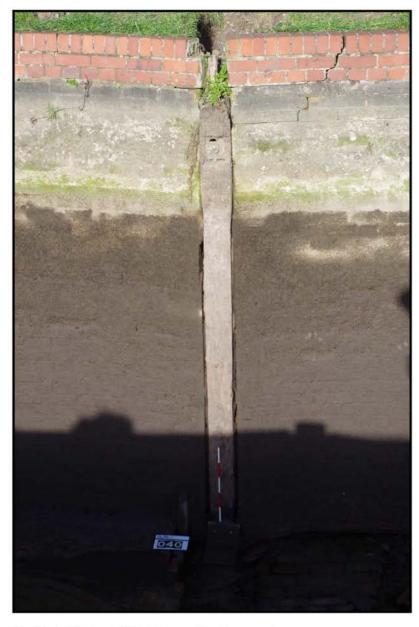
Fig 33.1: Context 040; king post before repair

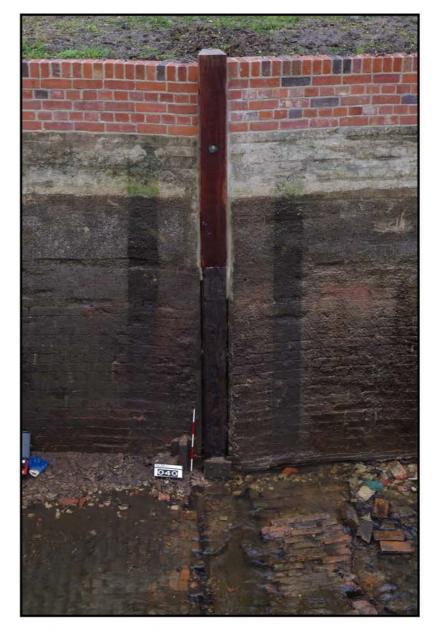
It was apparent that the mortice and tenon joints between the king posts and the transverse beams must have failed, or were believed to have failed, generally, around the lock. A number of metal brackets had been inserted to support this joint. These were not recorded specifically by this project but they may be seen in a number of the photographic figures (eg Figs 5, 11, 14, 15, 18, 32.2 and 33.2).

Fig 33.2: Context 040; king post after repair

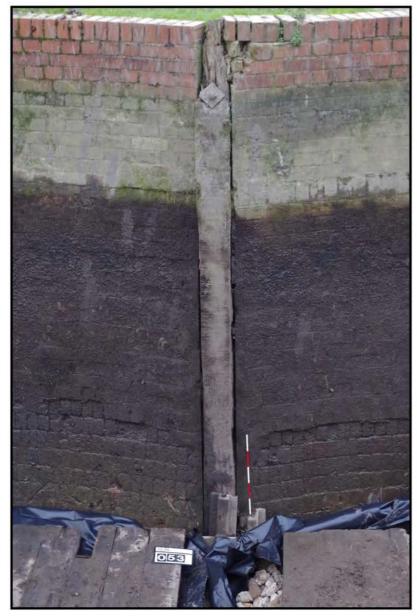
Fig 46.1: Context 053; king post before repair

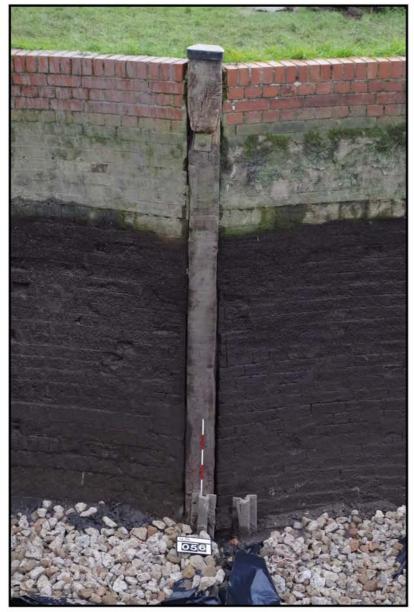
Fig 49.1: Context 056; king post before repair

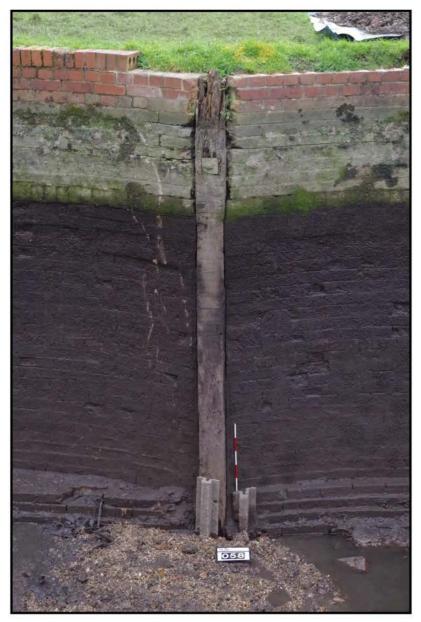
Fig 51.1: Context 058; king post before repair

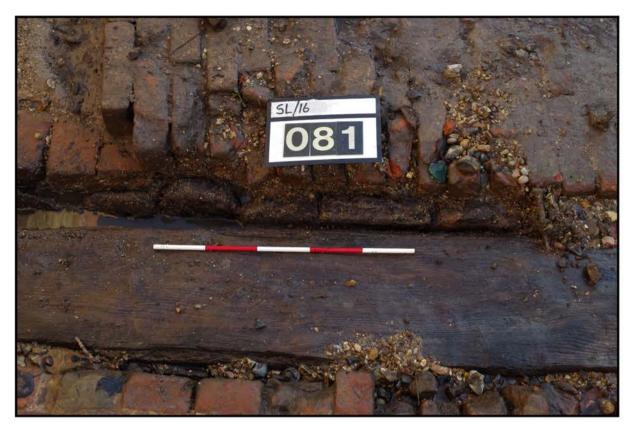
• timber piling secured with hand-made nails to a transverse beam (contexts 072 and 081; Figs 3.1 and 58).

Fig 58: Context 081; heads of timber piling

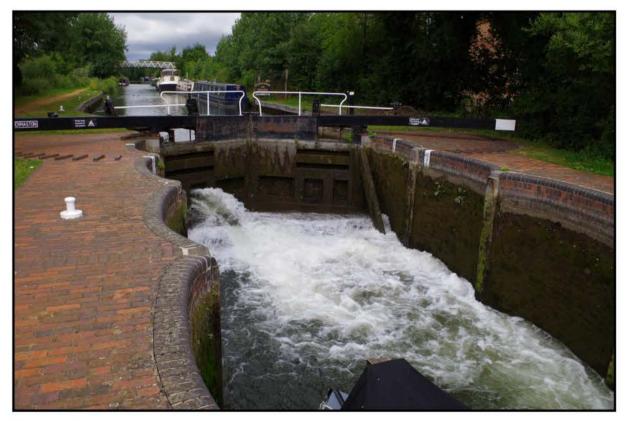
The brick invert at the western end of the lock was clearly intended to offer further protection against the effects of scour produced when the paddles at the upper end of the lock were opened. The need for this is demonstrated by the significant scour hole that was found upon draining of the lock, exposing the natural gravel (context 082; Figs 3.1 and 59) and severely eroding the transverse beam that passed through this position (context 087; Fig 3.1). It was not possible, at the time of the recording project, to directly observe the rush of water into the lock upon opening of the upper paddles. However, observation of a similar scalloped lock at Aldermaston showed that there was considerable turbulence, particularly in the vicinity of the first and second bays from the upper gates (Fig 71.3). At Sheffield Lock this is where the greatest erosion of the lock invert was located.

Fig 71.3: Aldermaston Lock showing turbulence caused by opening of gate paddles
