**Historic building recording
at Chisnell Lift Bridge
(Bridge 193),
near Deddington,
Oxford Canal,
Oxfordshire**

Martin Cook BA MCIfA
and Suzanne MacLeod BA

6th February 2017
Revised 24th February 2017

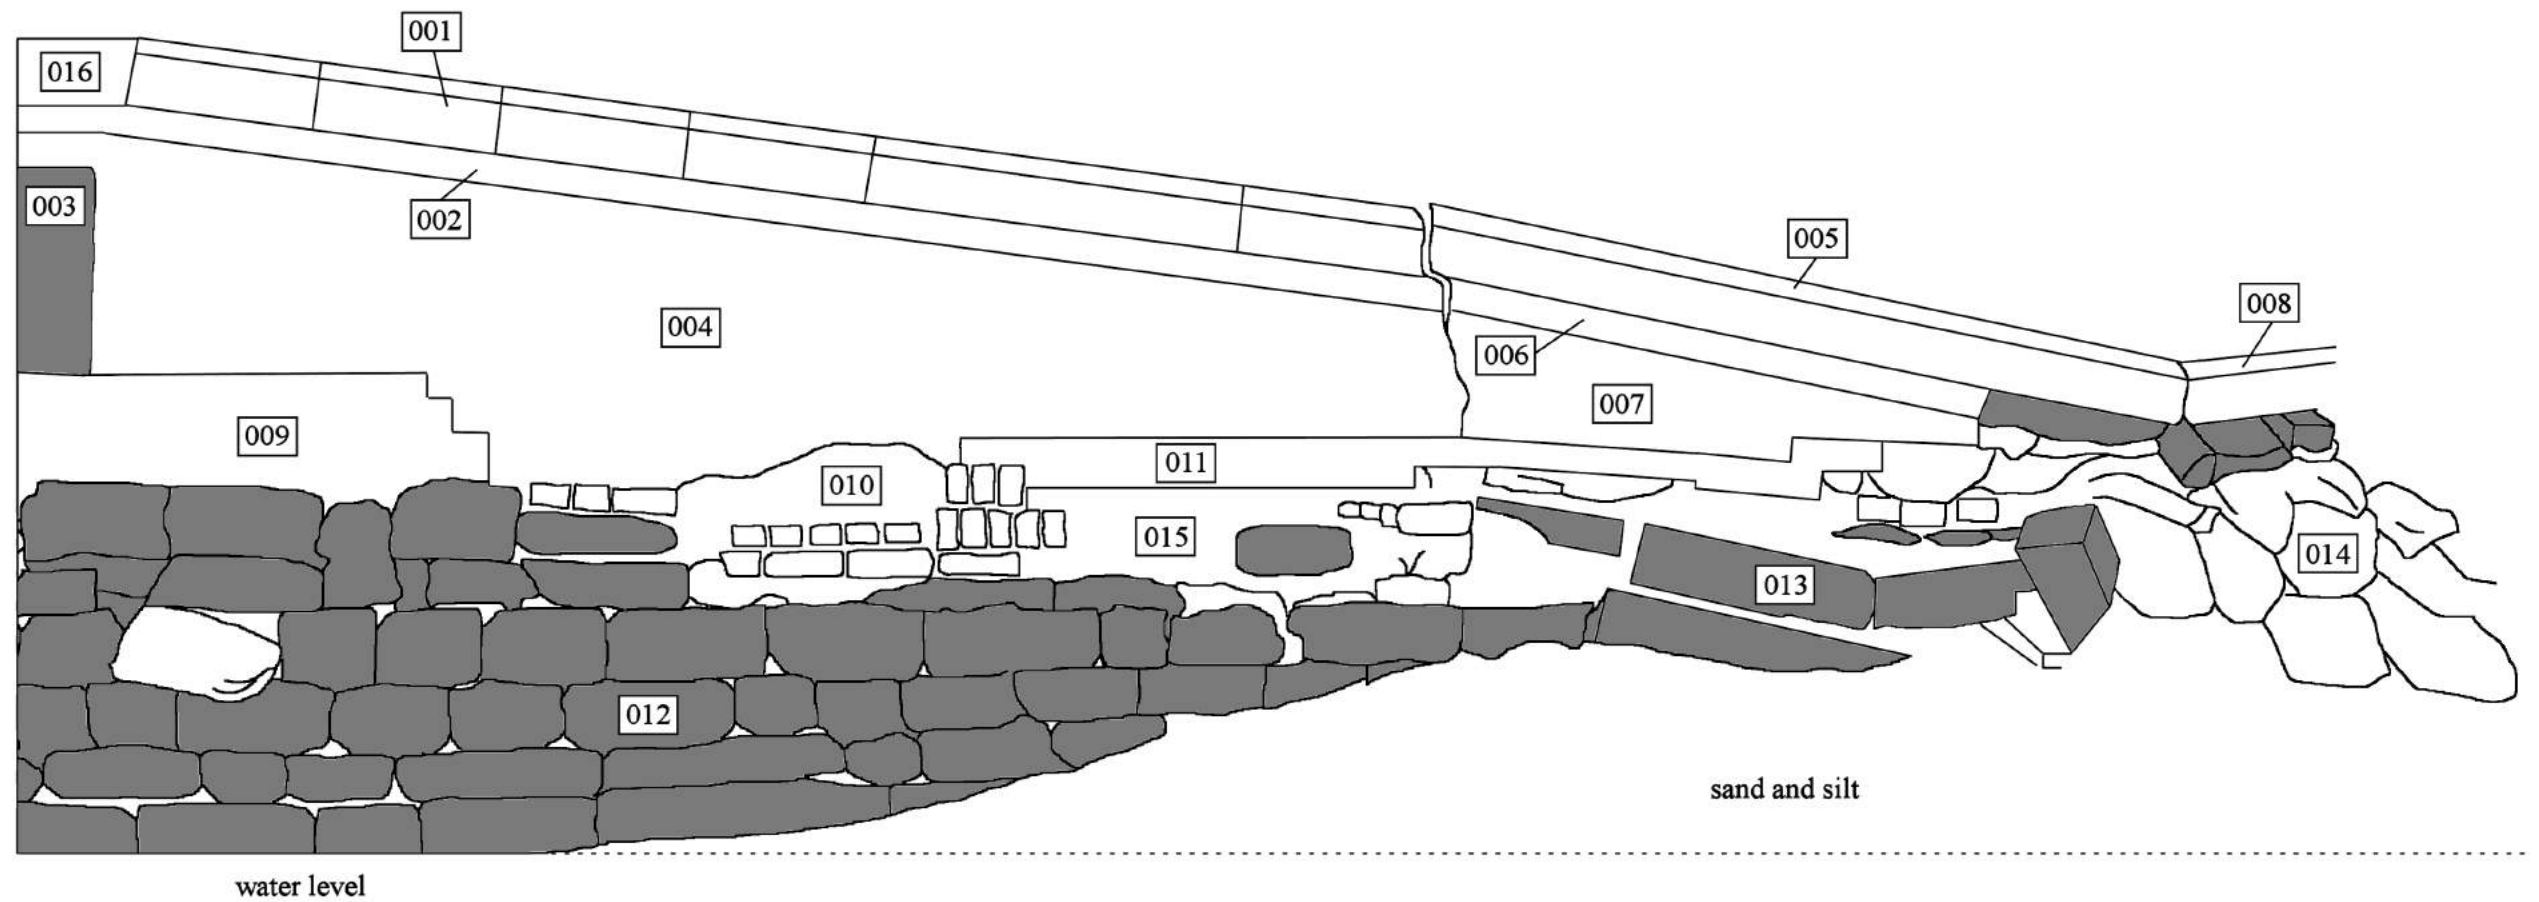
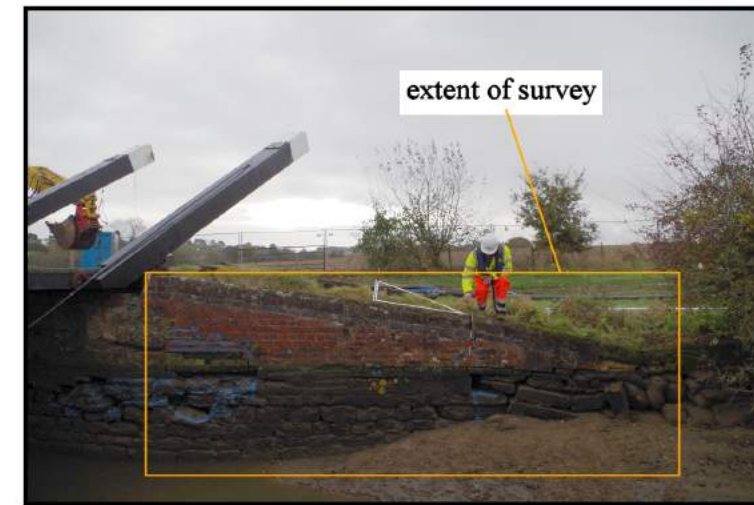
Fig 2.2: South-west wing wall

In the main this comprises medium to large squared, coursed stones lying below the working water level (eg south-west wing wall, context 012; Fig 2.2, south-east wing wall, context 024; Fig 2.3, north-east wing wall, context 036; Fig 2.4, north-west wing wall, context 051; Fig 2.5, north abutment, also context 051; Fig 2.6 and south abutment, context 067; Fig 2.7).

Above the water level are areas of red brick in English bond (eg south-west wing wall, context 004; Fig 2.2, north-east wing wall, context 031; Fig 2.4, north-west wing wall, context 048; Fig 2.5, north abutment, context 059; Fig 2.6 and south abutment, context 066; Fig 2.7).

On the join of the abutments and wing walls are massive rubbing stones (eg south-west wing wall, context 003; Fig 2.2, north-east wing wall, context 030; Fig 2.4, north-west wing wall, context 047; Fig 2.5, north abutment, contexts 030 and 047; Fig 2.6 and south abutment, contexts 003 and 063; Fig 2.7).

Stone coping stones exist on only one wing wall: south-west wing wall, contexts 001, 005 and 008; Fig 2.2.

This generally took the form of bricks replacing stone or concrete replacing stone (eg south-west wing wall, context 010; Fig 2.2, north-east wing wall, contexts 025, 026, 027 and 028; Fig 2.4, north-west wing wall, contexts 038, 039, 040, 041 and 042; Fig 2.5 and north abutment, context 060; Fig 2.6). There are also areas of blue engineering bricks (eg south-west wing wall, context 002; Fig 2.2 and north-west wing wall, contexts 044 and 045)

Concrete sand bags occur in various places (eg south-west wing wall, context 014; Fig 2.2, south-east wing wall, context 022; Fig 2.3, north-east wing wall, context 033; Fig 2.4, north-west wing wall, context 049; Fig 2.5, and south abutment, context 068; Fig 2.7).

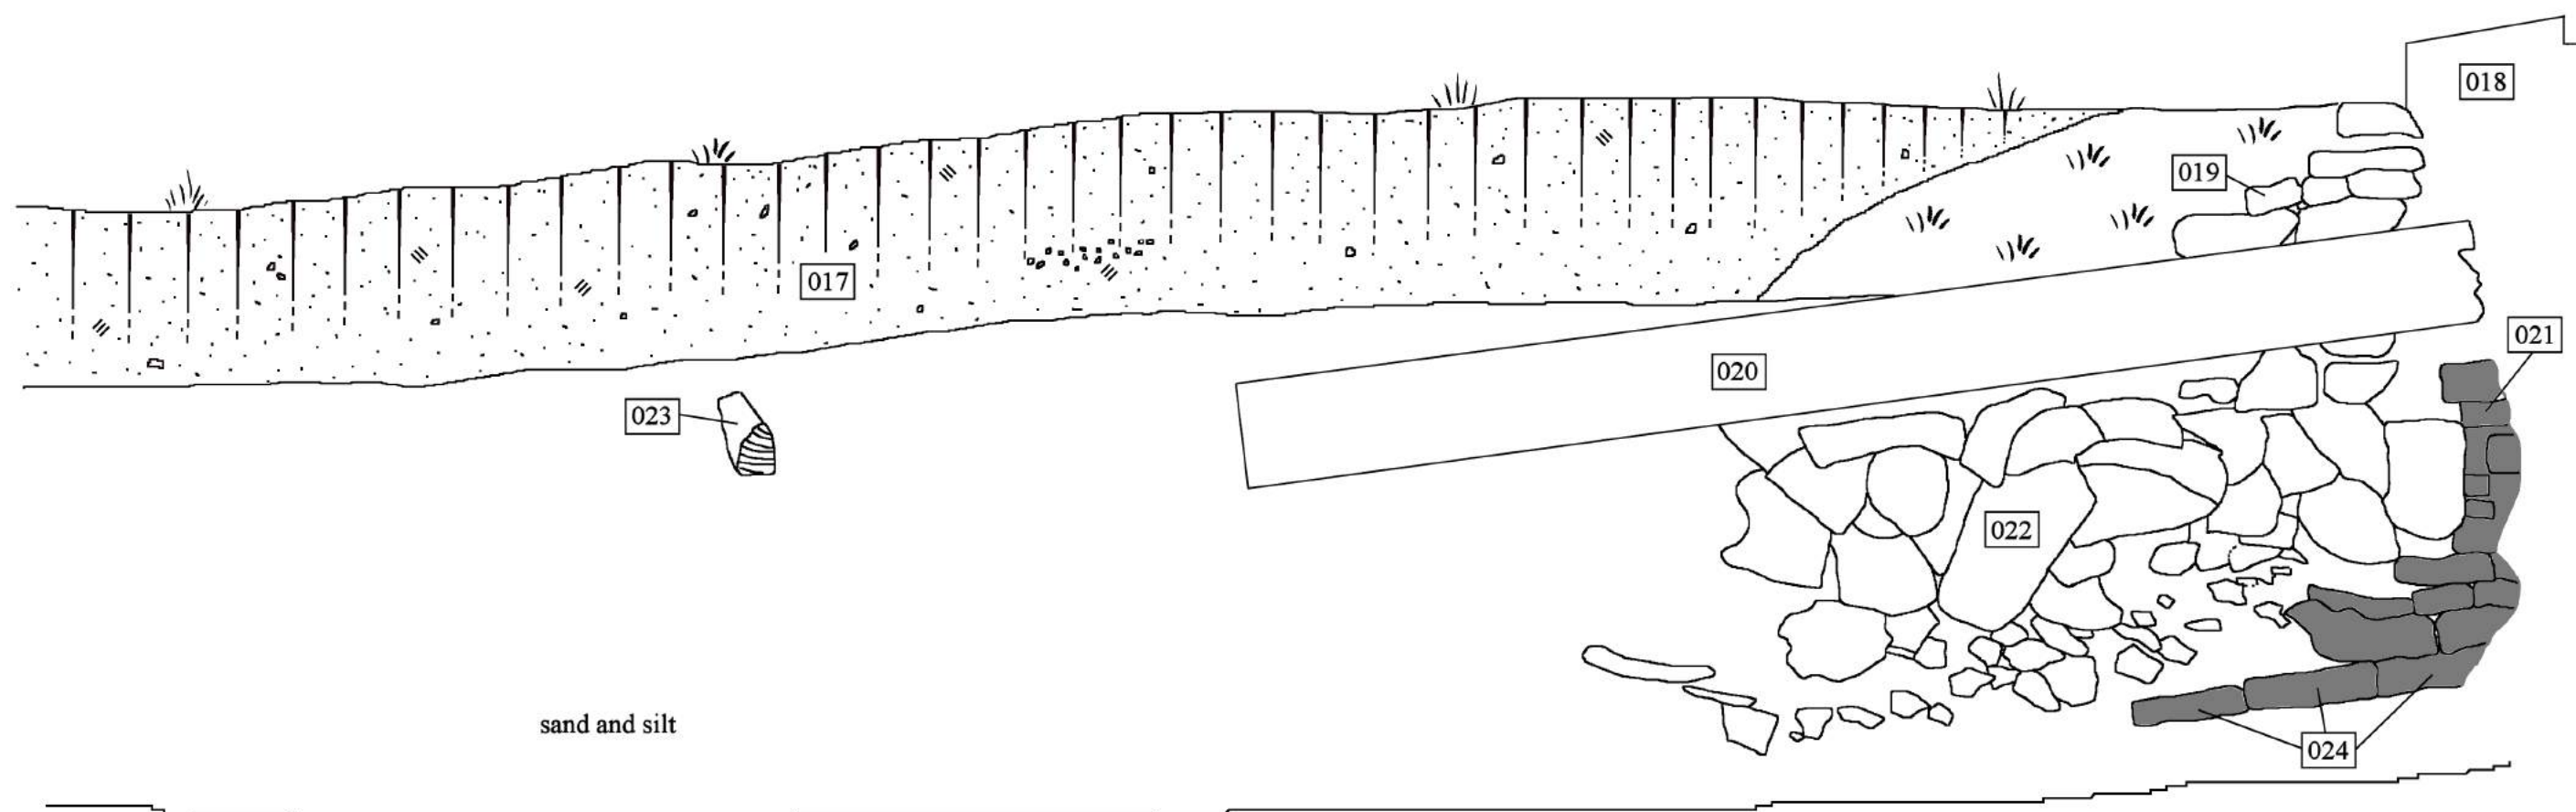
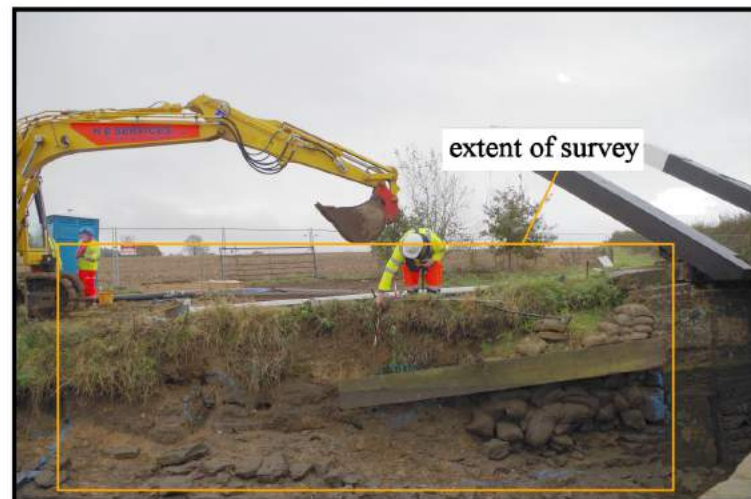
Fig 2.3: Fragmentary remains of south-east wing wall

Bridge 193 (Chisnell) suffered a partial collapse of the south-east wing wall on the off-side in July 2013. This left the bridge operational but the abutment required rebuilding. The opportunity was taken during the de-watering of the canal to carry out repairs to other parts of the abutments and wing walls. The bridge is listed Grade II.

Timber tie-backs were noted in a number of places (eg south-east wing wall, context 023; Fig 2.3, north-west wing wall, context 053; Fig 2.5 and north abutment, also context 053; Fig 2.6)

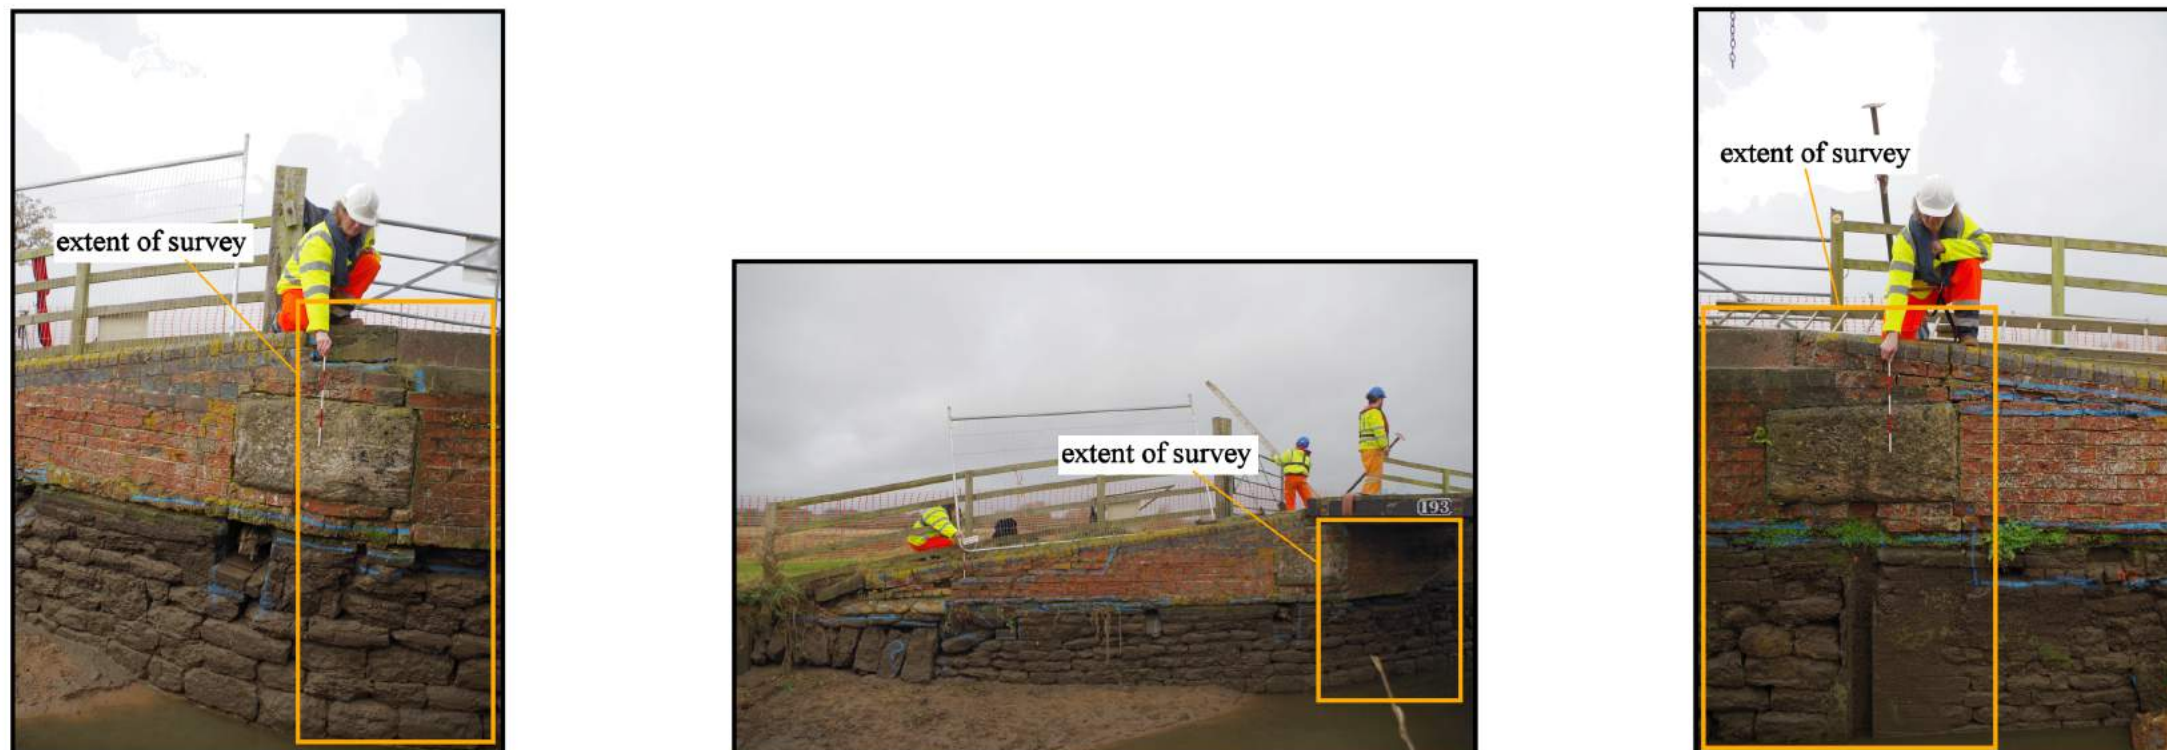
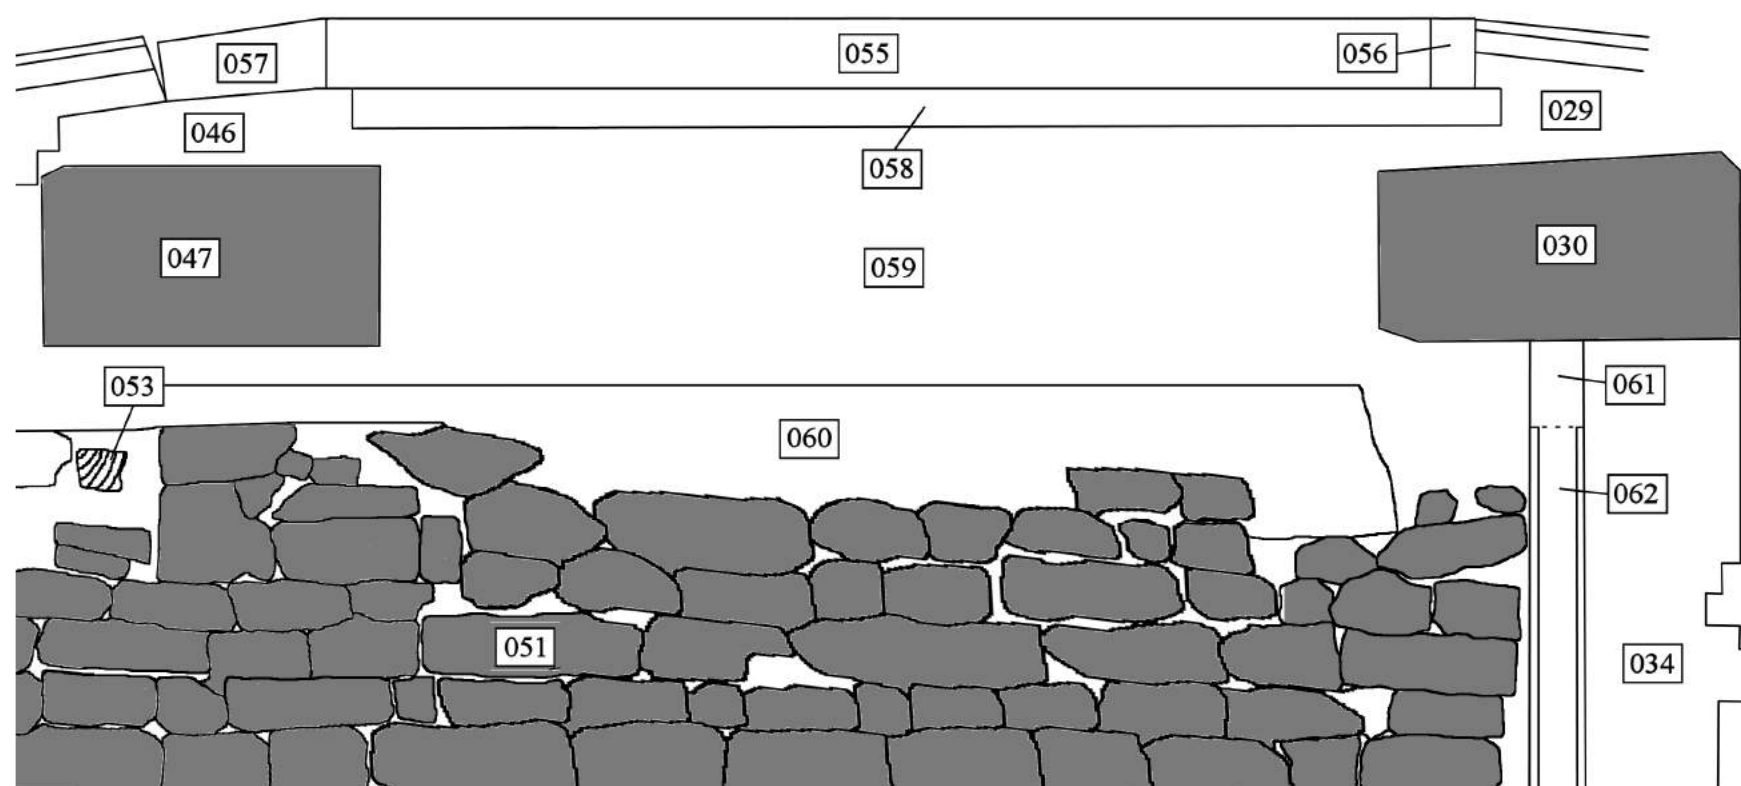
Fig 2.6: North abutment of bridge

These relate to the requirements for the operation of the modern bridge deck and the facility to drain the canal (eg north abutment, contexts 055, 056, 057 – part of the landing for the deck of the lift bridge and contexts 061 and 062 – a recess cut in pre-existing brickwork and metal 'U' channel – elements of the stop plank grove; Fig 2.6, and south abutment, context 065 - metal 'U' channel – stop plank grove; Fig 2.7).

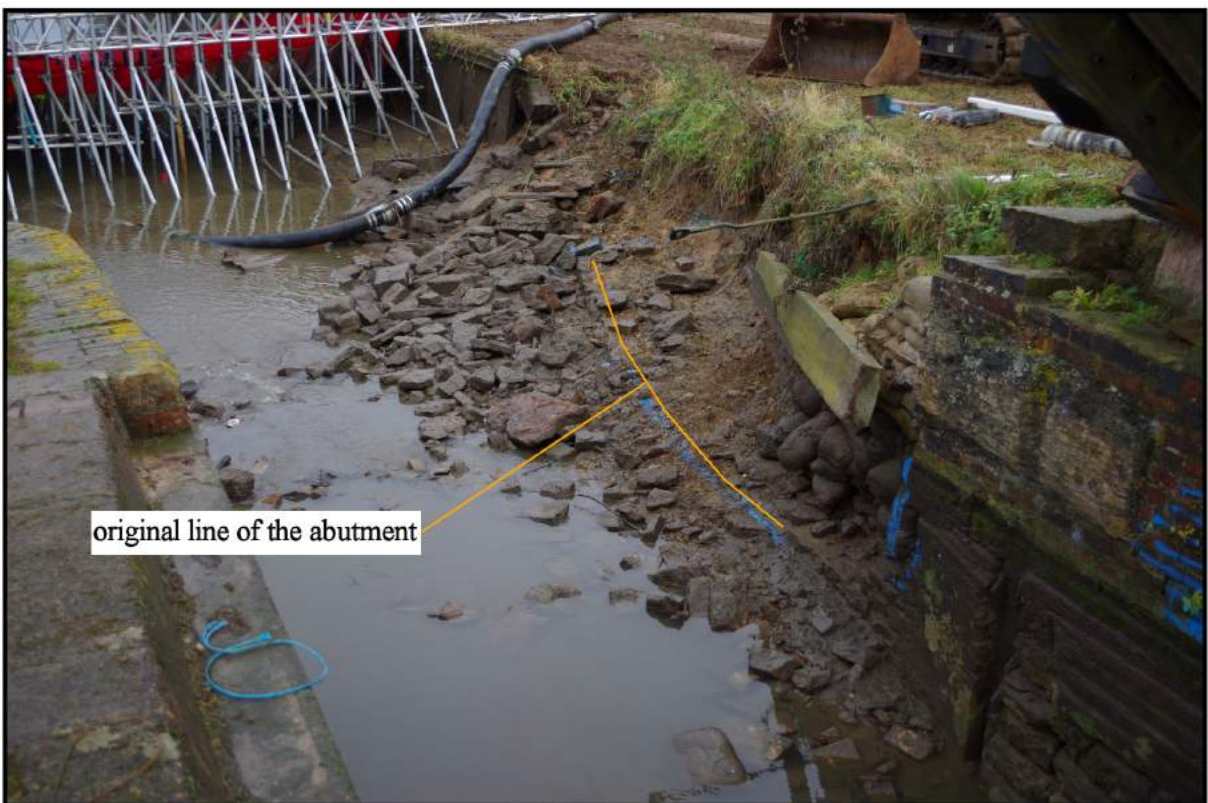
When clearance of the collapsed stonework of the south-east wing wall was complete, the original line of the wing wall (context 024; Figs 2.1 and 6) was identified and recorded.

Fig 6: View of the collapsed south-east abutment showing the original line of the abutment

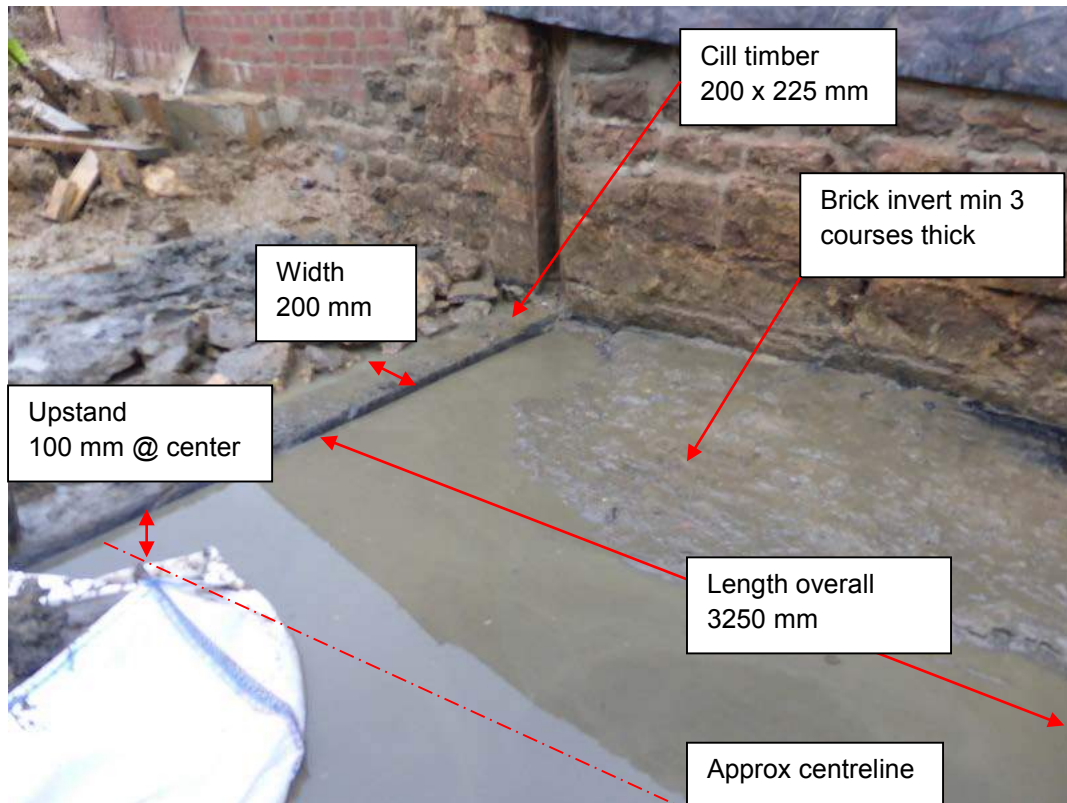
Bridge 193 : Invert between bridge abutments
