Archaeological building investigation and recording at 1 New Street, Childswickham, Worcestershire, WR12 7HQ

Martin Cook BA MCIfA

25th September 2019

The project was undertaken to level two standard, in advance of demolition of the property.

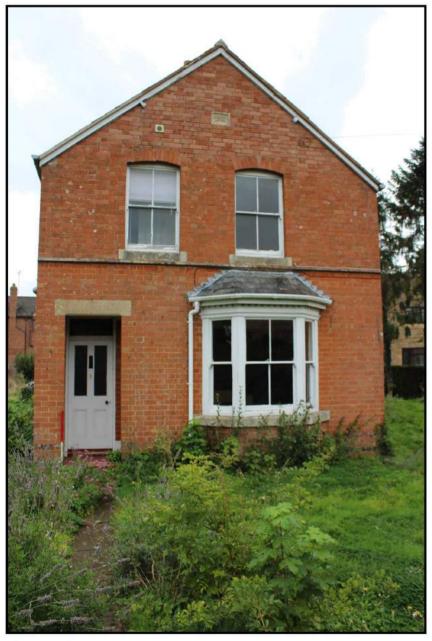
Fig 4: South elevation

The front (south) elevation (Figs 3.3 and 4) was the most elaborate, being constructed in Flemish bond in lime mortar, with a stone lintel over the door and stone cills to the windows. Immediately below the first floor cills was a stone string course. Single brick arches spanned the window openings. A date stone (1902) was placed in the gable. Near ground level was a course of blue engineering bricks, forming a damp-proof course and just above this, a course of battered bricks (Fig 5). There was a recessed storm porch with stone steps and tiled floor (Fig 6). Within the porch, the front door had the upper two-thirds glazed, which was typical of an Edwardian house and the panels formed in the lower part of the door had raised mouldings around the edge to make them appear deeper.

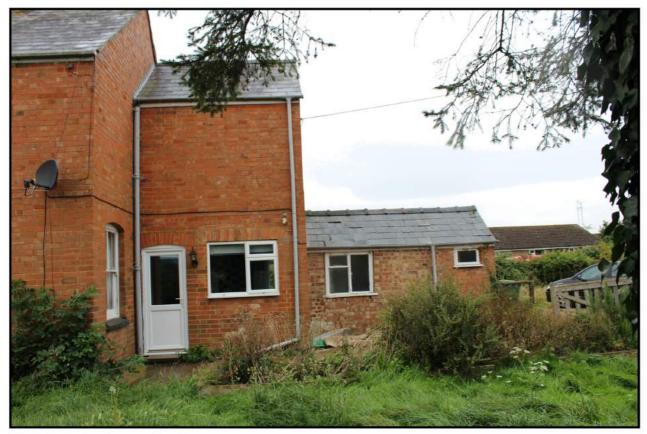
Fig 8: East elevation; north end

The other elevations (Figs 3.2 - east and west elevations, 3.3 - north elevation and Figs 6, 7, 8, 10, 11 and 12) were somewhat plainer. These were built in a version of Flemish bond (header/three stretchers/header in courses). The openings, where original, have single brick arches and blue brick moulded cills (Fig 9). The blue brick damp proof course continued around all three elevations.

A small extension was added to the Phase 2 structure. This was also in stretcher bond, had two small wooden windows at a high level and provided a lavatory at ground floor level (Figs 3.1, 3.2, 3.3, 8 and 11).

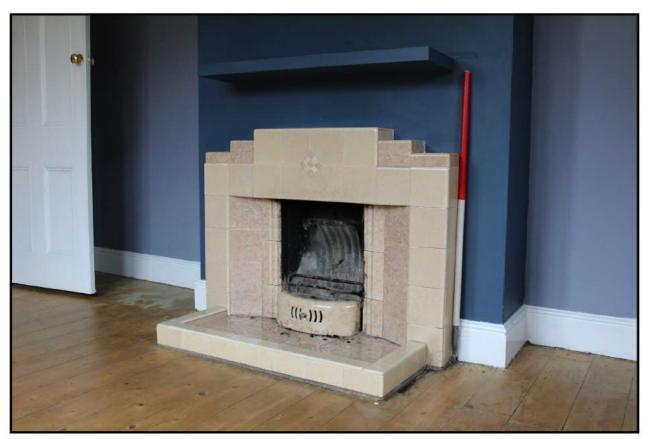
Fig 17: Room 2; sitting room, detail of fireplace

The tiled fireplaces in the principal ground floor rooms (Figs 17 and 20) probably date to the 1950s.

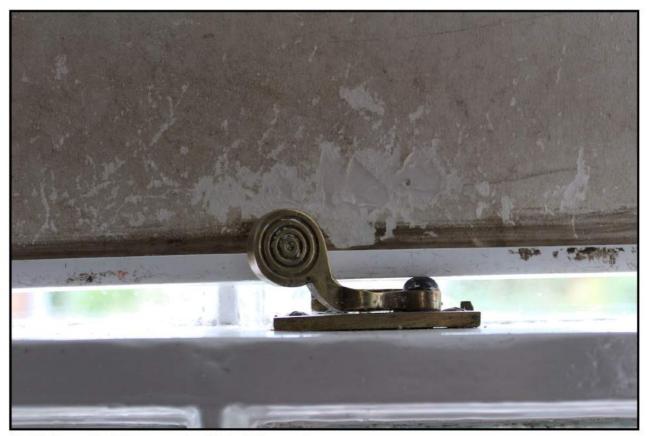
Fig 21: Room 3; dining room, detail of window catch

The interior has been redecorated over the years and only a few features may be assigned to the original construction of the house. These are the tiled floor in the hall (Figs 13, 14 and 15) the fireplaces on the first floor (Figs 28, 32 and 36) and the banister rail, spindles, the top and bottom newal posts and their caps. It is possible that the stair itself is also original but this could not be determined. The building retains sash windows in many of its openings but it is unlikely that these are original. The catches (Fig 21) may be.

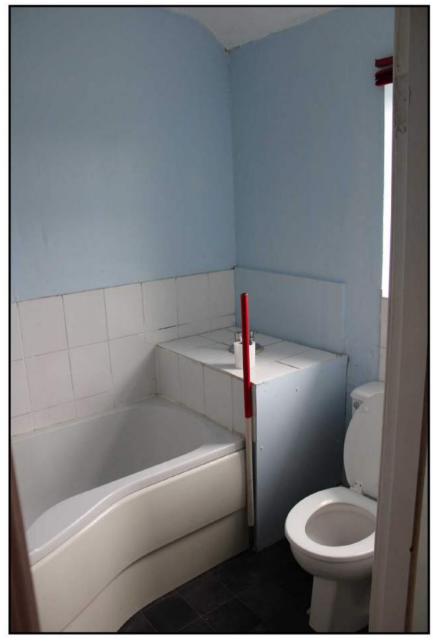
Fig 30: Room 8; bathroom, formerly part of first bedroom

The first bedroom was subdivided with stud partitions to provide a bathroom and toilet, accessible from the first floor passage, and an *en suite* (Figs 3.1 30 and 35).

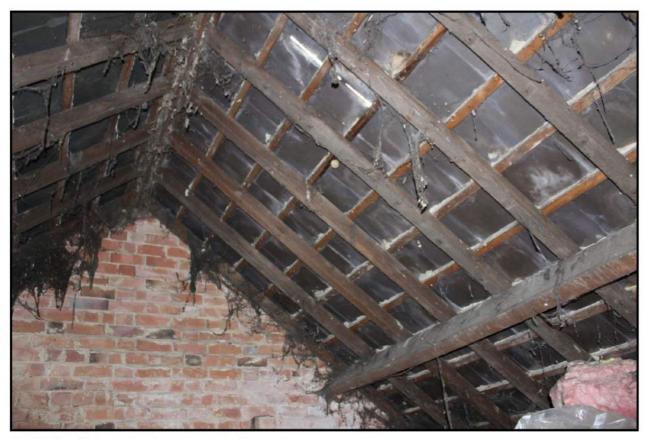
Fig 37: Roof space showing common rafter roof

The roof was of common rafter construction (Fig 37) with a ridge board and single, mid-height purlins, supported at the gables (the southern one of which they penetrated, Figs 3.3 and 4) and on the midcross-wall. The roof covering was of slate. Where it was possible to measure these slates, they were 24 inches by 12 inches (c 605mm by 305mm). Slates sizes were named after female nobility (a system devised by General Hugh Warburton at Penrhyn quarry in 1738). The examples at New Street, Childswickham were of the size known as 'Duchess'. The use of slate, which was light compared to the other, then commonly available, roof coverings, enabled the employment of both a lighter roof construction and thinner supporting walls.

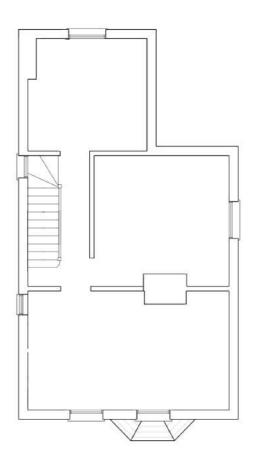
Fig 39: Conjectural original layout of first floor of 1 New Street, Childeswickham

One of the most significant changes to the internal layout of the house came in the later 20th century, or possibly early 21st century, with the creation of a bathroom and toilet and an *en suite* out of part of the area occupied by the first bedroom. An attempt was made to recreate the original layout at first floor level by removing the stud partitions and re-establishing the likely original positions of the solid walls (Fig 39).
