**BOX TREE HOUSE, 67 HIGH STREET,
HATFIELD, SOUTH YORKSHIRE**

BUILDING RECORDING REPORT

REPORT NUMBER 2010/17

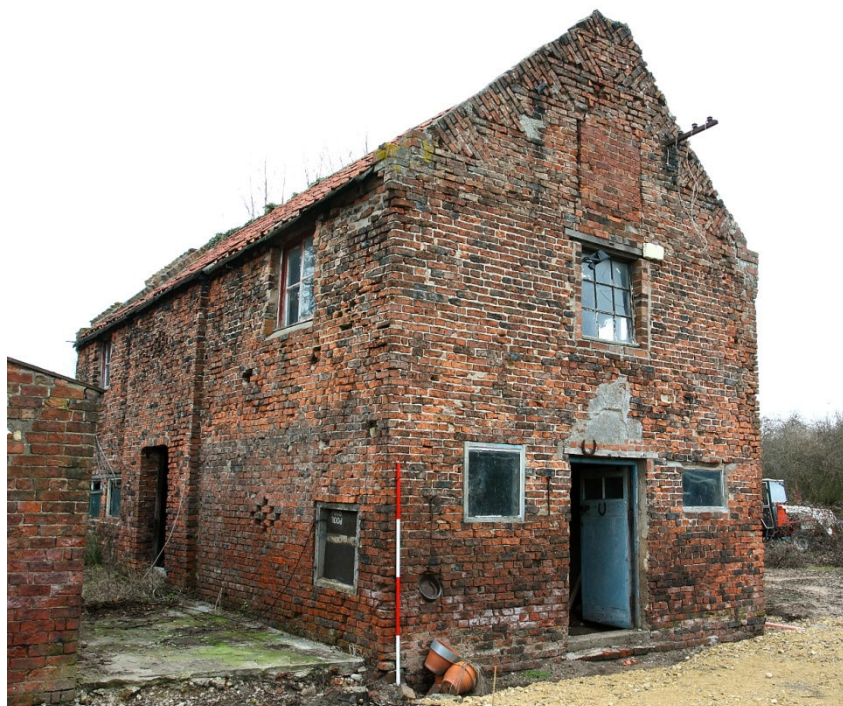
The entrance to the barn is via a central doorway some 1.3m wide and set within a projection that extends from the ground to the eaves. This facade projection, which is mirrored by a similar feature to the north elevation, projects some 100mm from the barn walling to either side. There is some evidence for a former opening to the western side of this elevation in an area now occupied by a window; this takes the form of a blocking (with larger 19th century bricks) in excess of 1m wide. To the ground floor there is a double arrangement of windows at the western side, both of simple, non-opening wooden frames, probably of the later 19th century. The truncation of brickwork at the edges of the windows indicates that these are insertions. To the eastern side at ground level there is a further opening. This does not contain glass but has a grill of ironwork to the interior, whilst two pintles to the west side of the frame indicate that it formerly had a shutter. To the first floor there are two windows of 'Yorkshire' sliding sash type. Truncation of the brickwork to the edges of the frames points towards their being later insertions, again probably during the 19th century. Through-wall vents created by the omission of individual bricks was evident in two places, one to the eastern side of the ground floor, the other to the central projection at first floor level. Each was of recumbent diamond pattern and consisted of nine voids. It would be anticipated that a similar arrangement would have been present to the western side at ground floor level, this absence may relate to the putative blocked opening in this area.

Plate 1 South and east elevation of barn, looking NE. Note feed tube adjacent to scale

Centrally located at the ground floor level was a doorway some 1.1m wide. The brickwork to either side of the doorway had been truncated indicating that this was an insertion, though whether this replaced an earlier narrower doorway could not be determined. There is evidence indicating the former presence of a first floor doorway/opening and this had been blocked up with 19th century bricks. Two windows were present to ground floor level, one to either side of the doorway. Whilst the frames appear likely to be replacements it is possible that openings here were originally present as the brickwork to the sides showed no sign of having been cut away. An inserted window was present to first floor level and occupied part of the lower portion of the blocked former doorway/opening. At a low level to the southern part of this elevation a blocked feeding pipe was present (see ground floor).

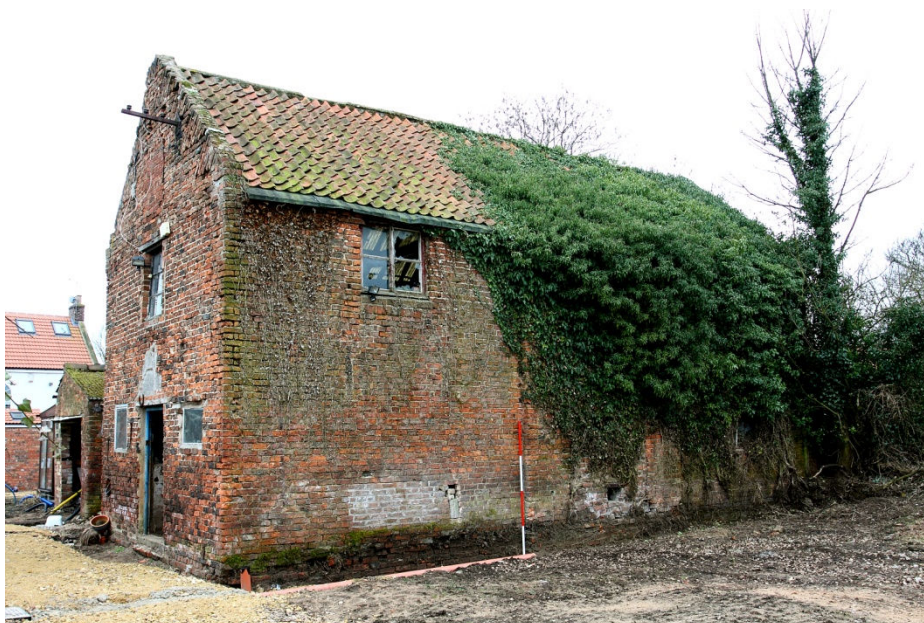
Parts of this elevation were heavily overgrown with ivy which at a higher level prevented accurate inspection. The central doorway arrangement of the north elevation originally mirrored that of the south elevation, though was marginally wider. This doorway was blocked up with 19th century brickwork and had subsequently had a window inserted. The frame of this window suggests an earlier 20th century date. An area of straight jointing to the brickwork immediately east of the blocked doorway may relate to a former opening. To the western side at ground floor level a sliding sash window had been inserted as had two more at first floor level. Two tall ventilation slits, subsequently blocked were present at the eastern side, these were some 450mm tall by 90mm wide.

Plate 2 North elevation of barn, looking SW

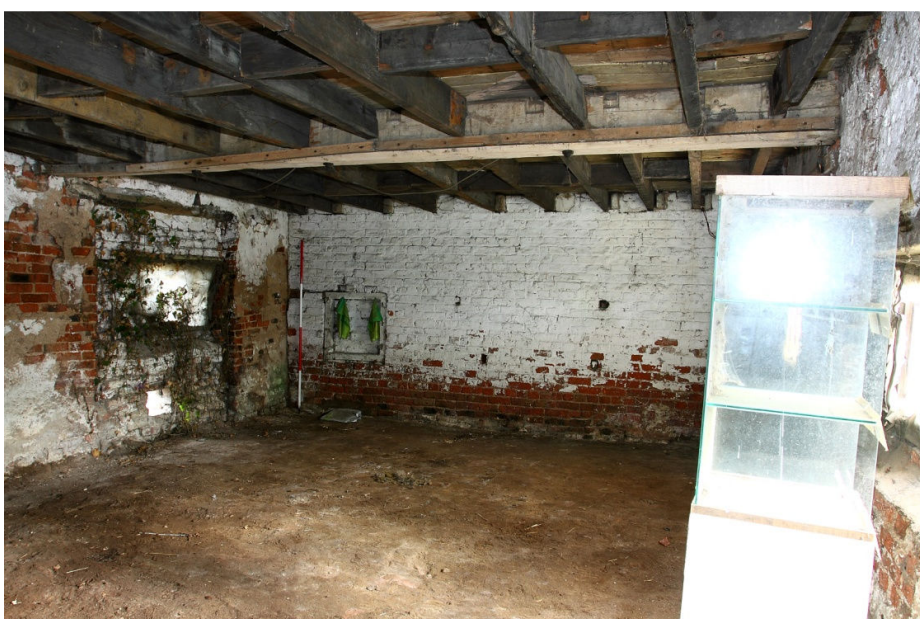
Plate 3 *Barn ground floor, western space, looking ENE. Note blocked N doorway, slots in beam for coggled joists and inserted 19th century wall with small blocked opening*

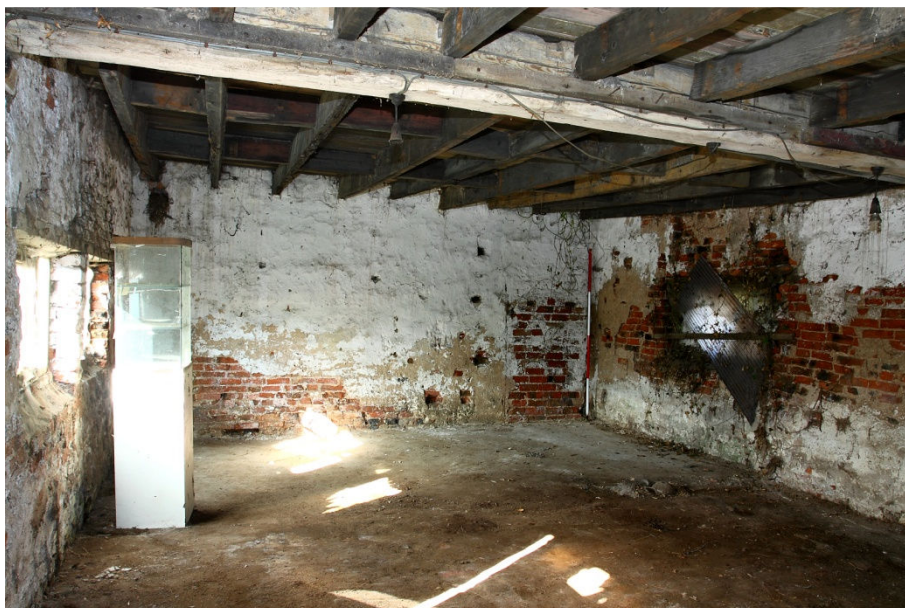
Plate 4 Barn ground floor, western space, looking WNW.
Note blocked doorway near corner

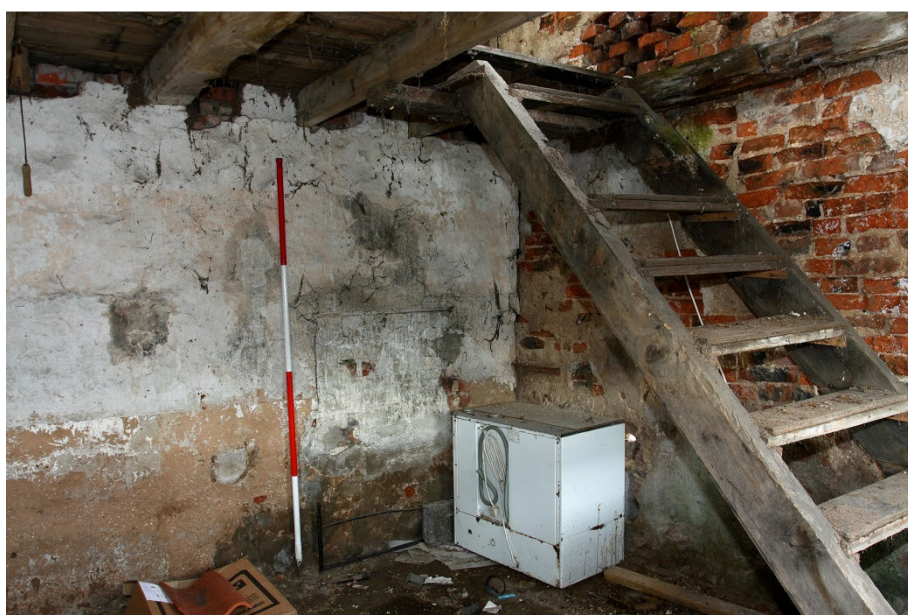
Plate 5 Barn ground floor, larger of the two eastern spaces, looking NW.
Secondary usage for livestock and showing steps to first floor

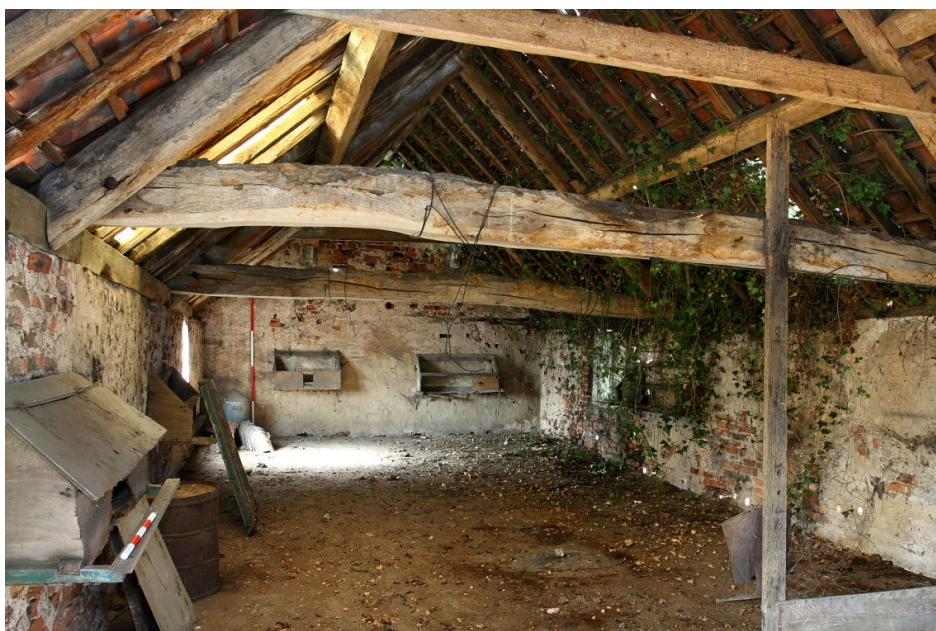
Plate 6 *General view of first floor, looking W*

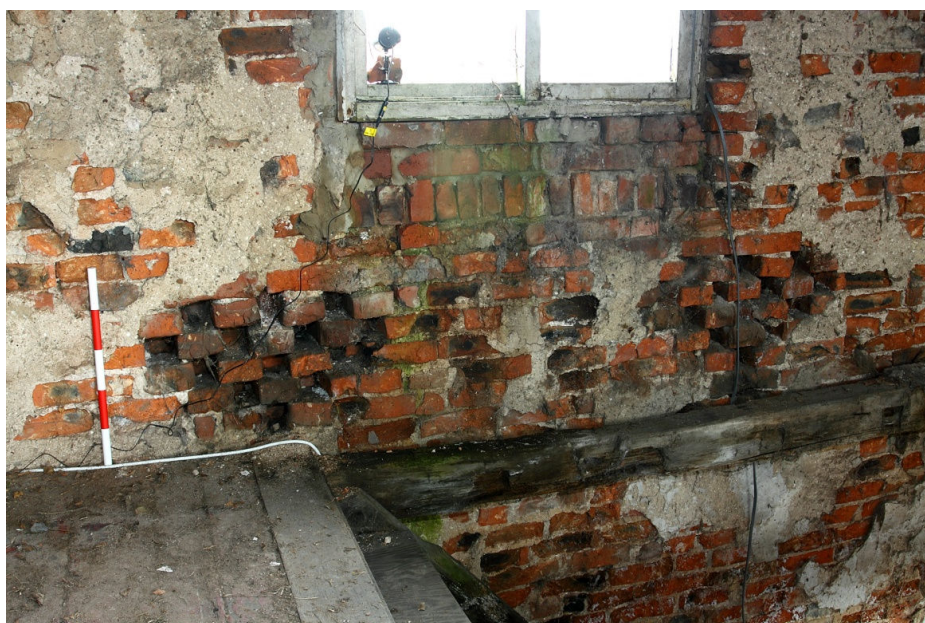
ground floor. To the north wall two areas of through wall vents were observed, one to the east the other to the west; these had been blocked-up to the exterior side of this wall.

Plate 7 *Blocked vents to E side of N wall below inserted window and adjacent to steps, note render to walls, looking NNE*

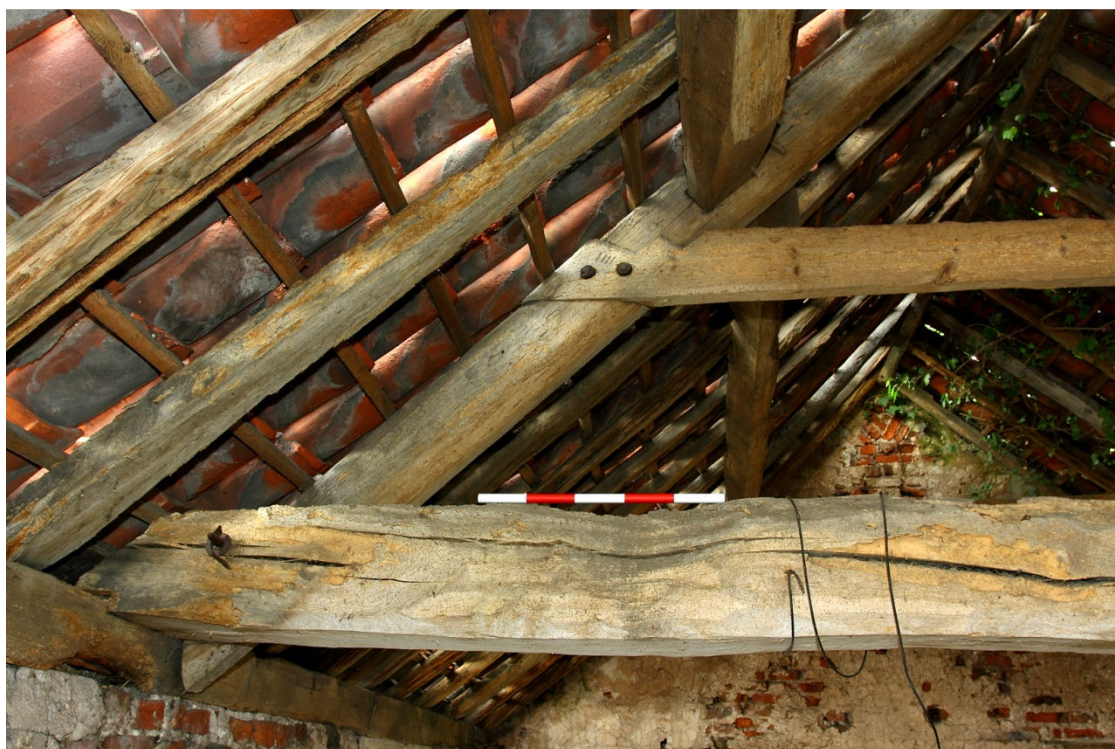
The roof structure of the barn is very largely original and of some interest. Two wall-plates extend fully along the north and south walls. The wall-plates support two roof trusses, one of which sits directly over the ground floor ceiling beam and the other over the suggested position of a former beam. The trusses are comprised of two principal rafters which are connected towards their bases by lap joints (simple butt joint involving no cut joint) to a tie-beam, the connection to the principal rafters and tie-beam being by single large iron bolts. Notches at the base of tie-beam and principal rafters facilitate the connection of both elements to the wall-plate. The upper ends of the principal rafters are connected by halved lap joints and at their apex support a square section ridge purlin. A low-level collar also links the principal rafters and these are connected by what appears to be an unusual form of notched lap joint, with these joints being additionally secured by two bolts to each side. The only assembly marks seen on the roof structure were related to the joints between principal rafters and collars. Large purlins extended between both trusses and from these to the end walls. The purlins, were of tenoned type, and tapered towards their jointed ends. They were secured by wooden pegs. The common rafters extended from the wall-plate and lapped over the purlins and ridge purlin.

The principal points of interest regarding this roof are the use of iron bolts and wooden pegs, the unusual joint connecting principal rafters to collars and the sole means of jointing between principal rafter and tie-beam being a single iron bolt. The contrast between the elaboration of the collar joint and the crudity of that of the tie-beam is stark. It is tempting to see the tie-beams as additional support added to a roof of common rafter type (i.e. with principal rafters and collar but no tie-beam), but not possible to verify such.

Plate 8 Detail of roof structure, looking W

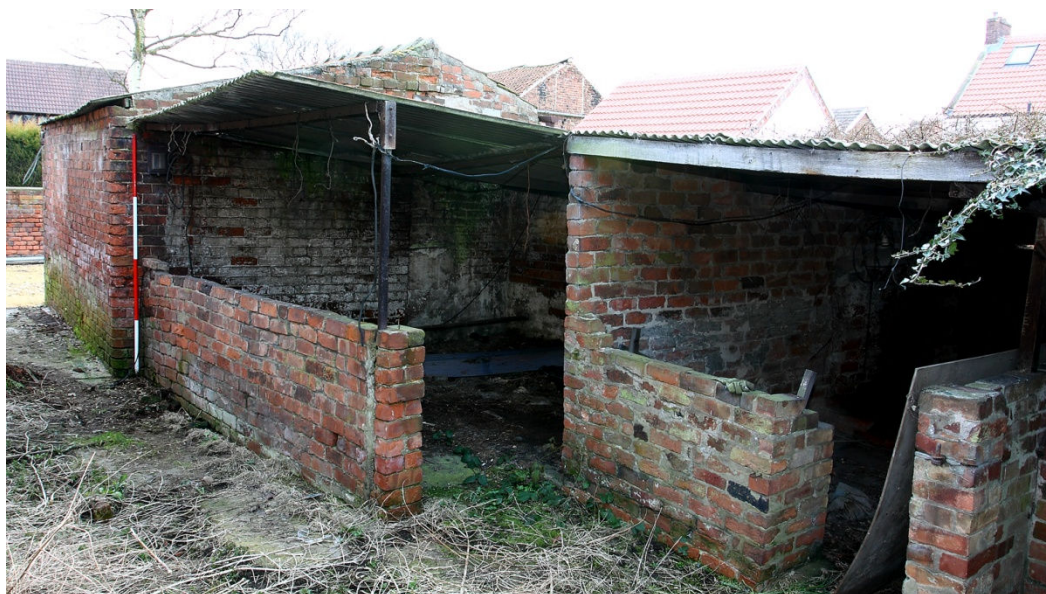
Plate 9 *Pigsties with store beyond, looking SE*

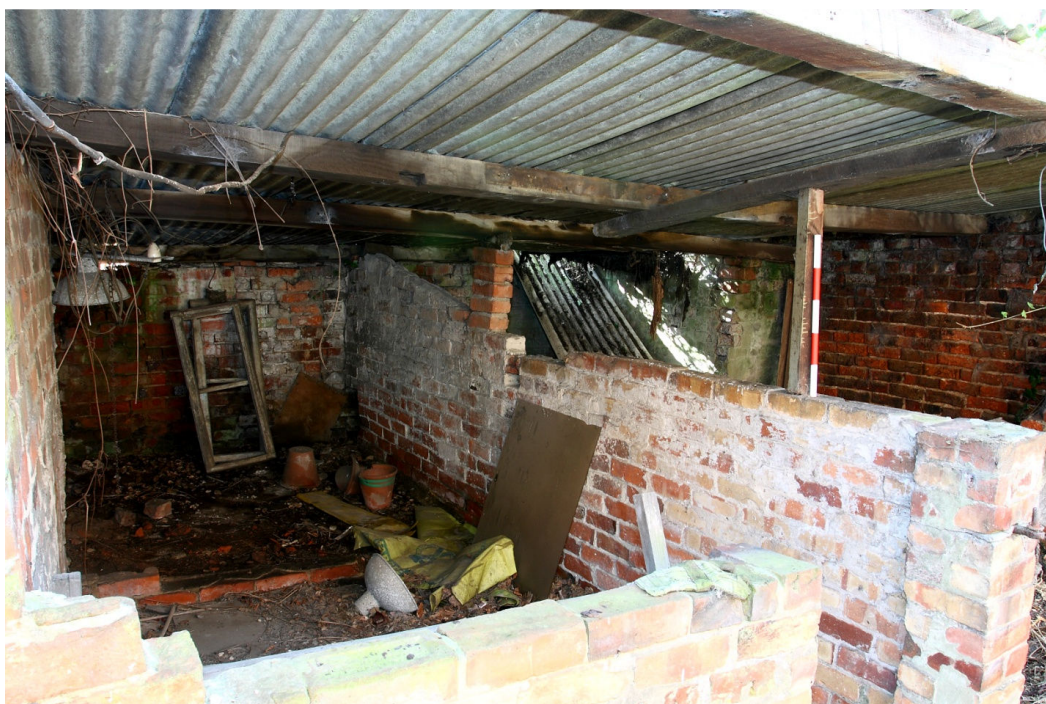
Plate 10 *Detail of western pigsties, looking SW*
