**HALL FARM, MAIN ROAD, HATHERSAGE,  
DERBYSHIRE**

**BUILDING RECORDING REPORT**

**REPORT NUMBER 2008/27**

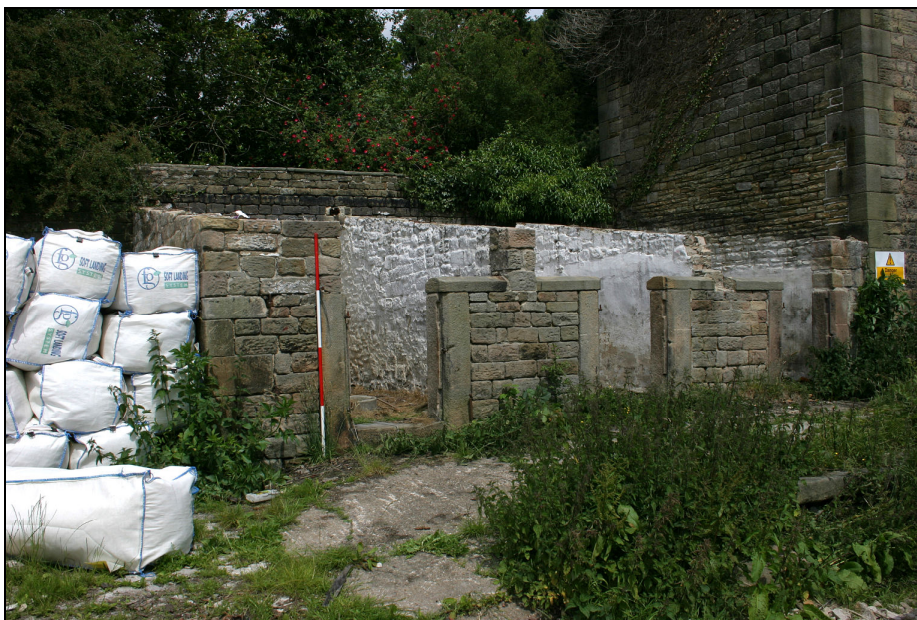
*Plate 1 Building A1, pigsties, south elevation*

These are located at the western end of the range and comprise three individual sties and an open fronted cart shed to the west. They are built of stone and currently have no roof. Originally they would have been roofed with stone or slate, although until recently had a covering of corrugated iron.

The sties take the form of three walls extending from the rear wall and angled downwards to the front in order to support a sloping mono pitch roof. The internal walls are composed of roughly coursed stone whilst the external faces are regularly coursed and tooled. To the front, south facing elevation, of each sty there is a doorway and an adjacent lower wall to provide light and ventilation. The door jambs are comprised of a single piece of stone grooved and socketed to take a door. The metal hinge pins still survive in-situ. The low walls at the front are topped with dressed coping stones. Towards the front of each sty there is an unusual circular grit stone feeding trough (Plate 11). The floors are stone flagged. Part way along the length of each sty there is a variation in the fabric of the dividing walls and a corresponding threshold in the floor. A map of 1924 (Figure 7) shows a small pen at the front of each sty, this shows that the roof only covered the rear half of the sty, a common style. Surviving fittings include bars at the rear of the stall to hold a feed trough and pipe work for a water supply.

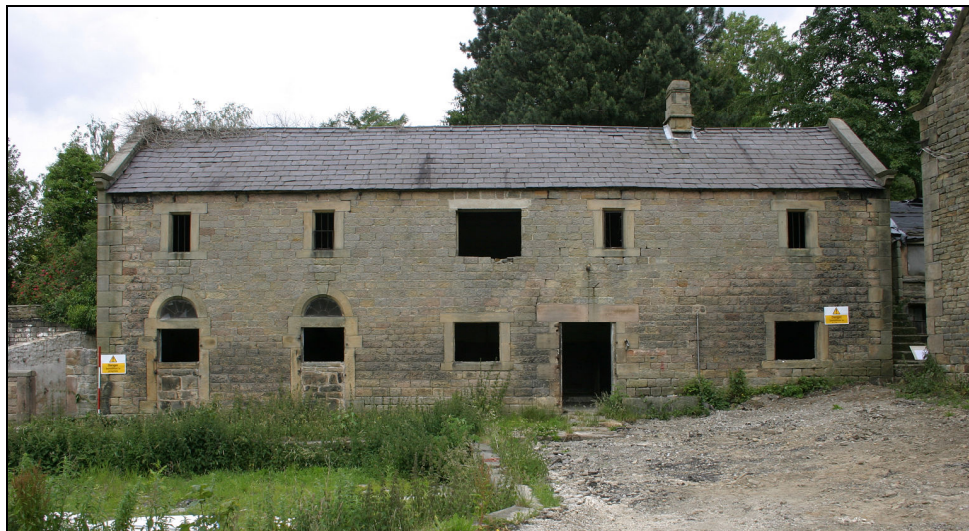
*Plate 2 Building A2, stable block, south elevation*

This is a two storey building built of grit stone bonded with lime mortar. It has ashlar quoins and door and window surrounds. The roof is of welsh slate with coped stone gables and carved kneelers, and there is an intermediate stone ridge stack. The building is rectangular in plan with three rooms on each floor. On the front south facing elevation the stone work is square dressed and tooled to show weathering. To the west on the ground floor there is a pair of doorways with a flat faced Gibbs surround and a chamfered lintel from which springs a fanlight with a keystone. In both these doorways the lower part has been blocked with stone, and the upper part has had a window inserted. The windows no longer survive but the

Building A2 was a stable block later converted to house cattle. Stylistically it would fit the date range of late 18<sup>th</sup> to mid 19<sup>th</sup> century. It is quite clear that first floor of A2 is an addition to an earlier wall, at least at the north side. But whether this is an earlier building replaced by the current A2 is unclear. It has a slate roof and assuming this is the original it places the origins of the current building at around 1840, when another slate roofed building on the south side of Building C is known from the 1840 map to have been built (Plate 20).

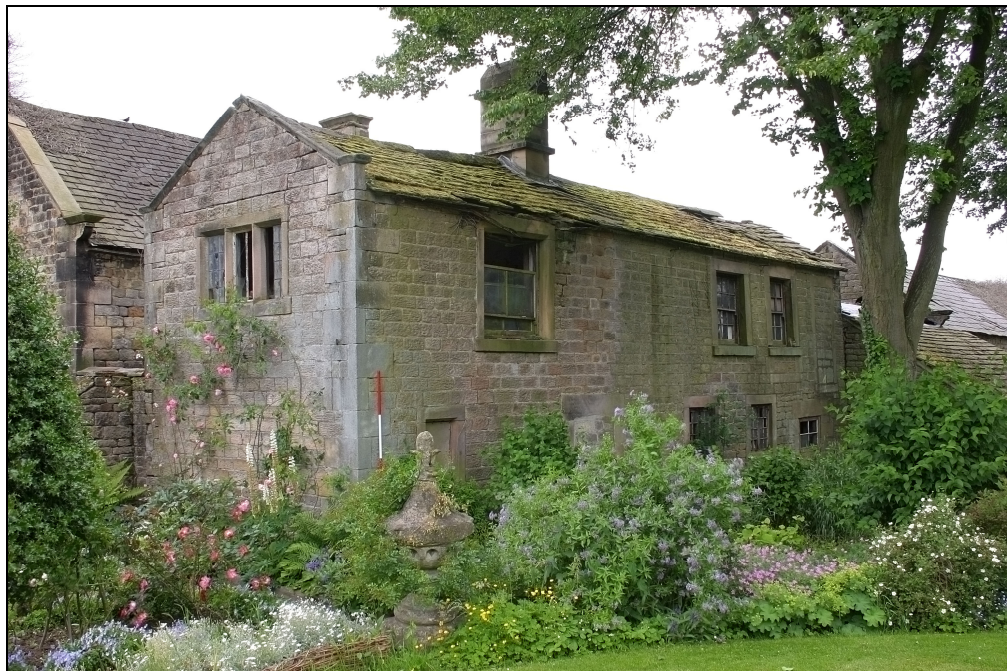
*Plate 3 Building A3, wash house, north elevation*

The northern elevation of A3 was formerly the main facade to this building with a range of open and blocked door and window openings. On the ground floor at the eastern end there is a narrow window with chamfered surround and the stubs of a pair of vertical iron bars. To the west of this there is a stone blocked doorway with a cranked lintel. West of here there is a pair of rectangular window openings with squared un-chamfered single piece stone surrounds. In both these examples the lower part of the window has been blocked by a single flag stone and the upper part has a 16 light wooden casement window inserted. Beyond this there is a further blocked doorway with a flat faced Gibbs surround. The lower part is blocked with stone and the upper part has a single four light casement window.

As with the opposing elevation this façade displays a similar difference in fabric both vertically and horizontally. There is no quoining at the western corner on this elevation. The level of the change in fabric matches that to the rear of A2 to the west and the lower portion of this wall is a continuous build westwards. Thus the lower part of the rear of range A is a single build extending from the end of A2 through to at least the middle of A3. The fabric in A3 has numerous nail holes in the mortar showing how it once supported some form of garden trellis.

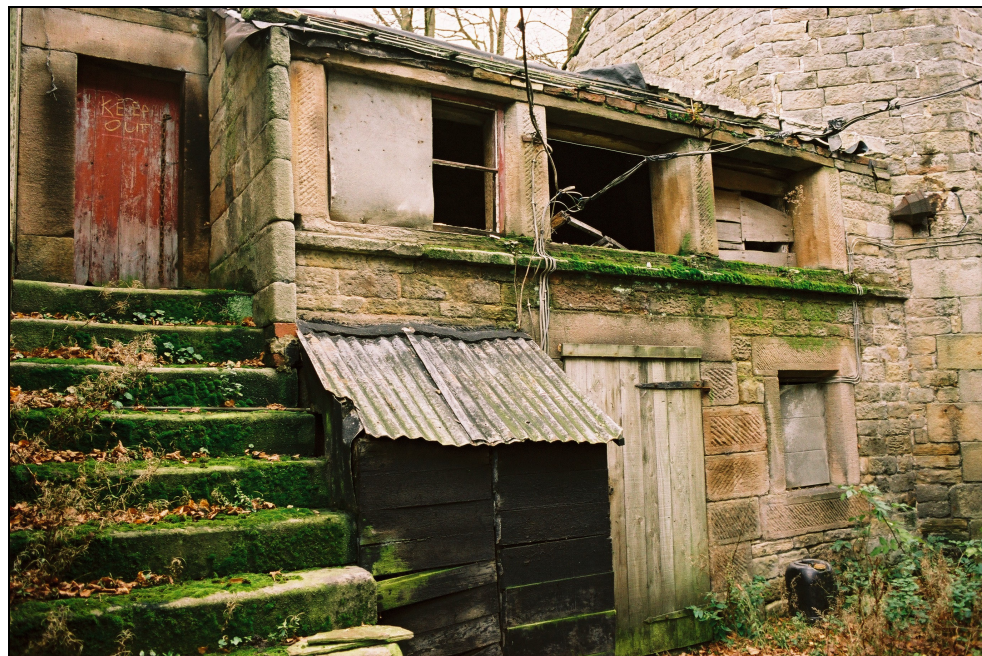
*Plate 4 Building A4, hen house, south elevation Photo courtesy Rural Solutions*

This building lies between and is set back from buildings A2 and A3. The rear wall is formed by the dividing wall for Hathersage Hall. On the north side there is a lean to in the grounds of the Hall. The lower part of the north wall is the continuous build which forms the rear of both A3 and A2. The upper part of the wall is clearly a different build and butts against the ends of A2 and A3 (Plate 17). As with A3 to the east there are numerous nail holes in the mortar from a garden trellis.

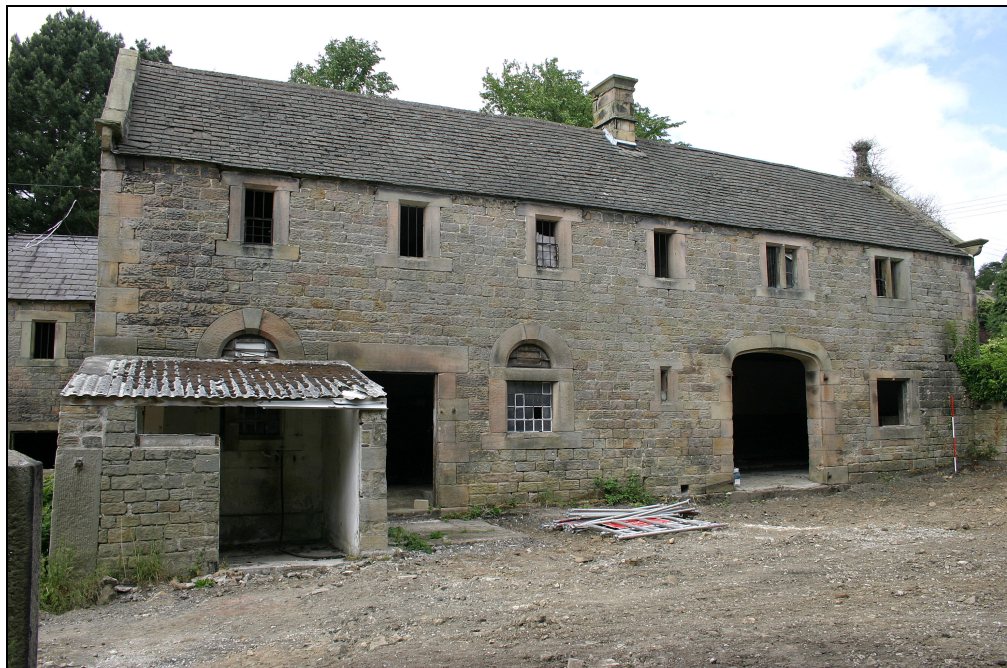
*Plate 5 Building B, coach house, south elevation*

Building B is on two stories and is built of regularly coursed grit stone with a brick inner face on the ground floor. It has ashlar quoins and door and window surrounds and the stonework has a rough tooling finish and is bonded with lime mortar. The roof is covered with concrete tiles with an off-centre intermediate ridge stack and narrow octagonal stone stack on the eastern gable. The building is rectangular in plan with two rooms on each floor separated by

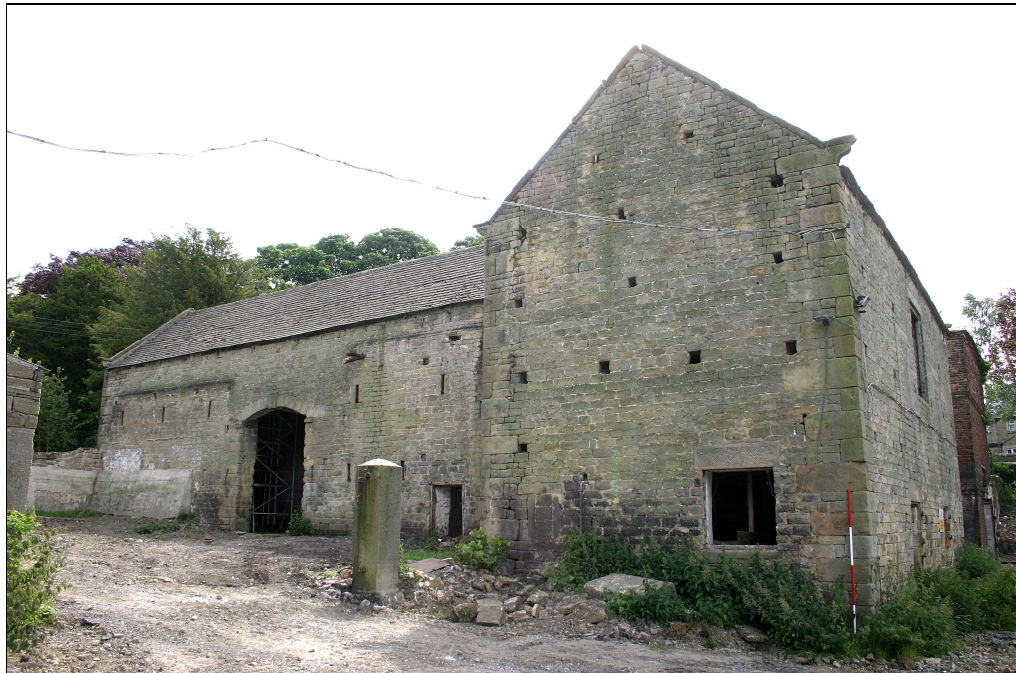
*Plate 6 Building C, barn, north elevation*

This is located to the south of Building B across the stable/coach yard and its east gable forms part of the dividing wall with the Hall. It is built of rough coursed grit stone with dressed quoins and is bonded with lime mortar. The roof is covered with concrete tiles with stone

On the northern elevation to the east of the archway three slit windows are masked by the concrete sides of a 20<sup>th</sup> century silage pit although they are still clearly visible on the internal walls. To the west of the arch there is a window and doorway opening into the lower level of the building. The window is clearly a later insert as it has timber lintel and jambs and has removed part of a ventilation slit leaving only the right hand jamb. The adjacent door has dressed stone surrounds and a heavily worn threshold leading to two steps down to the interior and from its style and nature of weathering is an original opening. To either side of the archway there are traces of timber and corrugated iron lean to structures which have since been removed. These include to the east the roof scar and enlarged ventilation holes to take joists and to the west holes cut to take roof timbers some remains of which still survive.

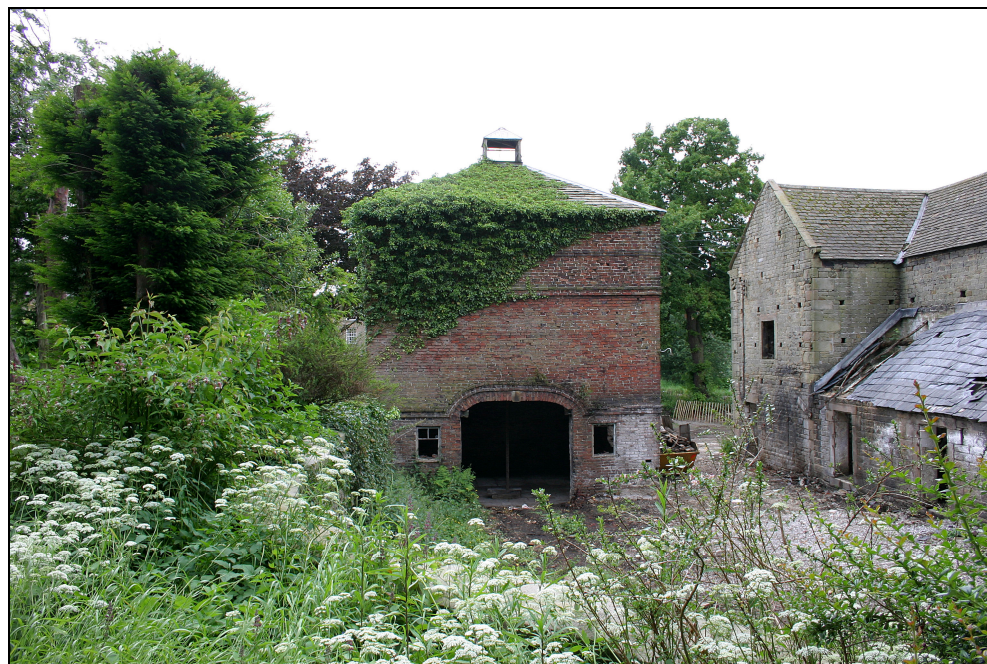
*Plate 7 Building D, dovecote, east elevation*

This building is located in the southern part of the complex. It is a brick built structure, square in plan with a pyramidal roof covered with stone flags and lead flashing and topped with a square wooden lantern/cupola. There is a carriage arch and flanking windows in the E elevation and a range of later inserted windows in other elevations. Internally there was a floor at first floor level above which rising through 2 storeys is the nesting chamber with all four walls lined with nesting boxes.

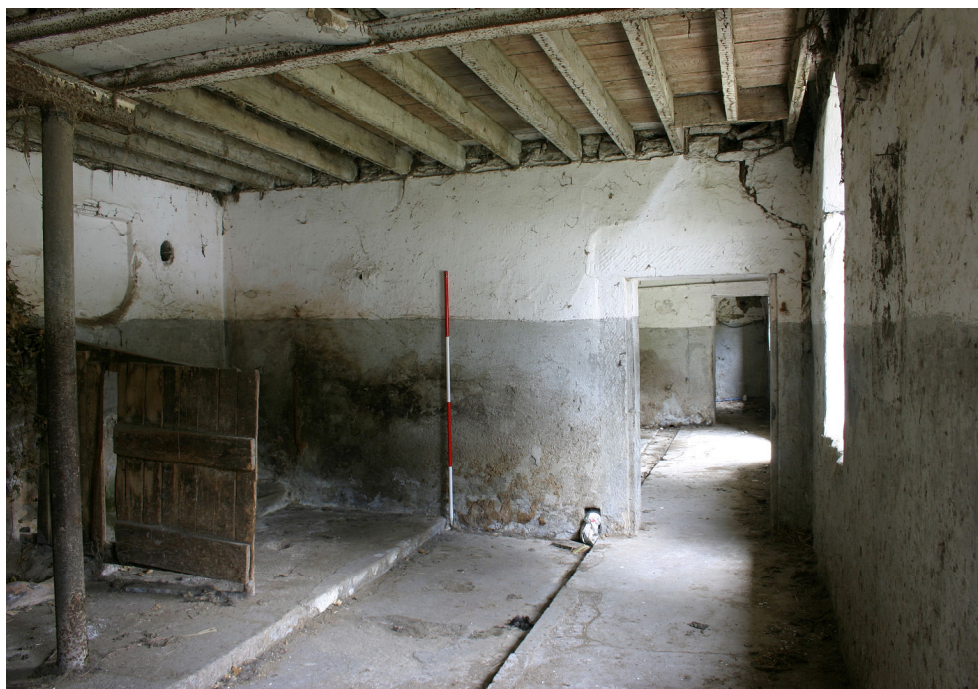
Internally the three ground floor rooms all have stock feeding troughs against the rear wall. These comprise ceramic troughs at ground level separated by a concrete block with every two troughs separated by short dividers called shippons to form stalls for two animals (Plate 12). There are two wooden shippons in the room to the west, three of concrete in the middle room and one of concrete in the smaller eastern room. All three rooms have a concrete floor with a central slurry channel 1.2m wide which drains to a midden in the yard to the front. The walls are covered with a lime wash the upper part being white and the lower grey in colour. The ceiling joists span across the building except in the room to the west where they run lengthways and are supported by a transverse iron girder and post. All the joists show nail marks from a former lath ceiling. Set into the rear wall of the room to the west there are two shallow round bottomed niches approximately 1.75m above floor level. These are located opposite the blocked doors and as there are remnants of fixings around the lower edges

these are interpreted as indents to supports semicircular feeding baskets set at the appropriate height for horses as opposed to cattle. (Plate 12) In the rear wall there are a series of circular and rectangular ventilation holes.

**Plate 12** Building A2, wooden shippon and recessed feeding niches in rear wall, facing east

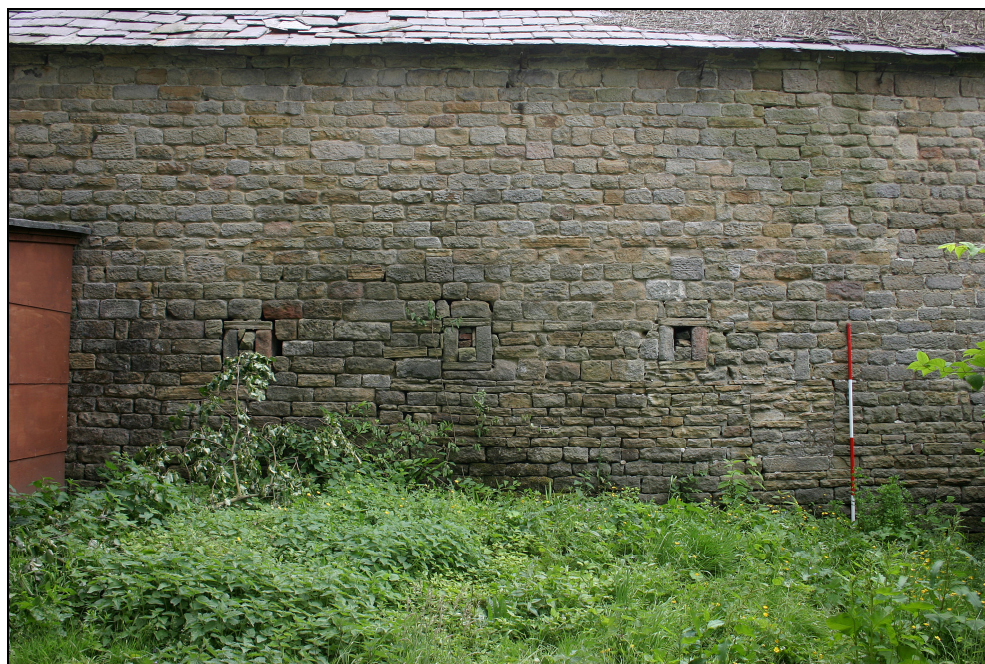
On the rear north elevation the fabric of the rear façade differs from the front in that the stones although squared are not dressed and tooled. The two rear corners only have dressed quoins on the upper part, the lower part being a pre-existing wall which extends as a continuous build to the east. Along the length of the rear wall there is a clear difference between the upper and lower parts (Plate 14) which is most clearly displayed on the return on the western gable (Plate 1). Here the upper part has the dressed and tooled fabric of the front façade, the lower part being narrower and un-squared stones. This suggests that the rear of A2 was a low wall with a return at the western end over which this building was built.

**Plate 14** Building A2, north elevation showing different build on upper and lower sections of wall

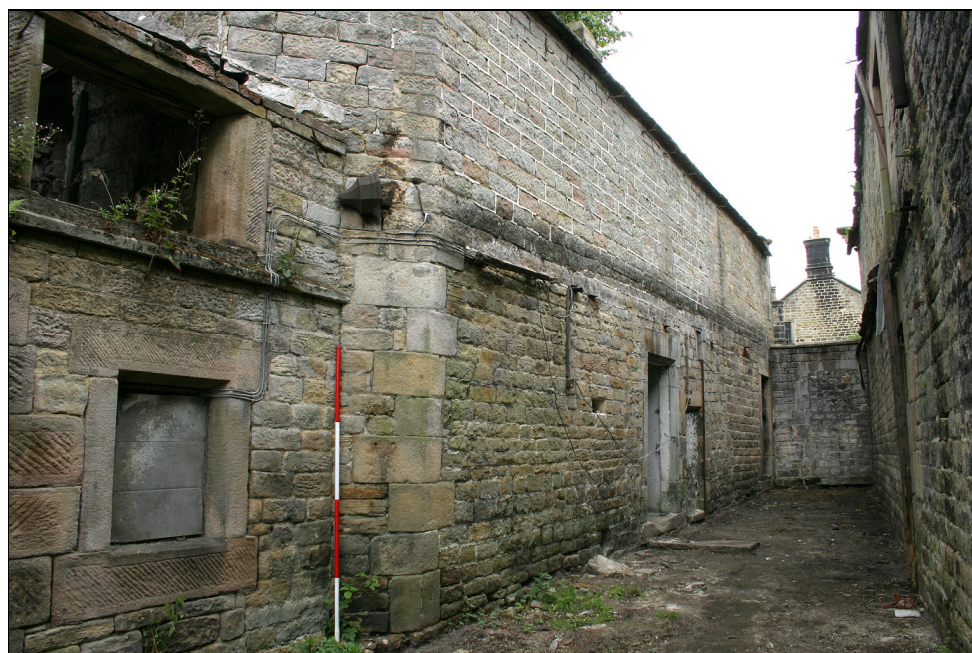
extending halfway along the south elevation at the level of the top of the quoining. Above this level the stones are mid grey in colour and have a distinctive rough diagonal tooling to replicate natural weathering whilst below this level the stones are slightly more irregular in shape, a paler more sandy colour and display the horizontal striations typical of natural weathering. This line also marks the rough position of a roof which formerly spanned the passageway so there would have been differential weathering on either side. However it is not thought that this would account for the nature of the change in fabric noted.

**Plate 15** Building A3, south elevation, showing single storey coining and differential build between upper and lower sections of wall

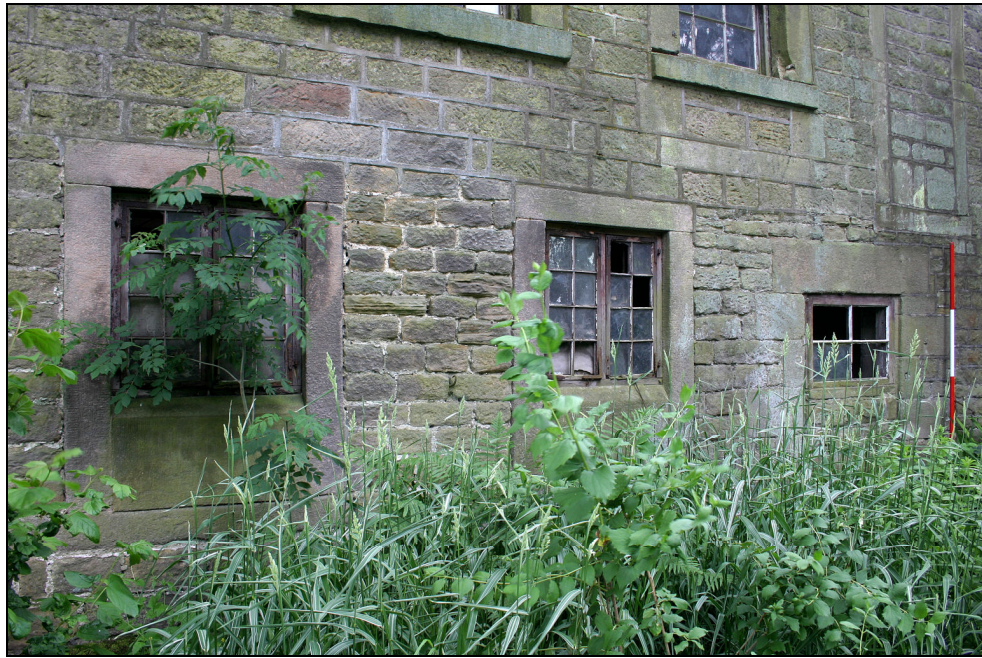
**Plate 16** Building A3, north elevation, showing differential build between upper and lower sections

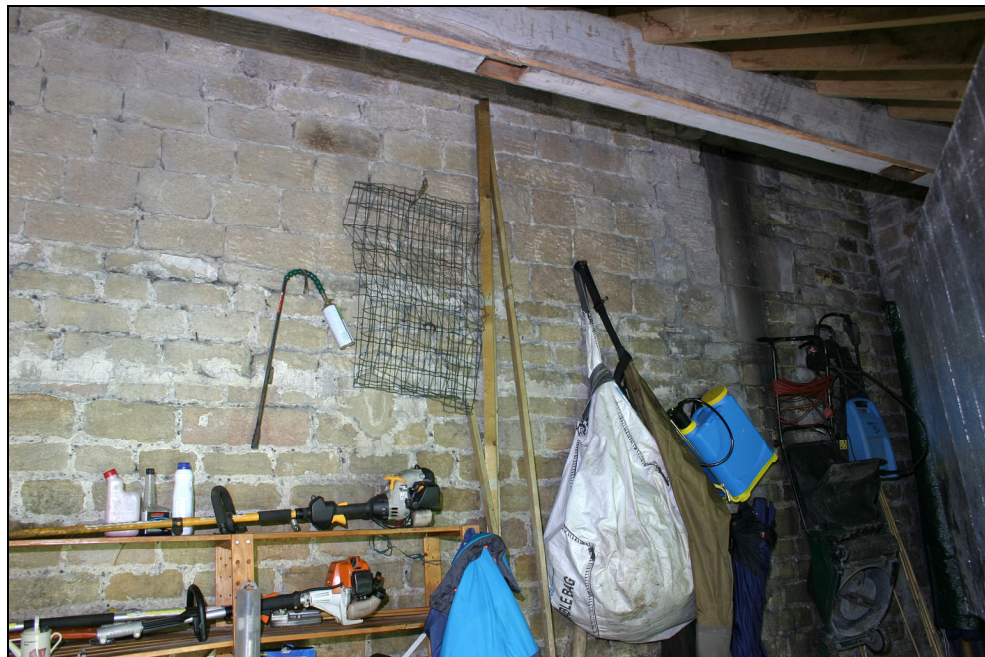
**Plate 17** Building A4, north elevation, first floor quoining for A2 visible at the dark patch to right and different build between upper and lower parts of wall identifiable

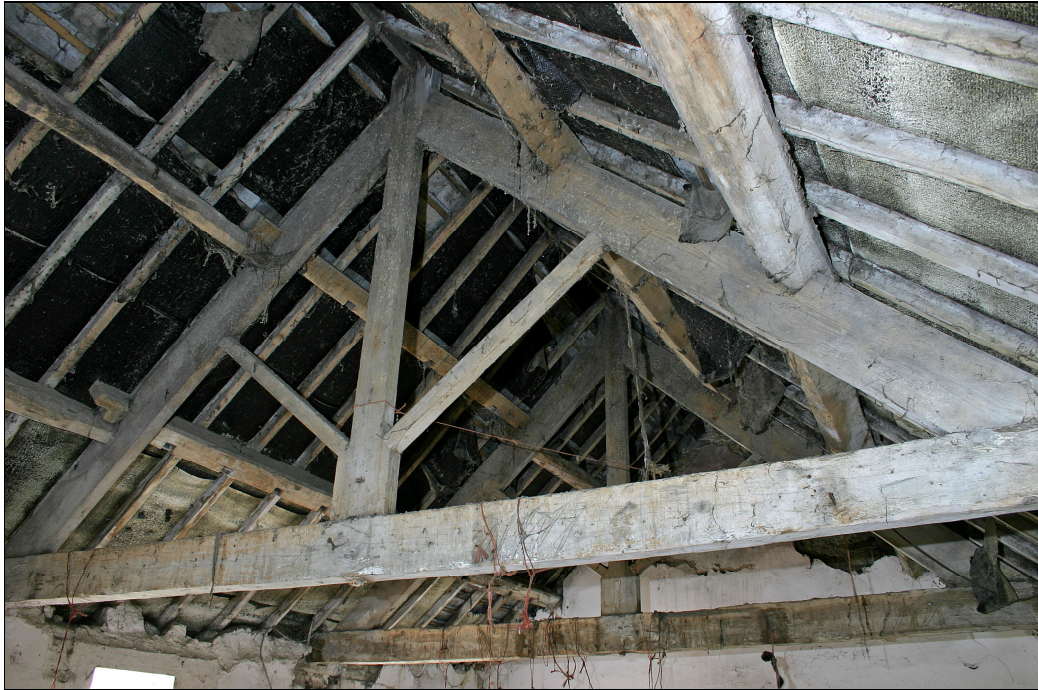
Access to the upper rooms is via opposing doors at the top of the stairs. Both rooms are open to the rafters and the roof structure can be clearly seen (Plate 19). It comprises a kingpost truss with double trenched purlins. In both rooms some of the purlins are square cut and notched to take joists and were presumably replaced when the roof was recovered. There are two trusses spanning each room. The roof has been lined with felt between the rafters and the covering. The room to the east has a chimney breast with a cast iron range set within. It has plastered and white washed walls and originally had a suspended ceiling which started partway along the rafters. There are lath nails on the rafters which indicate the ceiling's position and its line can be seen on the gable ends where the wall above is unplastered. The tie beams rest on the wall tops and thus would have been exposed below the ceiling. The tie beam closest to the door is boxed in with timber. The range is located in a chimney breast projecting into the room at the west end. This has a stone over mantle with a plaster batter on it which has the date 1969 alongside a set of handprints set into it. The floor beneath the fireplace has been strengthened below by the insertion of trimmer joists and planks. Although there is a chimney stack at the east end of this building there is no indication of a fireplace in either first or ground floor rooms and it is considered to be a decorative feature to be viewed from the Hall.

**Plate 20** Building B, first floor interior, detail of roof (Note re-used purlins on far side)

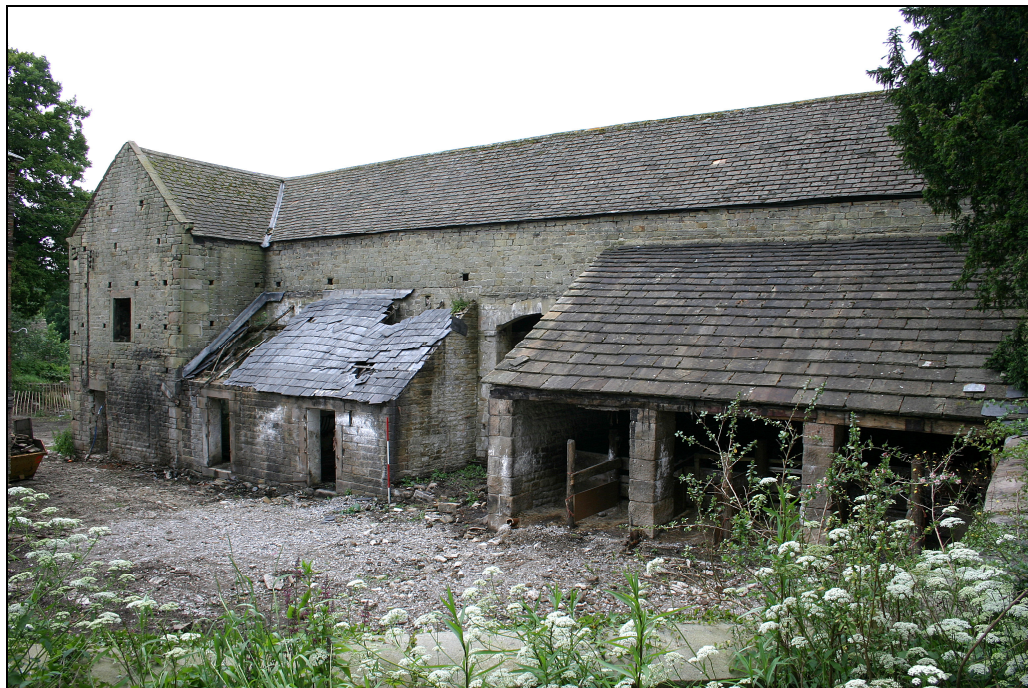
**Plate 21** Building C, south elevation, with 1840's additions

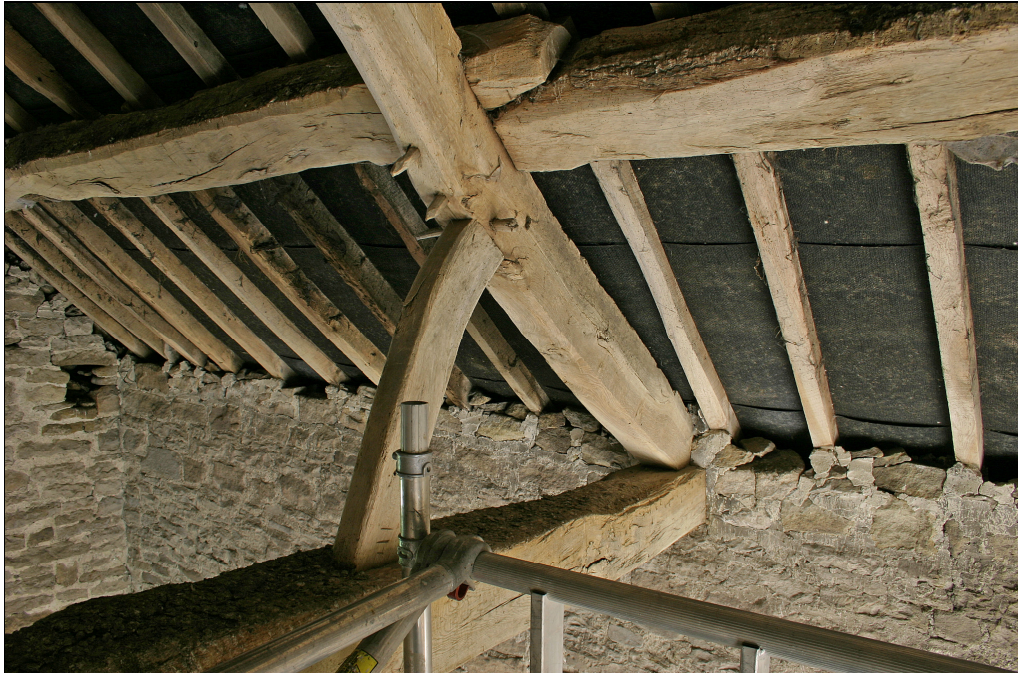
**Plate 25** Building C, detail of roof truss (Assembly marks visible to left of scaffold where the queen strut meets the tie beam)
