**THE LOUNGE CINEMA, NORTH LANE,
HEADINGLEY, LEEDS, WEST YORKSHIRE**

BUILDING RECORDING REPORT

REPORT NUMBER 2011/59

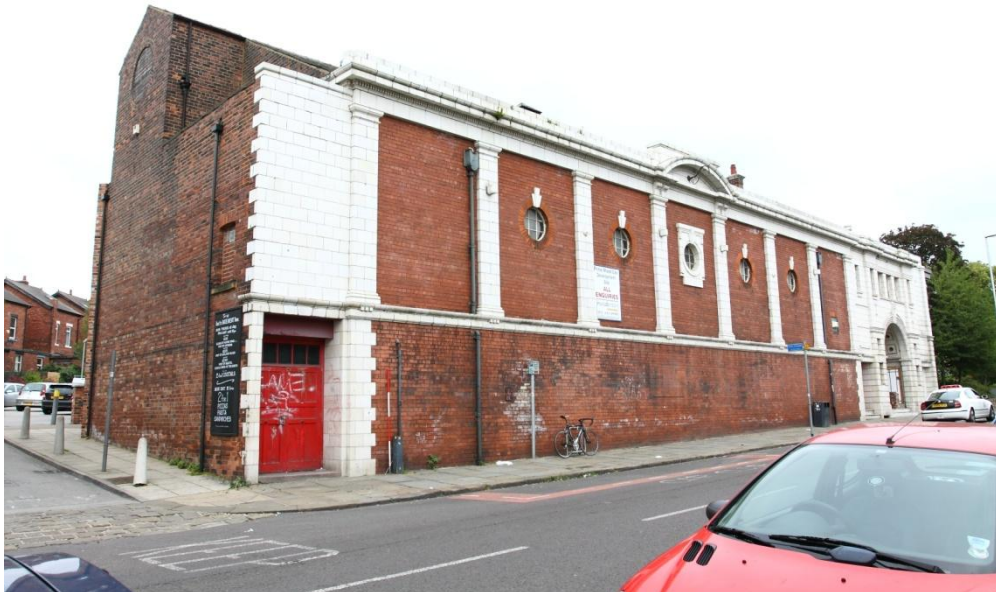
Plate 1 Overall view of the S.E. façade, looking N (8jpg)

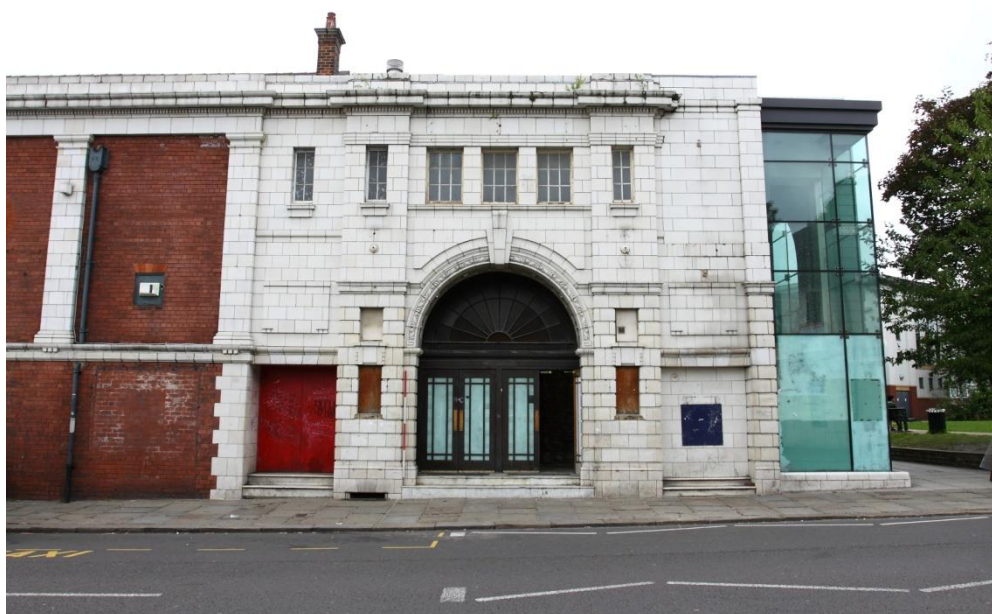
Just above pavement level to the south-west shallow projection, the upper part of a rectangular light/vent to the basement is evident (see Plate 2). Two circular white painted fittings mid height to the shallow projections, of identical form to two other examples noted on the main body of the cinema to this façade, may be parts of old light fittings.

Plate 2 The ornate entrance to the foyer, looking N.W.(16jpg)

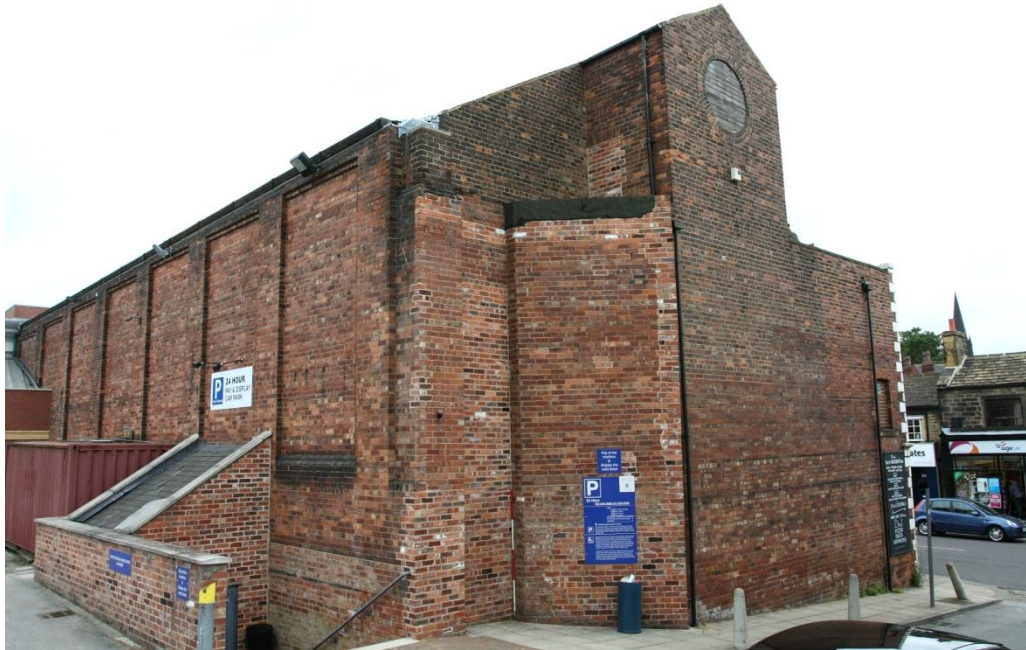
Plate 3 S.W. (end) elevation of the cinema, looking E. (4jpg)

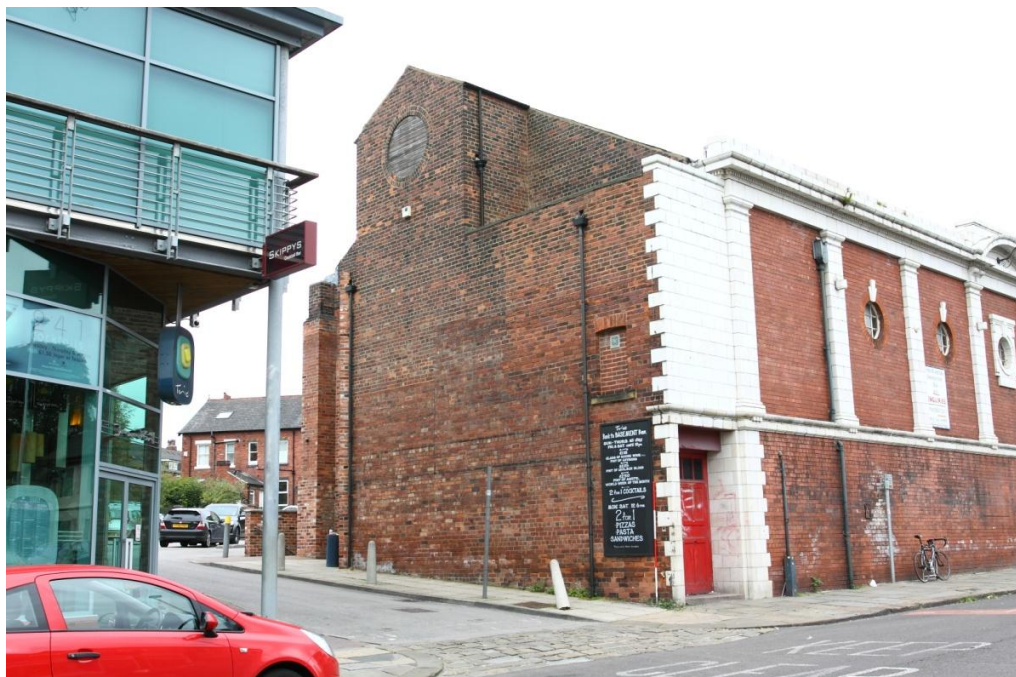
Plate 4 S.W. (end) elevation of the cinema, looking N. (5jpg)

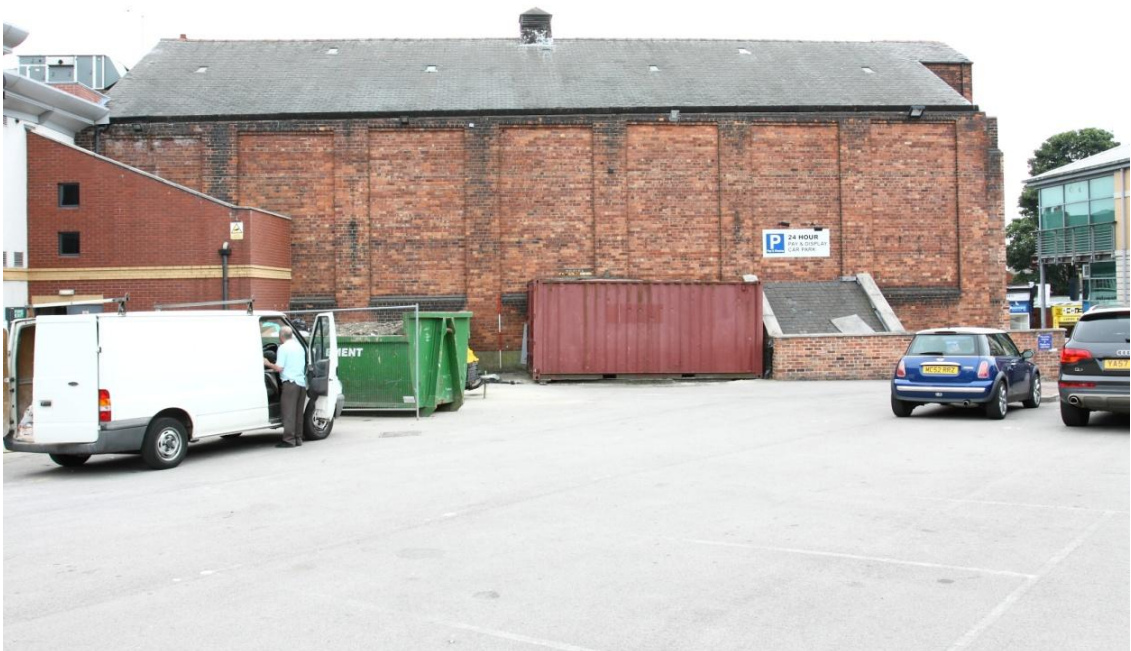
Plate 5 N.W. elevation of the cinema, looking S.E. (2jpg)

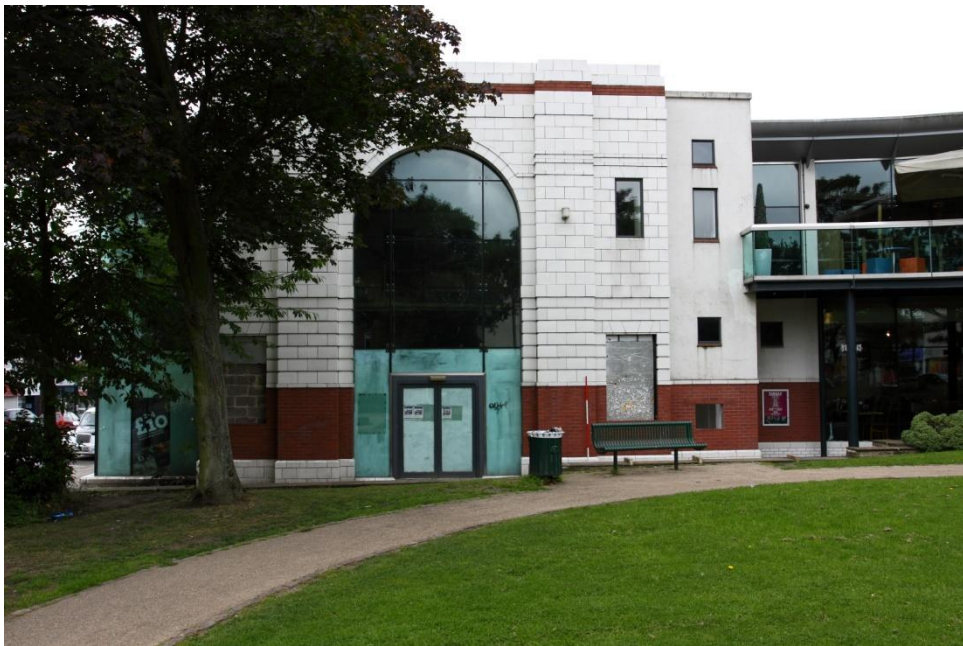
Plate 6 'Modern' N.E. elevation of the cinema, looking S.W. (14jpg)

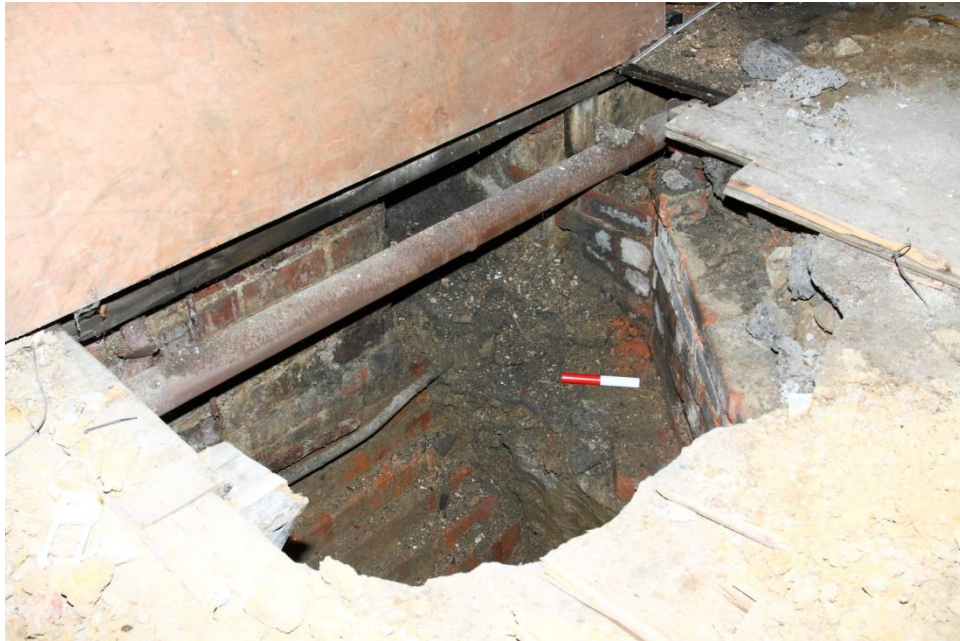
During the recording visit two internal engineering test-pits against the south-east wall of the cinema were seen to be open. These showed the brick footings of the walling to step out with at least four off-sets and to continue for a depth in excess of over 1m; the basal parts not being seen. A number of human-derived deposits were evident within the pits below the level of the flooring and these may relate to some sort of levelling up of the ground rather than simply representing the backfill of the foundation trenches. A brick lined duct for heating pipes definitely extends along south-east side wall and, according to plans of 1916, to the

Plate 7 Test-pit to S. internal corner area of the cinema, looking S. Note the pipe duct, offset footings, basal part of wall vent and brick lined end of 'sub-floor duct' (78jpg)

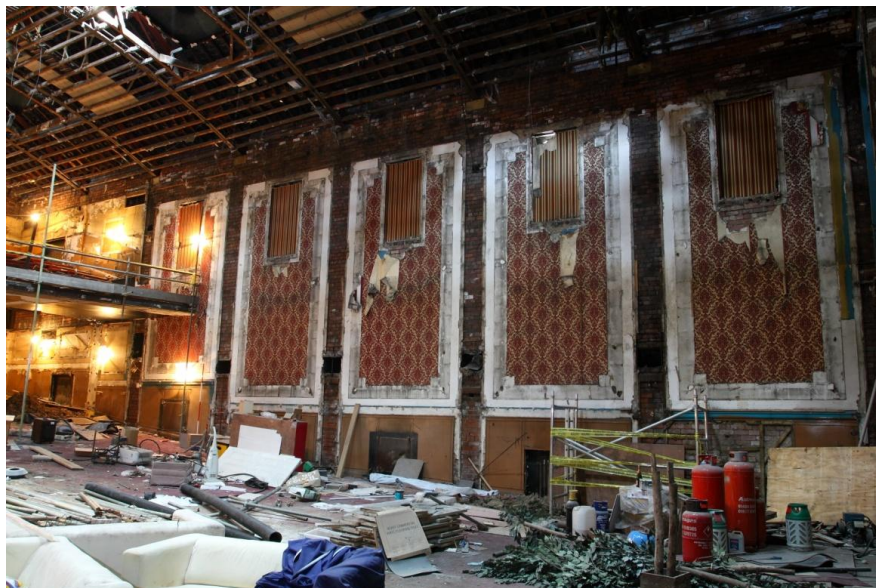
Plate 8 Part of the S.E. side of the auditorium showing decorative panels with inset panels obscuring circular windows. Former radiator positions can also be seen. Looking E. (21jpg)

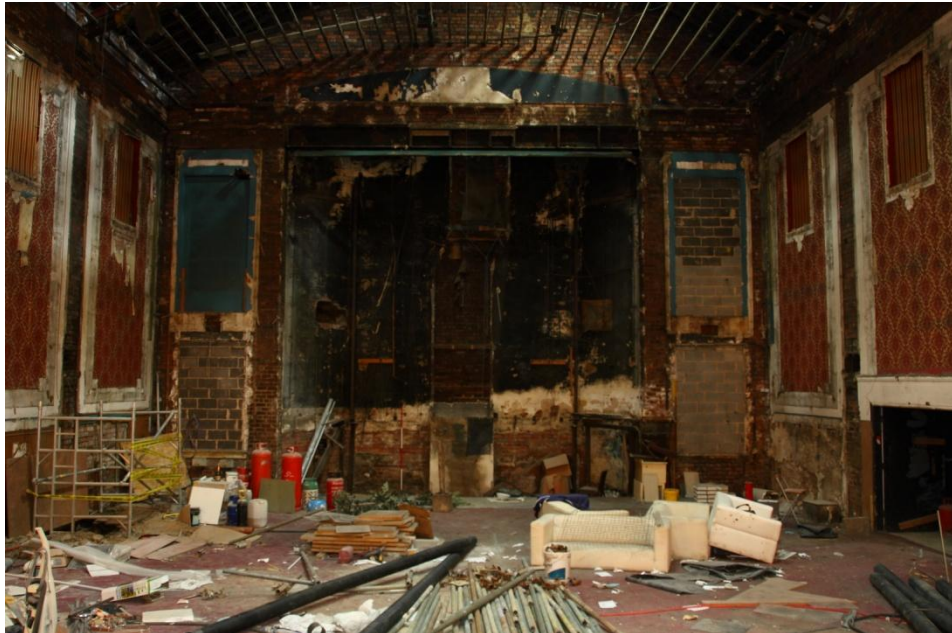
*Plate 9 Screen end of the auditorium showing blocked openings to either side, looking S.W.
Note chimney-like air flue in centre. (31jpg)*

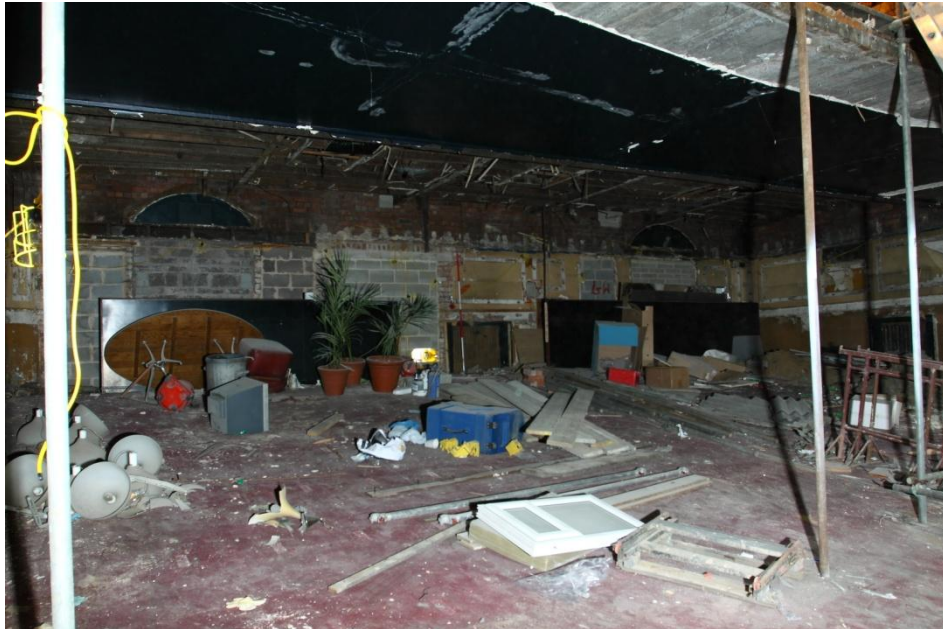
Plate 10 N.E. 'back' wall of the auditorium, looking E.N.E. The blocked up doorway to the foyer not shown on any plans lies immediately left of the ranging rod. (29jpg)

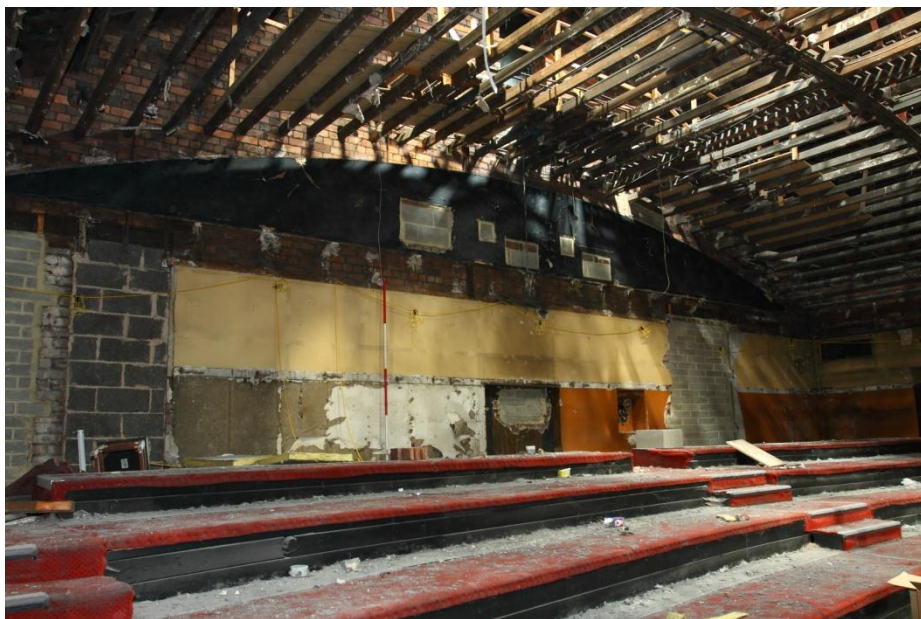
Plate 11 Rear wall of the circle showing blocked up openings, looking E. (42jpg)

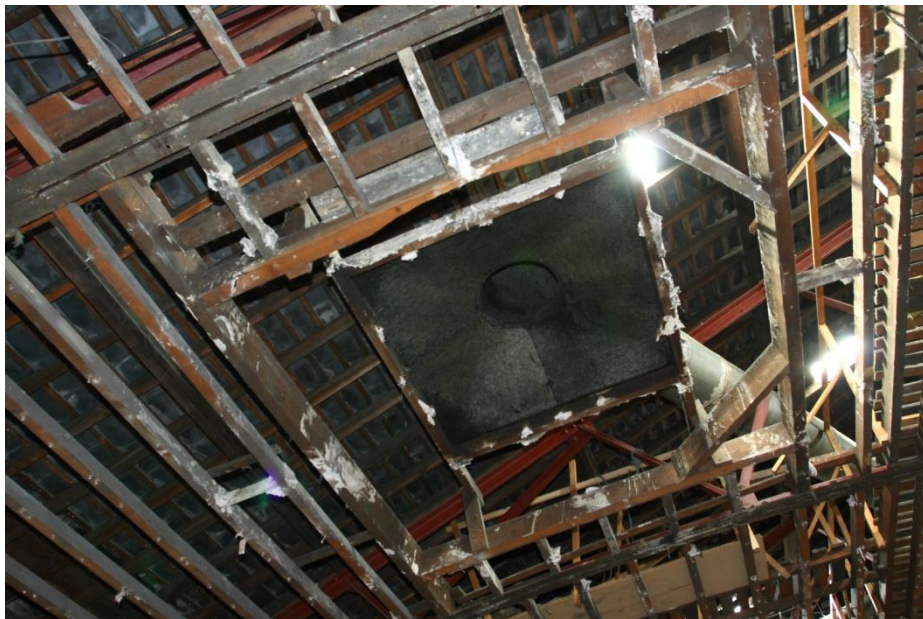
Plate 12 Roof vent, looking S.W. (37jpg)

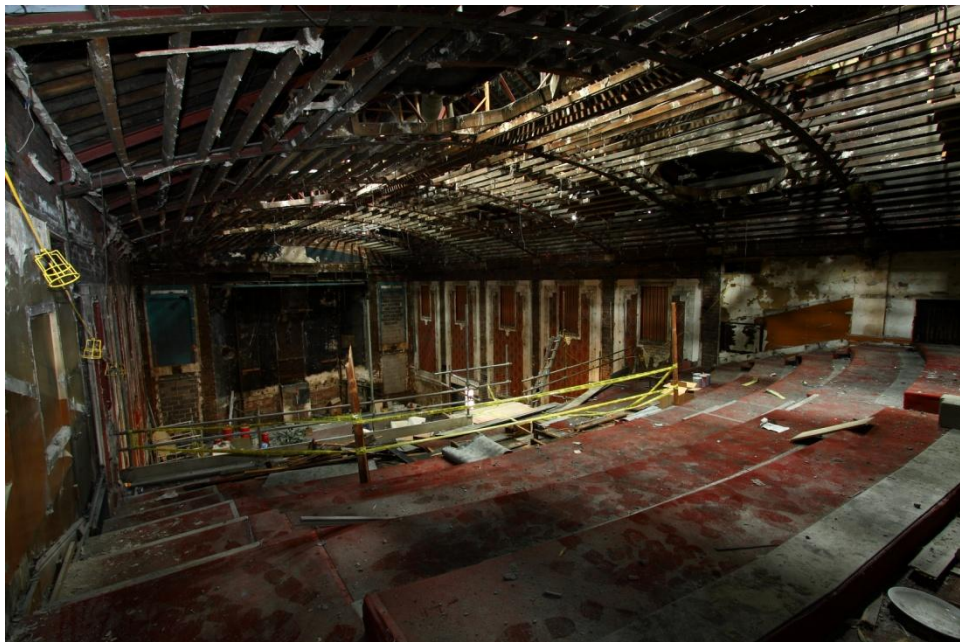
Plate 13 Overall view of the circle, looking W.S.W. (47jpg)

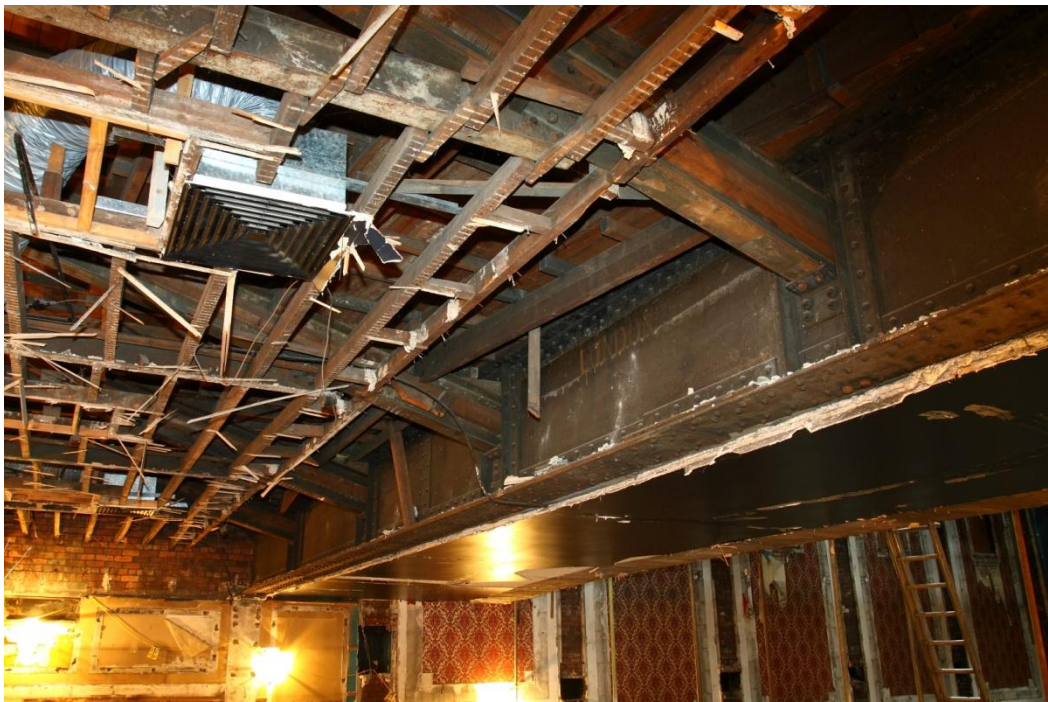
Parts of a modern ventilation system comprised of galvanised grille and flexi-pipe is visible to the underside of the circle where it served the rear stalls area (see Plate 14). There are no clear indications as to whether or not this replaced an earlier system in this area.

Plate 14 Structural details of the underside of the circle, looking S.S.E. (43jpg)

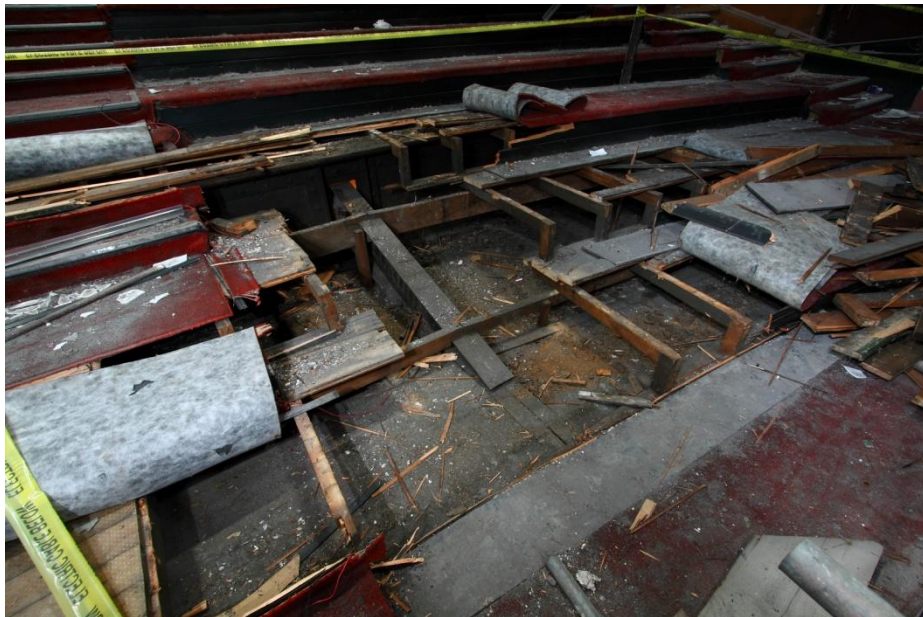
Plate 15 Framework for seating at the front of the circle, looking E.N.E. (50jpg)

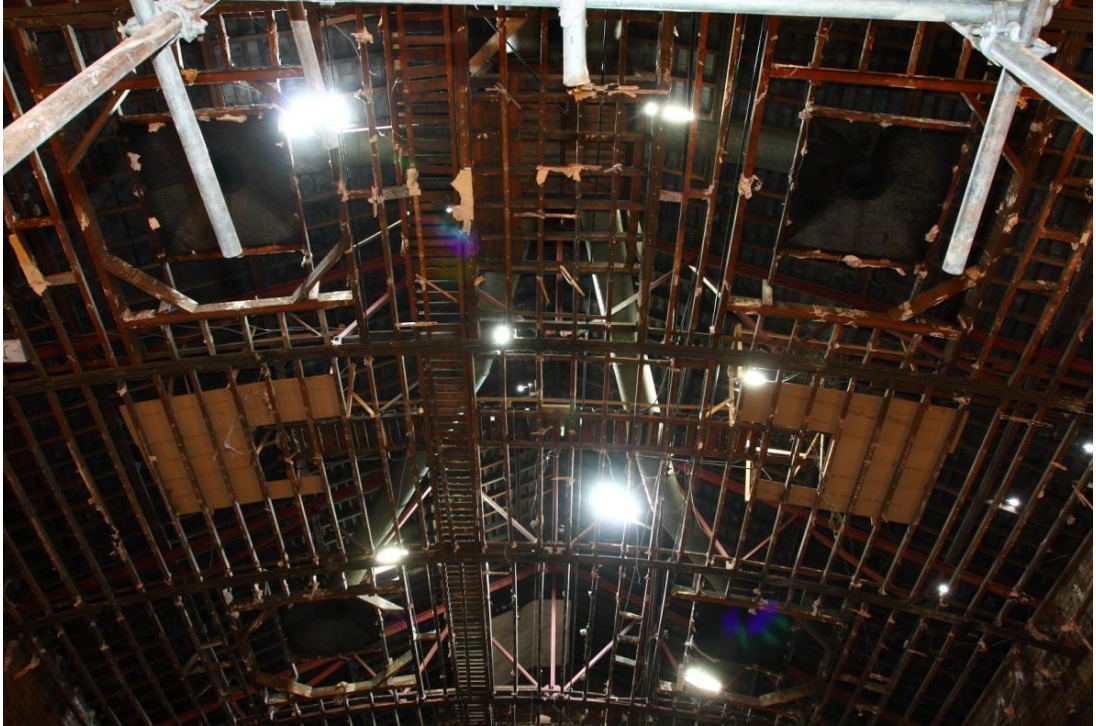
Plate 16 General shot of the ceiling and roofing arrangements above the auditorium, looking S.W. (30jpg)

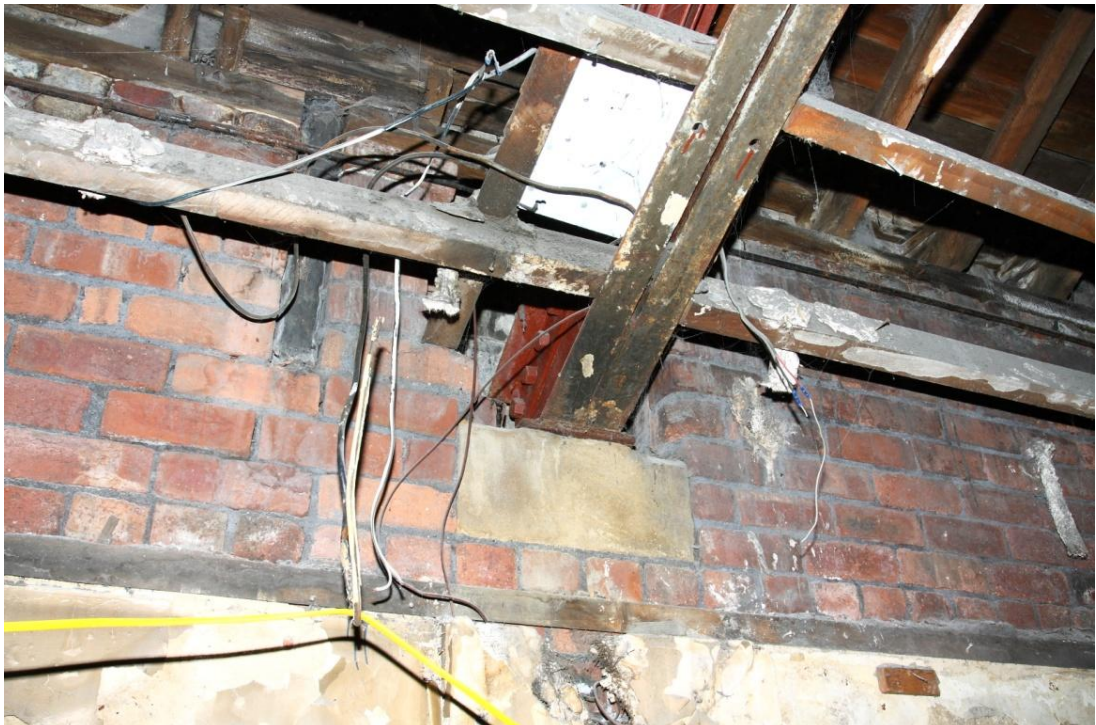
Plate 17 End of a truss sitting atop stone block, note ceiling timbers secured within 'doubled up' curved tie-beam, looking S.S.E. (39jpg)

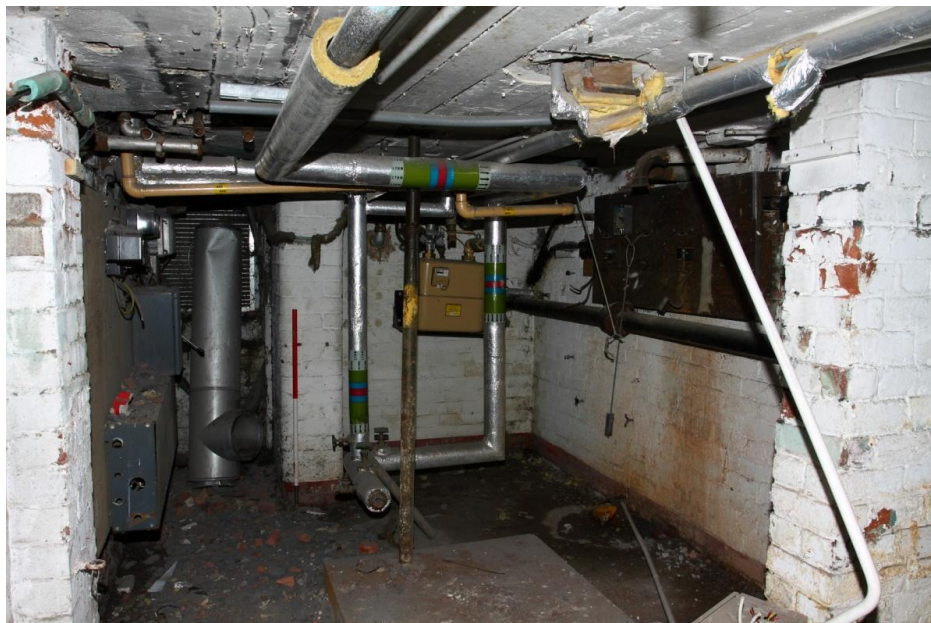
Plate 18 The S.E. chamber of the basement, looking S.E. Note switchgear, note water pipes, gas meter and mounting block. (60jpg)

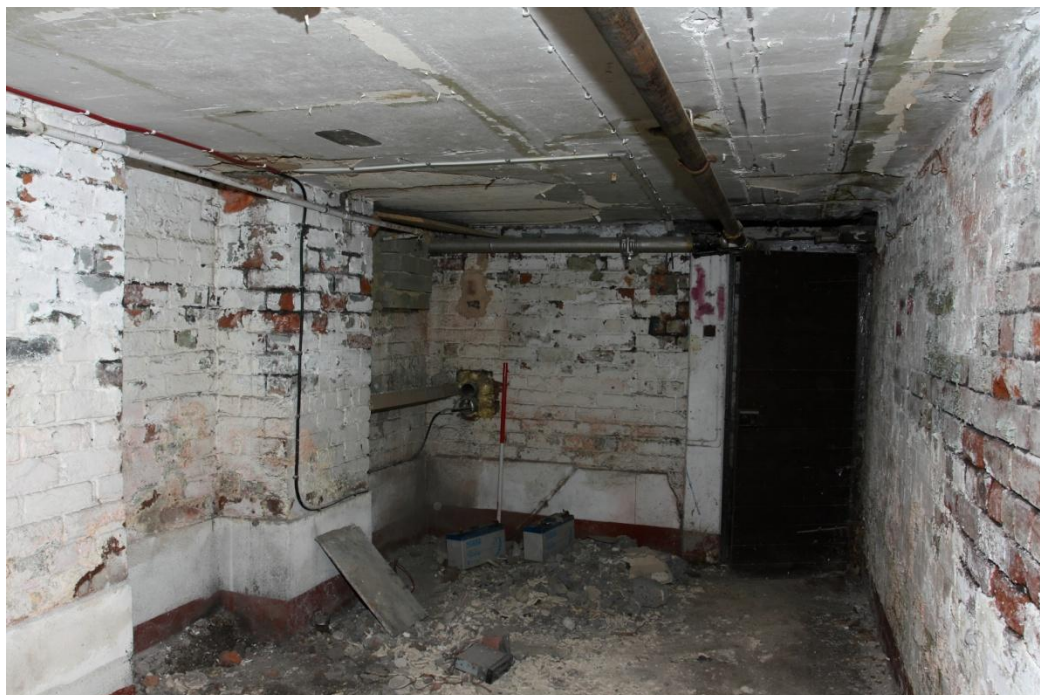
Plate 19 The N.W. chamber of the basement, looking N.W. The two brick projections to the left support the former fireplace and chimney above. (64jpg)

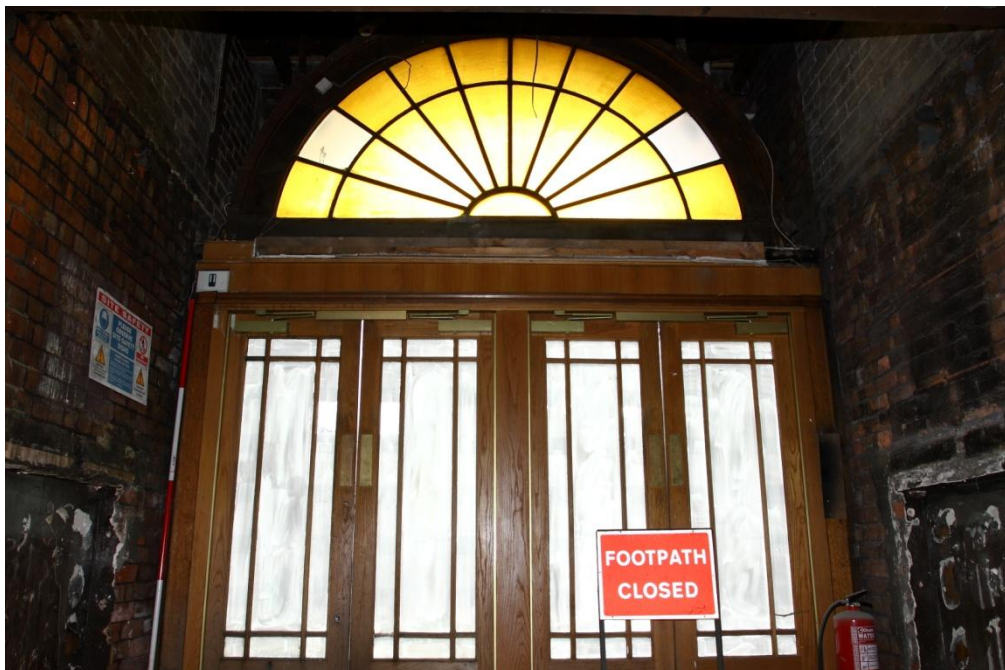
Plate 20 Entranceway to the foyer, looking S.E. Radiator recesses can be seen to either side. (55jpg)

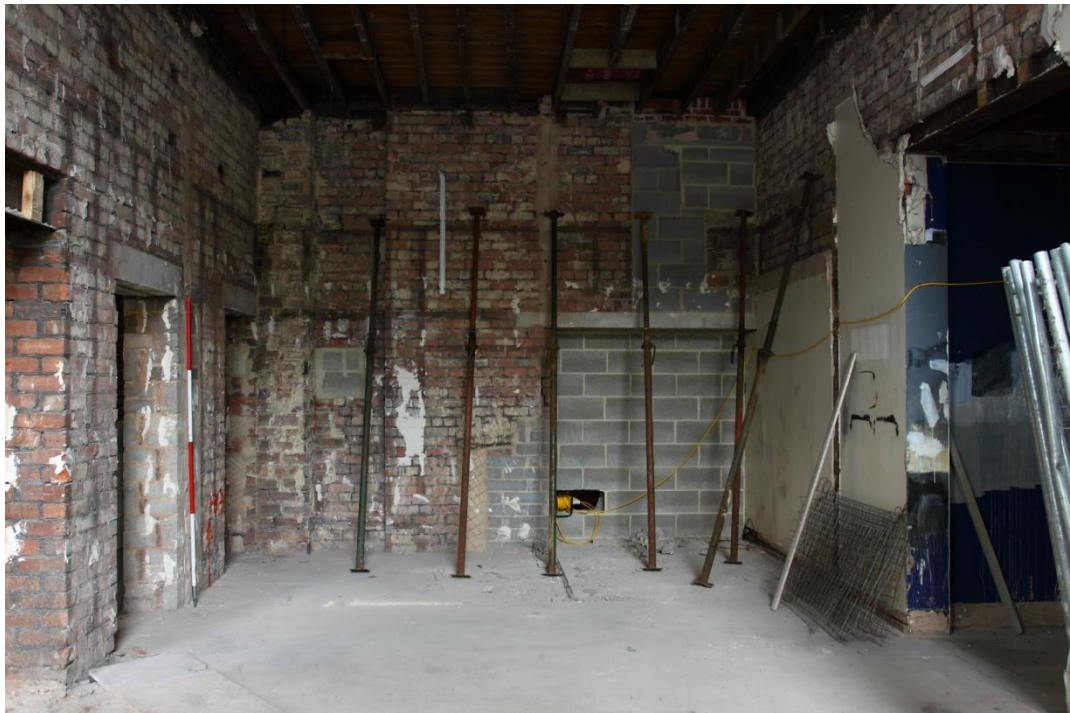
Plate 21 Central part of foyer, looking S.W. Scarring relating to part of the former fireplace can be seen immediately to the left of the blockwork and narrow horizontal and vertical lines can be seen against the brickwork elsewhere. (53jpg)

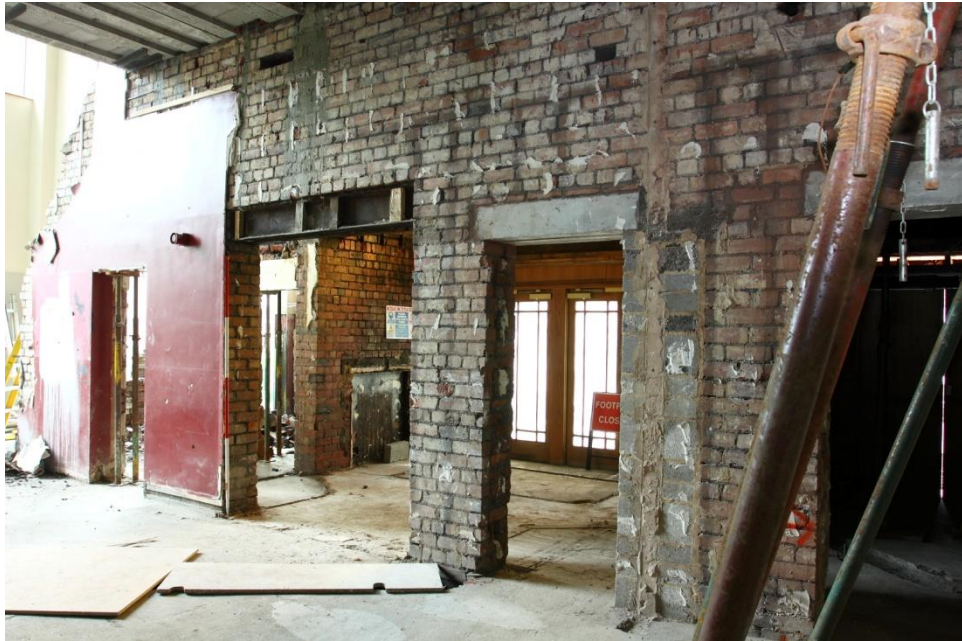
Plate 22 View to the main entrance from the central part of the foyer, looking E. (58jpg)

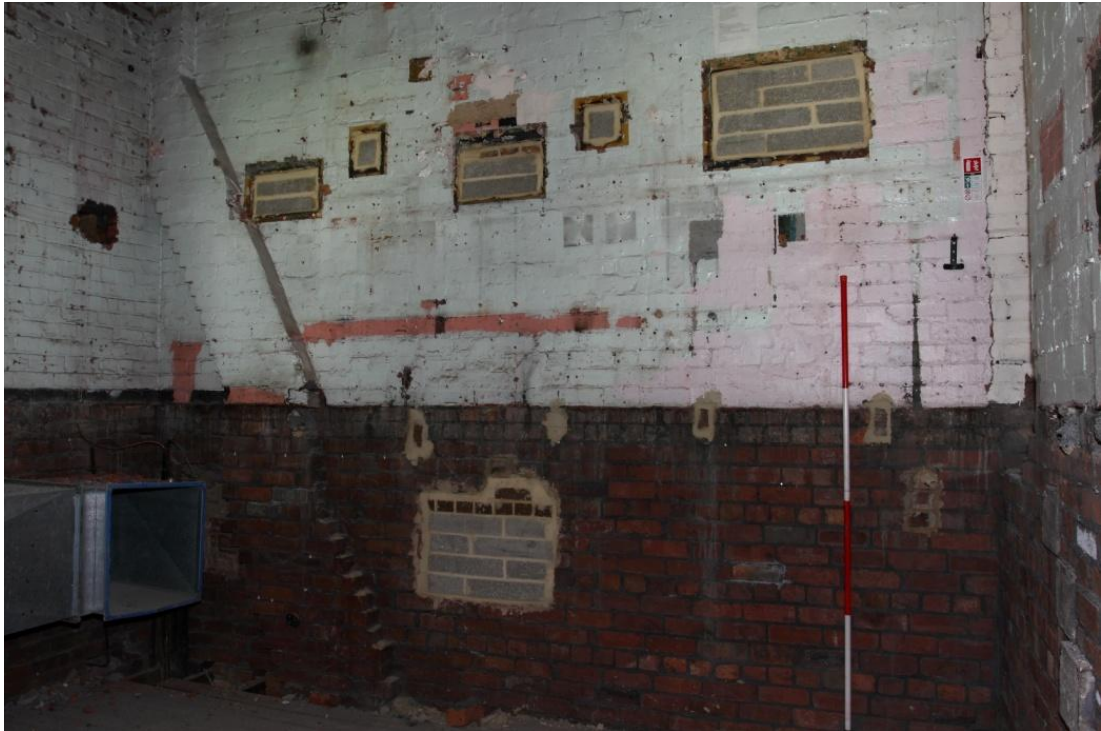
Plate 23 The S.W. wall of the projection room, looking S. Note the chimney flue and blocked apertures.(the lower blocking is not understood, there is no corresponding scar within the circle and it does not appear on any plans) (70jpg)

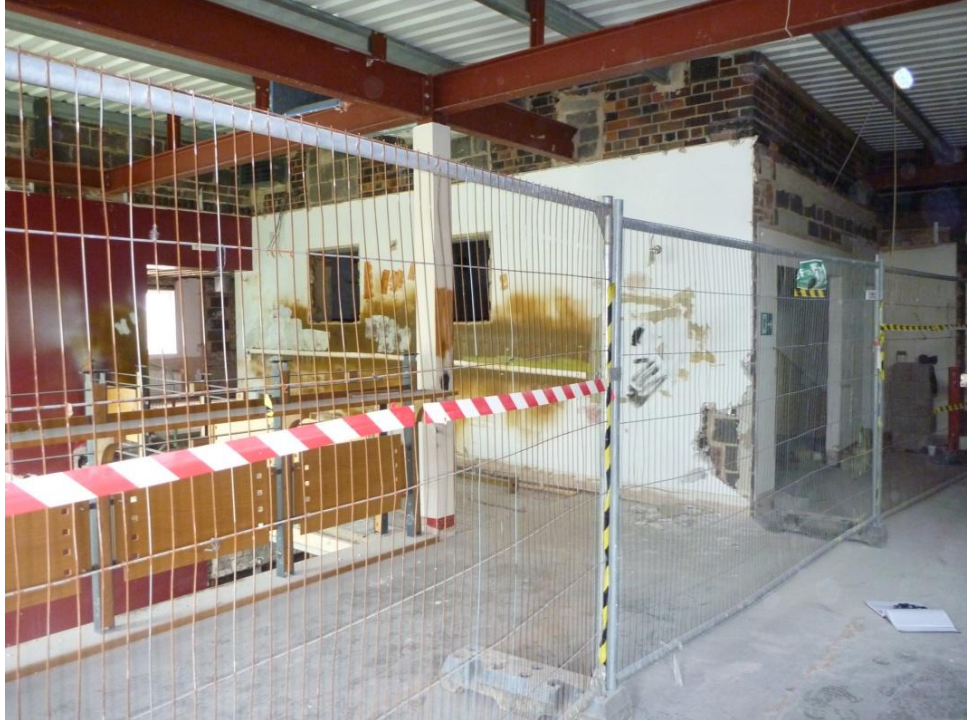
Plate 24 First floor foyer looking towards the projection room, looking S. (79jpg)

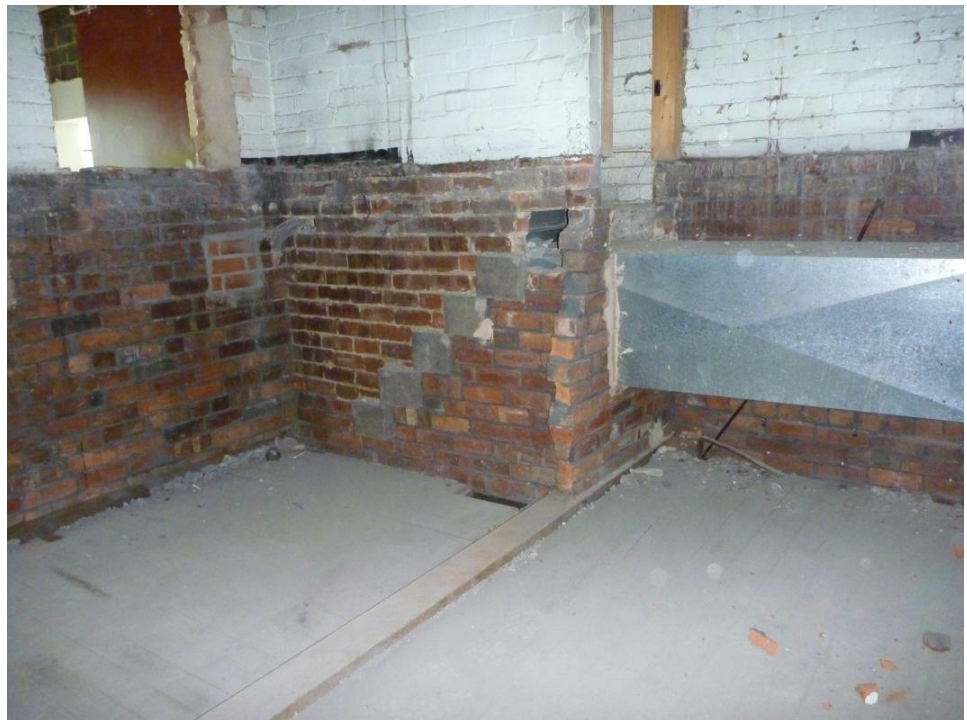
Plate 25 E. corner of the projection room, looking E. Note the truncated wall atop a girder separating the 'lantern room' (right) from the 'film room' (left). Step scars are also visible as is the door frame (top right) relating to the access to the roof space. (80jpg)
