SITE	Clifford's Tower and Bar Walls Lighting						
CLIENT NAME	Cit	City of York Council					
YAT PROJECT#	5942 YAT REPORT # 17/2017						
MUSEUM ACCESSION #	N/A	GRID REFERENCE	SE 5985 5983				
PLANNING REFERENCE #	N/A AAI OPS NOTICE # N/A

INTRODUCTION

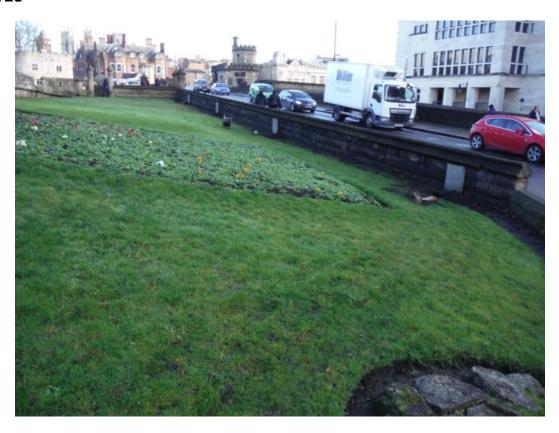
A series of five small slots were hand-excavated to the north-east of the inner bar walls, running parallel with an existing wall and following the inner curve in the wall to the north-west. These holes were approximately c.200mm wide and positioned in line with above ground fuse boxes that are visible at the side of the wall. These were excavated to expose the ducting and electrical cable, which were visible at c.200mm Below Ground Level (BGL) (Plate 1). Turf and topsoil was observed to extend to a depth of c.300mm. The backfill over the previous service run was indentified and consisted of dark brownish grey, sandy, silt containing moderate amounts of brick, broken tile and stones. A small amount of excavation was needed on the corner junction so as to run electrical cabling into the feeder box (Plate 2). Only turf, topsoil, and the backfill of the existing service run was disturbed by that excavation which extended only as far as the existing duct to a depth of no more than 300mm BGL.

Plate 1. Lighting fuse boxes visible on the wall with the slots excavated in front, facing north-east.

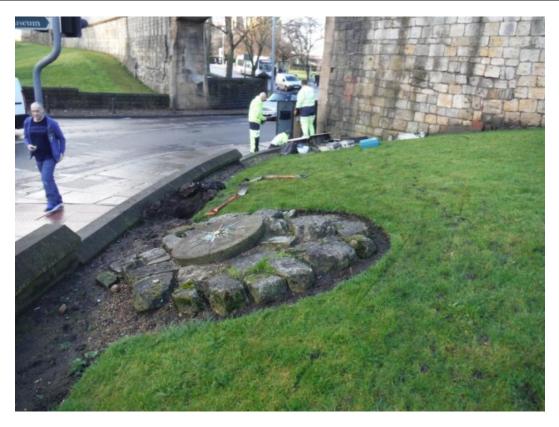
Plate 2. Lighting slot and cable running to fuse box, facing south-west.

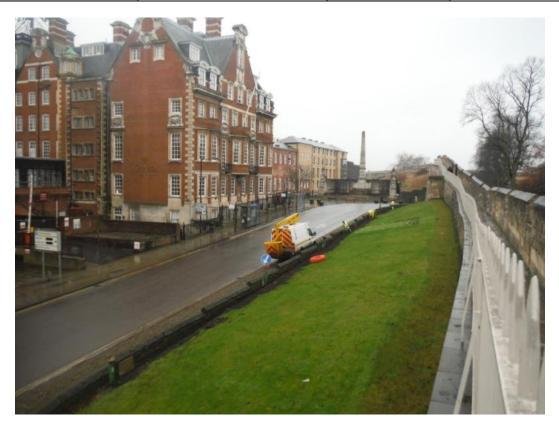
A trench to the south-east of the inner bar walls was hand-excavated, running parallel with the existing wall and following the inner curve of the wall to the south-west. A 65m section of trenching was exposed at c.300mm away from the standing wall. It was 200mm wide and reached a depth of c.300mm (Plate 3). Turf and topsoil was observed to extend to a depth of c.150mm and was friable, dark brown, sandy silt. The remainder was exposed between a depth of c.150-200mm BGL and was friable to firm, dark brown, clayey silt with lots of whole and partial bricks, mortar, pebbles, limestone and glass fragments. An electrical cable was discovered running the length of the trench and branching off into the light fittings that were being replaced; a 60mm diameter plastic ducting was inserted around the cable and the trench backfilled.

Plate 3. Fuse boxes and lighting plinths visible on the inner wall, facing south-east.

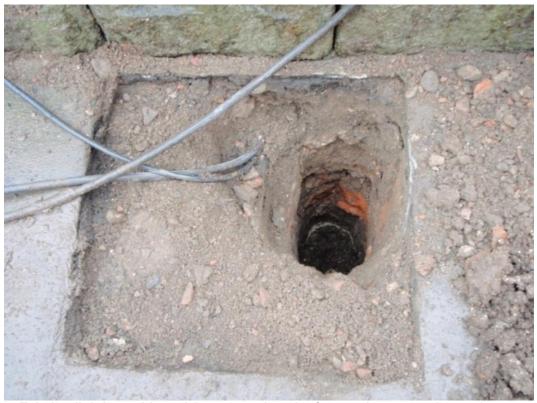
On the south-east corner of Station Road, on the exterior of the lower border wall, a deeper excavation took place to move a lamp post closer to the electrical cabling. The paving slabs were lifted next to the wall and an area c.400mm by c.400mm square was opened up for access, revealing a duct and electrical cable running through the area to the south-east. A slot approximately c.200mm wide was excavated to the right hand side of the existing cabling to a depth of 1m BGL. Underneath the paving slabs there was topsoil present which was c.20-30mm thick and was friable, dark greyish brown, sandy silt with

occasional small pebbles. The remainder of the sequence exposed between c.30mm-1000mm BGL was friable, light brownish grey, sandy silt with frequent broken brick, tile, mortar and charcoal lumps (Plate 4).

Plate 4. Existing lighting cable and 1m excavation slot for new lamp post, in south-east corner.

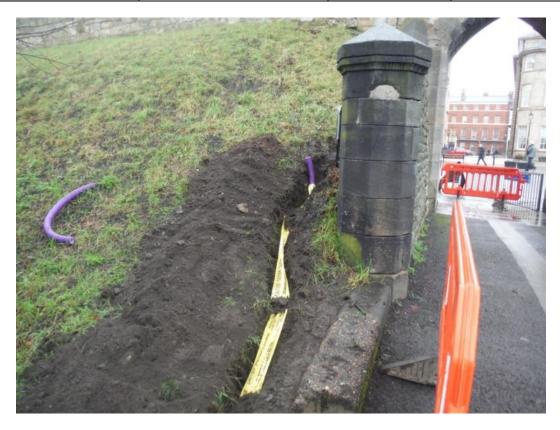
Plate 5. Replacement of ducting and electrical cable. facing east.

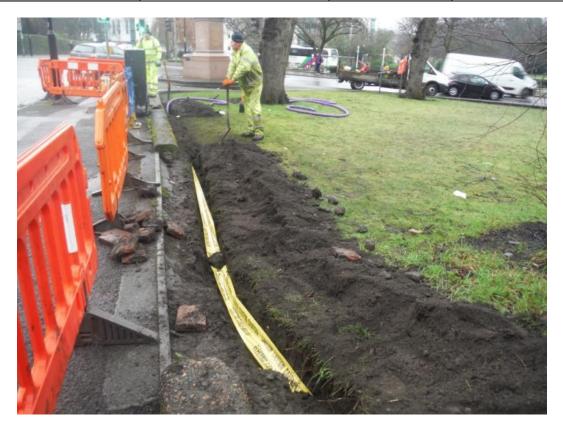
Plate 6. Ducting and electrical cable trench running into mains fuse box, facing west.

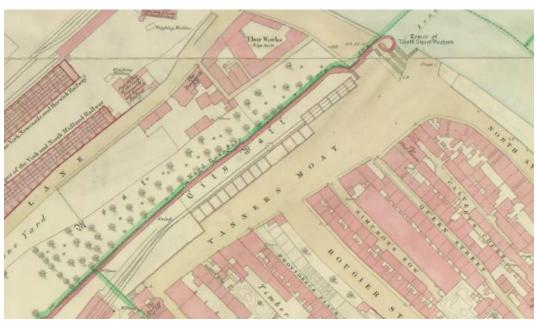
The sequence identified during these ground investigations and researched in historical sources suggests and explanation for the presence of solely disturbed and altered ground. On the 1852 OS map of York the site area is shown as railway tracks and sidings for a line that extended northwards and then stopped just before the tower of north street postern (Plate 7). It has also been recorded that the York and Midlands coal depot, which is Scheduled Monument (MY03727), was built on the works site in 1839 then abandoned in 1845 and subsequently demolished between 1856- 1875. This relates to the development and decline of the original York station built in 1839 within the city walls, which was depicted in Nathaniel Whittock's 'Birds-Eye view of the City of York, 1858 (Plate 8) and was only 70 meters to the south east of the current works site. There is also an extensive collection of black and white photographs held in archive by the York City Library which depicts the railway tracks and sidings in 1868 (Plate 9).

Plate 7. 1852 OS Map of site area, York.

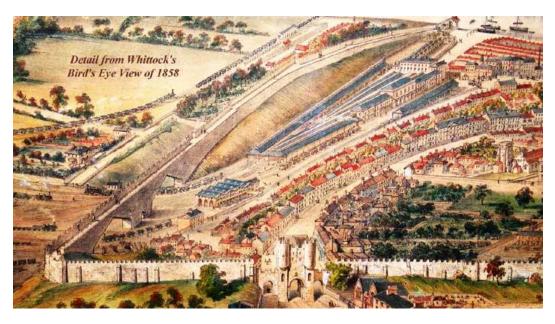
Plate 8. Nathaniel Whittock's bird's-eye view of the city of York, 1850. (Wilson, B., Mee, F. 2005. The City Walls and Castles of York: The Pictorial Evidence, fig.37. pg41.)

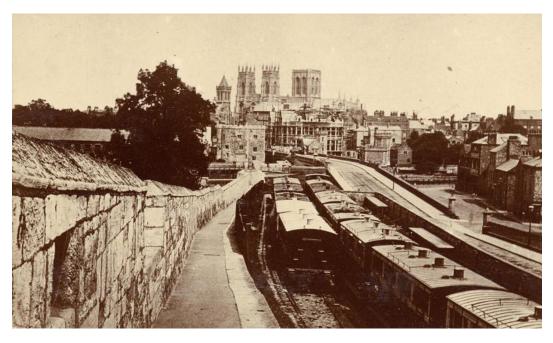
Plate 9. A view of the carriage sidings for the York and North Midland Line which were originally the York and North Midlands coal depot sidings.
