## **ARCHAEOLOGICAL INVESTIGATIONS AT 1 COFFEE YARD, YORK**

*EVALUATION AND BUILDING RECORDING REPORT*

Report Number 2017/69    July 2017

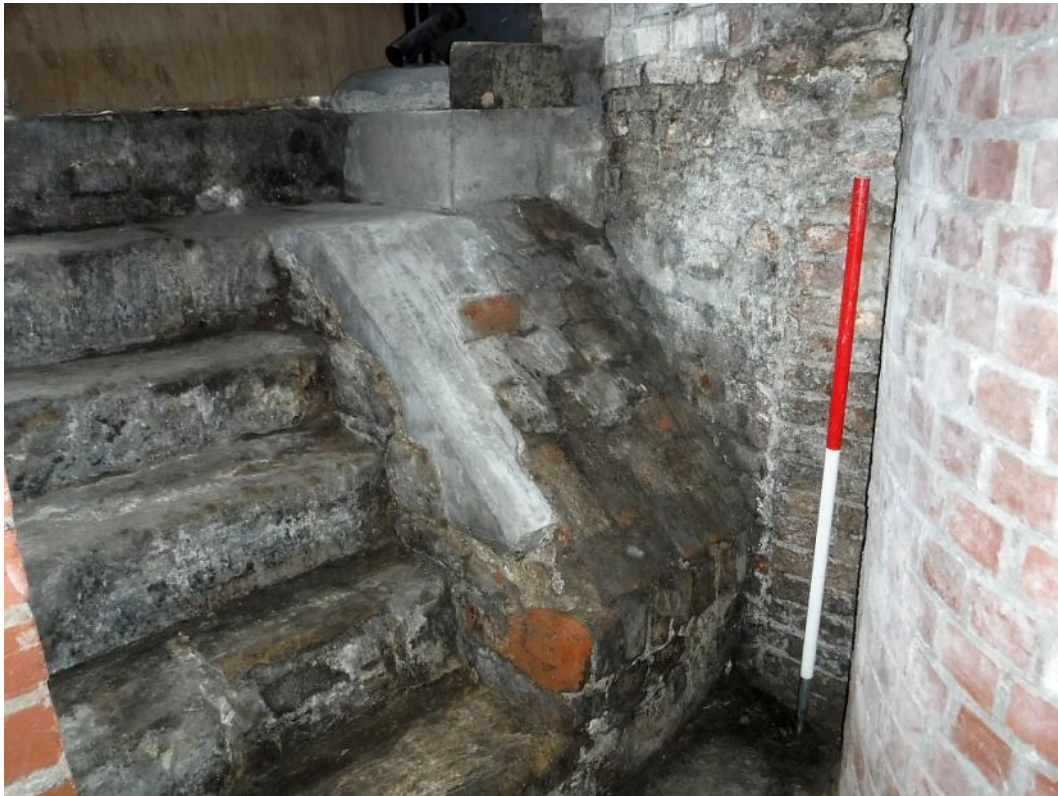
Bay 1 contained steps that had been heavily modified during 1990 renovation (Plate 1 photo 74). It is clear that the steps were originally wider, corresponding to old photographs where the doorway is shown as double width. Any possible articulation with upper parts of the building is not visible at present. The floor immediately adjacent also contains a brick alignment that also may represent earlier steps see 5.1.2 below. The buttress to Bay 2 appears to have been added later.

**Plate 1 Cellar steps, facing east, scale unit 500mm**

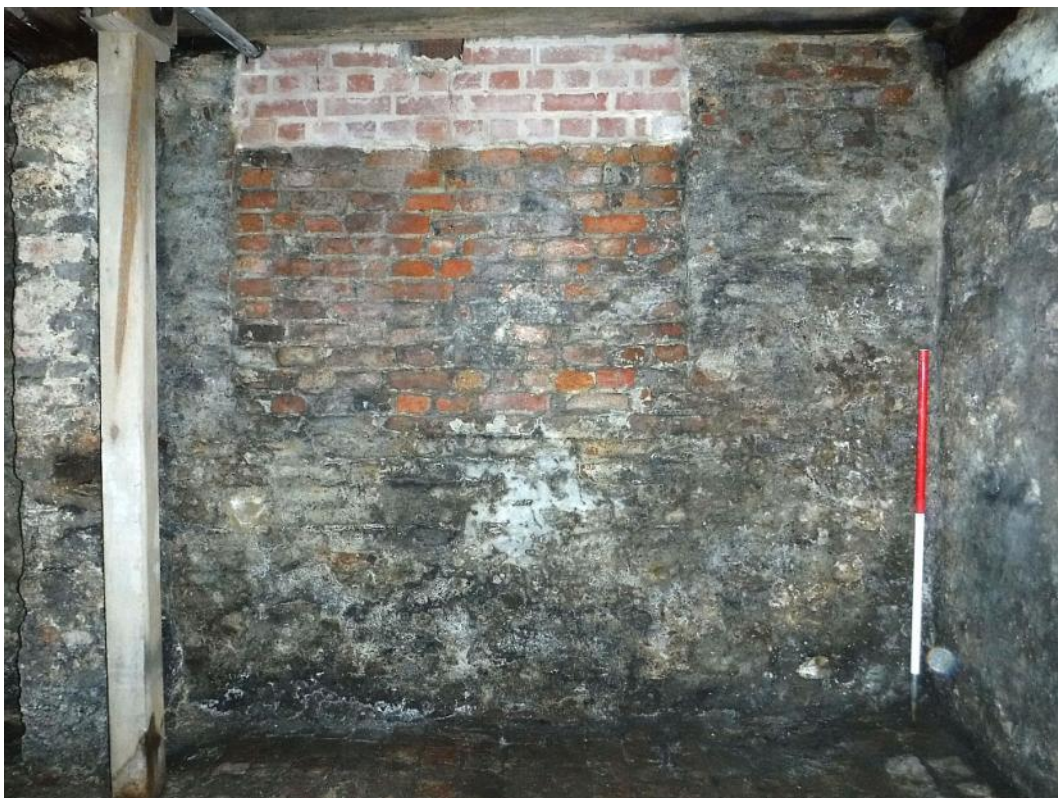
Bay 2 contained a now bricked-up light well originally circa 1.4m square. It was bricked up in two stages, the first being 18<sup>th</sup>/19<sup>th</sup> century and secondly during the 1990s renovation (Plate 2 photo 12).

**Plate 2 Bay wall and blocked lightwell, facing north-east, scale unit 500mm**

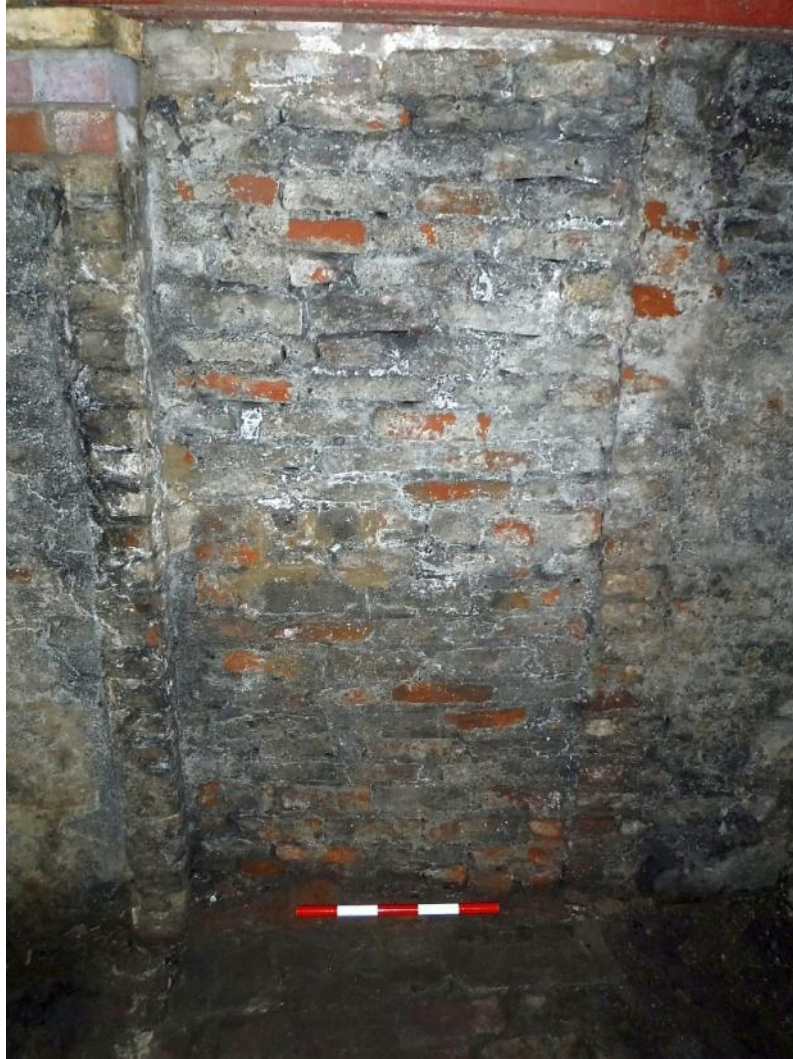
At the north-east end, 900mm from the corner, is what appears to be a blocked-up doorway. This is 890mm wide and continuous from floor to ceiling of basement (Plate 3 photo 32). The floor immediately in front also has what may be a threshold and clearly worn brick pavers, suggesting heavy use in and out of the basement. Presumably this relates to an old entrance into the building.

**Plate 3 Blocked doorway, facing north-west, scale unit 100mm**

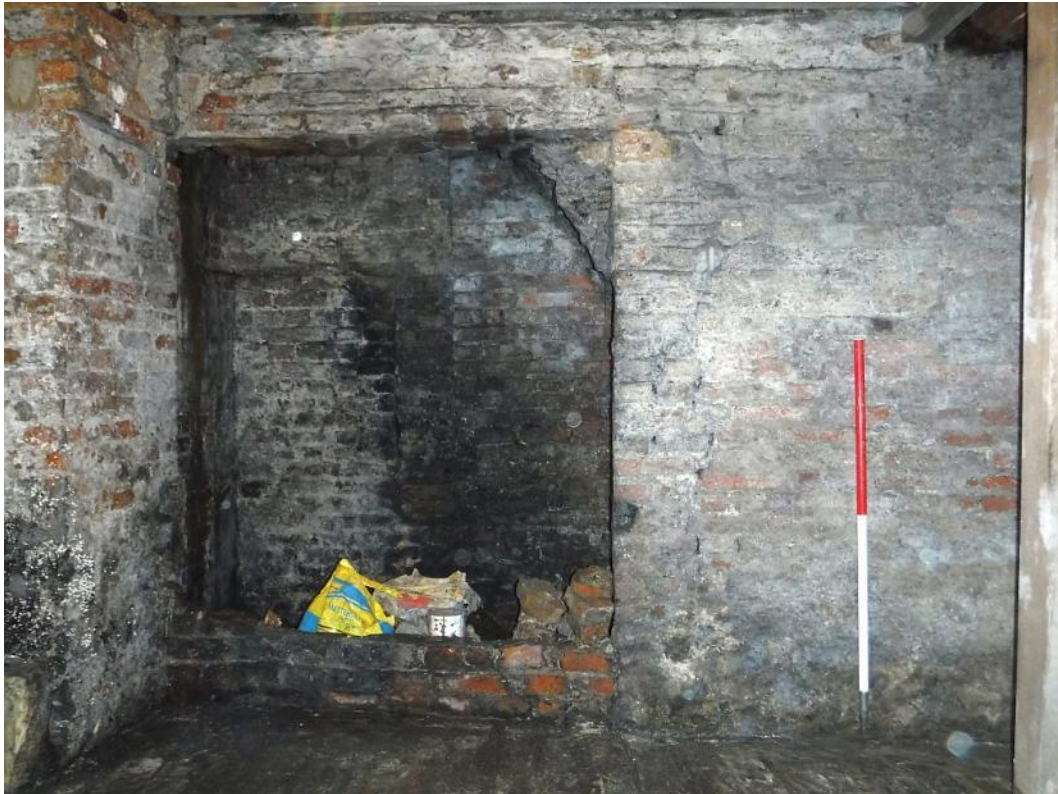
Bay 2 contains a substantial opening for the chimney. This was not investigated in detail due to safe access restrictions (Plate 4 photo 58). It had clearly been altered. The front had been remodelled and may have contained a range or similar insert in its later stages of use.

**Plate 4 Chimney opening, facing north-west, scale unit 500mm**

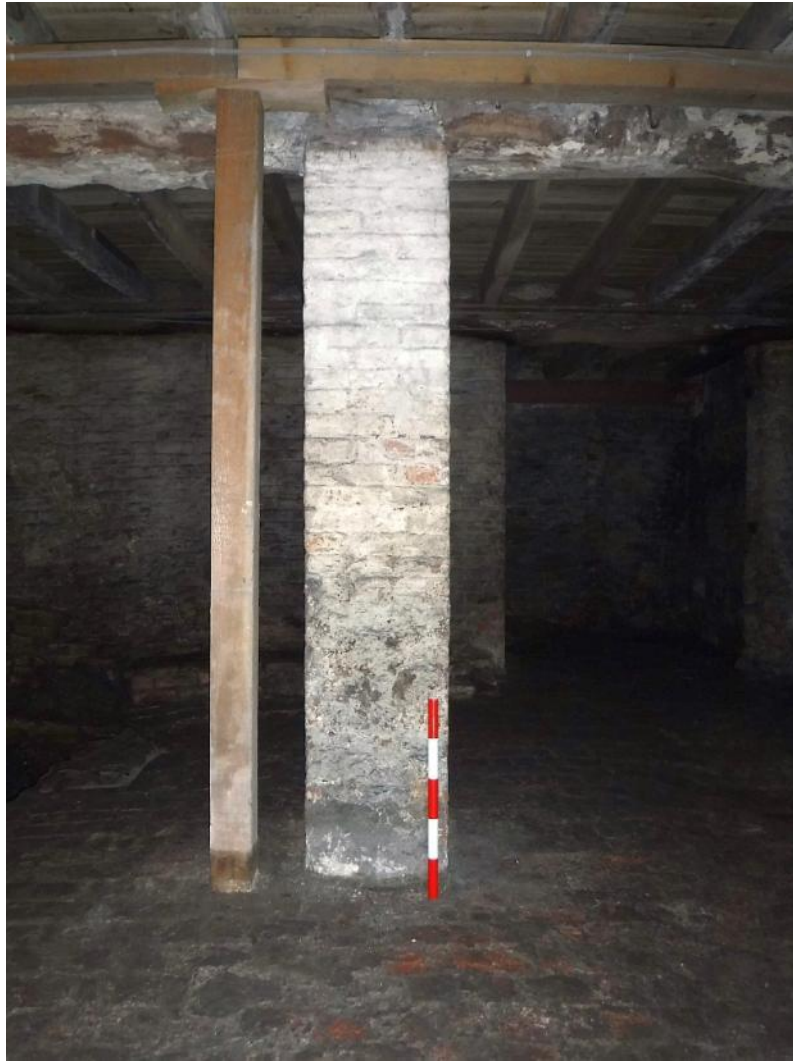
Between Bays 2 and 3 roughly central to the basement, a single brick column has been used to provide additional support (Plate 5 photo 114).

**Plate 5 Support column, facing north-east, scale unit 100mm**

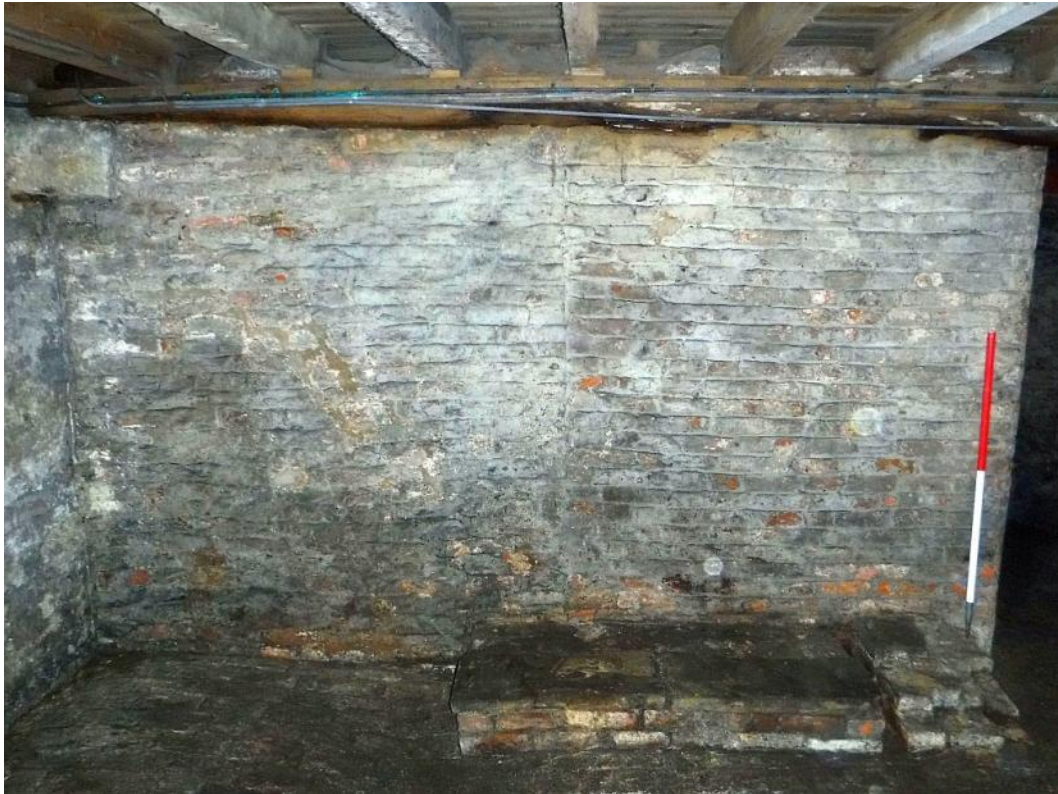
Between Bays 3 and 4 a partition wall has been built which also provided structural support. The central area of this is clearly earlier and mortar stains on the floor and wall to the north-west suggests this originally formed a separate room. The eastern return corner has a detail made up of cant bricks. This has been extended to join up with the basement wall to the

south-west (both walls can be seen in Plate 6 photo 52). It is likely at this point that the return walls to the north-west wall were removed, otherwise there would be no access to the room behind.

**Plate 6 Partition wall and later addition to left, facing north-east, scale unit 500mm**

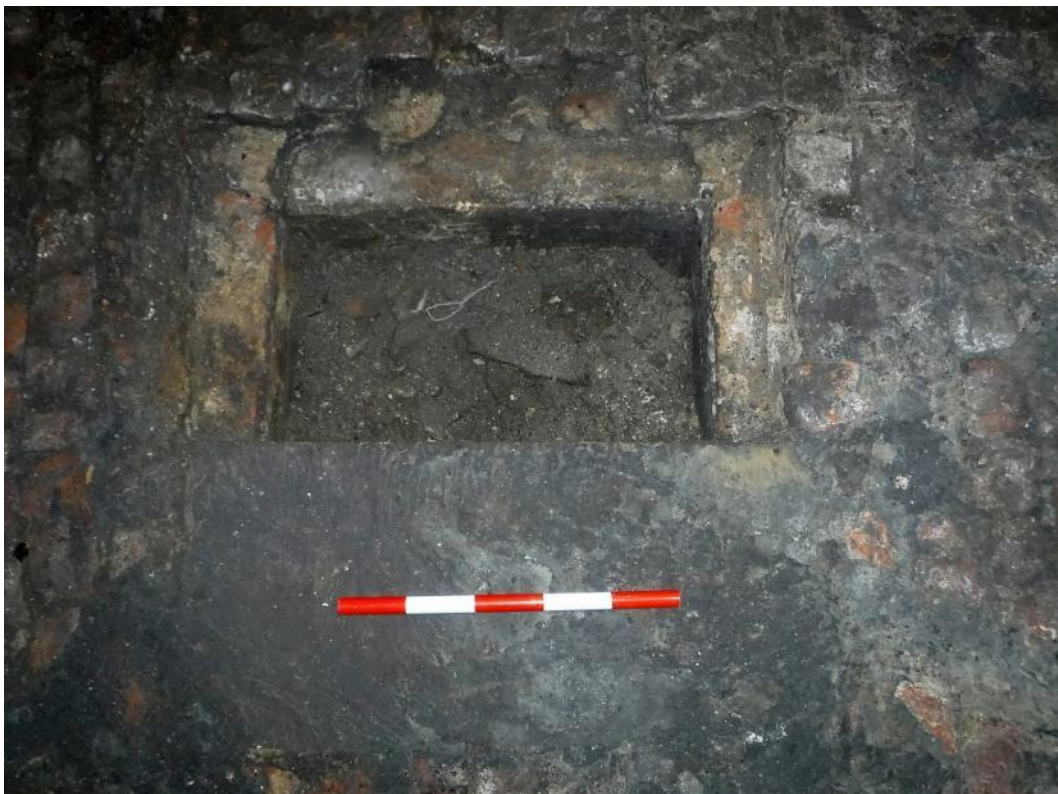
Within Bay 2 towards the north-eastern side a stone-lined well or tank appeared to have been built into the floor (Plate 7 photo 92). This is approximately 1.0m square and has previously been capped off by stone flags. A previous visit to the site, when the tank had been emptied, indicated this extends to more than 1.0m below floor level. It is unclear if this is an older structure built into the building or was added during its construction.

**Plate 7 Well or tank feature, facing north-west, scale unit 100mm**

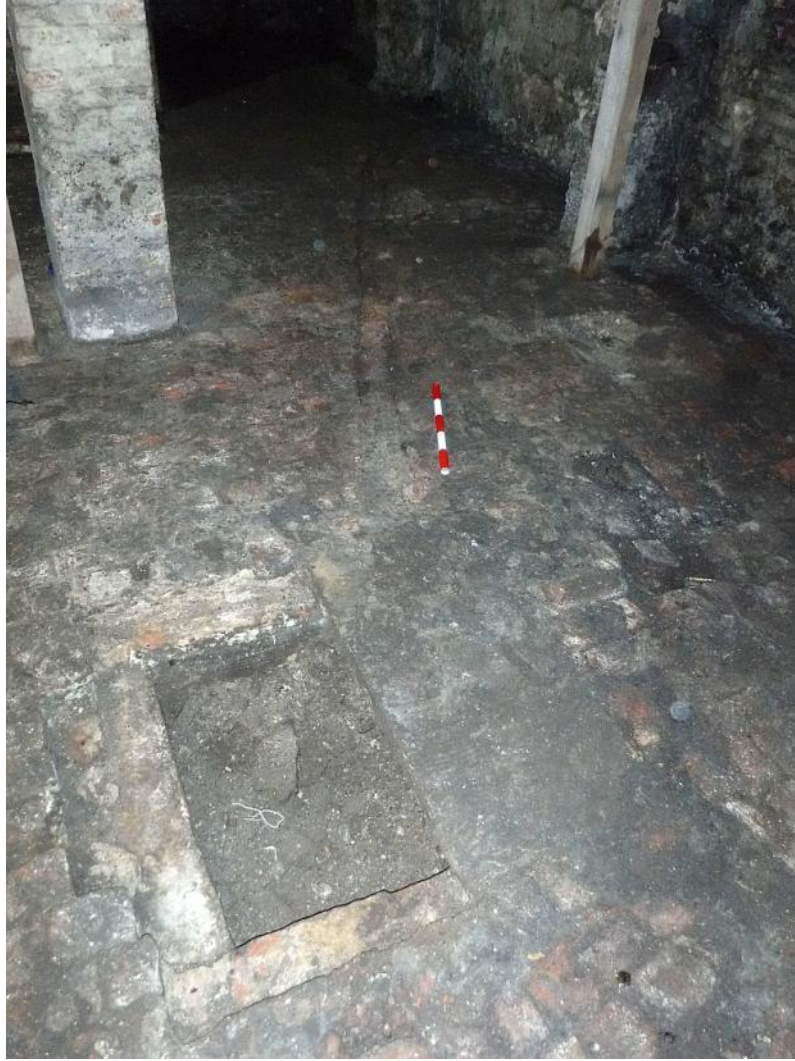
Running north from the tank or well, a recessed brick channel acting as a drain runs to the north-east wall at the northern end of Bay 3 (Plate 8 photo 97) through the buttress between Bay 3 and 4. It then exits the building through a culvert at the north-western end of the north-east wall. Extending a tape into the culvert indicated it continued for at least 2m.

**Plate 8 Well and surface drain, facing north, scale unit 100mm**

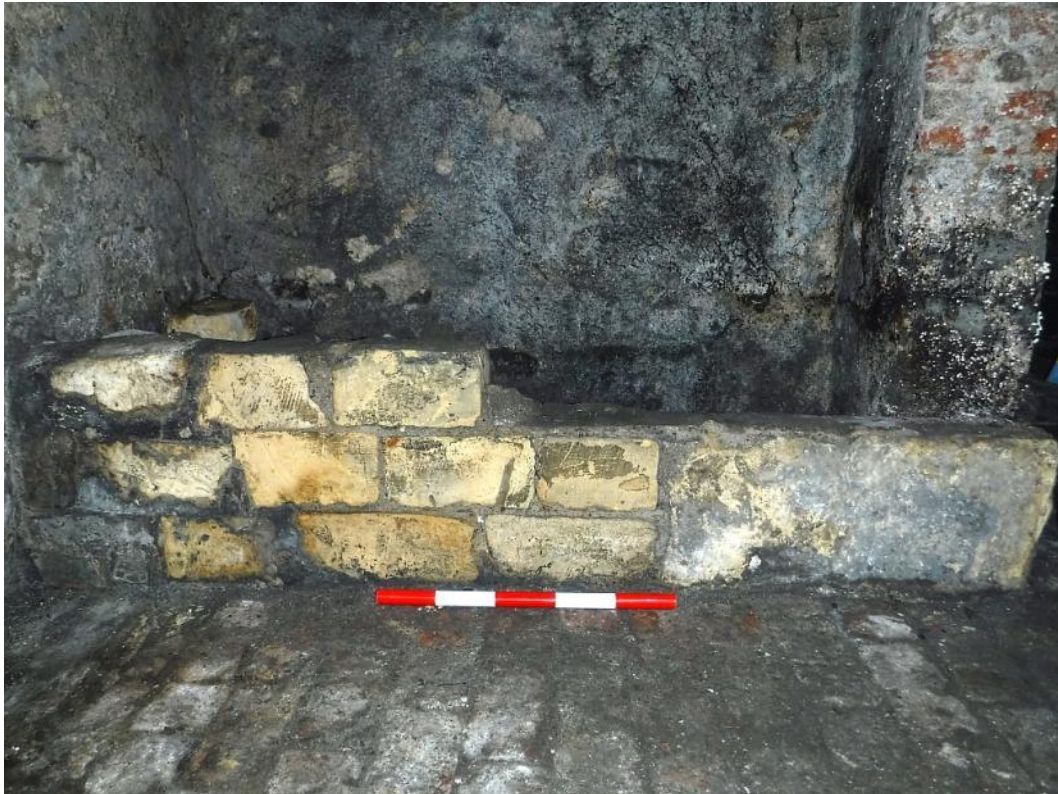
The structure in Bay 1 is clearly cement-bonded reused stone. This was most likely built in the last century (Plate 9 photo 108).

**Plate 9 20th century bench or platform, facing north-west, scale unit 100mm**

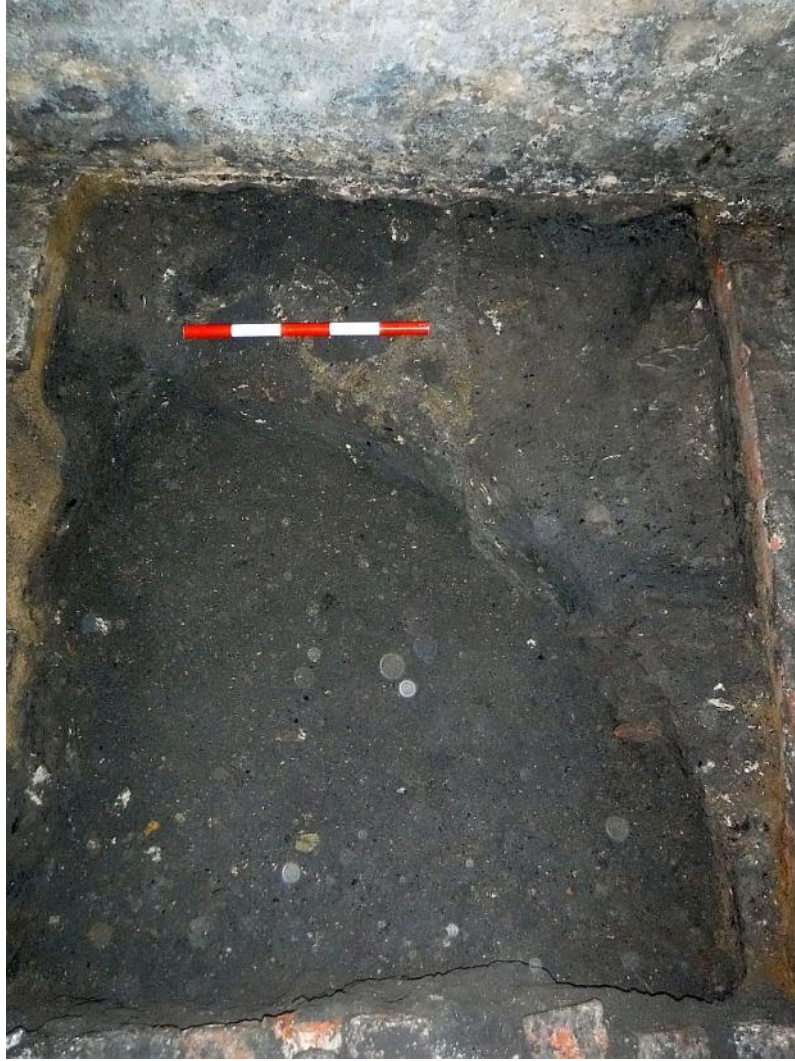
The earliest archaeological deposits encountered were a series of presumably medieval features predating the standing structure (Plate 10). These were at c.150mm below the cellar floor and 2.44m below the base of the ground floor floorboards. These extended for at least 500mm down, as seen in within the cut of the modern excavation. Although not excavated,

the medieval deposits appeared to be intercut pits. The backfill of a later intrusion (see below) suggests these features will contain pottery from the Roman period up to circa 1300 AD. These could easily be the base of pits from the latter period.

**Plate 10 Test pit 1 early deposits, facing north-west, scale unit 100mm**

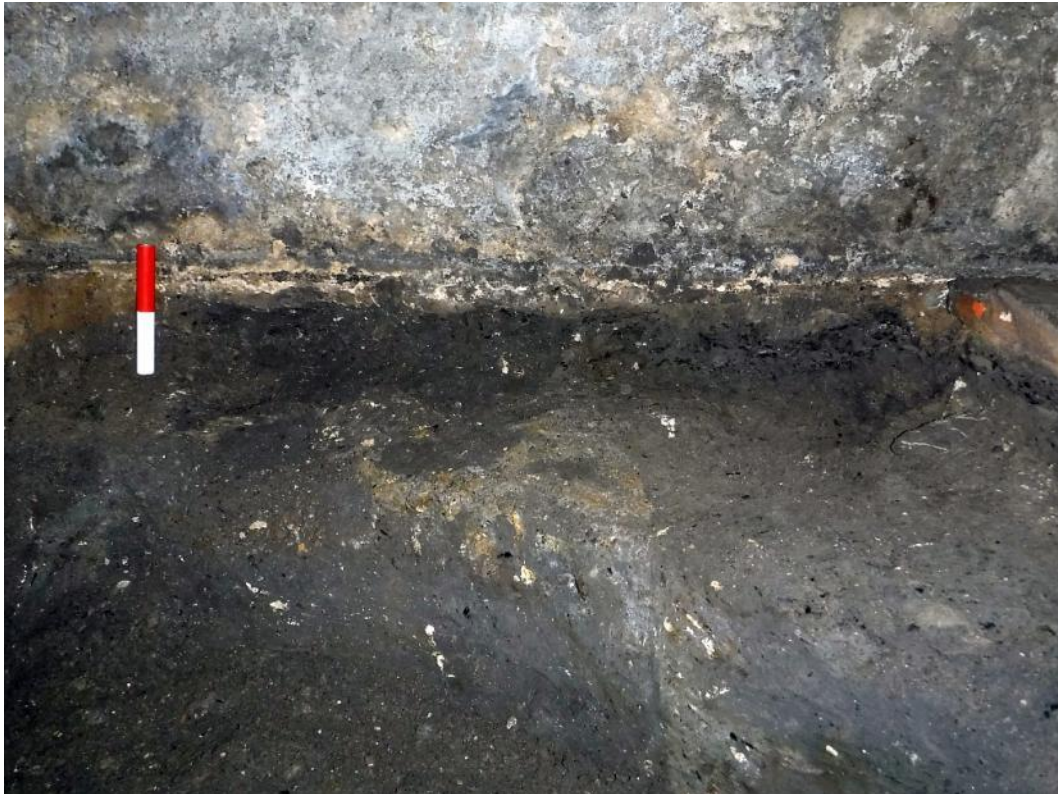
At the south-west end of the test pit was the basement wall (Plate 11). This was built directly onto the deposits described above, and was brick built apart from the lowest course which was stonework. Extending away from the basement wall was a mixed deposit up to 50mm thick, presumed to be linked with the construction of the building. The lack of mortar, stone and CBM fragments is unusual as this is what would be typically expected in a construction spread. However, it may be that the basement wall was built into a shallow trench that was then truncated when the basement was excavated out to its final depth. This interpretation is reinforced by the fact that the lower course of stonework would not have provided a suitable point to build off as a free standing wall.

**Plate 11 Test pit 1 wall base, facing north-west, scale unit 100mm**

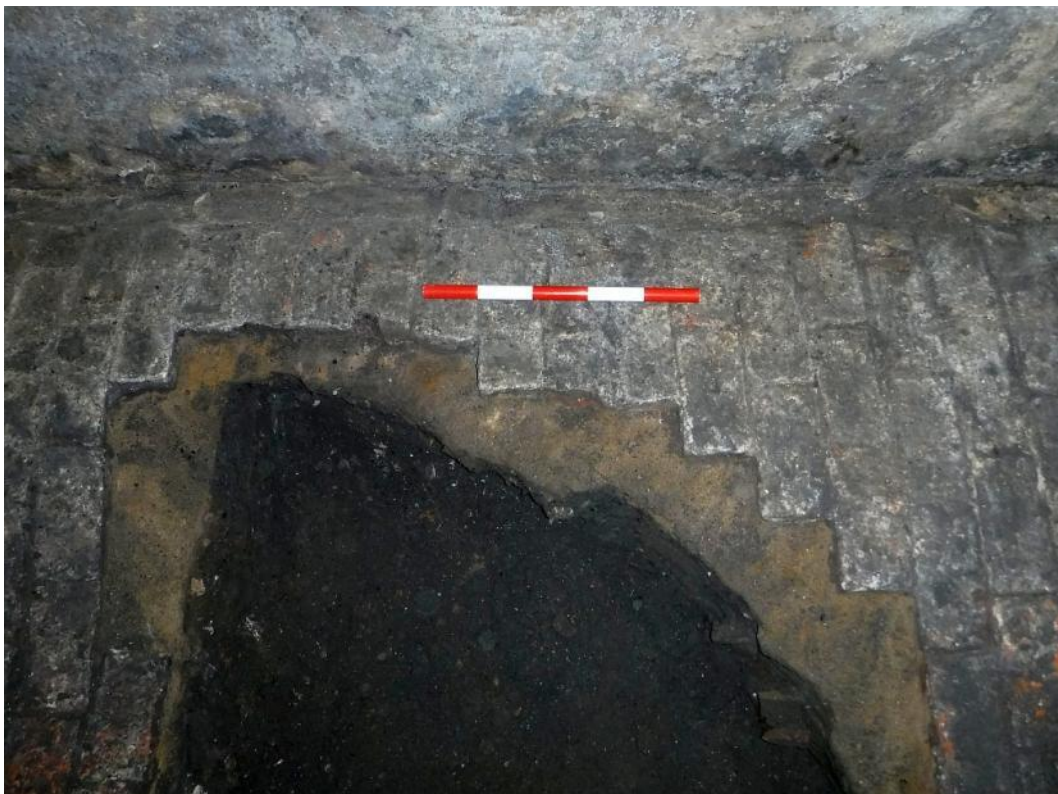
Butting up against the base of the wall was the original brick paver floor (Brick 230mm x 120mm x 54mm) bedded on top of c.50mm of sand (Plate 12). Bricks of this size are routinely dated between the 16<sup>th</sup> and 18<sup>th</sup> Century and therefore fit within the known chronology for the construction of the original building. Pottery was also retrieved from this level but was residual Roman material.

Cutting through the brick paver floor was what is thought to be a previous exploratory trench, for which no formal archaeological records can be easily sourced (See also plate 12). This was semicircular in shape with a straight edge to the south-eastern side. It appeared to continue well below 500mm from the brick surface. As referred to above, the backfill contained a wide range of pottery. It also contained small rectangular bone blanks which were discovered elsewhere on the brick floor during the initial cleaning process. This trench has clearly been dug through complicated, significant, archaeological deposits. Silver paper and rotten coated fibre board in the fill indicate this is clearly 20<sup>th</sup> century activity.

**Plate 12 Test pit 1 brick floor & modern excavation, facing north-west, scale unit 100mm**

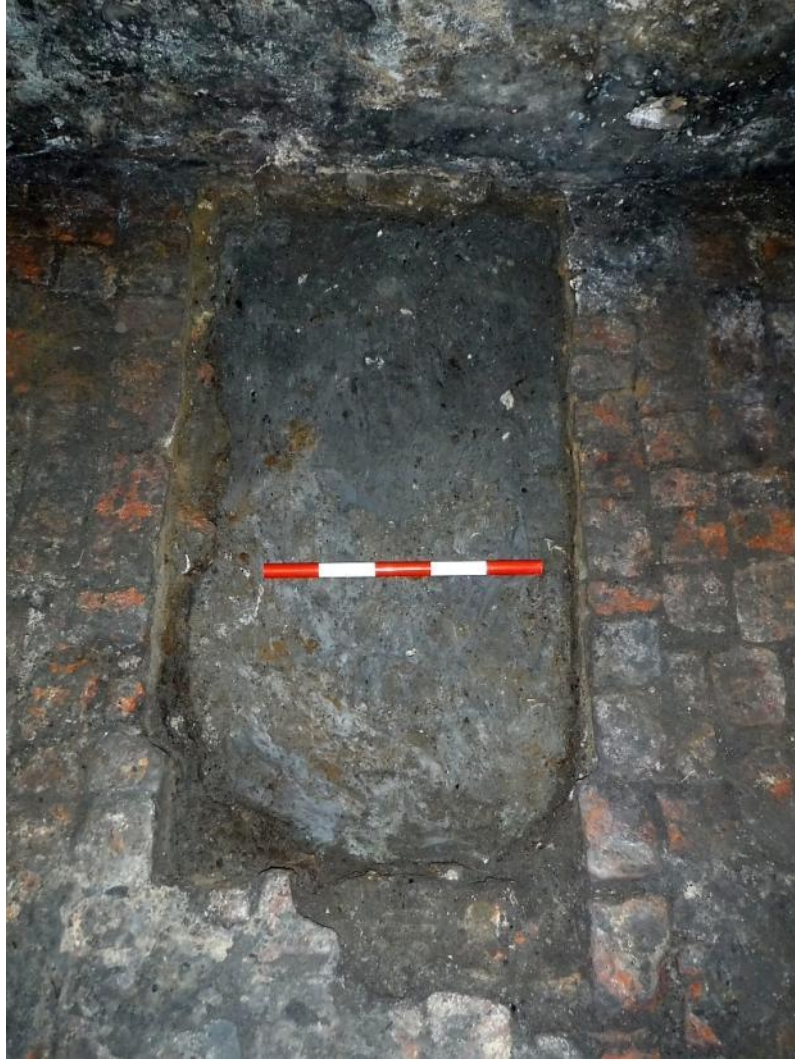
Test pit 2 had a very similar archaeological sequence to test pit 1. The earliest deposits encountered were at 150mm below the brick surface (2.52m below the base of the ground floor floorboards) (Plate 13). In this case these have not been disturbed by later intrusions (Plate 14 illustrates the north-west facing section of the trench).

**Plate 13 Test pit 2 early deposits, facing north-east, scale unit 100mm**

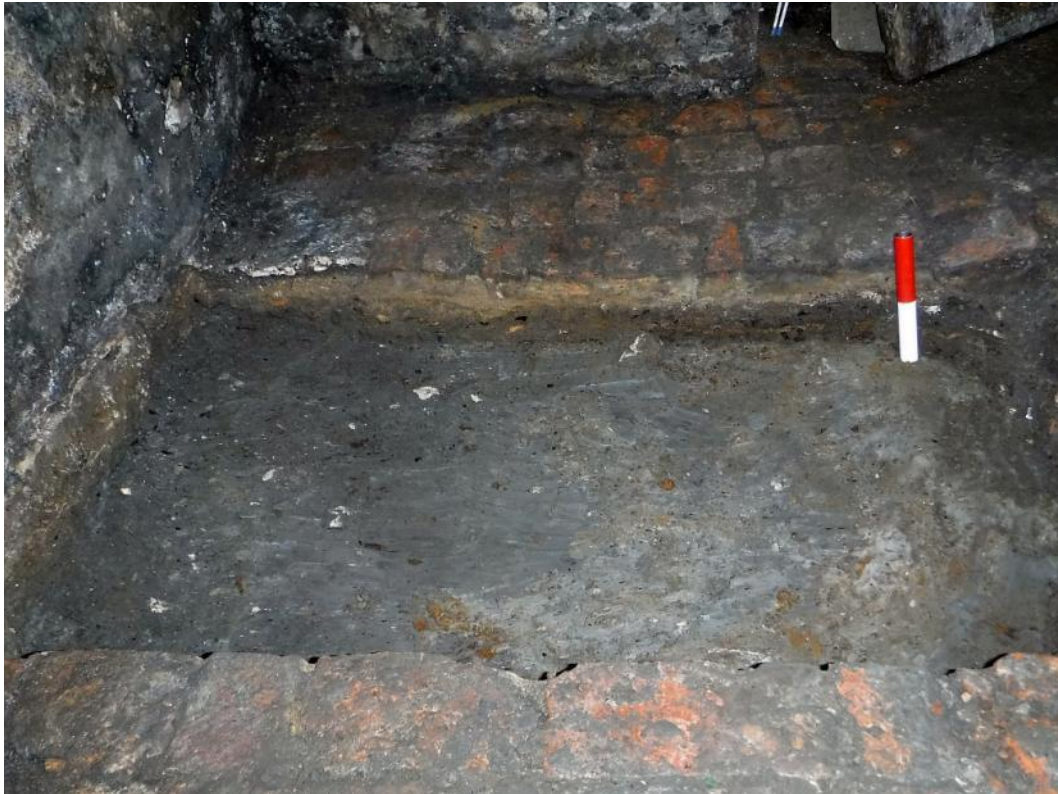
**Plate 14 Test pit 2 north-west facing section, facing south-east, scale unit 100mm**

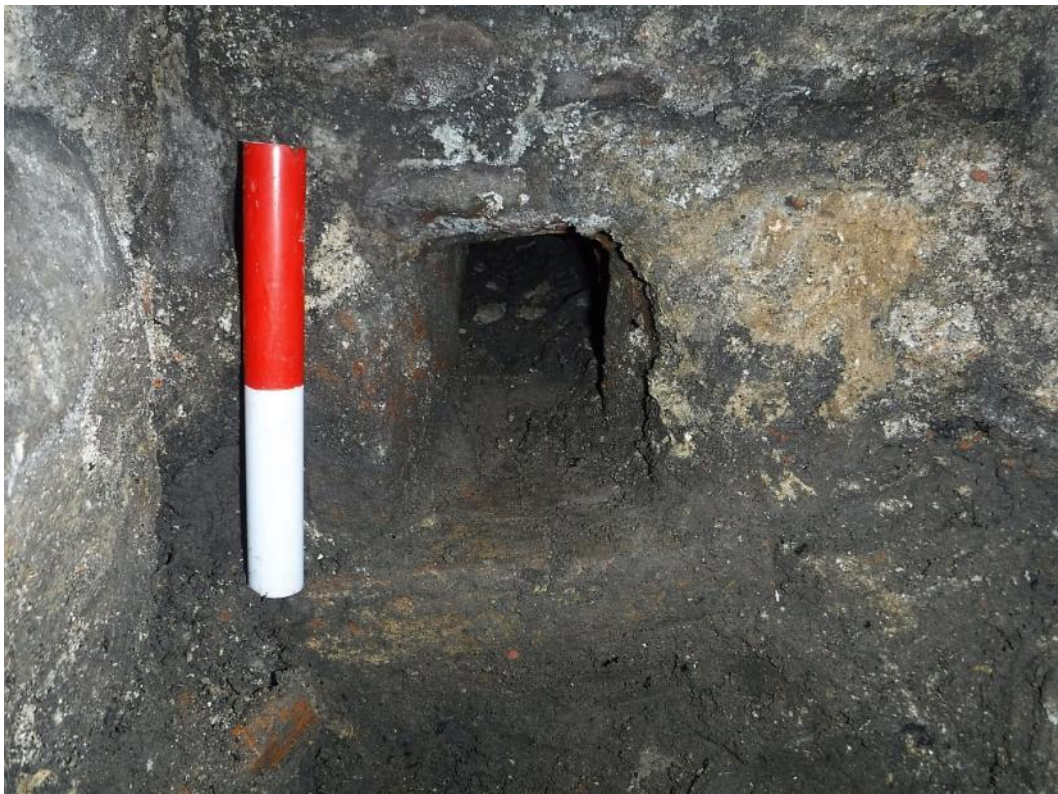
walls of the basement, which were built the same way as seen elsewhere. However, the presence of a drain or culvert in the far north corner, running north-east through the north-east wall, was of interest (Plates 15 and 16). This brick-lined structure appeared to be built at the same time as the standing building and clearly relates to the tank/well to the south.

**Plate 15 Test pit 3 culvert, facing north-east, scale unit 100mm**

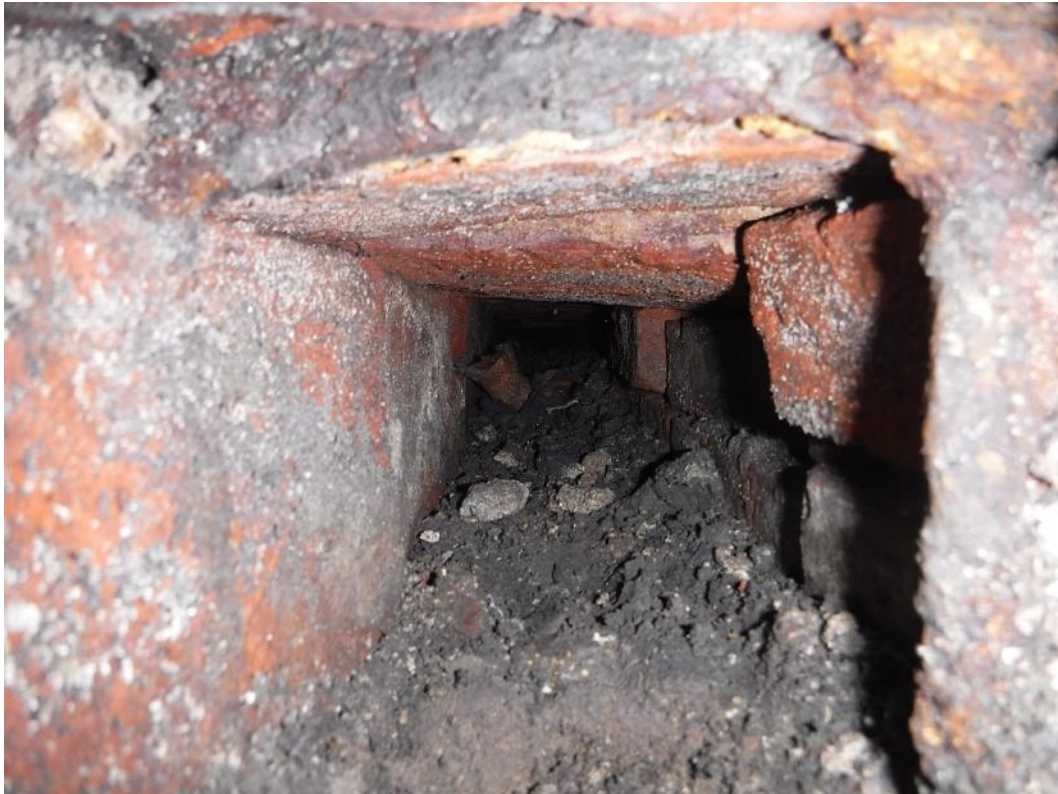
**Plate 16 Test pit 3 culvert (internal), facing north-east, scale unit 100mm**

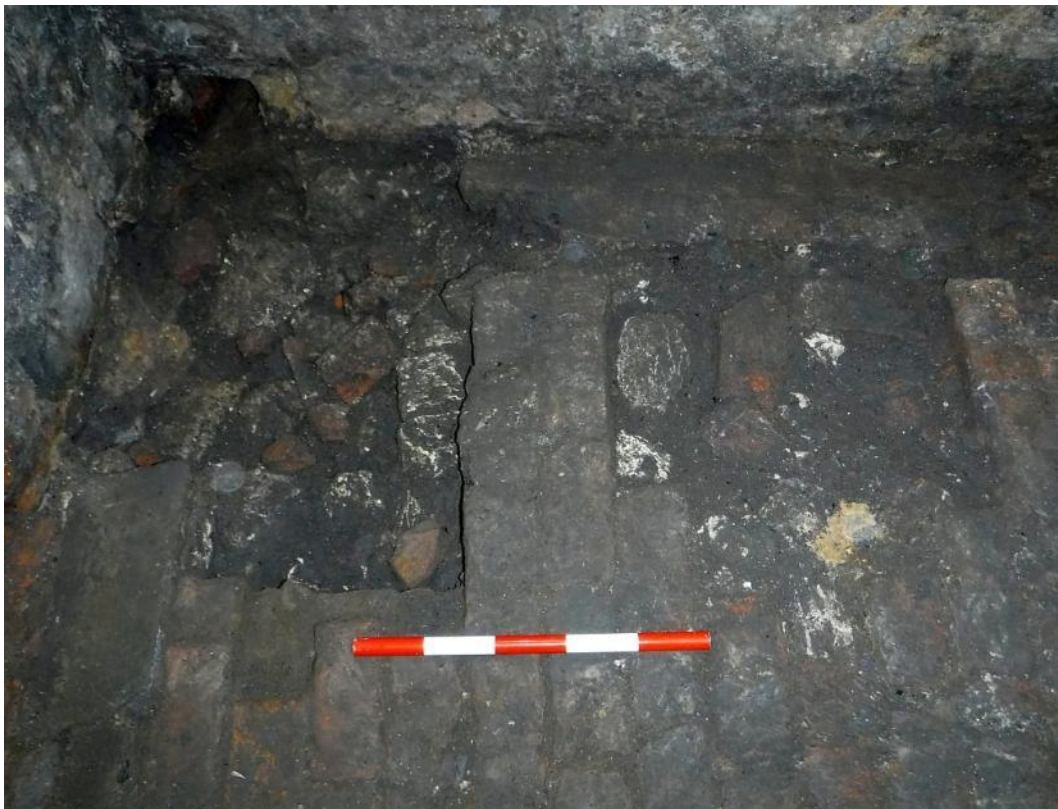
**Plate 17 Test pit 3 after excavation, facing north-east, scale unit 100mm**

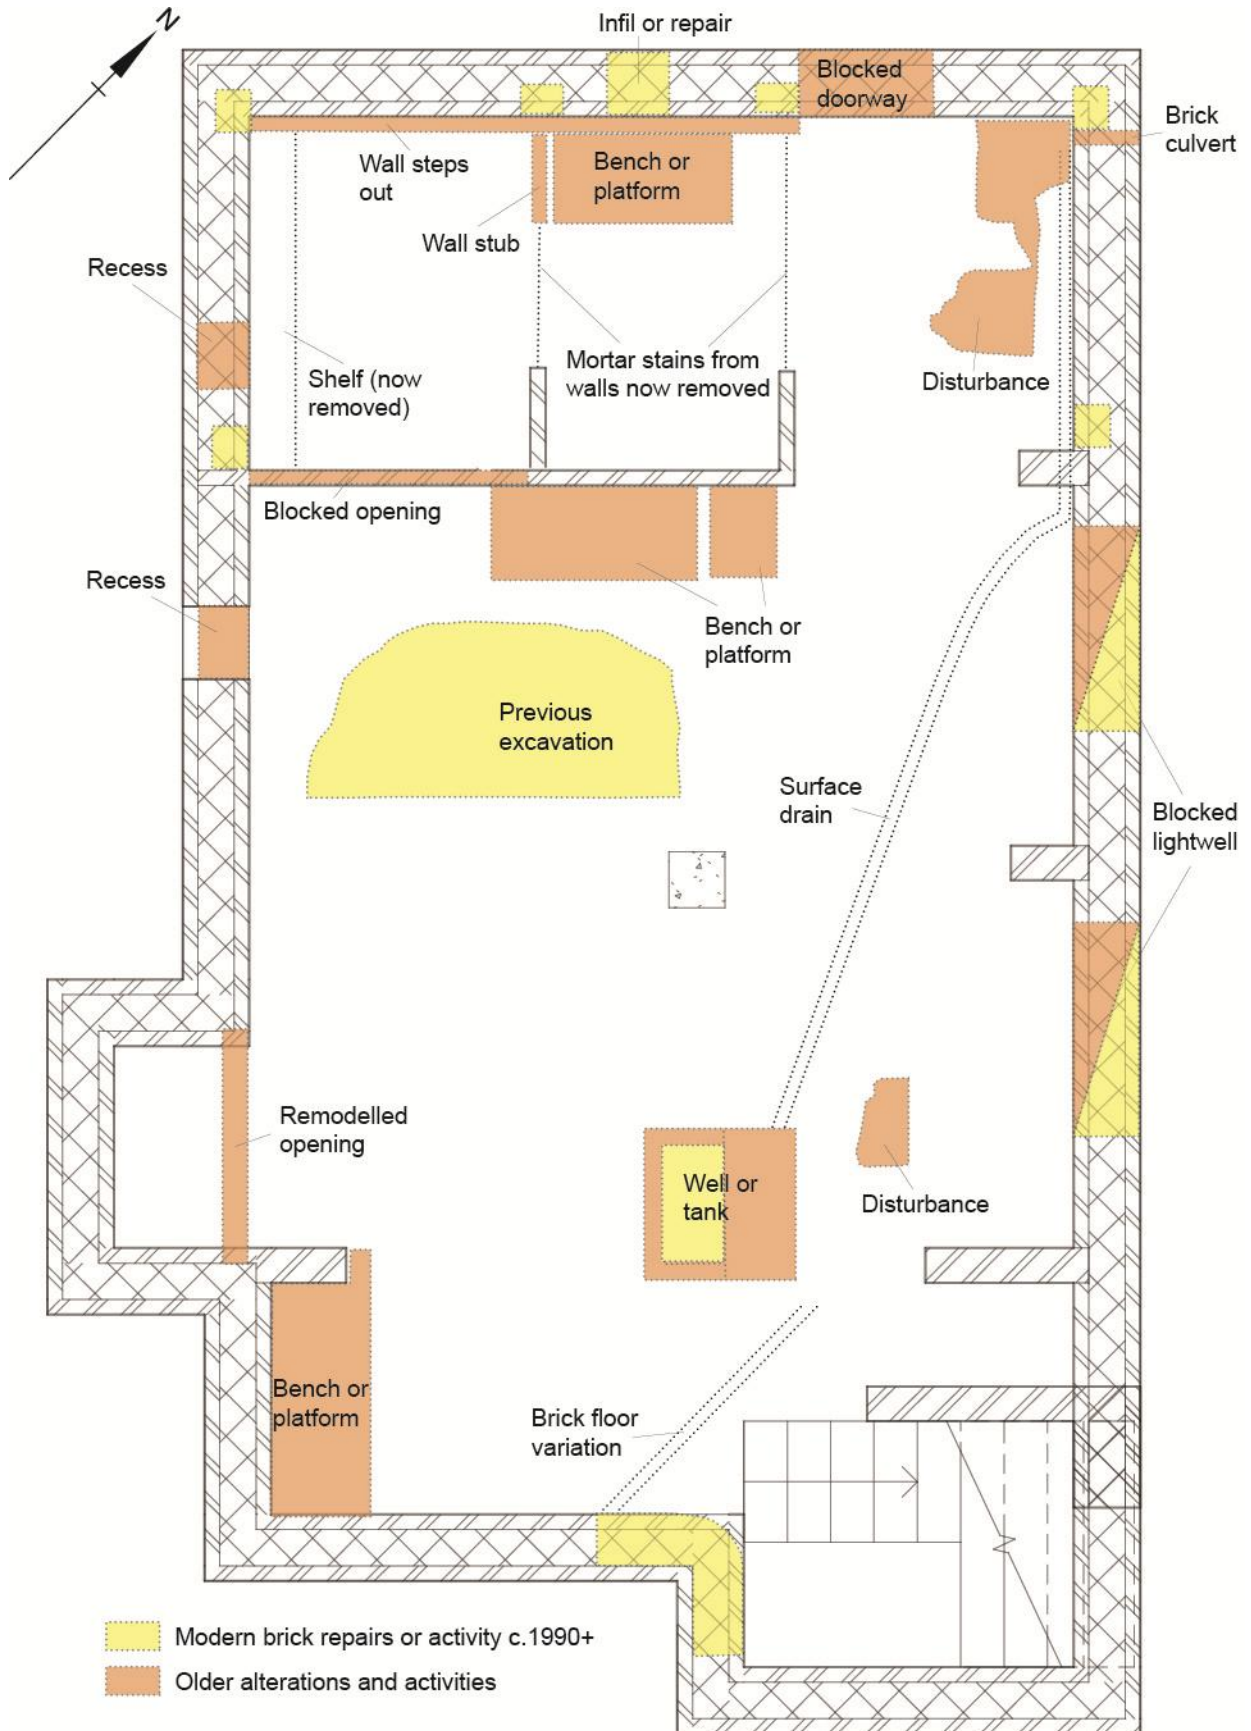
Figure 4 Basement Recording Results 1:50 (After 17/01171/FUL Drawing GA 100)

The results of the basement recording exercise can be seen in Figure 4
