ARCHAEOLOGICAL INVESTIGATIONS AT 43 TANNER ROW SEWER REPAIR

WATCHING BRIEF REPORT

Report Number 2017/116 January 2018

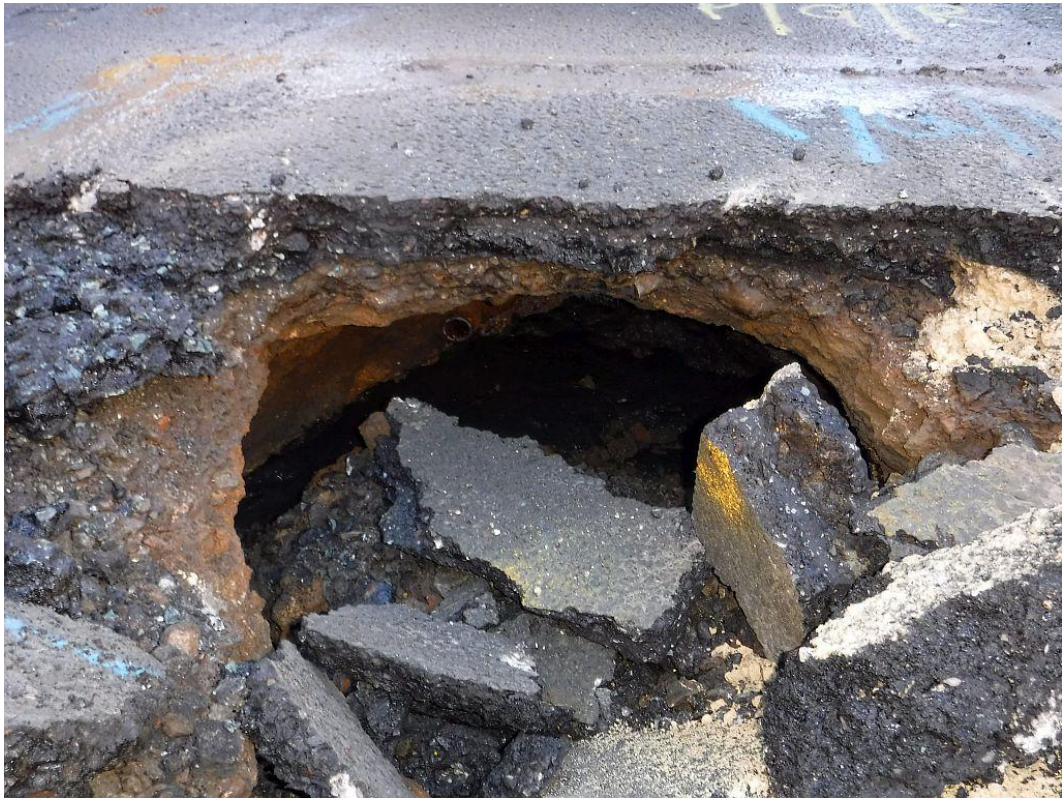
A hole opened up within the road surface on Tanner Row at the start of December 2017. Investigation by the Amey Utilities indicated that the sewer top had deflected in this area. Further investigation indicated the that sewer had collapsed and blocked c.6m to the southwest of this hole, with the resulting erosion from the collapse contributing to the sewer deflection and creation of the hole.

Plate 1 Sewer collapse, facing southwest

To repair the collapse and prevent further damage urgent works were required to excavate c.3.3m BGL, isolate the blocked/collapsed area, and repair the brick sewer.

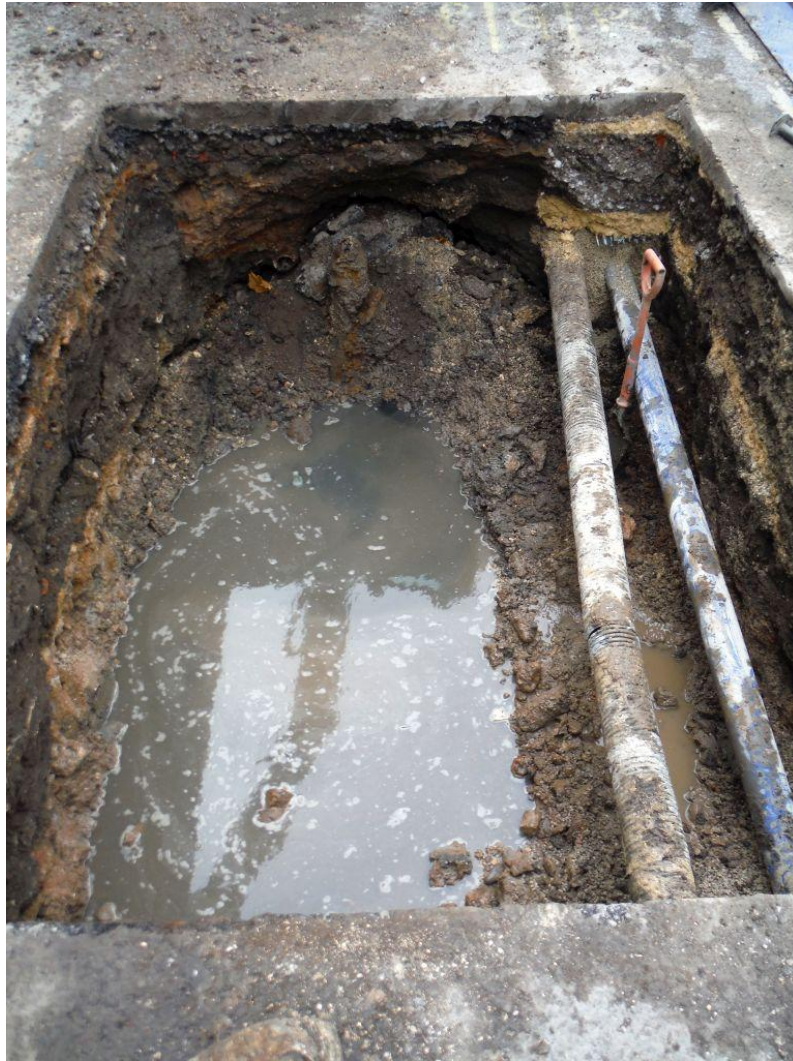
This process was significantly hampered by the collapse as indicated above. The collapse was not just isolated to the uppermost deposits as it expanded outwards as excavation continued (Plate 2). In addition further complications were caused by the presence of both live and dead services.

Plate 2 Sewer collapse extending lower in deposit sequence with contaminated liquid ingress, facing southwest

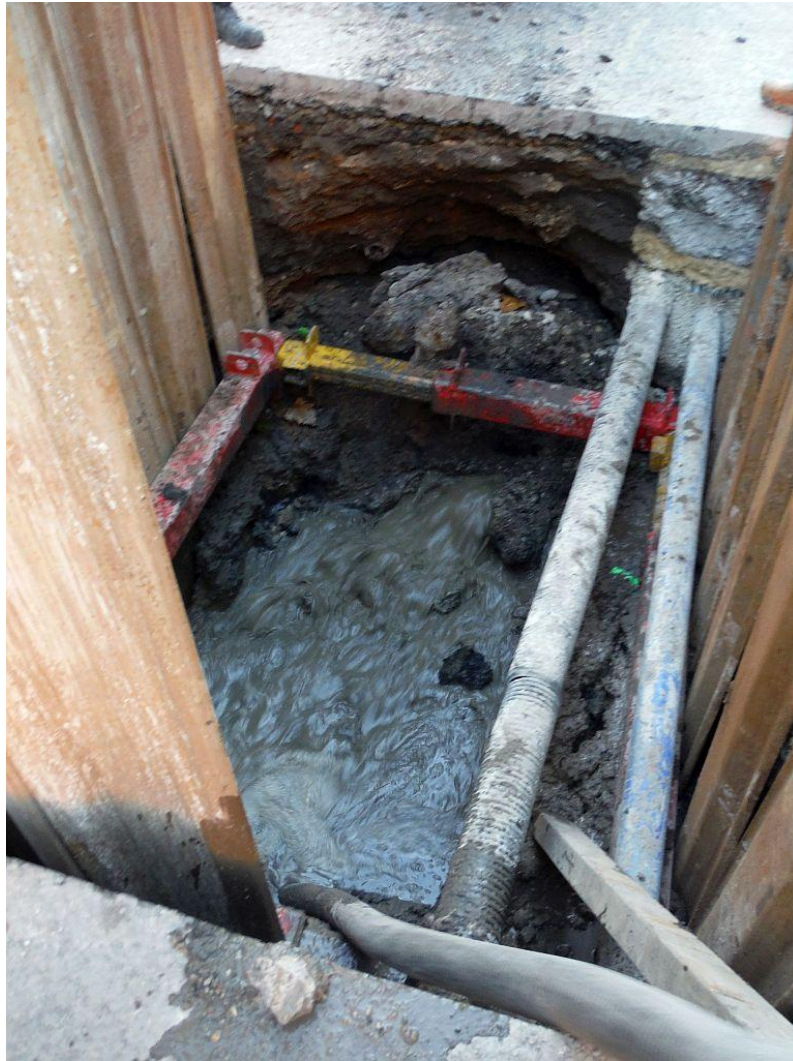
excavation and required constant pumping so the repair team could work (Plates 3 & 4). When the sewer was finally encountered the more solid elements of what had blocked the system then inundated the trench. It was only when the sewer blockage was removed, and the flow running as it should, that it was actually possible for the team to work unhindered.

Plate 3 Deeper excavation releasing pressure resulting in further contaminated liquid ingress, facing southsouthwest

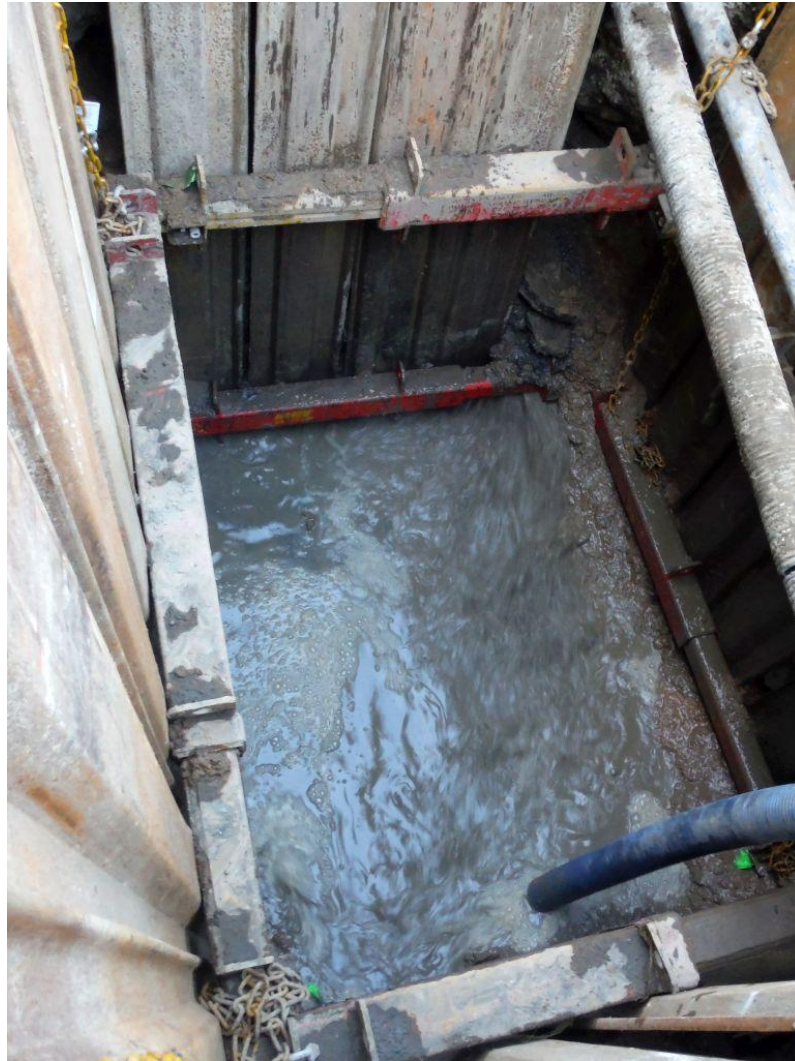
Plate 4 Further ingress of backed up contaminated liquids during deep machine excavation at just above the sewer collapse, facing west

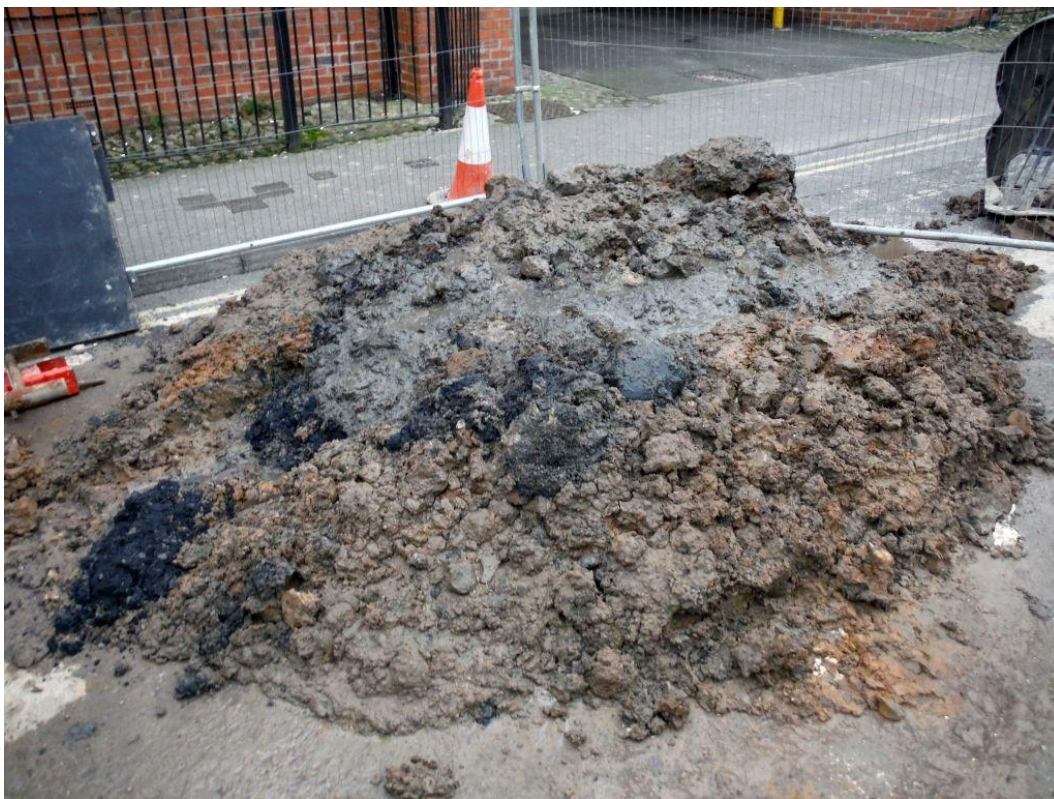
Finds were noted, but not retrieved, because of the contamination from human faecal material. Discussions with the repair team on site, coupled with the black 'anaerobic' type deposits, indicated the leak to the sewer system had been underway for a significant period of time. Plate 5 indicates the typical material machine excavated from the contaminated section as well as the modern black silt deposits.

Plate 5 Typical deposits removed from contaminated part of works

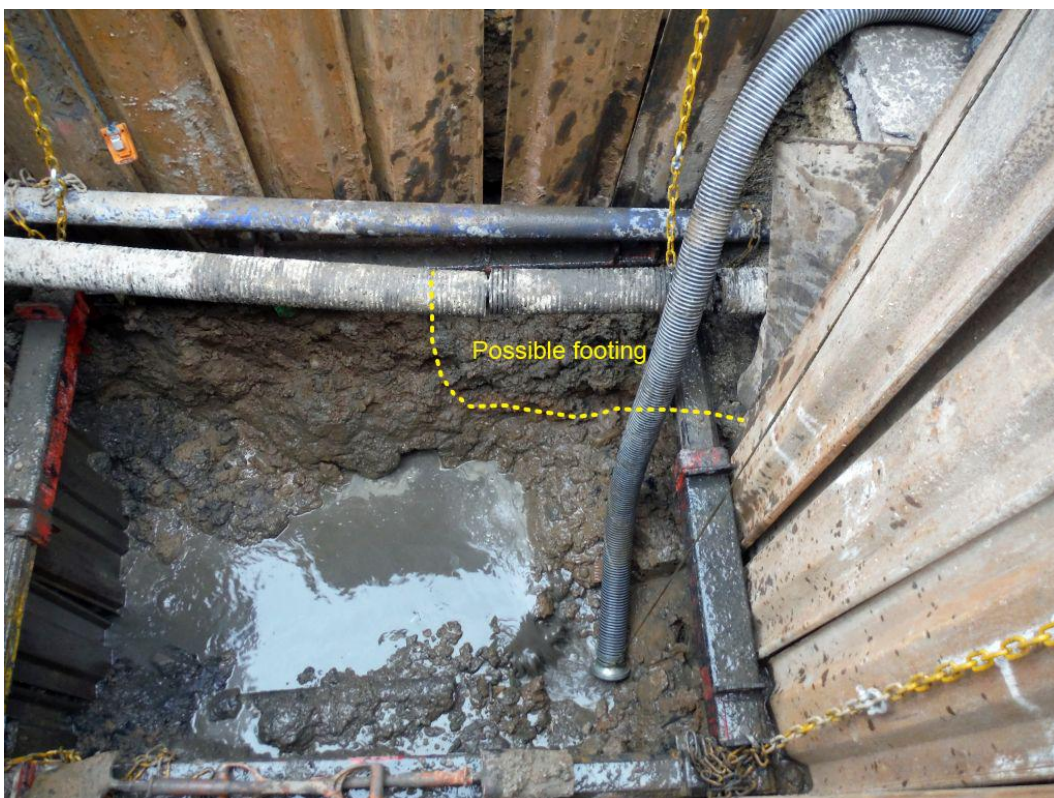
At the northern corner of the trench there was a significant concentration of cobbles (1008) (Plate 6). This was at c.1.3m BGL and continued to a depth of c.600mm. The shape in plan was unclear due to collapse and machine excavation but it appear to extend into the trench by up to 700mm. The cobbles were clearly larger than those seen in the undisturbed natural, up to 150mm diameter, and were in a matrix which was more brown than orange.

This feature was interpreted as a possible footing. With a lack of form, orientation and true dimensions further discussion is not possible. It did pre-date the road or surface described below, so indicates more than one phase of activity.

Plate 6 Possible footing (1008), facing northwest

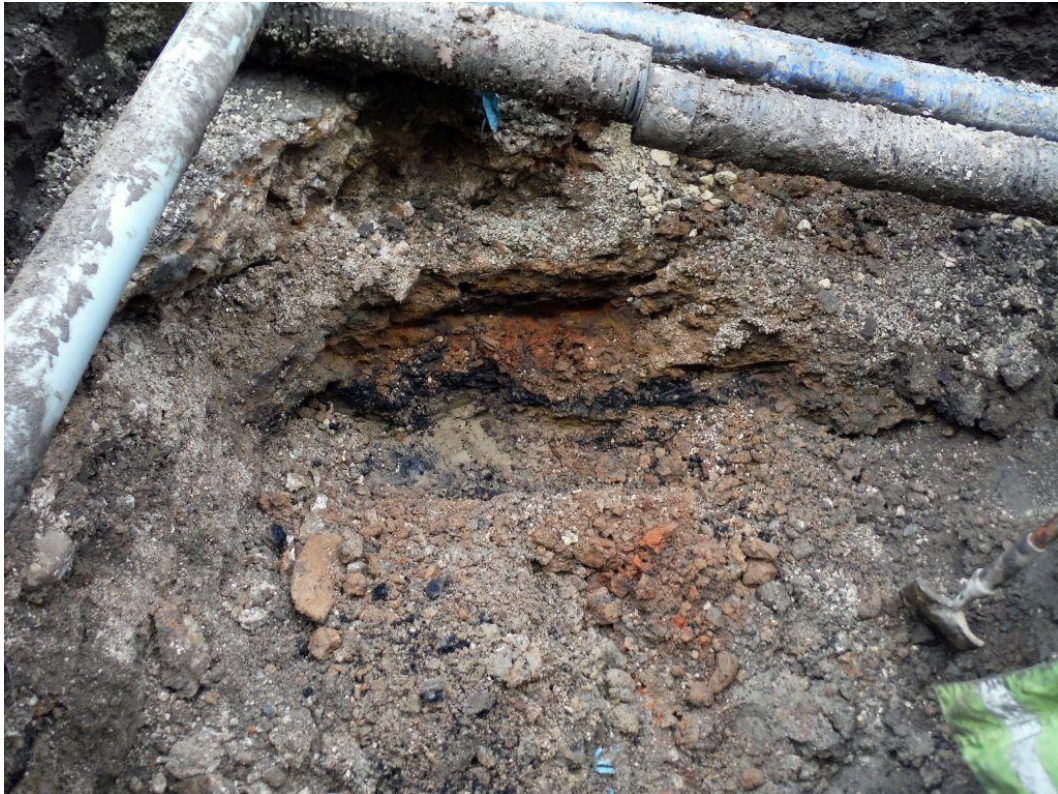
Towards the western corner of the trench was a deposit of charcoal and burnt clay/daub (1006) (Plate 7). This was seen at c.1.4m BGL and was c.300mm deep in total. Its shape in plan was not possible to determine due to machine truncation, though it may have been within a shallow pit.

Initially this was thought to have possibly been an oven or similar feature. However, during closer investigation it was clear that there was a layer of charcoal which was overlain by burnt clay/daub fragments. This suggested that there was disposal of materials opposed to in-situ use and collapse. Again this feature pre-dated the road or surface.

Plate 7 Burnt deposit, facing westsouthwest

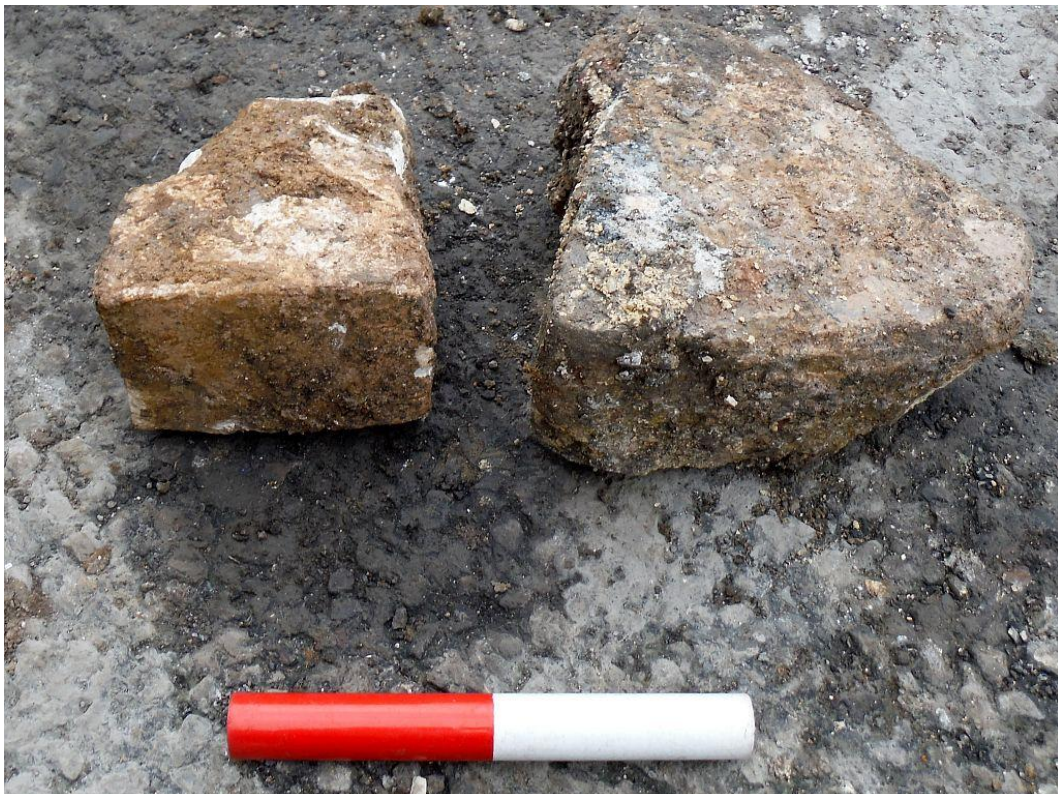
The makeup deposit (1001) was c. 400mm thick and consisted of light brown lime mortar with limestone fragment (including re-used blocks up to 200mm wide, Plate 8), cobbles and a smaller amount of CBM. This 'rubble' layer has been encountered previously (YAT 2012) and interpreted as a demolition layer to the lack of surviving surface. In this case a metallised surface was found.

Plate 8 Limestone blocks from rubble makeup (1001), scale unit 100mm

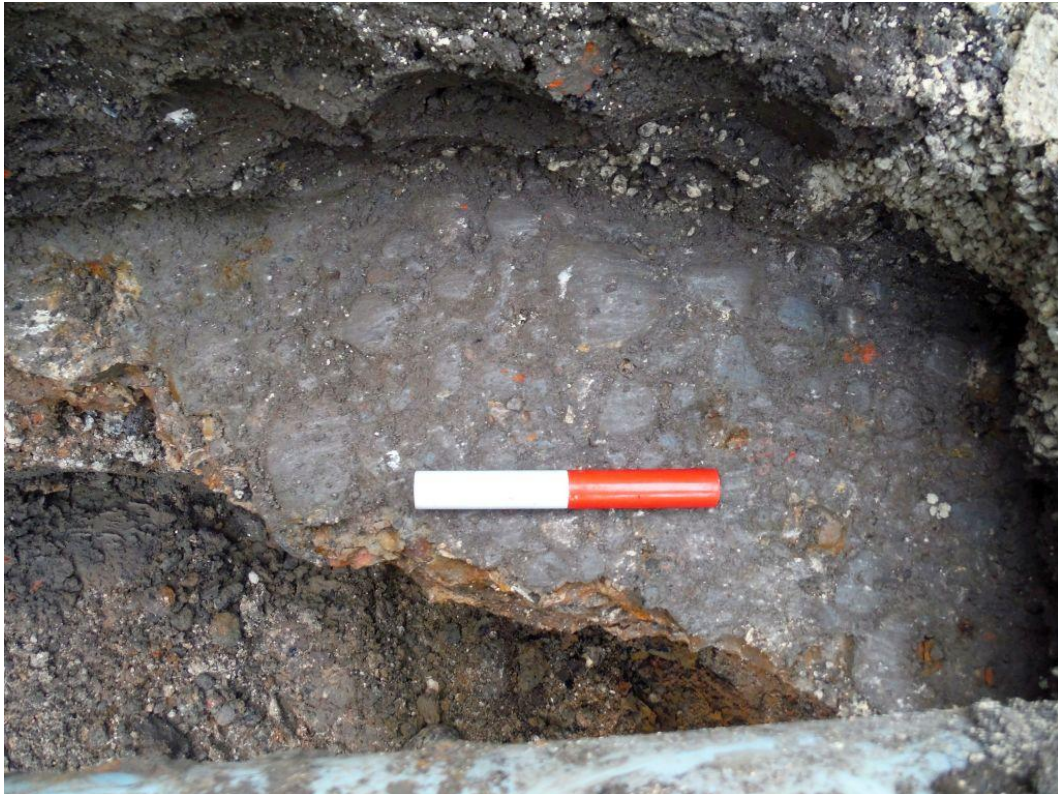
A metallised surface (1002) survived at the southwest end of the trench, initially extending up to 800mm into the excavated area. The surface was c.50mm thick and made up of small cobbles and pebbles compacted into a browner mortar than the makeup below. The surface survived at c.900mm BGL (14.6m OD).

Plate 9 Metalled road or surface, facing southwest, scale unit 100mm
