# YORK ARCHAEOLOGICAL TRUST

<b>SITE</b>	St. Mary's Church, Kirkgate, Thirsk YO7 1PR		
<b>CLIENT NAME</b>	Hambleton District Council		
<b>YAT PROJECT #</b>	6106	<b>YAT REPORT #</b>	2018/165
<b>MUSEUM ACCESSION #</b>	N/A	<b>GRID REFERENCE</b>	SE 4273 8228
<b>PLANNING REFERENCE #</b>	N/A	<b>AAI OPS NOTICE #</b>	N/A

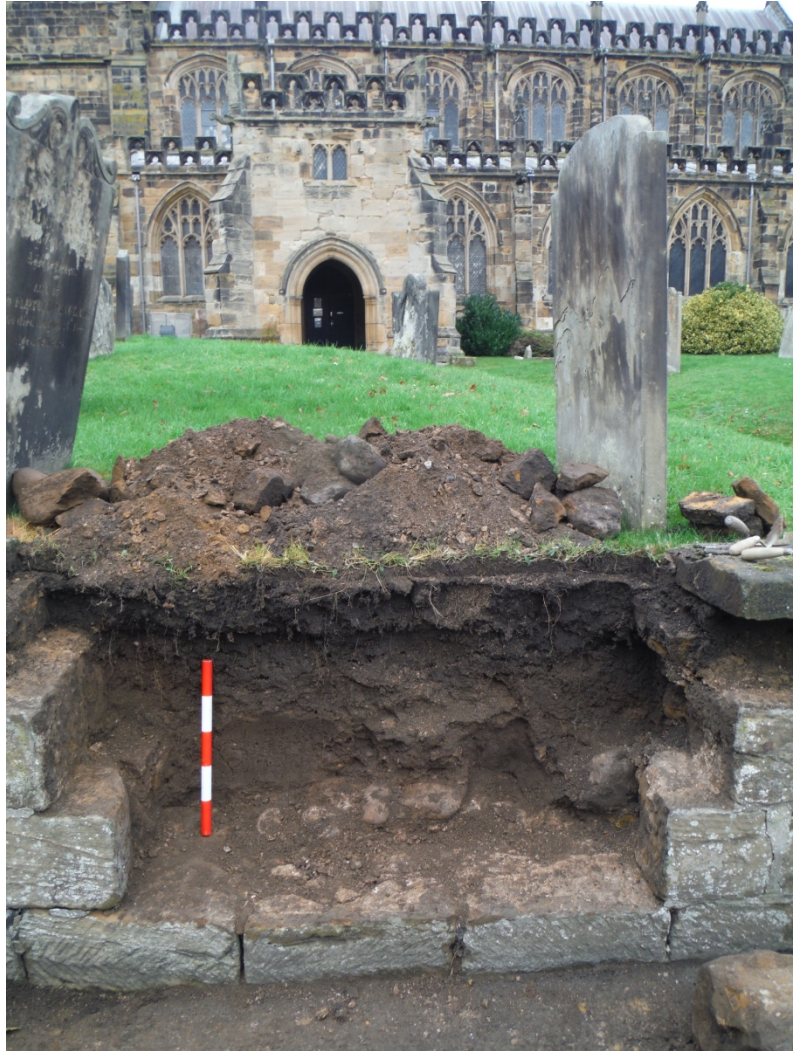
In the section of wall to the south of the church, the upper three courses of masonry were removed, along with part of a loose rubble infilling deposit against the inner face (Plate 1). This material was interpreted as construction backfill. In the section to the west of the church, the inner face of the wall was only partially removed, with some roughly coursed masonry left *in-situ* alongside the construction backfill (Plate 2). As the wall was then rebuilt to its original dimensions, it was not necessary to cut into any deposits that pre-dated the construction of the wall. As a result of this methodology, no inhumations or significant archaeological deposits were affected by the works.

Plate 1. North facing view of the churchyard deposits exposed behind the boundary wall (0.50m scale).

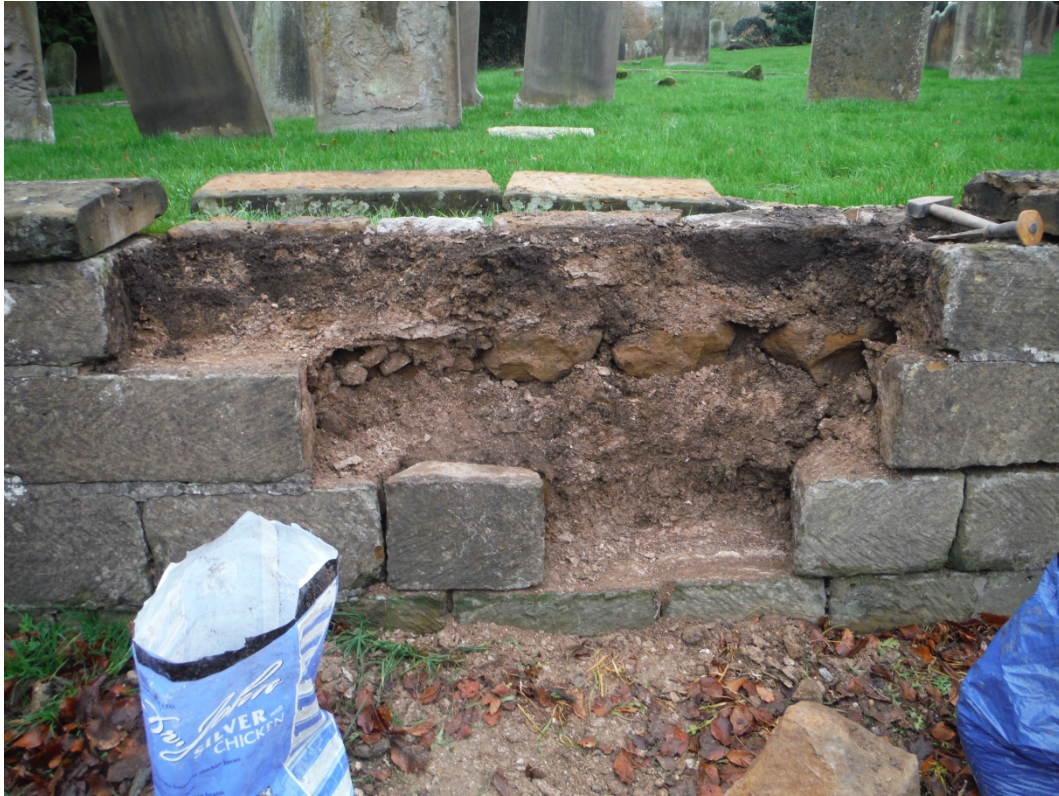
Plate 2. East facing view of the partially dismantled boundary wall.
