Archaeological Building Recording at 1a Coffee Yard, York

Ben Savine

YAT Building Recording Report 2018/145 December 2018

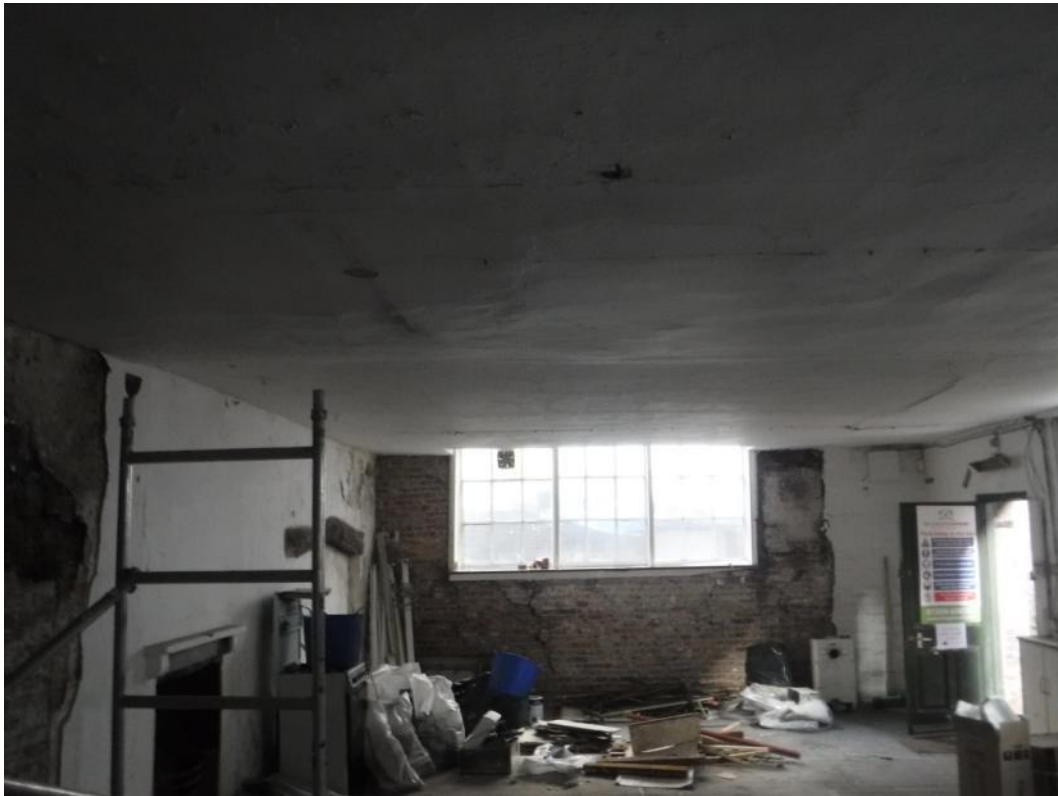
Removal of the 19th century suspended ceiling was undertaken by the principle contractor following a basic photographic survey (Plates 1 and 2). The 19th century ceiling was found to extend across the majority of the space, except in a recess at the southern end of the ground floor where a modern repair was in place (Plate 3).

Plate 1 Ground floor 19th century ceiling, facing north-west

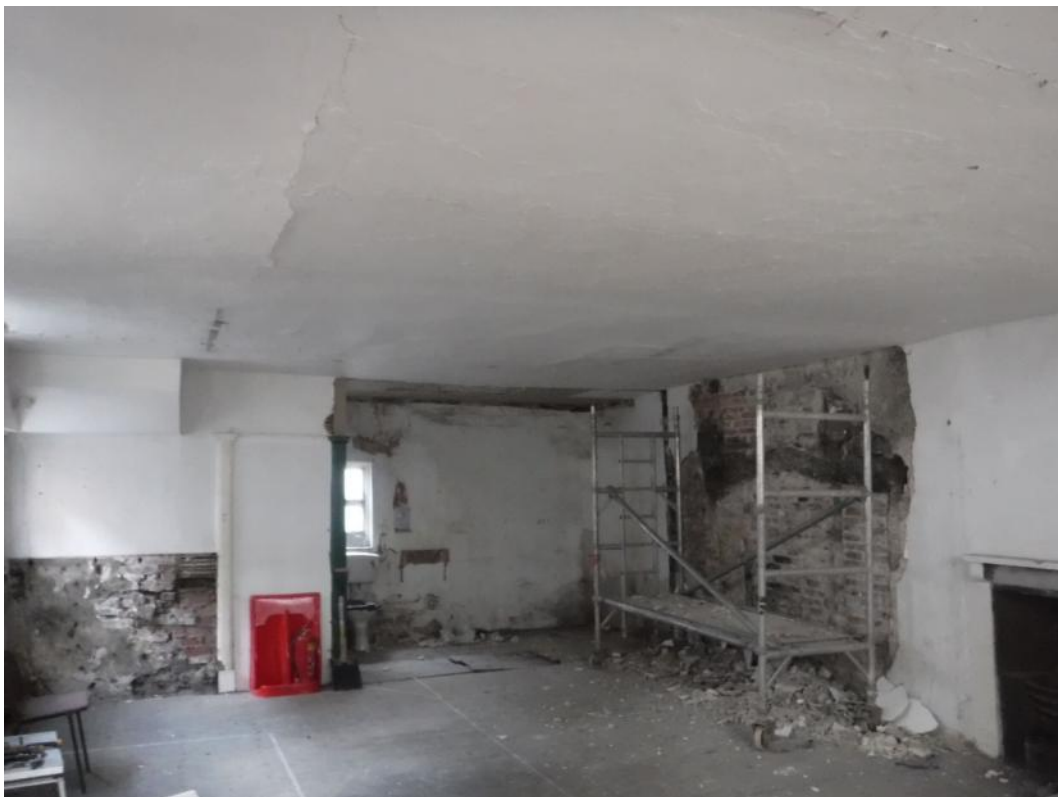
Plate 2 Ground floor 19th century ceiling, facing south

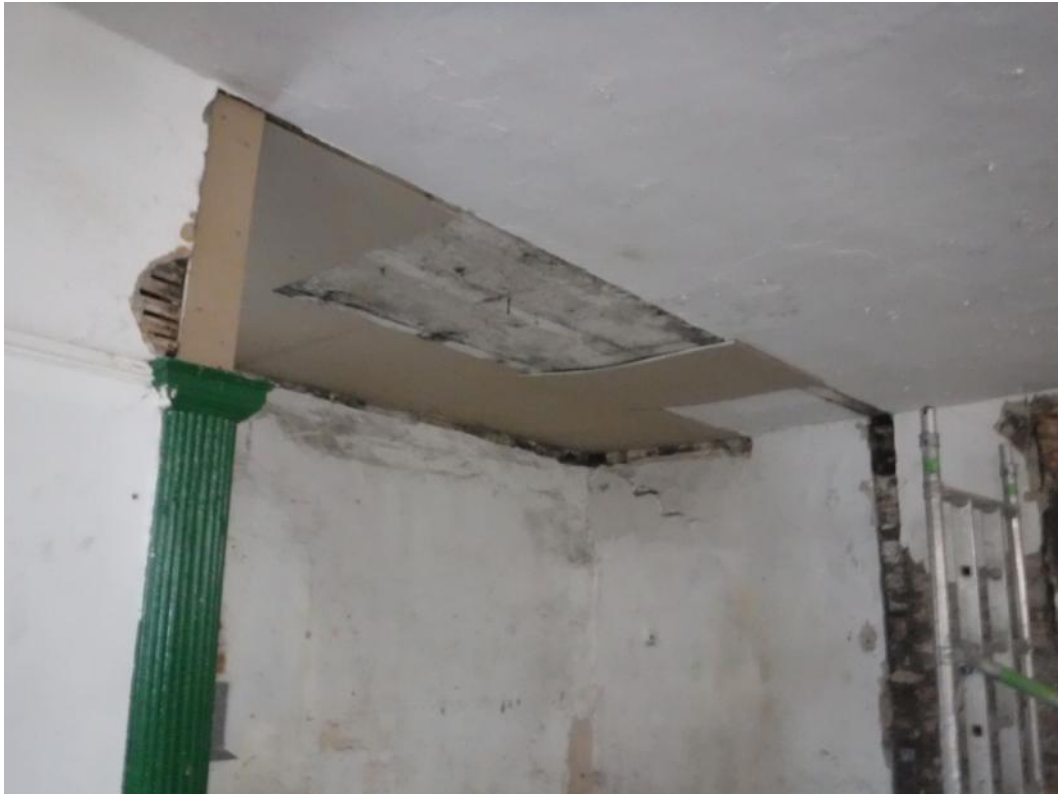
Plate 3 Modern repair to ground floor ceiling in recess at southern end, facing south

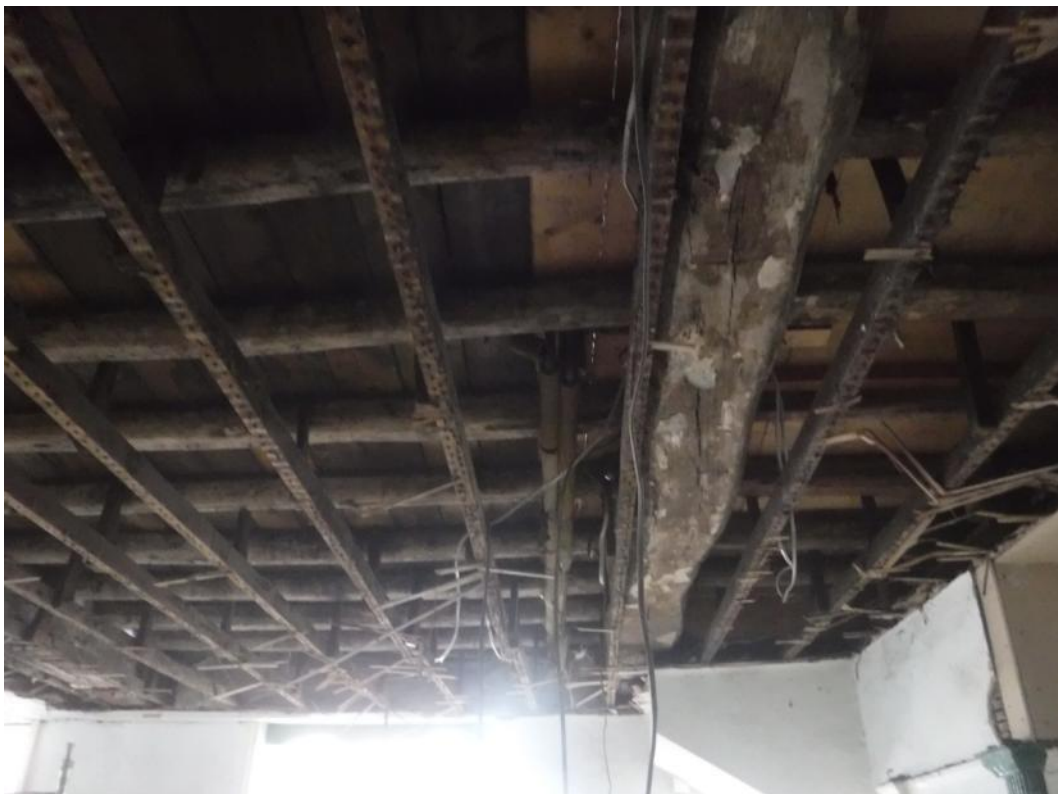
The removal works were undertaken in two phases. The first step involved removing the lath and plaster elements. With battens and joist hangers exposed (Plate 4) the second step was to remove them safely from the original 17th/18th century timber joists and beams.

Plate 4 Battens and joist hangers used to support the 19th century lath and plaster ceiling, facing north-east

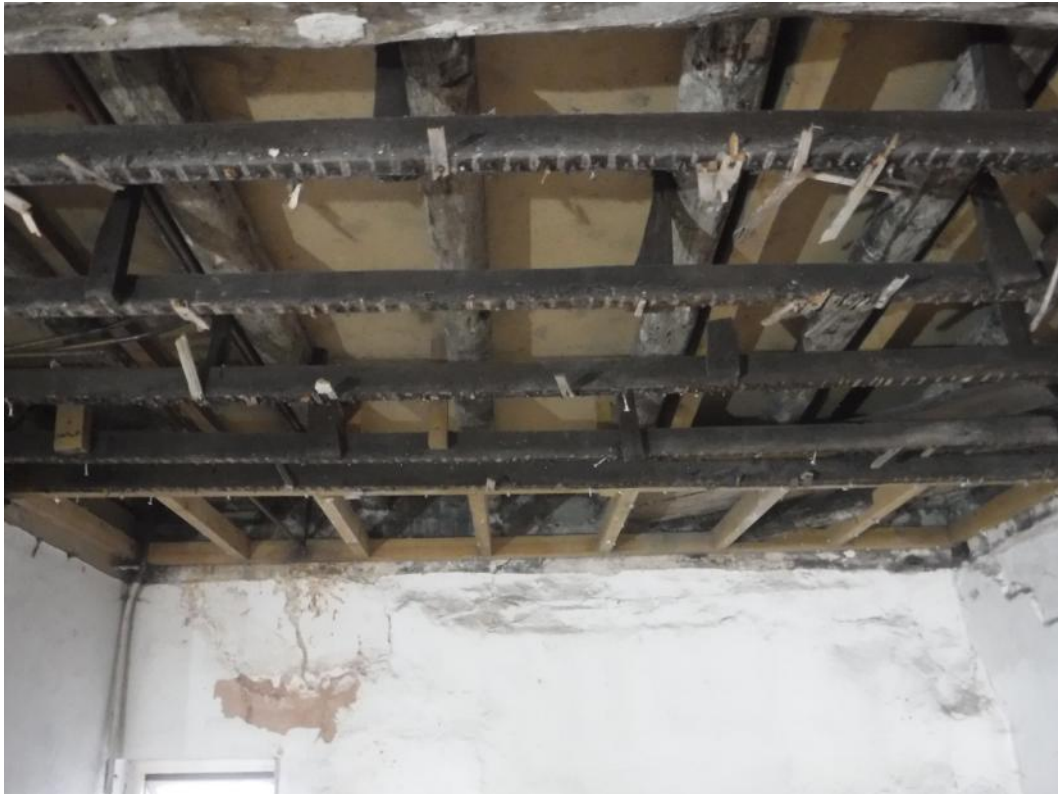
During the course of the stripping-out works modern timber battens were exposed in the recess at the southern end of the room where a recent ceiling repair was situated (Plate 5). At the northern end of the room, in an area measuring approximately 2.3m north-west/south-east and 1.8m north-east/south-west between the main entrance door, the window in the north-west wall and the first beam into the room from the north-west end of the ground floor, evidence for what is likely to have been a repair of the ceiling undertaken at some point in the

Plate 5 Modern battens alongside their 19th century equivalents at southern end of the ground floor ceiling, facing southeast

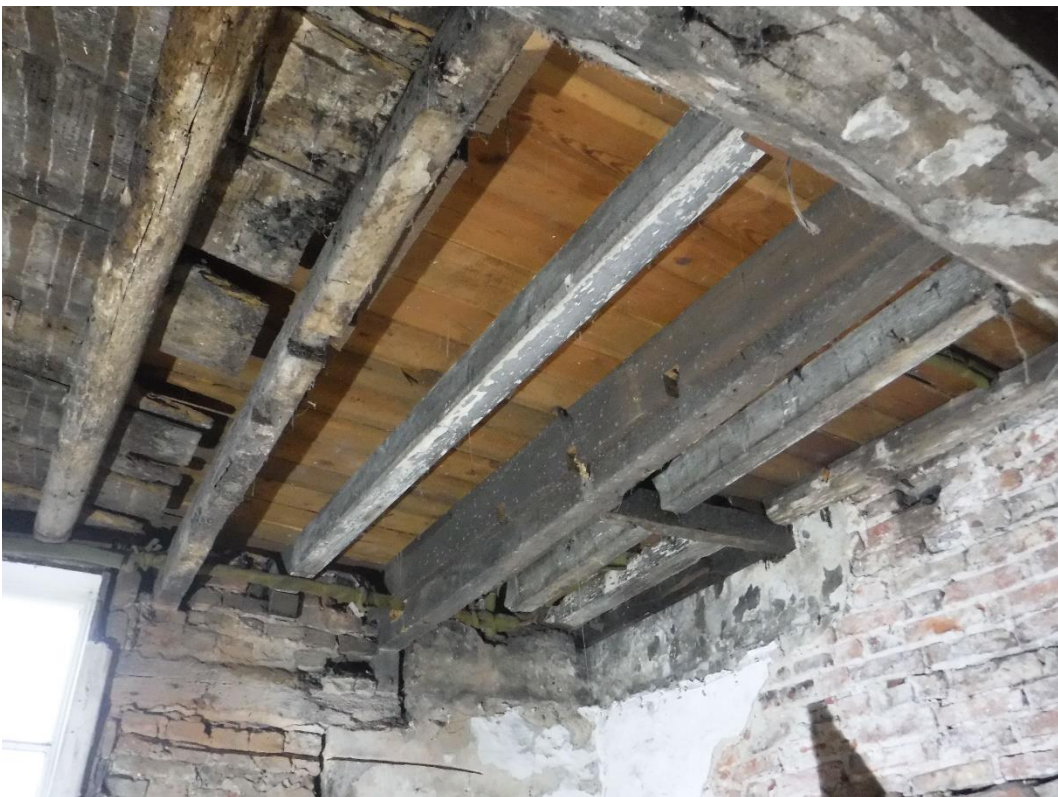
20th century was found (Plate 6). In this area the first floor floorboards had been cut away and replaced where they appear to have rotted (Plate 7). It appears that to facilitate this repair a section of the ground floor suspended ceiling was removed and the supporting battens cut away and temporarily removed. Five joists were then inserted, some of which appear to be reused timbers as they possess notches which do not appear to correspond to the ceiling or floor structure (Plate 7), above which new floor boards were placed. The 19th century battens and joist hangers were reinstalled and attached to the inserted joists (Plate 8) and a new section of ceiling installed.

Plate 6 20th century joists inserted at north end of the ground floor, note the deteriorated early floor boards to left of shot, facing north

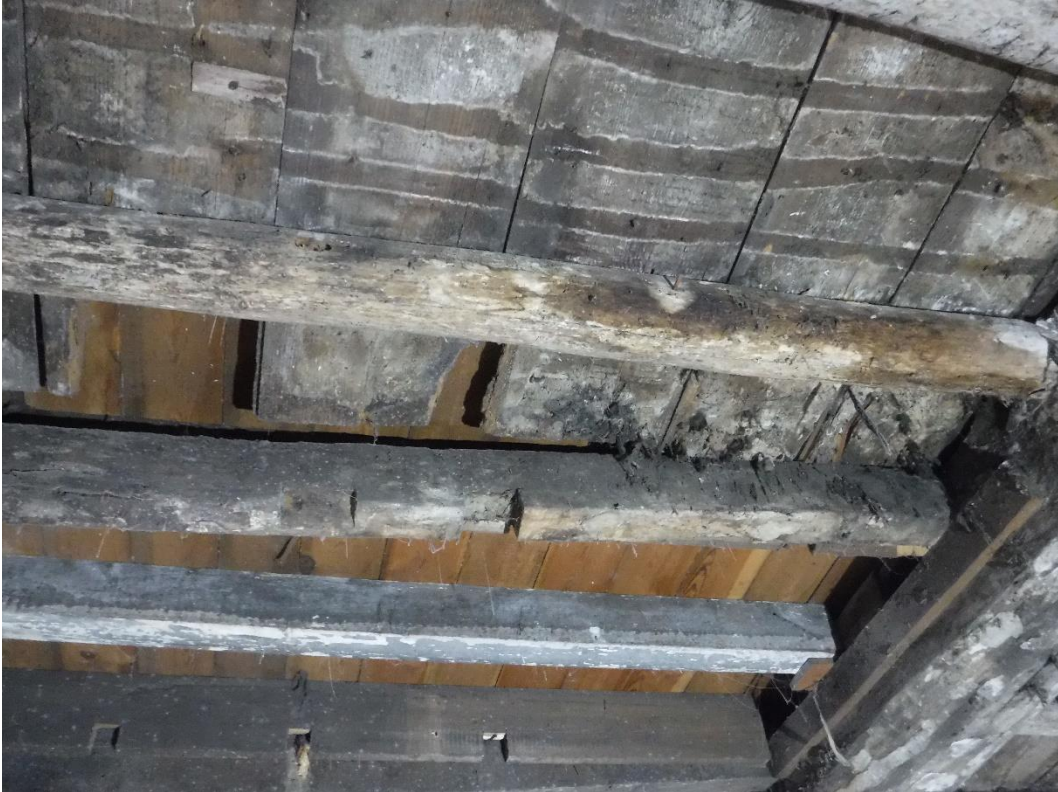
Plate 7 Deteriorated north-eastern ends of early floor boards at northern of the ground floor, note the reused timbers used as joists, looking north-east

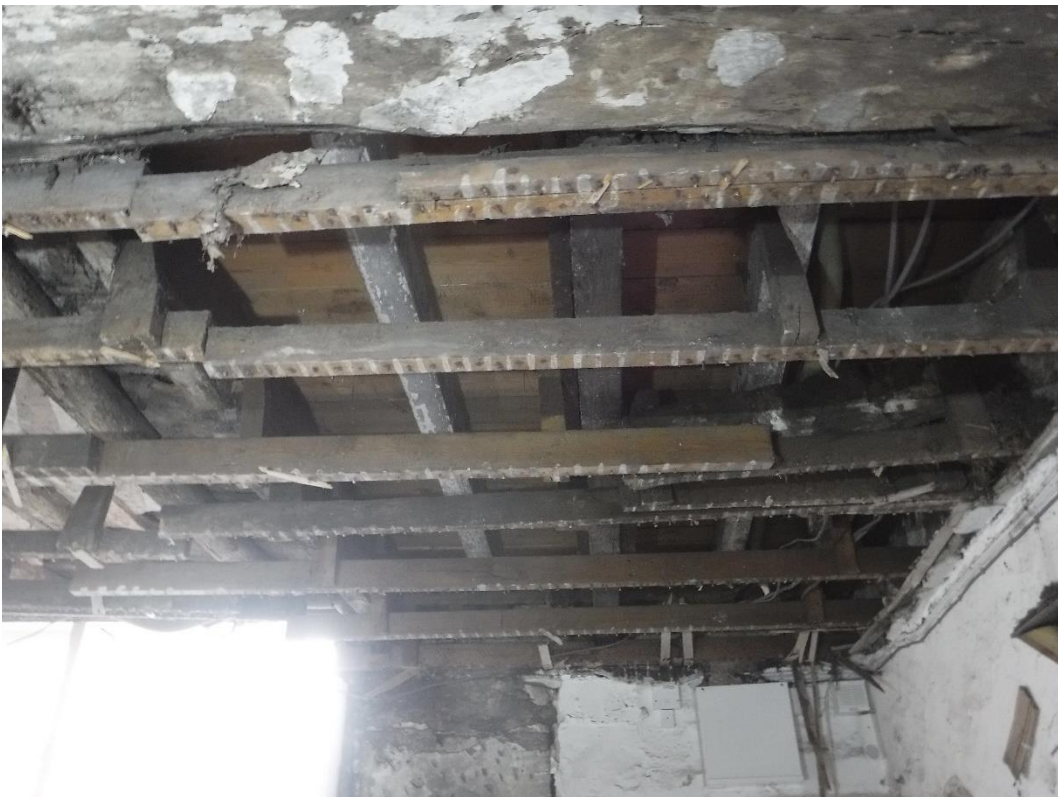
Plate 8 Reinstated 19th century ceiling battens and hangers across repaired section of ground floor ceiling in northern corner, looking north-west

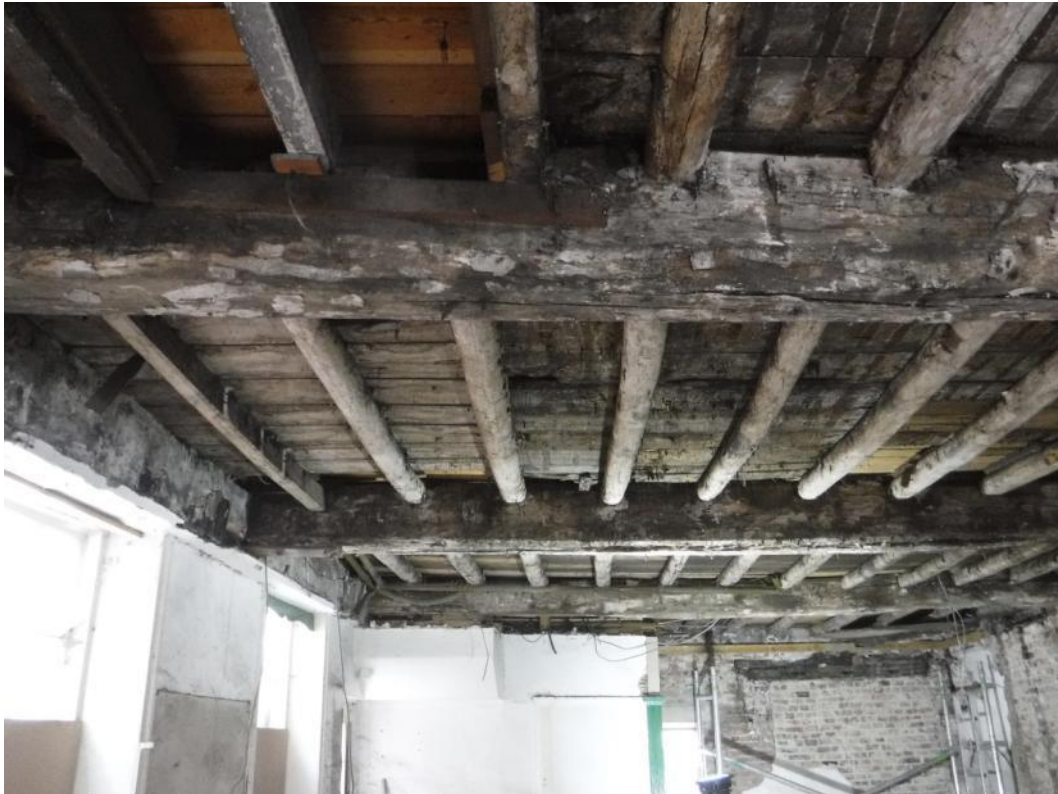
The beams, of which there are five, run north-east to south-west across the narrow axis of the room dividing the ceiling into four cells. The south-eastern end of at least the three beams uncovered in the middle of the ceiling have at some stage had remedial work undertaken, here supporting steel plate have been inserted and bolted on to the beams. Evenly spaced joists were observed to run north-west to south-east across each cell, with the line of joists remaining constant along the length of the room. Typically thirteen joists occupied each cell, however at the south end of the room a boxed-in staircase obscured the eastern corner of the ceiling, consequently it was not possible to observe and record the number of joists or how many might have been affected by the placement of the stairs (Plates 9 and 10).

Plate 9 Exposed 17th/18th century beams and joists with floor boards of the first floor above, facing south-west

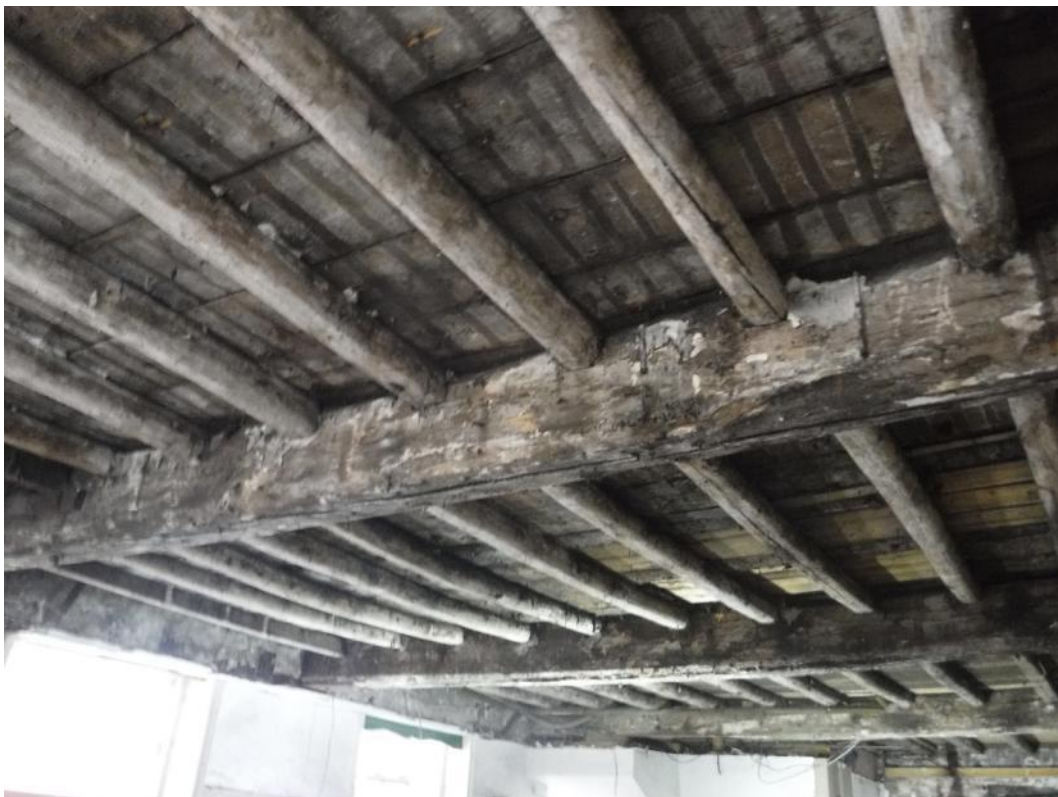
Plate 10 Exposed 17th/18th century beams and joists with floor boards of the first floor above, facing east

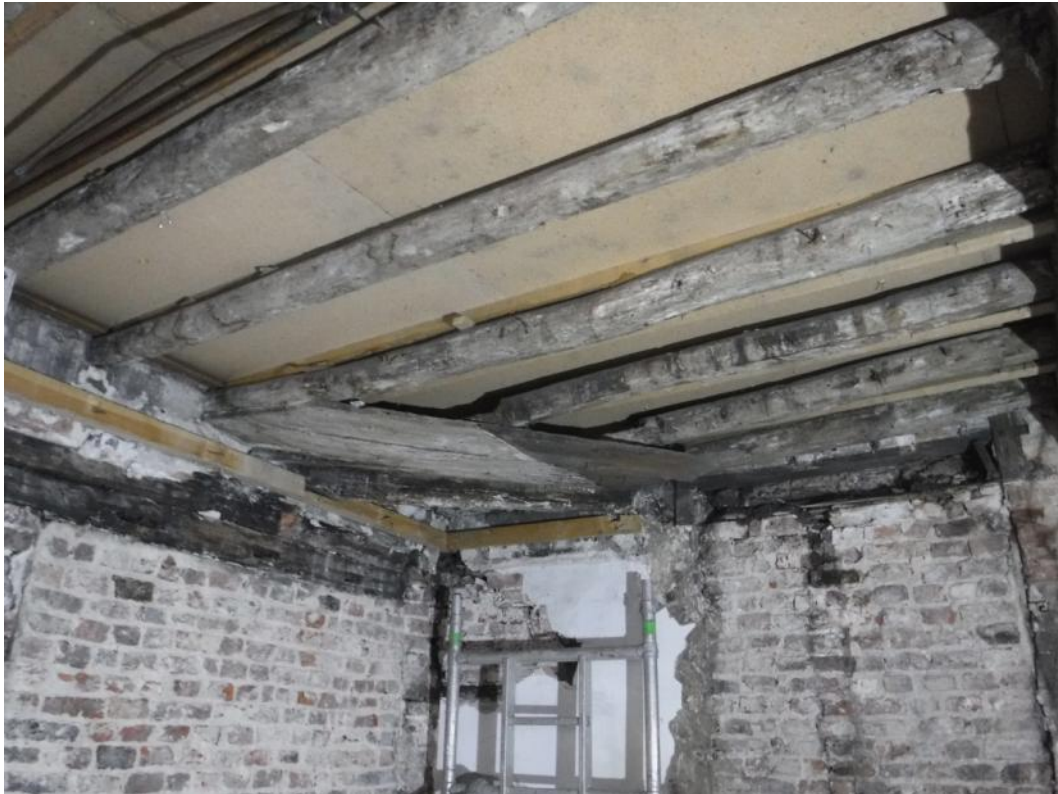
Also observed at the southern end of the room, set into the far southern corner, were five planks set at approximately 45° to the alignment of the room which extended across an area measuring 1.55m along the south-east wall of the room and 2.4m along the south-west wall of the room (Figure 2, Plates 11 and 12). The planks were supported by a joist below that ran the length of the central plank (Plate 13). The planks were fastened to the underside of four joists, of which the second and third were observed to have a cut-away on their upper faces corresponding to the extent of the planks fastened below (Plate 14). Although the purpose or function of this feature is not clear it does correspond to what appears to be a similarly angled corner present in the first floor space above.

Plate 11 Planks attached below joists in the southern corner of the ground floor ceiling, facing south

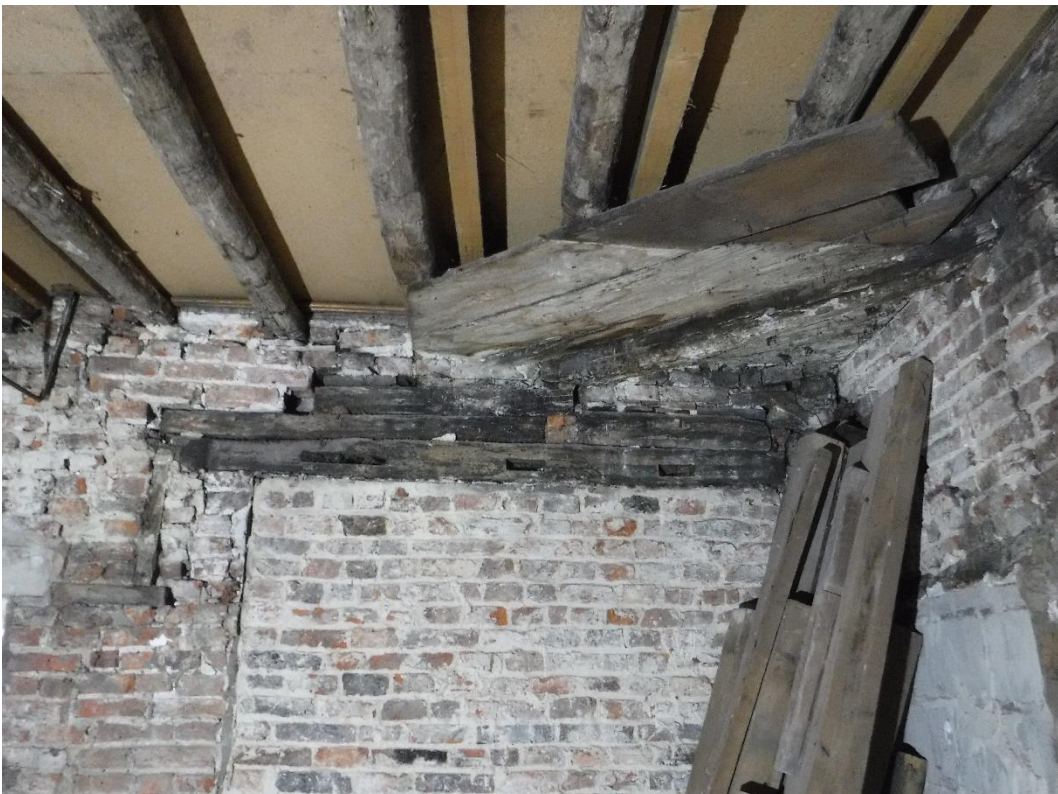
Plate 12 Planks attached to underside of joists in southern corner of the ground floor ceiling, facing south-east

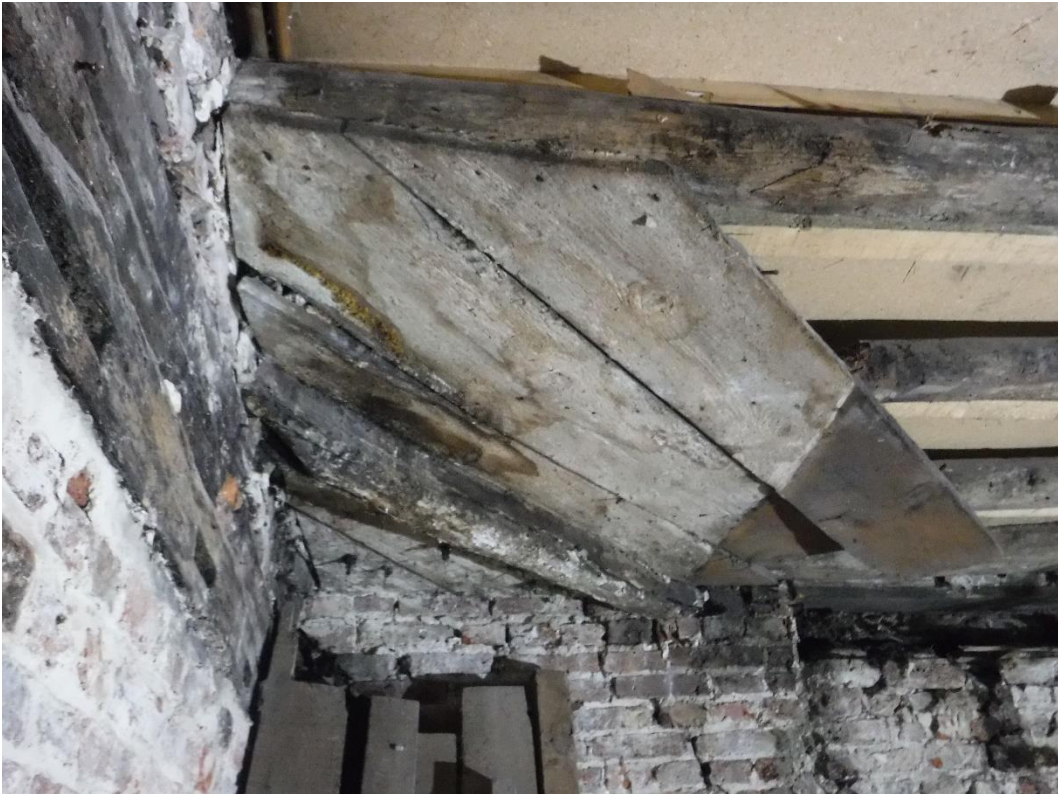
Plate 13 Detail of planks in southern corner of ground floor ceiling, facing south-west

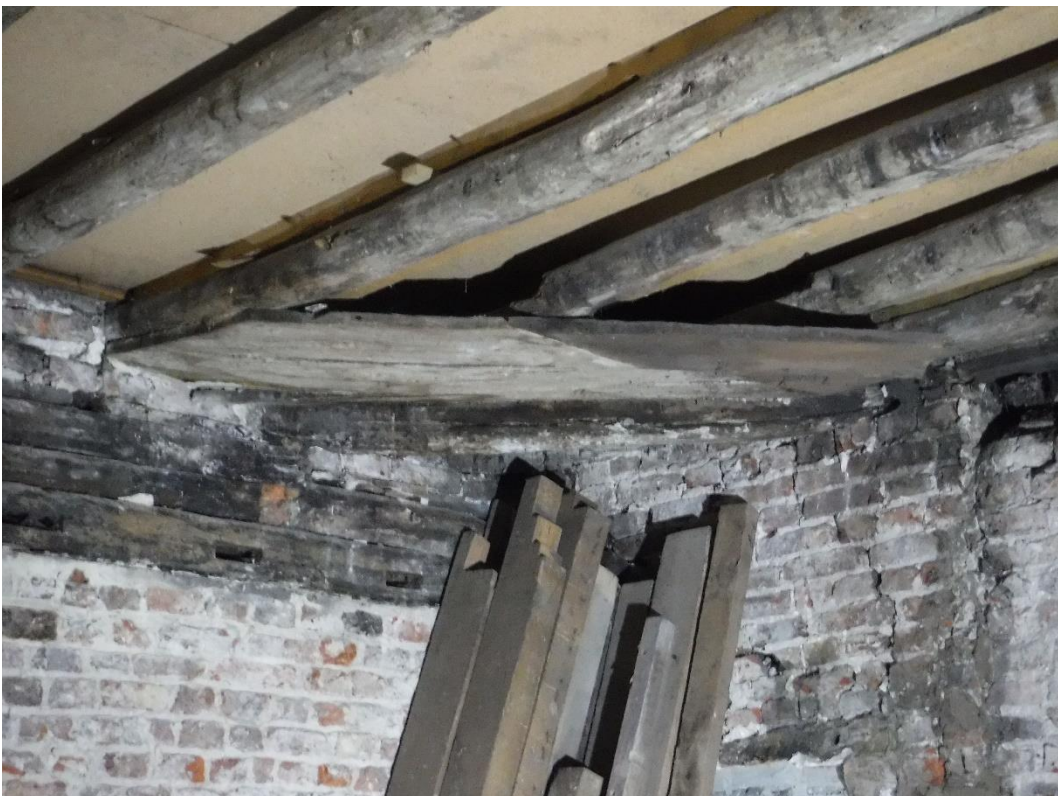
Plate 14 Detail of planks in southern corner of the ground floor ceiling, note the recesses on the upper part of the two joists running above the middle of the planks, facing south

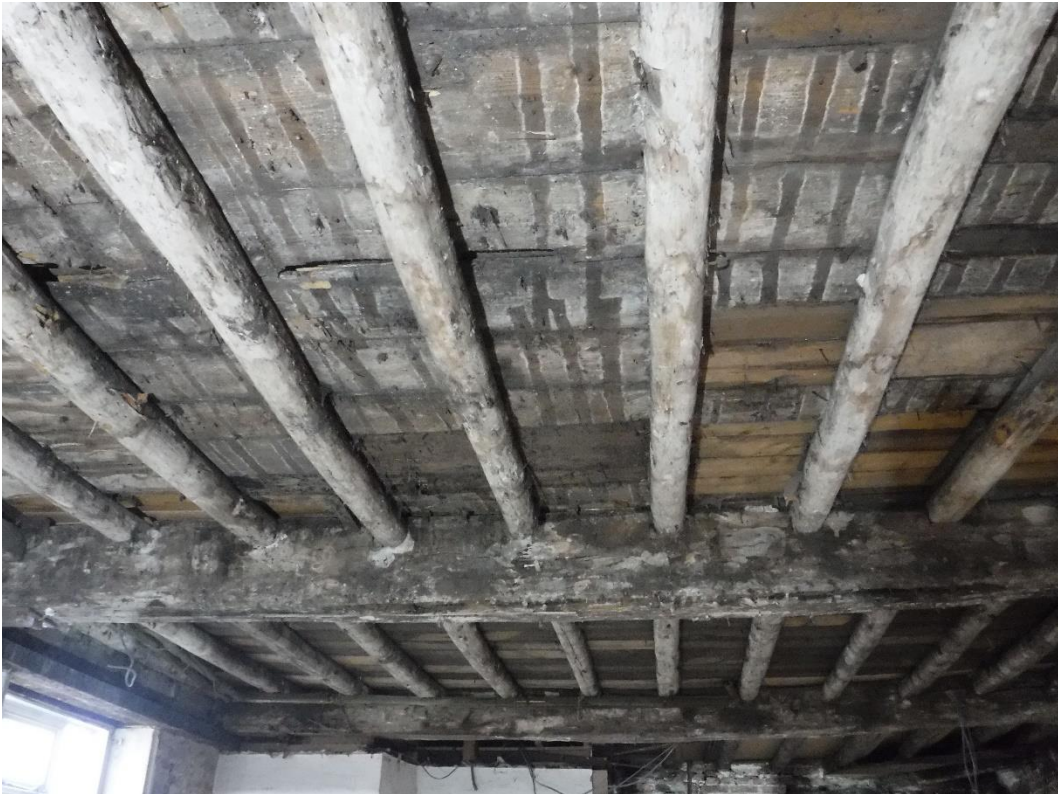
Where original floor boards survived traces of where laths were attached to their underside were apparent (Plate 15), however only a small area of this possibly 17th/18th century lath and plaster ceiling remained *in situ* covering an area no more than 2.5m². Remains of the early ceiling were found adjacent to the window in the north-west wall of the room, between the timber joists and beam close to the main doorway accessing the ground floor from Coffee Yard. This area of plaster was in very poor condition and much of the plaster had become detached from the laths. It was deemed unsafe by the principle contractor and was removed (Plate 16).

Plate 15 Traces of early lath and plaster ceiling visible on the underside of early first floor floor boards, facing south-east

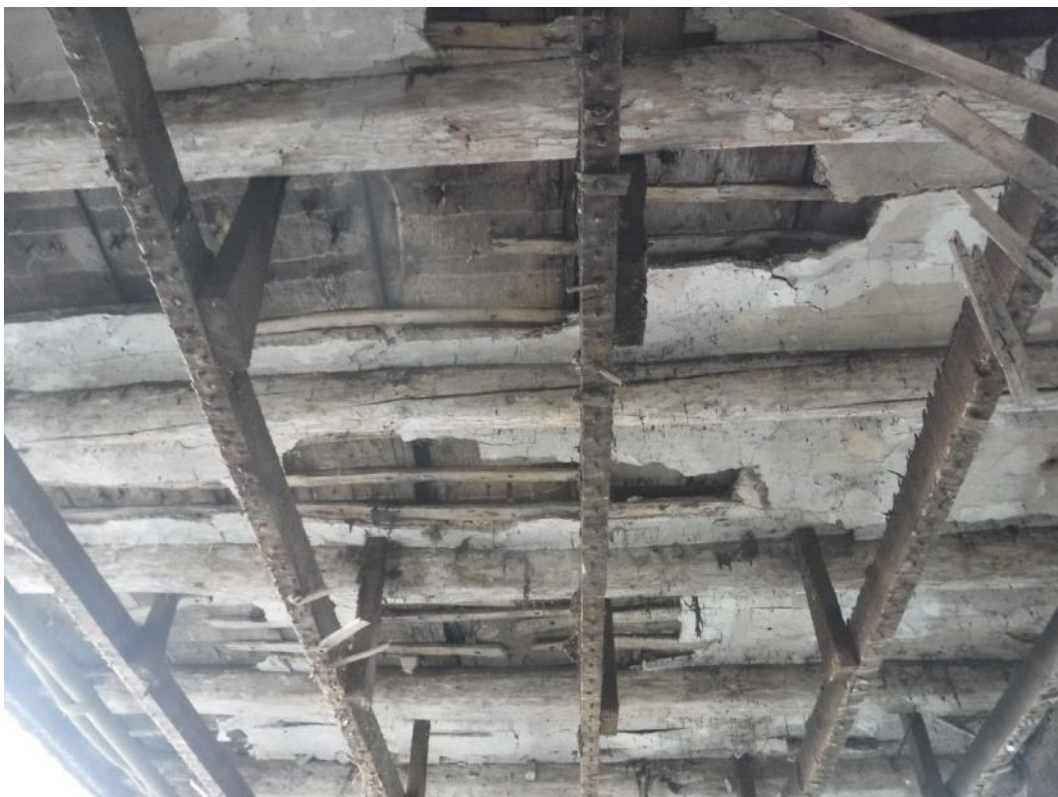
Plate 16 Fragmentary remains of an early lath and plaster ceiling present towards the northern end of the ground floor ceiling, facing north-east

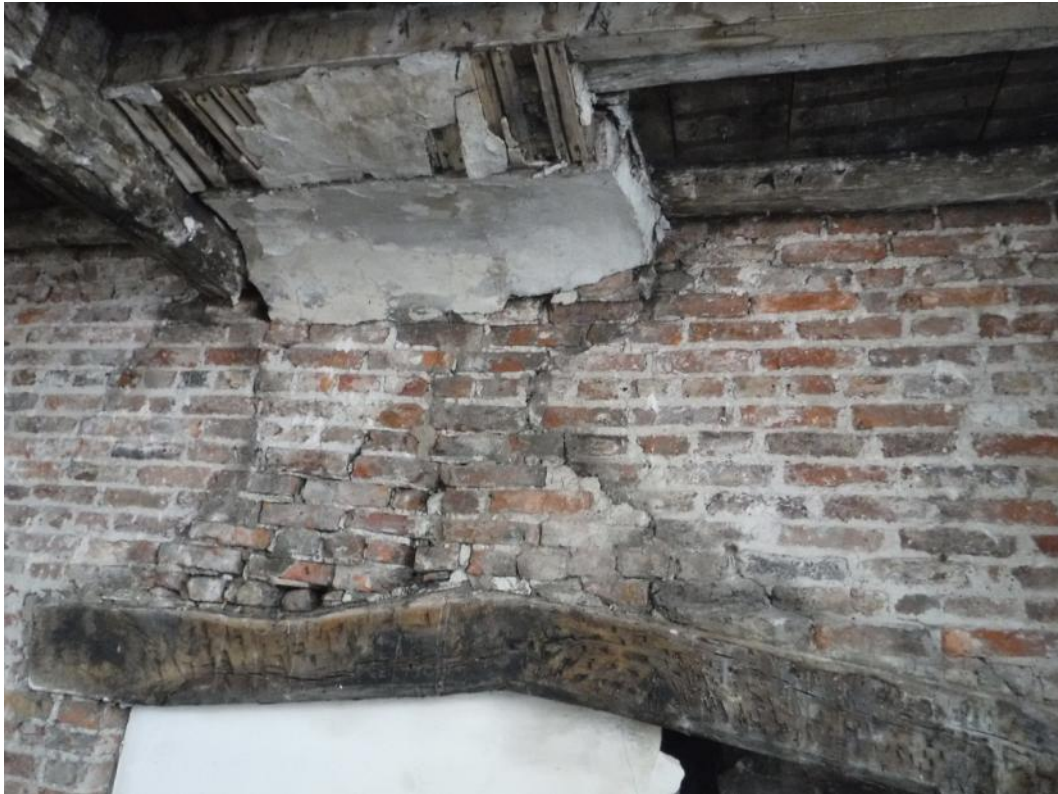
Directly above both fire places and the 19th century 'false' ceiling were found small brick vaults presumably providing support for first floor fire places (Figure 3, Plates 17 and 18). Whether these are original features or later additions is not clear, however where brick work was exposed it appears similar to those bricks used in the wall below.

Plate 17 Support for first floor fire place above the north-western ground floor fire place, facing south-west

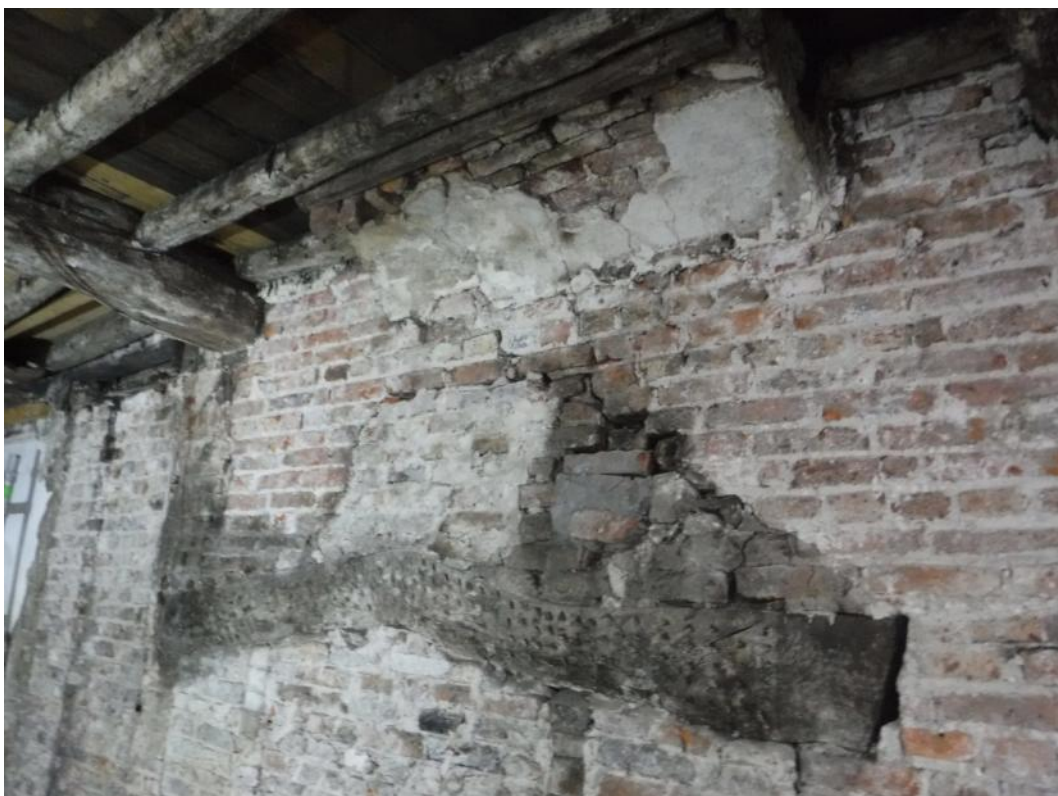
Plate 18 Support for first floor fire place above the south-eastern ground floor fire place, facing south
