OUSE RIVERBANK TIMBER STRUCTURE RECORDING

By Steven J Allen and Thomas Coates

INVESTIGATION AND ASSESSMENT

Report Number 2018/141 September 2018

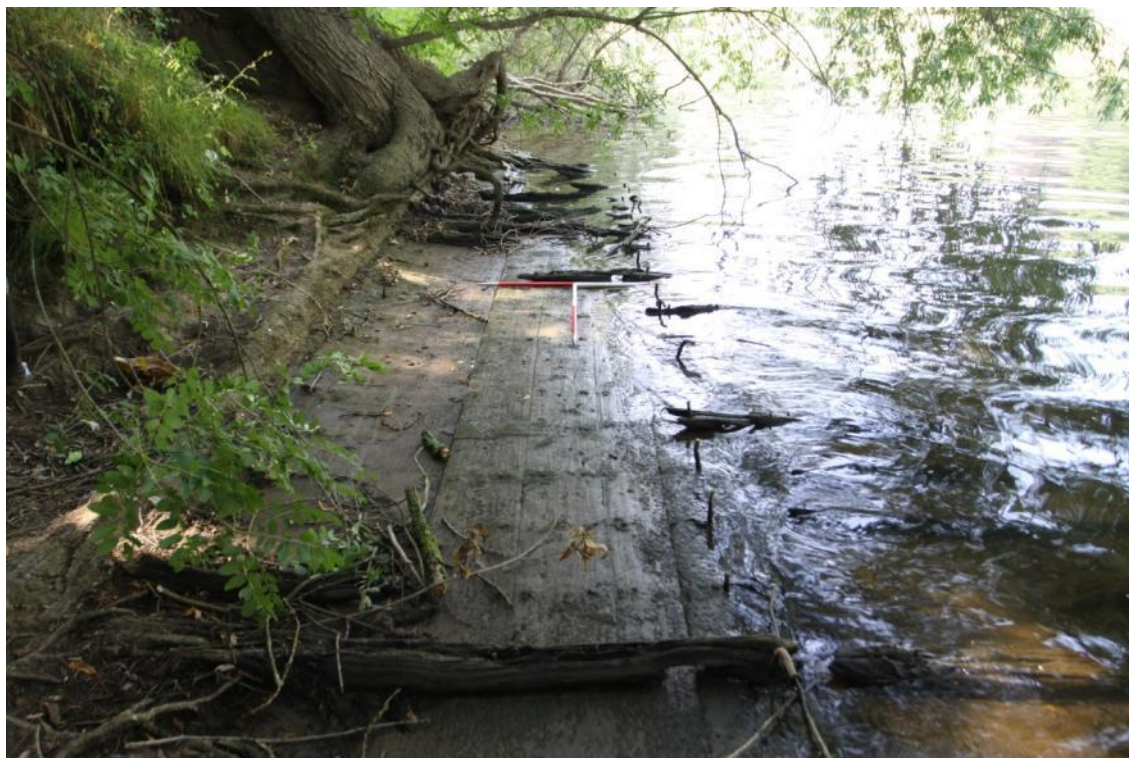
The structure is the substantially complete lower part of the hull of a river vessel, sunk on the east bank of the river Ouse. The vessel is parallel to, and partly buried by, the riverbank at this point which runs approximately north and south, and is partly overgrown with vegetation (plate 1). The hull dips slightly down into the river and towards the downstream end of the vessel. As a result, much of the hull to the landward side of the mid-line was exposed and visible while beyond the mid-line and towards the downstream end of the vessel, the rest of the hull was visible below the water (plate 2). The upstream end of the vessel and the hull planking on one side at the turn of the bilge was partly buried by subsidence of the riverbank.

Plate 1. Exposed planking in midships area of vessel looking south (downstream). 1m scales in 0.5m divisions

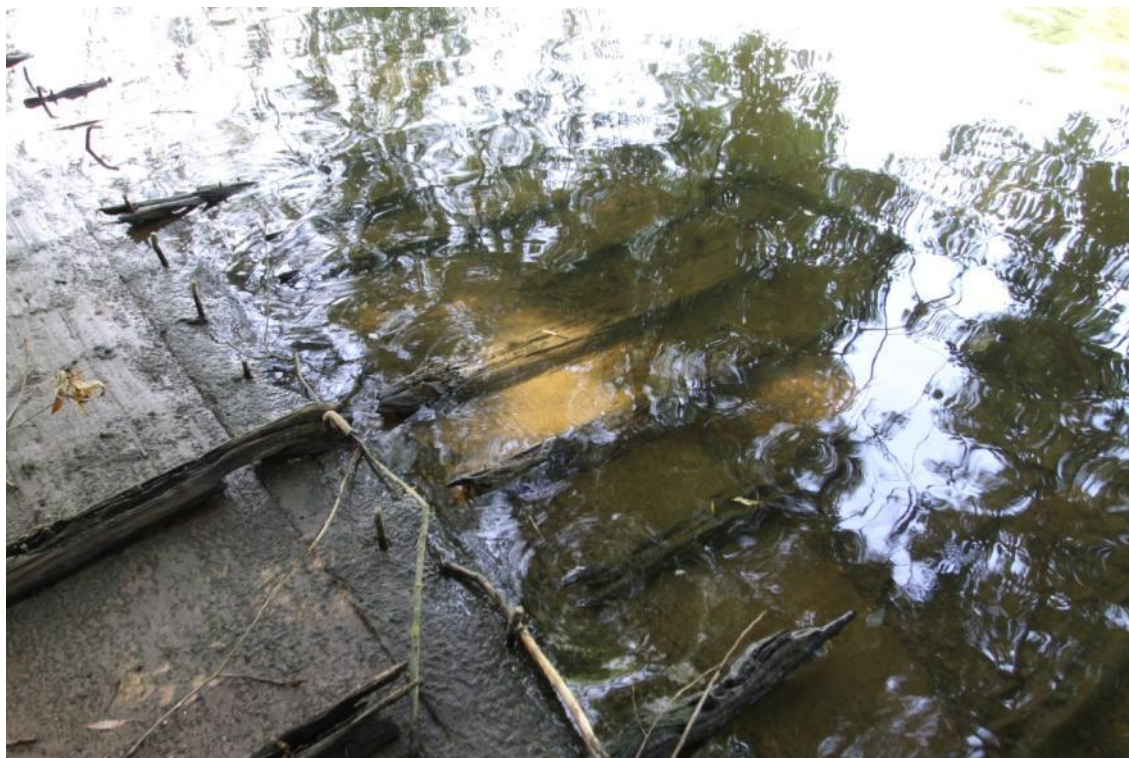
Plate 2. Submerged in situ frame elements. The row of nails are in the keel plank. Looking south west.

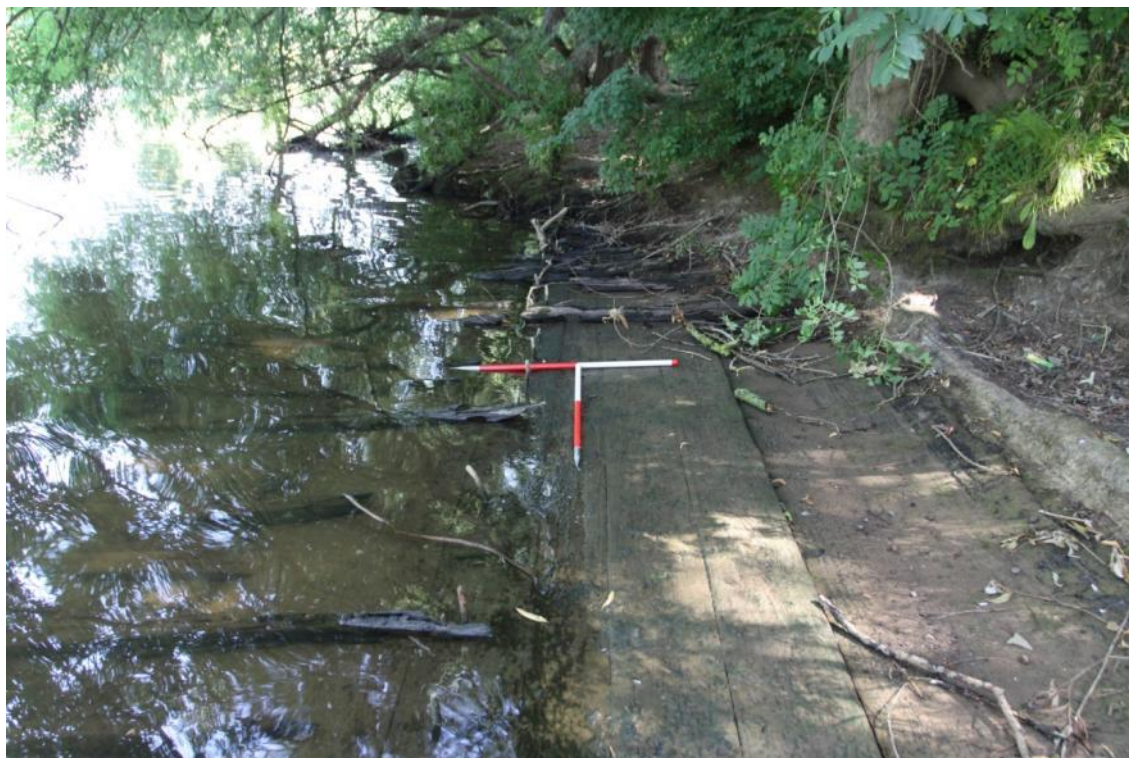
The vessel is of wooden construction with iron fastenings; the remains consist of the lower hull planking, the lower part of each side and parts of most of the frames (plate 3). A stem and stern post are visible but it cannot be determined which was the bow and which the stern as the hull is double ended. A scarf joint is visible on the keel plank and if the vessel follows the traditional orientation of such a joint then the bow should be the upstream or northern end of the vessel. The timber is in generally good condition- exposed surfaces are abraded leaving no surviving tool marks. Patches of raised plank surface, which have been protected until recently by overlying attached (and now lost) frames, show that around 2mm of surface have been lost to erosion since abandonment. The wood itself is waterlogged but hard and significant effort was needed to extract samples for species identification. The iron fittings are corroded but otherwise still sound.

Plate 3. Exposed planking in midships area looking north (upstream). 1m scales in 0.5m divisions.

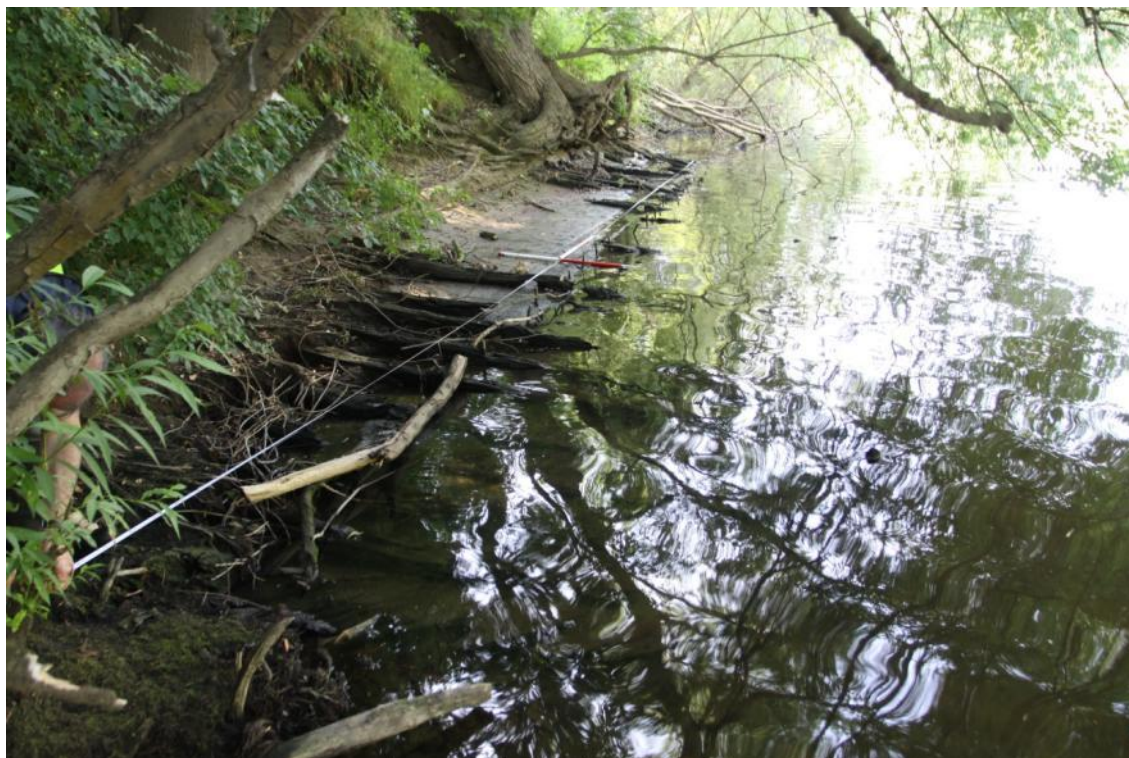
The hull planking (plate 4) is made from straight grained timber with few knots, identified as *Pinus sylvestris L.* (Scots Pine). The planks are generally around 300-320 mm wide and around 30-32 mm thick where measurable. The planks form strakes that are butted together edge to edge, a form of construction known as carvel built. No caulking was visible in the seams though this may have washed out over time. The aforementioned scarf on the plank forming the keel was the only definite joint visible, though the straight ends of some of the planks at the downstream end suggest other strakes were made up of end-to-end joined planks.

Plate 4. View of boat on riverbank looking south-south east. Tape runs along line of Keel. 1m scales in 0.5m divisions.

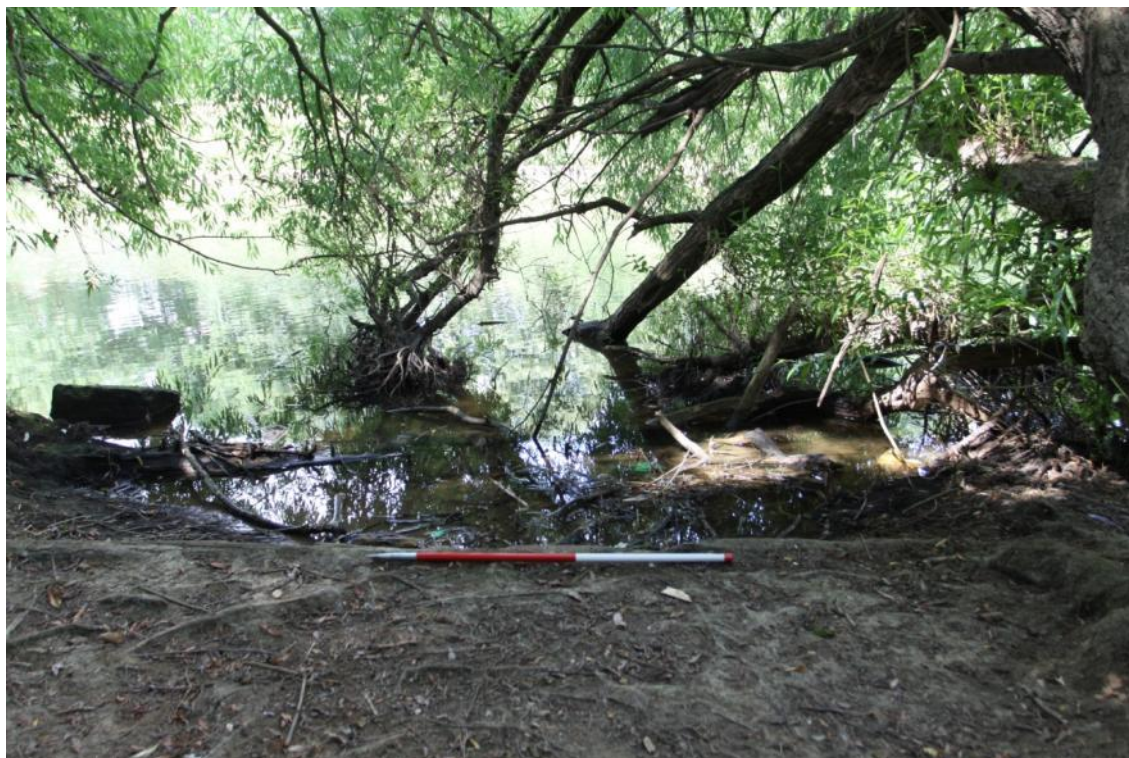
It was noted during the recording of the vessel that the end of a second such vessel (plates 5 and 6) is visible some 3 metres upstream of the upstream end of the vessel described, again embedded in the riverbank but largely inaccessible at the time of the visit.

Plate 5. Position of second boat north (upstream) from first boat, looking west. 1m scales in 0.5m divisions.

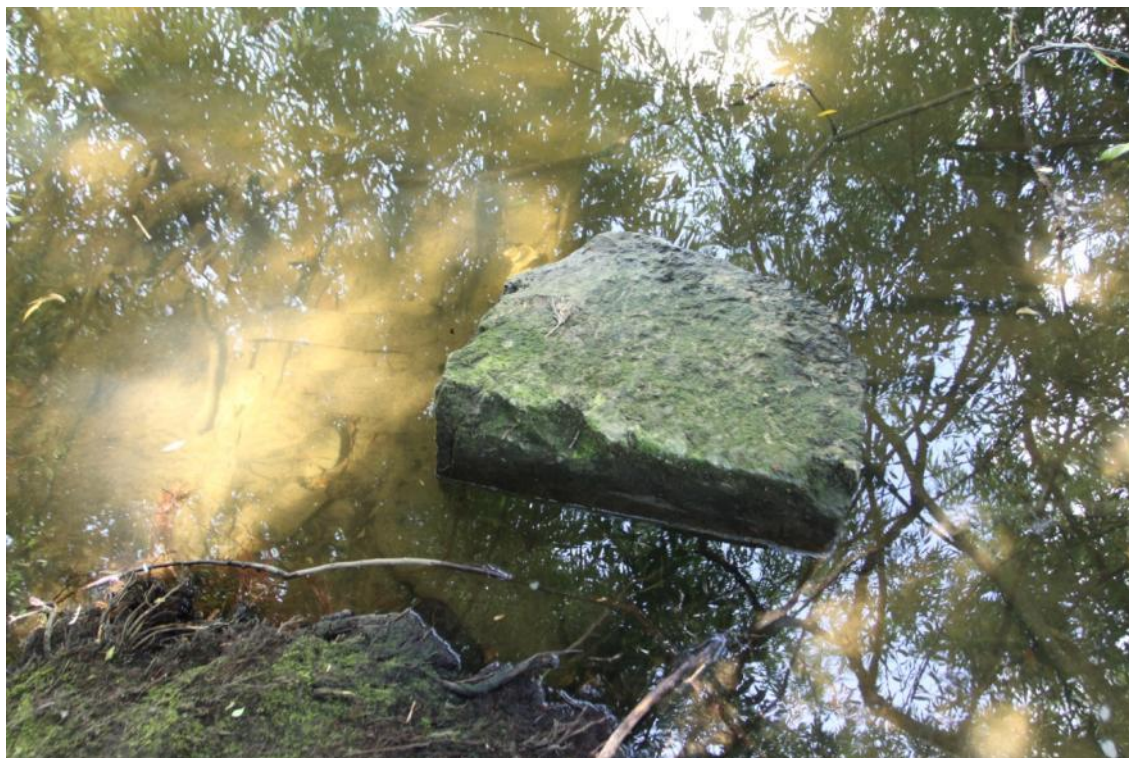
Plate 6. Submerged hull of second boat visible below water, looking approx. west.

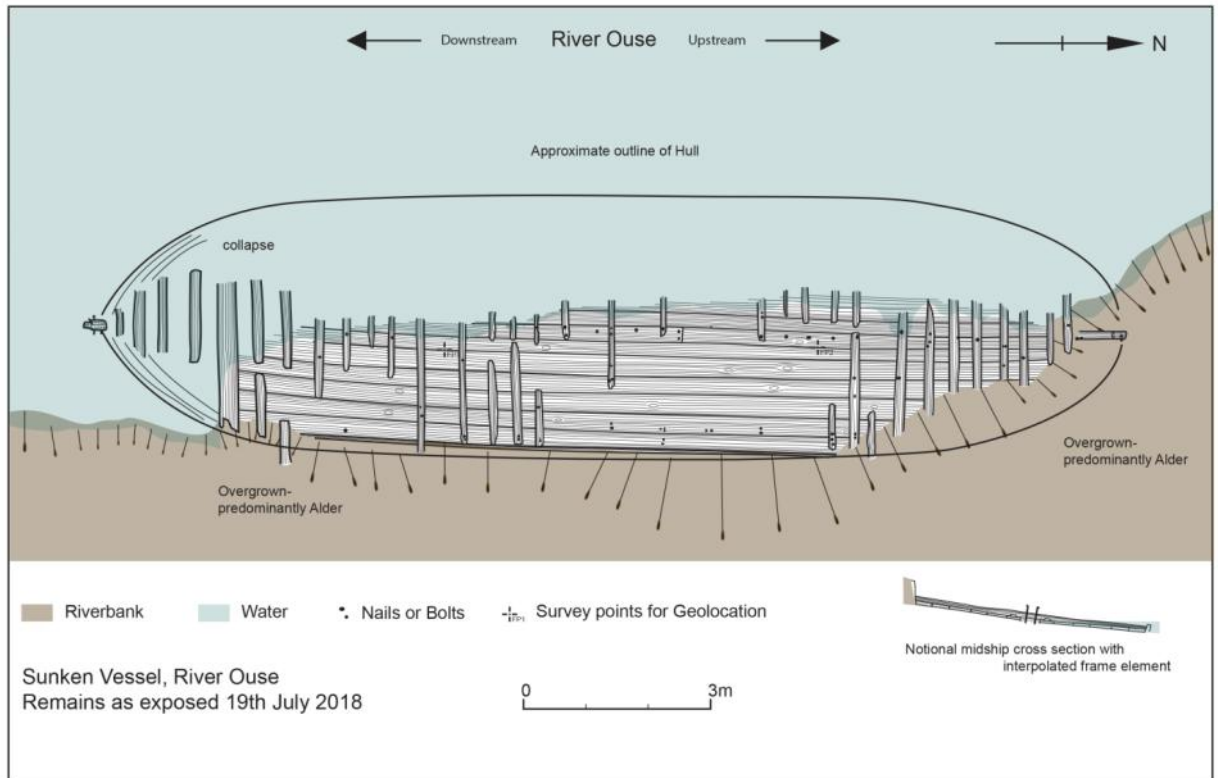
Figure 2. Plan of exposed structure and extent of visible submerged portions, 19th July 2018

The investigation was conducted on the 19th July. A 1:20 scale plan of the portions of the structure above water was made and overall measurements made where parts of the underwater structure were visible. Comprehensive photography was undertaken and wood species identification samples taken. Two fixed points were established using labelled roofing nails driven into the structure for geolocation on the 20th July, equipment being unavailable on the day of the initial visit. Handwritten notes and sketches were made to supplement the drawing and photography. Off-site the plan was imported into Adobe Illustrator CS6 and drawn as a digital file (figure 2).
