## Building Recording at NICE THINGS CAFÉ, 10 MARKET PLACE, HELMSLEY

By Becky Wilson

YAT Desk Based Assessment Report 2019/119 August 2019

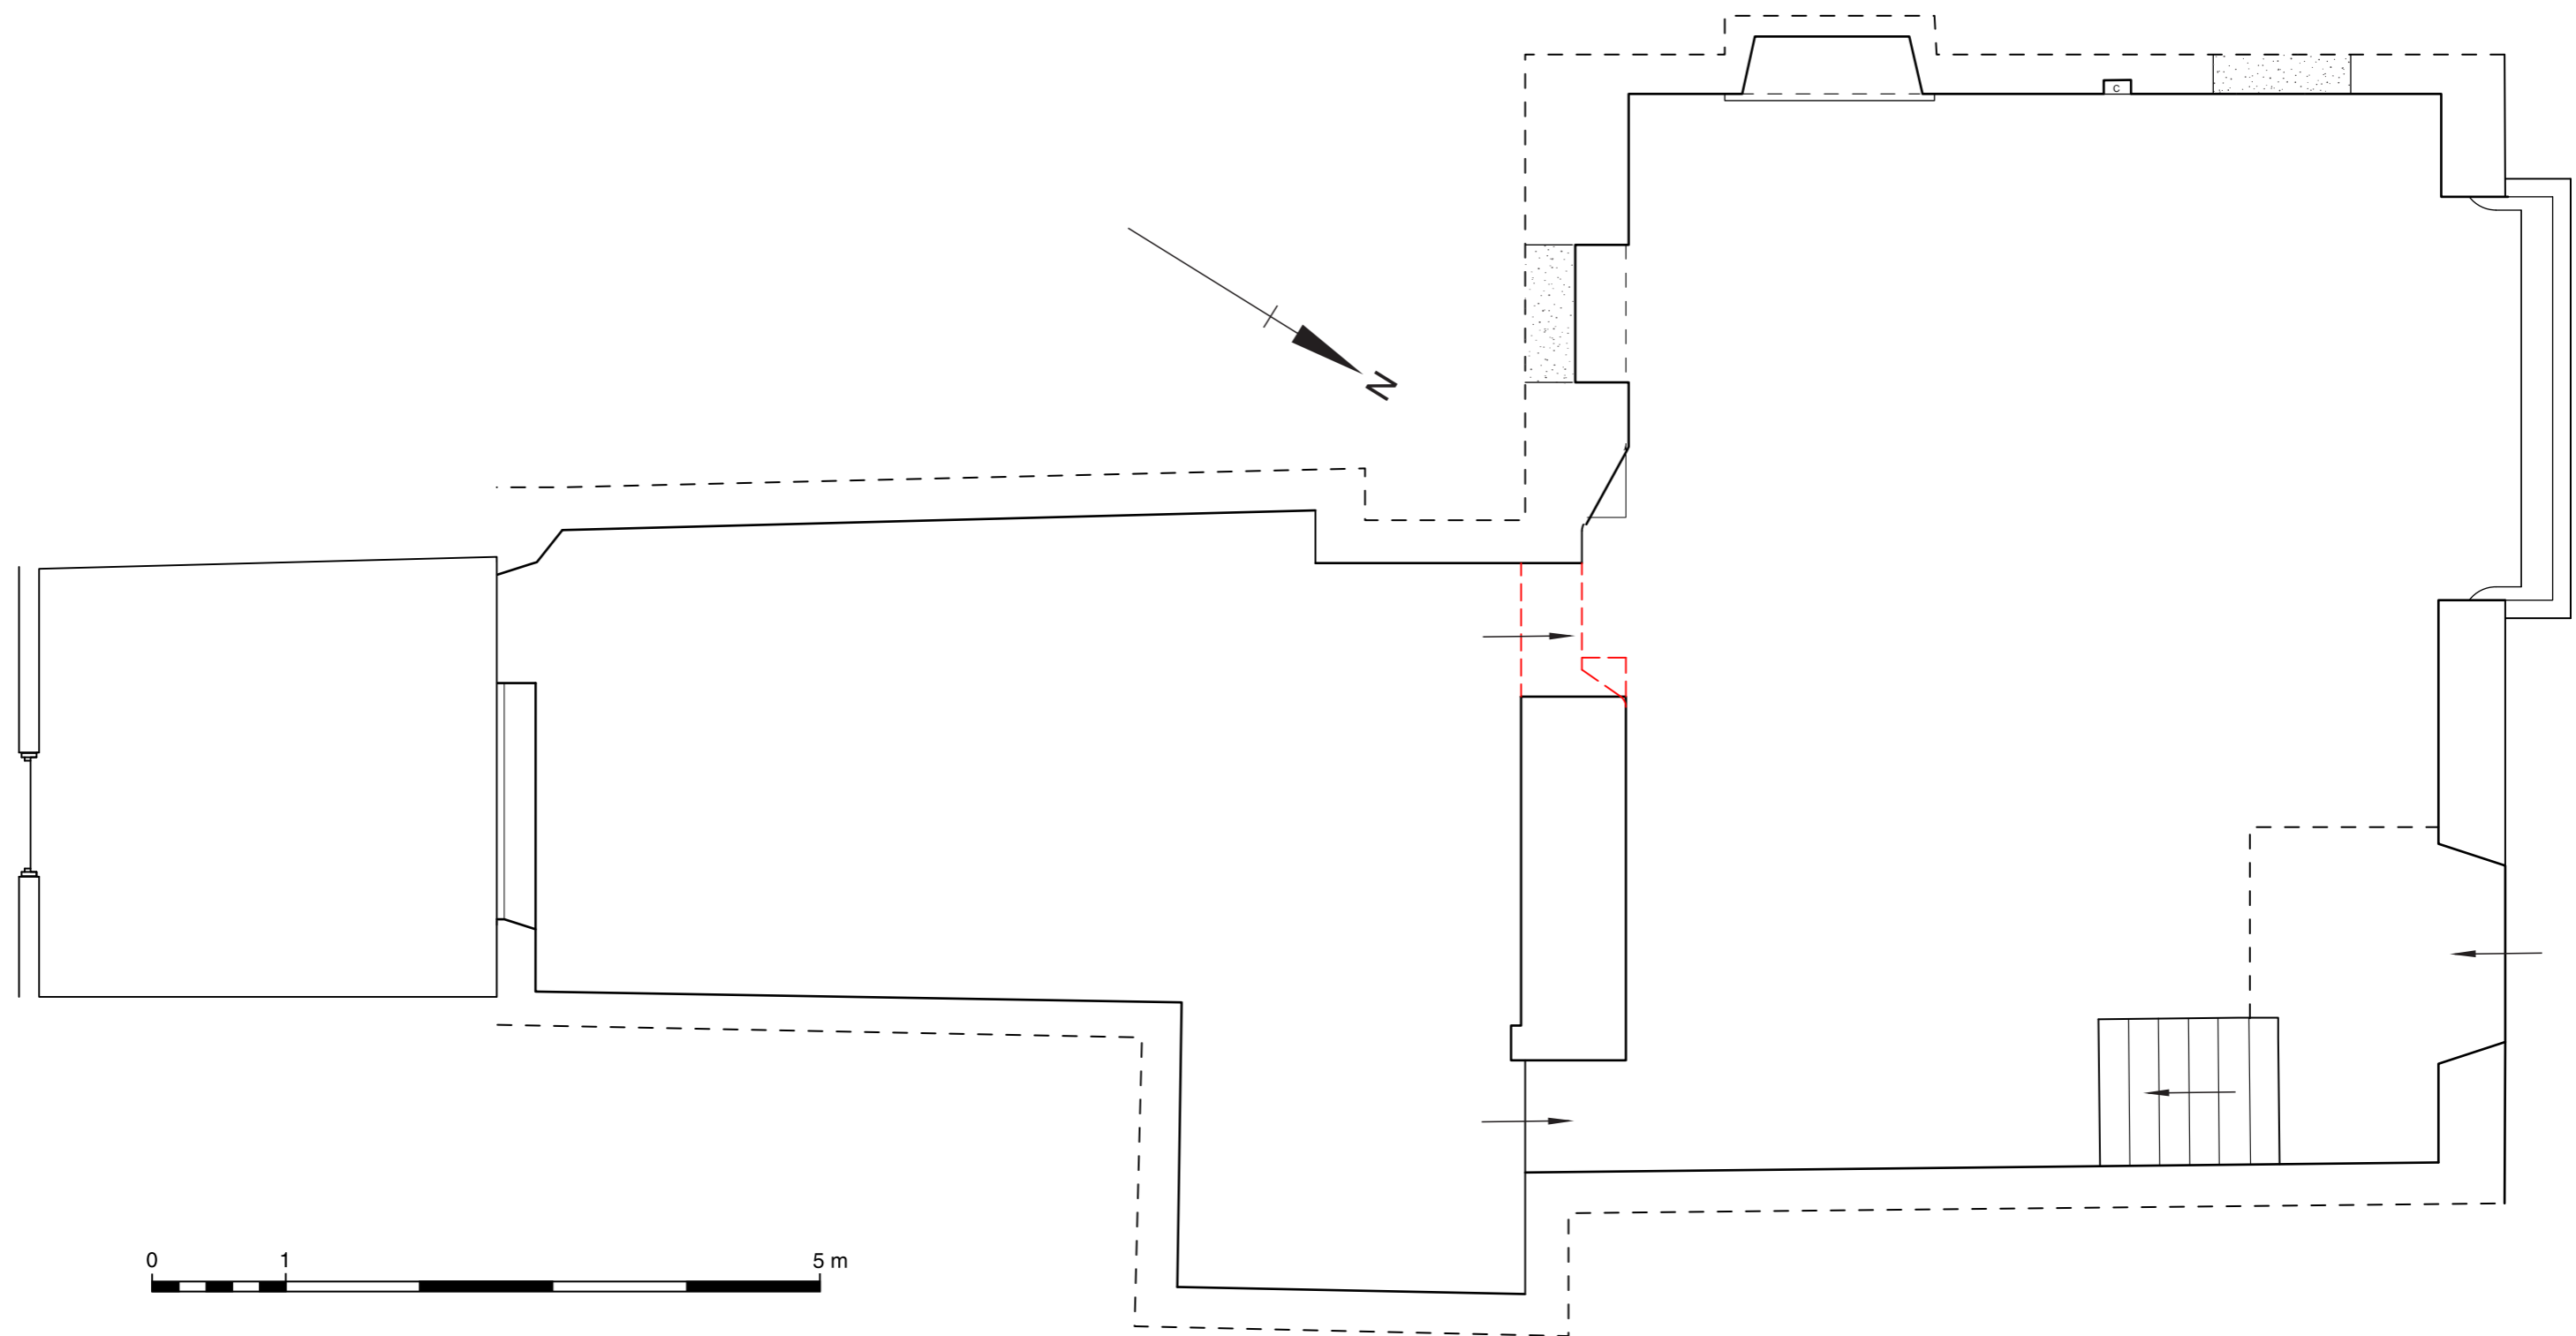
**Figure 14:** Plan of building including blocked doorway, removed window and altered fireplaces along western wall. Based on drawings from client and fieldwork drawings

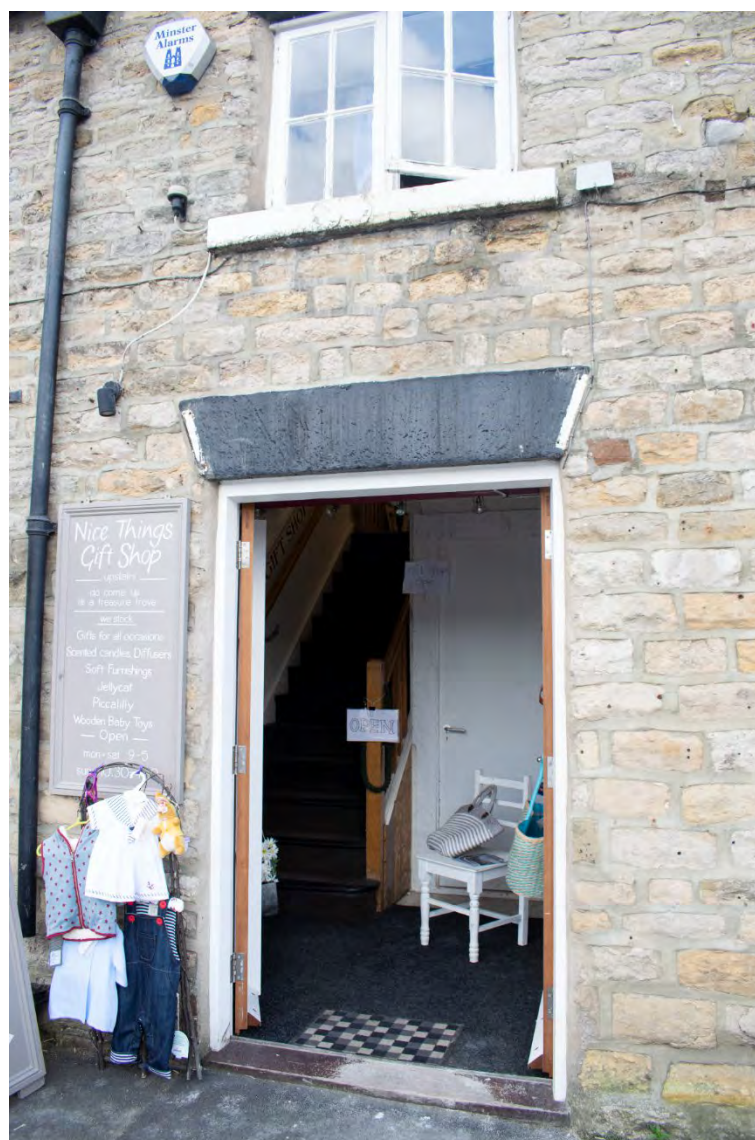
**Plate 2:** Altered entrance to property with original lintel and worn threshold. Looking south south-east.  
(Photo. 54, DSC\_0073).

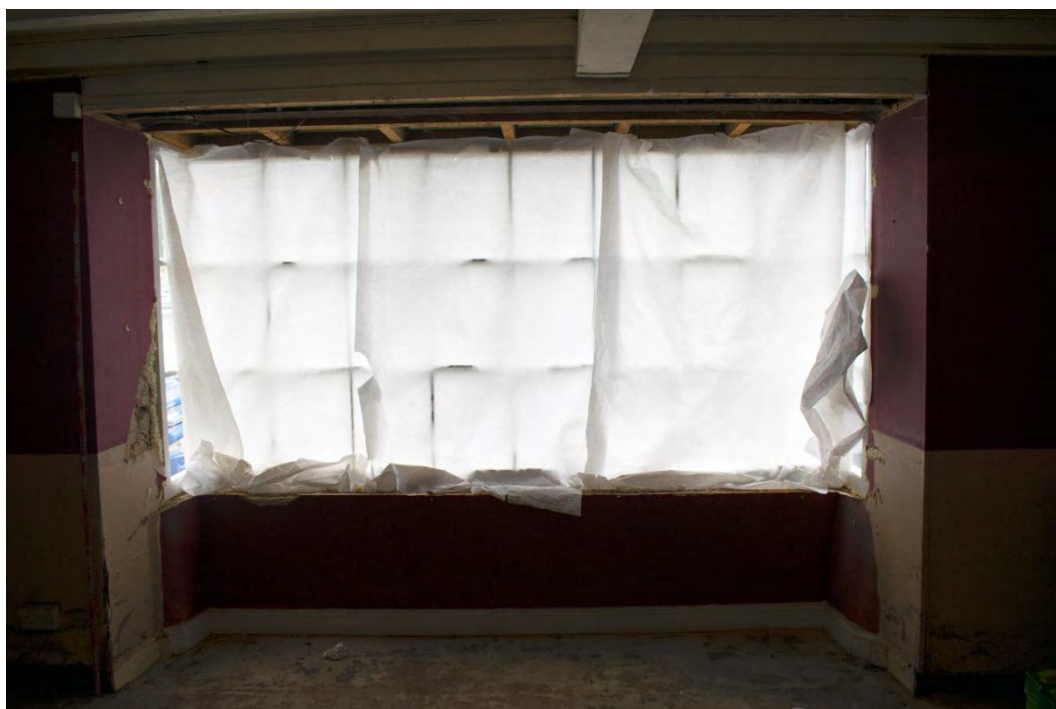
The north wall includes the bay window with the window sills removed (Plate 9). Staining is visible where the 20<sup>th</sup> century dado rail and wood panelling has been removed. The furnishings have been added post-1977 when the rear window was blocked.

**Plate 9:** North wall in original building. Interior of 1995 rectangular bay window addition. Looking north north-west. (Photo. 32, DSC\_0045).

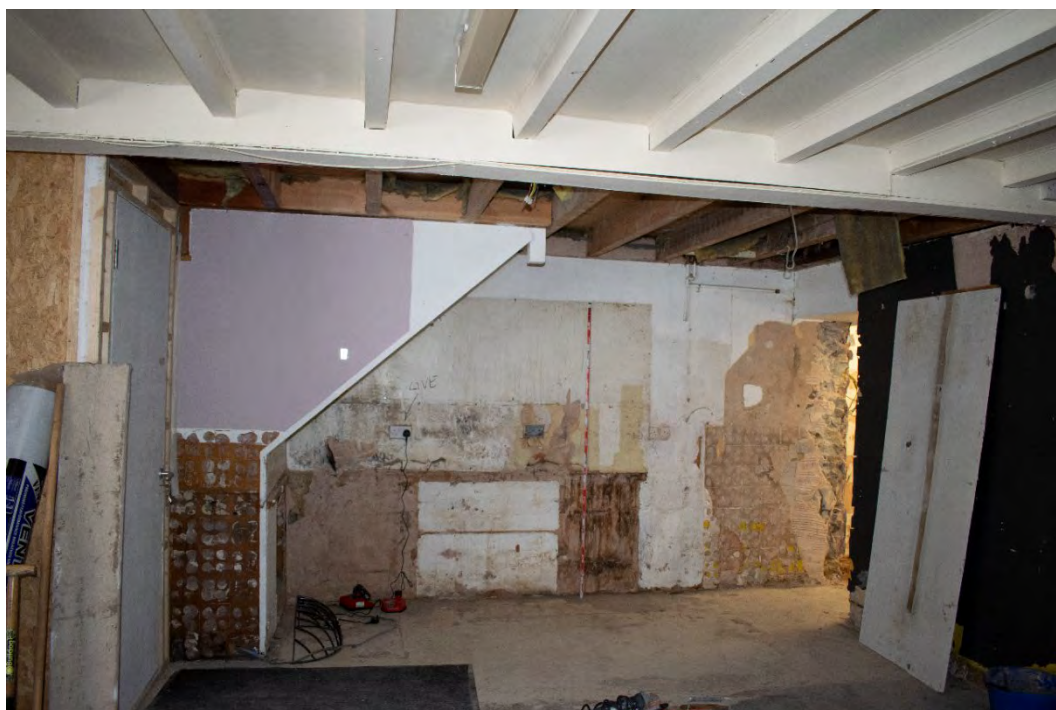
The straight staircase to the upper floor is attached to the east wall and ascends from the vestibule (Plate 10). The staircase is a 20<sup>th</sup> century addition and corresponds with the alteration of the entrance from the centre to the west of the property frontage. The wall shows the staining associated with the remains of a dado rail, lower wall wood panelling and shelving.

**Plate 10:** East wall in original building. Remains of wood panelling and dado rail visible along with staircase. Looking north-east. (Photo. 33, DSC\_0046).

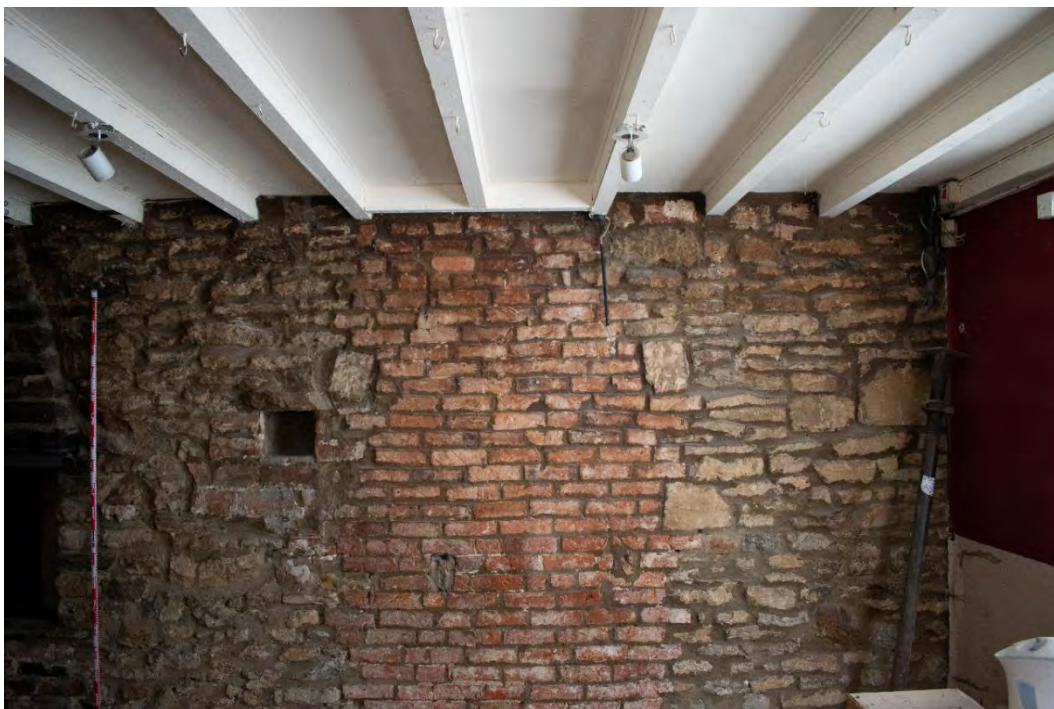
**Plate 15:** The brick-built rear of the chimney flue for 11 Market Place with two mortar filled features 1m from the ground. (Photo. 29, DSC\_0041).

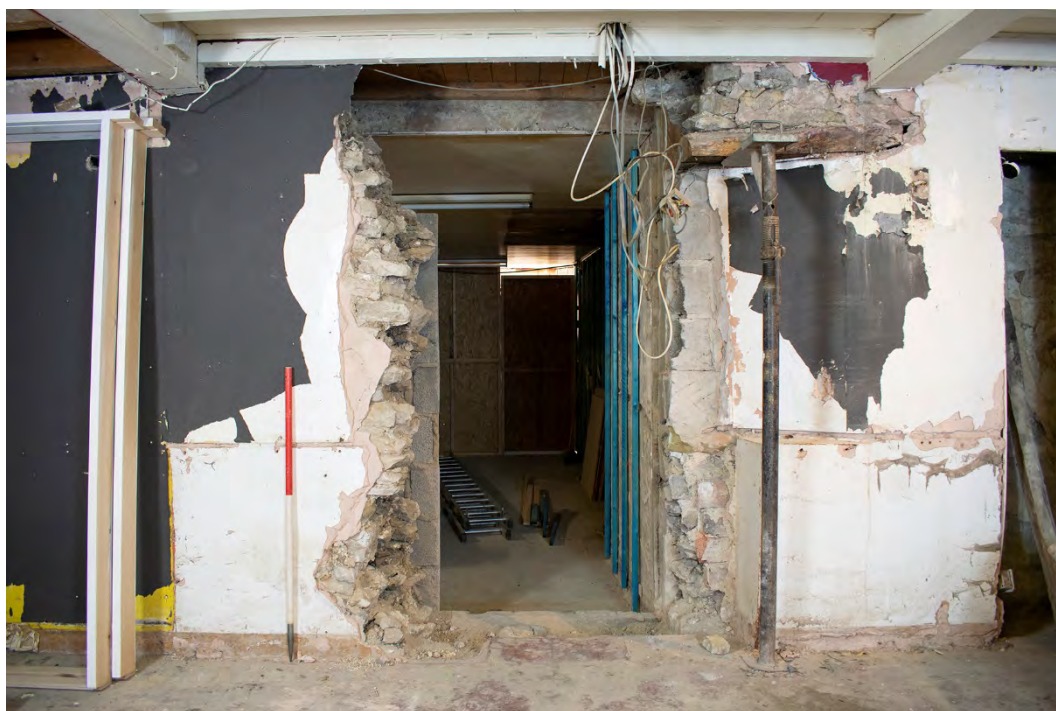
**Plate 18:** Infilled original rear window with splayed reveals. Partially removed to create a second opening into the rear extension. Looking south south-east. (Photo. 72, DSC\_0542).

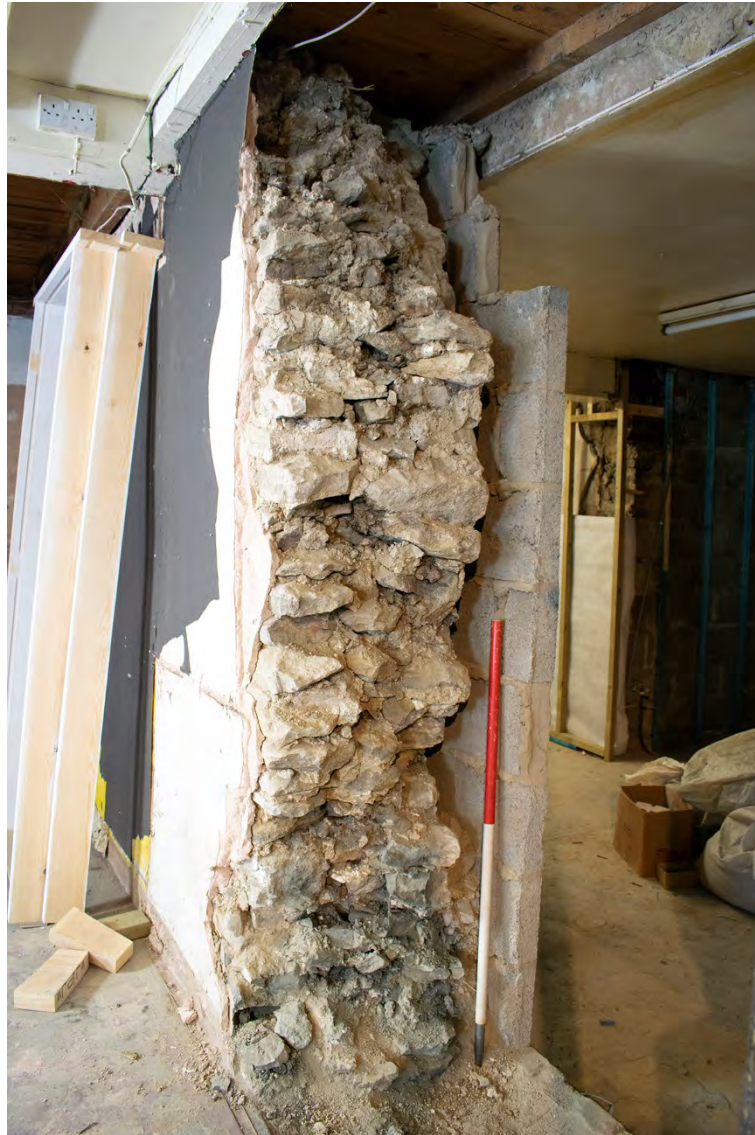
**Plate 22:** East side of removed window reveal where most elements have been removed. Original wall core is visible along with relationship to 1977 extension. (Photo. 69, DSC\_0440).

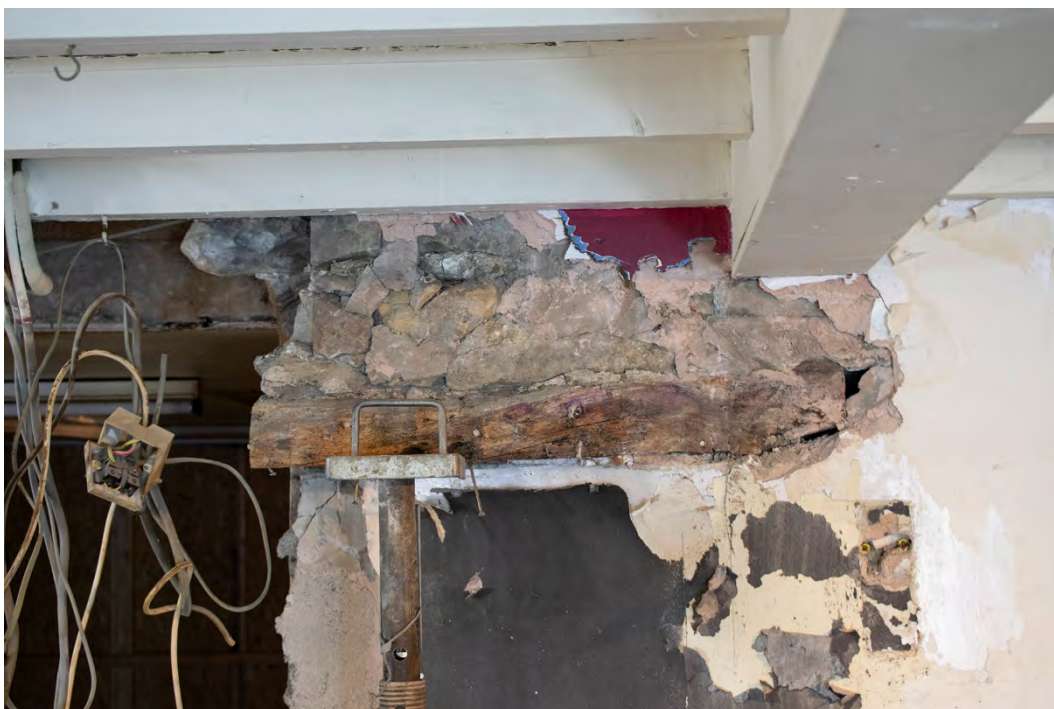
The oak lintel above the window was partially removed and could not be dated due to being compressed which warped the cross section (Appendix 4: Arnold, 2019). A section of the lintel remains above the surviving window reveal on the west side of the removed window (Plate 23). The lintel has been partially shaped, predominantly at either end of the beam, though the original shape and thickness of the wood has been retained across the beam (Plate 24). The east end of the lintel, still *in situ*, has a chamfered end. The centre of the lintel, above the opening for the window, has deteriorated the most through the compression the wood from the weight of the stone walls above. A rectangular notch has been cut into one face of the lintel which would have sat at the eastern end of the window at the edge of the splayed reveal, facing outwards; this was for a vertical post or jamb stud that supported the lintel and the wider window area with reveal. The lintel likely predates window and served the original rear doorway. No corresponding notch or beam is visible on the surviving west reveal though staining on the lintel above the end of the reveal suggests a feature was once attached to the lintel; in photos from before the removal of the window (Plate 20) a decorative board was affixed across the top of the wall and window from this point. The west jamb stud is likely affixed to the rear of the lintel and is disguised by the plaster reveal.

**Plate 23:** Section of lintel that remains *in situ* above the removed window. Compression at the centre of the lintel is visible in the left of the picture. (Photo. 72, DSC\_0482)

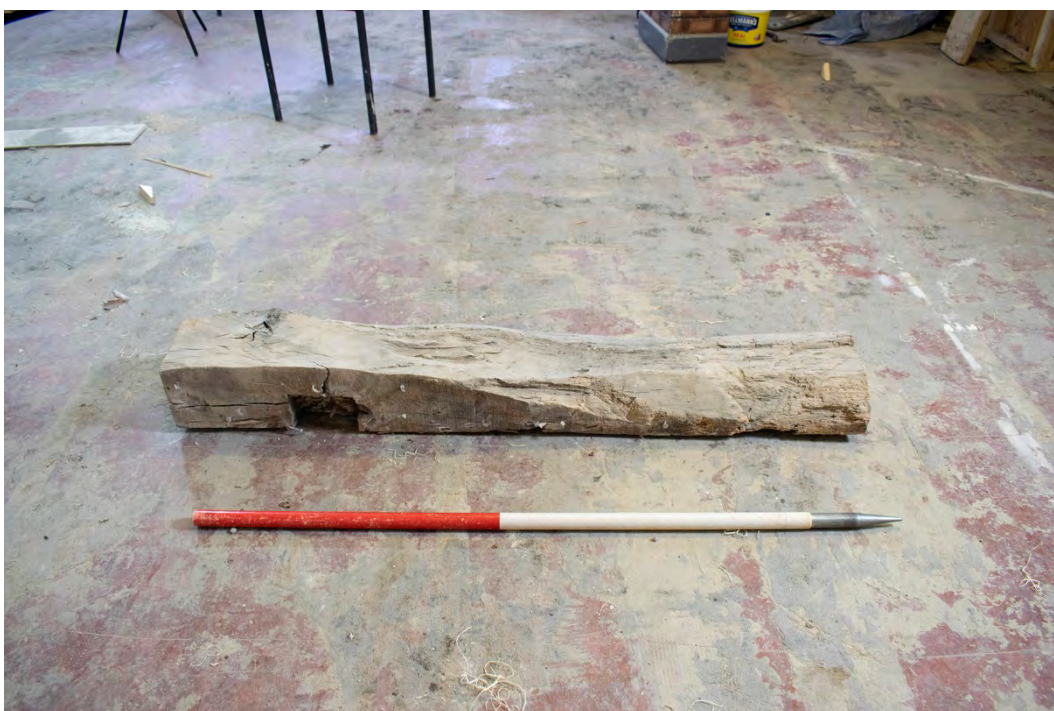
**Plate 24:** Removed lintel with shaped end and small notch for joint cut out. (Photo. 75, DSC\_0603).

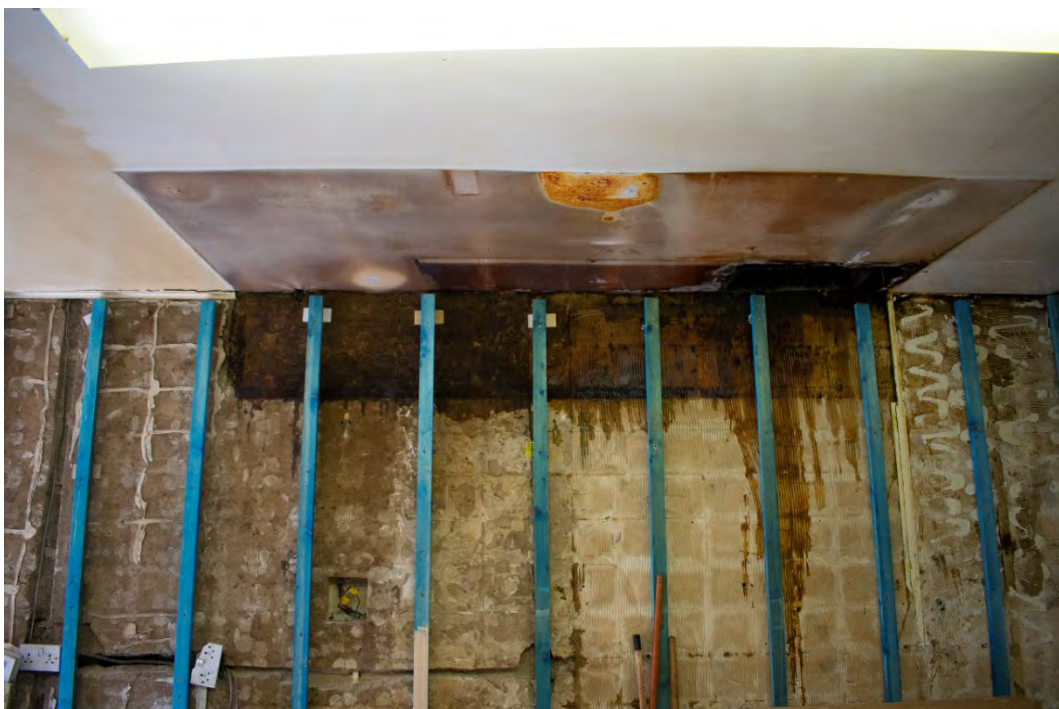
**Plate 28:** Staining on the walls from fats and oils, indicative of the rooms use as a kitchen. (Photo. 17, DSC\_0023).
