## Building Recording at Duttons for Buttons, 32 Coppergate, York

YAT Building Report 2019/157 October 2019

On 10<sup>th</sup> October 2019 York Archaeological Trust undertook a course of Building Recording at Duttons for Buttons, 32 Coppergate, York, YO1 9NR (NGR SE 60444 51728). The works involved a Level 2 recording of external timbers exposed during improving and repair of the façade.

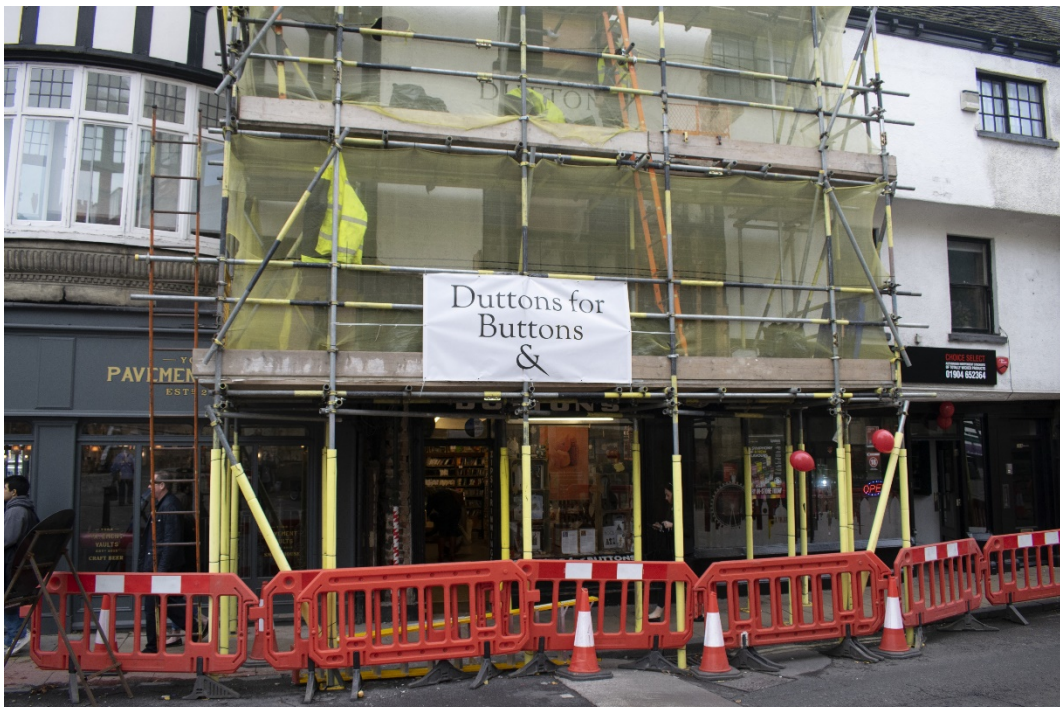
The north-west facing elevation is entirely clad in white cement render with timber features consistently painted black (Plate 2). The ground floor features two unequal bays. The left bay contains a slightly recessed timber doorway with cornicing and a rectangular fanlight. The second bay features a large single pane display window with timber surrounds. The first floor, which jetties out 0.5m, features a single bay containing a large 19<sup>th</sup> century window alteration. The window contains a central nine-on-nine light sash with four vertical panes serving as sidelights. The windowsill is flush with the wall. The second floor also features a single bay with a smaller window, potentially 18<sup>th</sup> century. The window, and its neighbouring equivalent at 30 Coppergate, are slightly recessed. The window is in the 'Yorkshire light' style and has a horizontal sash featuring nine-on-nine lights. The window sill projects from the wall.

**Plate 2** North-east facing elevation.

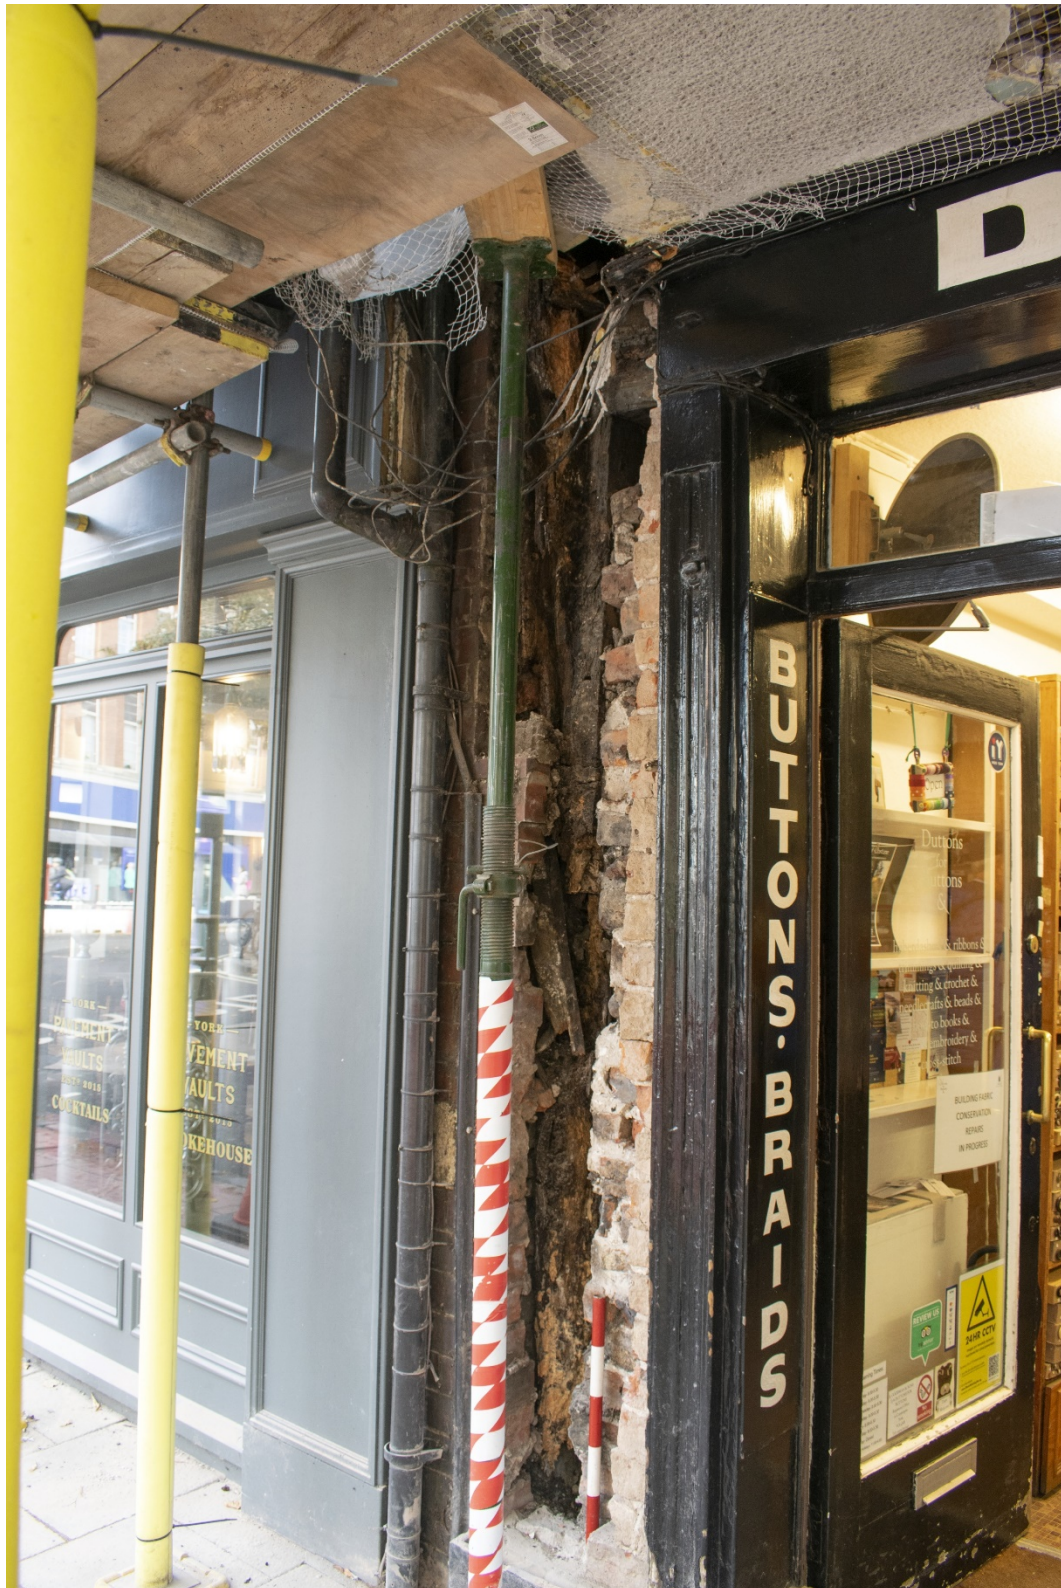
A small section of brickwork and render was removed to the north-east of the entrance way and revealed part of the timber framework for the building set upon a large 400mm wide post pad stone (Plate 3). An original timber corner post was exposed supporting a floor beam for the upper floor. The original timber post, 100mm wide, had deteriorated towards the base and no longer extended to the post pad. Two additional repair timber planks had been affixed to the north-east side on the post for support. Inspection of the condition of the wood showed severe woodworm infestation in the original timber post and floor beam above (Plate 4).

Plate 3 Ground Floor timber post on stone post pad.

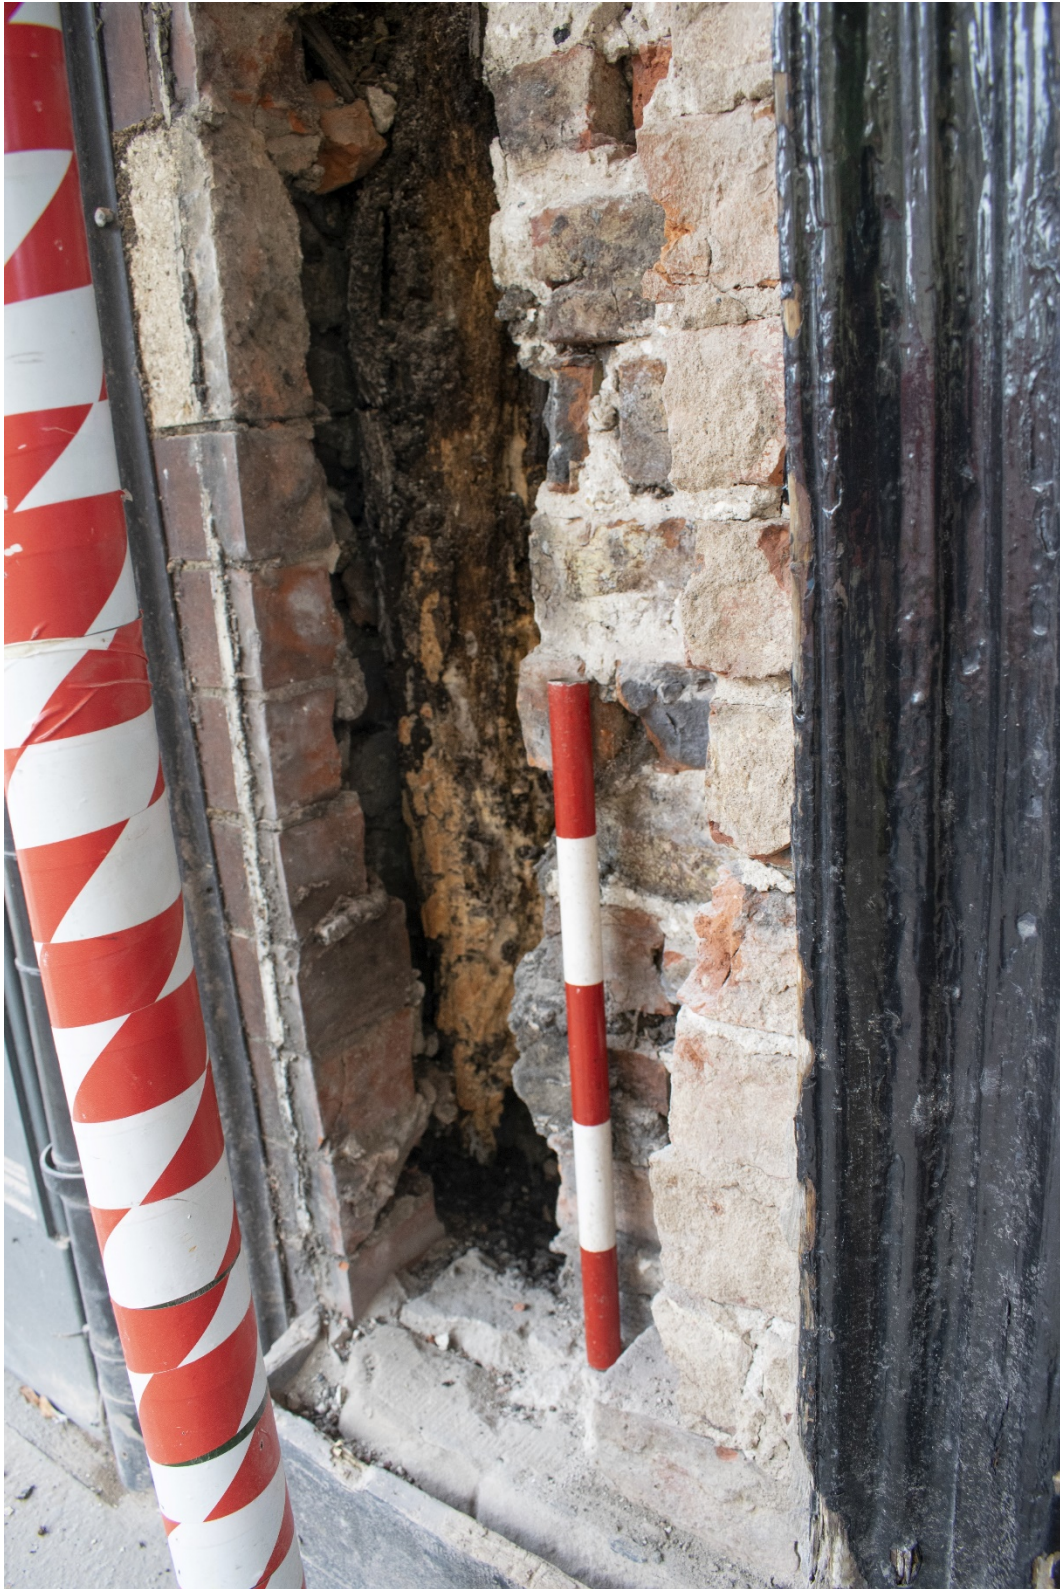
**Plate 4 Base of timber post with wood worm deterioration.**

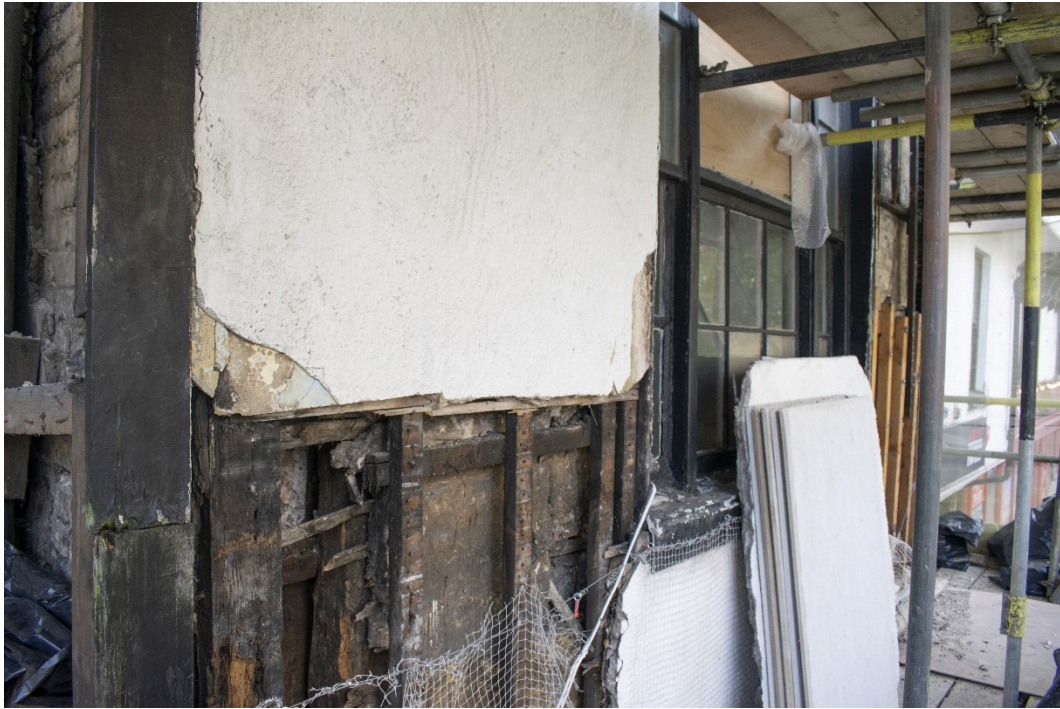
**Plate 5 Overview of first-floor jetty works.**

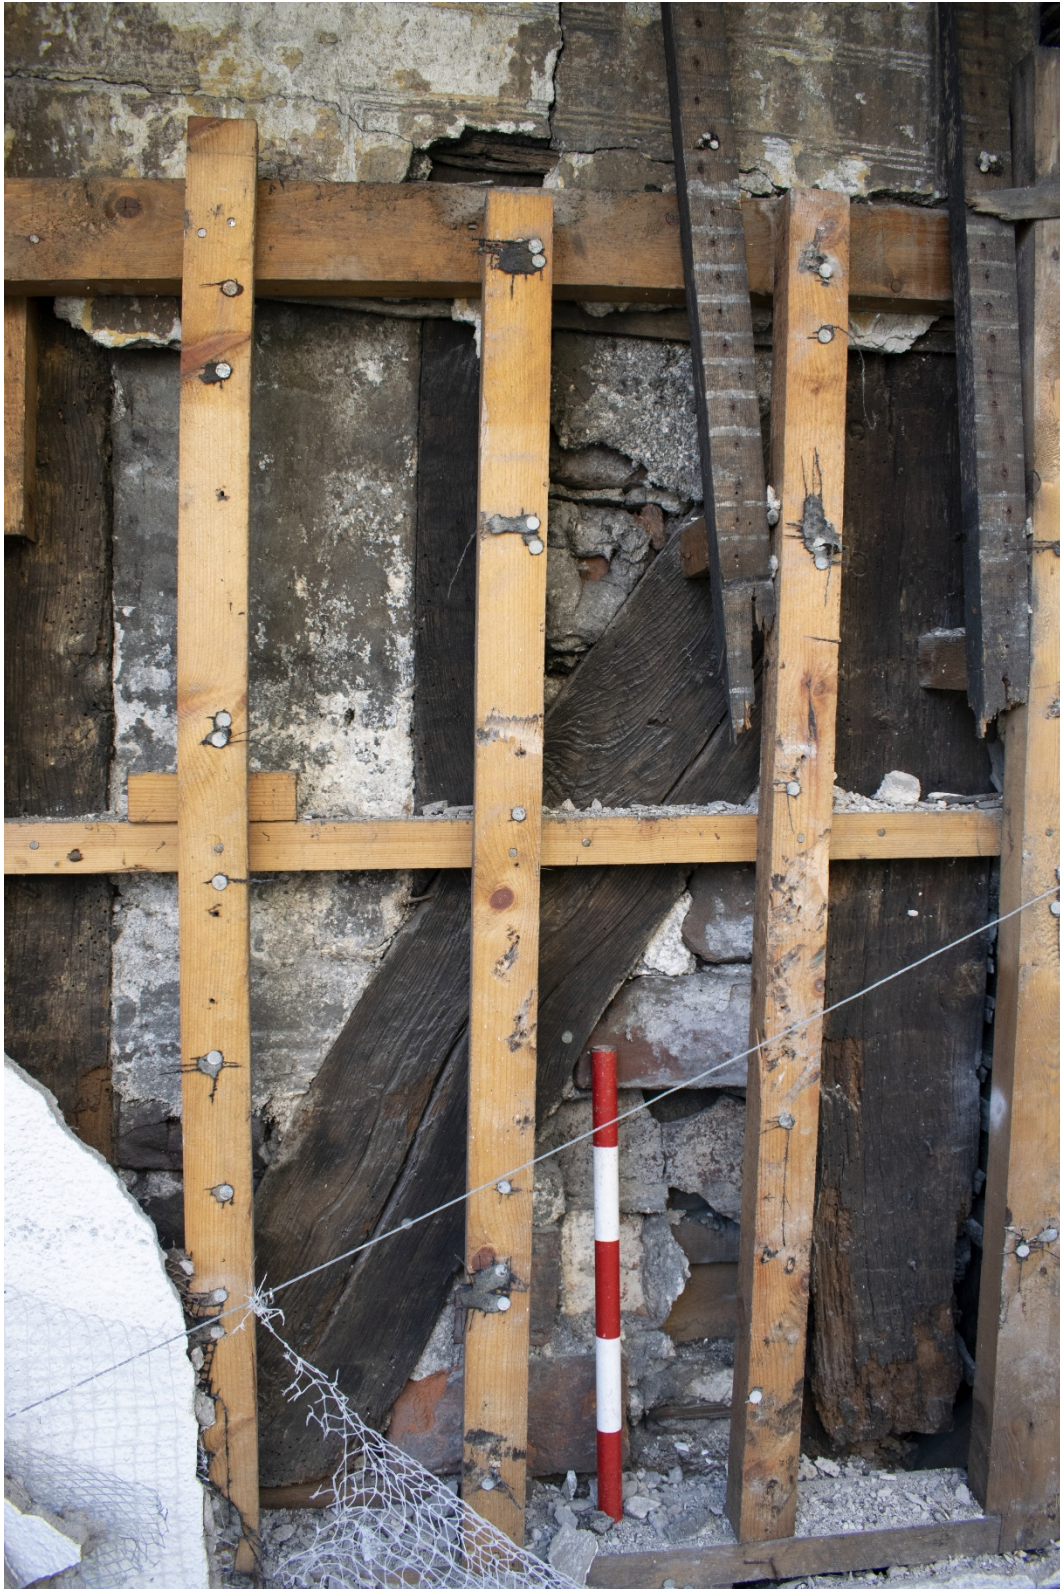
The bressummer timber is visible in both exposed sections and appears to have been partially chamfered. Earlier buildings reports did reference some carving on the bressummer. As with the ground floor timber wood worm and general deterioration was present predominantly on the left side of the jetty. The right side was in good repair.

**Plate 6 Detail of surviving timber frame on right side of jetty.**

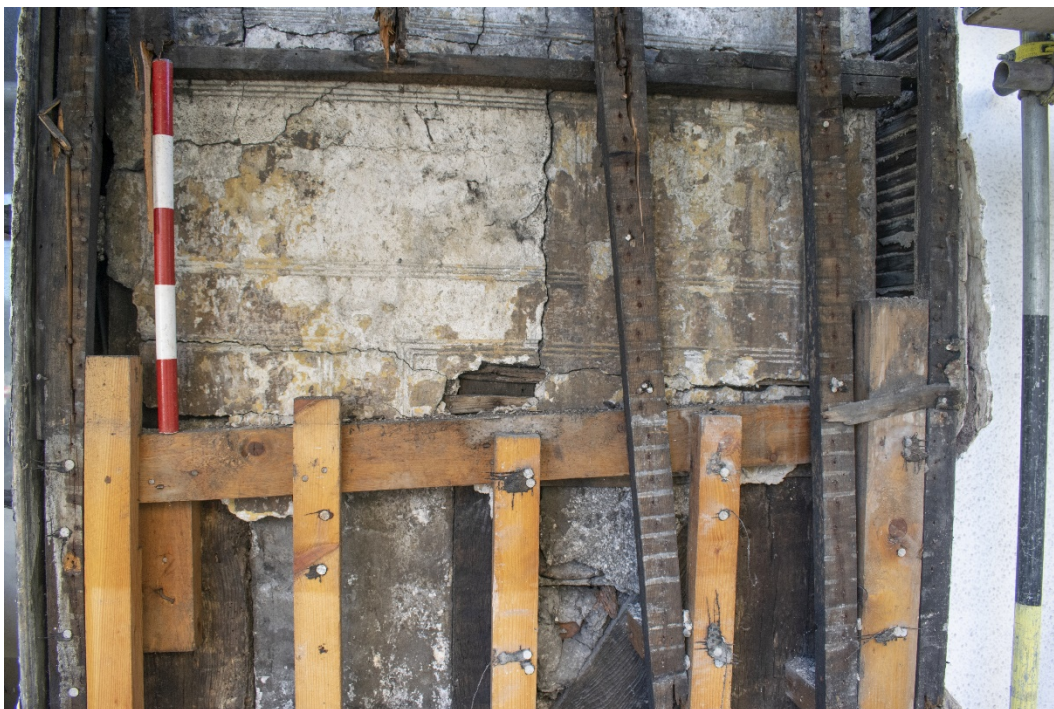
Removal of modern cement render revealed both original timber framing for the jetty as well as earlier exterior cladding for the property in the form of two phases of lath-and-plaster walls (Plate 5). There was variation in the form of the timber frame on the right and left sides of the jetty, on either side of the central window. The right side, a 1.35m section of wall, appeared largely original to the building and featured two timber posts 200mm wide with a central diagonal brace (Plate 6). A small stud timber extends vertically from the centre of the brace. The infill material is handmade brick which were predominantly 50mm thick. Towards the top of the first floor the earlier phase of lath-and-plaster featured incising (Plate 7).

**Plate 7 Incising on early lath-and-plaster rendering.**

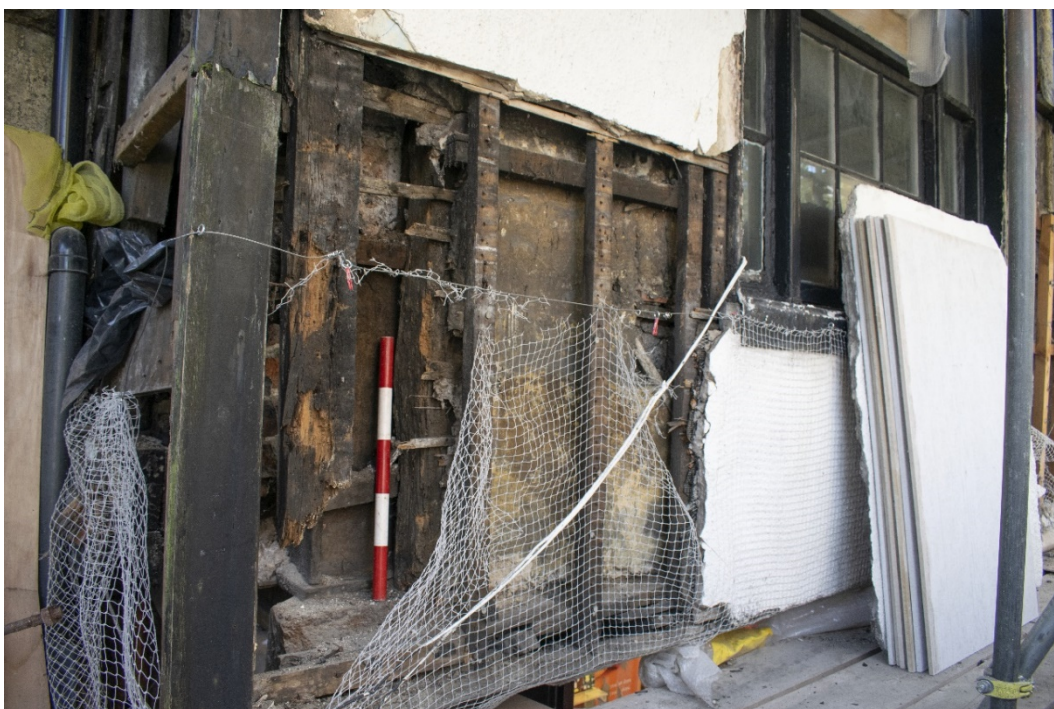
The left side of the jetty has been altered with smaller and an increased number of vertical timber planks as opposed to two posts (Plate 8). A series of smaller planks replace the left corner

post of the jetty. A large section of the lath-and-plaster render survives in this section of the wall. A section of the floor structure was also exposed with original 20mm thick planks resting on a floor beam (Plate 9).

**Plate 8 Deteriorated planks on left side of jetty.**

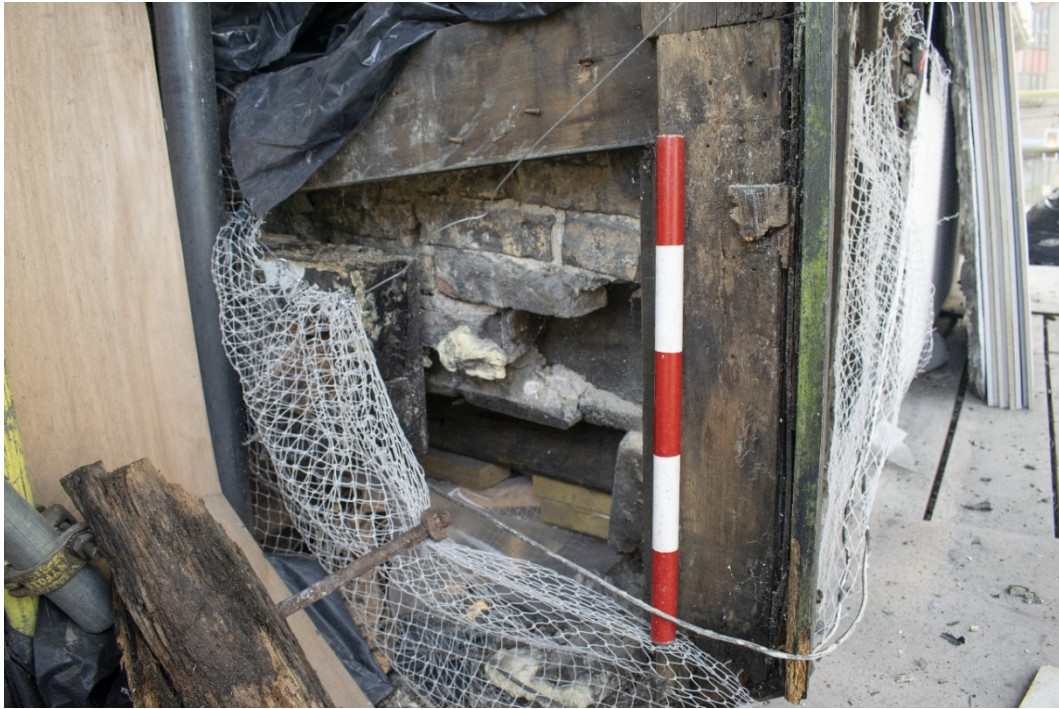
**Plate 9 Floor structure with planks and timber beam.**
