ALL SAINTS CHURCH, KIRKBY OVERBLOW,

HARROGATE, NORTH YORKSHIRE

WATCHING BRIEF REPORT

REPORT NUMBER 2010/14

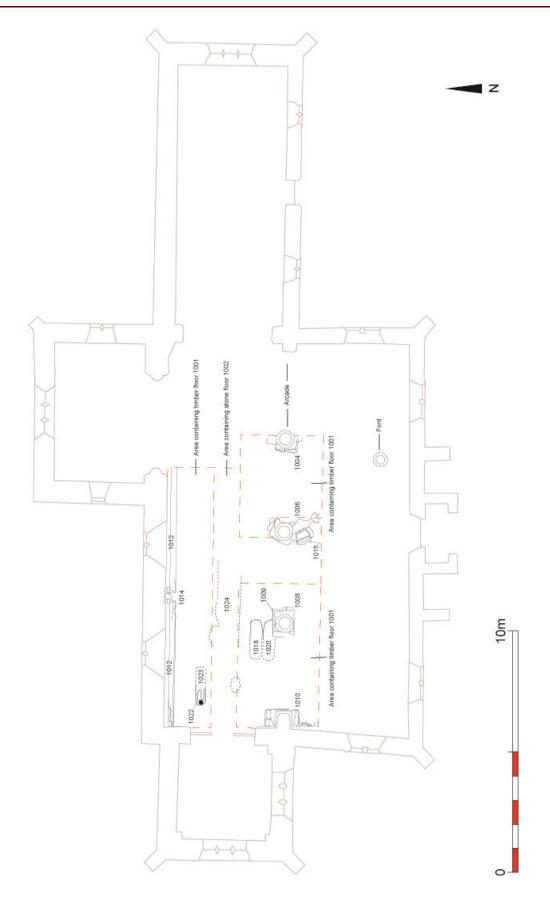
Figure 2 Works area with recorded features. Adapted from client's plan.

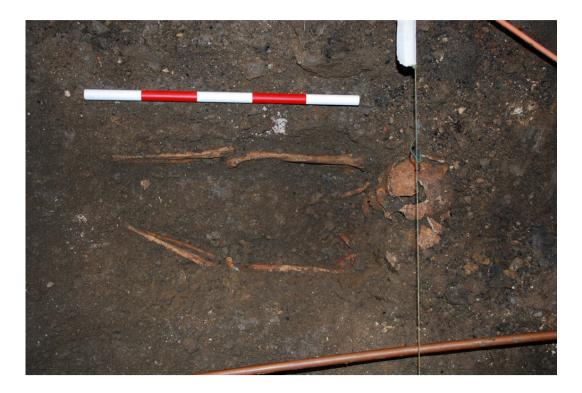
1026 was cut by one confirmed grave, 1023, and two probable graves, 1020 and 1018 (Figure 2), all of which were identified at the depth limit of excavation. Grave cut 1023 was aligned east-west and contained an adult inhumation, 1022, which was encountered by the groundworks team during ground reduction and partially exposed by the attending archaeologist to confirm articulation. 1022 was recorded before being covered over, and was supine, with the right arm extended by the side and the left arm flexed at the elbow so the left hand lay across the pelvis area. There was no evidence of a coffin or fittings, and the arms were both 'rolled inwards' within a cut only just wide enough for the burial, suggesting that the body had been buried in a tightly wrapped shroud (Plates 1 & 2). The backfill, 1021, was a loose, mid brown clayey silt barely distinguishable from 1026.

Plate 1 Inhumation burial 1022 looking south

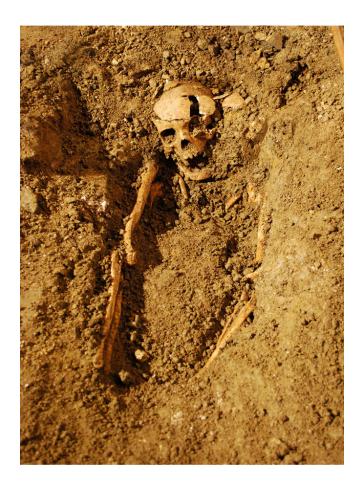
Plate 2 1022 detail, looking west

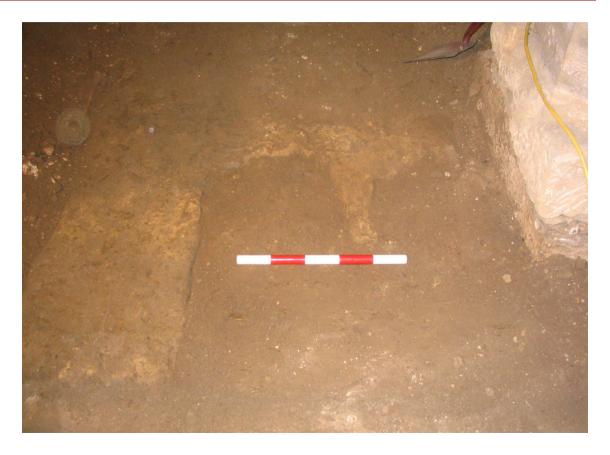
Cuts 1020 and 1018 contained fills 1017 and 1019, both friable dark brown clay silts. Their size and orientation (Figure 2, Plate 3) strongly suggested that they were graves, but neither were excavated as they lay beyond the depth limit of excavation.

Plate 3 Possible graves 1018 (left) and 1020 (right), looking east

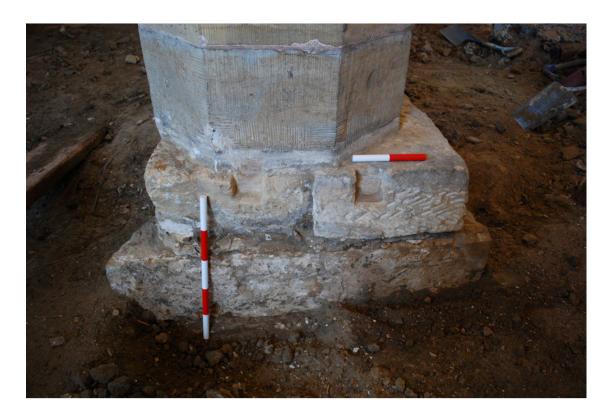
Cut through backfill 1019 was 1009, the construction cut for pier footing 1008 (Figure 2). The footing 1008 consisted of two roughly dressed limestone blocks measuring 0.42m by 0.84m by 0.20m thick, mortared on a plinth of roughly-dressed limestone fragments up to 0.30m across (Plates 4 & 5). This created a foundation measuring 1.20m x 0.85m across and at least 0.50m deep upon which was placed a polygonal base that forms the lowest above-floor element of a pillar in the single arcade within the church (Figure 2). The two large blocks had small mortice holes cut into their upper surfaces which had held the joists of the timber floor,

Plate 4 Pier footing 1008 looking north

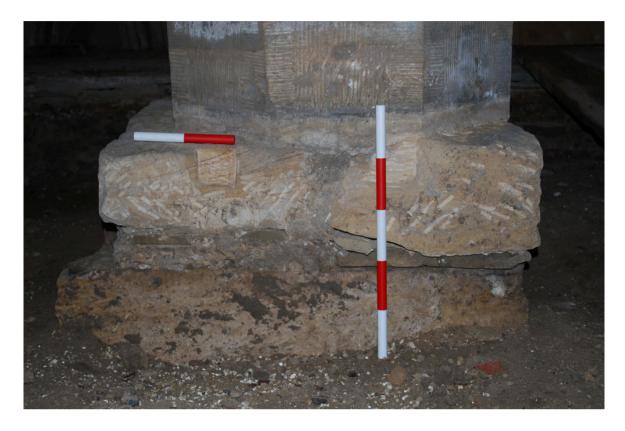
Plate 5 Pier footing 1008 looking south

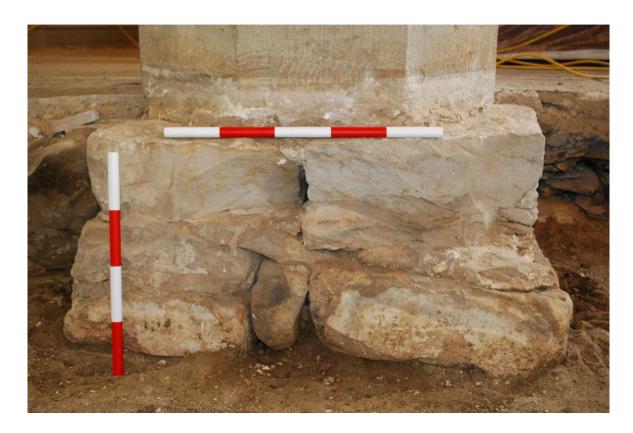
The other exposed pier footings, 1011, 1007 and 1005 were constructed in a similar manner to 1008 (Figure 2, Plates 6-8) and were all cut into 1026. Also cut through 1026 was 1012, a low structure running across the base of the north nave wall for the length of the trench (Figure 2, Plate 9). This structure was 0.25m wide and 0.12m high, and was interpreted as a possible wall bench or a footing for the floor beneath the pews. The upper surface bore mortar impressions of a further course which had subsequently been removed, and was interrupted at a point 5.15m east from the tower by a 0.30m wide opening with a rendered lining, 1014 (Plate 10). This led into a channel running through brickwork behind the plaster wall face, and was interpreted as a flue opening for an early heating system. Cut through pier footing 1006 was a brick and concrete lined opening leading to a brick-lined channel heading south beyond the limit of excavation (Figure 2, Plate 7). This structure, 1015, exhibited signs of heat-damage and was also interpreted as a flue forming part of a former heating system.

Plate 6 Pier footing 1004 looking east

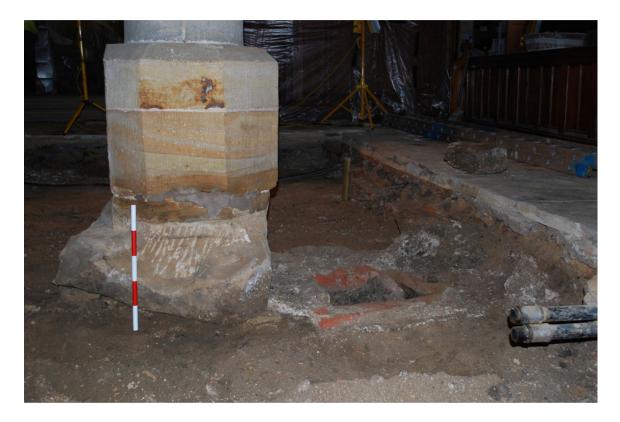
Plate 7 Pier footing 1006 with later flue 1015 looking east

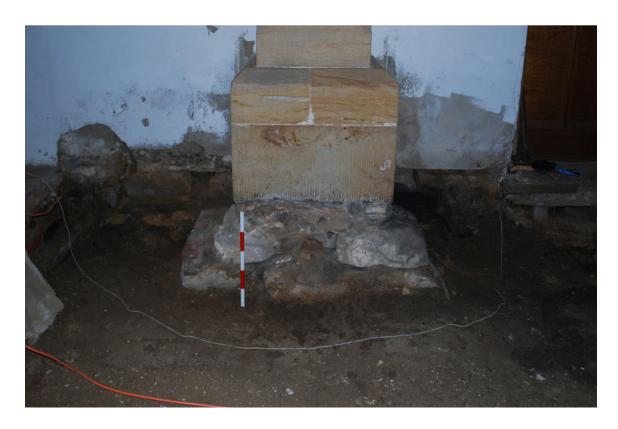
Plate 8 Pier footing 1010 looking west

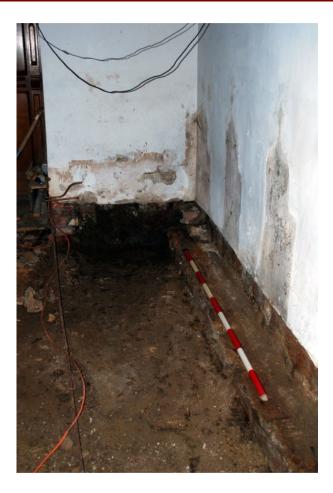
Plate 9 Structure 1012, looking west

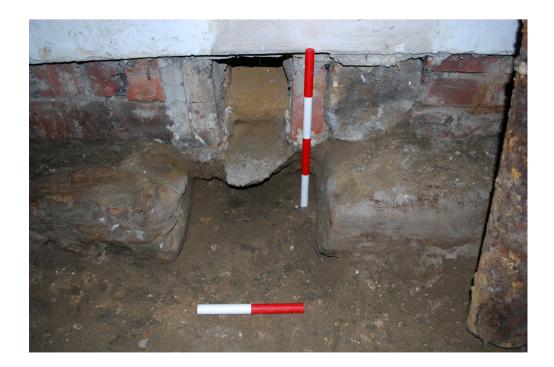
Plate 10 Flue feature 1014 looking north

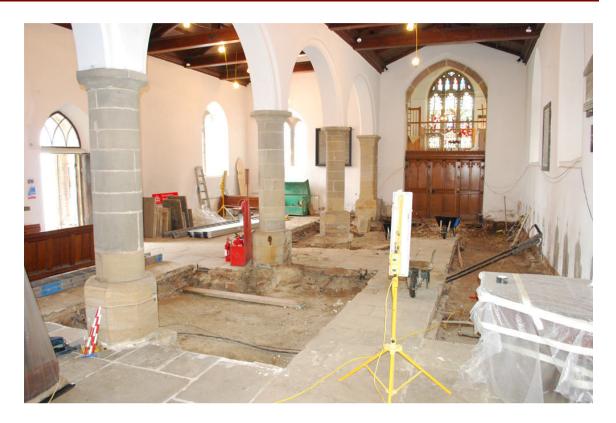
In the area beneath the stone-paved aisles a series of brick-built dwarf walls had been placed to carry the floor and the space in between filled with loose brick rubble, 1003, some of which had also been used to partially fill in the void beneath the timber floors (Plates 11 & 12). This material was removed along with the brick walls, exposing the features described above. In the area of the main aisle, a disturbed deposit of loose-friable mid-dark grey sandy silt was observed. This deposit, 1024, contained moderate amounts of disarticulated human bone and was interpreted as a disturbance associated with the construction of the stone aisle floor, 1002. It was noted that the only identified burials were observed either side of this disturbance, under the timber floor, 1001, suggesting that other burials were once present across the entire area.

Plate 11 General view looking south-west, showing pier footings and sub-floor deposit 1003

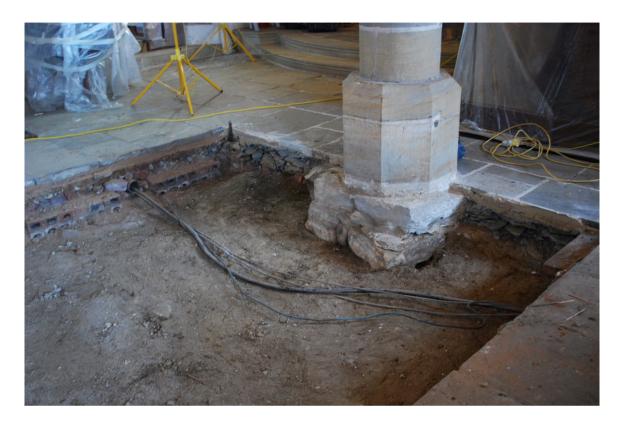
Plate 12 Looking north-east: dwarf walls and sub-floor deposit 1003 with footing 1004

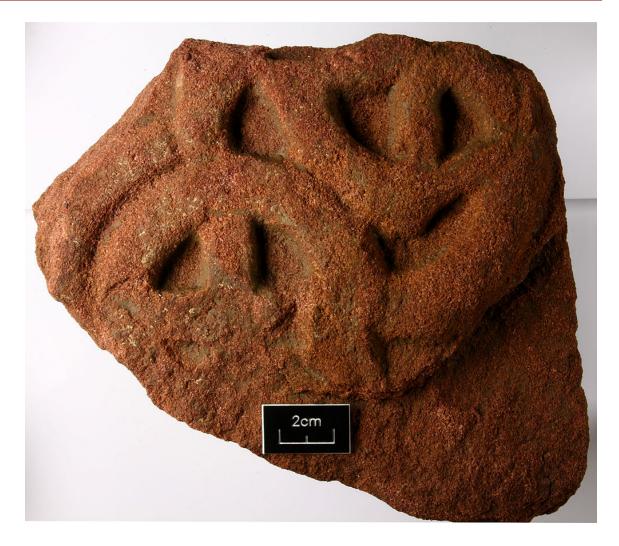
Perhaps of most significance for the history of All Saints', however, was the recovery of a carved architectural stone fragment from the sub-floor rubble 1003 (Plate 13). This was retained and has been provisionally identified as a piece of Anglo-Scandinavian ornamental structure dating to the late 10/early 11th century. Fragments of this date are often associated with parish churches that have early origins (Hall, 179). On the basis of this initial interpretation, therefore, given the known early history of All Saints' church, it is strongly recommended that further work be undertaken to further identify this fragment, which if confirmed would represent a significant addition to the corpus of known Anglo-Scandinavian stone work in this region.

Plate 13 Anglo-Scandinavian stone fragment
