# CONDITION ASSESSMENT OF THE SHIRE DITCH, THE MALVERN HILLS, HEREFORDSHIRE AND WORCESTERSHIRE

Tom Vaughan

6<sup>th</sup> February 2006  
revised 22<sup>nd</sup> February 2006

INVESTOR IN PEOPLE  
Project 2817  
Report 1384  
WSM 34769  
/HSM 43068

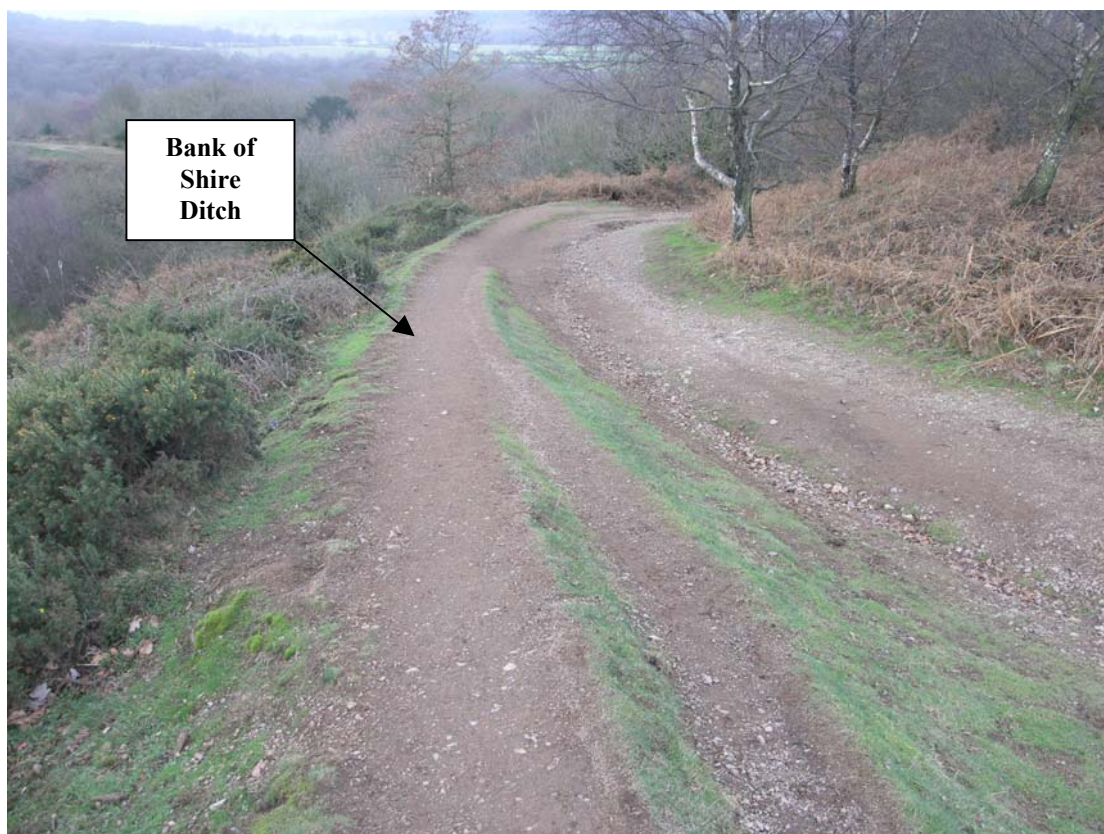
- The route behind the bank has become incised due to water action and the surface has a certain proportion of loose natural gravel. This has created an uncomfortable walking surface and the bank provides a more comfortable alternative.
- The bank provides a better view than the route behind.

To make the route along the bank more difficult to follow it is recommended that the scrub on the approach from the north be allowed to develop over the bank in a narrow band to divert people off the bank. In addition the desire line on the bank should be dressed with a locally sourced soil and re-seeded. Care needs to be exerted in this dressing not to alter the form of the monument and therefore the dressing should be limited to that necessary to create a slight domed profile.

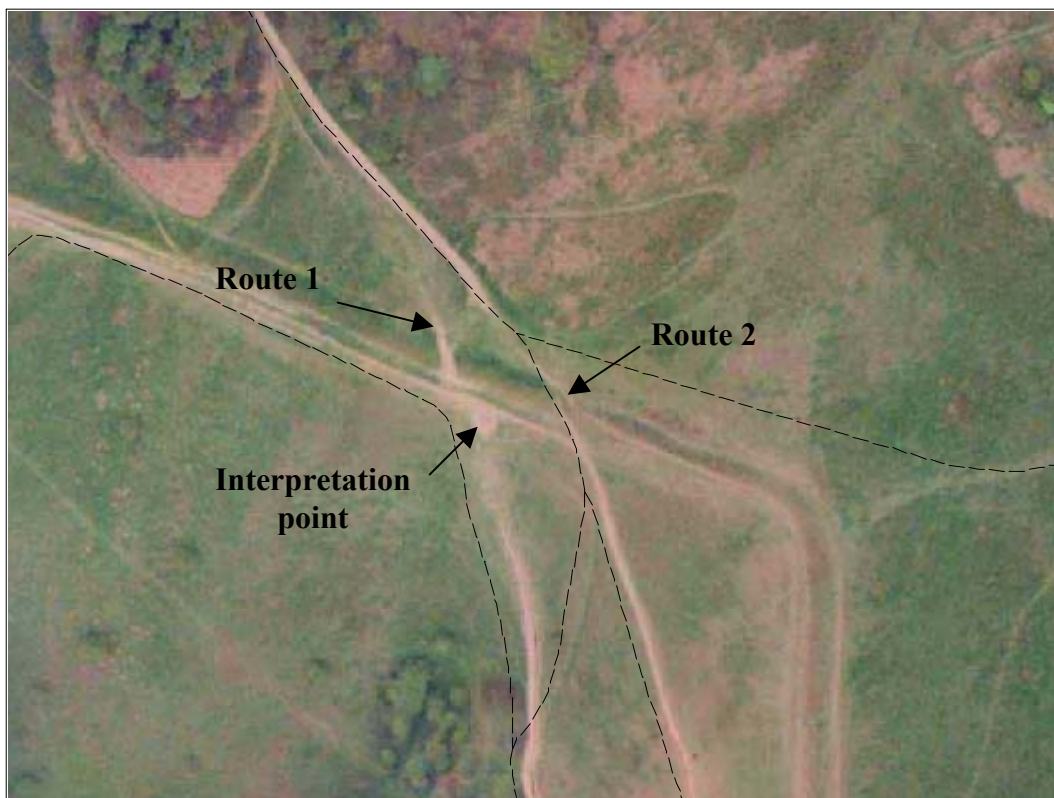
Plan of site. Images Copyright to Herefordshire Council © 2006 Simmons Aerofilms Ltd

The Shire Ditch is crossed by two recreation routes that have eroded the main and counterscarp bank of the monument. The continued use of these routes is causing further incision of the route and erosion on the sides. Route 1 is influenced by the location of an interpretation point immediately south of the Ditch. Route 2 is a Public Bridleway in Worcestershire, but is not defined in Herefordshire.

- Install an aggregate mix path (20mm aggregate mixed with soil, grass seed and slow release fertiliser).

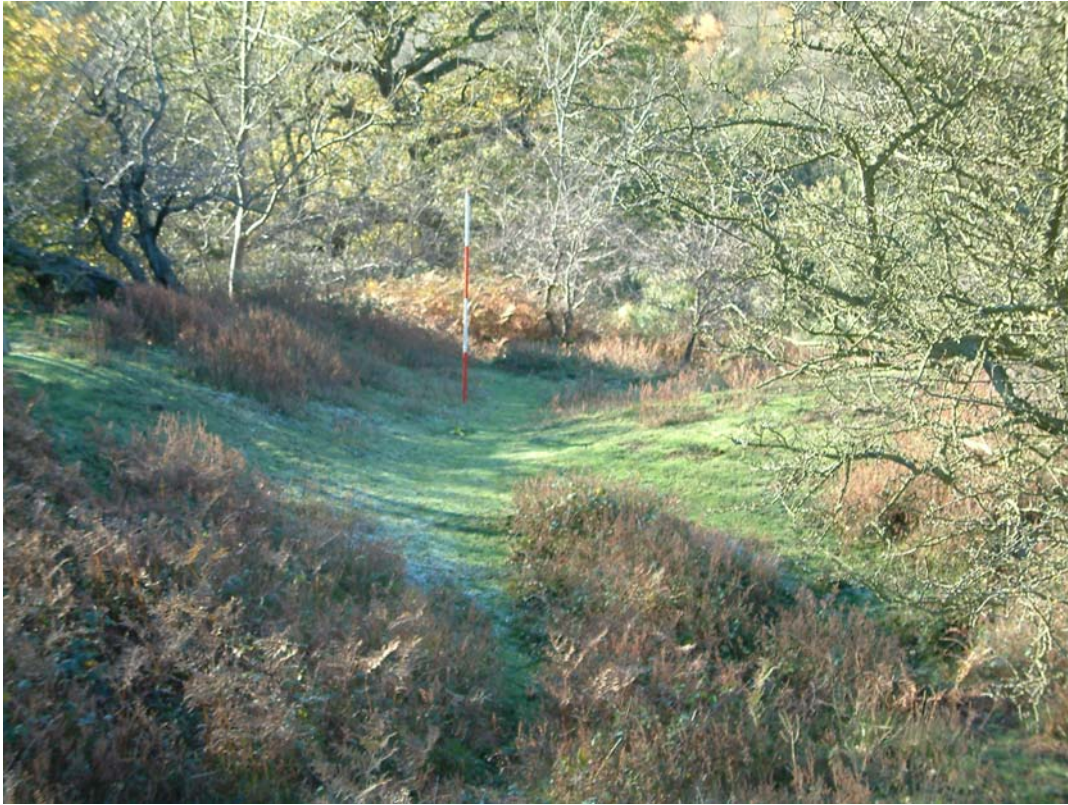
<b>Management Unit:</b> South end of Midsummer Hill		<b>NGR (from - to)</b> SO 75983 36733 - 76152 37081	<b>Number</b> 2
<b>Site Owner</b> Eastnor Estate / Malvern Hills Conservators		<b>HER/SMR ref.</b> WSM 03719	
<b>Description</b> Between east edge of Hollybush Quarry and Midsummer Hill hill fort rampart to north. Under short grass with occasional hawthorns, low scrub and bracken Occasional bare earth. Fenced off with no footpath or stock access Location confused by terrace to east Banks well defined; ditch somewhat silted Occasional rabbit burrow & extensive droppings			
<b>Survival Visible components</b>	Good		
<b>Condition % affected</b>	Good		
<b>Vulnerability</b> Minor weathering Minor rabbit activity Erosion over quarry edge			
<b>Significance Within the monument</b>	High		
<b>Risk to significance</b>	Low		
<b>Priority Based on factors above</b>	Medium		
<b>Remediation</b>	Monitoring - M3

*Plate 1: Unit 2, view south south west of ditch toward Holly Bush Quarry (photo 3).*

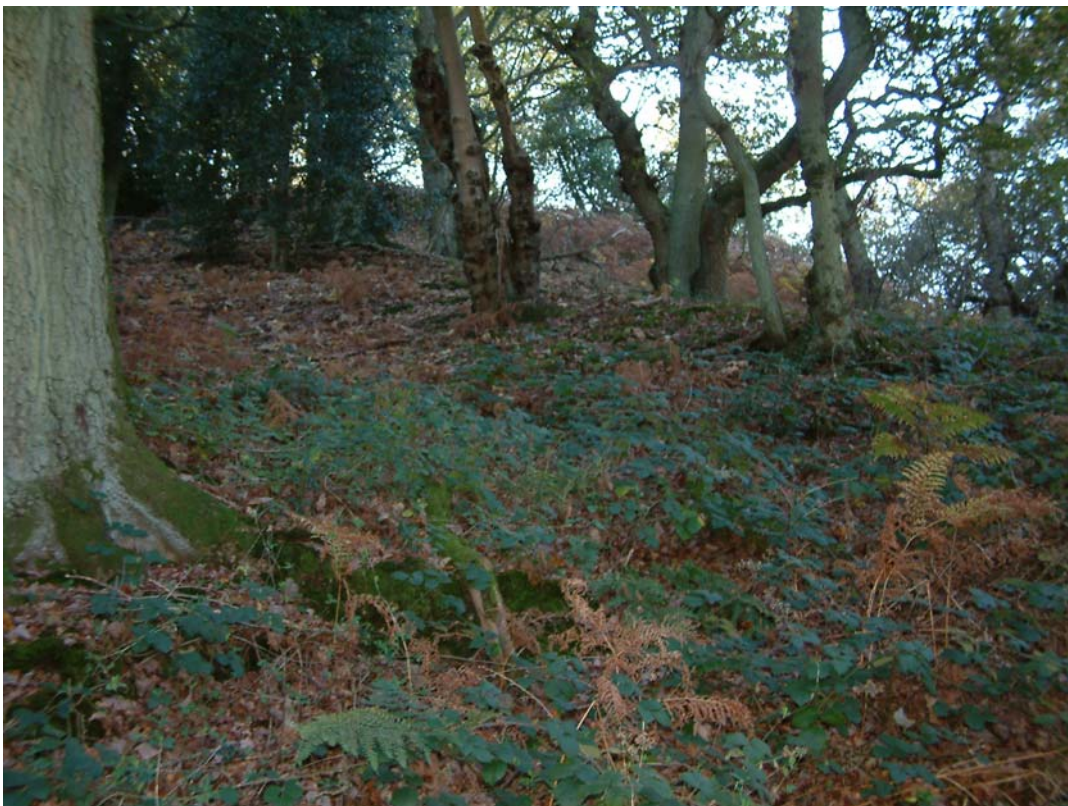
<b>Management Unit:</b> North end of Midsummer Hill		<b>NGR (from - to)</b> SO 76136 37684 - 76136 37974	<b>Number</b> 4
<b>Site Owner</b> Eastnor Estate / Malvern Hills Conservators		<b>HER/SMR ref.</b> WSM 03721	
<b>Description</b> North end of Midsummer Hill down to the Gullet Cutting. Bank to west is under minor footpath to south end; worn flat as ridge to west Ditch to east is generally under bracken, saplings and scrub; inaccessible at mid point; very silted and indeterminate within northern half down slope; Little or no defined bank to east. Mid point of ridge is under open woodland with clearings, e.g. SO 76187 37789, where bank comprises bare rock under roots, leaf mold and moss. Northern half is under mature trees with occasional grass clearings and patches of scrub. Within northern third down slope there is no defined ditch, the bank comprises a shallow earthwork of bare rock and moss on the ridge below trees and occasional scrub. A dense screen of holly trees lies directly above the Gullet Cutting.

<b>Survival Visible components</b>	Good-poor		
<b>Condition % affected</b>	Good/medium		
<b>Vulnerability</b> Tree roots Scrub - bracken Minor rabbit activity Minimal silting from vegetation Erosion down slope			
<b>Significance Within the monument</b>	Medium		
<b>Risk to significance</b>	Low		
<b>Priority Based on factors above</b>	Medium		
<b>Remediation</b>	Removal of saplings - S3 Clearance of scrub - S2 Monitoring of rabbit activity - M2 & B2 Monitoring of weathering - M3		
<b>Figure</b>			
<b>Plates</b>  2	<b>Photos</b>  14-25

*Plate 2: Unit 4, view south west of eroded bank on north side of Midsummer Hill (photo 24).*

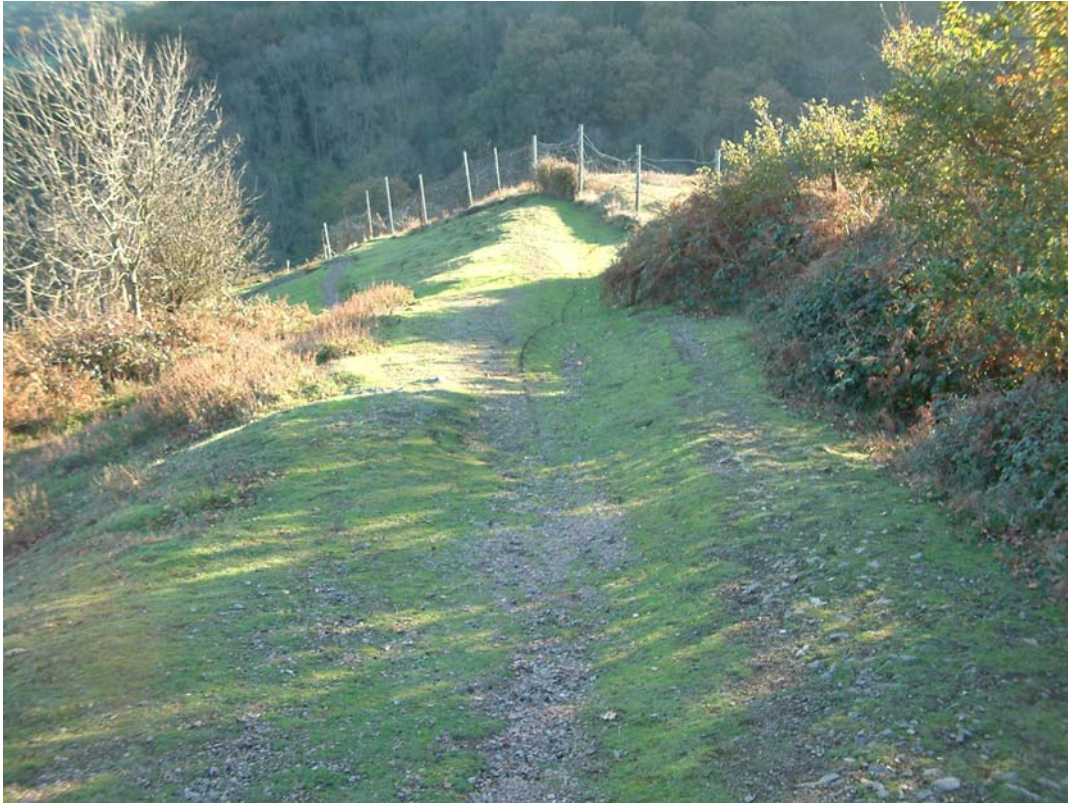
<b>Management Unit:</b> Swinyard Hill		<b>NGR (from - to)</b> SO 76208 38158 - 76199 38627	<b>Number</b> 6
<b>Site Owner</b> Malvern Hills Conservators		<b>HER/SMR ref.</b> WSM 03873	
<b>Description</b> South side of Swinyard Hill up to peak. Footpath cuts across ditch and then along bank to west, occasional bike tracks, worn to short grass with bare rock and soil (10-40%). Occasional severe erosion along sections of path and at peak - worn to bare rock and soil Ditch to east very shallow and silted, occasional sections obscured by dense bracken. Occasional rock outcrops. Occasional rabbit burrows.			
<b>Survival Visible components</b>	Poor/medium		
<b>Condition % affected</b>	Good		
<b>Vulnerability</b> Weathering of ridge and peak Minor rabbit activity Footpath erosion			
<b>Significance Within the monument</b>	Medium		
<b>Risk to significance</b>	Medium/low		
<b>Priority Based on factors above</b>	Medium/low

*Plate 3: Unit 6, view south of erosion to bank and ditch on Swinyard Hill toward the Gullet Quarry (Photo 30).*

<b>Remediation</b>	Repair path erosion - RE1-4 Cut back sections of bracken to widen spread of traffic - R2 Monitor rabbits - M3		
<b>Figure</b>			
<b>Plates</b> 3 & 4	<b>Photos</b> 28-39

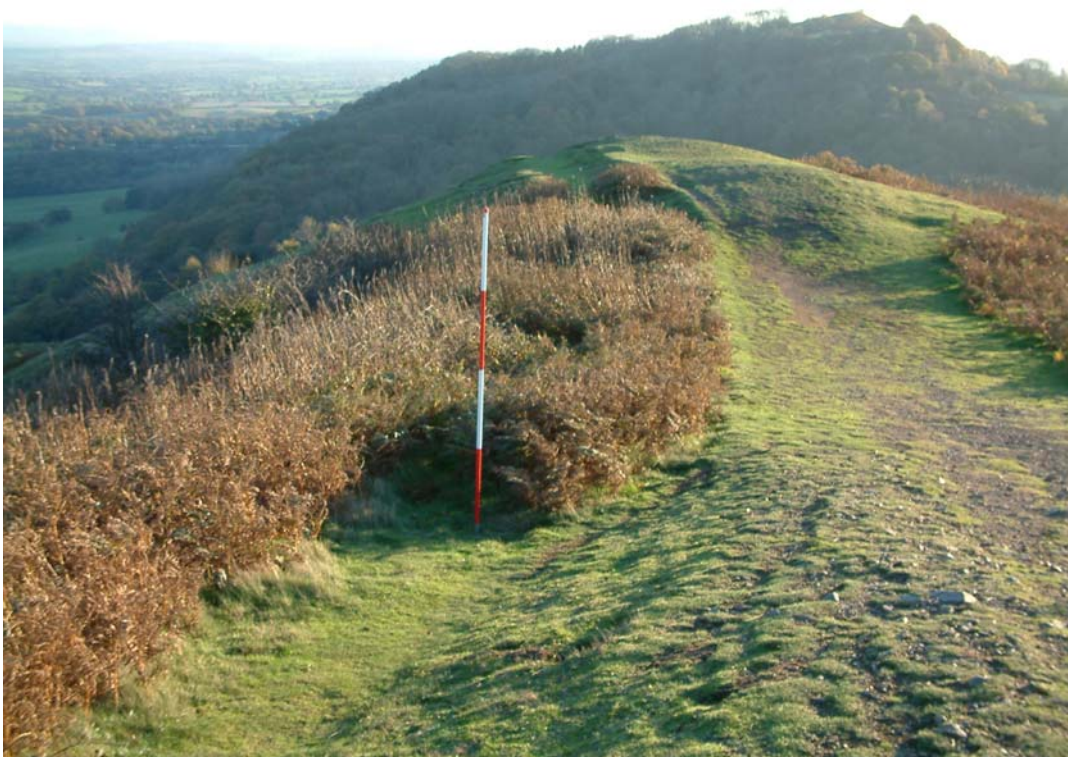
*Plate 4: Unit 6, view south of bracken on bank and eroded path on Swinyard Hill ridge (Photo 35).*

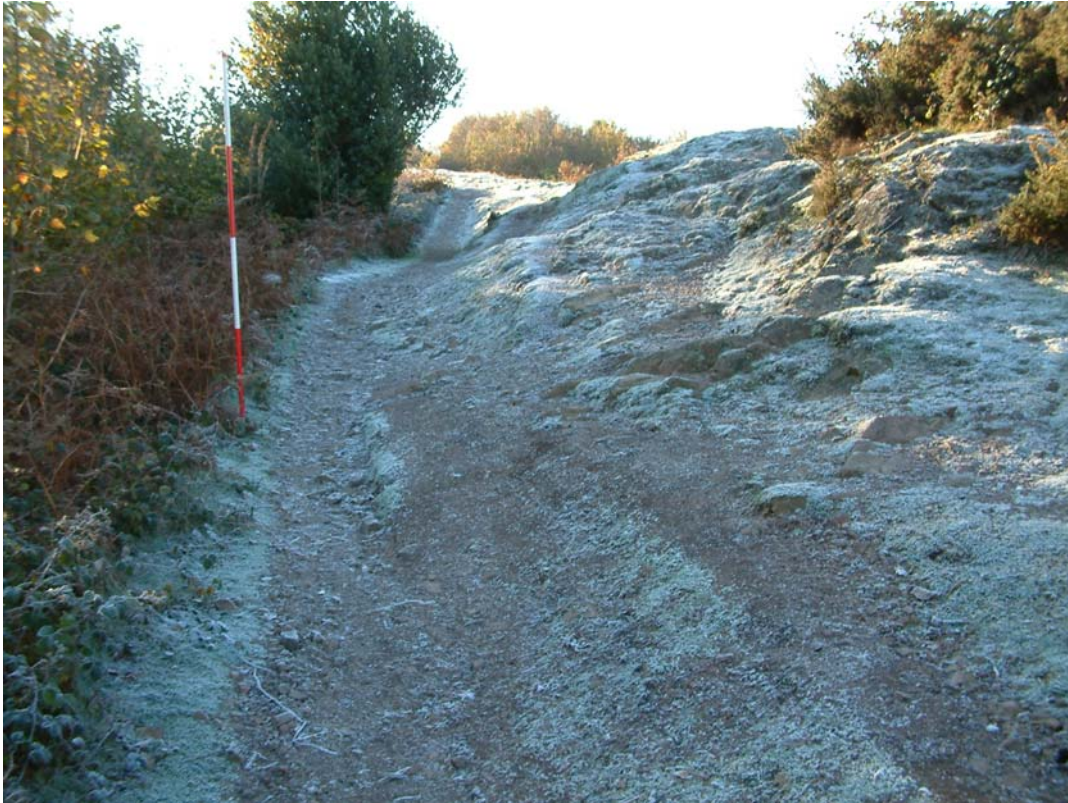
<b>Management Unit:</b> Swinyard Hill		<b>NGR (from - to)</b> SO 76169 38863 - 76194 39013	<b>Number</b> 8
<b>Site Owner</b> Malvern Hills Conservators		<b>HER/SMR ref.</b> WSM 03722	
<b>Description</b> Northern-most end of Swinyard Hill down to Silurian Pass. Ridge to west under short grass with frequent bare rock and earth Path below ridge along bank, worn flat and eroded to gravel and bare earth. Ditch further down slope under dense trees and scrub and inaccessible but clearly defined to north end. Occasional rabbit activity on east side of ridge Sections of bank have extensive bare rock and earth with evidence of water erosion Quarry on ridge at SO 76177 38994			
<b>Survival Visible components</b>	Poor/medium		
<b>Condition % affected</b>	Poor/medium		
<b>Vulnerability</b> Weathering of ridge and path Erosion and wear to footpath Siltting and root activity in east ditch			
<b>Significance Within the monument</b>	Medium

*Plate 5: Unit 8, view south of erosion to path on bank on Swinyard Hill (Photo 43).*

<b>Risk to significance</b>	Medium/high		
<b>Priority Based on factors above</b>	Medium		
<b>Remediation</b>	Clear scrub and saplings from ditch - S2 Repair of erosion to bank and ditch - RE2 Encourage traffic away from ditch footpath - R3 (within constraints of MHC Acts) Monitor - M3		
<b>Figure</b>			
<b>Plates</b>  5	<b>Photos</b>  41-49

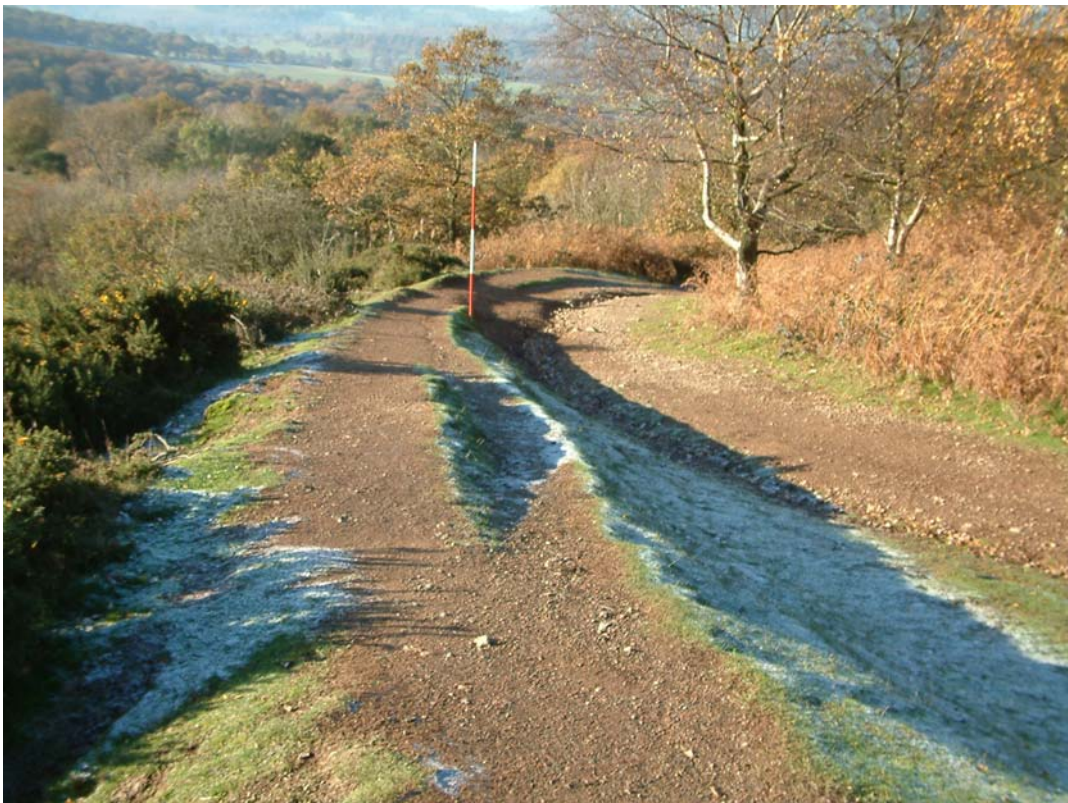
*Plate 6: Unit 9, view west of erosion to bank on south end of Hangman's Hill (Photo 51).*

<b>Significance Within the monument</b>	Medium		
<b>Risk to significance</b>	High/medium		
<b>Priority Based on factors above</b>	High		
<b>Remediation</b>	Reseed bank - R1 Deter traffic along bank - R3 Reinstate existing path 1 RE4 Gorse removal from sections of ditch - S2 Monitor rabbits - M3  See also Section 6.7.1		
<b>Figure</b>			
<b>Plates</b>  6	<b>Photos</b>  50 & 51

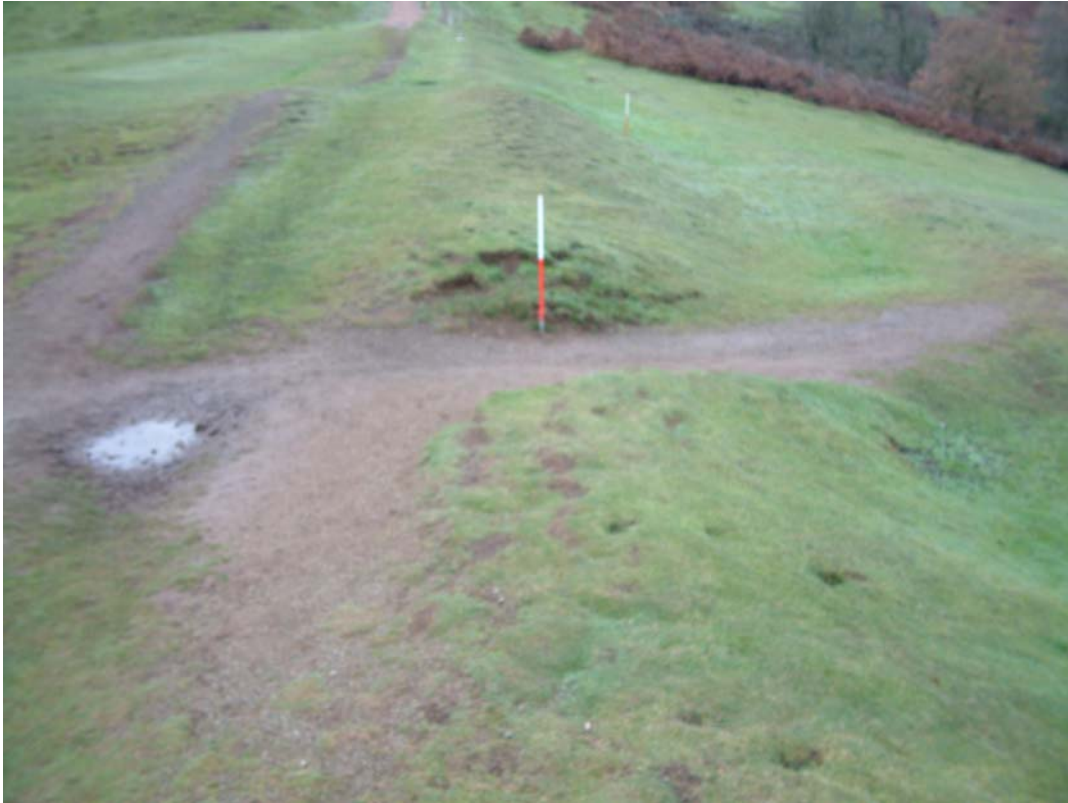
<b>Management Unit:</b> Broad Down - Herefordshire Beacon		<b>NGR (from - to)</b> SO 76266 39470 - 76104 39535	<b>Number</b> 10b
<b>Site Owner</b> Malvern Hills Conservators		<b>HER/SMR ref.</b> WSM 03722	
<b>Description</b> Broad Down saddle to Herefordshire Beacon British Camp hill fort ramparts. Well-preserved section. Slightly silted ditch with main bank to south-west. Under short grass with occasional weathering and a rock outcrop toward the south-east end. Two major paths cross the ditch on the saddle: At SO 76231 39480 a path diagonally across bank and ditch, down to bare rock and gravel with extensive weathering to the exposed sides At SO 76209 39491 a wide gravelled Bridleway, with a ramp deliberately infilling the ditch. At SO 76159 39513 to the west, a sheep track diagonally crosses the ditch, alongside outlier of bracken, wearing down to bare earth Main path lies to south-west up to south entrance into British Camp; worn to bare earth (with patches of imported gravel) on saddle and recently reinstated by MHC up to hill fort. At SO 76100 39533 below hill fort ramparts, a narrow minor path cuts diagonally across ditch, worn to bare soil and gravel with water borne erosion into ditch. Outcrop of bracken within ditch from north at west side of saddle

<b>Survival Visible components</b>	Good		
<b>Condition % affected</b>	Good		
<b>Vulnerability</b> Weathering Footpath erosion across ditch and on saddle Water erosion from rampart path			
<b>Significance Within the monument</b>	High		
<b>Risk to significance</b>	Low		
<b>Priority Based on factors above</b>	High		
<b>Remediation</b>	Deter use of minor paths and emphasize Bridleway - R1 and R3 Cut back bracken to reroute animal track - S2 Reseed and reinstate minor path scars - RE3 Monitor animal activity - M3  See also Section 6.7.2		
<b>Figure</b>			
<b>Plates</b>  7	<b>Photos</b>  62-74

*Plate 7: Unit 10b, view west north west eroded bridleway across bank and ditch on Broad Down saddle, east of British Camp (Photo 66).*

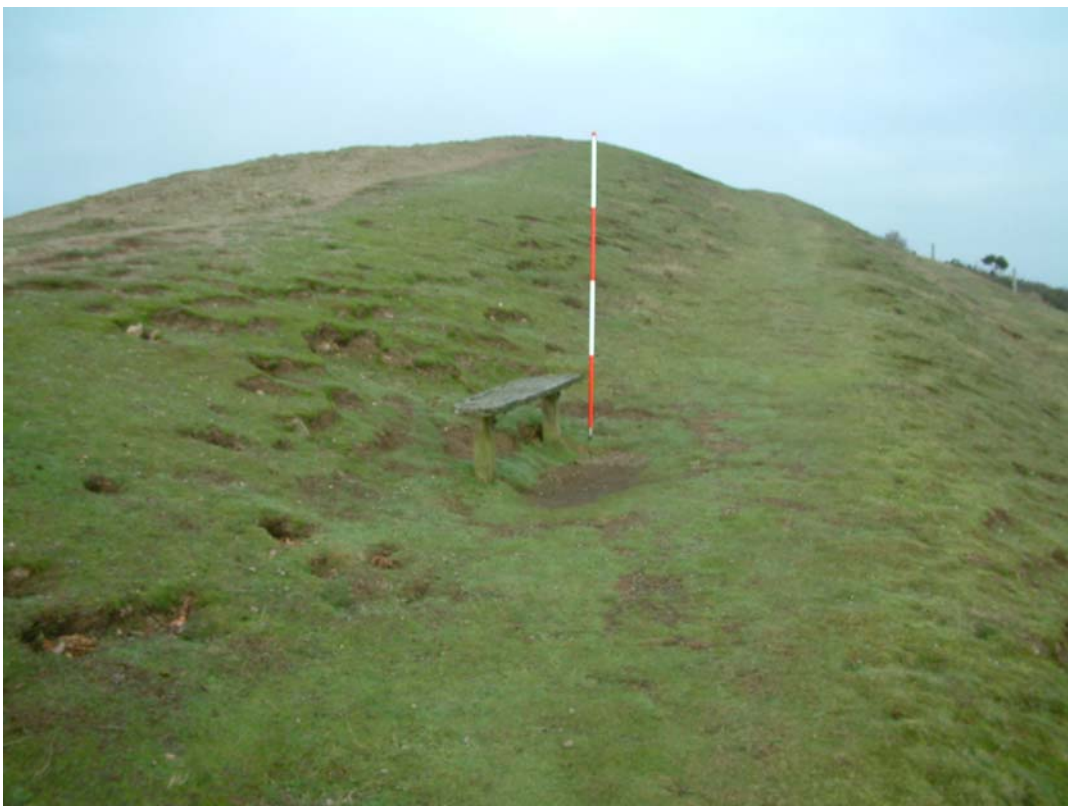
<b>Management Unit:</b> Black Hill		<b>NGR (from - to)</b> SO 76742 40889 - 76814 41367	Number 14
<b>Site Owner</b> Malvern Hills Conservators		<b>HER/SMR ref.</b> WSM 03750 / HSM 3818	
<b>Description</b> Peak and upper ridge of Black Hill. Bank to west under footpath, worn flat, to bare earth, gravel and occasional rock outcrops. Ditch to east is shallow and generally under short grass with scrub cut back on lower slopes. Animal track along southern c220m of ditch adj. to scrub, worn to bare earth Quarry fence, with concrete posts along middle of ditch for c 95m on peak Frequent weathering on slope of bank at peak At SO 76814 41170 a bench within ditch near peak At SO 76839 41315 an iron boundary marker below peak Minor track in ditch north of boundary marker, wearing to bare earth, with scrub and trees adj. to east.			
<b>Survival Visible components</b>	Good		
<b>Condition % affected</b>	Good/poor

<b>Vulnerability</b> Weathering at peak and along bank path Footpath erosion on bank, minor path in ditch to north and animal track in ditch to south			
<b>Significance Within the monument</b>	Medium		
<b>Risk to significance</b>	Medium		
<b>Priority Based on factors above</b>	Medium		
<b>Remediation</b>	Deter path within ditch - R3 Repair of weathering - RE1 Cut back scrub further away from ditch to move animal track - R2 and/or G1 Monitor - M3		
<b>Figure</b>			
<b>Plates</b>  8	<b>Photos</b>  94-104

*Plate 8: Unit 14, view north of silted ditch and flattened bank with bench on Black Hill (Photo 98).*

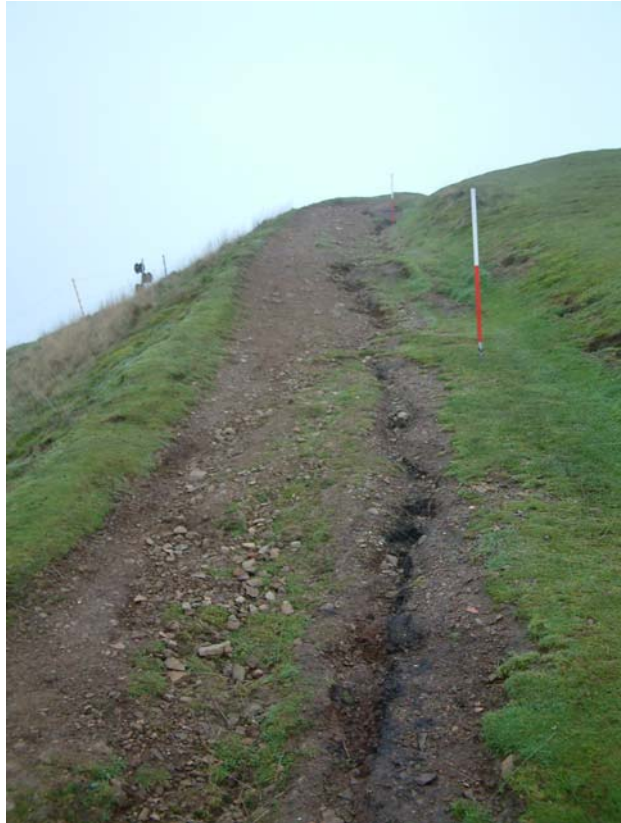
<b>Management Unit:</b> Pinnacle Hill		<b>NGR (from - to)</b> SO 76789 42122 - 76819 42406	<b>Number</b> 16
<b>Site Owner</b> Malvern Hills Conservators		<b>HER/SMR ref.</b> WSM 03823 / HSM 3822	
<b>Description</b> From the peak of Pinnacle Hill down to the saddle to the north, west of the Holy Well. Bank below ridge with ditch to east. Main path on bank largely worn flat, to bare earth and rock with water erosion, down to saddle where it crosses over to ridge path and minor path continues along this side. Grazing and scrub fenced off with temporary electric fence along silted ditch with animal track along, eroded to churned earth. Ditch to east is steep and under pasture to south and scrub to north Temporary water bowser and trough located within bank on saddle at SO 76797 42390. At SO 76773 42334 a bank adjoins outer ditch from east - possible unrecorded field boundary?  Area terminates at north end of saddle where footpath forming a Bridleway to the north-east crosses ditches: at this point no earthworks are extant, the ridge slopes down to either side; the Bridleway may utilise the outer ditch which has been altered and lost until further north (Area 17).

<b>Survival</b> Visible components	Medium/Good		
<b>Condition</b> % affected	Medium		
<b>Vulnerability</b> Weathering esp. along bank and ridge Footpath and water erosion along bank and sections of ditch Siltling and root damage to ditch Stock erosion of ditches			
<b>Significance</b> <b>Within the monument</b>	Medium		
<b>Risk</b> <b>to significance</b>	Medium/High		
<b>Priority</b> <b>Based on factors above</b>	Medium/High		
<b>Remediation</b>	Deter footpath along bank with temporary boundary - R3 Reseed and reinstate weathered sections - RE2 and RE4 Cut back scrub further away from outer ditch - G3 Move temporary fencing east, below ditch counterscarp - G2 Resite temporary bowser - G2 Monitor - M3		
<b>Figure</b>			
<b>Plates</b>  9	<b>Photos</b>  127-137

*Plate 9: Unit 16, view south south east of water erosion to path on bank on Pinnacle Hill (Photo 128).*

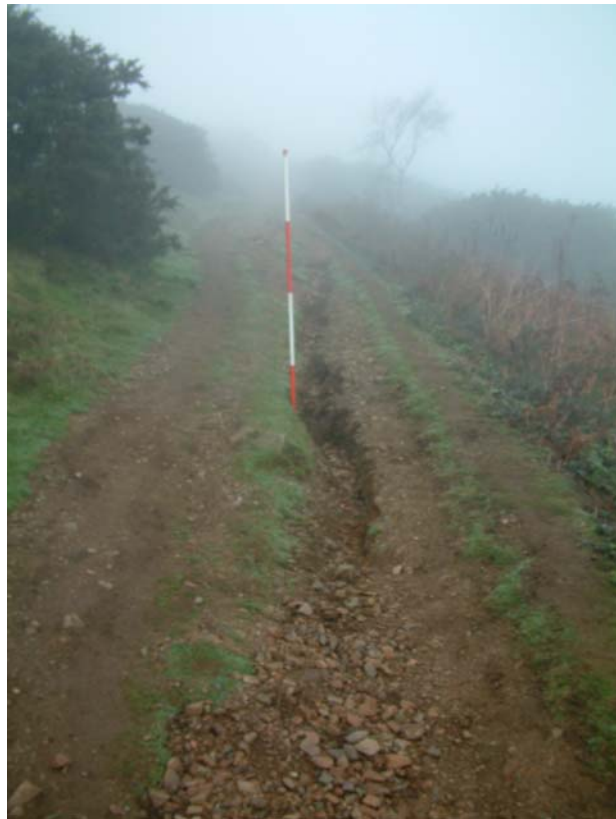
<b>Management Unit:</b> Summer Hill		<b>NGR (from - to)</b> SO 76911 44237 - 76934 44741	<b>Number</b> 21
<b>Site Owner</b> Malvern Hills Conservators		<b>HER/SMR ref.</b> WSM 03820 and 03752 / HSM 3821	
<b>Description</b> From the Gold Mine saddle, up the south side of Summer Hill to the peak; east of Earnslaw Quarry, Malvern Common and The Firs. No defined ditches due north of saddle - area inaccessible under gorse and scrub. Bridleway along bank, worn flat to bare earth and soil. Water plant has truncated ditch to east between SO 76918 44258 and 76916 44303. Bank and ditches truncated by path to water plant at SO 76904 44272 with imported gravel. Unclear if there is a ditch north of water plant; inaccessible under gorse and trees. Bank variously under grass, gorse and scrub; bridleway along ridge to west. Extensive water erosion within bridleway at SO 76915 44406, 76915 44457, 76916 444505 and to north summit. Irregular paths across bank at SO 76913 444386 and 76913 44482 worn to bare earth and gravel. Minor path from north-east cut through possible east ditch at SO 76915 44473; bare rock in west ditch adj. Possible west ditch northwards from SO 76911 44551, generally grassed with occasional gorse; weathered north of SO 76904 44604. Minor path/animal track across bank and west ditch at SO 76904 44604, worn to bare earth and stone. Field boundary from south-east adjoins ditch at SO 76934 44728. Area terminates north of peak where worn path on bank turns north-west across west ditch and onto ridge (continued as Area 22).

<b>Survival</b> Visible components	Medium/poor		
<b>Condition</b> % affected	Medium/poor		
<b>Vulnerability</b> Weathering of bank on summit Footpath erosion Water erosion			
<b>Significance</b> <b>Within the monument</b>	Medium		
<b>Risk</b> <b>to significance</b>	Medium/High		
<b>Priority</b> <b>Based on factors above</b>	Medium/High		
<b>Remediation</b>	Deter access across bank - R1 Deter access along bank path and reroute along ridge - R3 Reinstate water eroded sections - RE4 Clear gorse and scrub to south end - S2 or S3 Monitor - M3		
<b>Figure</b>			
<b>Plates</b>  10	<b>Photos</b>  179-192

*Plate 10: Unit 21, view north of water erosion to path on bank, gorse on ridge and bracken in ditch on Summer Hill (Photo 187).*

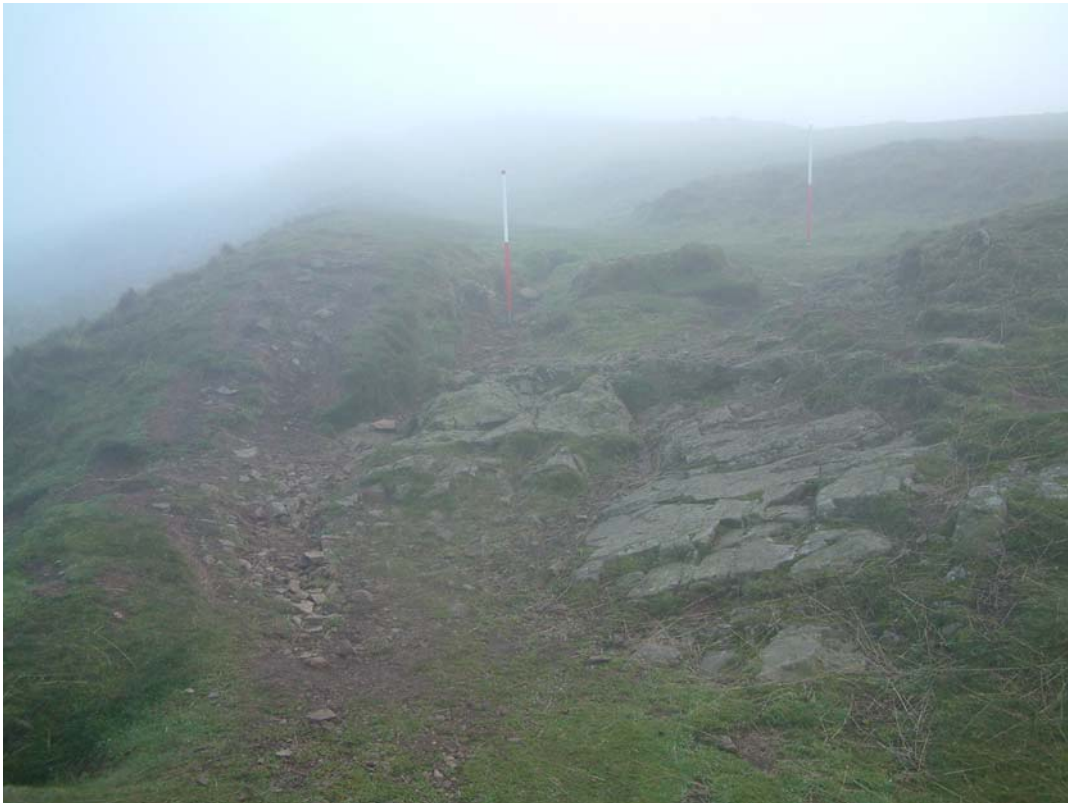
<b>Management Unit:</b> Worcestershire Beacon		<b>NGR (from - to)</b> SO 76885 45253 - 76861 45435	<b>Number</b> 24
<b>Site Owner</b> Malvern Hills Conservators		<b>HER/SMR ref.</b> WSM 03816	
<b>Description</b> From main path by rock outcrop at peak of Worcestershire Beacon down slope to north; separated from Area 25 by Bridleway. Possible double ditch below peak; west ditch (or worn bank?) is under path worn down to bare rock, gravel and soil, with water erosion down steeper gradient, e.g. SO 76865 45291; east ditch is under long grass. Bench at SO 76876 45260 cut into west bank Quarry in west ditch at SO 76854 45306 Single defined ditch only from SO 76856 45364 southwards. Ditch bisected by a rarely used Bridleway at SO 76856 45364 over a rock outcrop, where banks and ditch are eroded down to bare rock. At south end single ditch is generally under long grass with very occasional erosion to bare earth. Bank to west under grass worn to bare rock under minor path. Minor bank to east under grass with less bare rock Bisected by main Bridleway at SO 76858 45385, completely in-filling ditch and truncating banks

<b>Survival Visible components</b>	Poor		
<b>Condition % affected</b>	Poor/Medium		
<b>Vulnerability</b> Weathering and water erosion on path down steep gradient Footpath erosion			
<b>Significance Within the monument</b>	Medium		
<b>Risk to significance</b>	Medium/High		
<b>Priority Based on factors above</b>	Medium/High		
<b>Remediation</b>	Reseed and reinstate path and ditch - RE2-4 Deter access along bank path - R3 (within constraints of MHC Acts) Monitor erosion on Bridleways - M3		
<b>Figure</b>			
<b>Plates</b>  11 & 12	<b>Photos</b>  223-235

*Plate 11: Unit 24, view south of rock outcrop and erosion to ditch, below quarry on Worcestershire Beacon (Photo 228).*

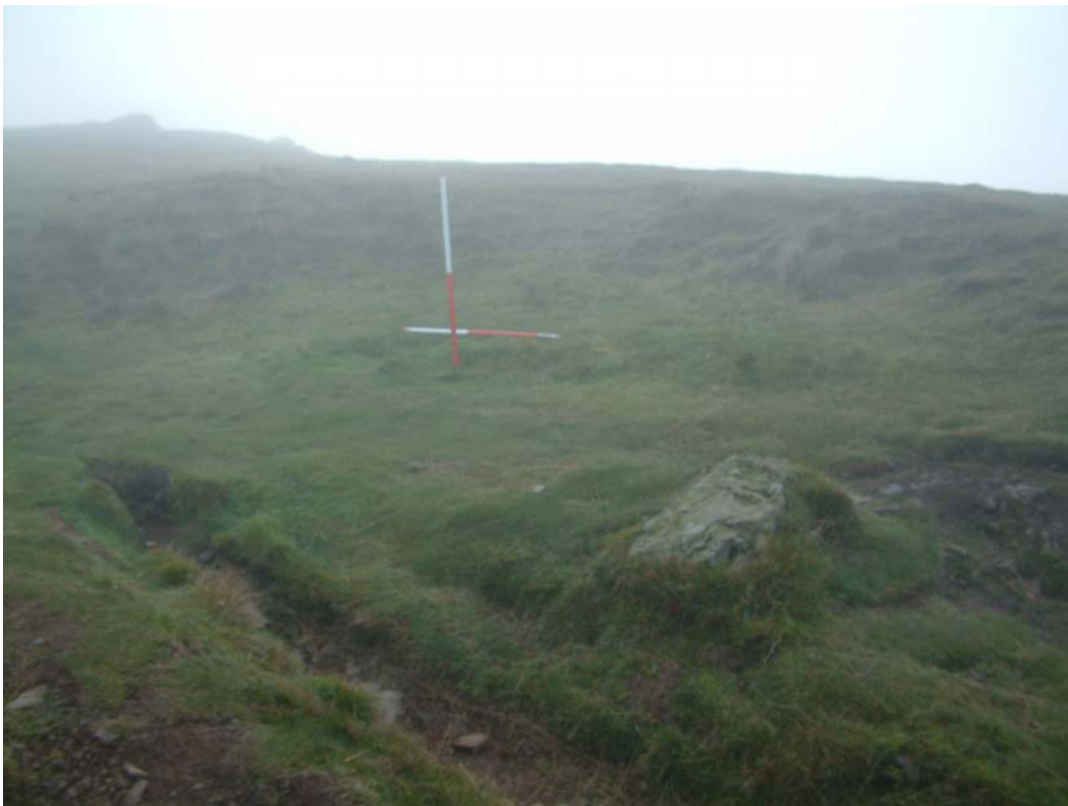
*Plate 12: Unit 24, view south west of quarry, with water erosion to ditch, on Worcestershire Beacon (Photo 227).*

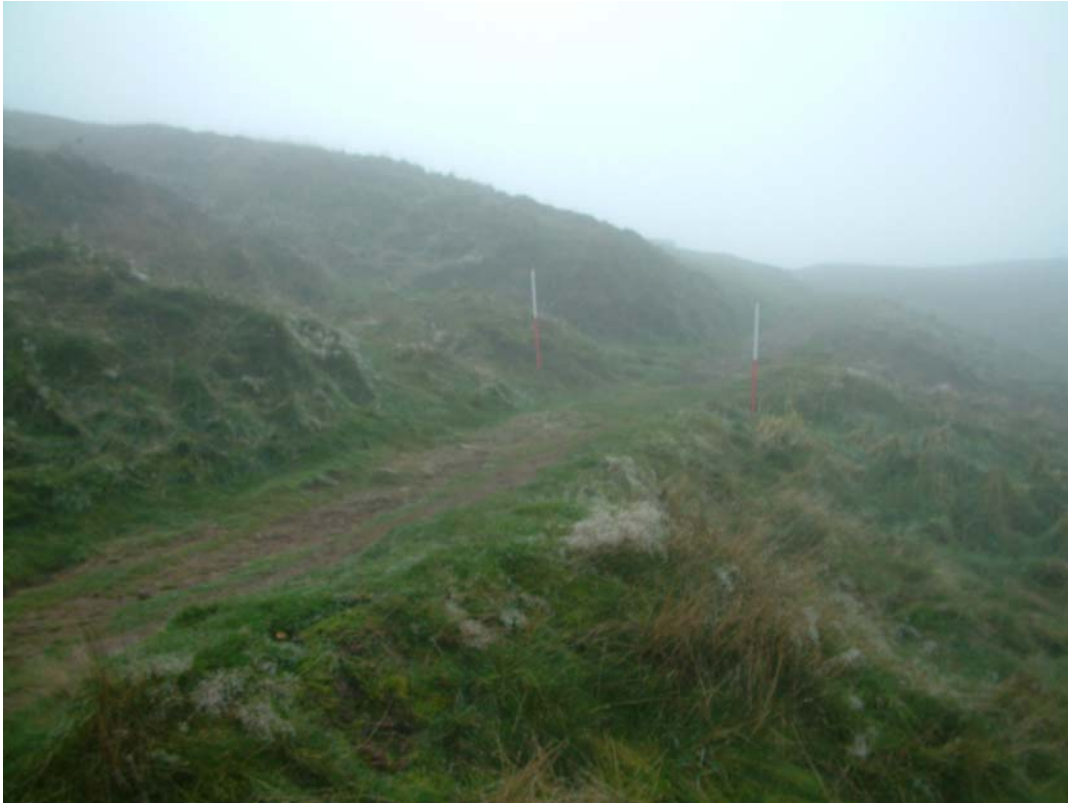
<b>Management Unit:</b> Sugarloaf Hill		<b>NGR (from - to)</b> SO 76858 45651 - 76896 45796	<b>Number</b> 26
<b>Site Owner</b> Malvern Hills Conservators		<b>HER/SMR ref.</b> WSM 03816	
<b>Description</b> From the saddle south-east of Sugarloaf Hill down to the south side of Happy Valley/Green Valley, west of St Ann's Well. Bridleway to south of area completely in-fills ditch and is worn to bare gravel and soil. Ditch with banks to either side, under long grass with frequent gorse bushes. Bench on west bank at SO 76853 45654 Bisected by perpendicular Bridleway at SO 76858 45686, worn to bare earth and rock Minor path up west side of ditch between two east-west paths, patches worn to bare earth. Minor Bridleway alongside west bank, cuts across ditch at SO 76862 45745, ditch silted and banks eroded but stable under grass and no present erosion. Ditch obscured by scrub and woodland north of minor path Area terminates where north end of ditch is truncated by quarry within woodland.

<b>Survival Visible components</b>	Medium/Good		
<b>Condition % affected</b>	Medium/Good		
<b>Vulnerability</b> Erosion across Bridleways Siltling			
<b>Significance Within the monument</b>	Medium		
<b>Risk to significance</b>	Low/medium		
<b>Priority Based on factors above</b>	Low		
<b>Remediation</b>	Monitor - M3 Clear gorse - S3 Thin out woodland - S3		
<b>Figure</b>			
<b>Plates</b> 13 & 14		<b>Photos</b> 208-215

*Plate 13: Unit 26, view west south west of bridleway across banks and ditch east of Sugarloaf Hill (Photo 211).*

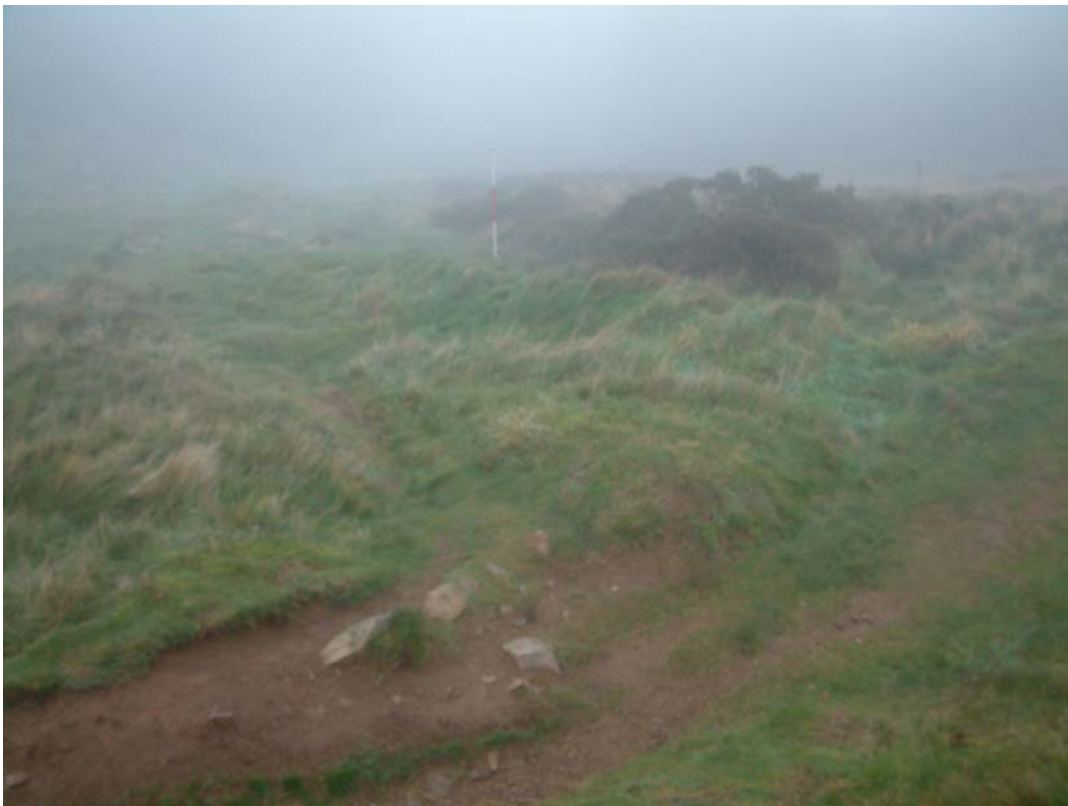
*Plate 14: Unit 26, view north north east of path across banks and ditch east of Sugarloaf Hill (Photo 212).*
