HISTORIC BUILDING  
RECORDING  
AT  
MOAT HOUSE, LEIGH SINTON,  
WOCESTERSHIRE

Interim (pre watching brief)  
7<sup>th</sup> December 2006

Project 2894  
Report 1486  
WSM 35960

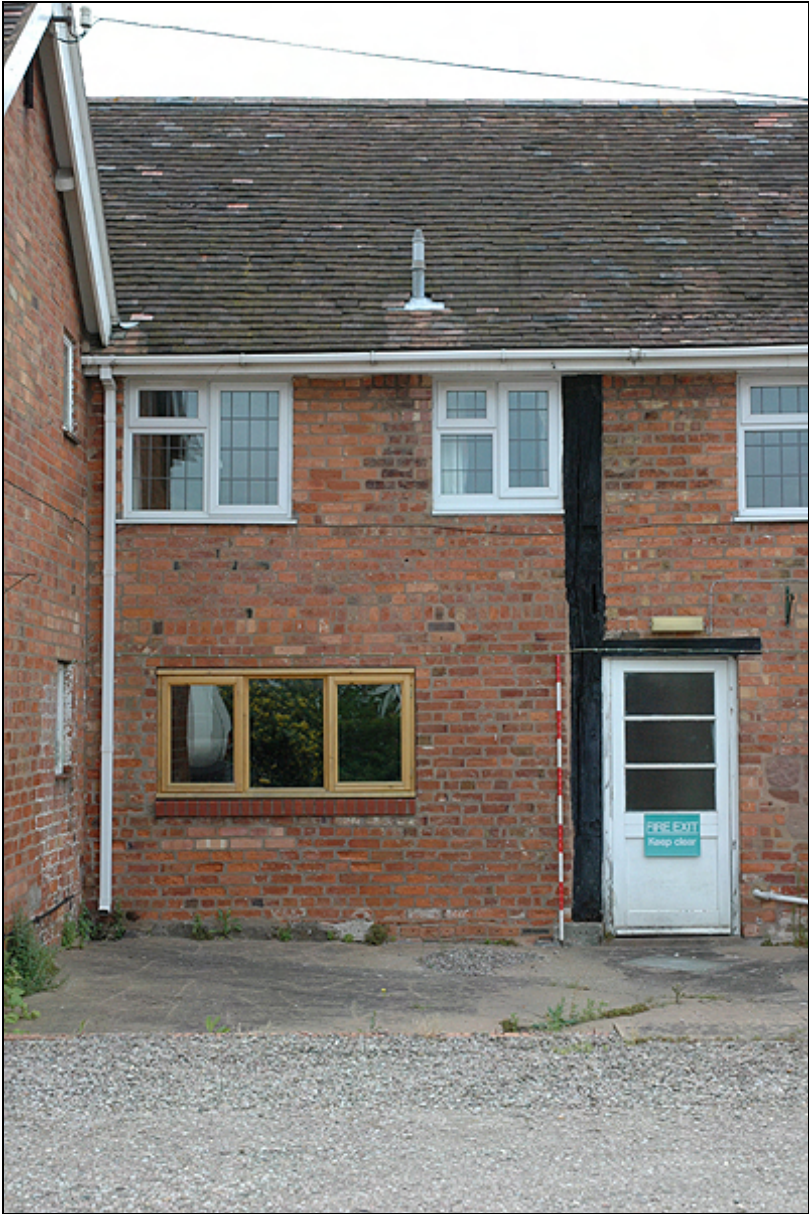
*Plate 2: West elevation of Moat House showing timber post and rail*

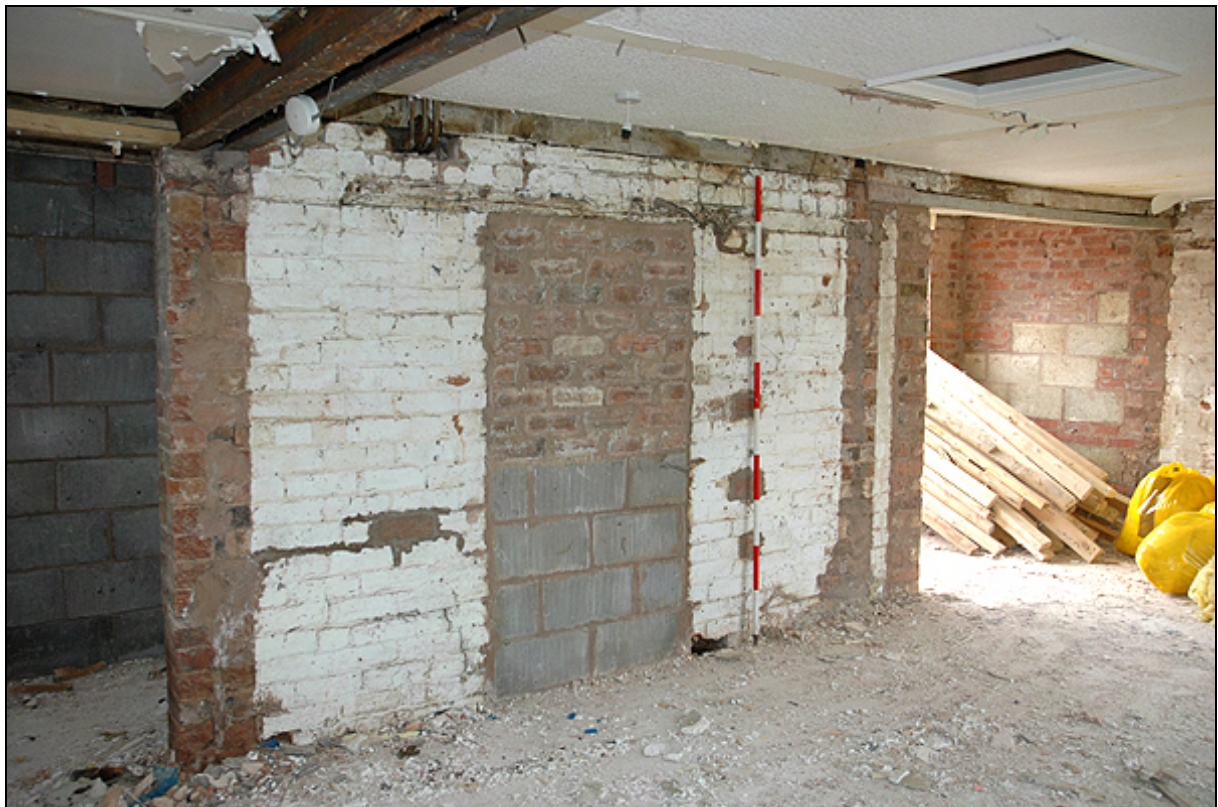
*Plate 6: Blocked opening in c1800 building*

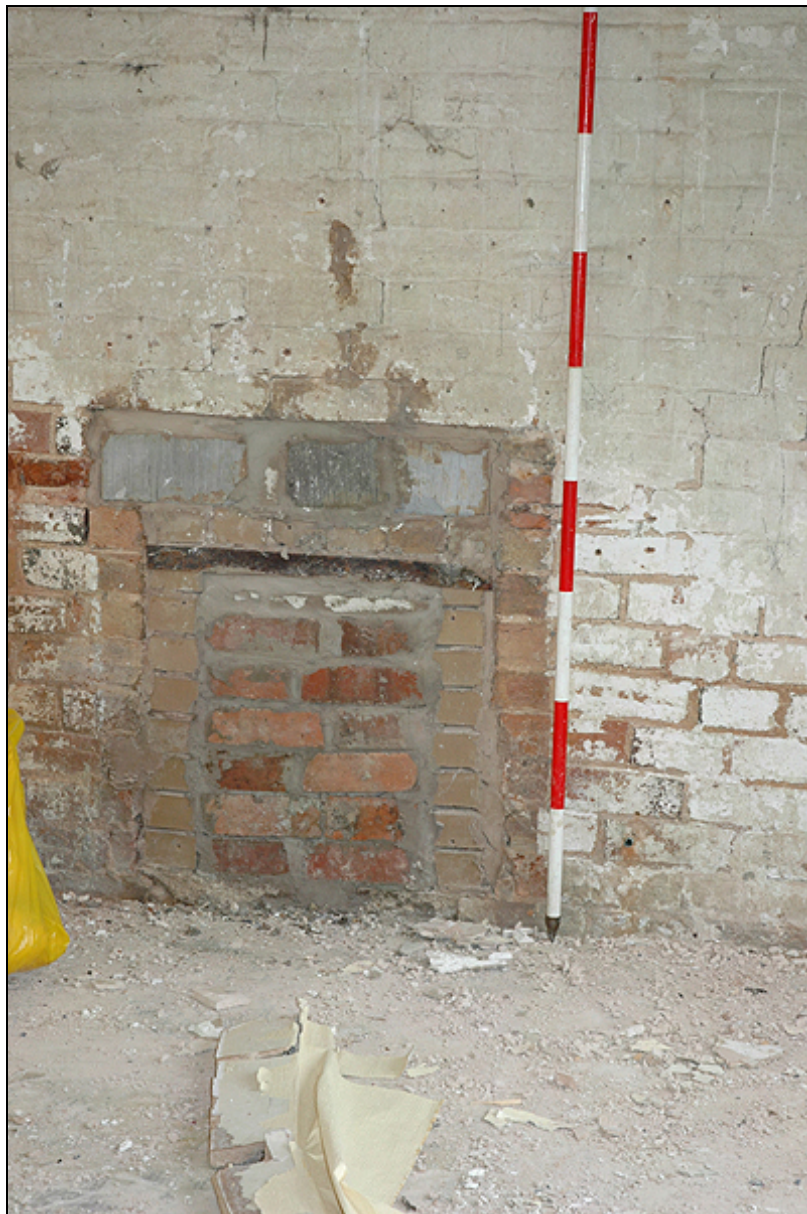
*Plate 8: Position of hearth on interior of c1800 building*

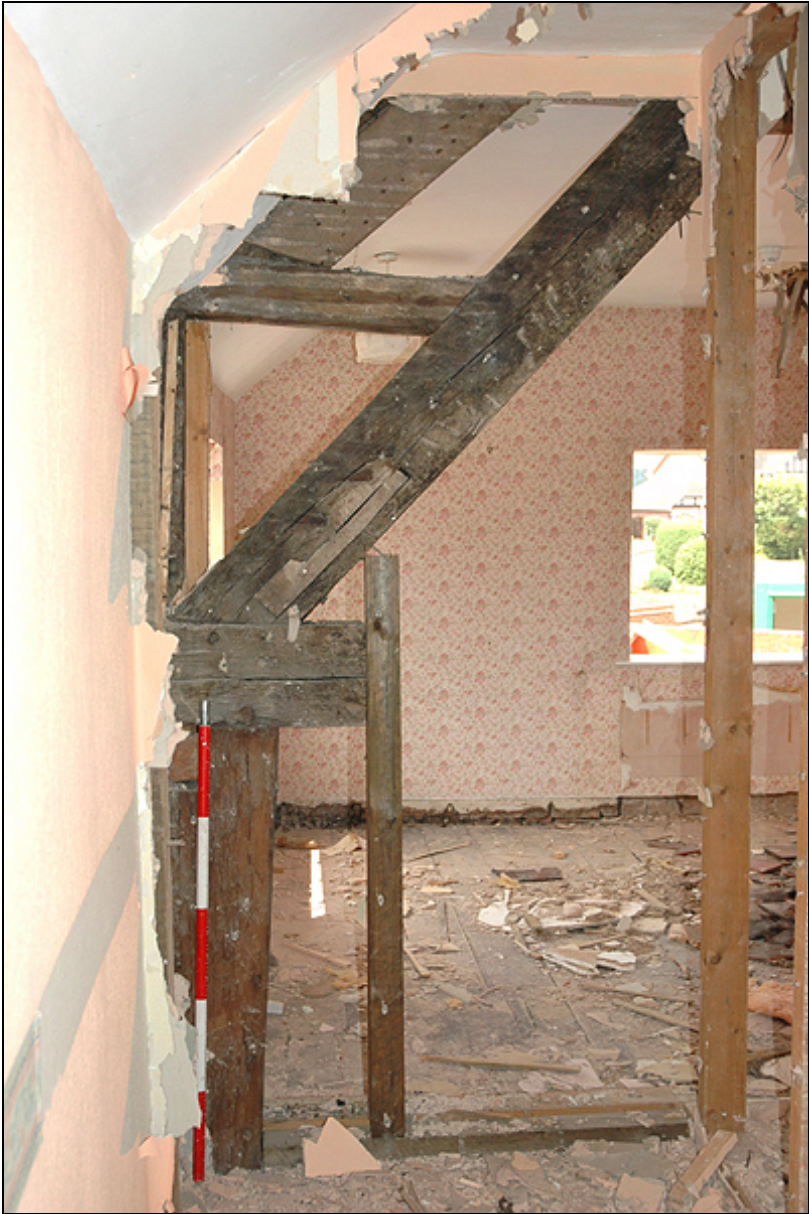
*Plate 10: Room 21, cut off tie beam extending beyond length of principal rafter*

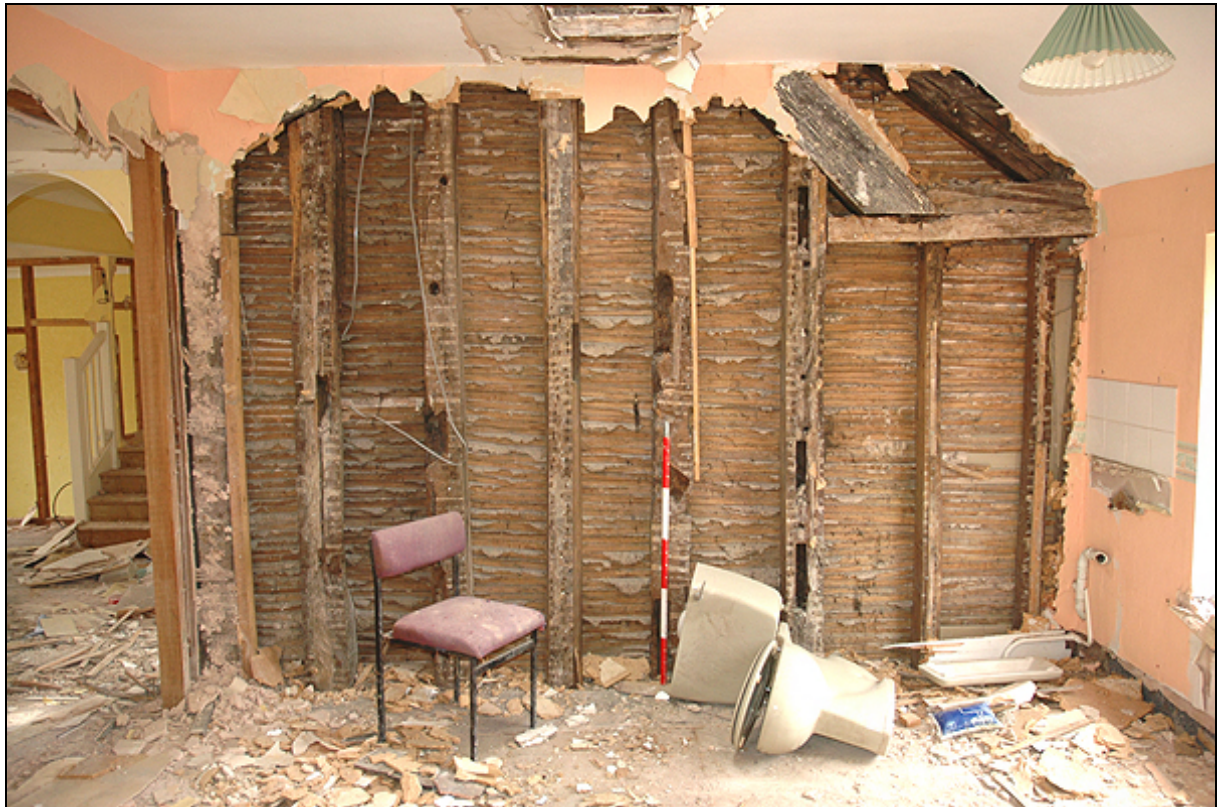
*Plate 11: Room 20 showing c1825 stud partition with reused timbers*

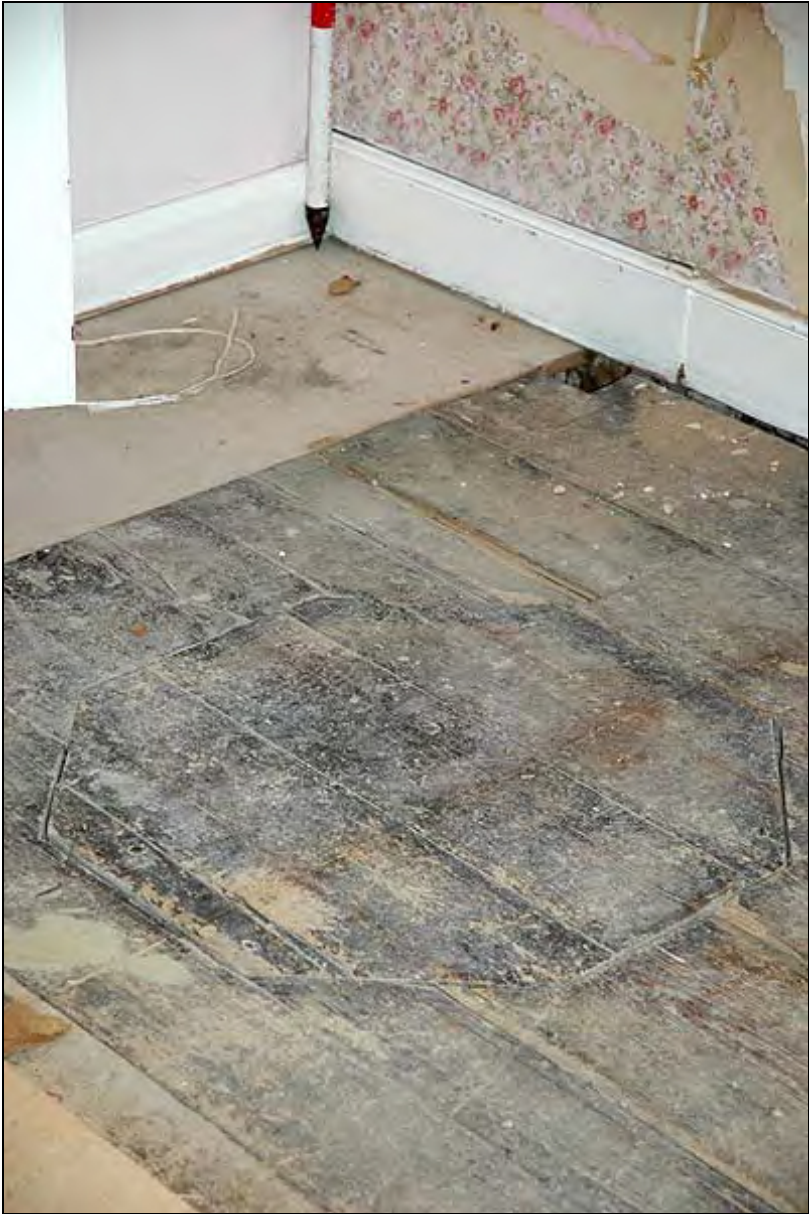
*Plate 12: Hop or grain hole in floor of room 21*

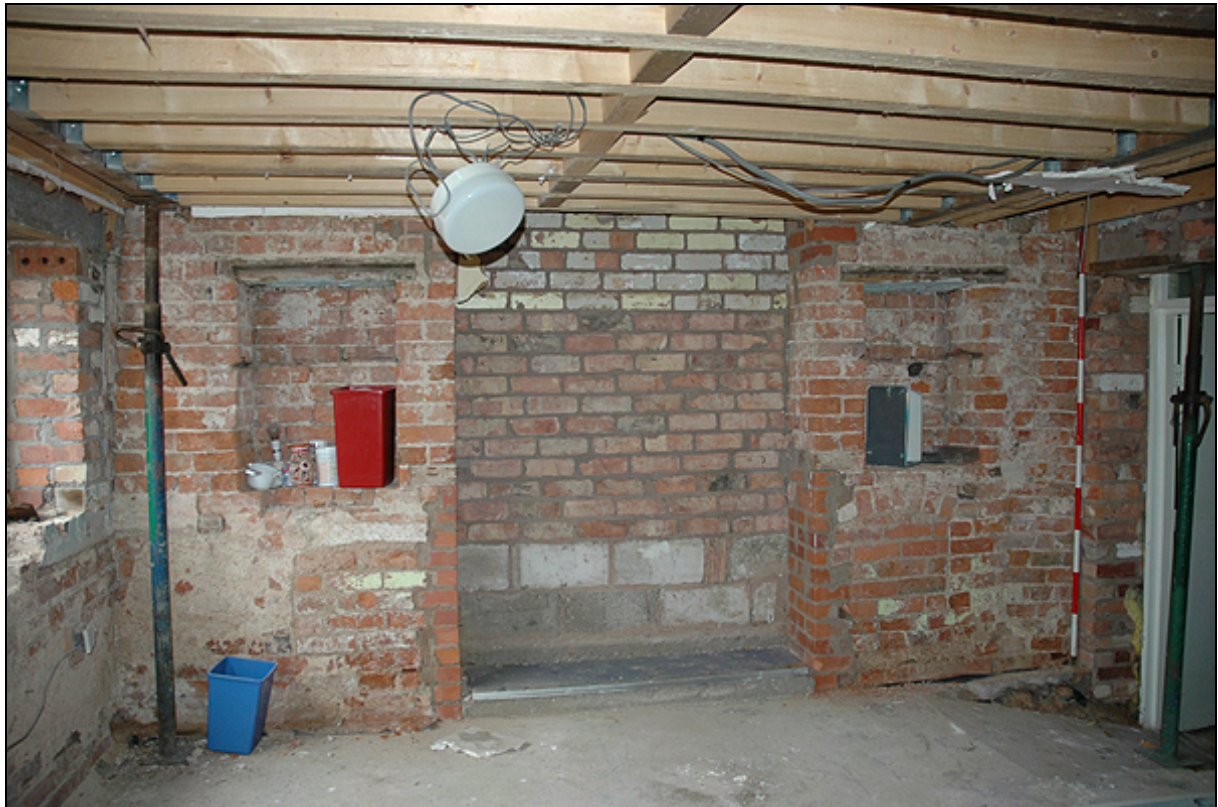
It is probable that at this time the north wall of the original building was also altered. An inglenook fireplace had been created on the ground floor, in room 16 (Plate 13). This had bread ovens on each side of the inglenook opening (Plates 14 and 15).

*Plate 13: Ground floor, room 16, of original phase building, inglenook added c1825*

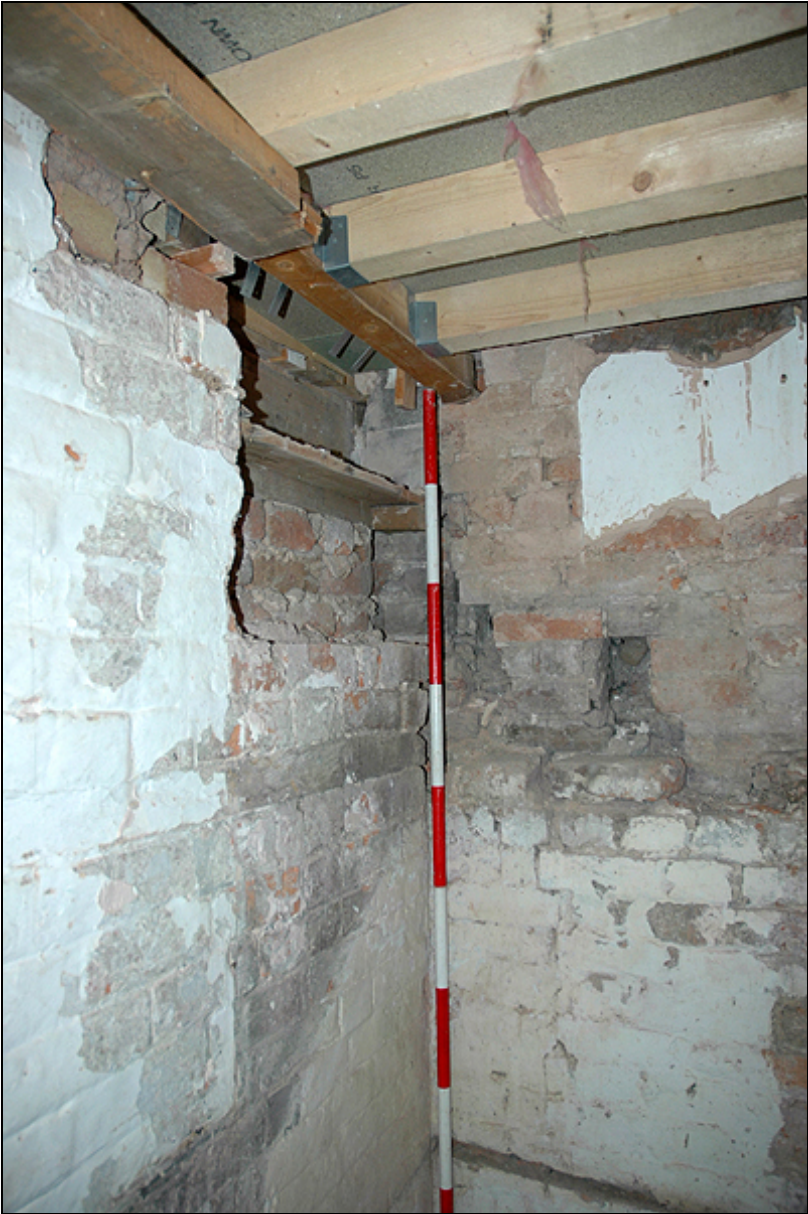
Also at this time a staircase was added into the 16<sup>th</sup> century part of the house. The only evidence for this survived in room 16a, the toilet for room 16 (Plate 17). Where the top stair was still in place. The fixing points were visible in the wall and the line of the staircase could be seen in paintwork.

*Plate 17: Position of former staircase*
