HISTORIC BUILDING APPRAISAL
AT
ST JOHN'S CHURCH,
SUMMERFIELD, HARTLEBURY,
WORCESTERSHIRE

2 July 2007

Project 3016
Report 1548
WSM 36106

Historic building appraisal at St John's Church, Summerfield, Hartlebury, Worcestershire

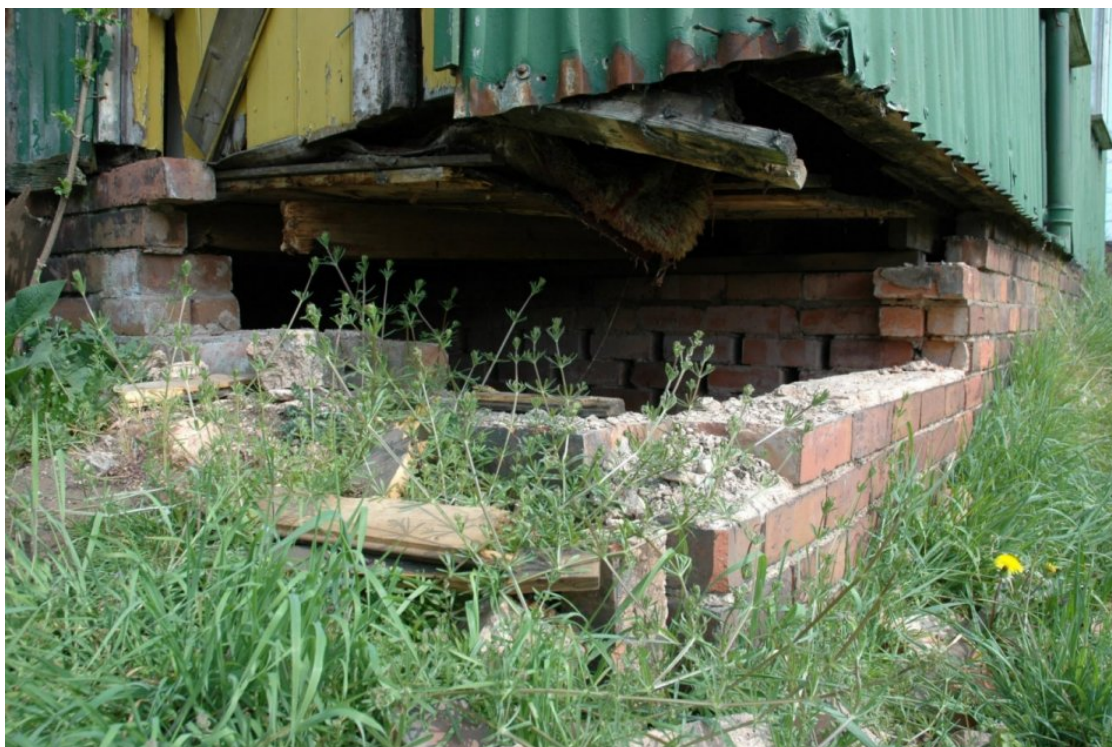
The building is constructed of a brick plinth of English garden wall bond varying from three brick courses at the south-east corner to fourteen at the north-west, is built directly onto earth, and supports the timber frame of the building (Plate 4). The frame is clad in corrugated iron sheets, of variable size depending on location on the building but generally of 0.60m width (8 or 9 ridges). The corrugated sheets reach to the roofline, with additional sheets above at the gable ends, and are cut to fit around the windows (Plate 5). Fixing of the sheets to the frame consists of dome headed metal nails with washers, generally three equidistant along the length of the sheet at every fourth ridge (Plate 6). Around the windows fixture is adapted to the shape of the window and nails without washers are used. The roof covering is also of

The interior walls and the ceiling are of painted tongue and groove timber boarding with timber floorboards throughout the main church (not including the western addition). The walling and floorboards are consistent and seem contemporary with the original construction of the building (Plates 17 and 18). The floorboards are nailed, by metal nails, to floor joists running east to west across the building. The joists are supported on at least one further brick plinth, which appears to run the length of the building (Plate 19), although only a small part of the under floor area was exposed and not accessible. Some of the flooring in the south-western corner and along the western side of the main hall has been damaged by the collapse of part of the brick plinth here (Plate 4).

Plate 4 Support for timber frame

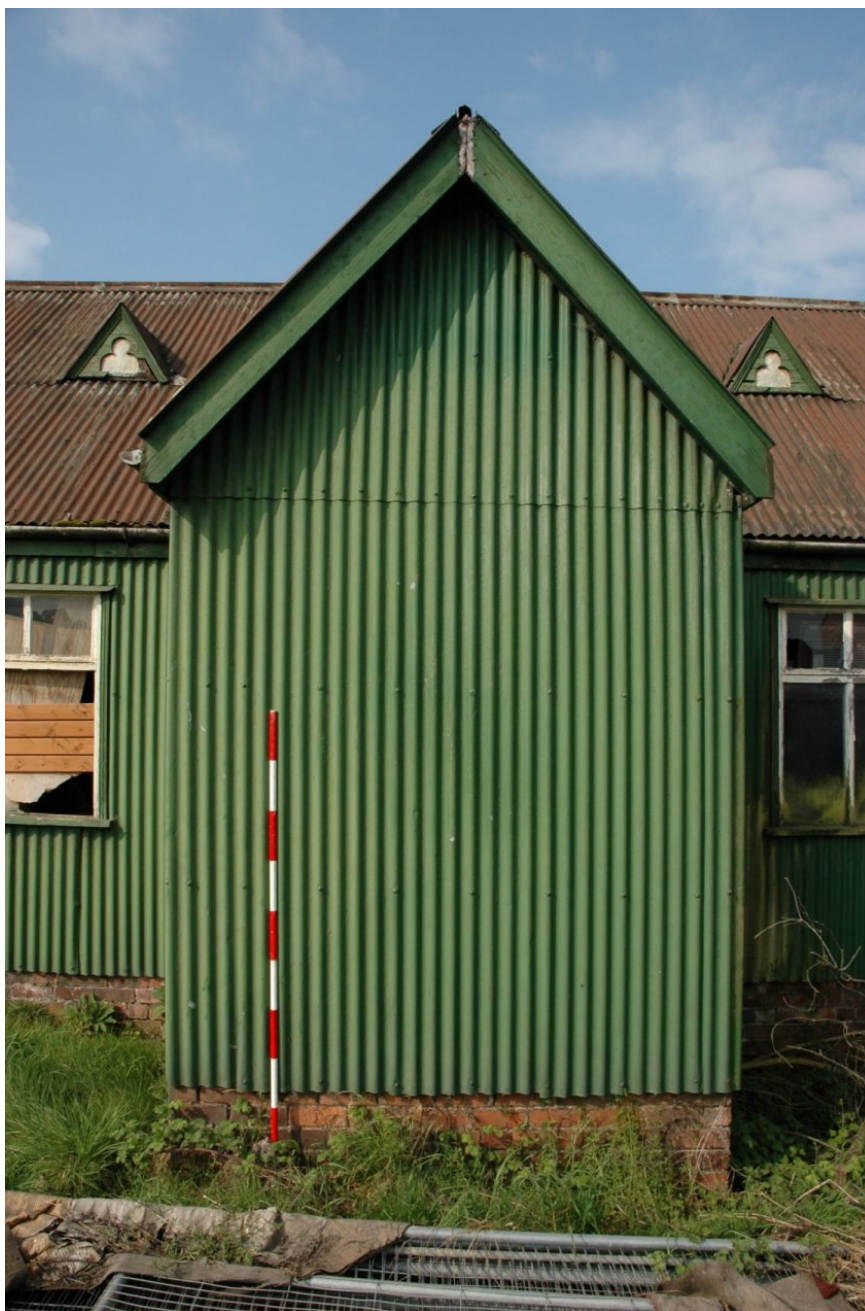
The style of the four windows in the east wall coincide with that of the large north window and those in the alcove projection (Plates 12 and 13). The five windows in the west wall and the three in the south coincide and appear to be of a more modern design in comparison (Plates 14 and 15). The east door is timber of four panels, and probably a recent replacement, with a stone step, the west door is dilapidated but appears to have been originally of timber boards (Plate 16), as do the two doors of the western addition. In the southern gable a square timber-framed window is visible (now boarded over; Plate 15) and at a similar height, within the east and west roofs, are four triangular dormer-style ventilation holes, now blocked but originally of a cusped design still visible in three of them (Plate 5).

Plate 5 Example of sheeting for gable ends, from east

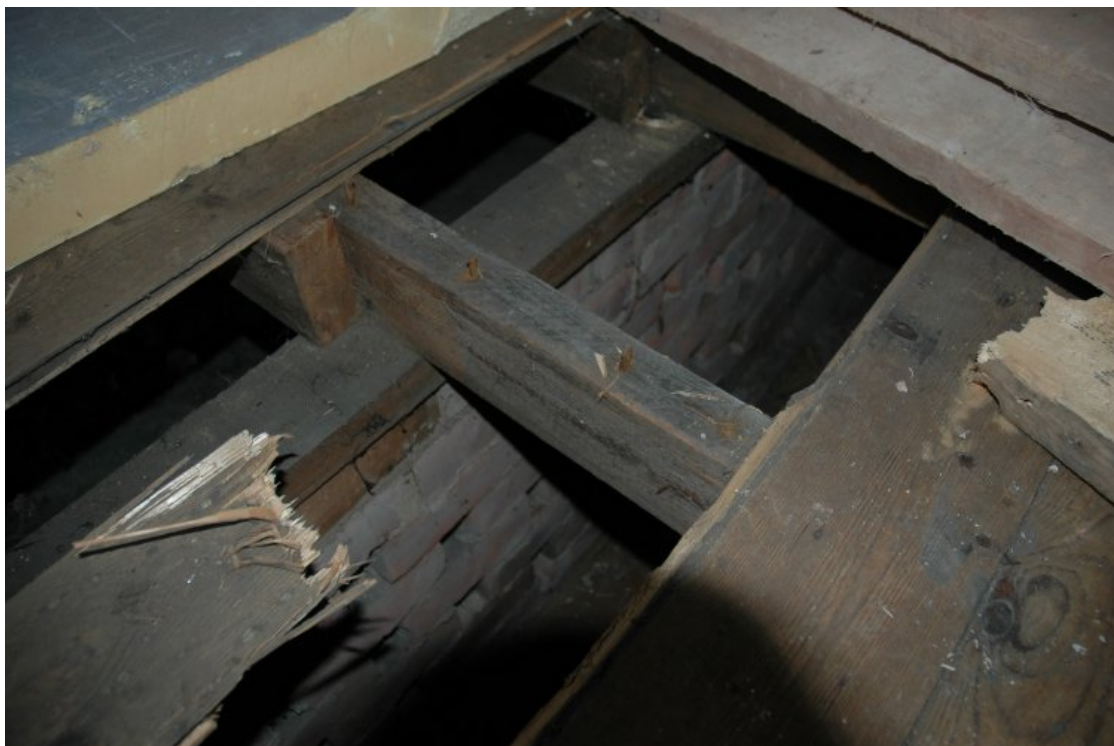
Plate 19 Joists supported on brick plinth

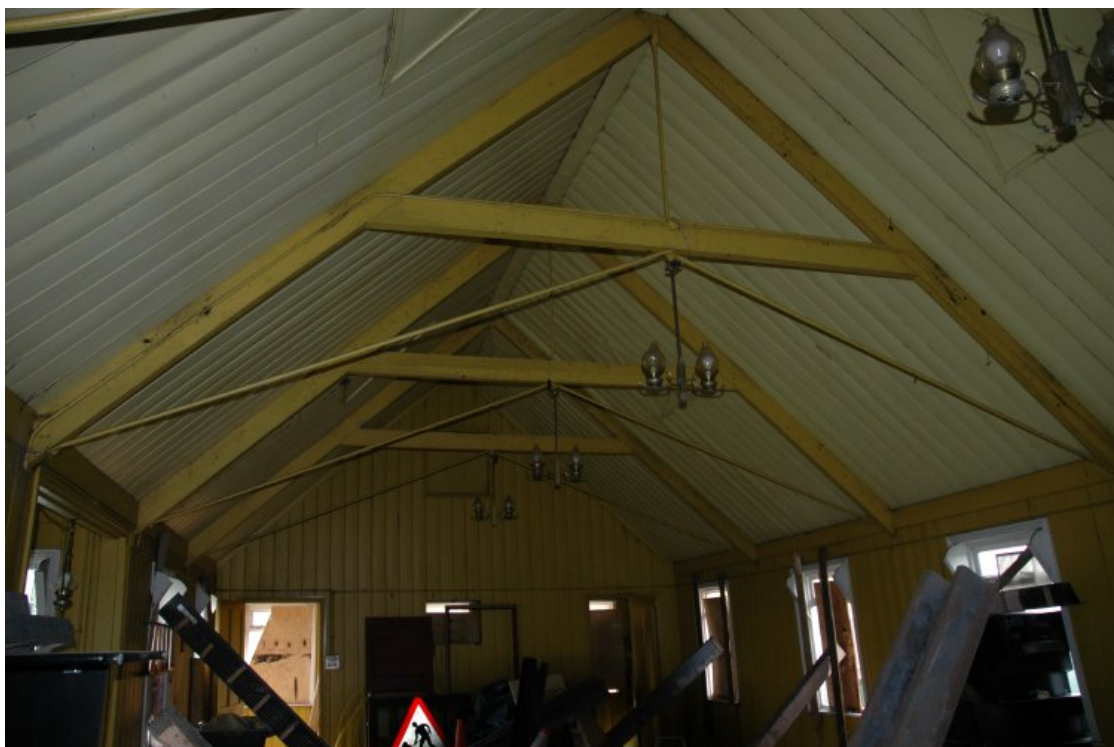
Each of the four exposed roof trusses consists of two principle rafters and a collar beam of timber with a vertical metal rod secured to the rafters at the ridge by two metal bolts and to the collar beam by a third bolt which also secures two horizontal metal rods to the collar beam (Plate 20). Each of these horizontal rods is attached to the top of the east and west walls (presumably through the panelling to the timber frame) by a further metal bolt (Plate 21). The trusses at the north and south gable ends are not exposed.

Plate 20 Trusses facing south

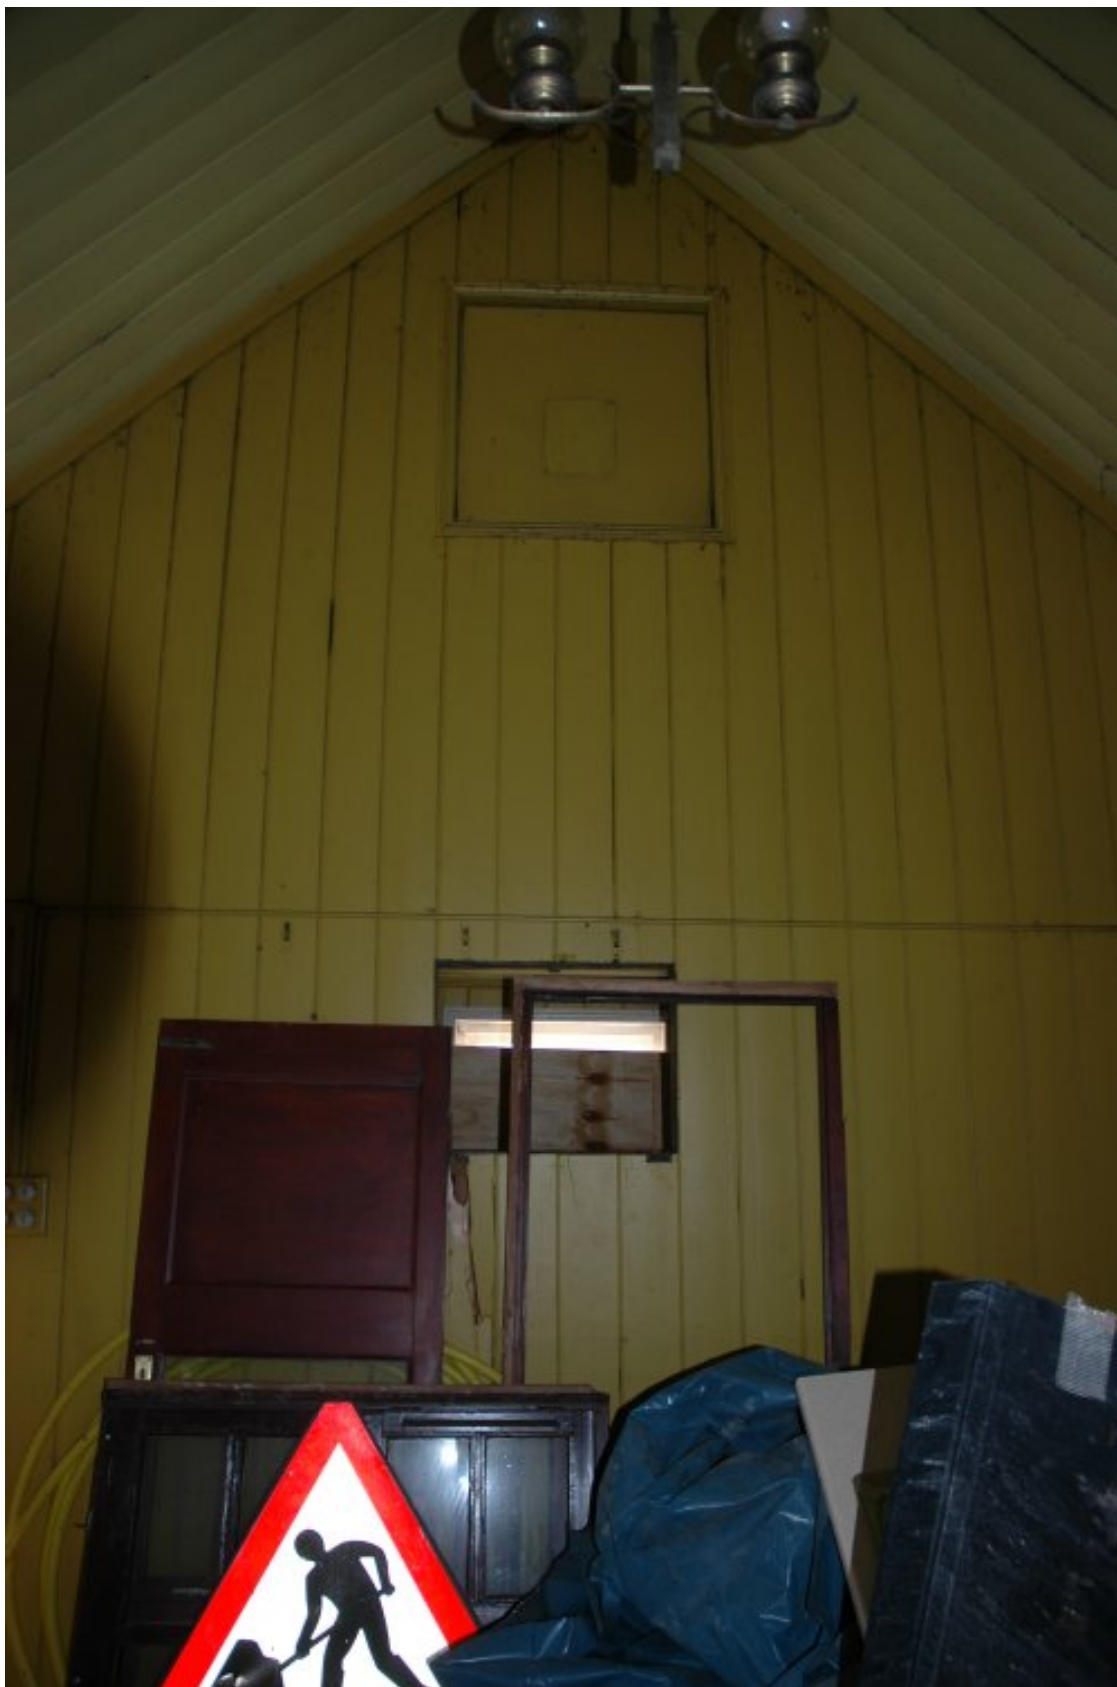
Plate 27 Blocked window in south gable

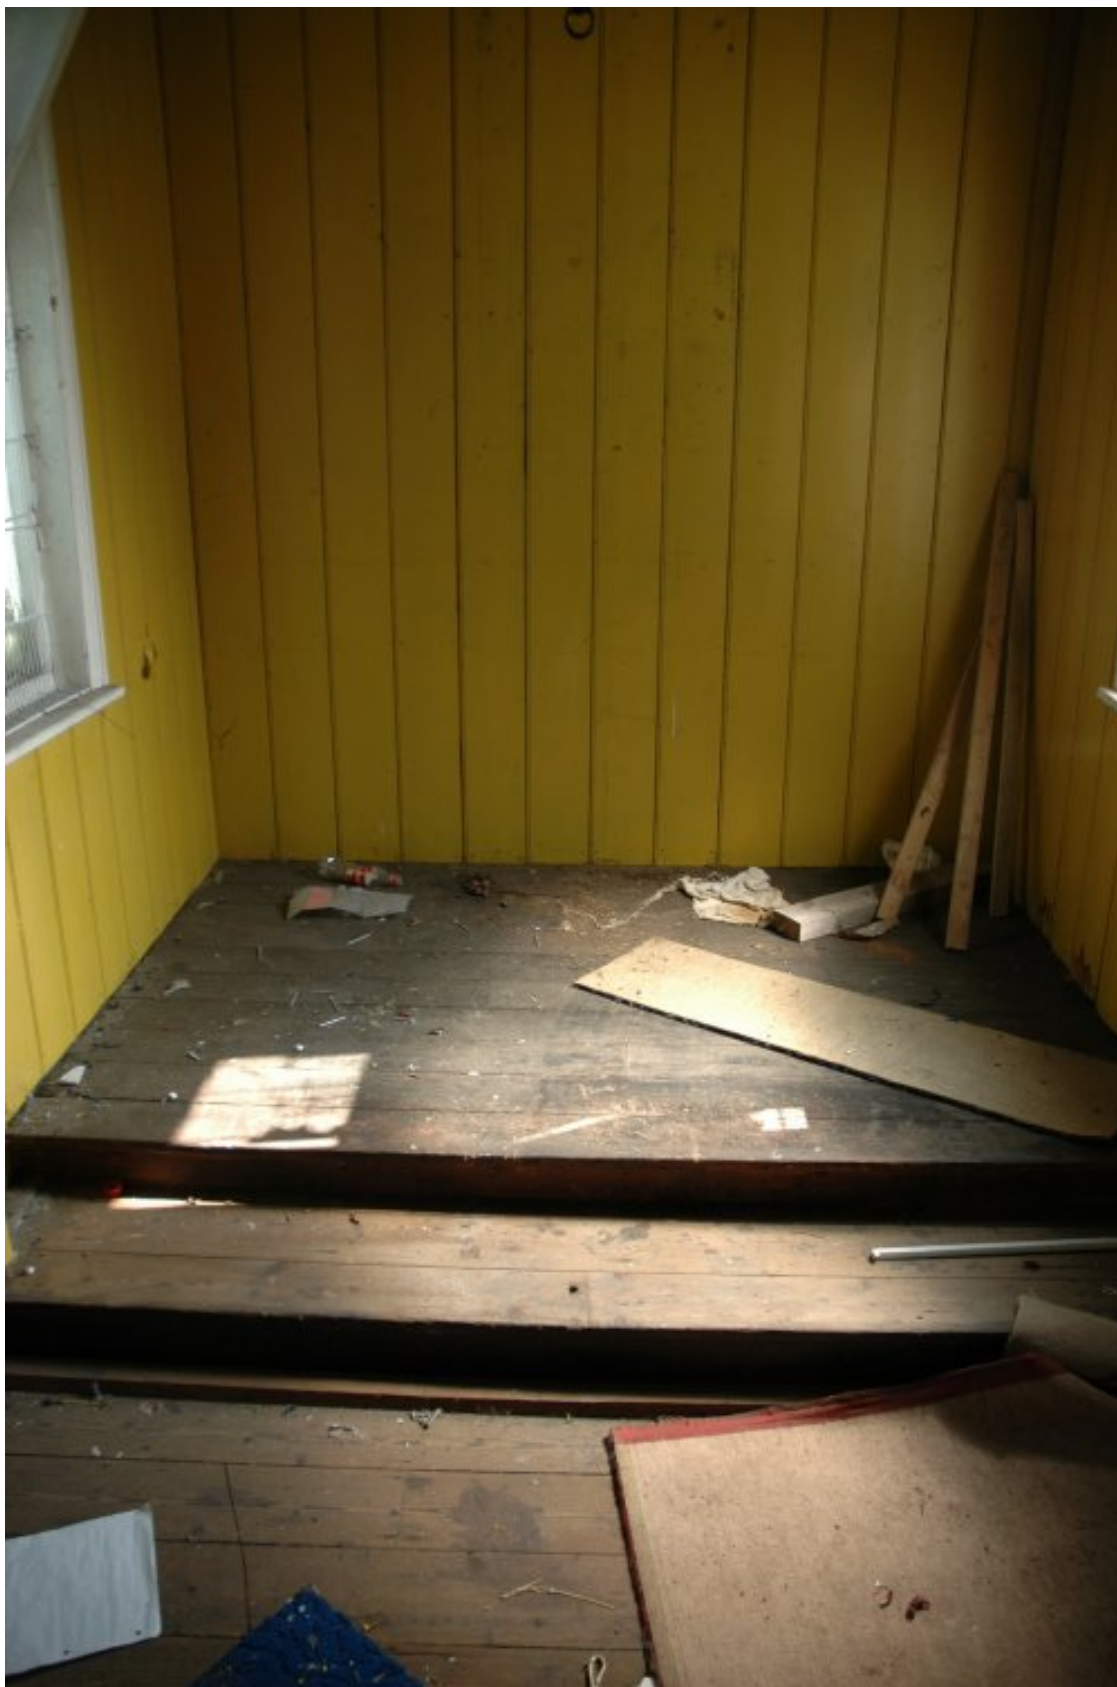
The alcove is rectangular with windows to north and south and two steps leading up from the nave with a wooden moulded surround to the entrance. On top of the first step, at approximately the mid-point is a small circular hole, probably made for a vertical bolt, and associated scrape marks in the floorboard (Plates 29 and 30). These suggest that the alcove was at one point divided from the nave by a pair of doors, probably one of which was ill-fitting, secured by a bolt. In the timber at the roof ridge four regular circular holes have been made and from one now hangs an electric light.

Plate 29 Bolt hole in alcove floor

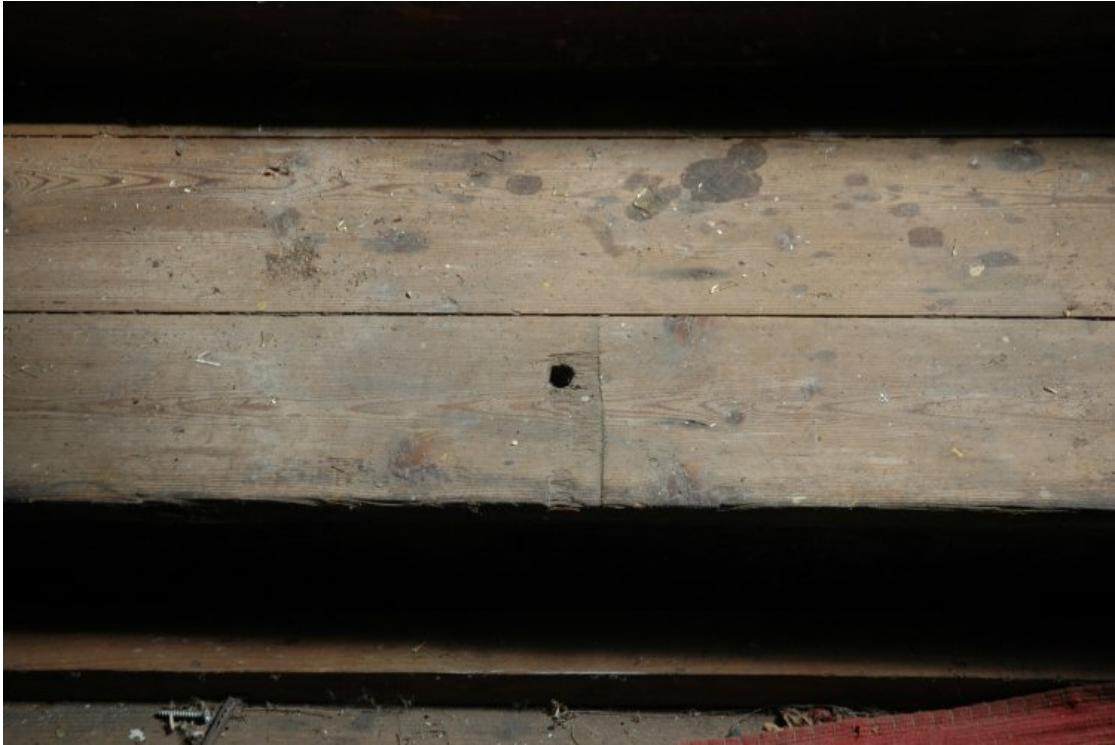
Plate 30 Bolt hole in alcove floor
