HISTORIC BUILDING  
RECORDING  
AT  
COURT FARM, HANLEY CHILD,  
TENBURY, WORCESTERSHIRE

27 July 2007

Project P3066  
Report 1561  
WSM 37302

## **Historic building recording at Court Farm, Hanley Child, Tenbury, Worcestershire**

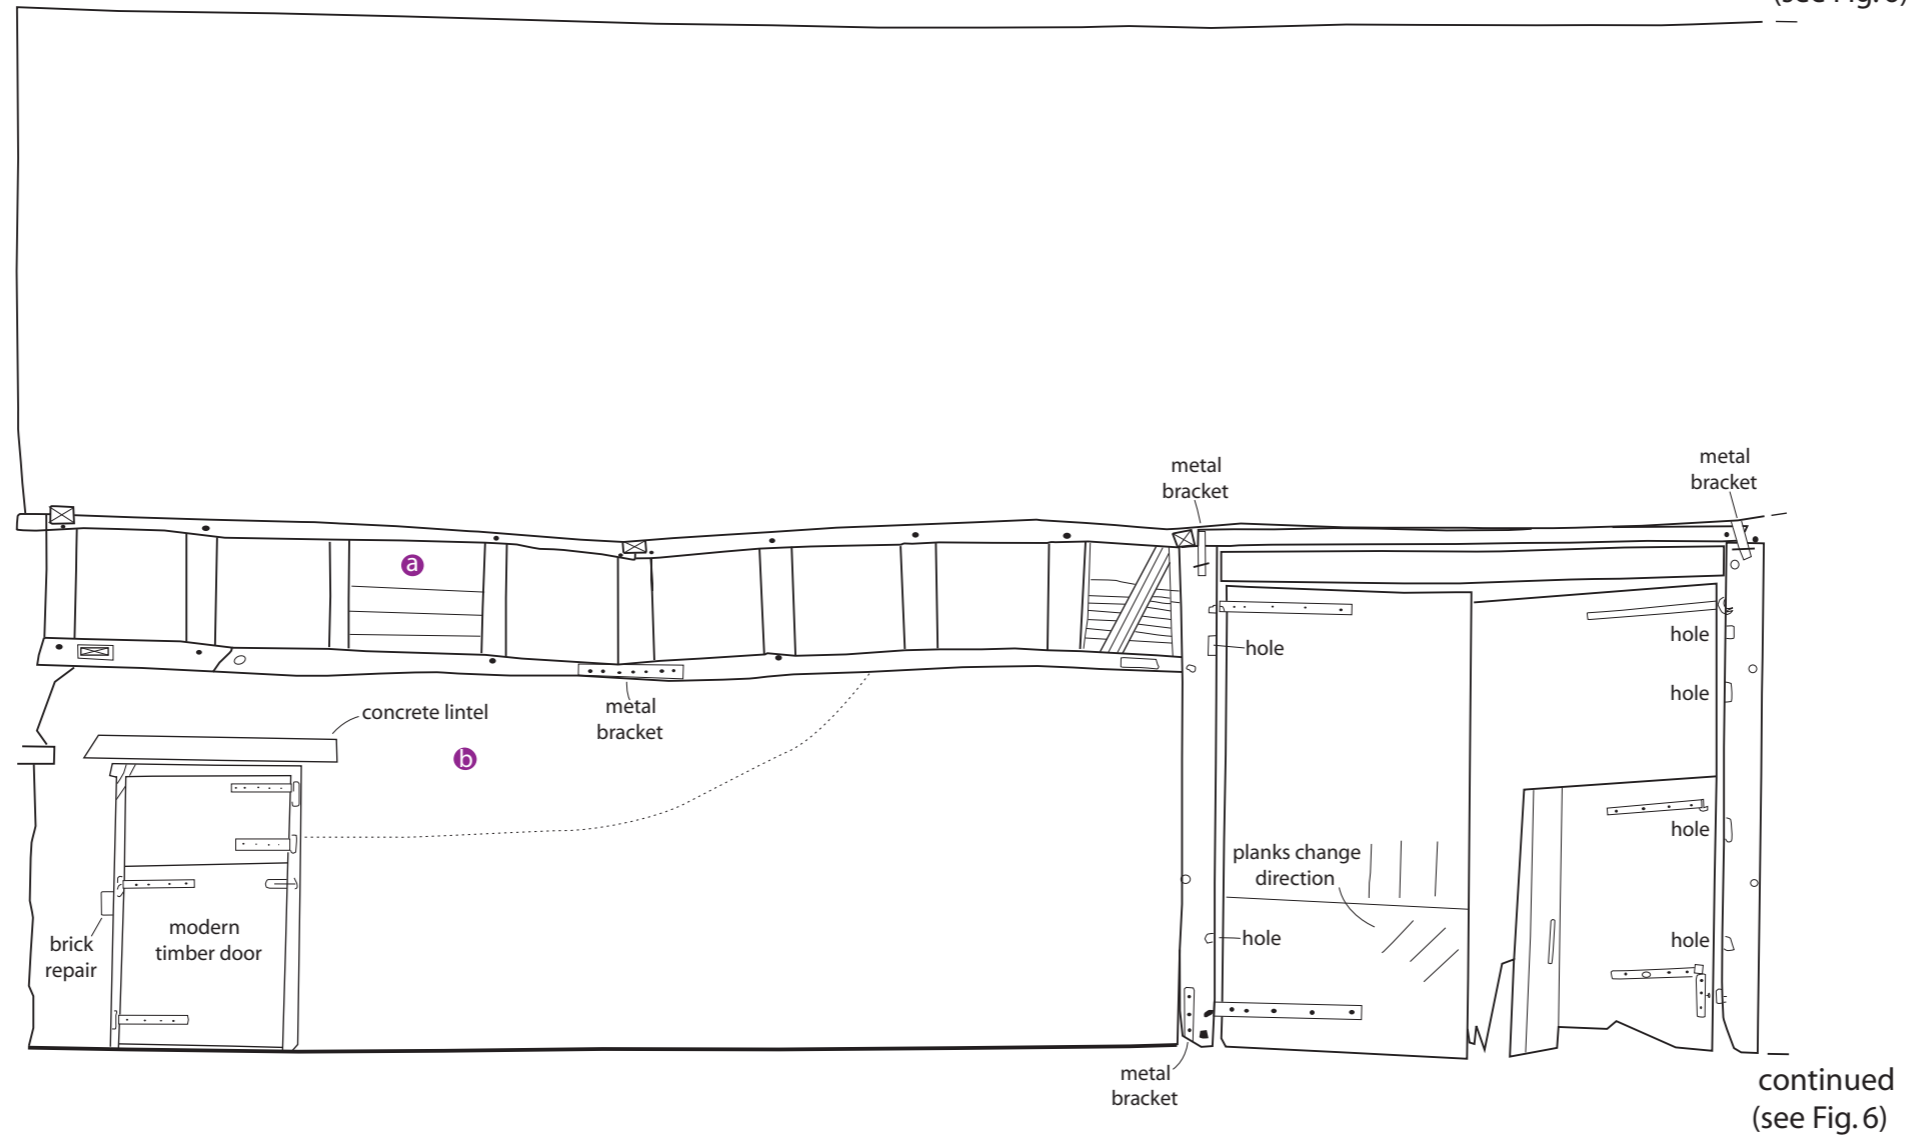
Figure 5

- KEY
- a** Where boarding missing, timber unpainted and unblackened and evidence of original wattling.
  - b** The stonework of the upper level of this wall differs from the rest. It includes stone other than red sandstone, tile and brick within an orange coloured mortar

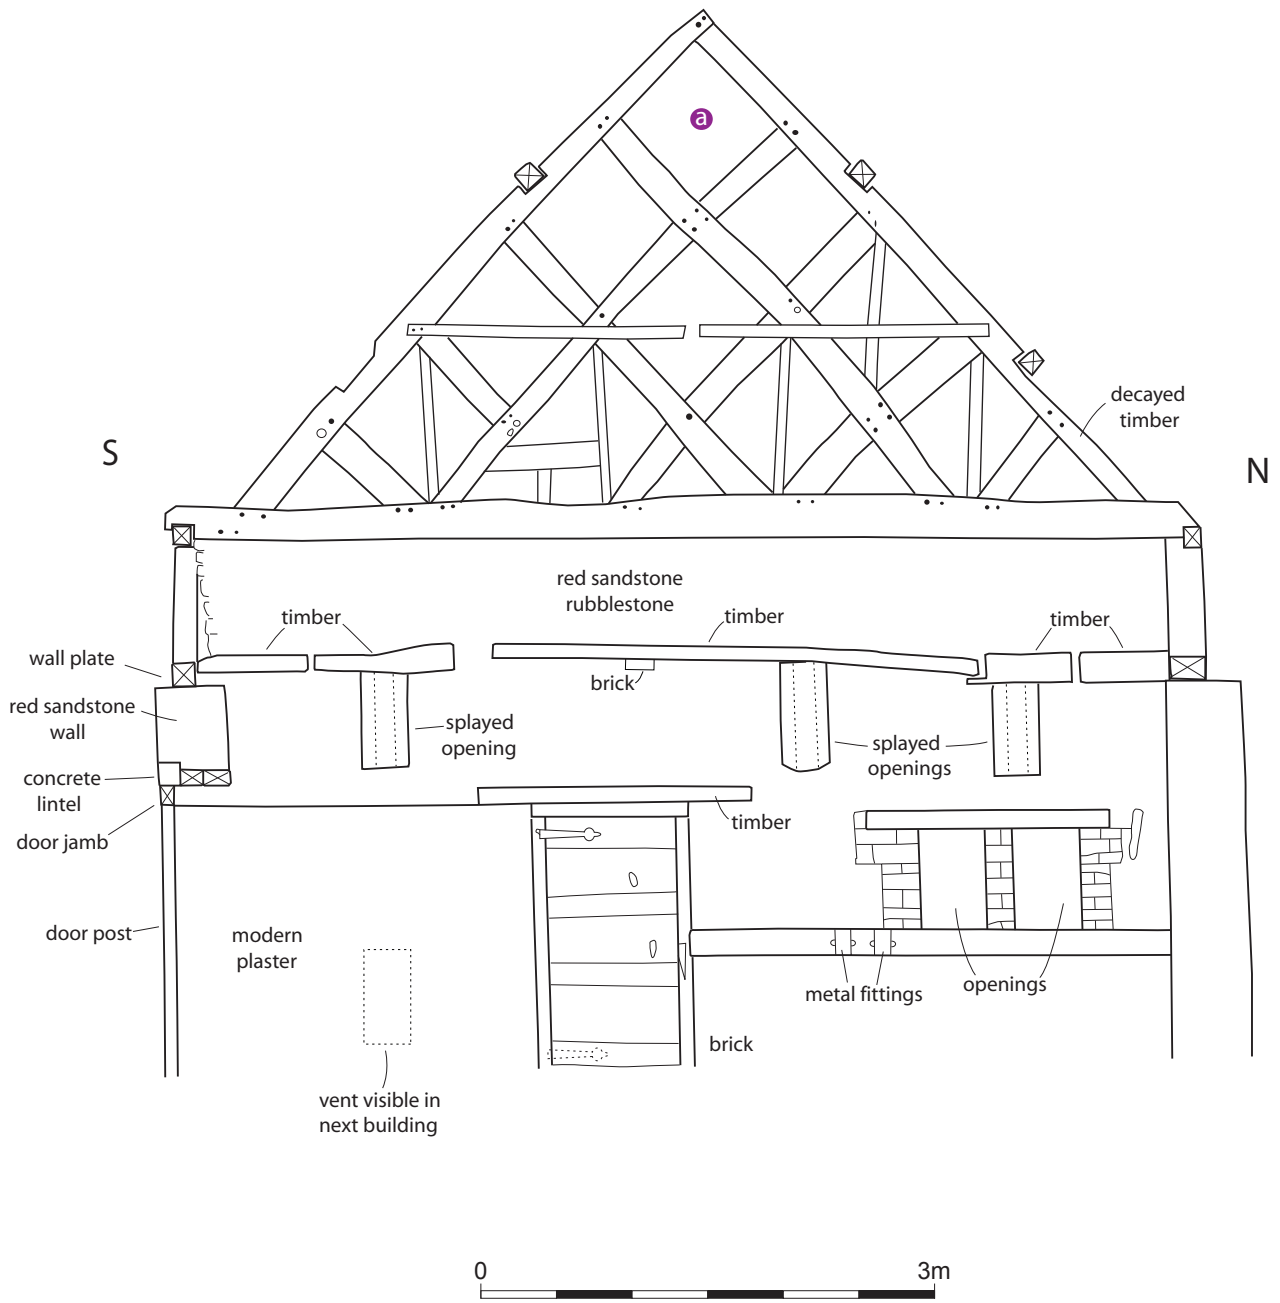
*Figure 13*

**a** Timbers show auger holes in each panel, evidencing earlier wattling within the panels.

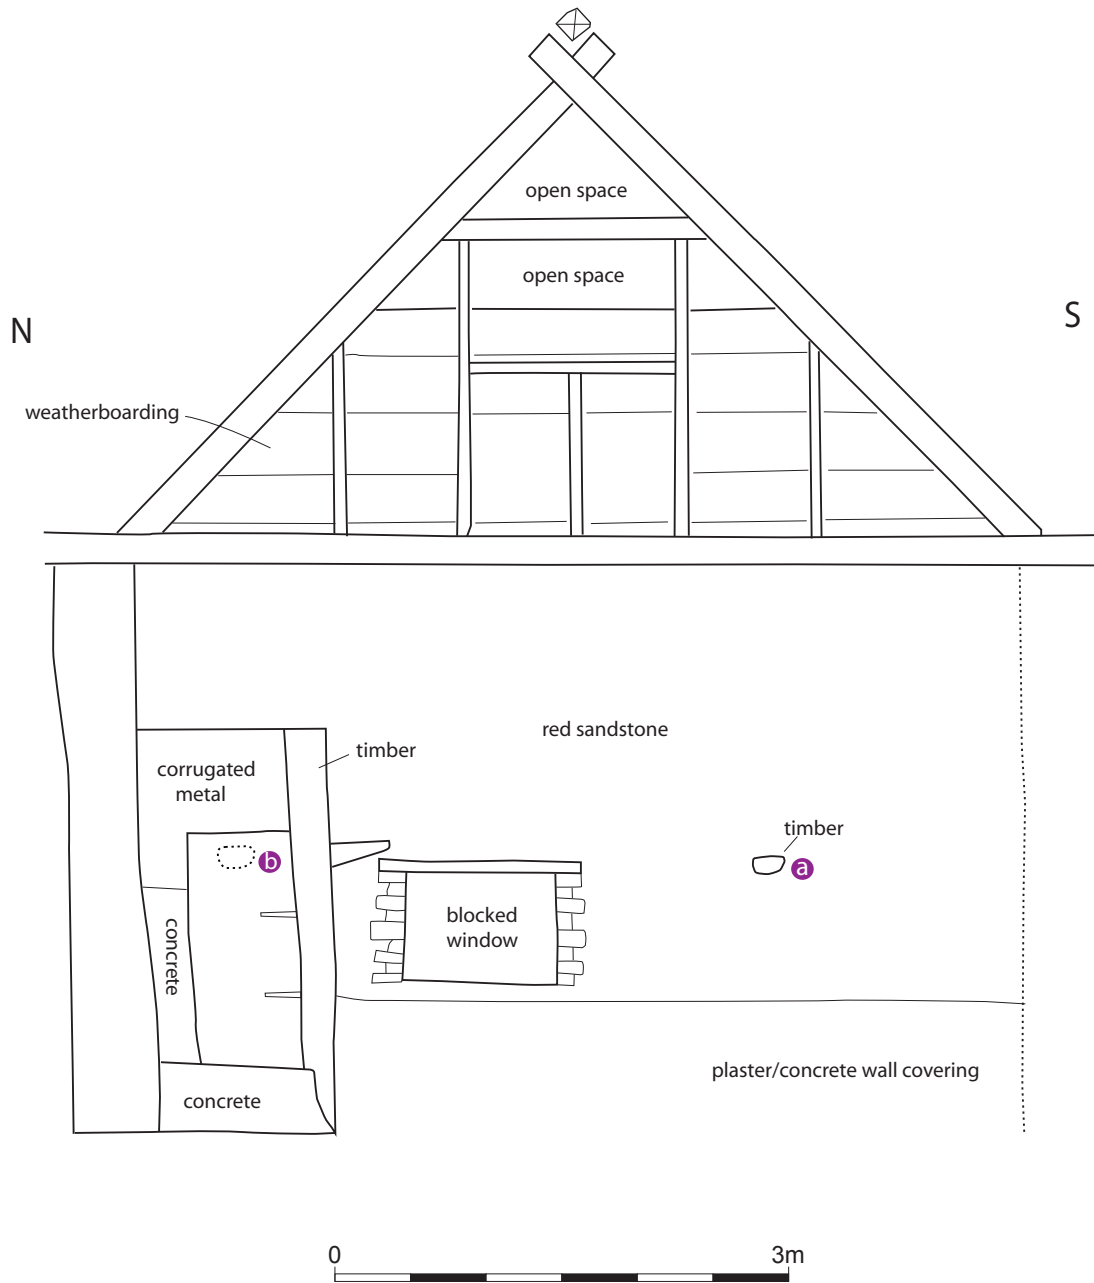
*Figure 38*

KEY	
<b>a</b>	timber corbel in wall
<b>b</b>	timber corbel visible in wall inside store room

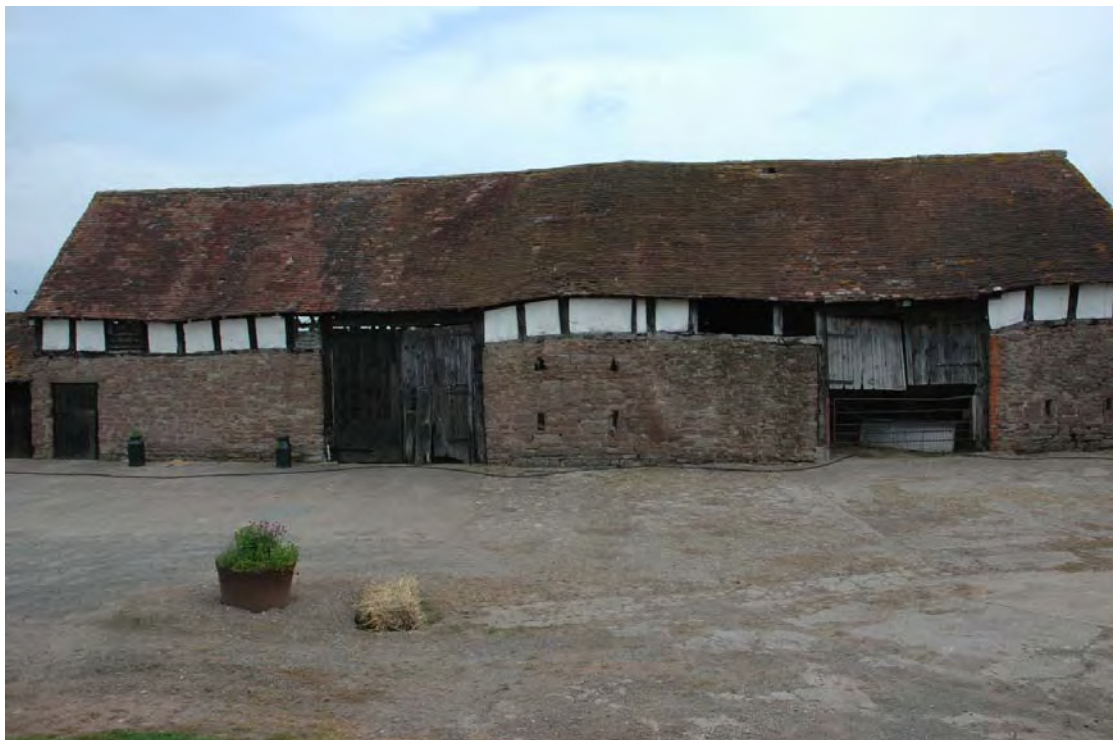
**Plate 4: The Barn, south elevation**

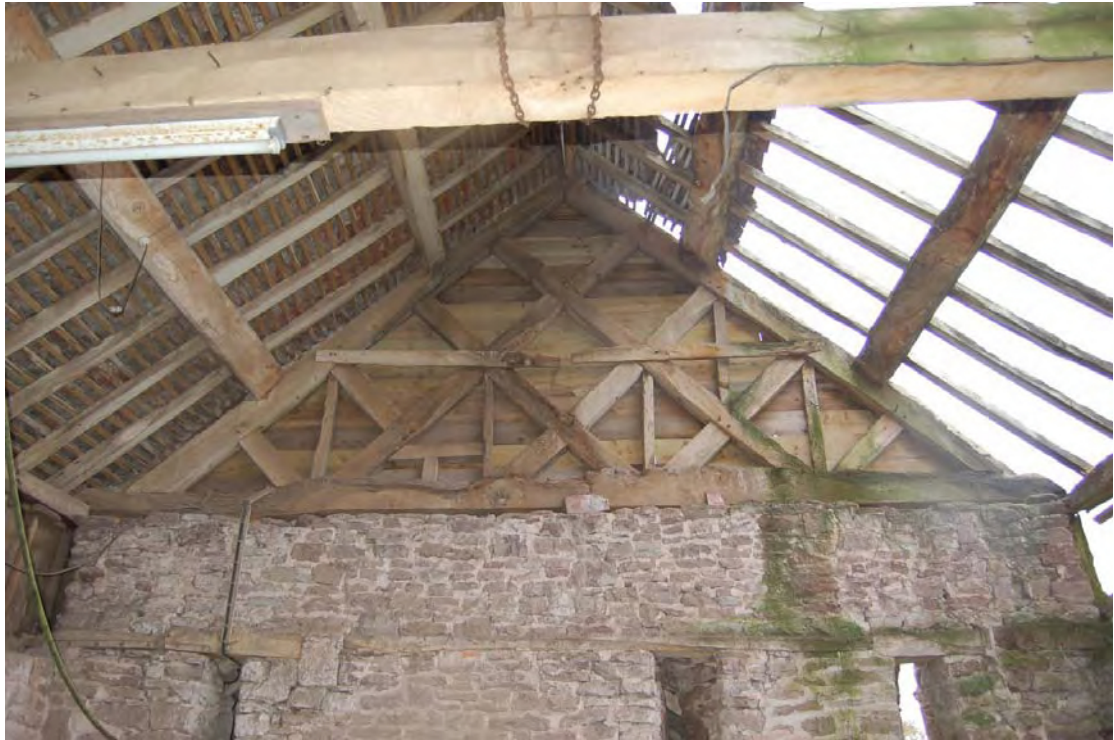
**Plate 7: The Barn, east end showing diamond panelling. Auger holes in the panels show that original wattling has been removed.**

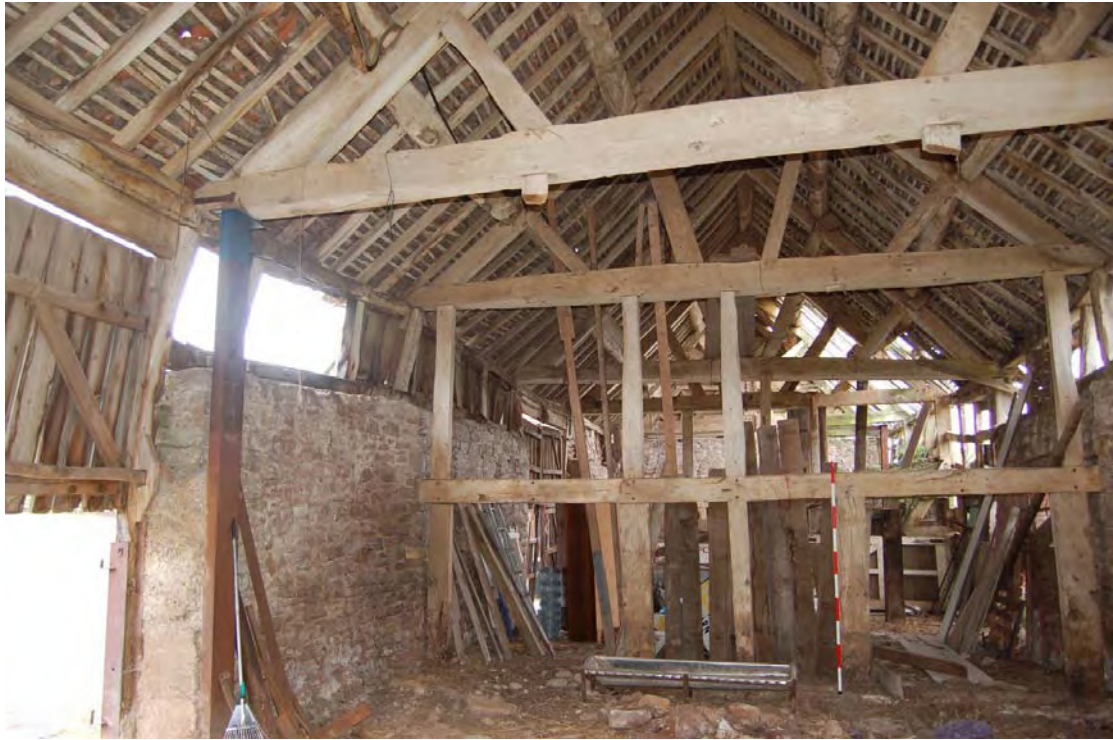
**Plate 11: The Barn, evidence of original divisions of barn into bays (see remains of lower timbers below truss in foreground)**

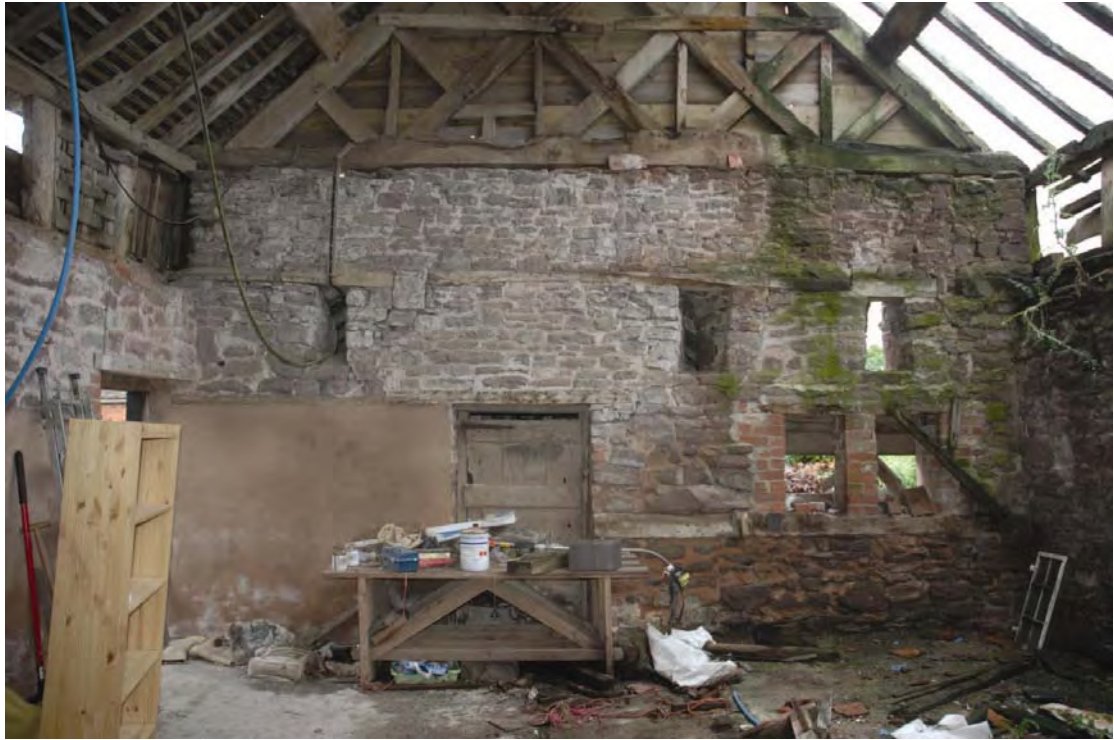
**Plate 13: The Barn, eastern wall with small central door**

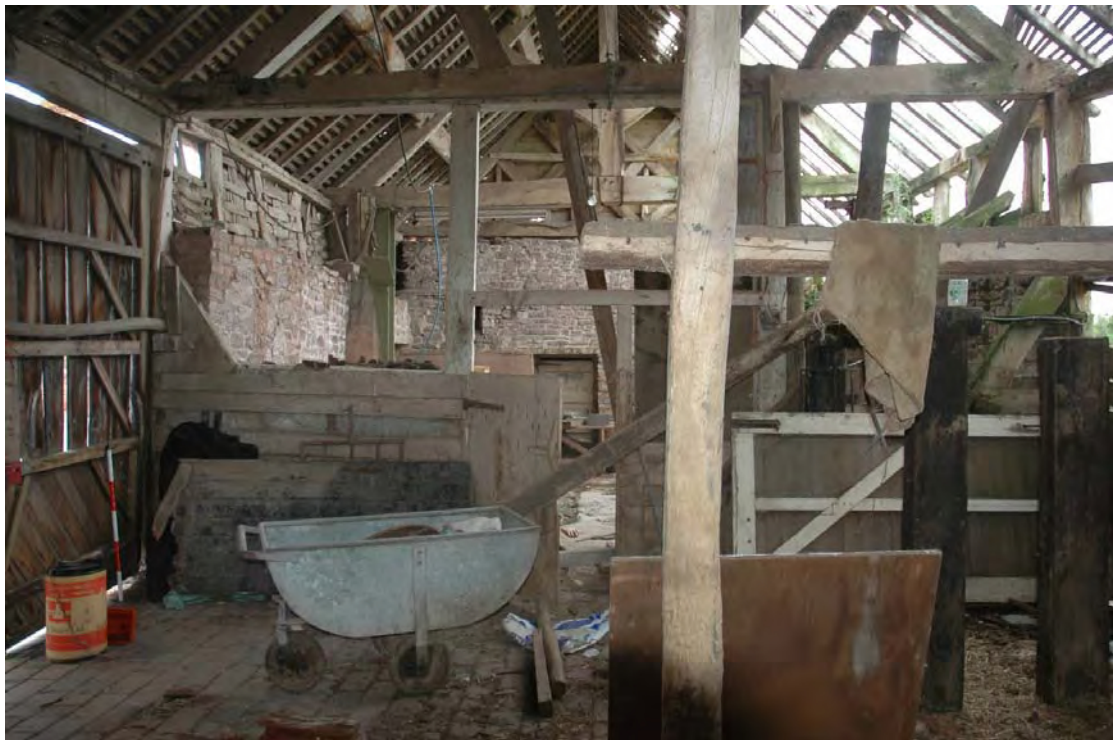
**Plate 14: The Barn, Truss 2 with boarding and door of division across barn.**

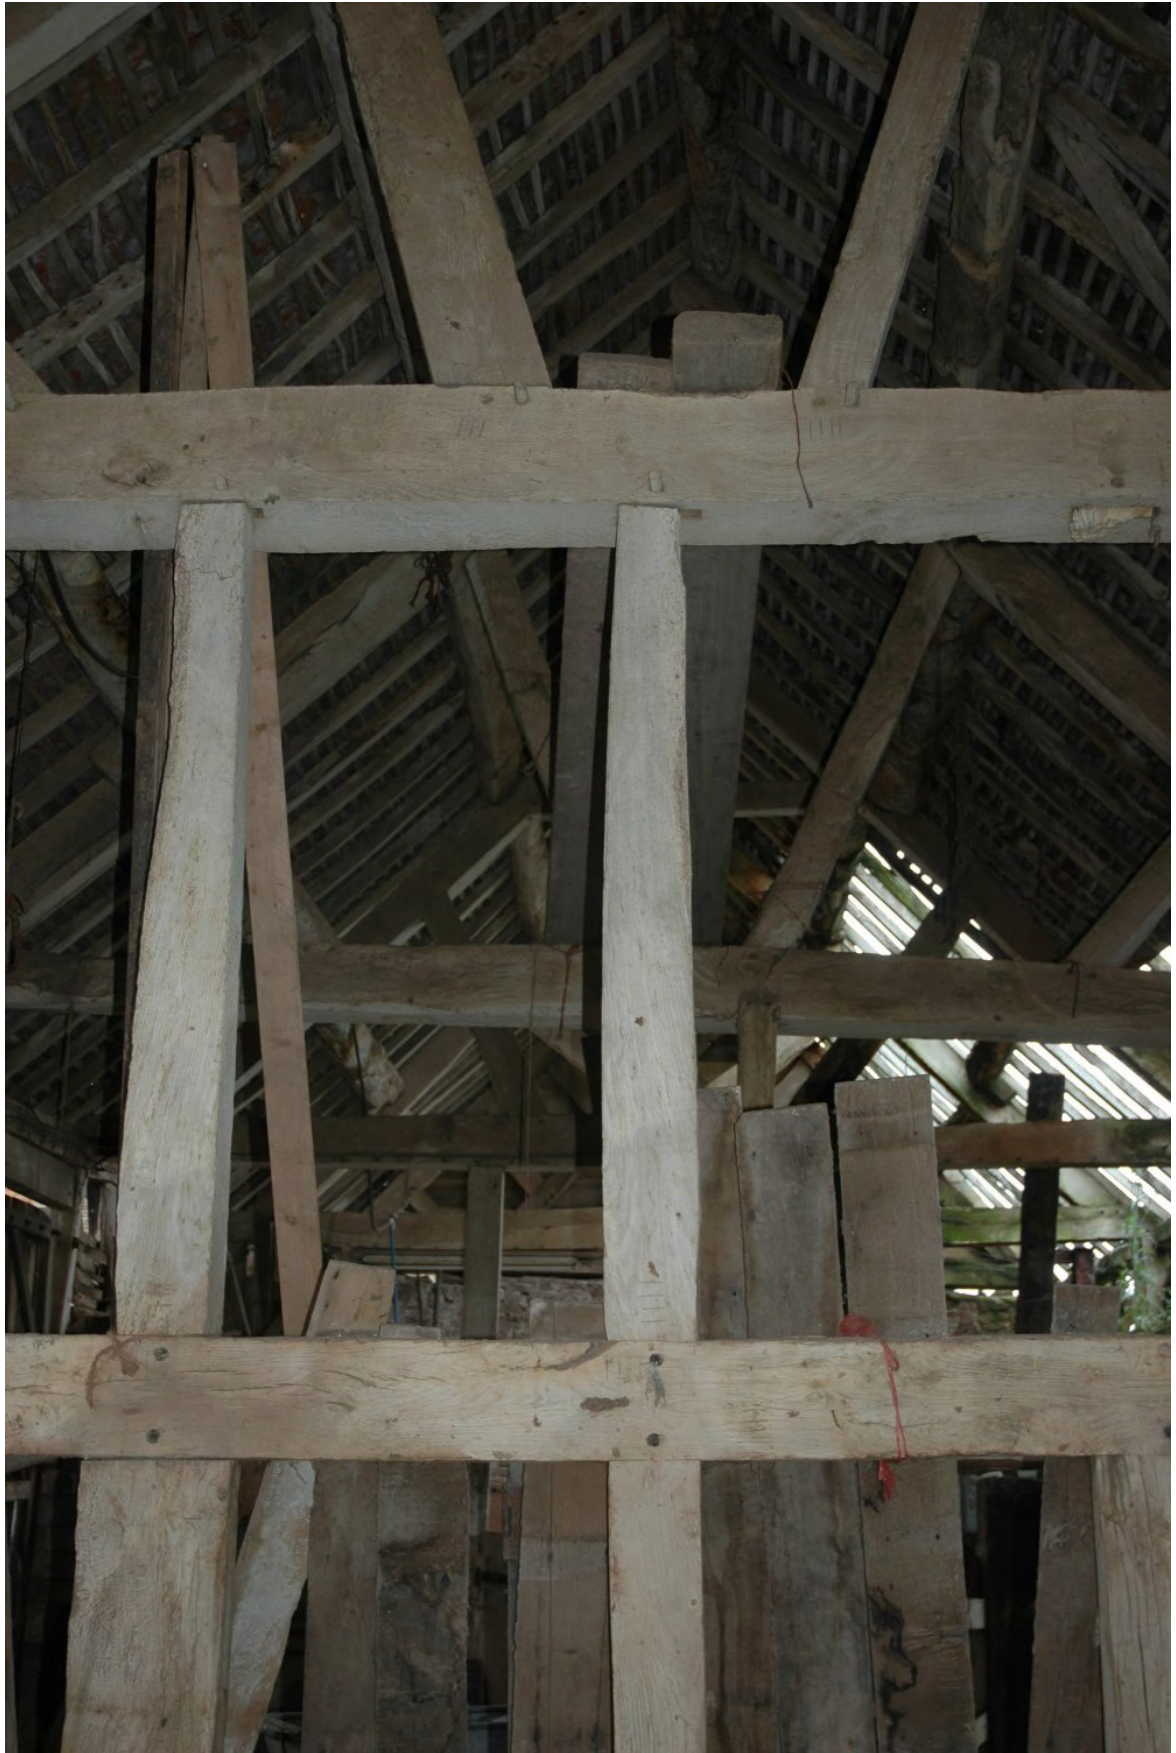
**Plate 15: The Barn, Truss 4 and carpenter's marks**

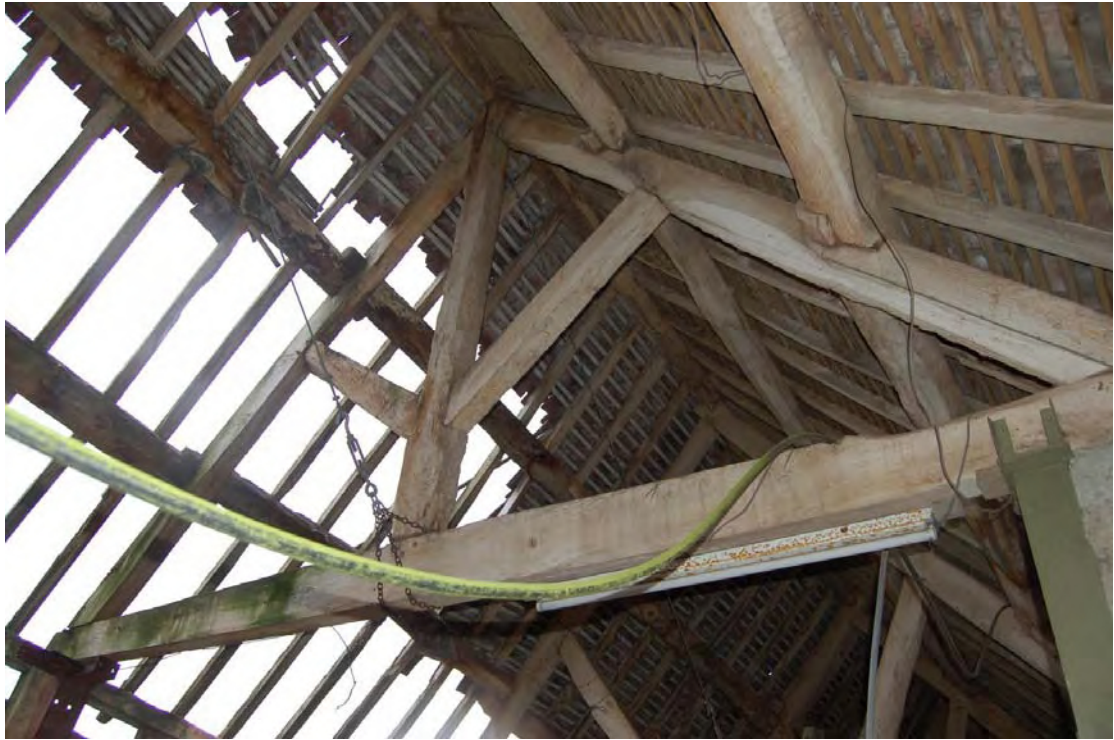
It may have been also during this phase that the original roof truss of Truss 1 was replaced with the later king post type, which was generally adopted in the 18<sup>th</sup> and 19<sup>th</sup> centuries (Harris 2003, 85).

**Plate 16: The Barn, Truss 1, King Post.**

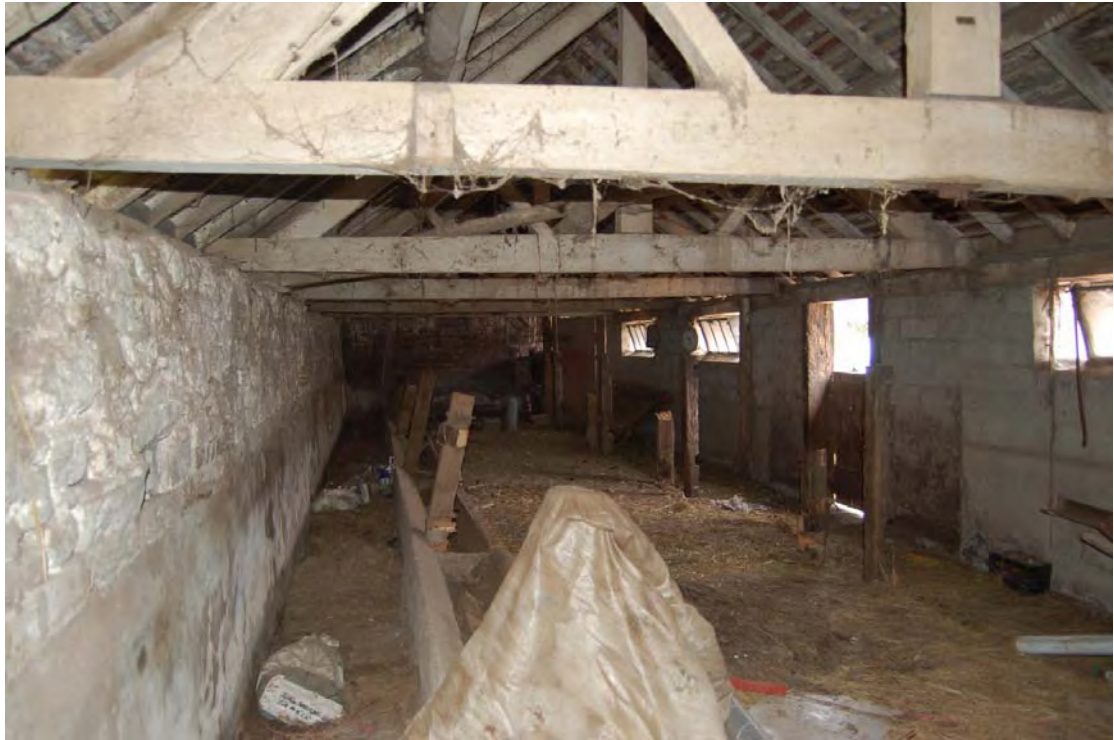
**Plate 20: The Animal Shed, Room C, looking south east showing remains of the posts of stalls and a trough running down the building.**

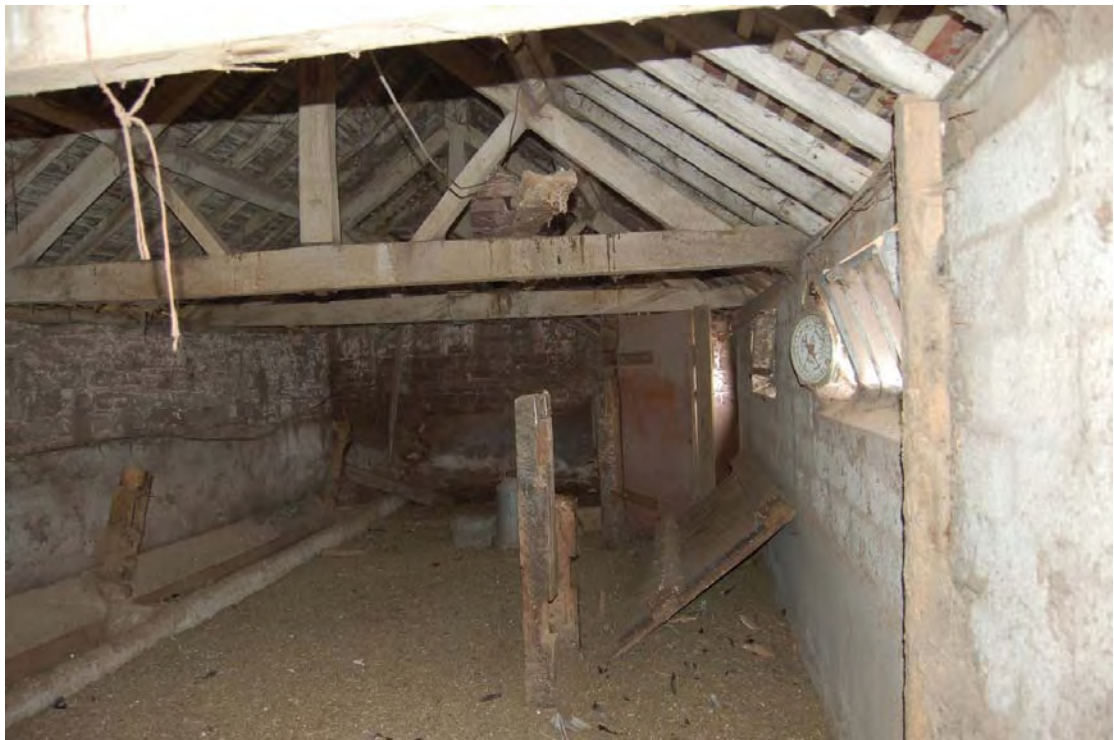
**Plate 21: The Animal Shed, Room C, looking south east showing door in the distance and remains of corridor.**

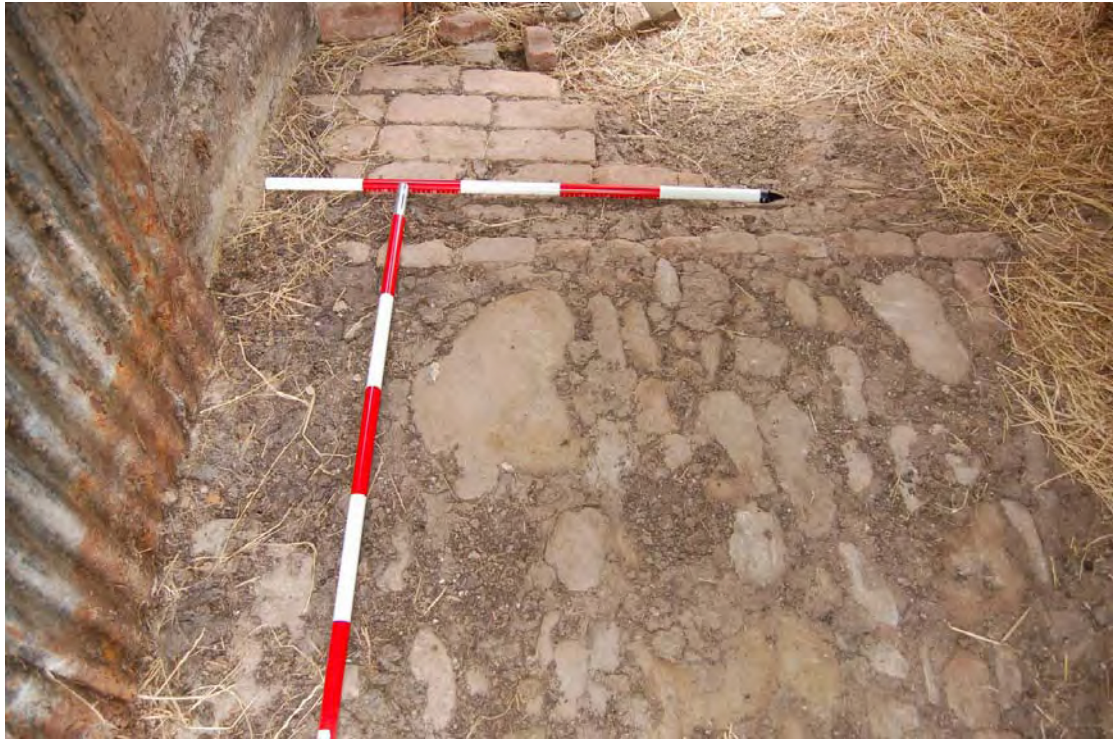
**Plate 22: The Animal Shed, Room B, remains of stone flooring within middle room (looking east)**

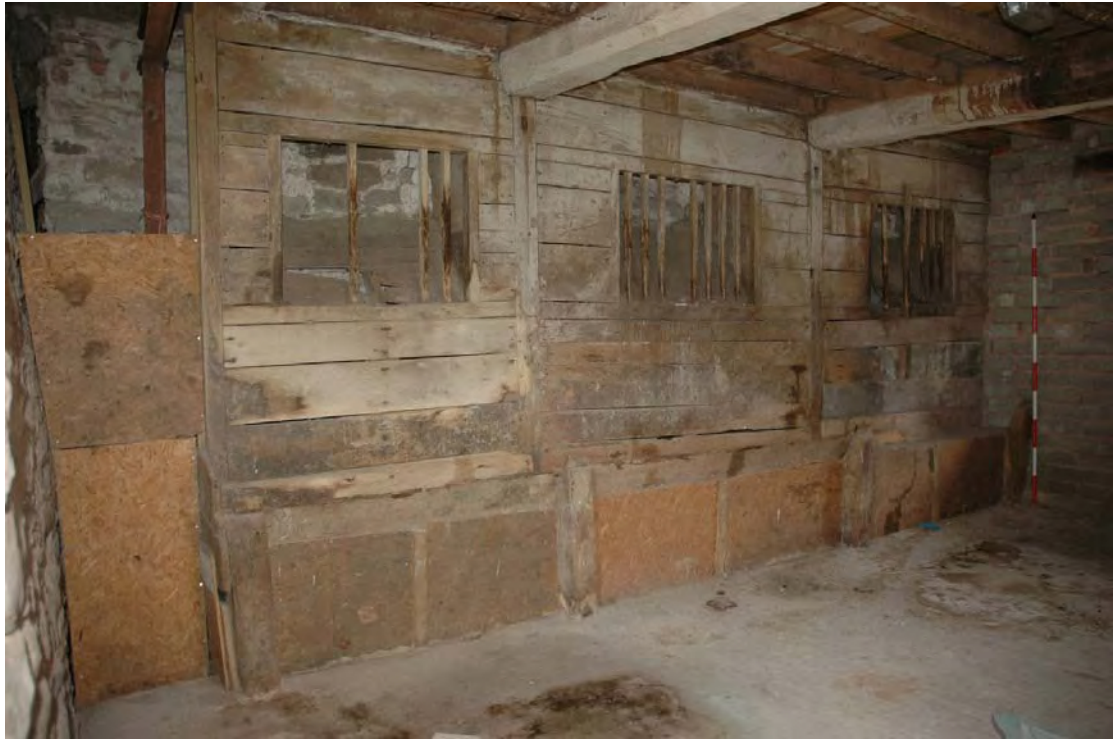
**Plate 24: The Stable, west room ground floor showing 3 mangers and troughs.**

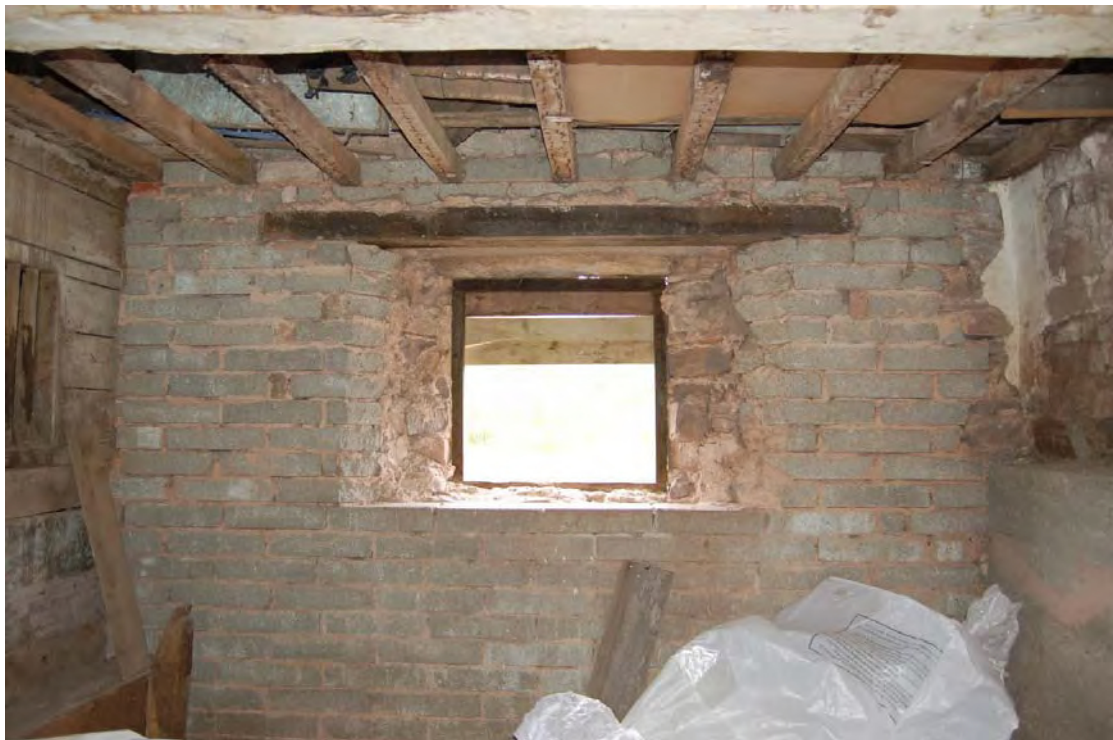
**Plate 25: The Stable, west room, ground floor, showing plaster covering red sandstone in corner of western wall and remains of southern wall.**

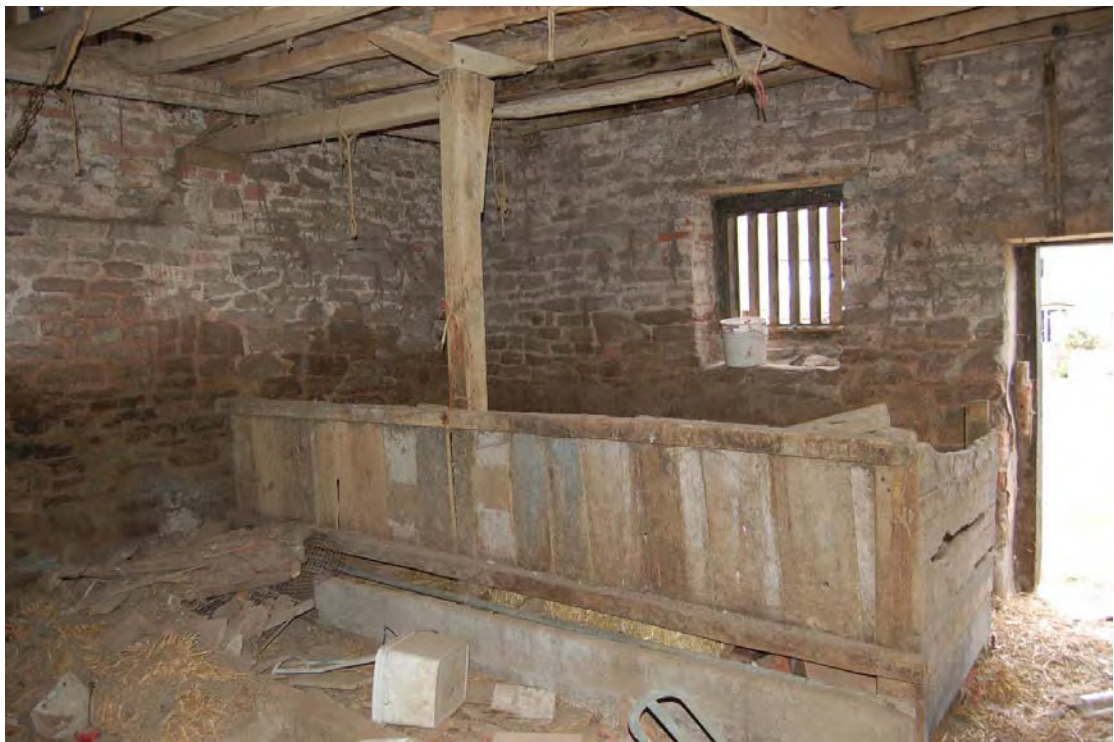
The eastern part is a single unit with two wooden partitions approximately 1m high (Plate 27) and a small, enclosed room or cupboard (Plate 28). This unit may have acted as a loose box for working or sick horses, or foaling mares. The small room may have been used for storing tack and equipment (a saddle or rein rack, fixed to the room's timber-frame seems contemporaneous). There is evidence of a number of earlier windows, now blocked. Three, which are visible only from inside the building, are equally spaced across the south wall, one centrally placed in the east wall with another towards the north-east corner.

**Plate 27: The Stable, east room, ground floor showing partition.**
