BUILDING RECORDING  
AT  
ABBAY GATE, EVESHAM,  
WORCESTERSHIRE

26<sup>th</sup> September 2003

Project 2401  
Report 1186  
WSM 32957

## Building recording at Abbey Gate, Evesham, Worcestershire

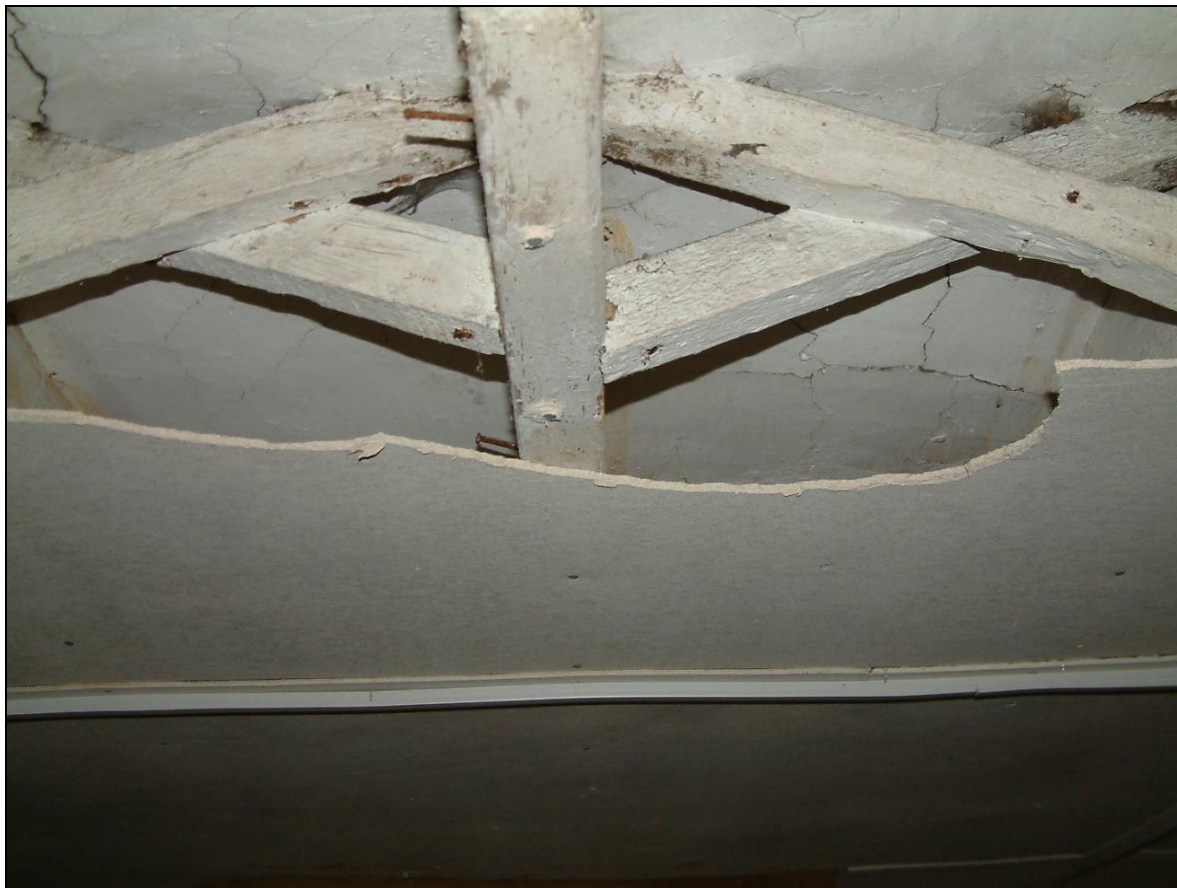
*Figure 4: Investigation hole G2*

Investigation hole	Fig no	Type	Information	Description
G2	4	Floor	Floor boards and lath plaster resting on joists	Accessed from below in the cellar. The floor boards are covered by a lath and plaster ceiling, which is lime washed. The joists, which measure 8" deep have herring bone struts and both have lime washed surfaces indicating that they would have been visible.
G3	5	Floor	Floor boards on joists	Accessed from below in the cellar. The floor boards are 7" wide by ¾" deep and rest on joists that are 5 ¾" deep by 2 ¾" wide. These joists run into a main beam
G6	6	Floor	Floor boards on top of beam and joists with lath and plaster below	Oak boards run along the room east-west and measure 6" wide by ¾" deep. There is a principal beam in the centre of the room and oak joists that measure 7" deep. These rest on a lath and plaster ceiling
G8 a	7	Floor	Half floor boards on joists standing on brick on soil fill. Half concrete.	Floor boards measuring 6 ¾" wide and 1" deep on top of joists that are 2 ¼" deep. The joists are standing on narrow handmade bricks on top of a mixed gravelly subsoil with a large amount of lime mortar. This occurs in the south half of the room only the rest of the floor is concrete.

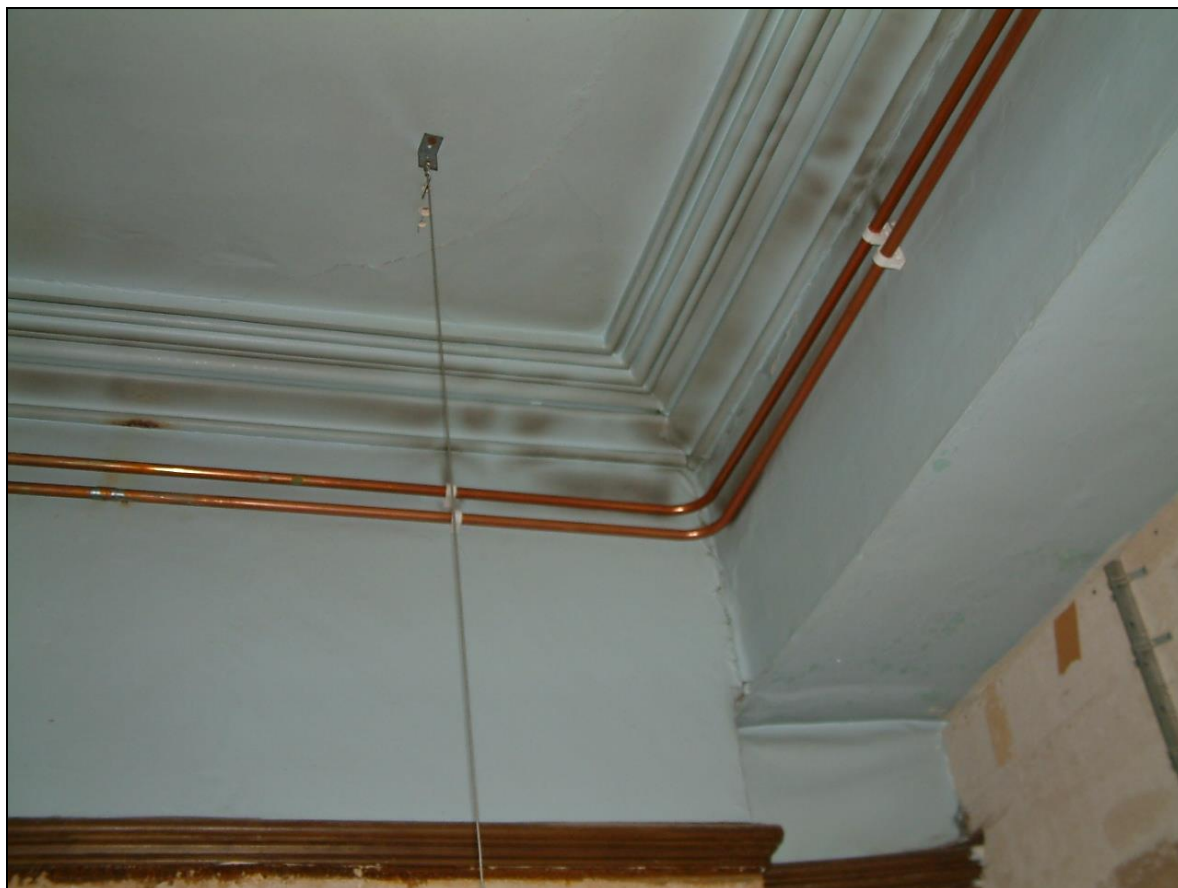
*Figure 8: Investigation hole G8b*

G8 b	8	Roof	Suspended ceiling	Suspended ceiling is hiding an open space that still has the original moulded cornice in place
F1	9	Floor	Chipboard above floor boards on joists with void below then second floor	Chipboard surface on top of oak floor boards measuring 6" wide by ¾" deep standing on joists 8" deep and 2 ¼" deep. The void below this is 3' 8" deep and then another floor of boards. These are on the same level as rooms F12 and F13
F2	-	Borescope	Looking behind panelling through ventilation hatch	Revealed that panelling was attached to original timber, could see peg holes but most of it has been removed. New wall behind panelling and original timbers. New wall has been added from adjacent room and can be seen by blocked door in wall only visible from within room F2
F5	10	Floor	Floor boards and chipboard on floor joists and floor beam with	Chip board and modern floor boards, measuring 9 ½" wide and ¾" deep,

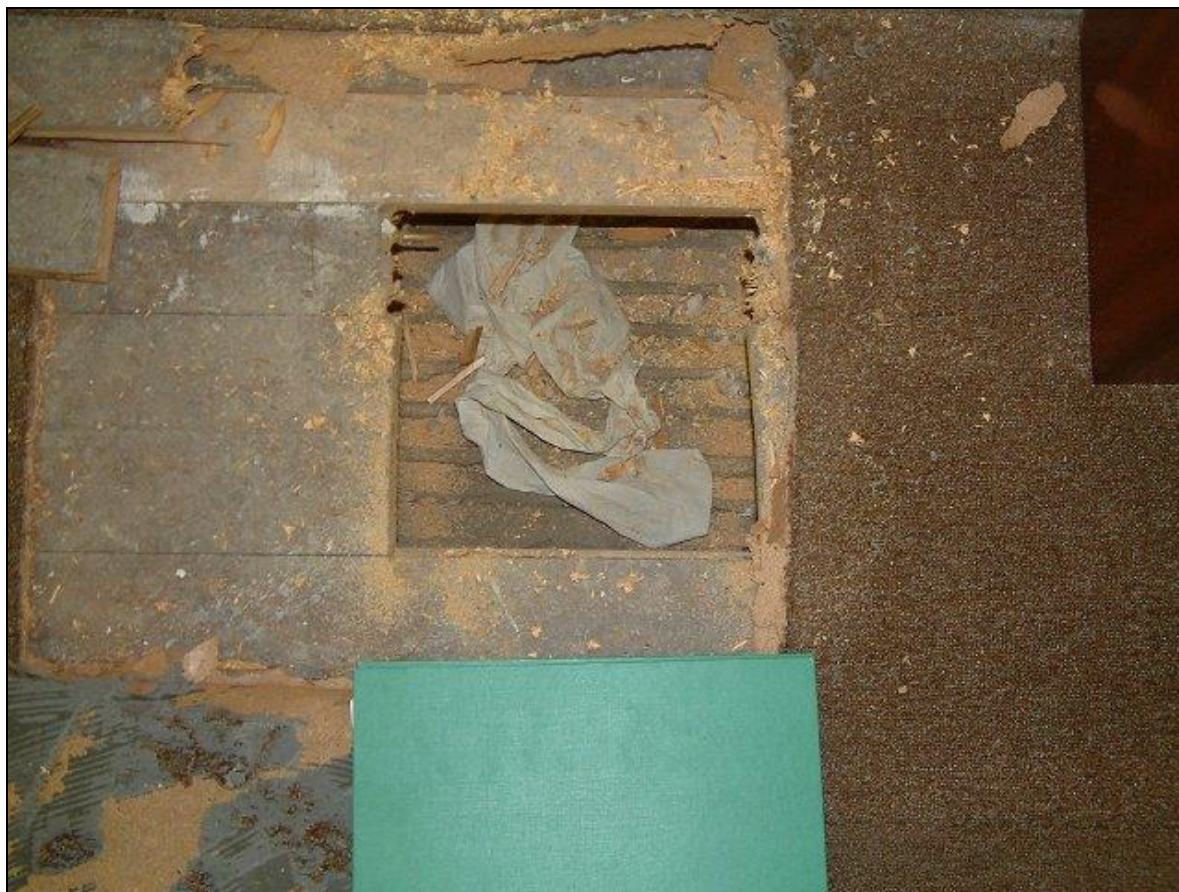
*Figure 12: Investigation hole F13*

F13	12	Floor	Chipboard boards onto joists above lath and plaster	Tongue and groove chipboard boards measuring 4" wide by $\frac{7}{8}$ " deep and running across the room north-south. These are attached to joists that are 7 $\frac{1}{4}$ " deep and are above a lath and plaster ceiling.
F15 a	13	Floor	Plywood surface onto floor boards onto joists above a second floor also on joists with lath and plaster below	Plywood above modern tongue and groove boards measuring 4 $\frac{1}{2}$ " wide sitting on joists $\frac{1}{2}$ " wide. The second floor is older and the boards measure 6" wide by $\frac{3}{4}$ " deep sitting on top of joists 5" deep above lath and plaster. Both floors run along the room east-west.
F15 b	-	Roof	Two plain trusses and brick chimney	Two plain triangular roof trusses held up by steel due to failure as a result of insect attack. Roof c300-400 years old with original trusses and purlins. Bricks chimney has been built off the north stone wall.

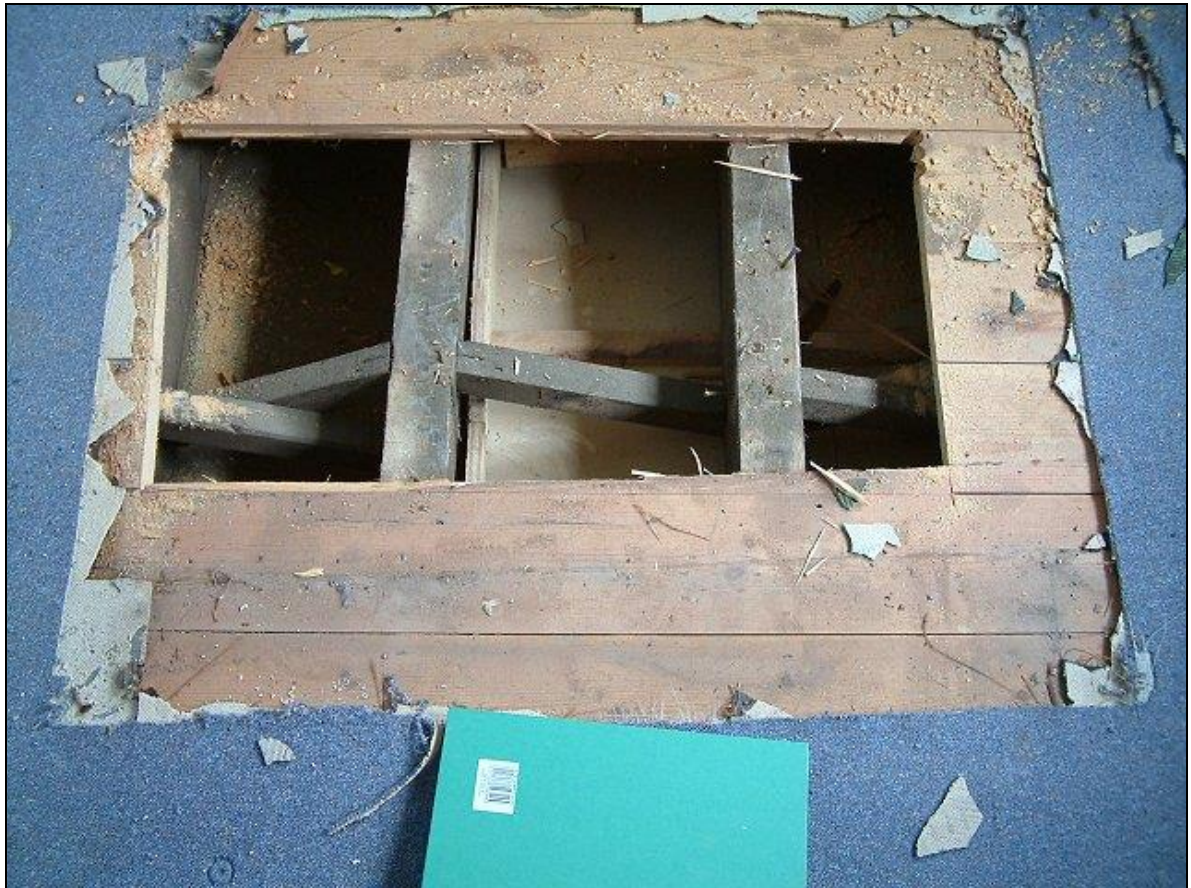
*Figure 14: Investigation hole F18*

F18	14	Floor	Floor boards sitting on joists above an MDF ceiling	c1940s tongue and groove pine boards measuring 6" wide by 1 $\frac{1}{4}$ " deep on joists 7" deep with herring bone struts. The joists run into the second skin of the exterior (west) wall and are sitting on top of the barrel arch MDF ceiling from the floor below.
F19 a	15	Roof	Plaster board ceiling opening into roof space.	The plaster board ceiling has glass fibre insulation. This is suspended above a roof space formed by king post trusses and purlins with modern plaster board panels between. The trusses are possibly of late 18 <sup>th</sup> century date although the beams are older and have unused mortices.
F19 b	16	Floor	Floor boards sitting on joists above lath and plaster.	The floor boards measure 6" wide by $\frac{3}{4}$ " deep and run across the room at an angle east-west. The joists are 5" deep above the lath and plaster and this cavity is filled with a large amount of sawdust probably from the original use of the room.

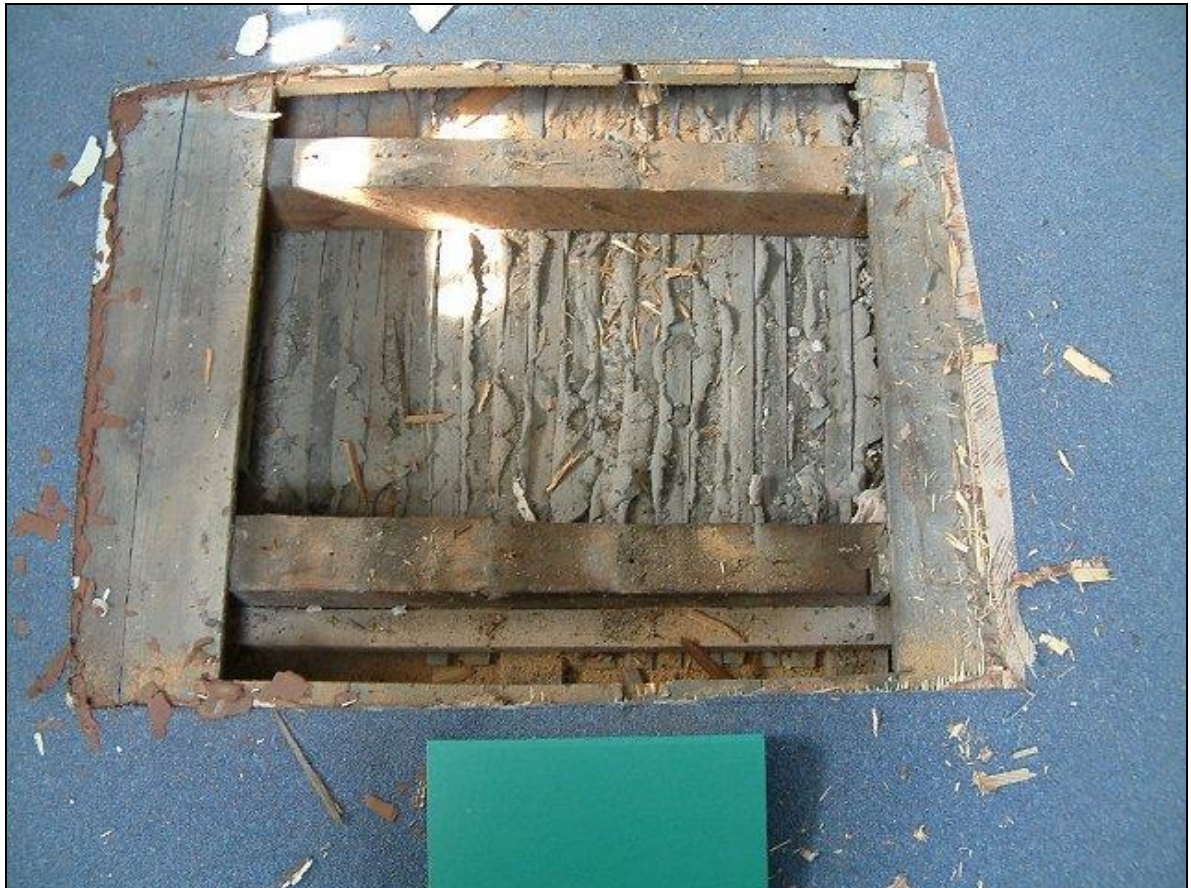
*Figure 18: Investigation hole F22a*

F22 a	18	Floor	Wooden floor boards sitting on joists with lath and plaster below	Boards are narrow, 4 ½" wide and ¾" deep, and run across the room north-north-east to south-south-west
F22 b	19	Floor	Wooden floor boards sitting on joists with lath and plaster below	Boards are narrow, 4 ½" wide and ¾" deep, and run across the room north-north-east to south-south-west
S2	20	Floor	Chipboard onto floor boards on top of joists. Second floor below with lath and plaster below that	Chip board stapled down on to floor boards measuring 8 ½" wide by ¾" deep. These are sitting on floor joists that are 7" deep and have another floor below them. This second floor has boards running across the room north-north-east to south-south-west. These boards measure 10 ½" wide by 1" deep and a lath and plaster surface 7" below this.
S4	21	Floor	Two floor board surfaces sitting on joists and truss with suspended ceiling below and wide laths	Modern tongue and groove floor planks measuring 4 ¼" wide by ¾" deep. These are on top of an earlier floor with boards measuring 8 ½" wide sitting on top of a truss and joists measuring 10" in depth. Immediate below floor is a wide lath ceiling but a suspended ceiling covers the rest of the area.

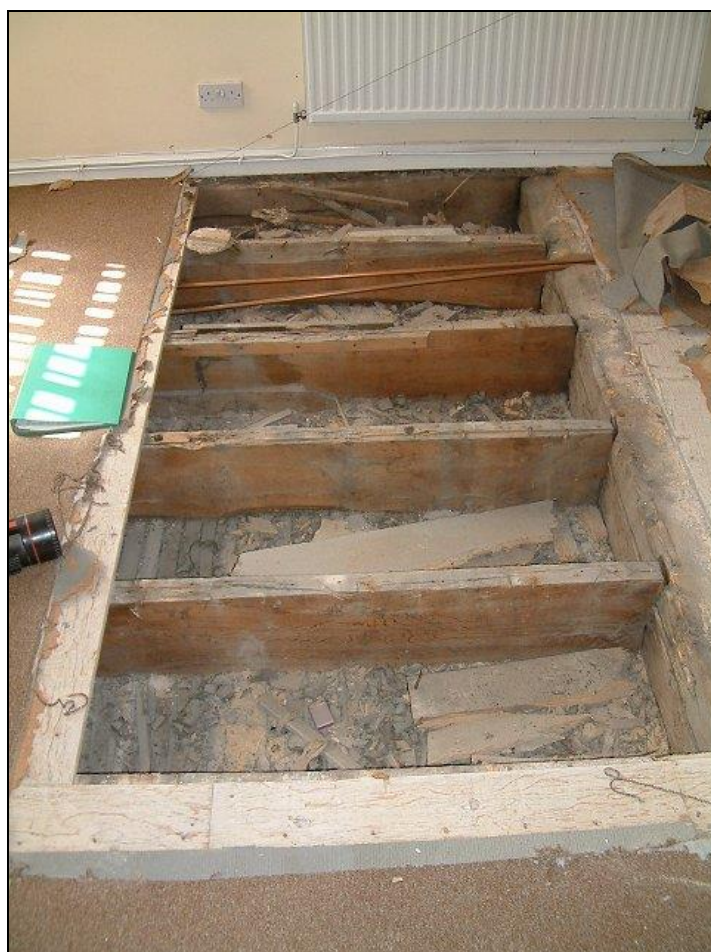
*Figure 22: Investigation hole S5*

S5	22  23	Floor	Chipboard on top of plywood sitting on joists and main beam. Lath and plaster below	Chipboard is on top of plywood sheets measuring 6' by 4'. These are directly on top of joists and a main beam. The joists measure 2 ¼" wide and 9 ¼" deep and the beam measures 8" wide by 10" deep. The joists run into the main beam and the beam runs into the truss. Every joist is bored with holes, and have carpenters marks, to hold something attached from above. Below the joists and beam is a lath and plaster ceiling.
S6	24	Floor	Plywood on to floor boards sitting on joists above lath and plaster	Plywood sitting on top of oak boards measuring 8 ½" wide by ¾" deep. These are sitting on joists 9 ¾" deep and 2 ½" wide above a lath plaster ceiling.
A		Bulkhead	Hole put through lath and	The floor boards behind stud wall are

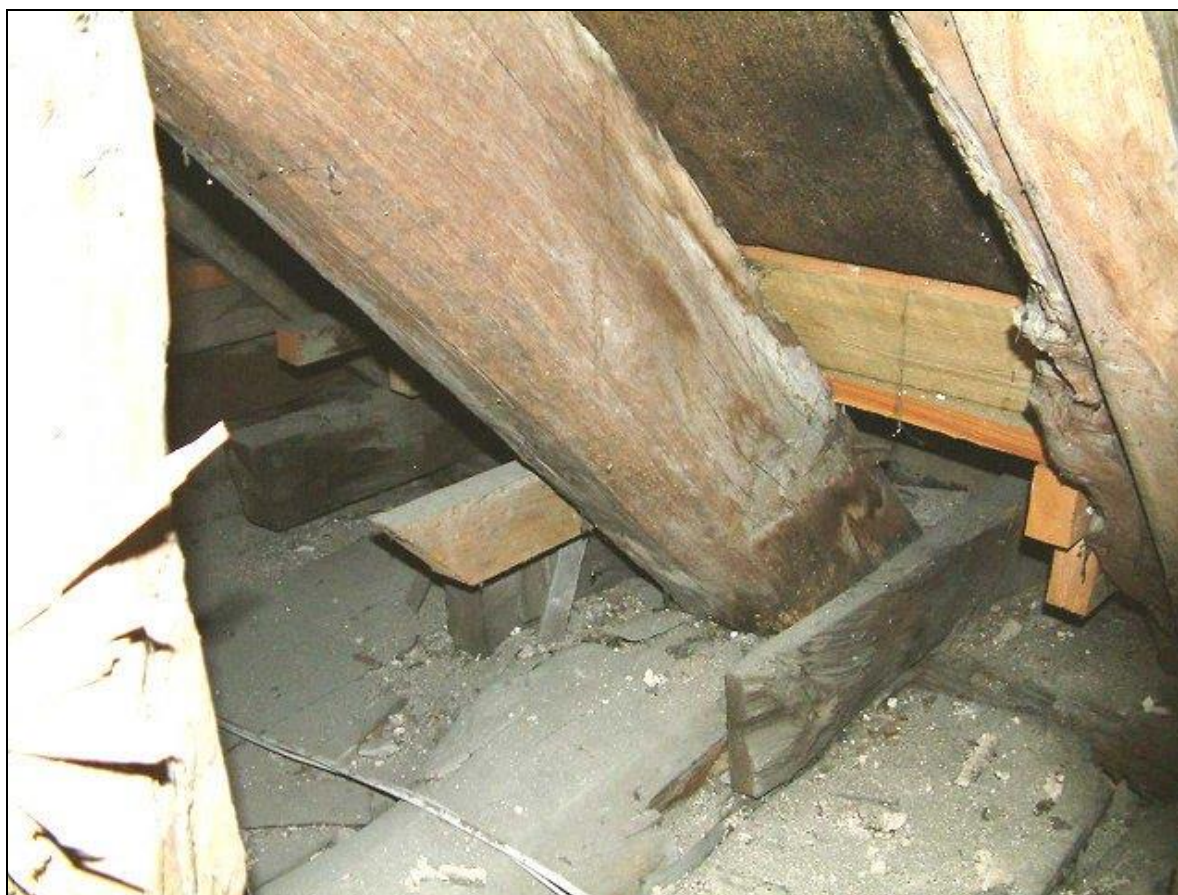
*Figure 25: Investigation hole A, truss 1*

25		plaster in room S7. Showing ends of 3 trusses, wall plate and masonry wall, cantilever eaves and guttering timbers.	13 7/8" wide. Truss 1 is oak and has brown rot, death-watch beetle, fungus and dry rot. Peg securing principal rafter has split beam due to slippage caused by overloading of floor and their remedy of this in room S2. Truss 2 is also oak but of different age. Truss 3 has been weakened by woodworm. Some timbers of cantilever eaves and common rafters have been replaced, as has section of wall plate between trusses 1 and 2. Trusses possibly original to gatehouse 17 <sup>th</sup> century phase.
	26			
	27			
	28			
B	29	Bulkhead	Hole through lath and plaster in room S3. Truss exposed.	Truss is supported by wall plate. Void in wall over opening and wall plate is supported by a prop. Rather than rebuild wall to height of wall plate when inserting window, the lintel is a wood board and the wall plate is propped up.

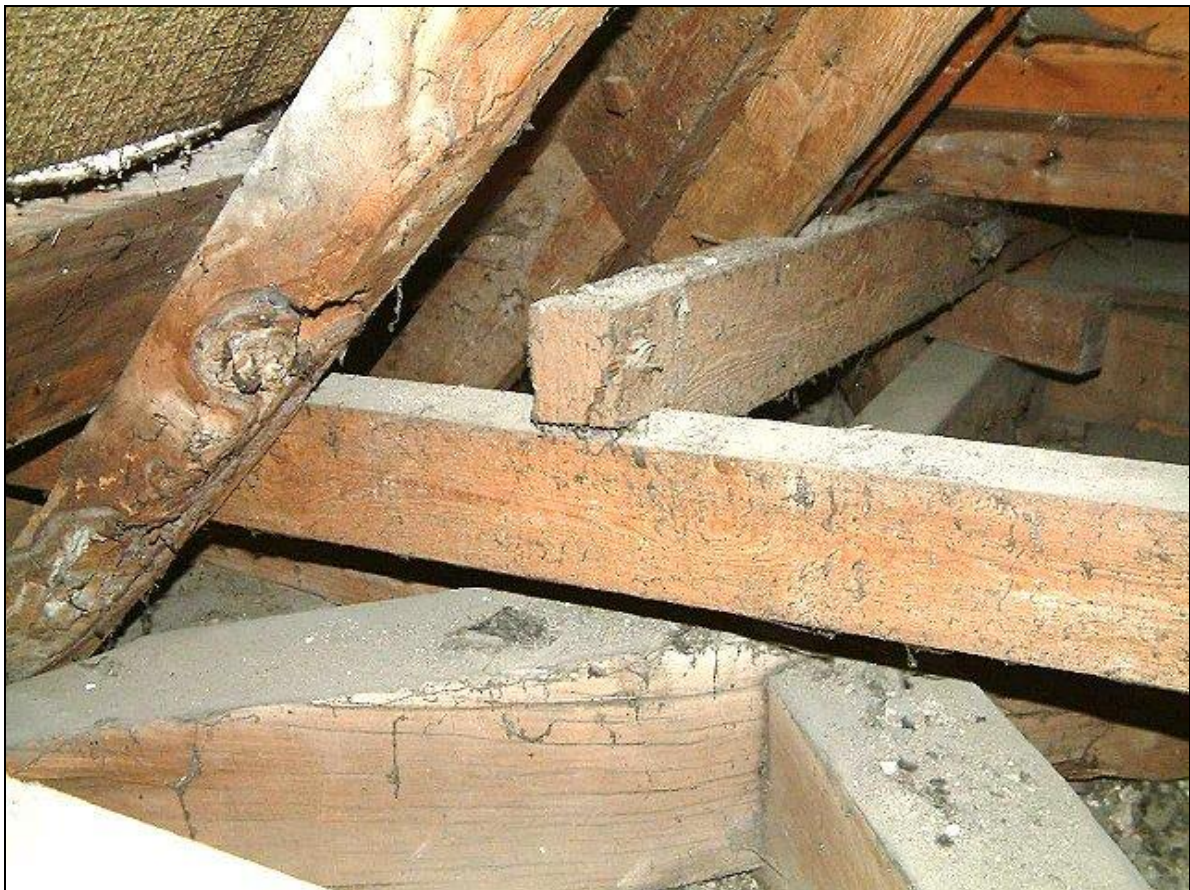
*Figure 31: Investigation hole C, dragon tie beam and truss*

30			
C	31	Bulkhead	Hole through lath and plaster in room S6. Dragon tie and beam and truss exposed.	Dragon tie is below beam from hipped roof, inverse from usual. Death-watch beetles present. The truss has slipped by 2" and tenon joint has pushed through the mortice. Several of the rafters have fractured.
