BUILDING RECORDING AT  
PALMERS END FARM,  
ELDERSFIELD,  
WORCESTERSHIRE

Project 2293  
Report 1121  
fieldwork WSM no 32055

## **Building recording at Palmers End farm, Eldersfield, Worcestershire**

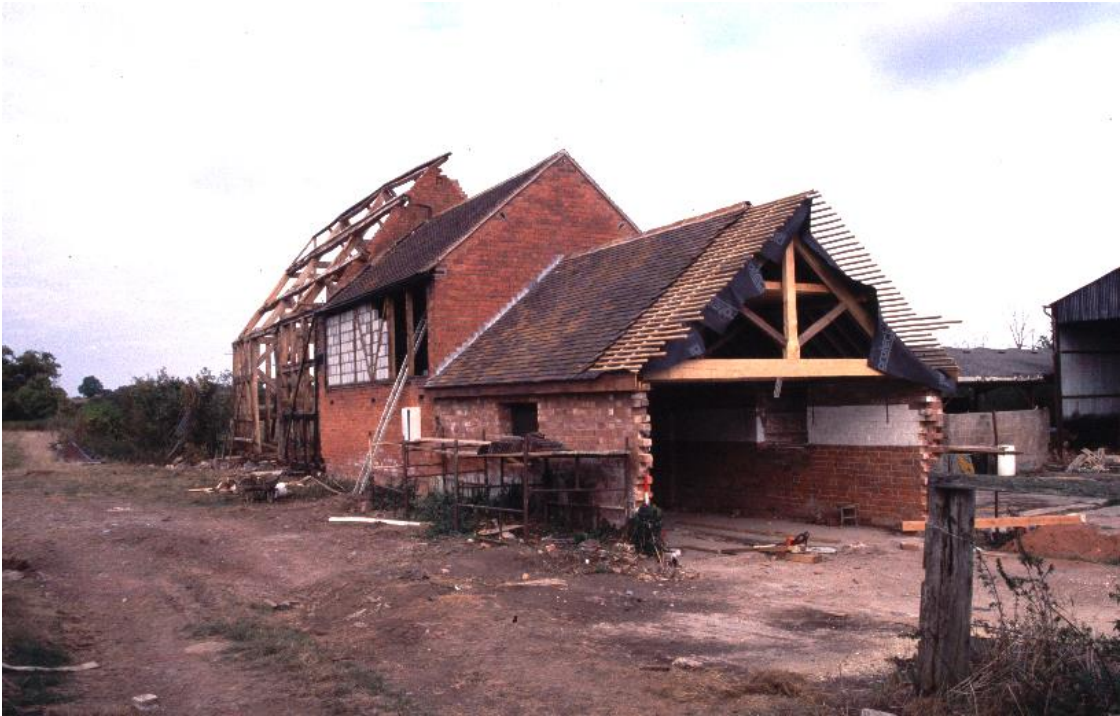
**Unit 1.** This is single storey, rectangular brick-built cow shed extension butted against the south gable end of Unit 2 (Plate 1). The structure is built of machine-made bricks fixed in a Double Flemish bond. The building appears to have once had an extension on its southern side that had been demolished by the time of the building recording along with the south wall of Unit 1. Two windows were present in Unit 1, located in the western and eastern walls, the window in the western wall had been added as part of the conversion scheme and the window in the eastern wall was original but had been altered as part of the conversion. The unit was roofed with ceramic tiles and supported by three king post roof trusses (Plate 2). The floor was brick at the north end and concrete at the south end with a drainage channel approximately in the centre running from north to south (Plate 3). A doorway is present in the northern gable wall leading into Unit 2 (Plate 4).

Plate 1. Units 1-3 the milking parlour, cowshed and threshing barn looking north-west

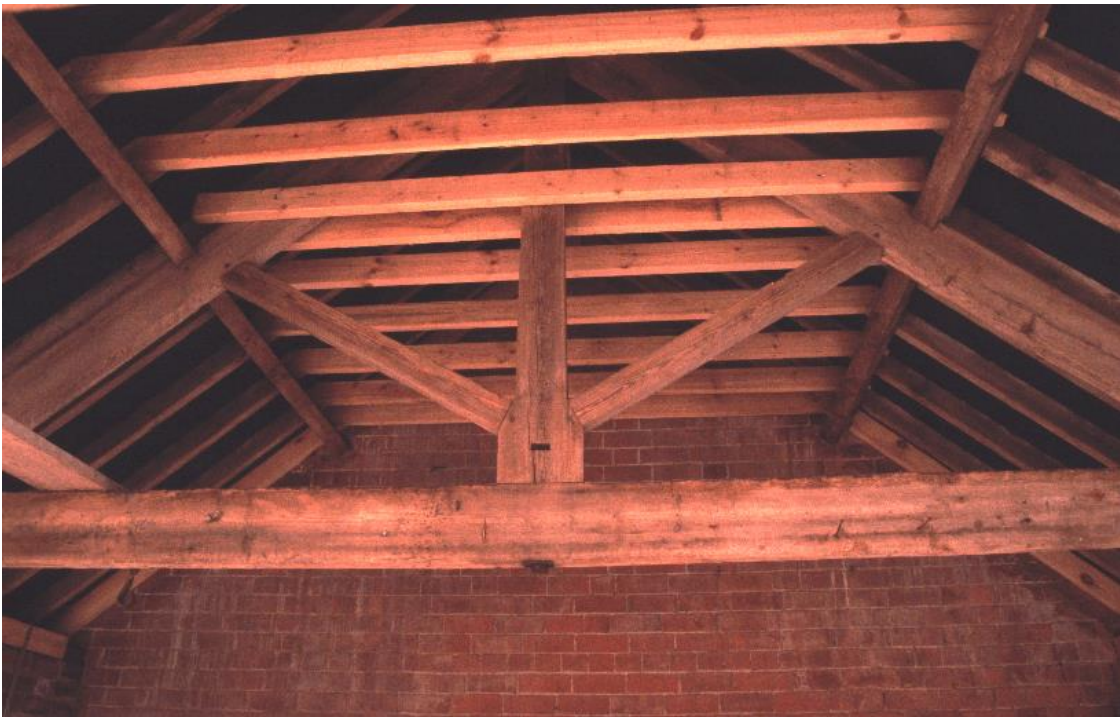
Plate 2. Unit 1, roof trusses in the milking parlour.

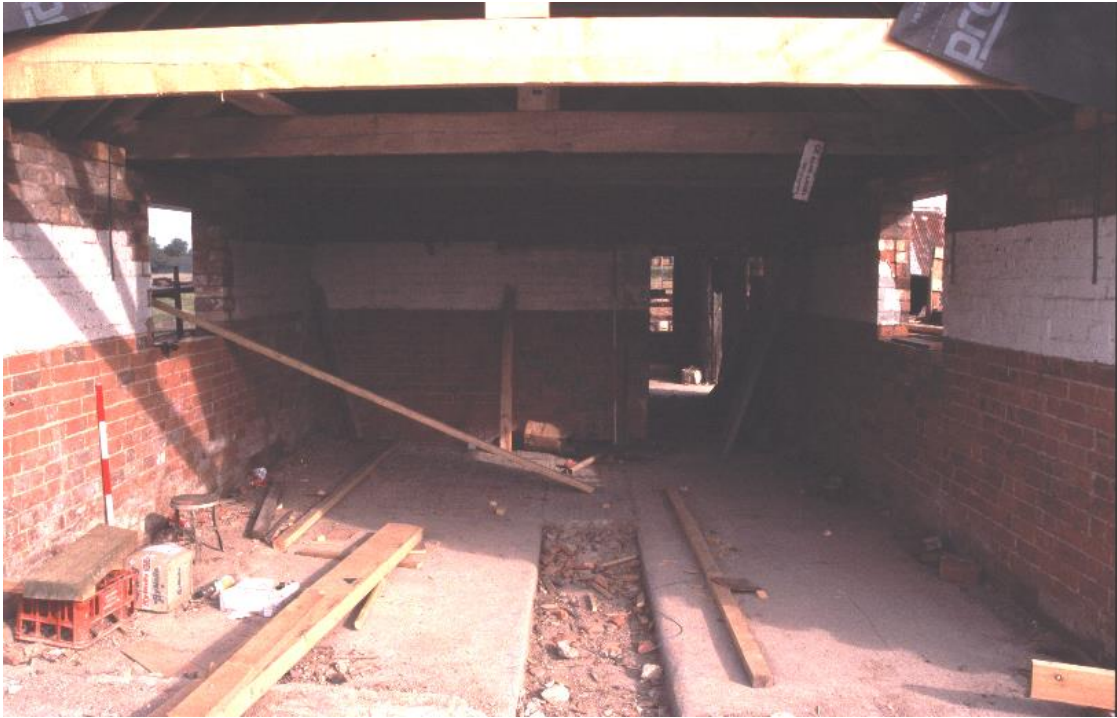
Plate 3. Unit 1, milking parlour interior, looking north

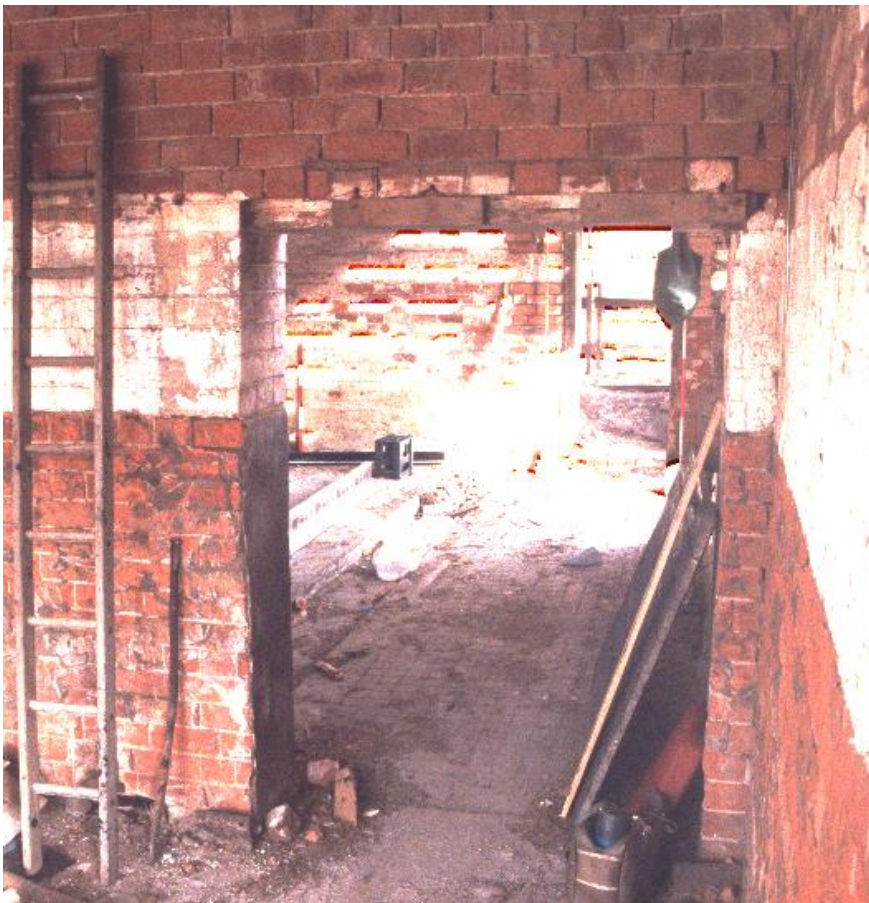
Unit 1 was a single storey extension to Unit 2 and also appears to have been a cowshed/milking shed. A doorway has been added between Unit 1 and Unit 2 and a timber lintel inserted. The brickwork was left in a fairly rough finish where the doorway had been knocked through and a sliding steel gate had been added. An enamelled sign nailed to one of the roof trusses refers to a milking machine manufacturer and it seems that this room would once have housed milking equipment and the demolished building to the south may also have been part of the dairy.

Plate 4. Doorway between milking parlour Unit 1 and Unit 2

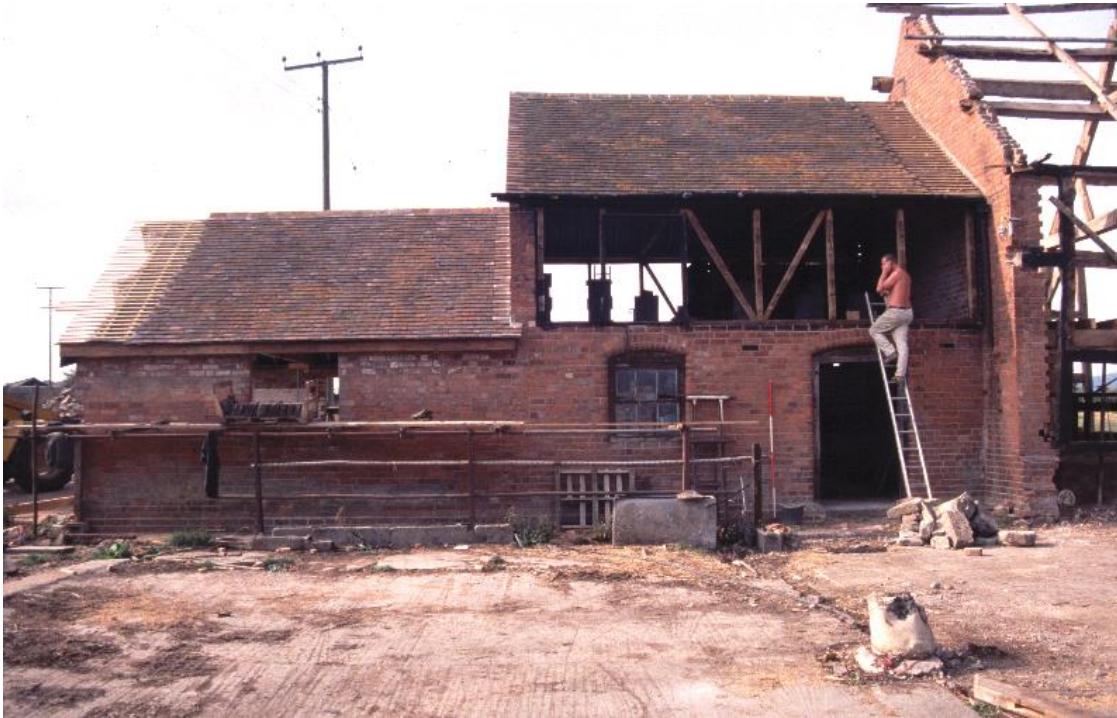
**Unit 2.** This is a two-storey cow shed structure with a hayloft above. It is brick-built with a English garden wall bond abutting Unit 3 to the south. Unit 2 has a window and a door in the eastern wall leading from the farmyard (Plate 5). Inside on the floor was a concrete stall area sloping down into a central drainage channel, running north to south with a brick floored passage along the eastern side (Plate 6). Iron air vents were present for ventilation at ground floor ceiling level. The above the cattle shed area on the first floor was a hayloft. The eastern and western walls on the first floor were open at the time of the recording but had previously been timber clad. The roof was covered by ceramic tiles and was supported by two king post roof trusses.

Plate 5. Units 1 and 2 looking west

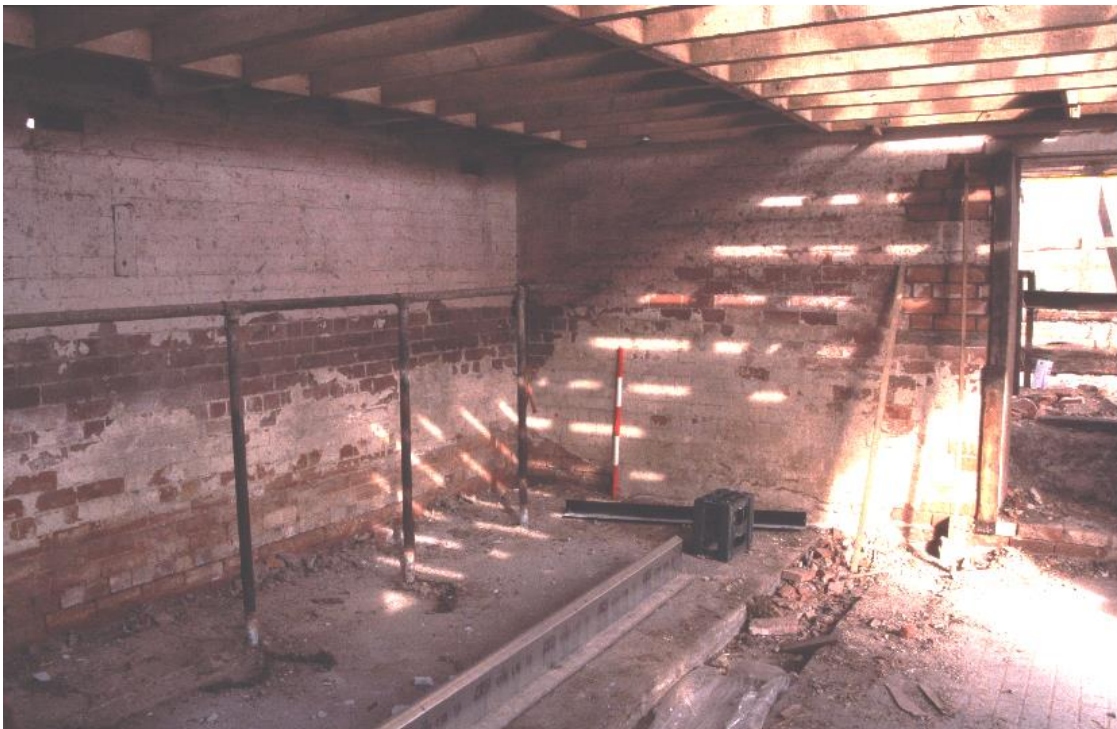
more spacious, well lit and hygienic accommodation, opposed to the ill lit and poorly ventilated conditions of before, hence the windows and the central floor drain. The animals would have been tethered along the western wall in stalls, steel stanchions for the tethering are still present but are probably modern replacements of the originals. Manure would have been collected from the central drain during mucking out. An interesting feature is the curved edged bricks around the door, which were often used in cow houses to prevent the animals injuring themselves on sharp corners as they passed through (Plate 19). The doorway leading from the Unit 2 to Unit 3 has been added as part of the present conversion work.

Plate 6. Unit 2, cowshed interior facing north-east showing the stanchions for tethering cattle and the central floor drain.

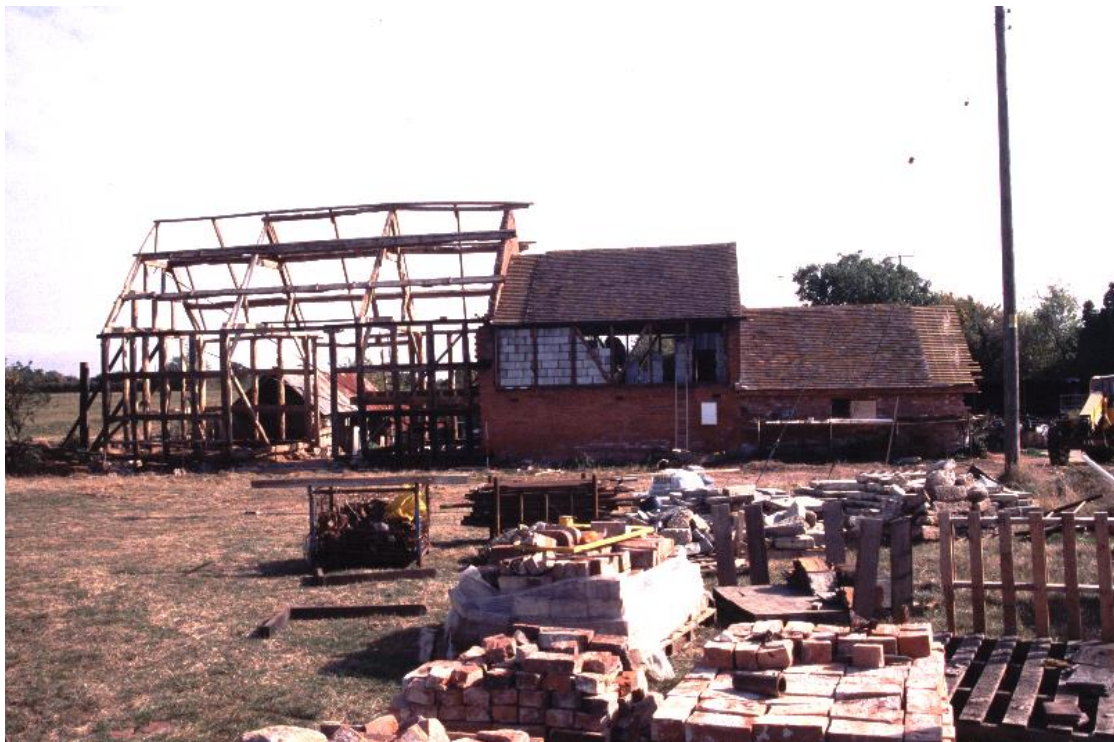
**Unit 3.** This is a timber box-frame, three bay threshing barn with large doorways opposite each other in the eastern and western walls (Plate 7). At the time of the building recording the barn had been stripped completely to its box-frame. The barn had previously had a ceramic tile roof with the walls cladded with wooden boards. The southern gable wall of the barn has been replaced by a brick wall of English garden wall bond, that also forms the northern gable wall of Unit 2 (Plate 8). The sill beams at the base of the frame had previously sat on a stone rubble plinth that had been largely removed at the time of the recording, leaving the frame resting on wooden props (Plate 9). The rubble plinth survived only in the north-east corner of the structure. The barn had three bays formed by six wooden post uprights measuring 200mm x 200mm and the southern brick gable wall with three tie beams spanning the structure between pairs of posts and with wall plate beams connecting the posts around the perimeter of the structure (Plate 10). Sill beams were also present inside the barn running aligned east-west dividing the floor space by linking the bases of the posts either side of the doorway. Braces were also present on the western side doorway, strengthening between the post and the sill beam and the post and the tie beam.

Plate 7. Units 1-3, looking east

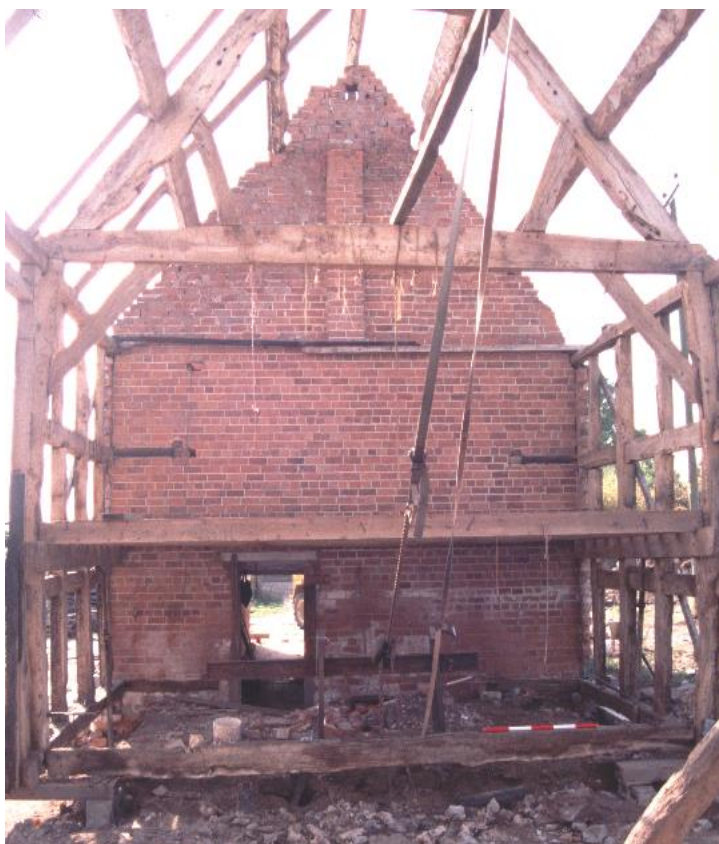
Plate 8. Unit 3, looking south showing the replacement brick wall at the southern end of the threshing barn

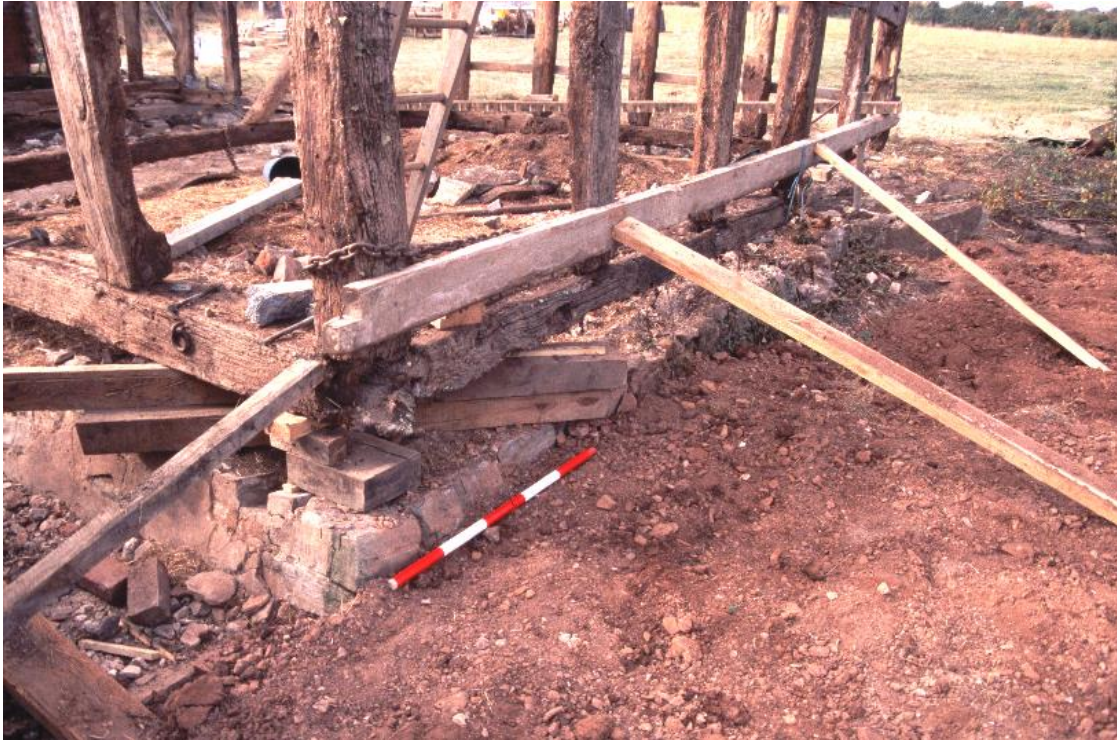
Plate 9. Rubble plinth and sill beams at north end of threshing barn

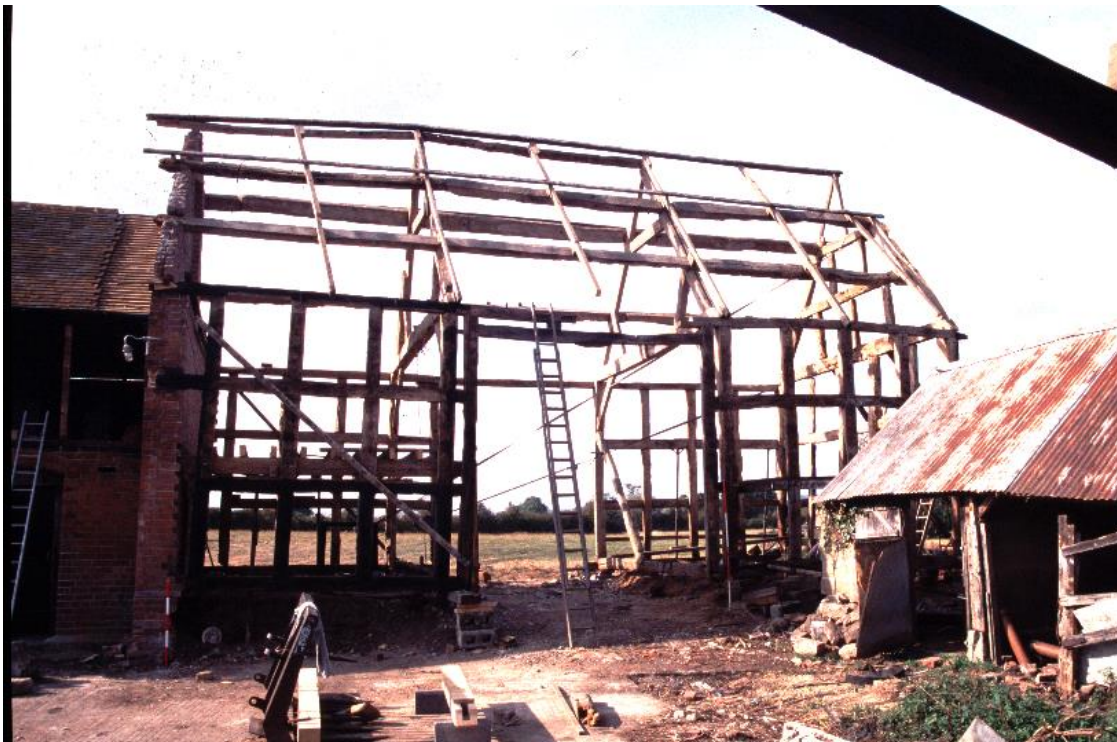
Plate 10. The threshing barn, eastern elevation.

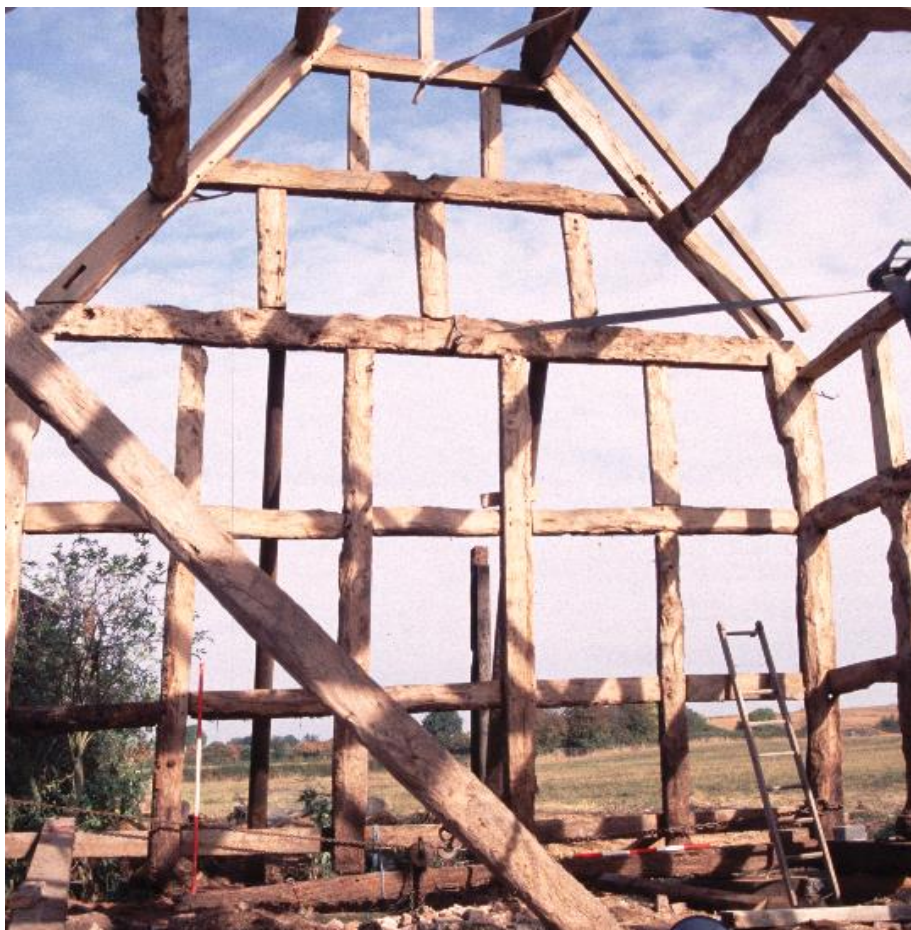
The roof was supported on three wooden trusses and the brick gable end wall. The northern end gable wall had the rafters supported by two collars, the collars were then braced by Queen posts (Plate 11). There are three Queen posts sitting on the tie beam bracing the lower collar and above this two further Queen posts brace the upper collar. A final post rests on the

Plate 11. North wall of threshing barn from interior looking north-east

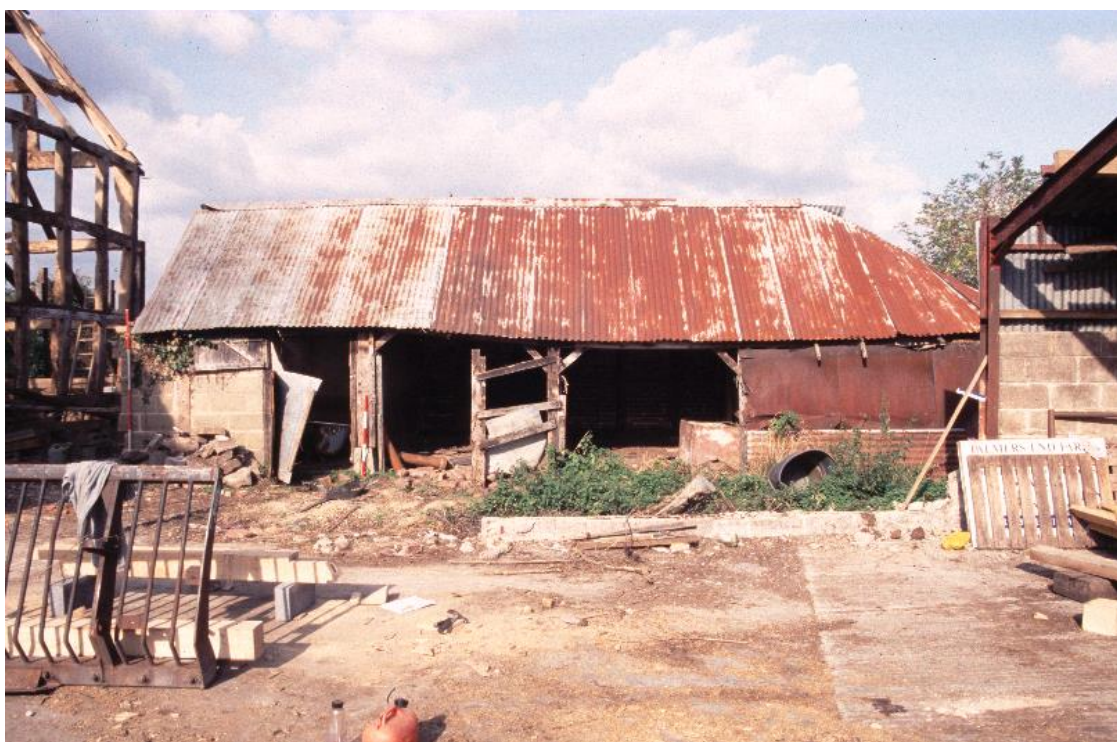
**Unit 4.** Unit 4 is a single storey shed running along the northern edge of the farmyard (Plate 12). The structure had eight bays but at the time of the recording the first had been partially demolished as part of the conversion, while bays five, six, seven and eight had collapsed (Plate 13). The building was timber-framed but had been heavily modified in places with modern breeze block walls. The best preservation was at the rear northern side of the structure where the wooden sill beam rested upon a substantial stone foundation that also doubled as revetment for a ditch running east to west behind Unit 4 (Plate 14). The rear wall was formed of a series of wooden vertical studs with a single row of horizontal rails topped by a wall plate and infilled with brick-nogging in stretcher bond. Many of the bricks had been replaced by modern machine made bricks but some thin hand made bricks remained. The front southern side of the building was open with posts spaced at regular intervals with braces supporting a wall plate and ties beams spanning across to the back wall (Plate 15). The bays were divided up into stalls by posts and staves (Plate 16), in many places these had been patched up with corrugated iron or replaced entirely with breeze-blocks. The floor was covered with machine made bricks. The roof was a simple principal rafter roof covered in corrugated iron, this seemed to have replaced the original.

Plate 12. Southern elevation of Unit 4 cowshed

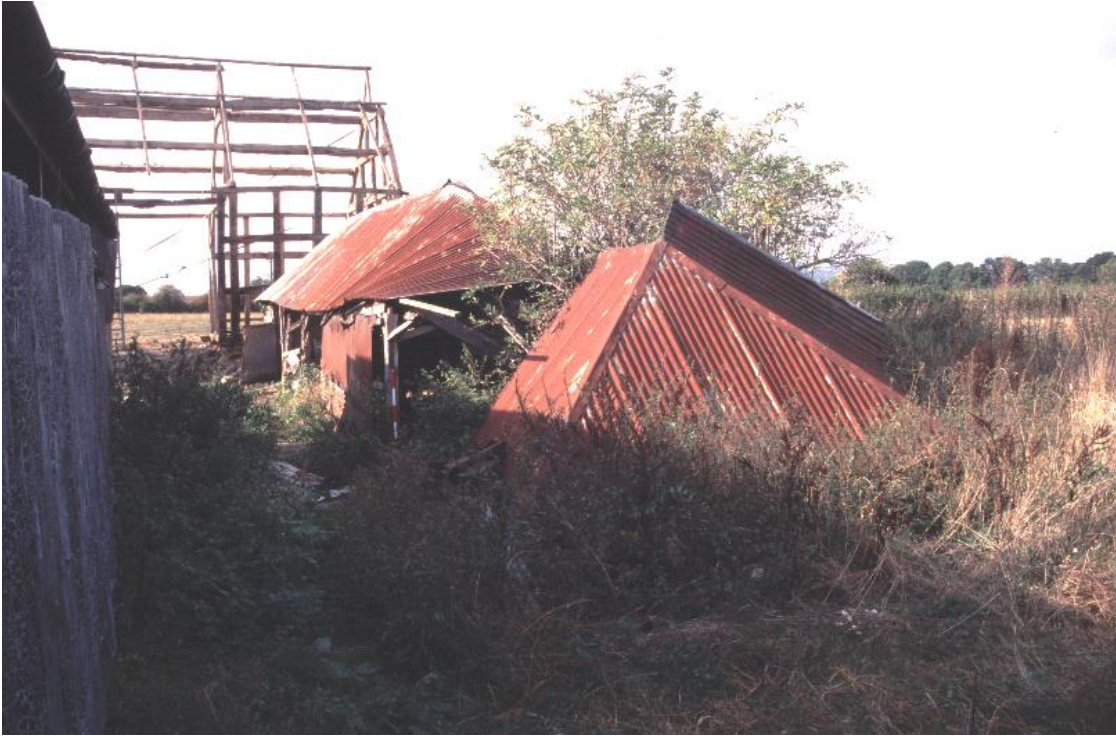
Plate 13. Collapsed eastern end of cowshed, Unit 4

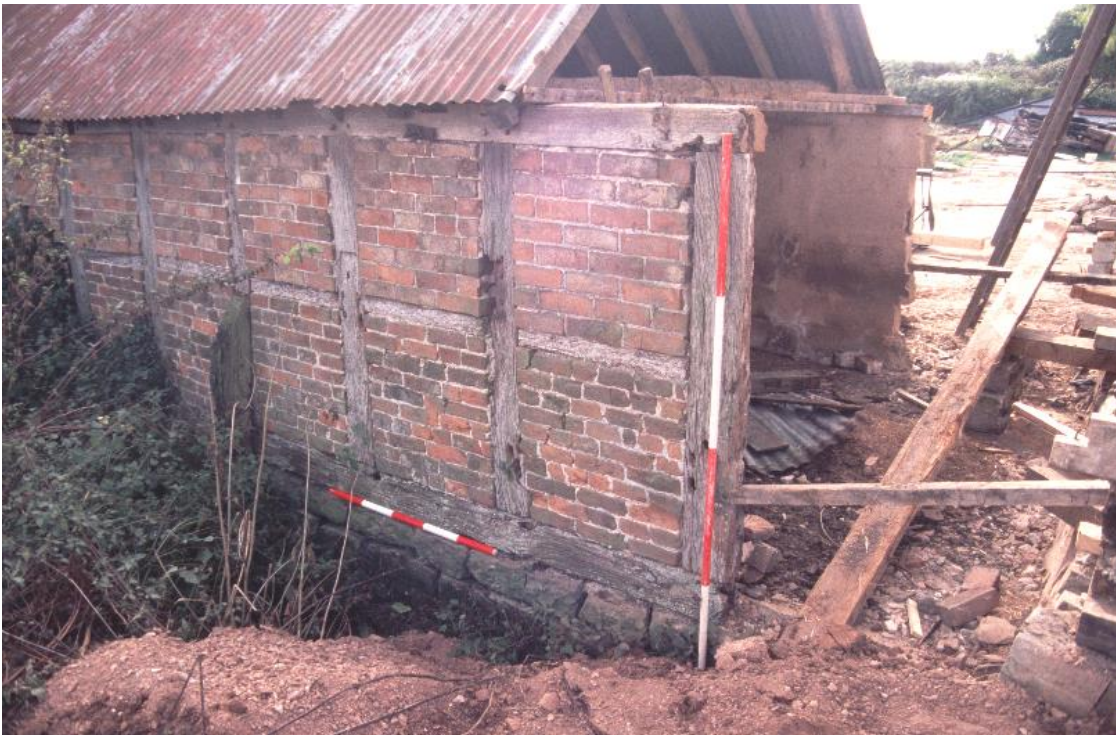
Plate 14. Rear wall of cowshed, Unit 4 showing brick-nogging

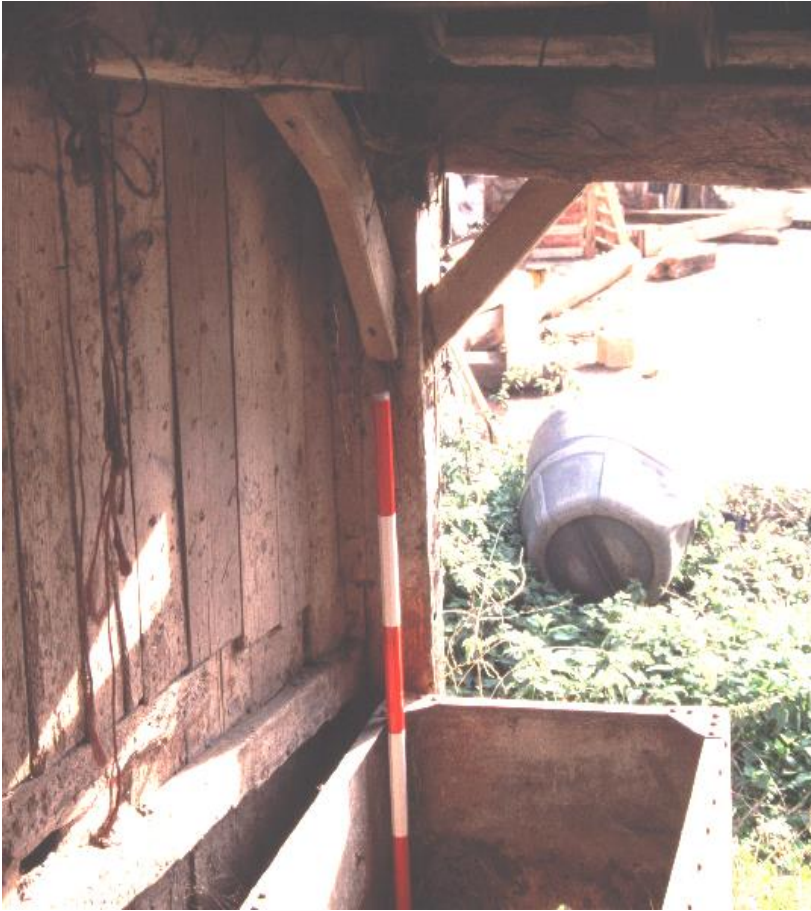
Plate 15. Unit 4, post with braces at front of cowshed

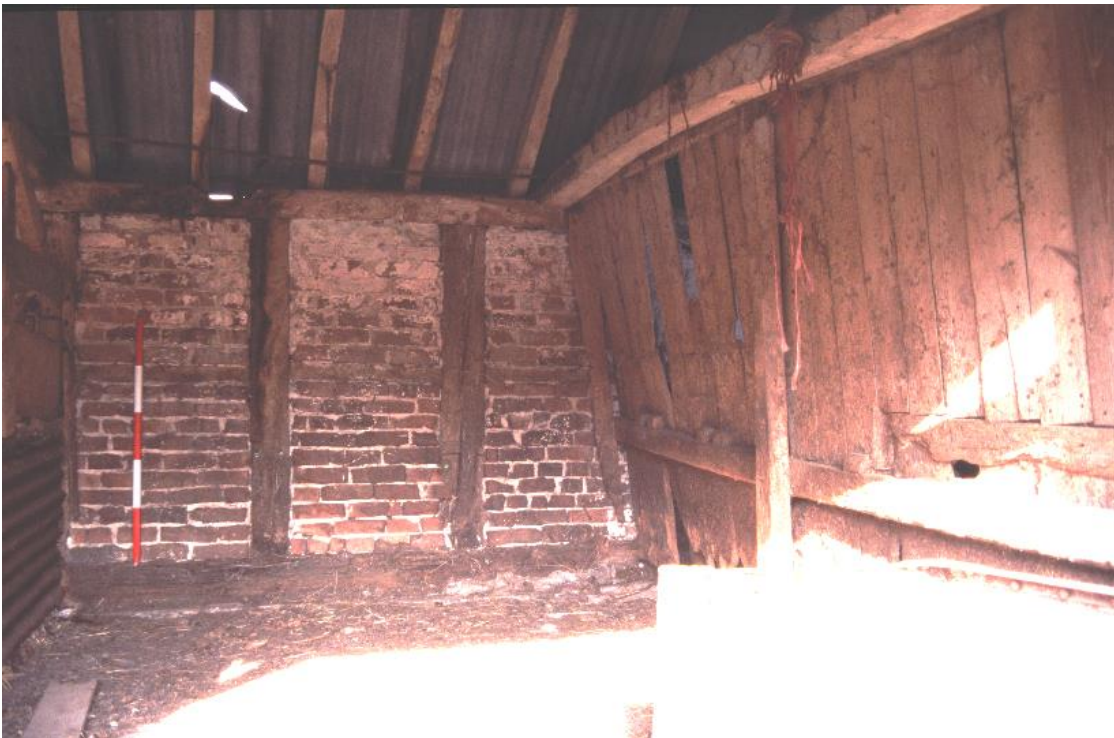
Plate 16. Interior of cowshed, Unit 4 showing stalls

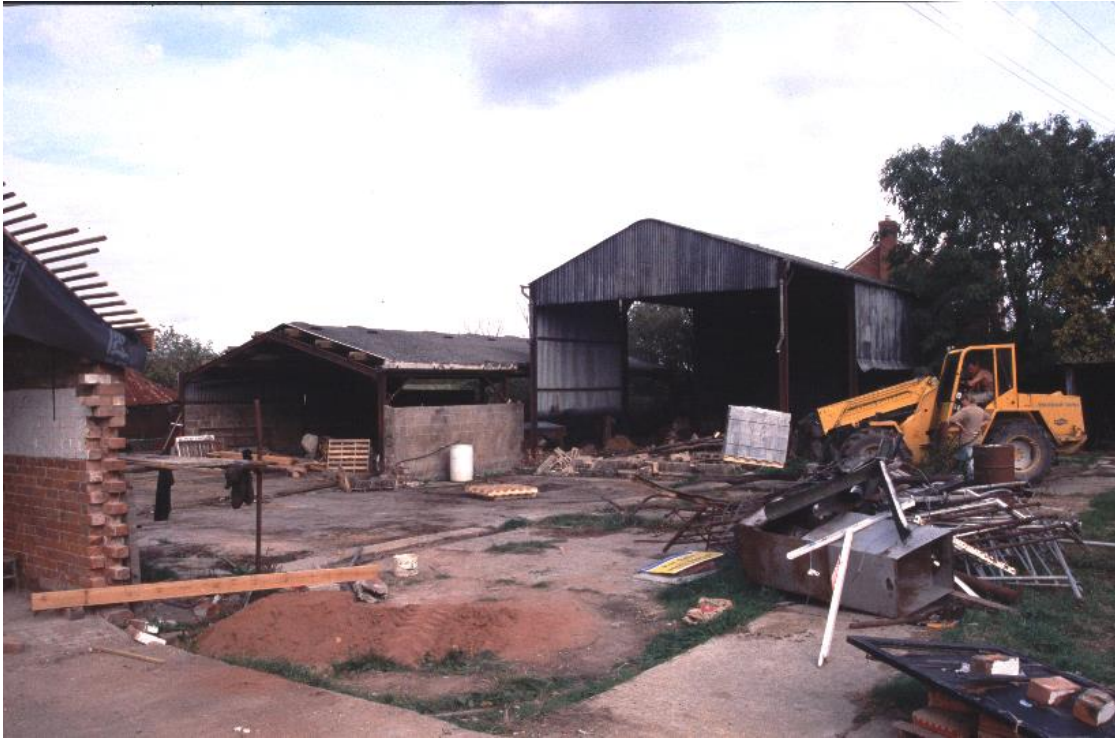
Other buildings present in the farmyard were modern steel-framed barns covered in corrugated iron (Plate 17).

Plate 17. Modern steel framed barns along eastern edge of the farmyard

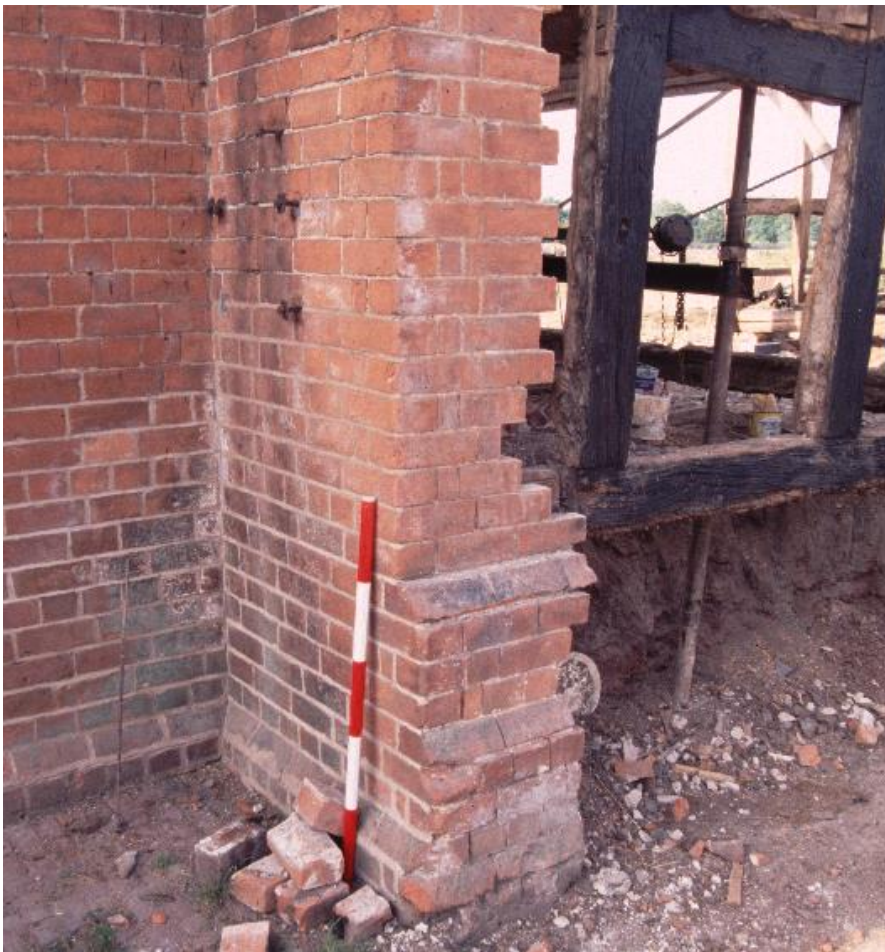
Plate 18. Buttress at south-eastern corner of the threshing barn.

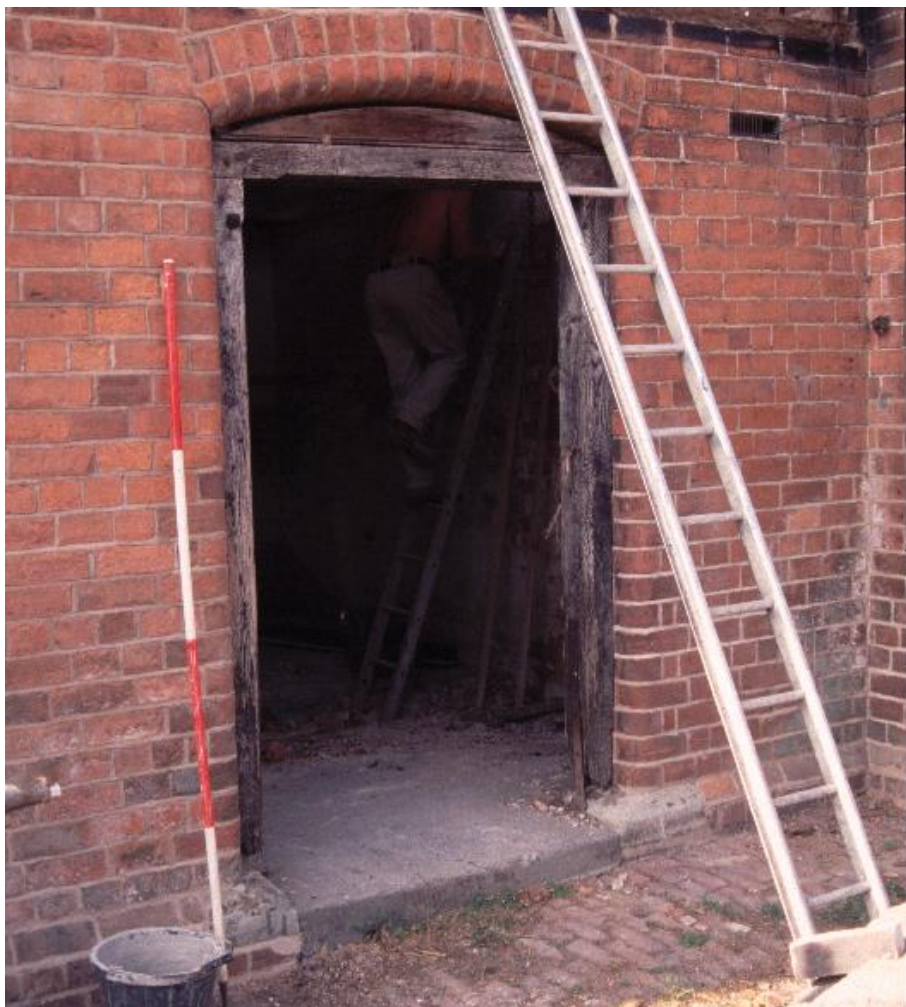
Plate 19. Doorway into Unit 2 cowshed with rounded bricks
