Archaeological watching brief and building recording at Eastham Bridge, Eastham, Worcestershire

Status:
Date: 18 August 2016
Author: Tim Cornah, tcornah@worcestershire.gov.uk
and Tom Vaughan, tvaughan@worcestershire.gov.uk
Illustrator: Carolyn Hunt, chunt@worcestershire.gov.uk
Project reference: P4867
Report reference: 2367
HER reference: WSM 67959 and 67960
Oasis id: fieldsec1-259801

A programme of archaeological watching brief and building recording was undertaken at Eastham Bridge, Eastham, Worcestershire (NGR SO 65917 69060). It was undertaken on behalf of Worcestershire County Council following the collapse of the bridge on 24 May 2016.

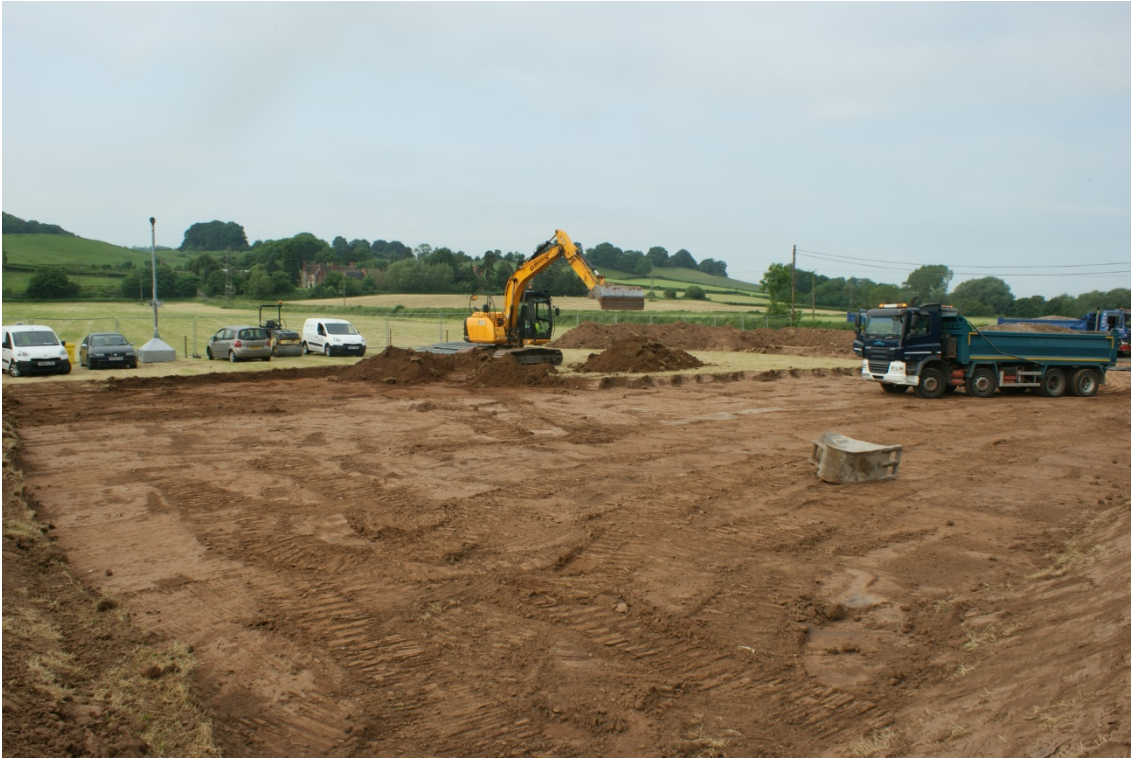
Subsoil deposits were noted across the site (Plate 1), though the machining depth was not always sufficient to reach it. This deposit (101) was compact homogenous orange clay silt. No dating material was recovered from this layer.

Plate 1 Topsoil strip of main compound area, view south-east

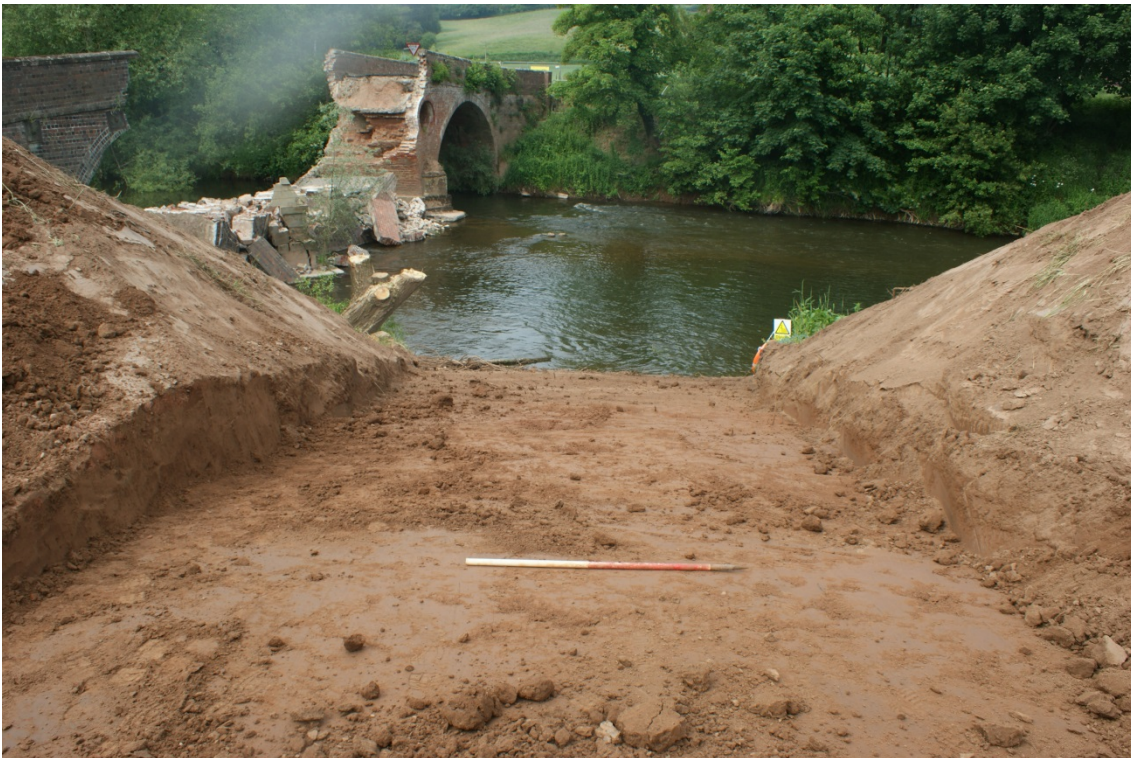
No clear geological deposits were present although a mid red-brown silty clay deposit (102) was seen at points on the slope down to the river which may have been the top of the natural deposits, but may similarly have been an undated alluvial deposit (Plates 2-3).

The topsoil and subsoil profile was clearly visible in the strip for the access ramp on the bank sloping down to the river (Plates 2 and 3).

Plate 2 Topsoil strip for access ramp down the riverbank, view north

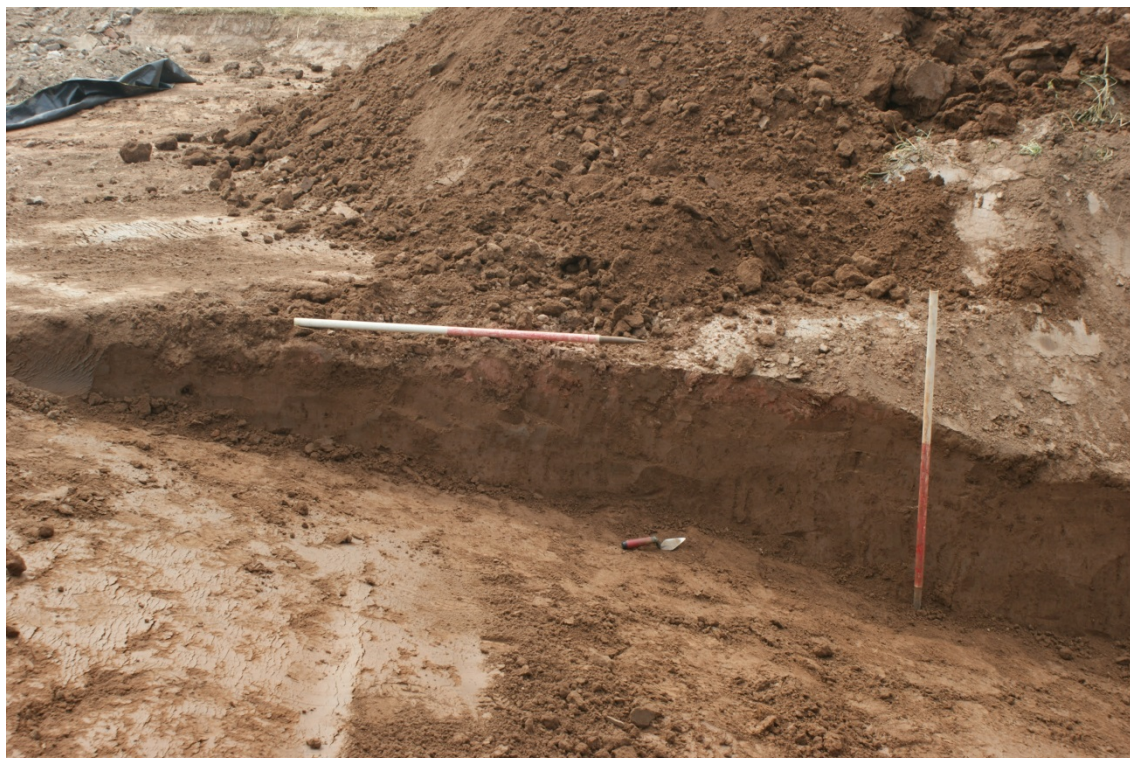
Plate 3 Topsoil strip for access ramp down the riverbank, west section, view west

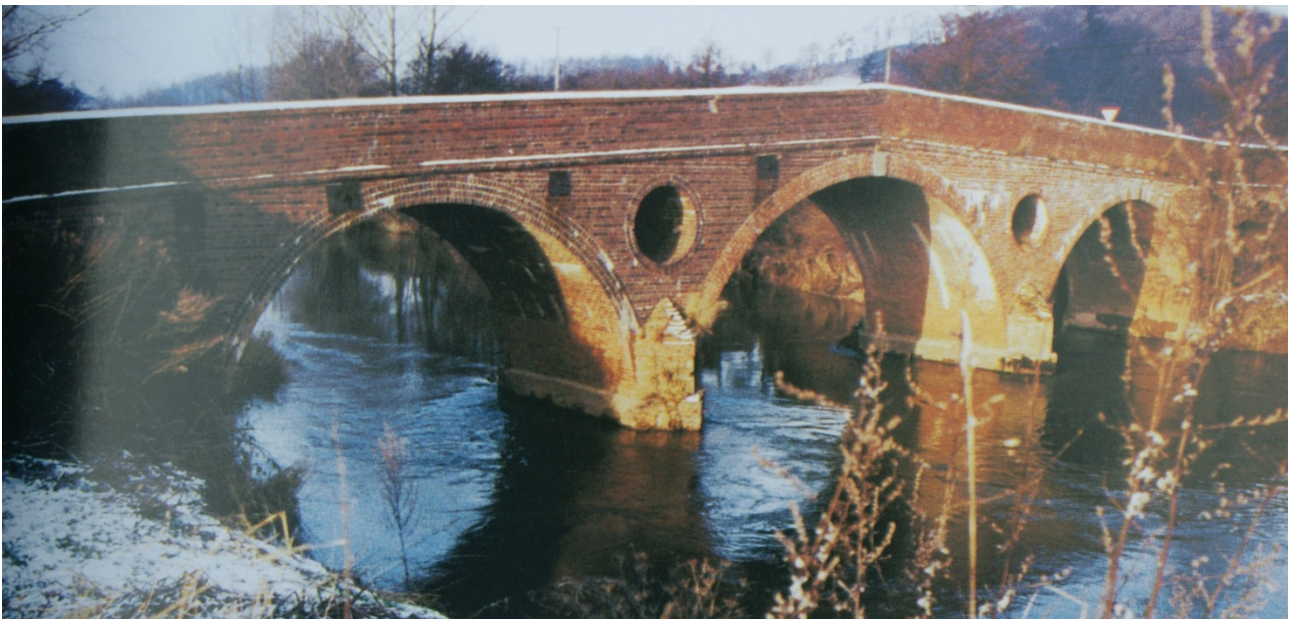
The bridge as it remained before its collapse kept the general shape and layout of its first phase (Plates 10 and 17). This can be seen by the two piers within the river which were not rebuilt in Phase 2 or after. These positions demonstrate that the bridge was designed with three arches, the central arch being slightly wider than the two others. Only about one third of this phase of the bridge remained after the Phase 2 rebuild.

The extent of the works can be seen from a late 20th century photograph of the bridge (Plate 10), which compares closely with the intended repairs (Plate 9), the only significant visual difference being a change in the height of the side wall.

Plate 10 Late 20th century picture of the bridge, looking north-west (Douglas Opperman 2000)

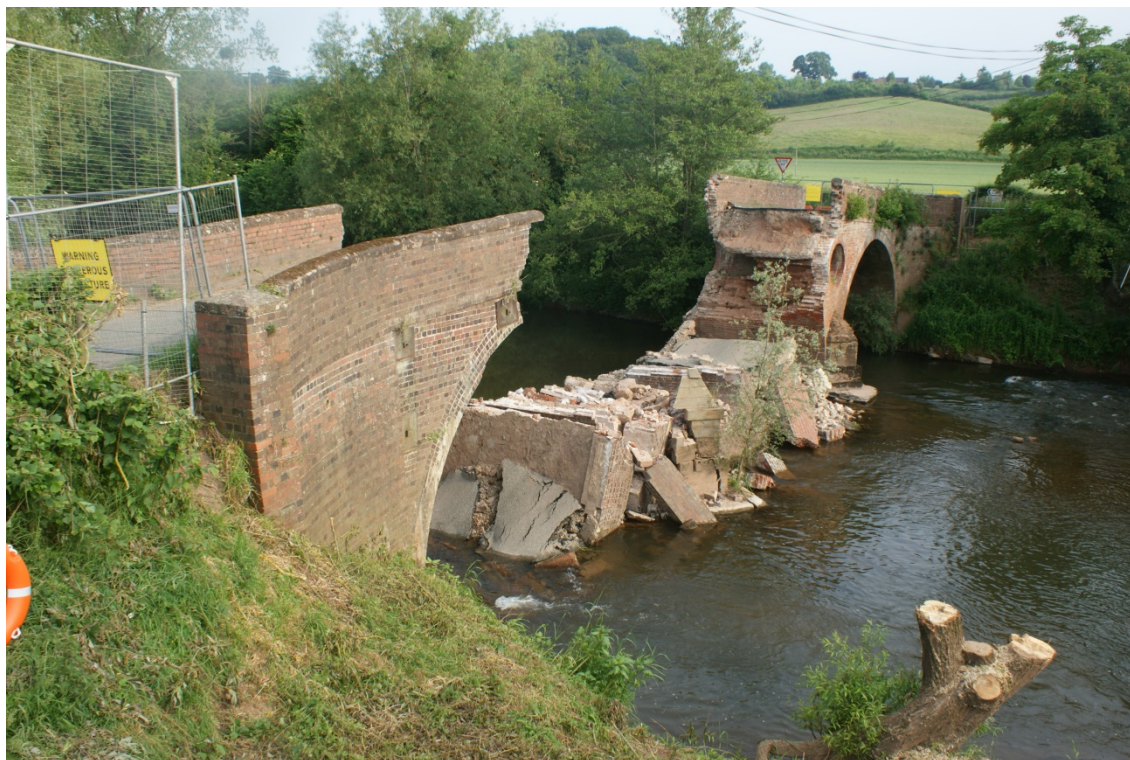
The flanking walls splayed outwards on the northern side, a style copied during the repair work on the southern side (Plate 11). The flanking walls ended at a brick pillar. No original road surfaces remained, presumably having been removed during later alterations. As the debris of the collapsed bridge was removed by machine, no bricks certain to have originated from this phase could be recovered for detailed recording.

Plate 11 The collapsed bridge, view north-west

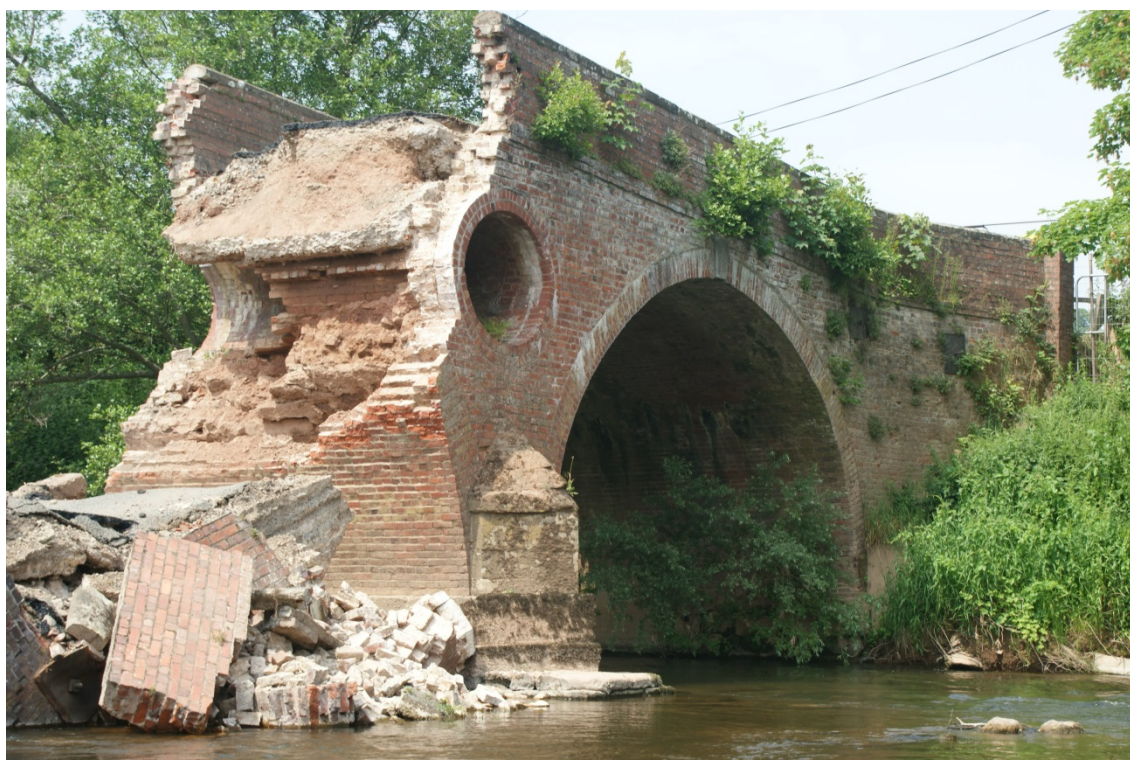
The river was spanned by elliptical brick arches, one and a half bricks length in depth (Plate 12). These arches were further supported by rough stonework on their upper side (Plate 14) and two circular holes within the spandrels above the two piers to allow flood water through, though only one of this phase remained. The fill within the bridge appears to have been compacted clay marl, visible within the section closest to the northern bank (Plate 14). This was held in place by flanking walls either side, also of one and a half brick lengths in width. This wall had a brickwork string course at broadly road surface height and was capped with stones.

Two metal plates (Plate 12), indicating the position of tie rods running through the structure, were visible. These are unlikely to be part of the original design as they were not specified in the original documentation, but were identified as present before the Phase 2 rebuild. This suggests a currently unknown phase of repair of the bridge, which post-dates the watercolour painting of 1830-1853 (Plate 17).

A tarmac road surface with a pipe running along the western side of the road was added at some point in the 20th century, probably along with the hardcore surfaces below (Plate 12). In the late 20th the bridge was repointed and some areas of brickwork repaired, although these alterations were not obvious after the bridge had collapsed.

Plate 12 The collapsed bridge, view north-west

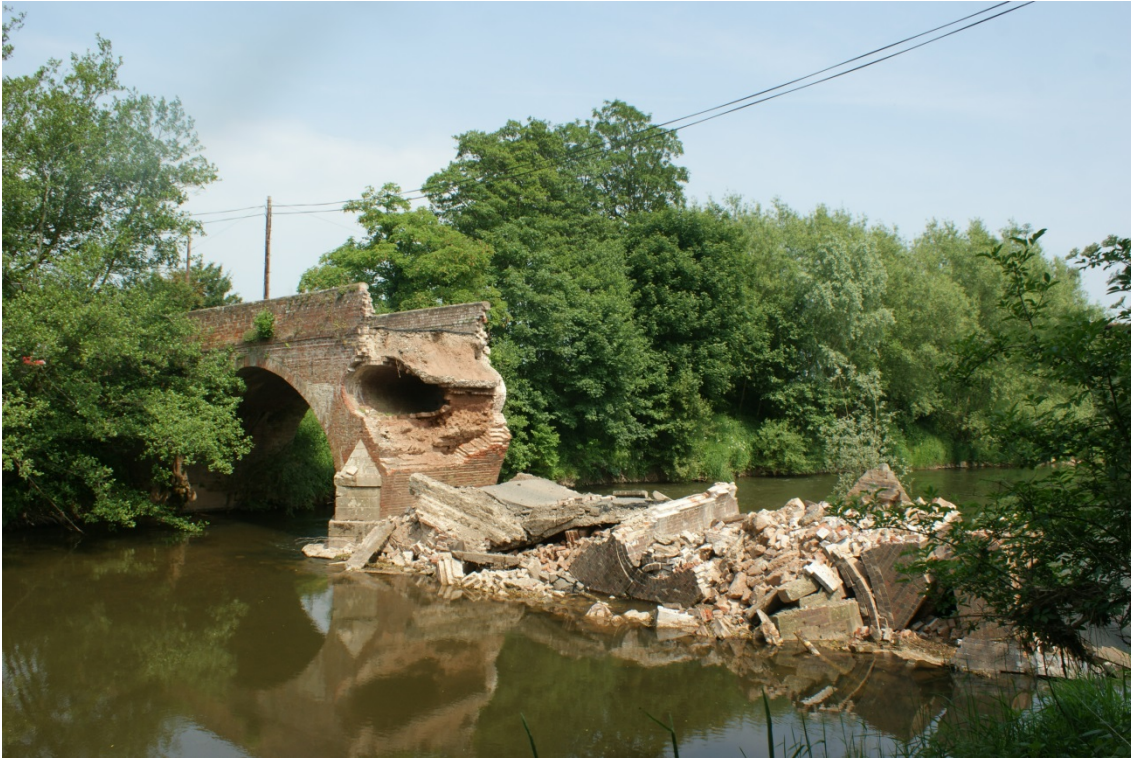
Plate 13 The collapsed bridge, view north-east

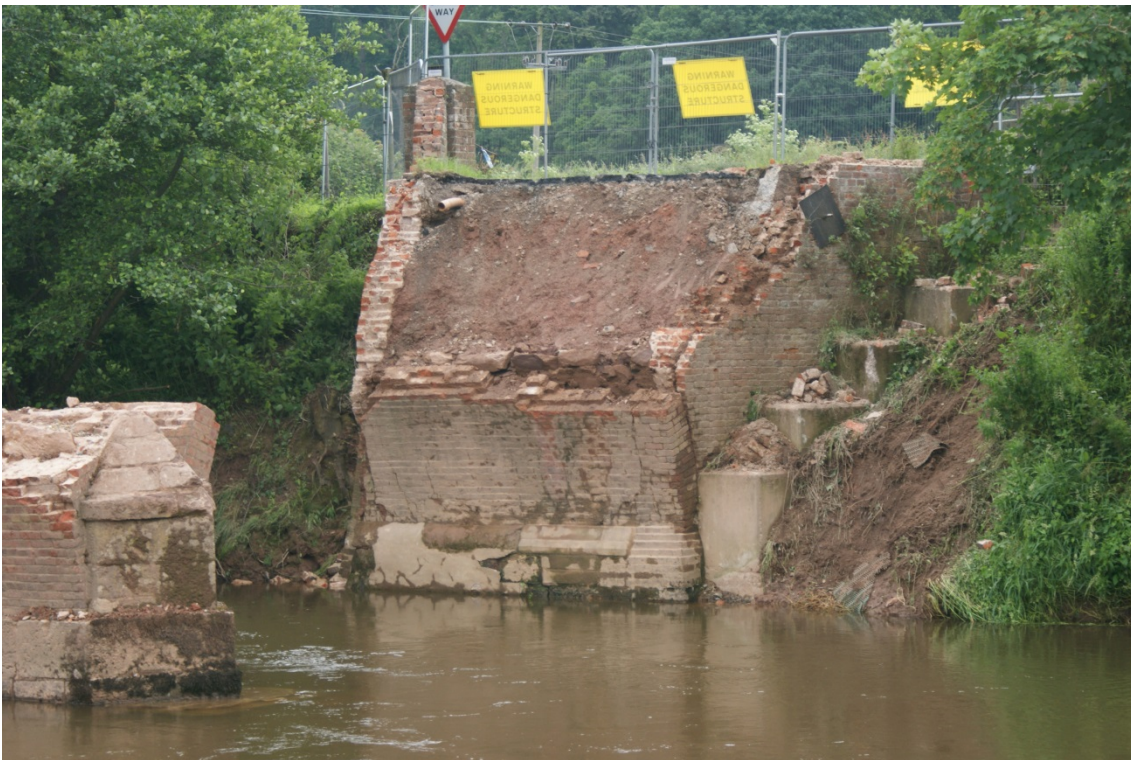
have been limestone, a rock type which was available locally. Sandstone ashlar, also available locally, was visible on the northern side closest to the bank at water level (Plate 14).

Plate 14 The north spring of the bridge and northern pier after the removal of much of the structure, showing the original infill, ashlar blockwork at its base and stonework backing the brick arch, view north-west

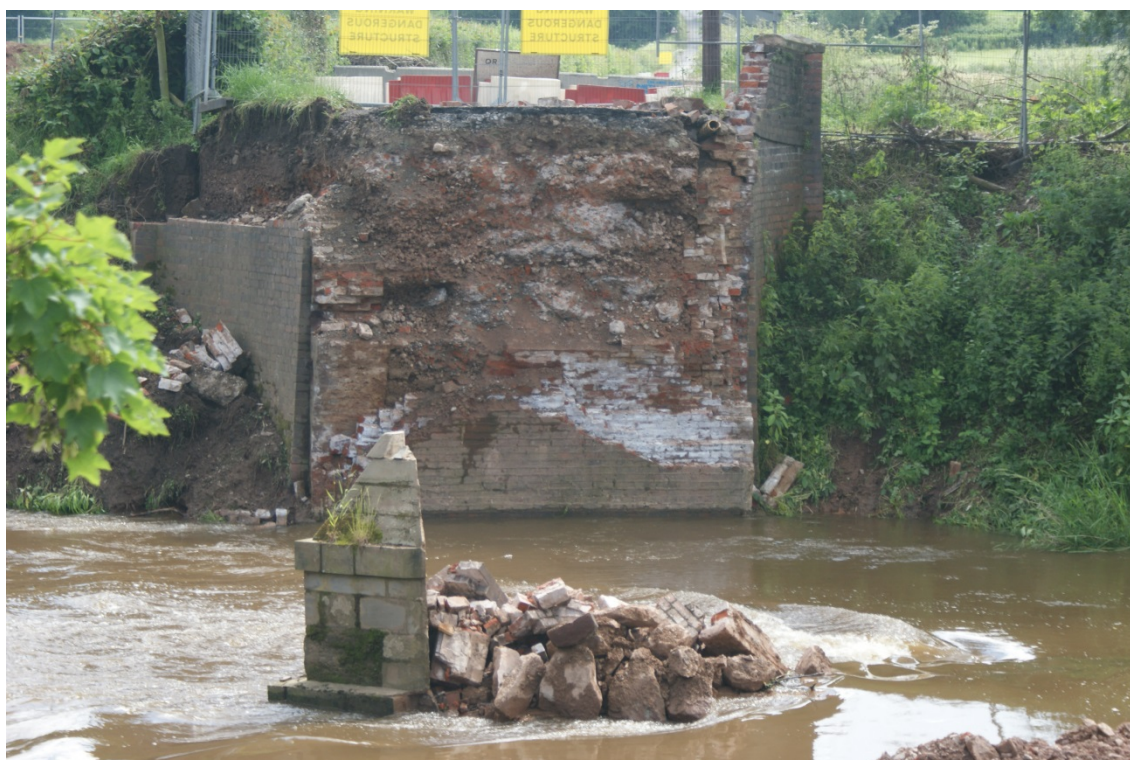
Plate 16 The south spring of the bridge and southernmost pier, showing the 1898 infill, view

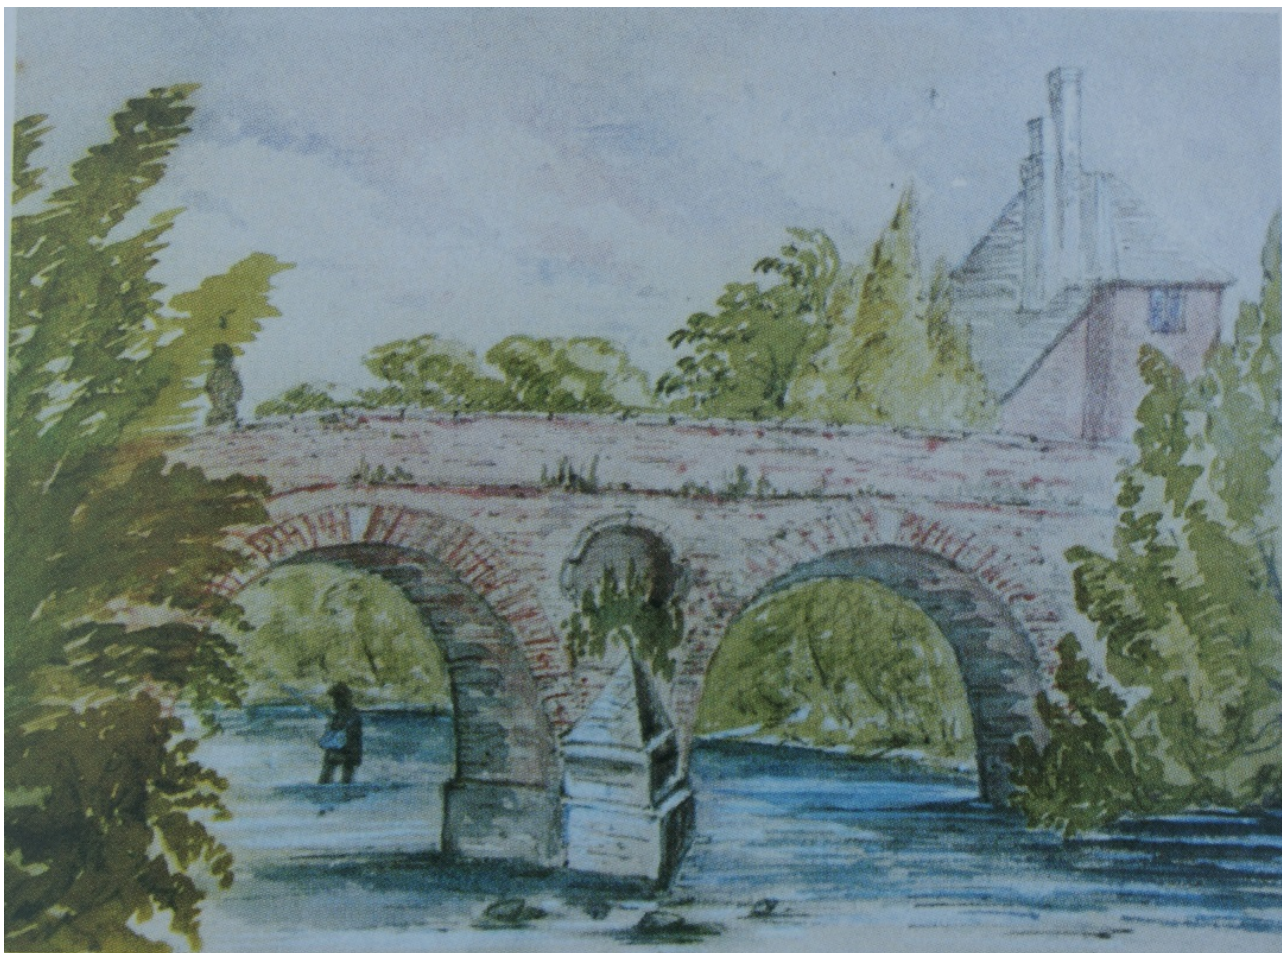
Plate 17 Watercolour painted by William Lea between 1830 and 1853, view north-west (reproduced in Douglas Opperman 2000; from Museums Worcestershire collections)
