Archaeological watching brief and building recording at Eastham Bridge, Eastham, Worcestershire

Status: Revision 2: 30 March 2017

Project reference: P4867

Report reference: 2367

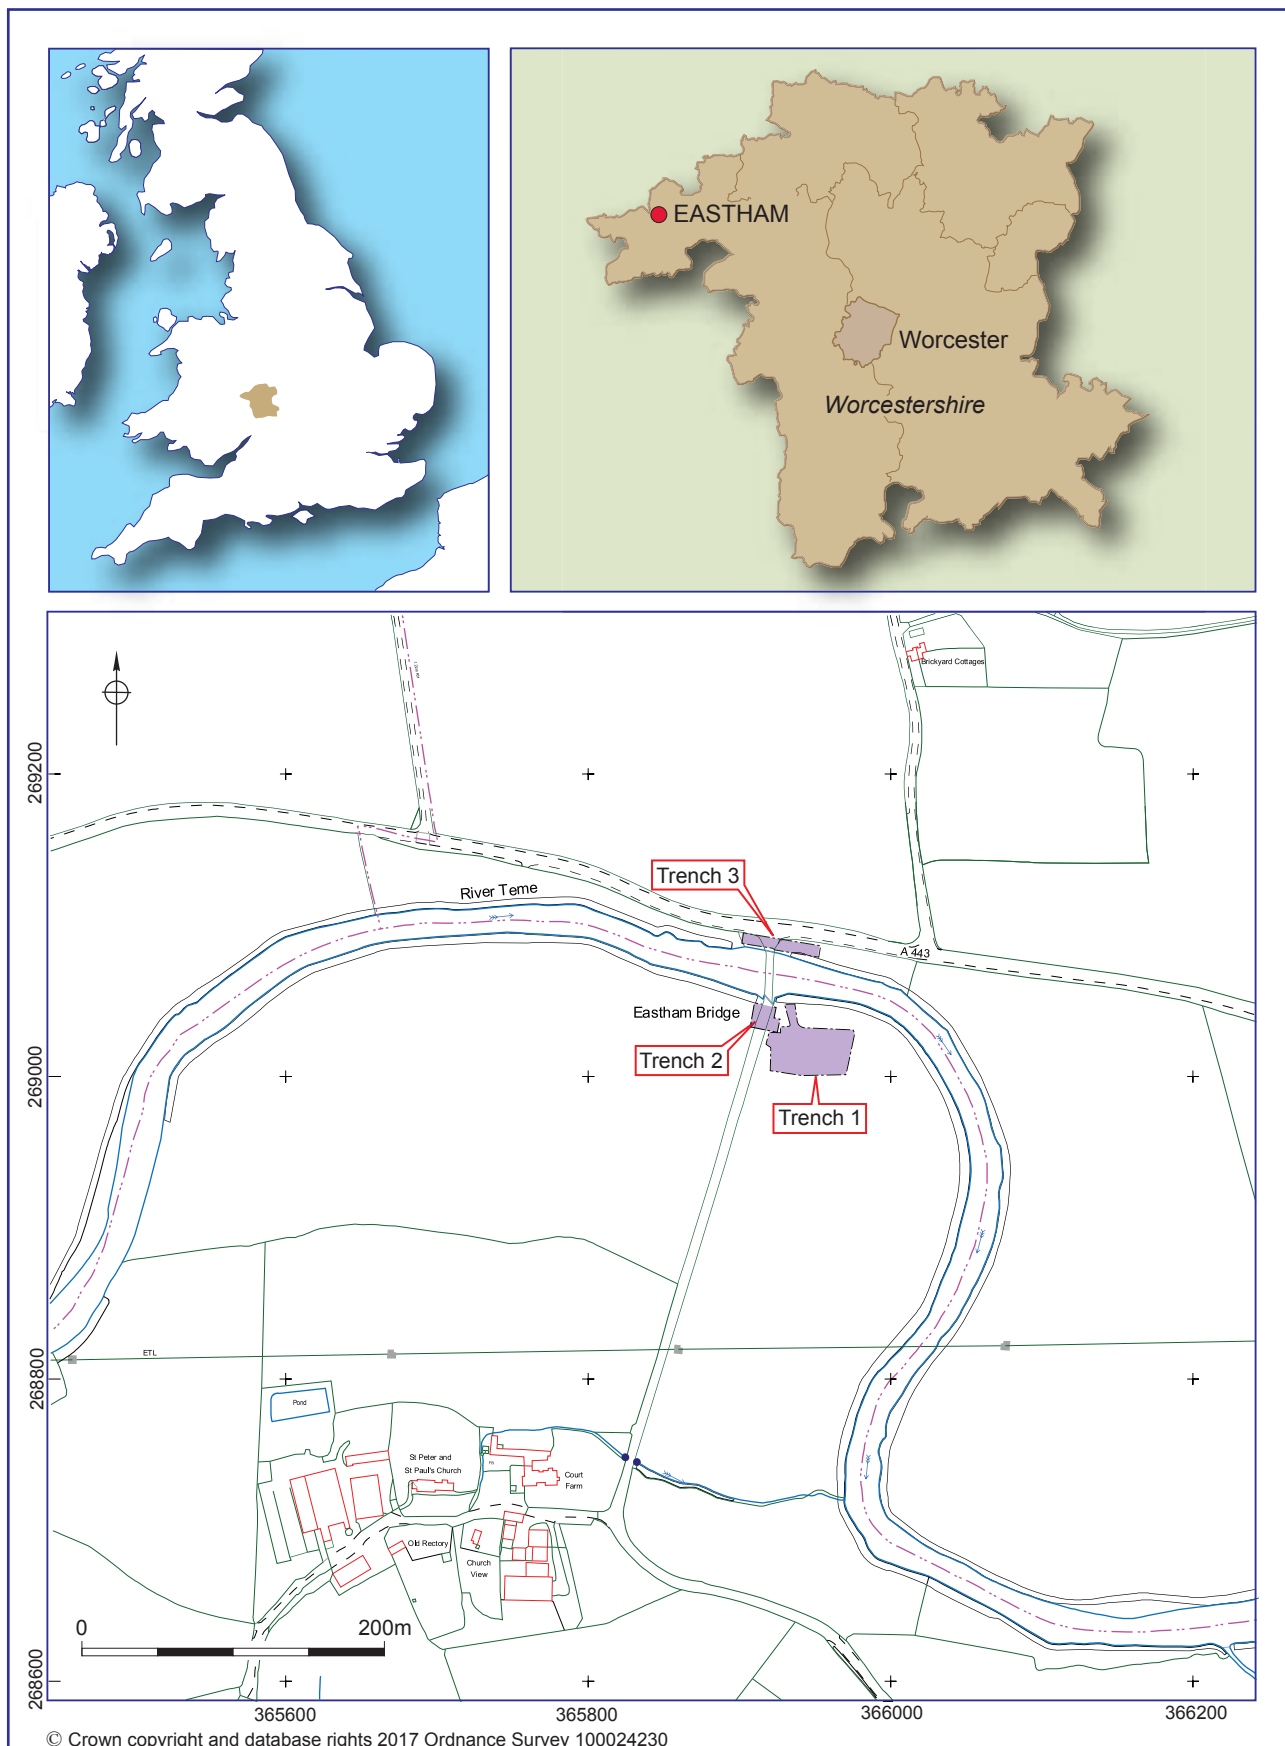
Figure 1

Topsoil (100, 200 and 300) was a firm mid brown clay, which was noted across all three areas, to a depth of approximately 0.25m. The topsoil and subsoil profile was clearly visible in the strip for the access ramp on the bank sloping down to the river (Plate 9 to Plate 11; Fig 1: Trench 1).

Location of the site and watching brief trenches

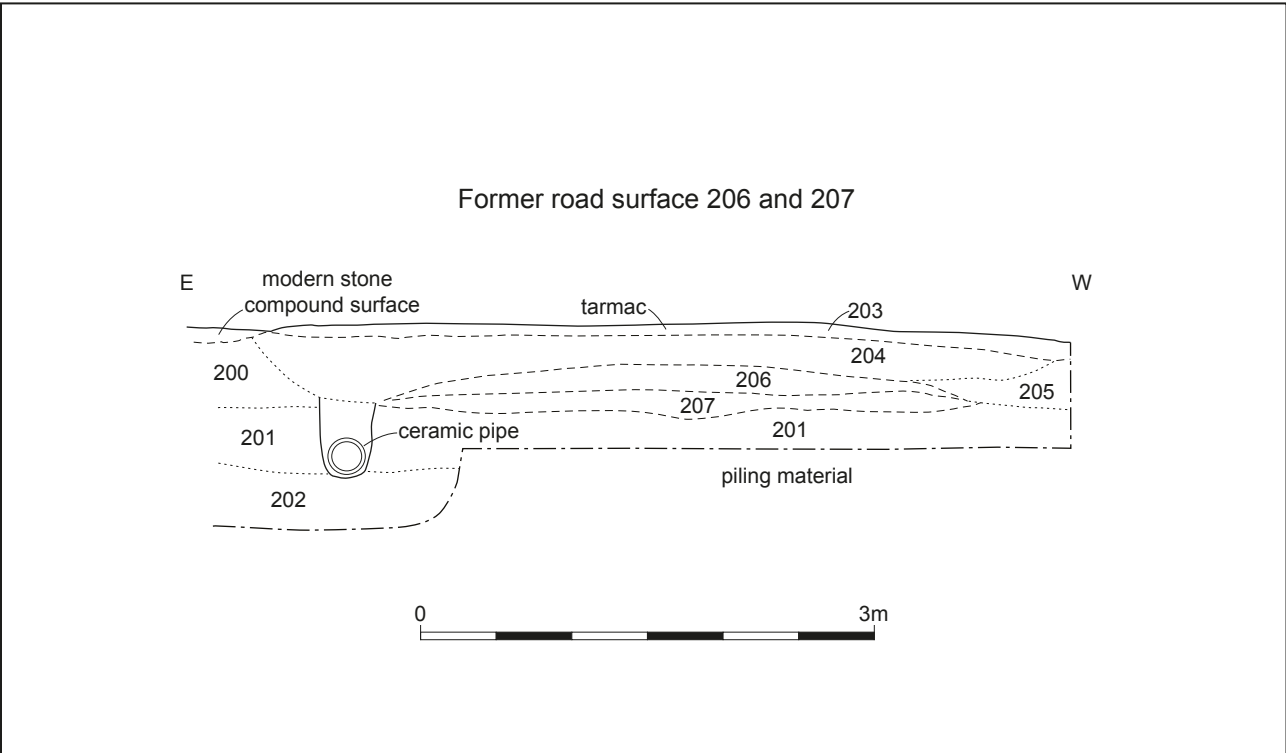
Figure 4

Within Trench 2, an earlier road surface was present under the modern road (201) (Plate 13 and Plate 14; Fig 4). This was 4.10m wide and extended to a depth of 0.38m, with a noticeable camber to either side from the centre. Its top layer (206) consisted of a sub-rounded stones within a compact white lime matrix. Below this was a layer of sub-rounded stones (207) within a light pink clay matrix, likely to have been a bedding layer for (206). A light brown grey silt layer (205) had built up in the eastern side of the road.

Trench 2: section through road south of bridge (see Fig 5 for location)

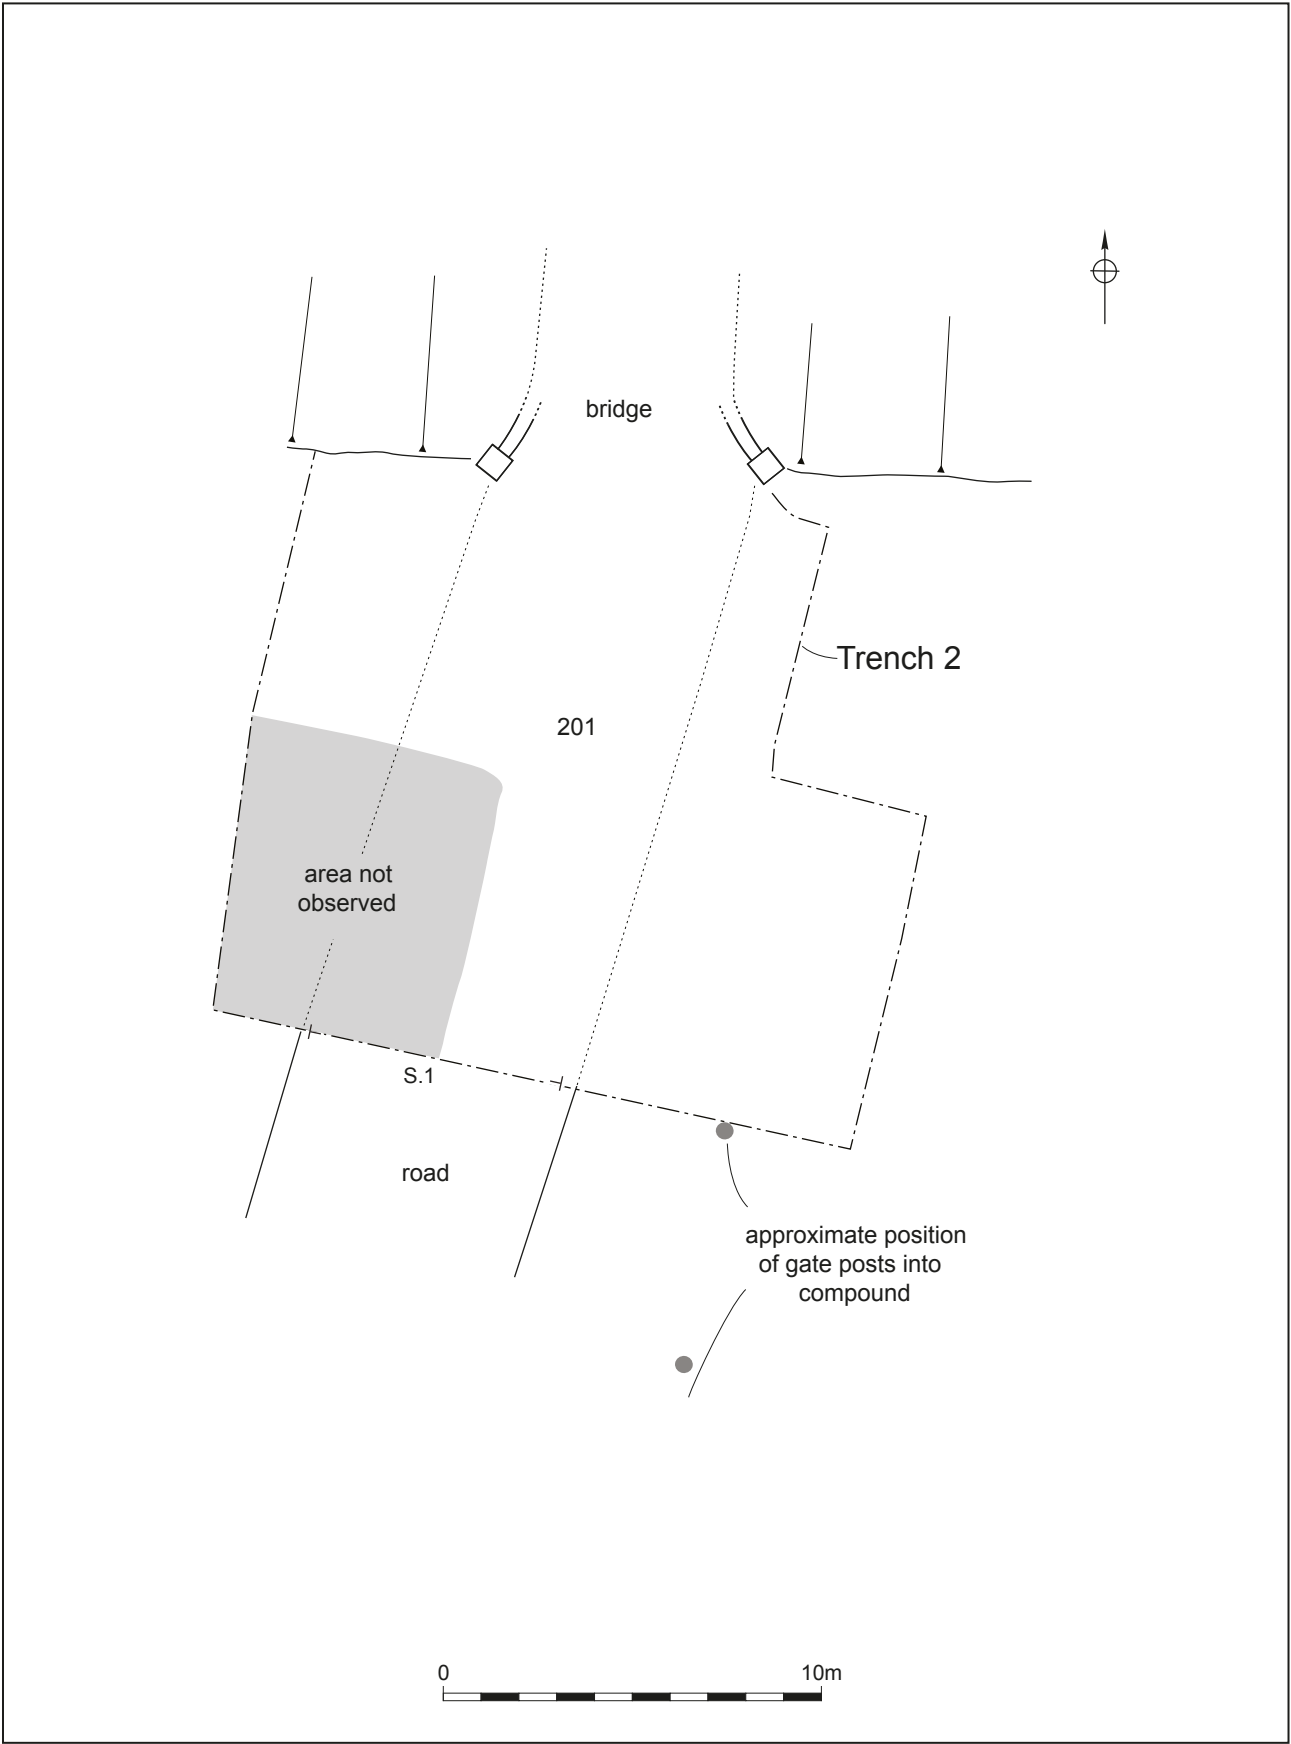
Figure 5

Plan of Trench 2

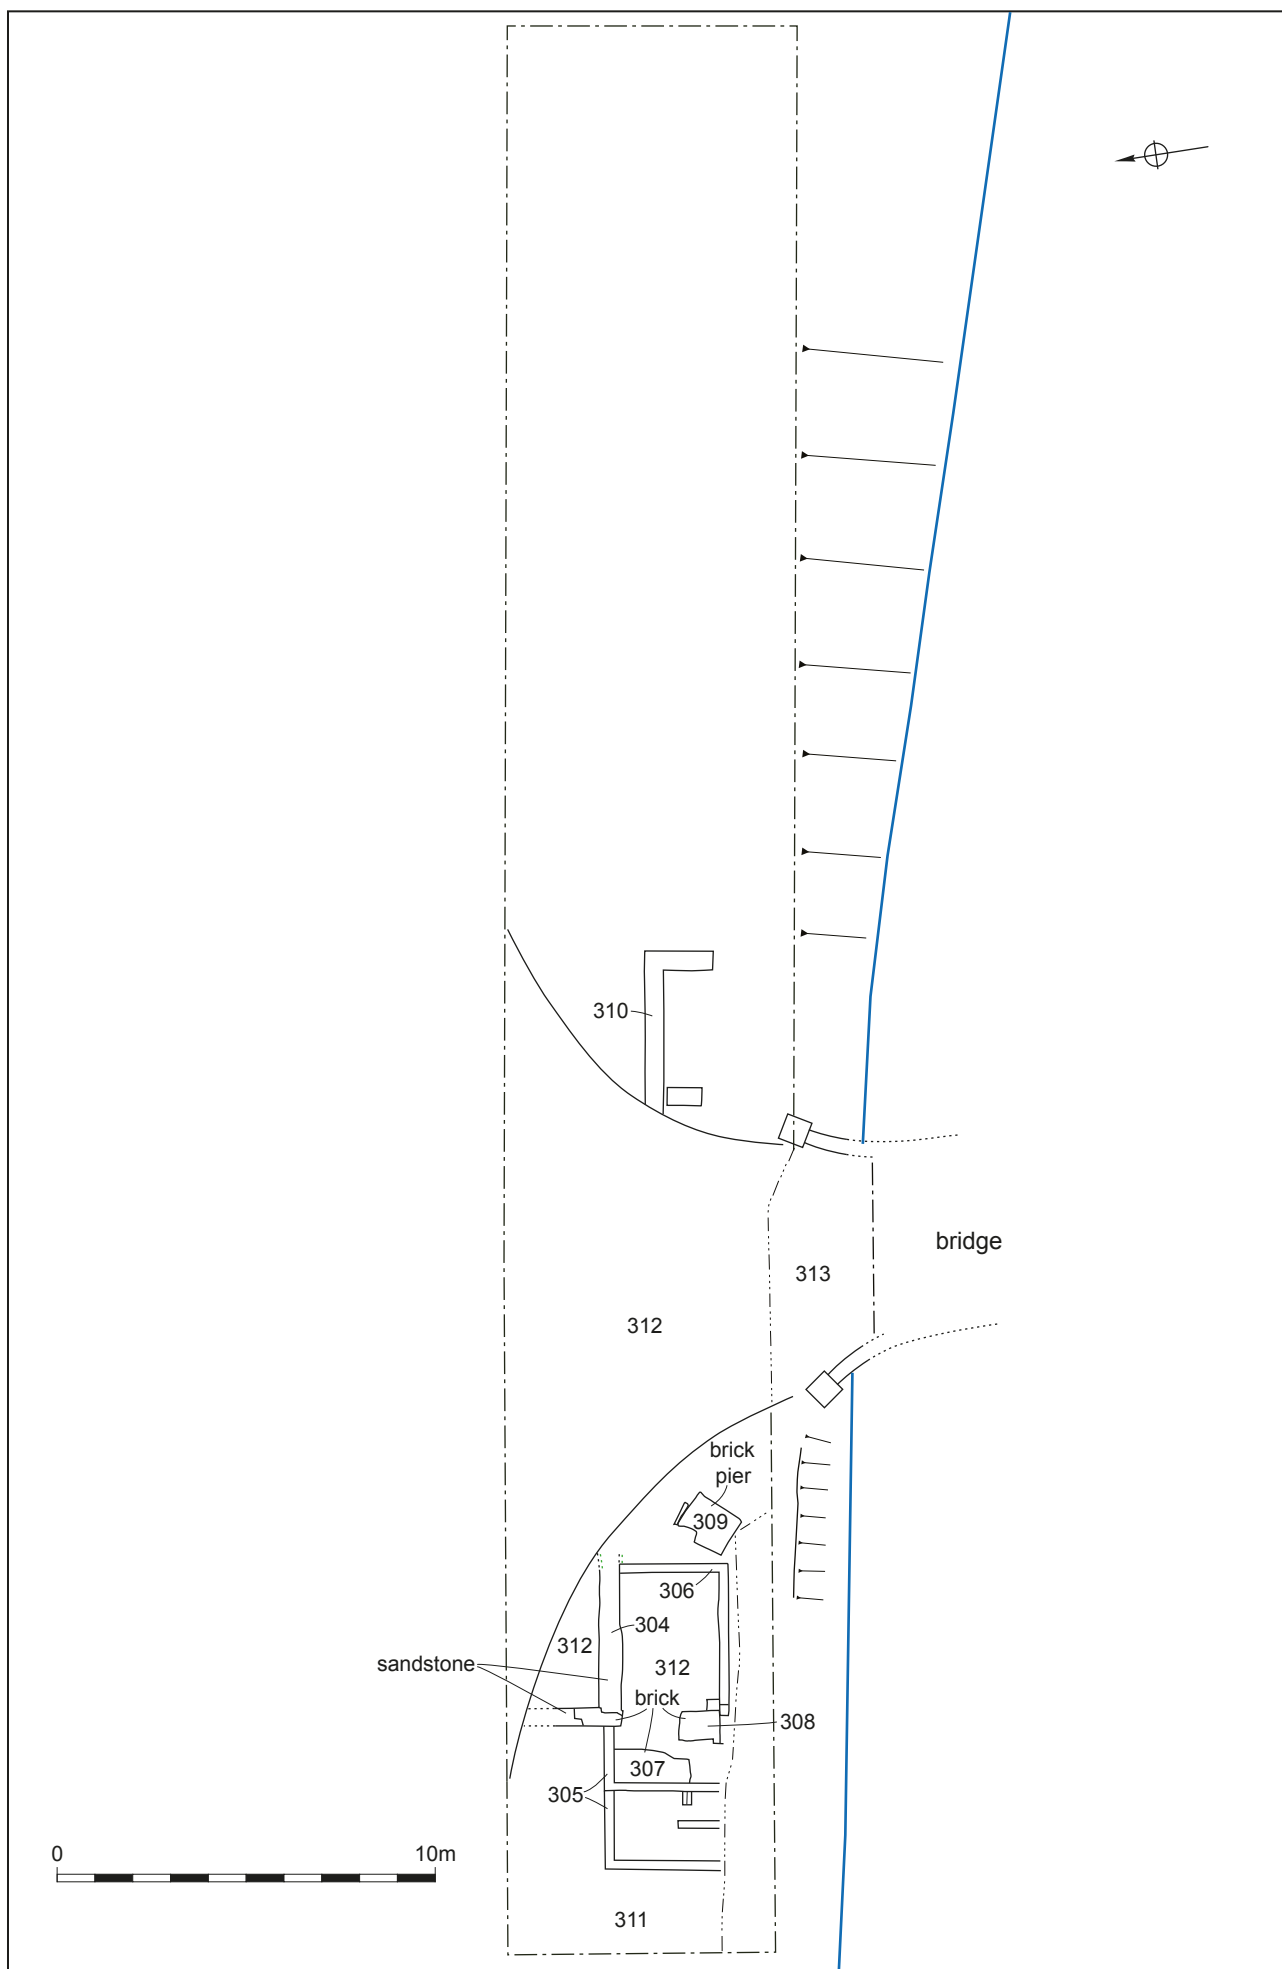
Figure 6

Also within Trench 3, a series of walls were present. Wall (304) (Plate 16; Fig 6) consisted of a foundation of rubble sandstone, with one small area of brick on the south-east corner, indicating that the structure above was originally brick built. The structure was 5.80m long and truncated on the northern side by the modern road, indicating that it may have been demolished when the road was widened to its present width. This corresponds closely to the position of the toll house visible

Butted onto the south of wall (304) was further brick wall foundation (306) which created a small room on the south side of the toll house, further added to with walls (305). Two areas of brick flooring remained intact (307 and 308). A single squared stone at the east end of wall (308) suggests a doorway position at this point, as confirmed by break in the wall and a possible small slate drain. Structures are not depicted on the 1839 tithe plan, but are shown in the painting which predates 1853. The painting depicts them as having a cat slide roof, so ground floor only. All of the brick structures cut deposit (311) which was soft light brown silt sand, possibly a levelling deposit associated with the initial construction of the toll house and bridge.

A further small surface constructed of flat laid bricks (309) (Plate 17; Fig 6) partially remained, aligned in a north-east to south-west direction, between the toll house to the bridge. On the north-east side of the bridge was a further wall (310) (Plate 18) which formed a corner and is likely to have been part of a wall running up to the bridge, as seen on the 1903 map (Fig 3). These structures had concrete footings and are likely to be late 19th century or early 20th century alterations.

Plan of Trench 3 north of bridge with toll house footings to west

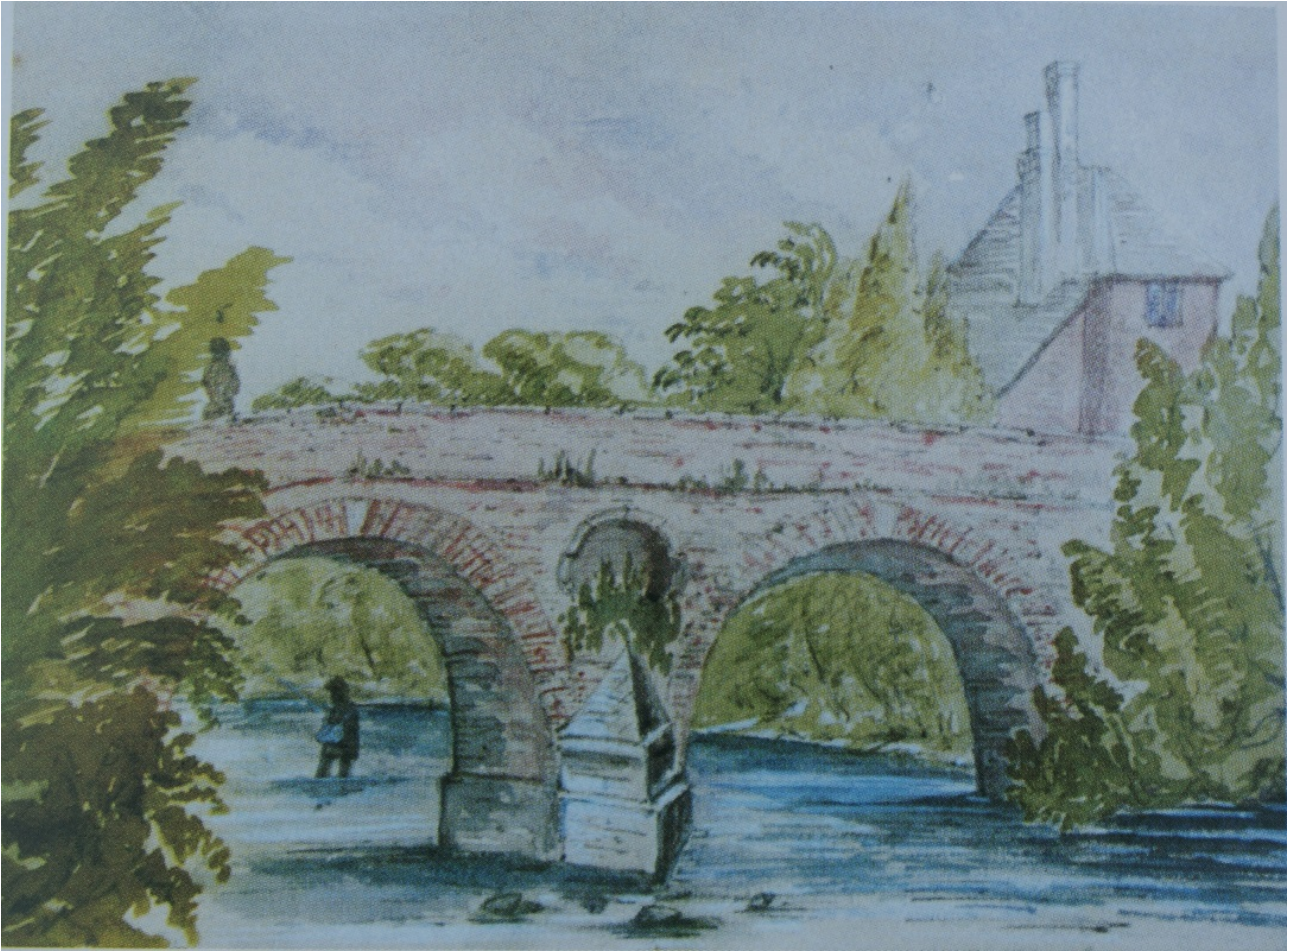
A painting of 1830-1853 shows the northern half of the eastern elevation of the bridge and the toll house adjacent on the north bank (Plate 6; Figs 3 and 6), which was demolished in the early 20th century.

on the 1839 tithe plan and Ordnance Survey maps up to 1903 (Figs 2 and 3) and a mid-19th century painting (Plate 6). The painting shows the building as rectangular and aligned east to west, which would make (304) the longer dimension of the building. This would have made for a small single room building, with one room above, as suggested in the painting.

Plate 6 Watercolour by William Lea, between 1830 and 1853, view north-west (reproduced in Douglas Opperman 2000; from Museums Worcestershire collections)
