Recording of Ladygrove Stone Wall, Lawley Phase 11, Lawley Village, Telford, Shropshire

Worcestershire Archaeology
for Persimmon Homes

April 2020

Wall recording report

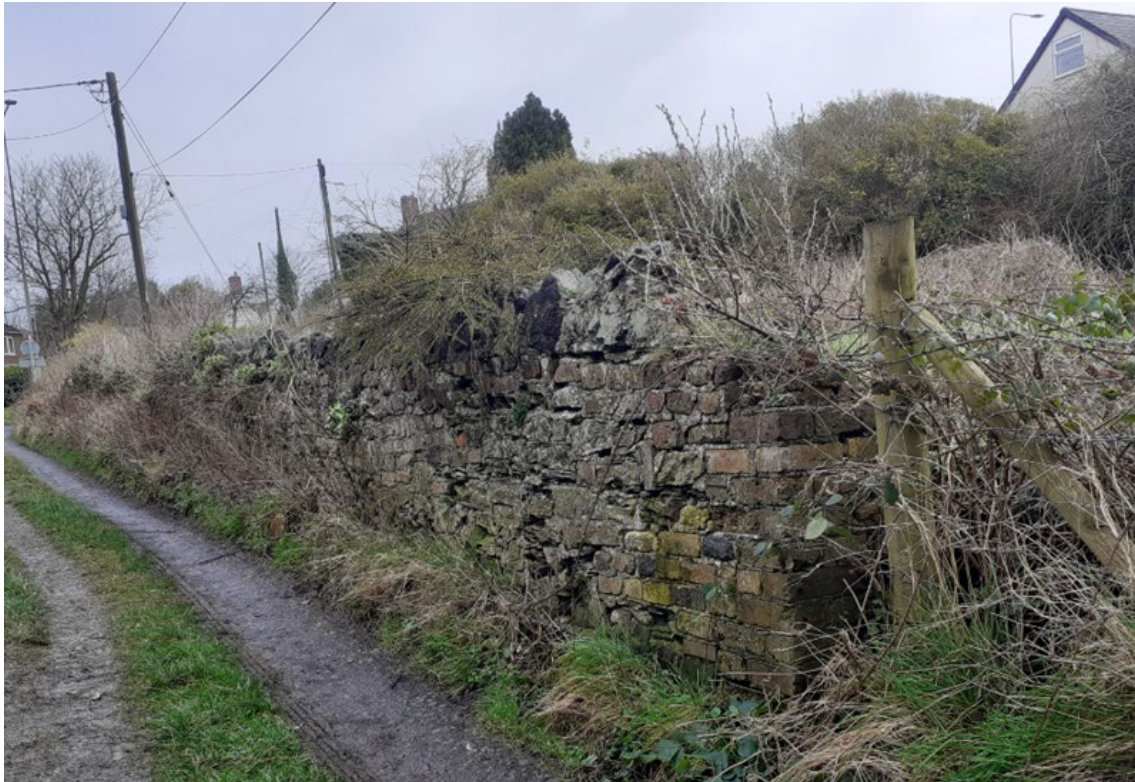
Plate 1 The wall, south end, looking north-east

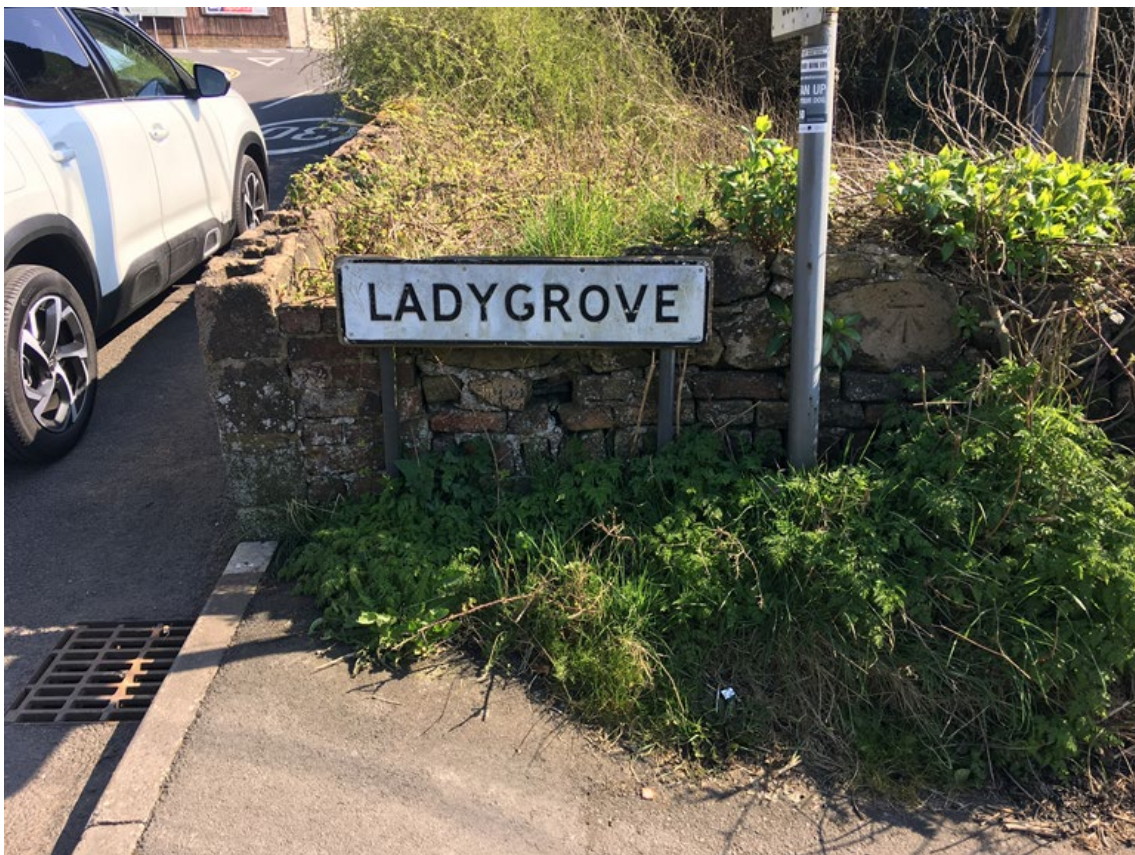
The wall (Plate 1 to Plate 7) is aligned in a broadly north-east to south-west direction on the eastern side of Ladygrove track, at its northern junction with Station Road. It was built primarily of undressed rubble stonework with inconsistent coursing, using a large variety of stone sizes. A benchmark has been carved into one of the stones at the northern end (Plate 2), registered at a 193.36m AOD. The wall is sporadically covered in dense patches of vegetation.

Plate 2 The wall, north end, at the junction of Ladygrove and Station Road, looking south-east

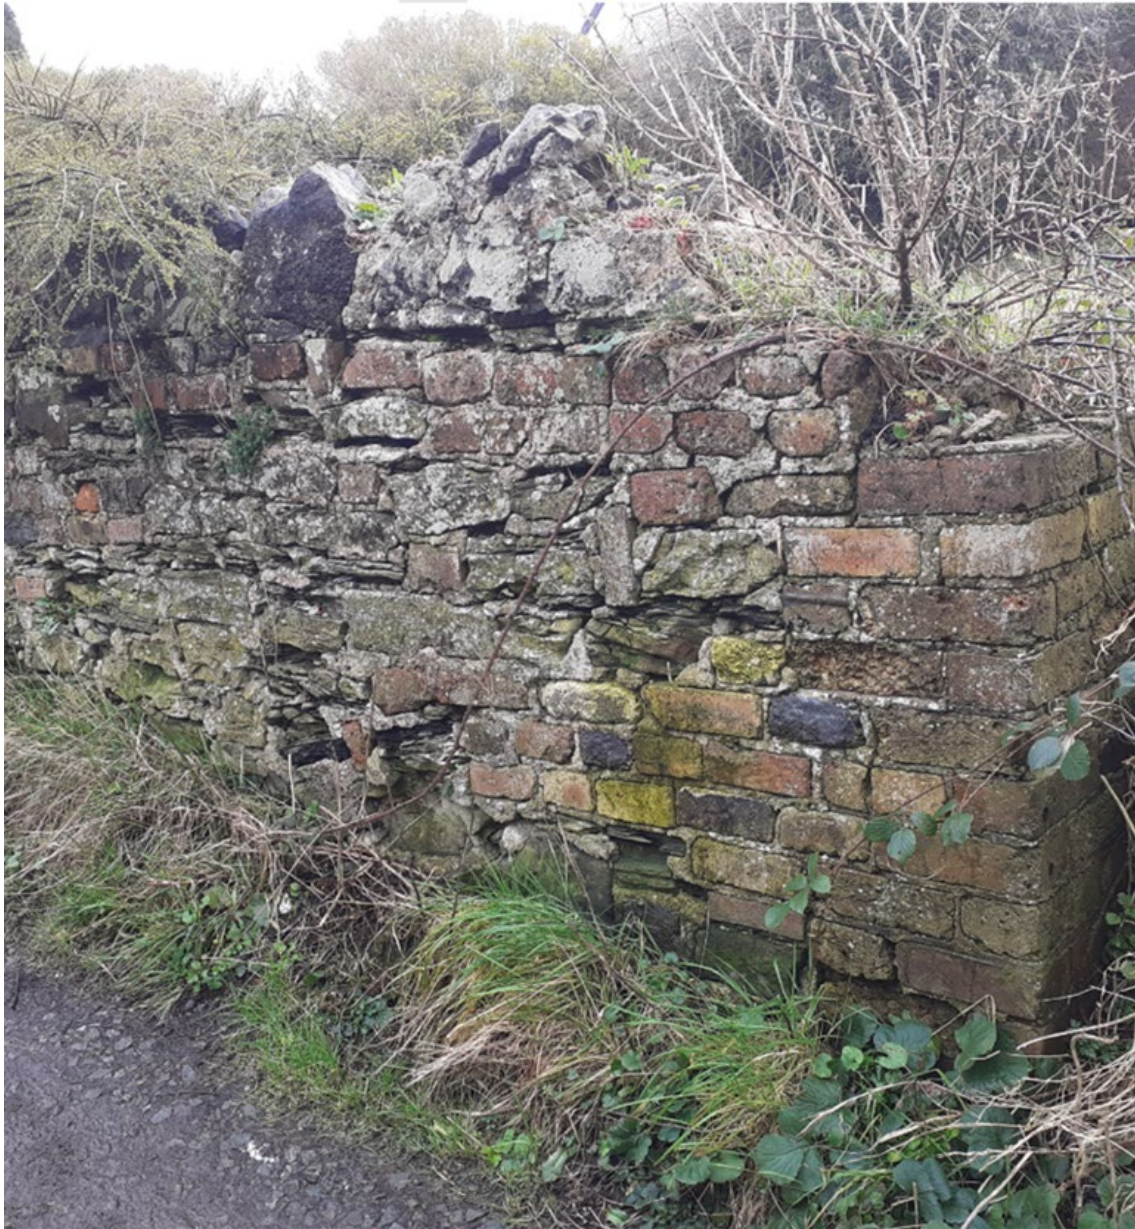
Plate 3 The wall, detail of south end, looking north-east

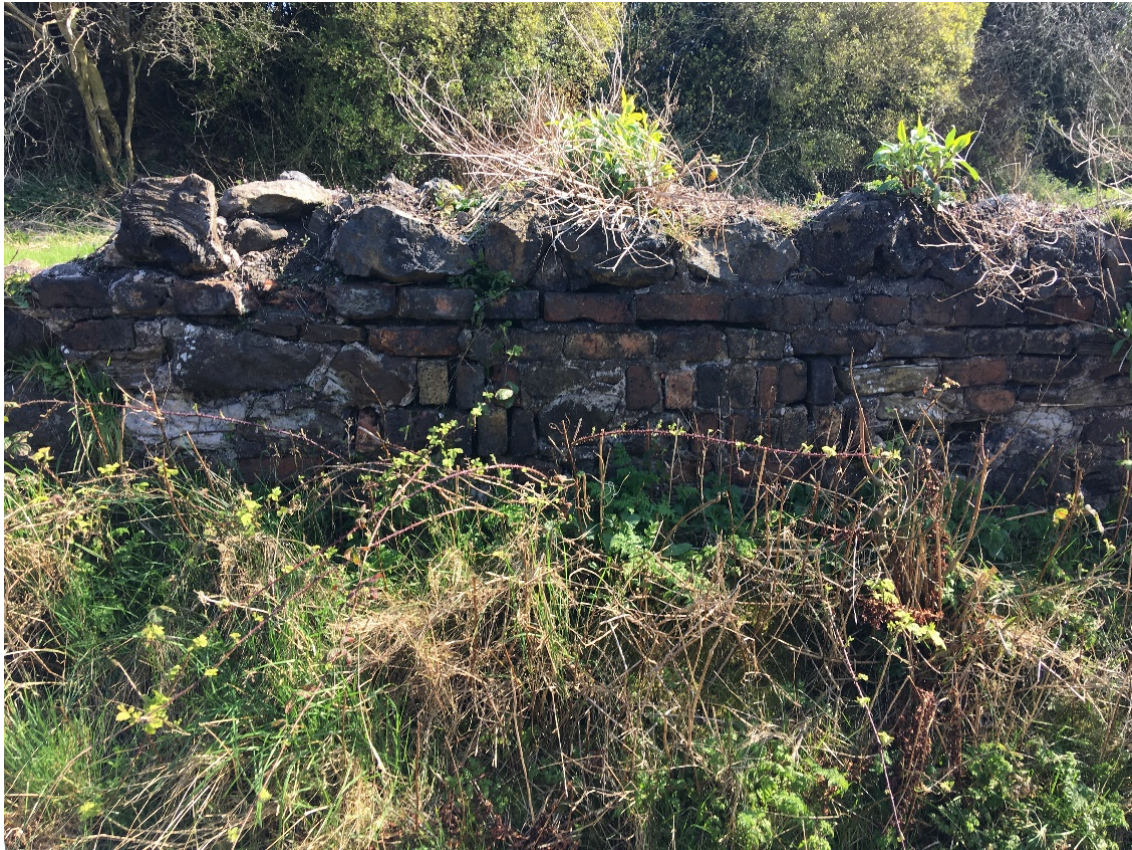
Brick of varying width and colour were used at structural key points such as its end in order to gain a squared and neat edge. Whilst these were more typically laid in horizontal coursing, they were of both whole and partial bricks, with most laid stretcher along the direction of the wall and others across with the headers showing. Occasionally, some bricks were vertically placed. Brick appears to have been the predominant material used in repair as there were a number of patched areas in the wall. It is possible that some of these were blocked vertical openings (Plate 4 and Plate 5), although these were not consistently vertical and much more likely to be patch repairs.

Plate 4 The wall, looking south-east

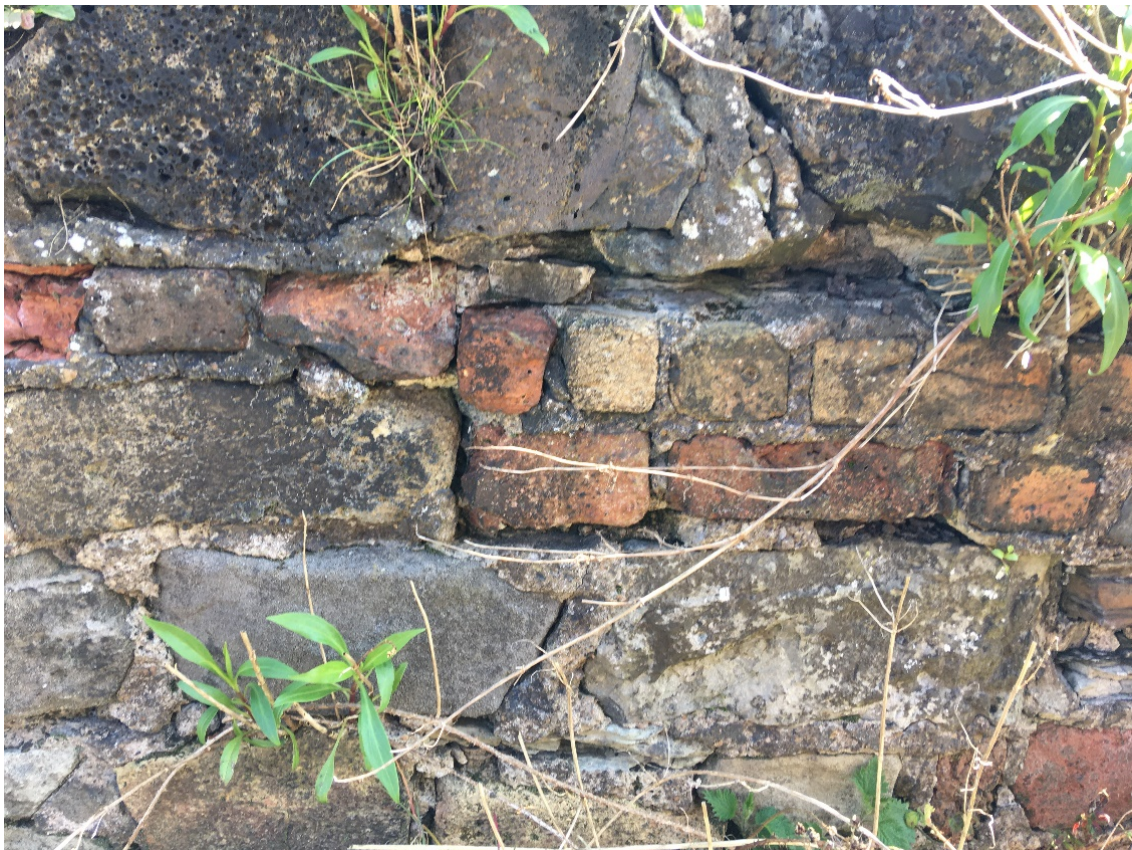
Plate 5 The wall, detail, looking south-east

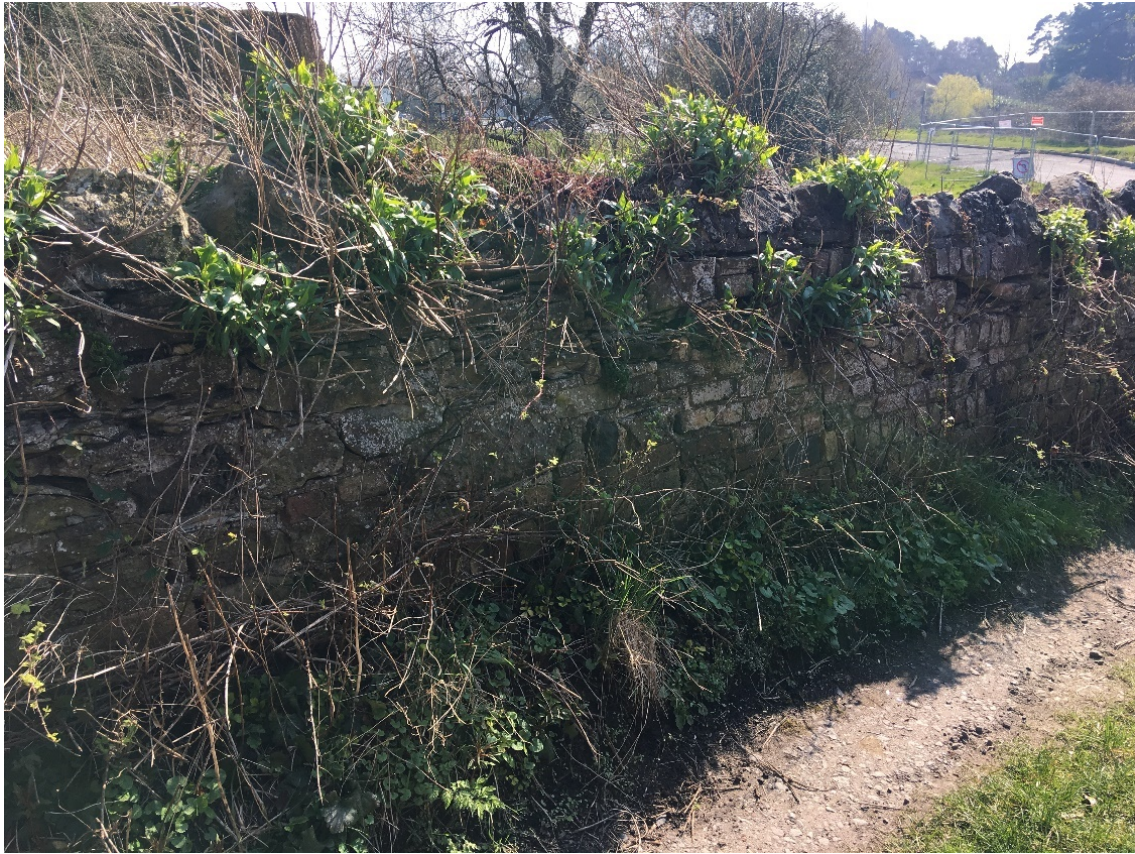
Plate 6 The wall, looking south

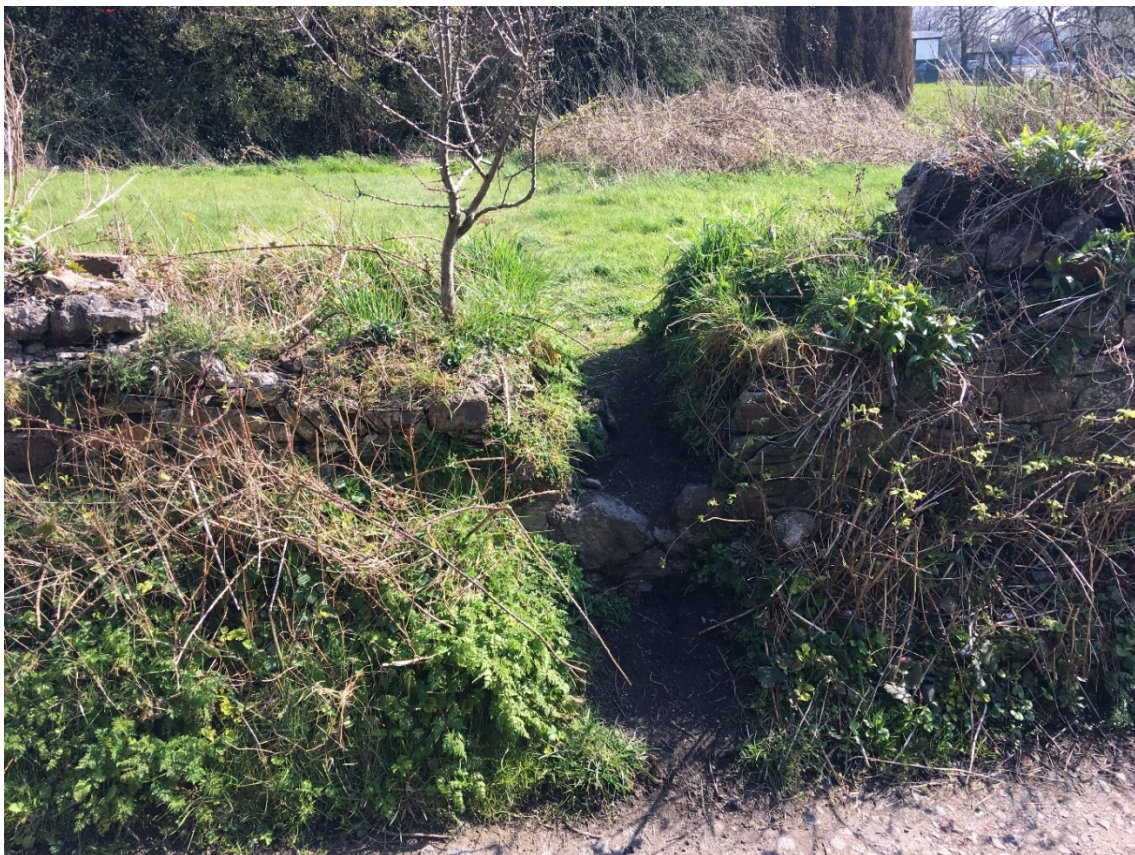
Plate 7 The wall showing some deterioration in its condition, looking south-east
