# Heritage statement for Eastham Bridge, Eastham, Worcestershire

Status: **Version 1**  
Date: **October 2018**  
Author: Tim Cornah, [tcornah@worcestershire.gov.uk](mailto:tcornah@worcestershire.gov.uk)  
and Tom Vaughan, [tvaughan@worcestershire.gov.uk](mailto:tvaughan@worcestershire.gov.uk)  
Illustrator: Carolyn Hunt, [chunt@worcestershire.gov.uk](mailto:chunt@worcestershire.gov.uk)

A heritage statement was prepared for Eastham Bridge, Eastham, Worcestershire (NGR SO 65917 69060). It was commissioned by Worcestershire County Council, following the collapse of the Grade II listed structure on 24 May 2016, and discussions between Malvern Hills District Council and Historic England.

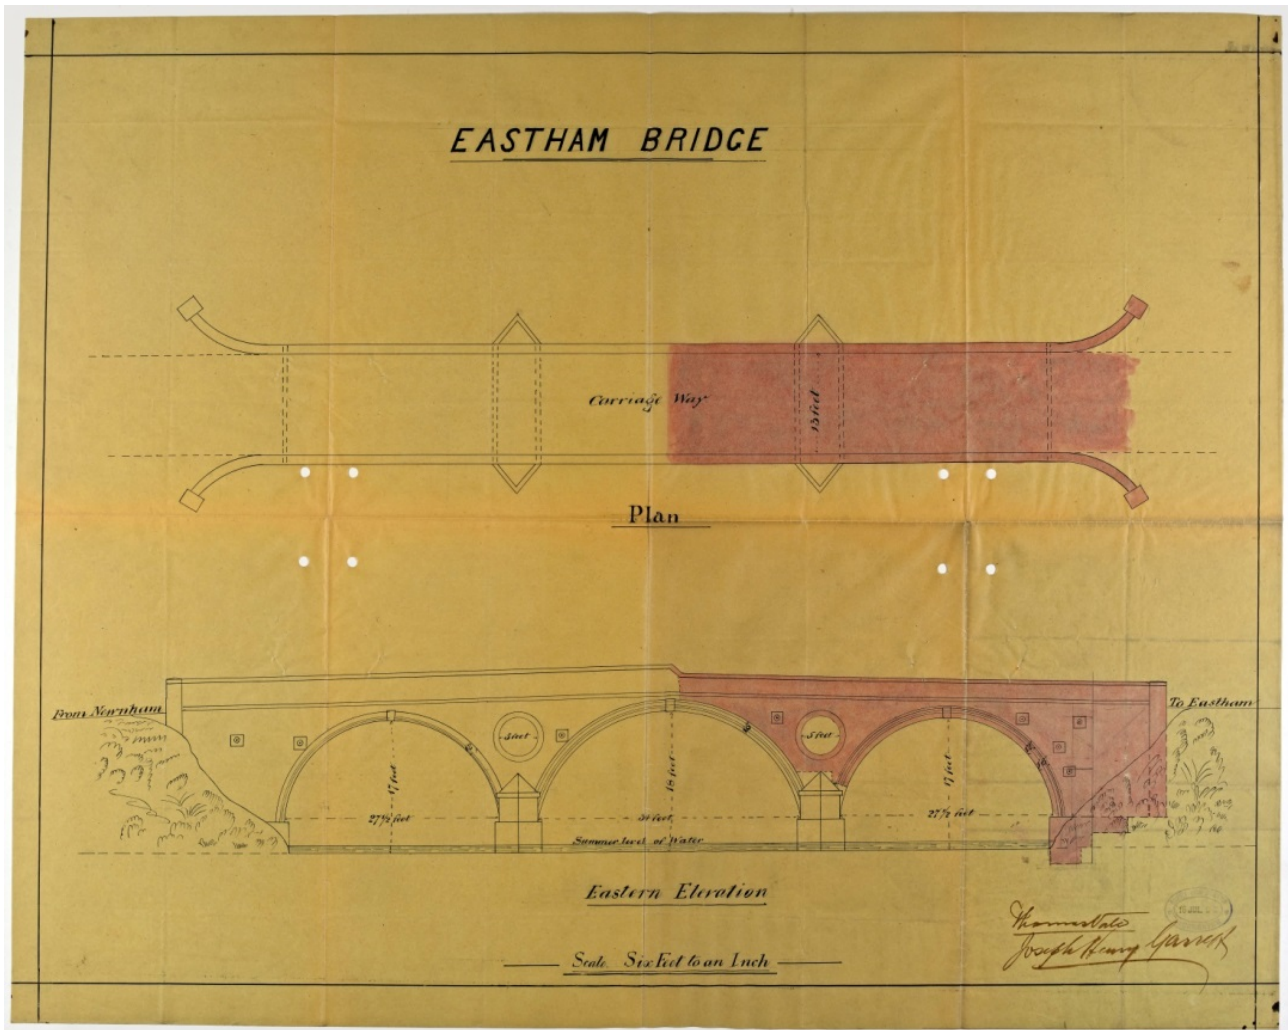
The extent of the works can be seen from a late 20<sup>th</sup> century photograph of the bridge (Plate 8), which compares closely with the intended repairs (Plate 7), the only significant visual difference being a change in the height of the side wall.

Plate 7 Illustration showing the intended 1890s repairs (in pink; identified as the eastern elevation, but it is actually the western elevation; WRO BA2324 ref 250-1)

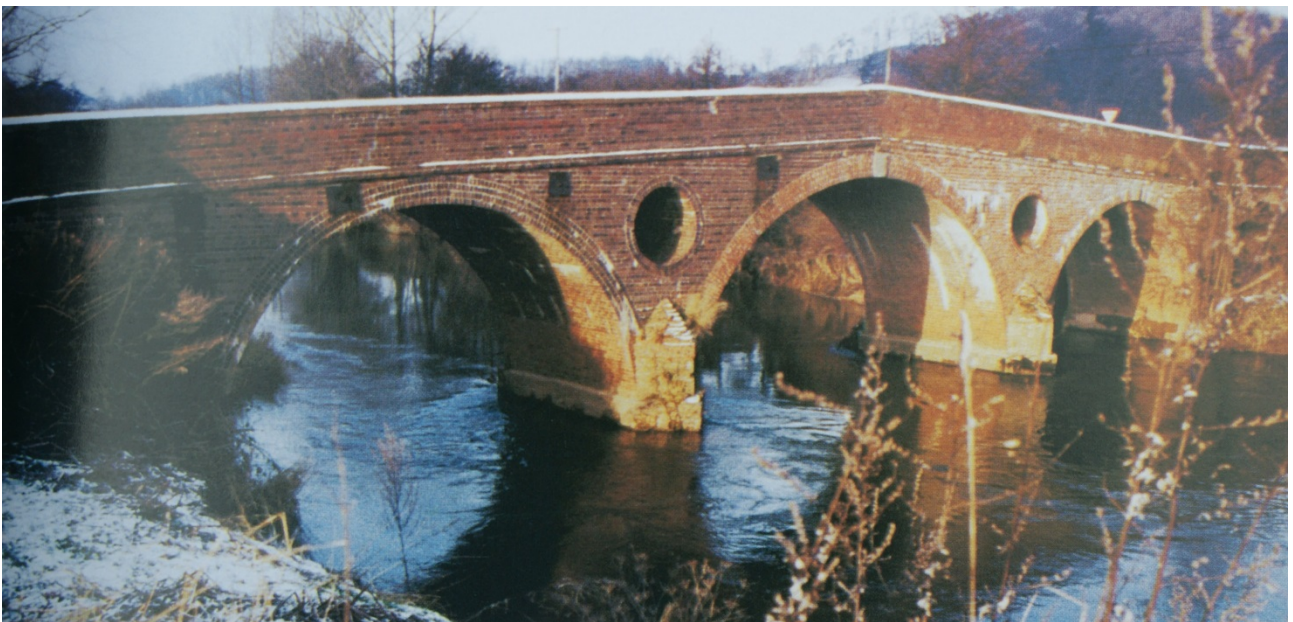
Further repair works were undertaken in 1994 including repointing, brickwork repairs and a diver inspection of the underwater foundations (Eastham Historical Society u/d; Plate 8).

Plate 8 Late 20<sup>th</sup> century picture of the bridge, looking north-west (Douglas Opperman 2000)

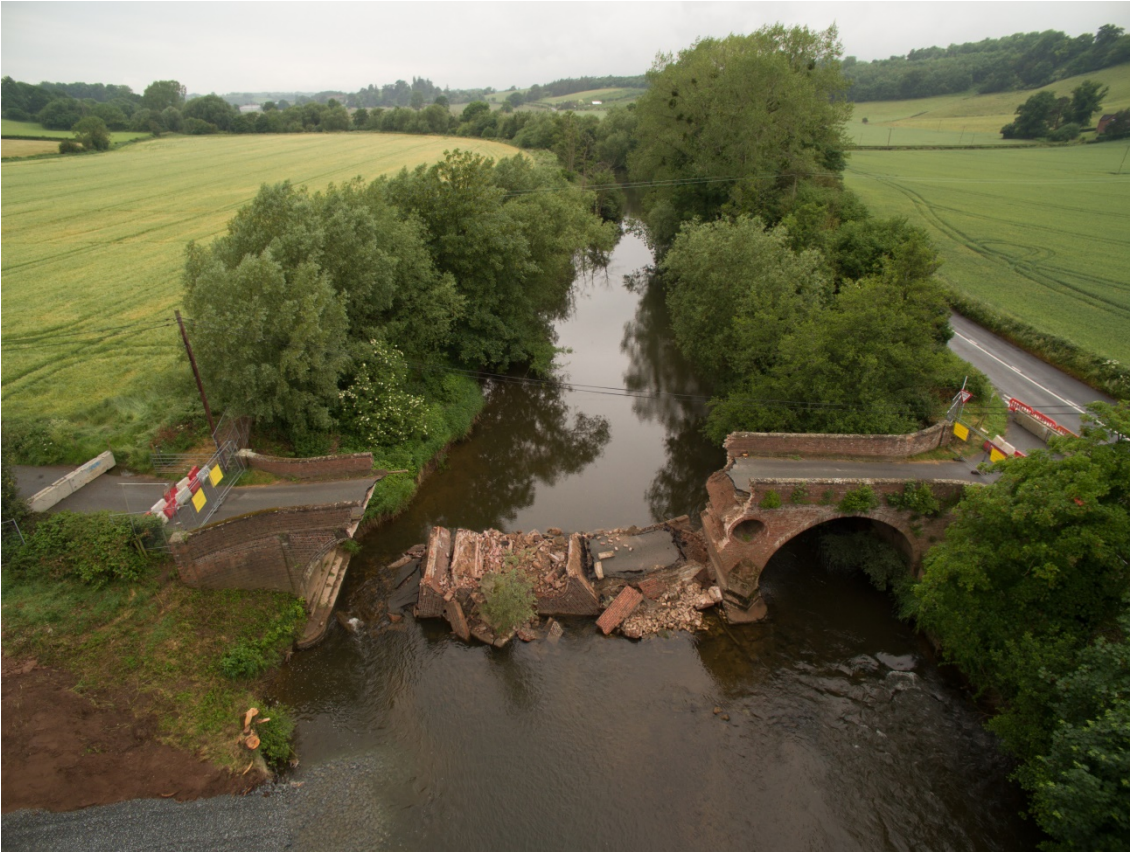
*Plate 9 The collapsed bridge looking west along the Teme towards Tenbury, no scale*

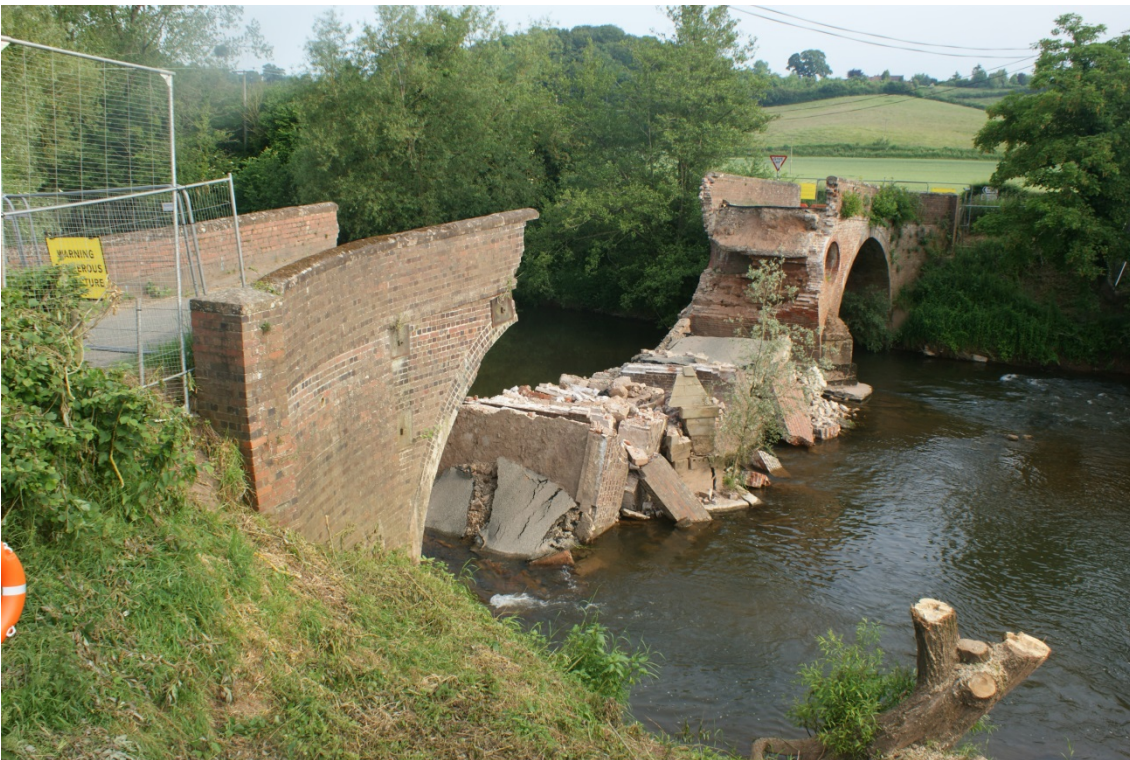
*Plate 10 The collapsed bridge, from the south bank, view north-west, no scales*

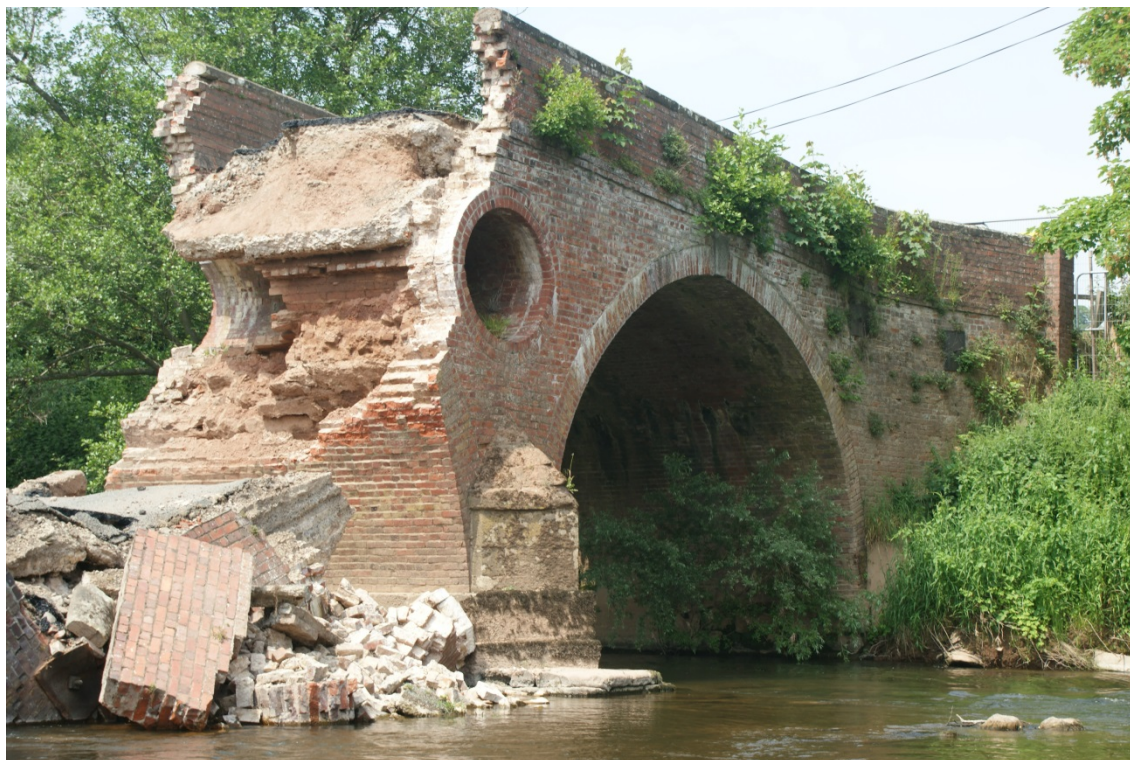
*Plate 11 The collapsed bridge, from the south bank, view north-west, no scales*

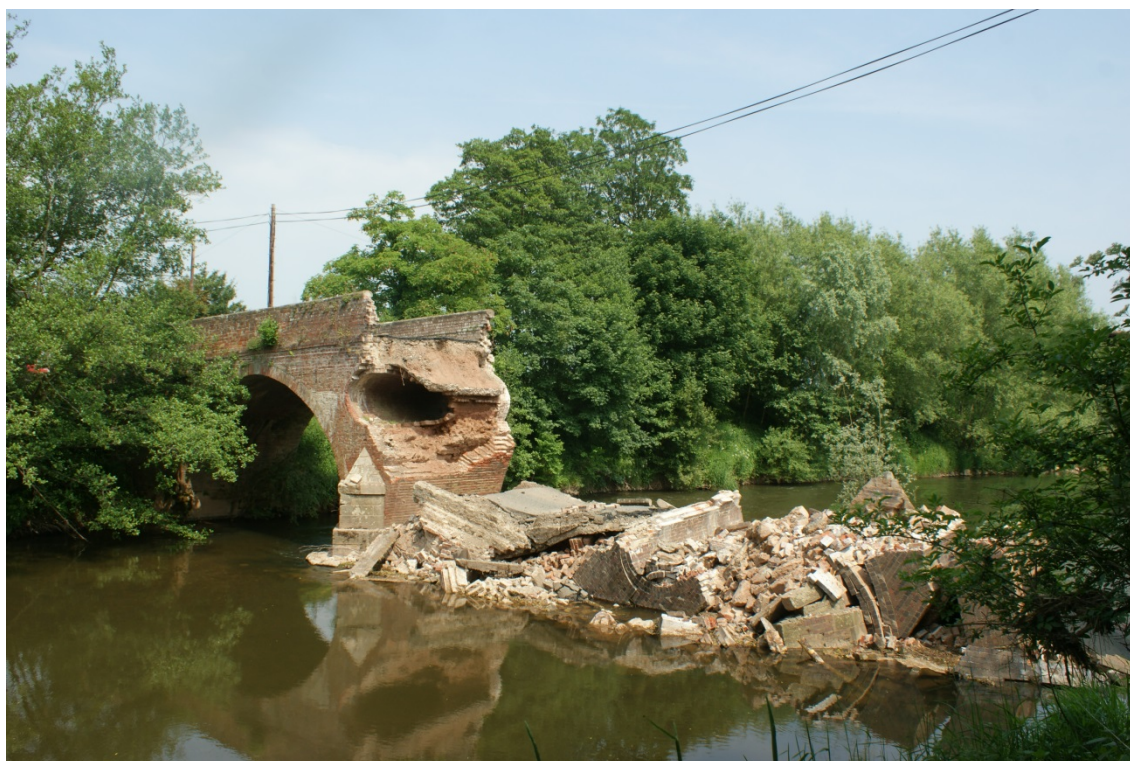
*Plate 12 The collapsed bridge, from the south bank, view north-east, no scales*

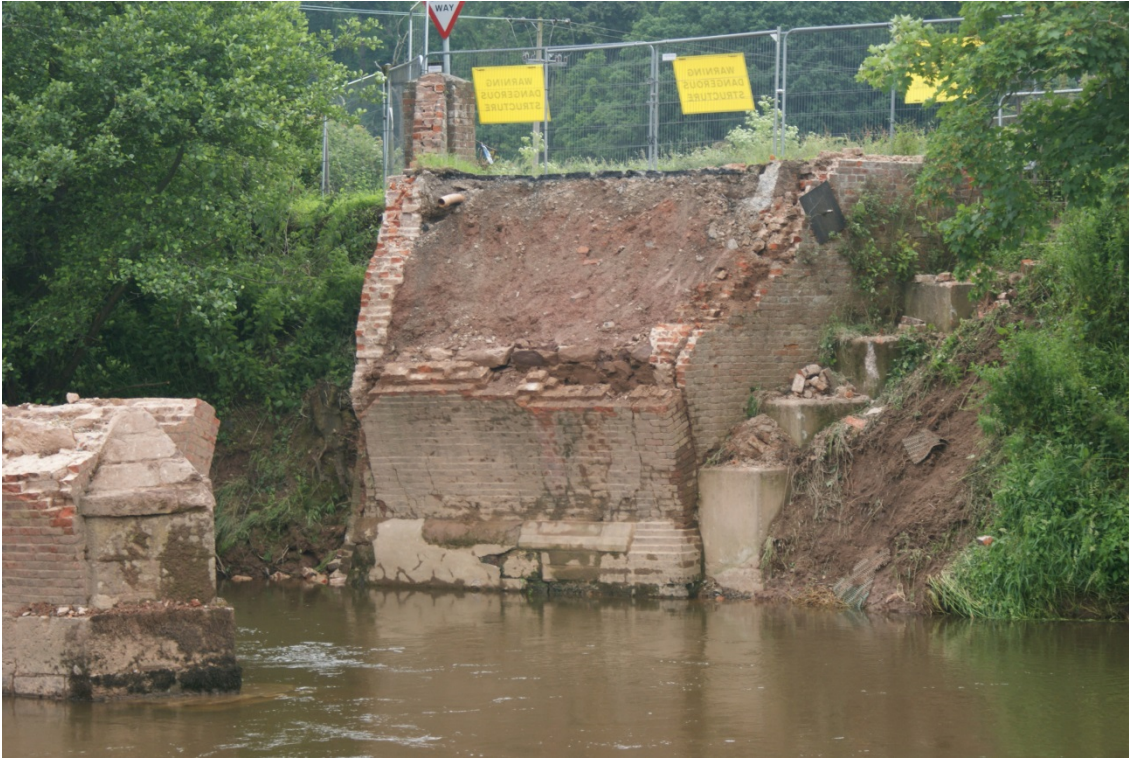
*Plate 13 The north spring of the 1793 bridge and northern pier after the removal of much of the structure, showing the original infill, ashlar blockwork at its base and stonework backing the brick arch, from the south bank, view north-west, no scales*

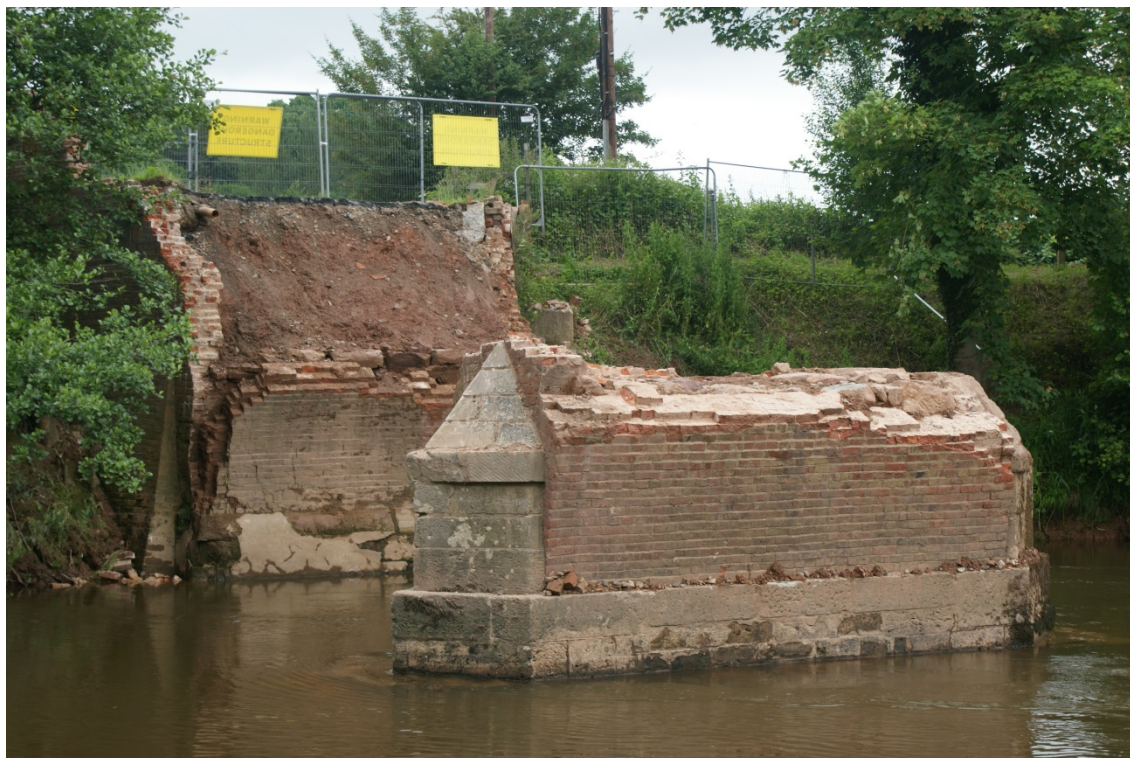
*Plate 17 The bridge after the removal of loose material, showing the original infill and details of the central piers, from the south bank, view north-east, no scales*

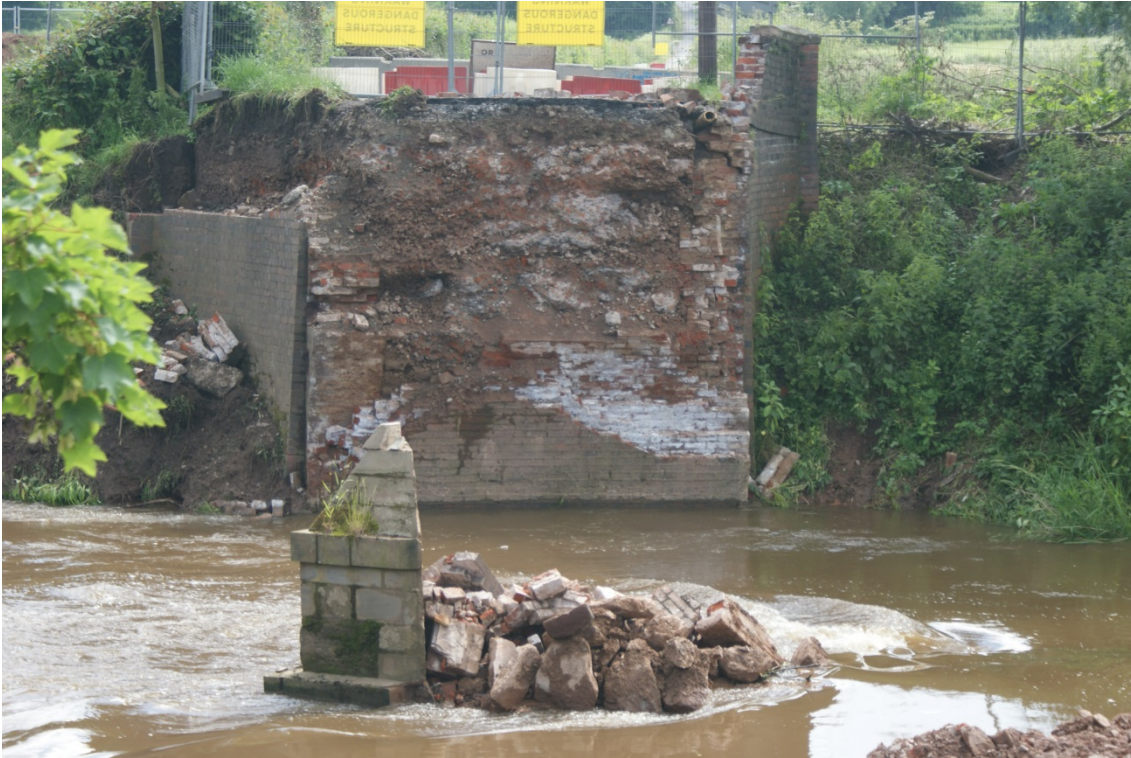
*Plate 19 The 1898 south spring of the bridge and southernmost pier, after the removal of loose material, showing the 1898 infill, from the north bank, view south, no scales*

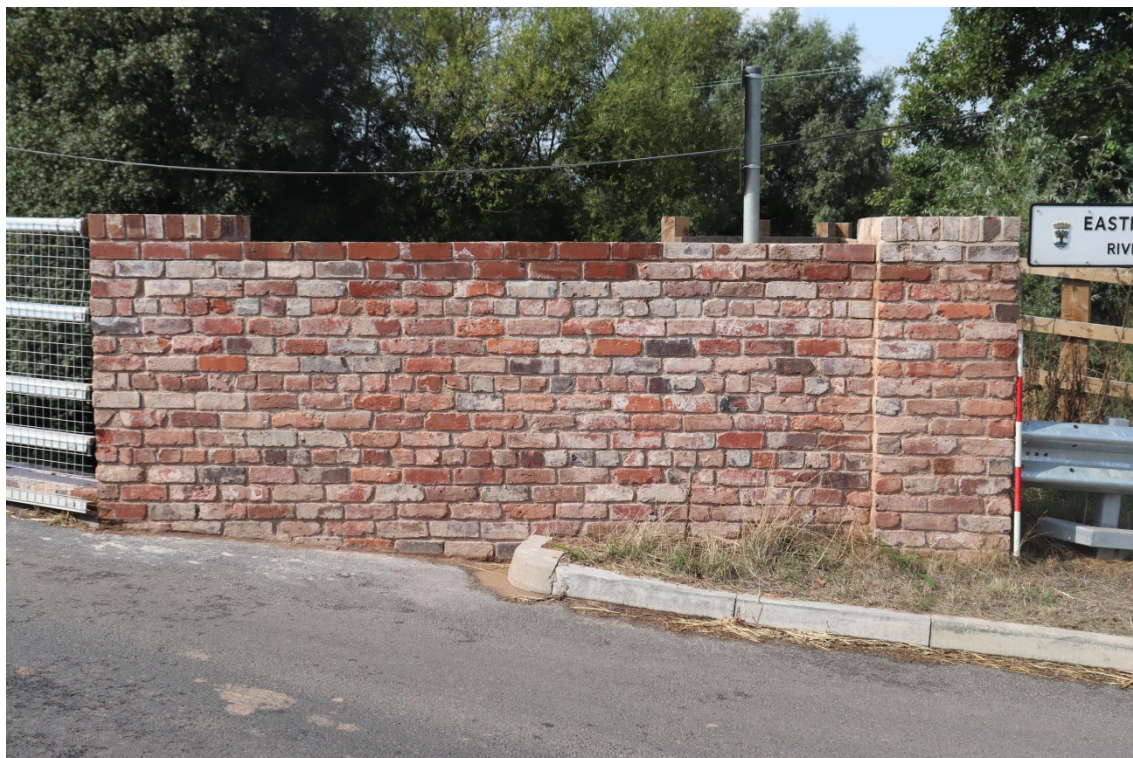
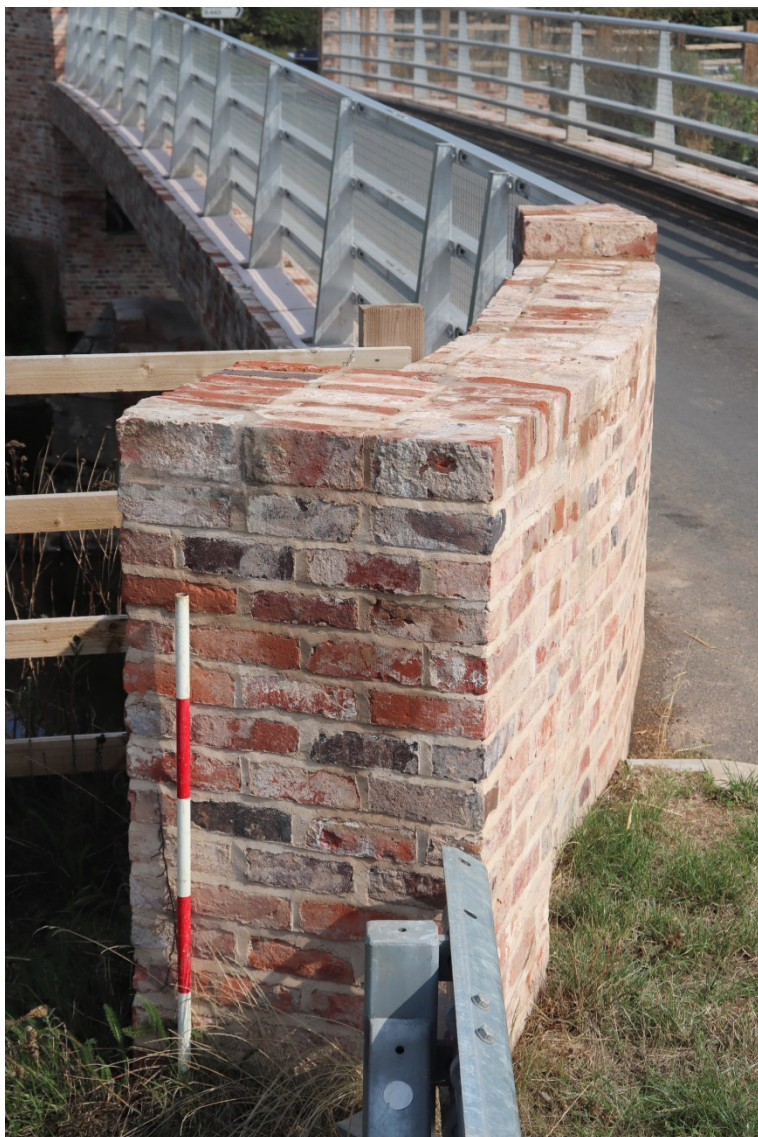
*Plate 27 View of the rebuilt bridge wing walls, looking south-west*

*Plate 28 View of the rebuilt bridge wing walls, looking south*

Below the double string course of the original bridge, the brick coursing was of English garden wall bond, although with between one and five stretcher courses between header courses. The parapet and wing walls were consistently of three stretcher courses, as is more typical of English garden wall bond. This bond type was used in the reconstruction of the bridge (Plate 27 and Plate 28)

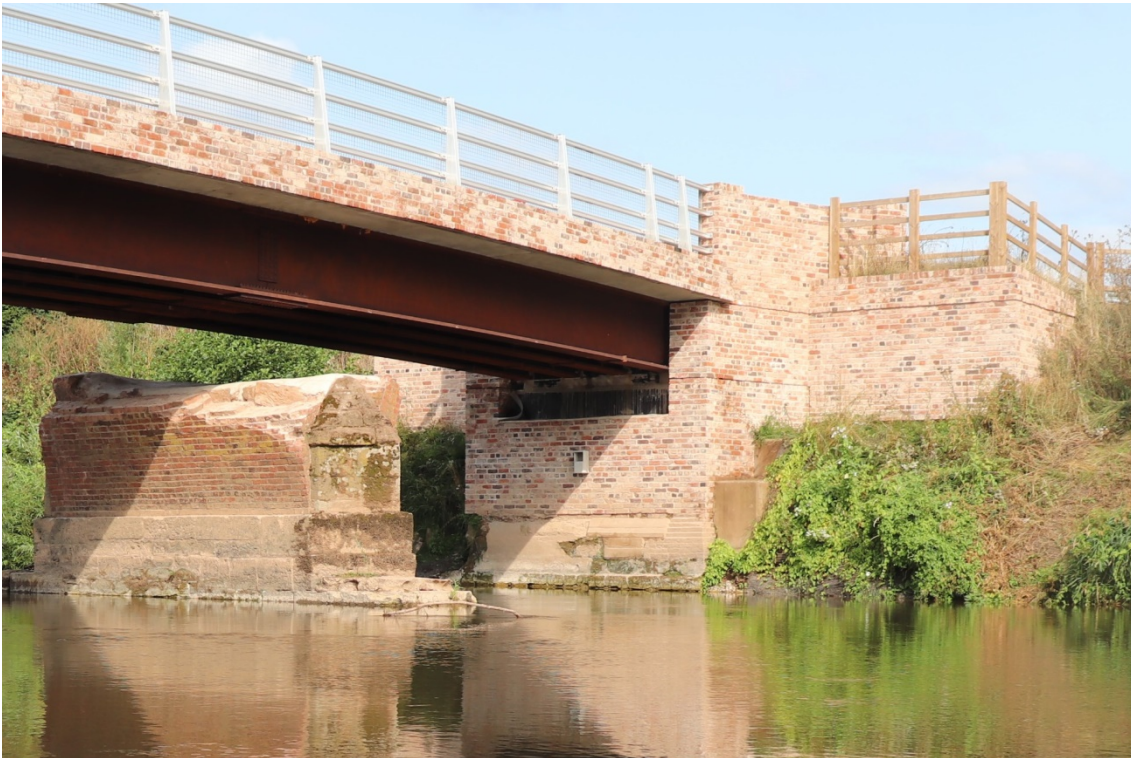
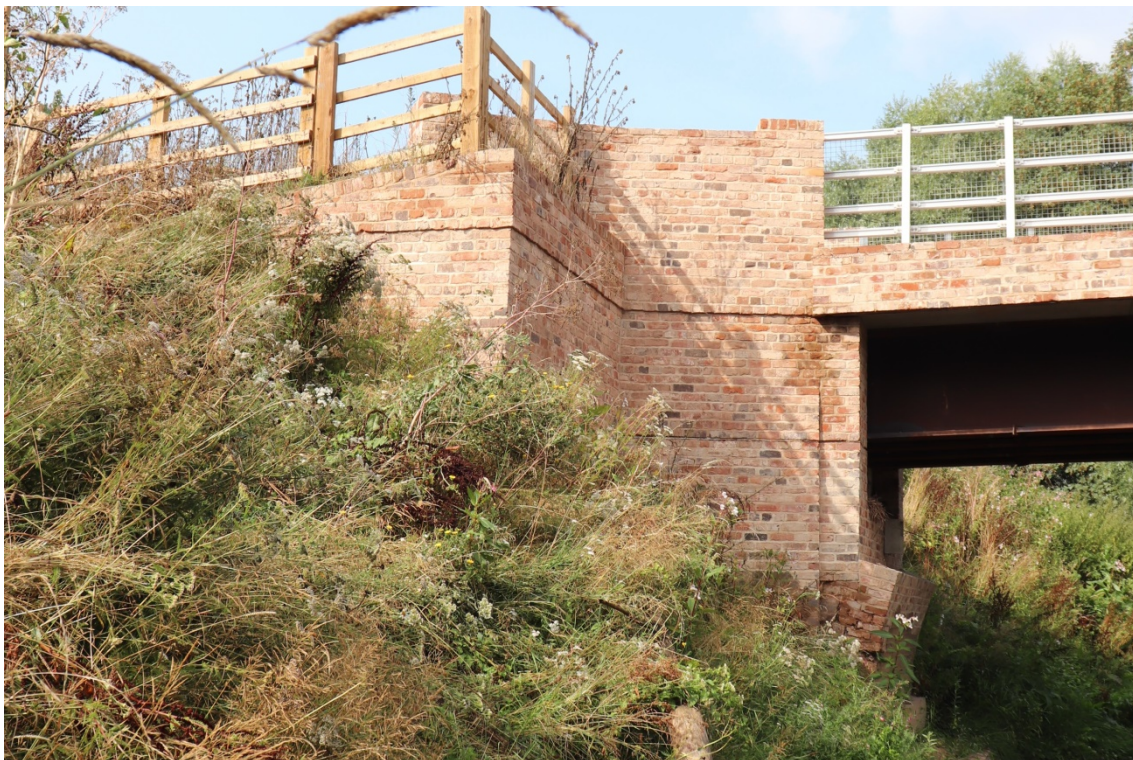
*Plate 29 View of the rebuilt bridge revetment walls with the two brick depth string course visible, looking north-west*

*Plate 30 View of the rebuilt bridge revetment walls with the two brick depth string course visible, looking west*

The flanking wall of the original bridge had a double depth brick string course at broadly road surface height on their exterior side, as noted previously and within the listing. This feature was recreated within the rebuild as a string course which extended from the base of the bridge span around the revetment walls cladding the pile caps (Plate 29 and Plate 30).

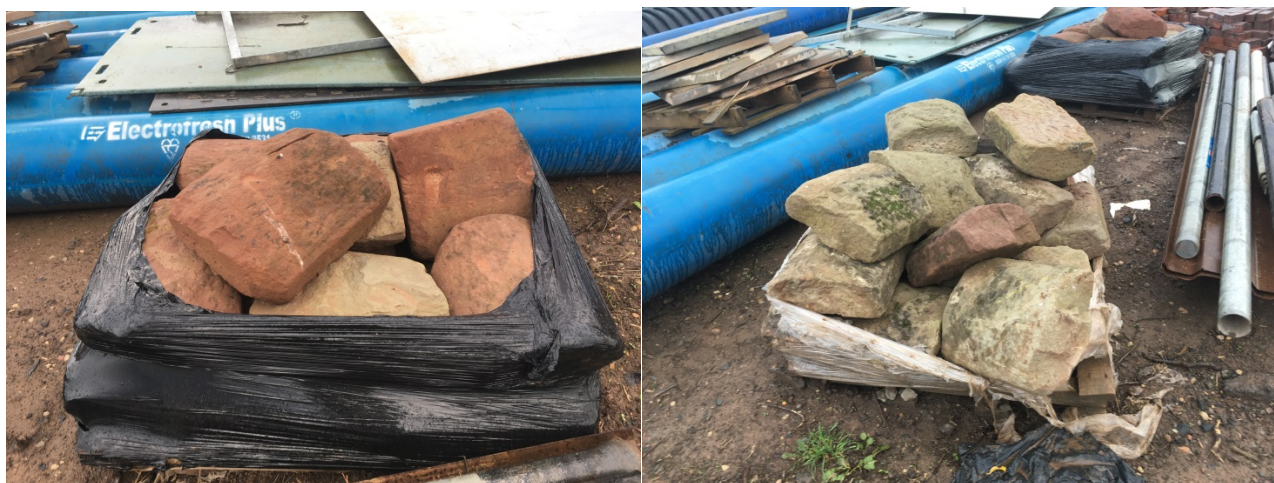
The collapse and subsequent demolition of the bridge unfortunately damaged most of the original copings. A selection was salvaged (Plate 31) and these will be used to design the new coping stones. Plates 18 and 31 show the design of the coping and pier caps in the 1793 structure. The replacement stone would mirror this as closely as possible and be agreed with the conservation team at Malvern Hills District Council. Pier caps will be placed on the end piers and coping will run across the tops of the wing walls and along the sides of the bridge on top of the existing brick work. The visualisations (Figures 1 – 2) are indicative only and the new pier caps will not stand as high, as they will be based the measurements of the salvaged pier cap held at The Ketch depot.

*Plate 31 The salvaged copings*
