MAP ARCHAEOLOGICAL PRACTICE Ltd.

Marsden Park Farm Walton Road Nelson Lancashire

SD 86041 37991 Planning Ref. 13/14/0458P MAP 5.23.2014

Photographic Building Record: Barn and Cottage

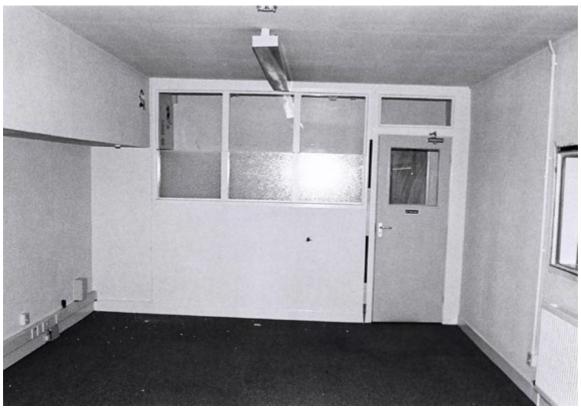
Plate 25. Barn Interior: First Floor. Facing North.

- 6.4.3 The entire first floor had been inserted and was fitted out for offices (Pls. 21-30). The roof trusses and blocked doors/loading hatch were of note in the north-western extension (Pl. 21). The only original window was a small arched window, possibly an earlier dovecote opening over the central arched door (Fig. 4 & Pl. 24). The large trusses had been fully partitioned off (Pls. 25, 26 & 27).

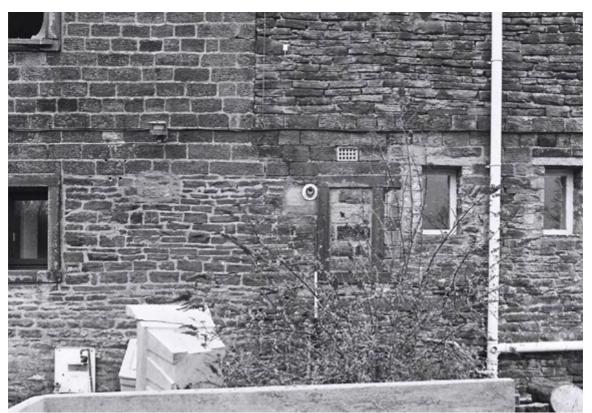
Plate 37. Cottage Exterior: West Elevation. Facing East.

and 900mm tall. All the windows have a stone surround. Of architectural note was a blocked window on the western elevation on the ground floor (Pl. 37) suggesting that a previous single storey cottage was wider as this part of the extension wall is the built of the same materials as the ground storey. This blocked window had been cut through by the later extension. The later extension to the south is two storeys high to the west, sloping steeply to the east and constructed of rustic, possibly reused stone. There are two small inserted windows on the ground floor in the extension.
