A Standing Building Survey and Evaluation Excavation at 1 Cricketfield Road, Seaford, East Sussex

LW/09/0672
Project No. CBAS0089

by
Chris Butler MIFA
with a contribution from Keith Butler

December 2009

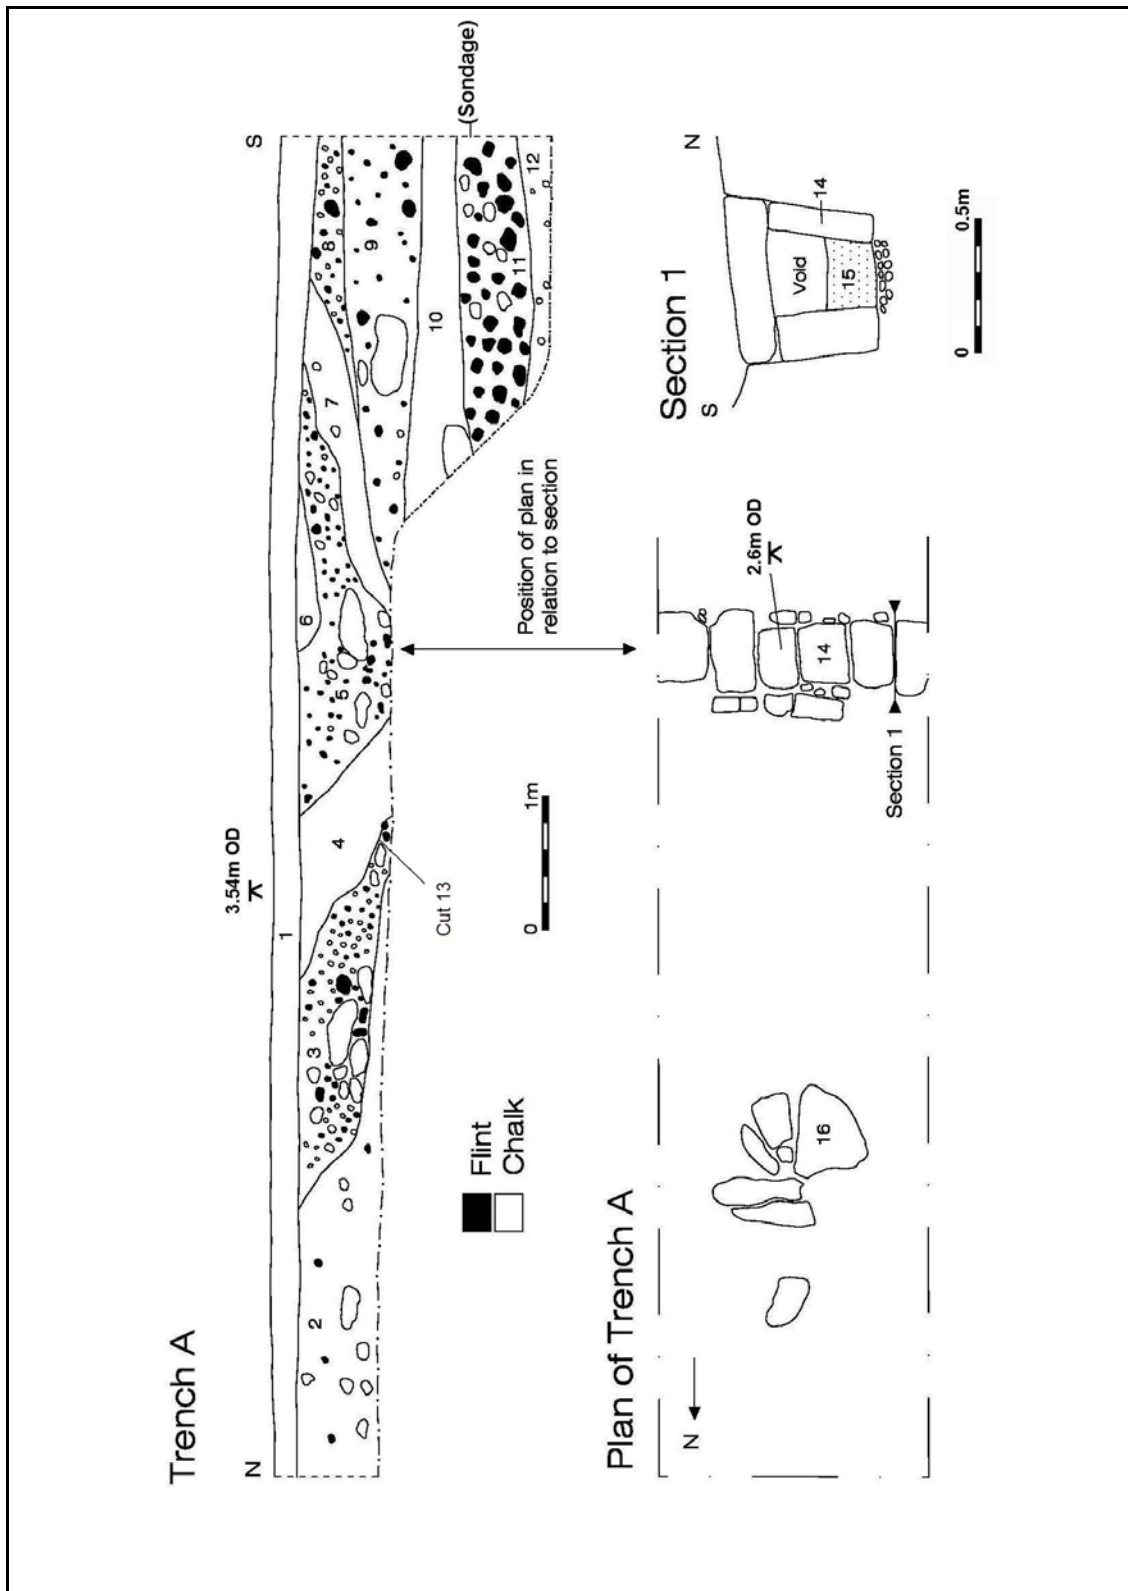
Fig. 9: 1 Cricketfield Road, Seaford: Trench A; section and plan, and section of the Chalk Drain (Context 14)

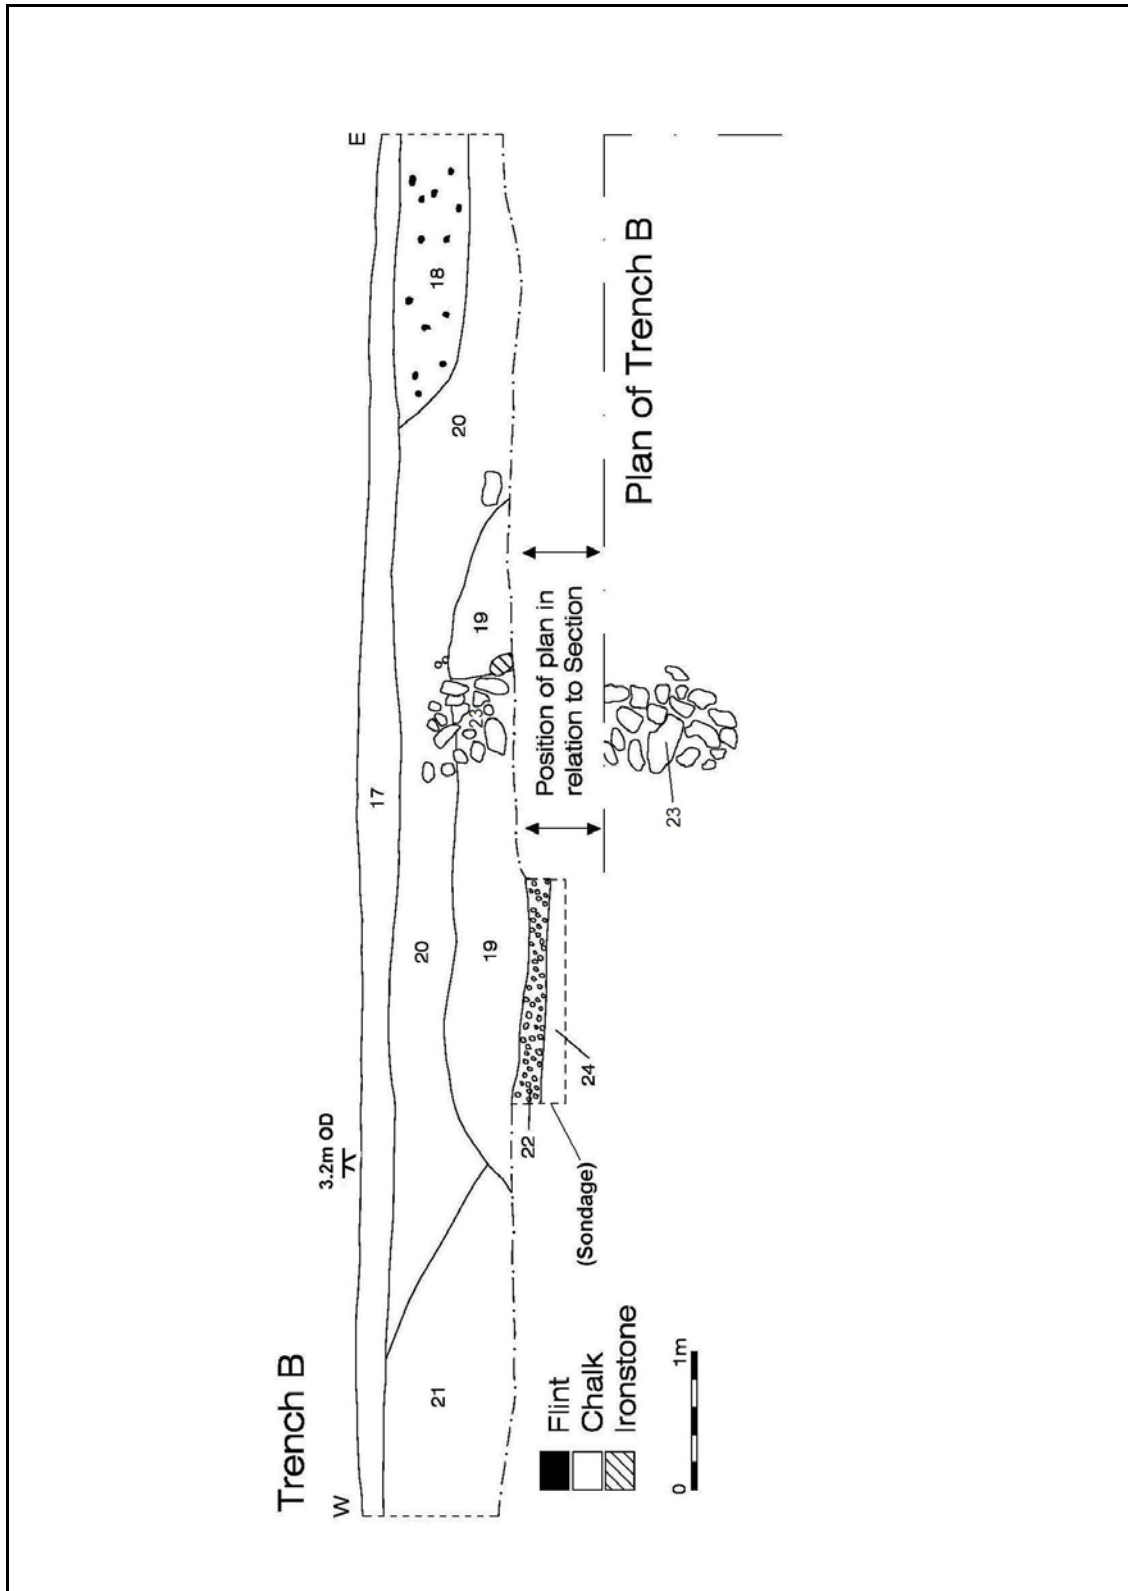
Fig. 10: 1 Cricketfield Road, Seaford: Trench B section and plan

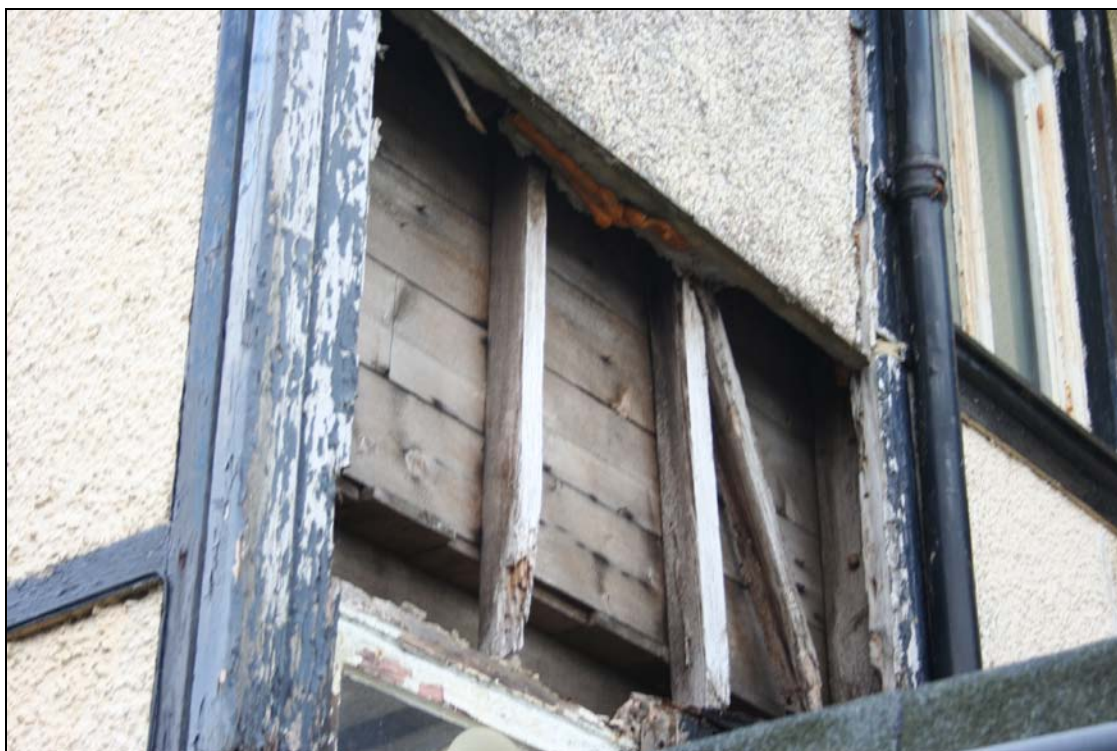
Fig. 15: 1 Cricketfield Road, Seaford: External view of construction showing missing concrete panel

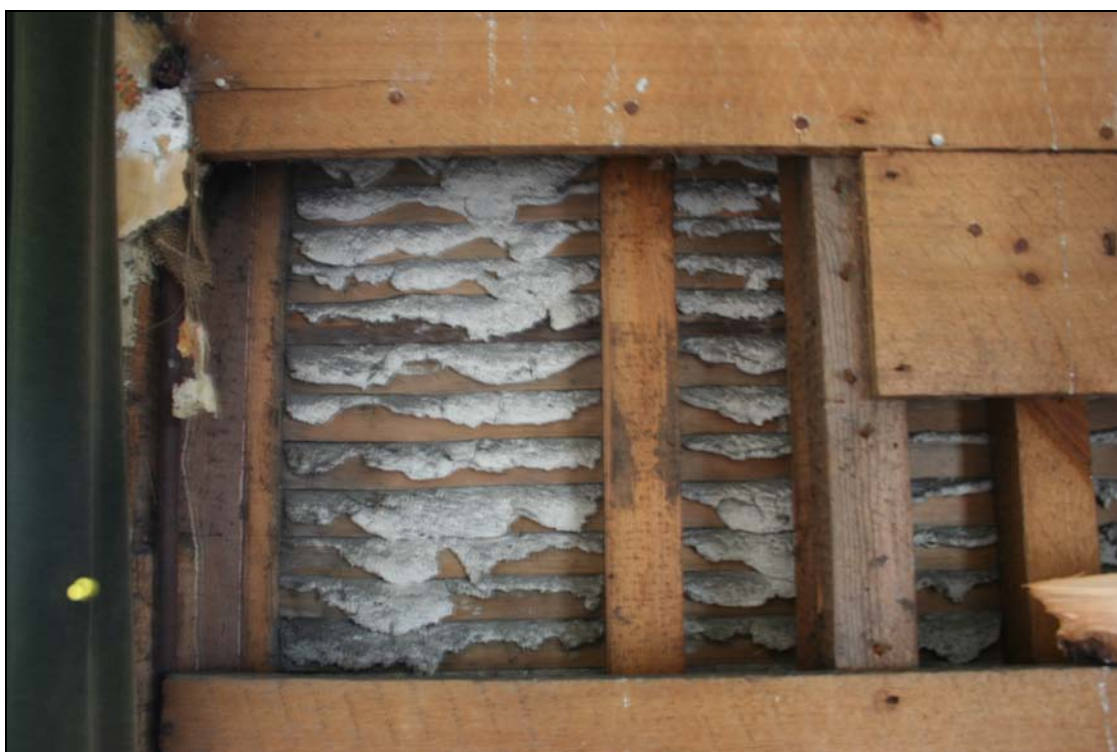
Fig. 16: 1 Cricketfield Road, Seaford: Interior view of construction showing laths and wooden framework, and wooden plank walls

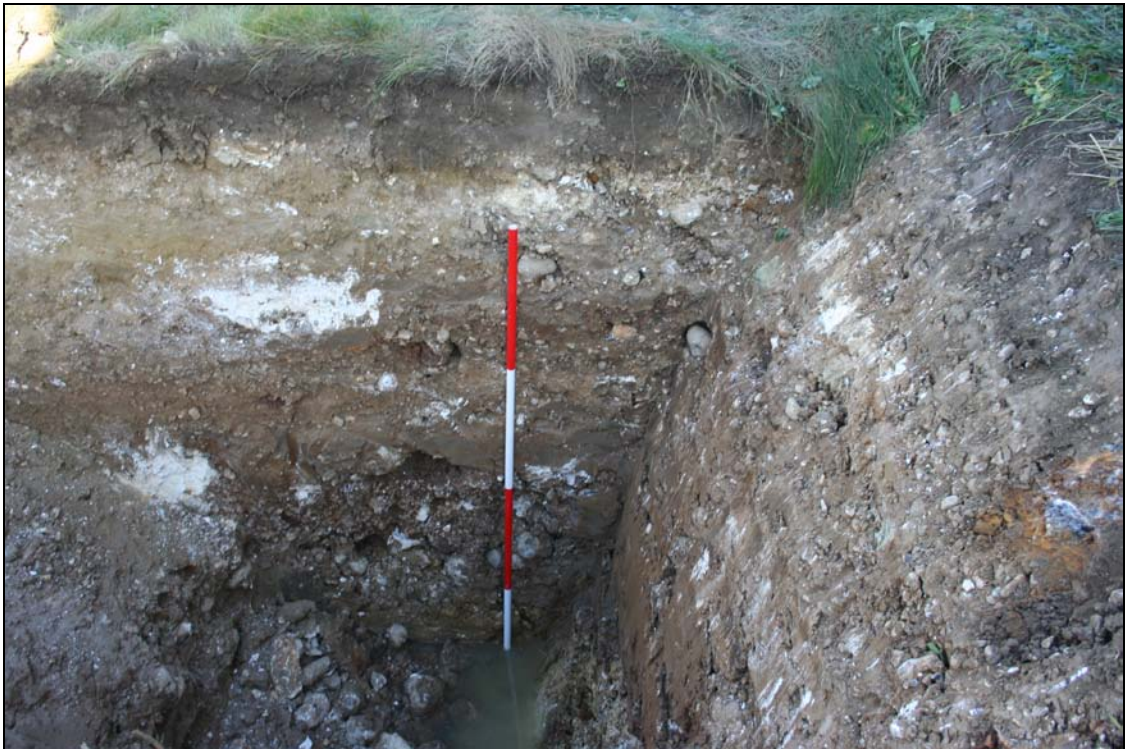
- 5.12** Excavation of most of the trench ceased at the point at which these features were found (c.800mm depth), however a sondage was excavated to a deeper depth of 2.4m at the south end of Trench A, to investigate the deposits and to see if the natural could be reached (Fig. 19).

Fig. 19: 1 Cricketfield Road, Seaford: Section of sondage in Trench A

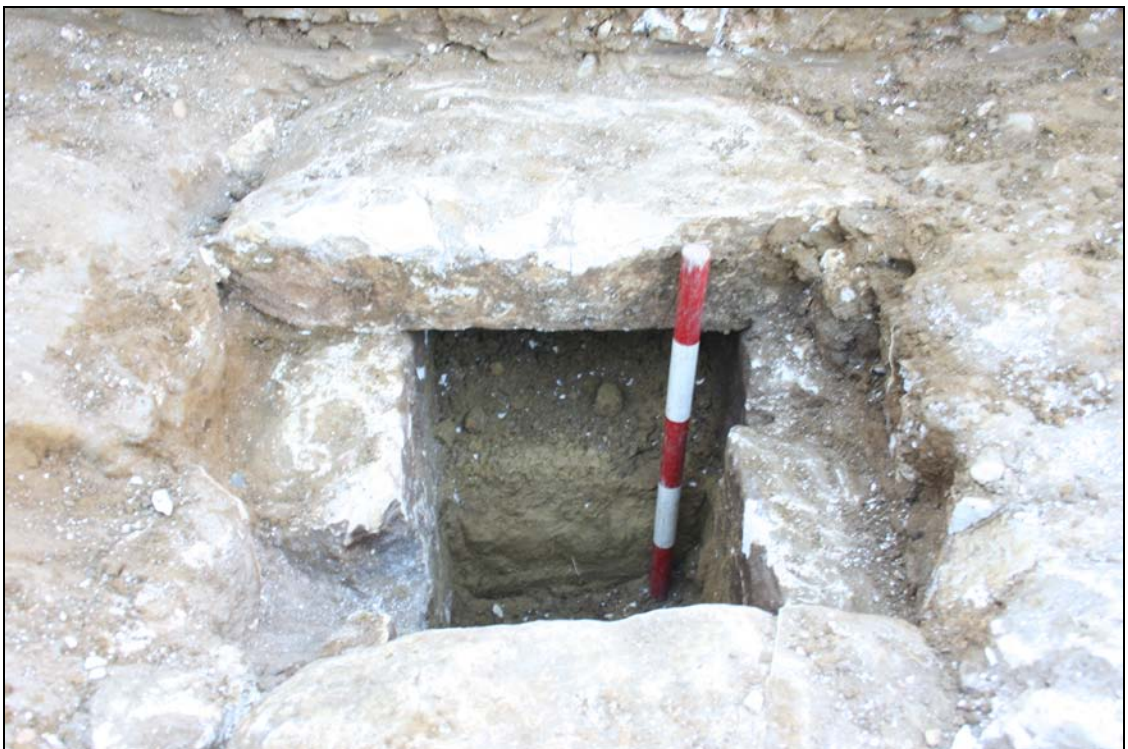
- 5.10** The fill in the lower part of the drain comprised a sterile loose to firm orange-brown sand (Context **15**) with no coarse components, and no artefacts were recovered from it. There was no chalk base to the drain, the bottom simply being the underlying layer (Context **3**) into which the drain had been cut.

Fig. 20: 1 Cricketfield Road, Seaford: The chalk drain (Context 14)
