**Monitoring ditch clearance work at  
Middle Barn Farm,  
Pevensey Levels,  
East Sussex**

Project No. CBAS0162

by  
Clive Meaton

November 2010

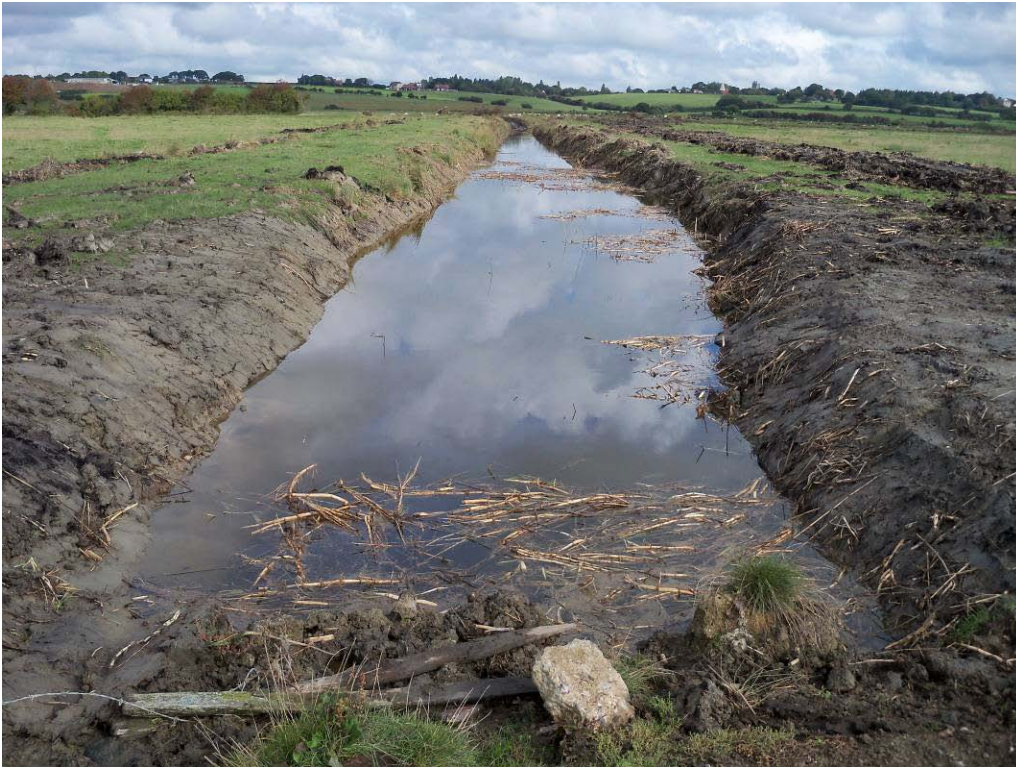
Plate 1. From P.1 Looking North

The edges of the ditch were completely smeared. No finds were observed within the spoil. At P.2 an area of burning was recorded in the side of the ditch, this was associated with several burnt tree stubs, and presumably related to the grubbing out of the adjacent hedge line.

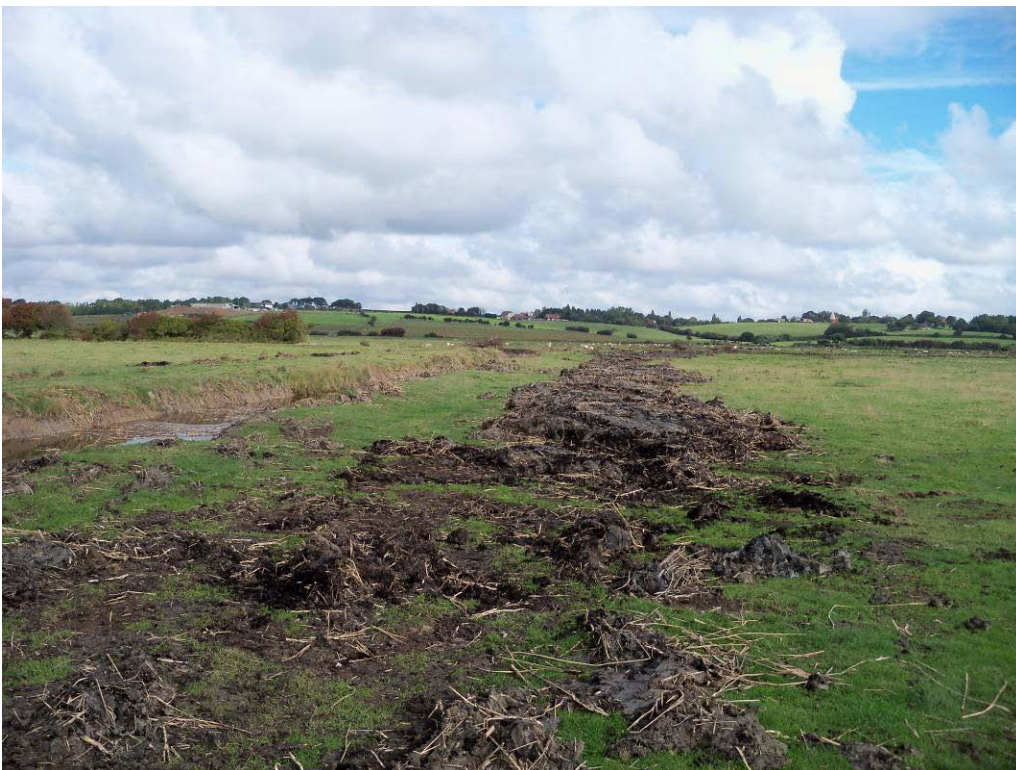
Plate 2. Up Cast Spoil from Drainage Channel P.1 to P.2

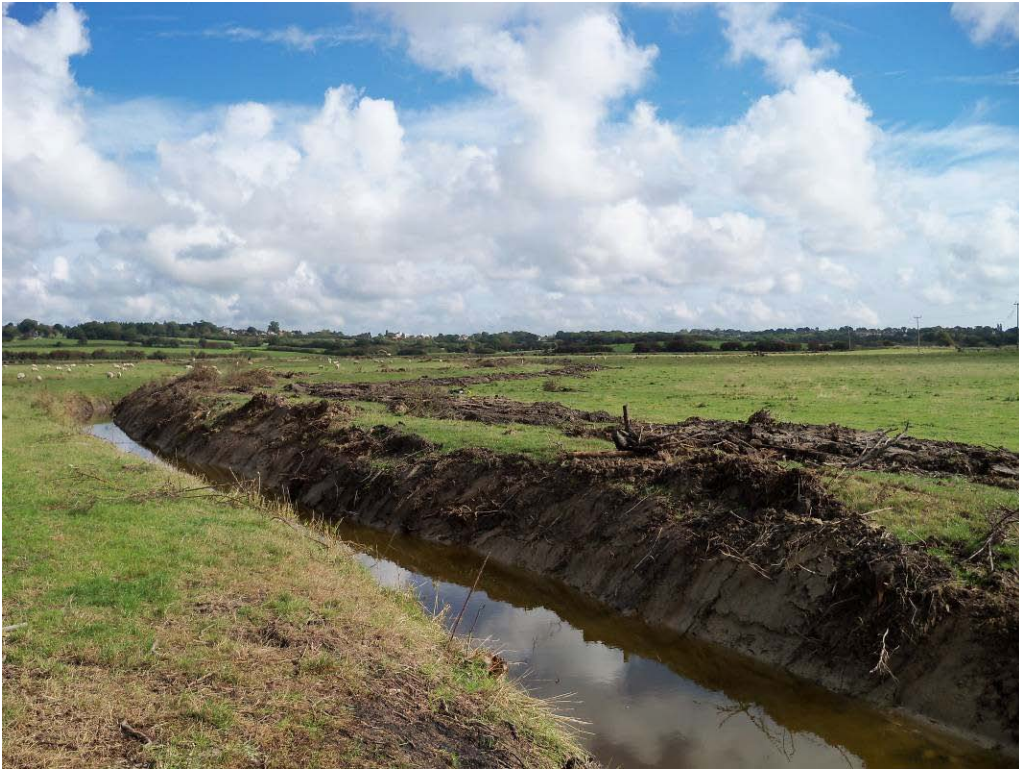
Plate 3. From P.2 Looking Northeast

Some clean ditch sides were observed, revealing approximately 300-400mm dark brown plough soil overlying a mid brownish-yellow alluvial clay. Most ditch sides however were smeared, and no features were identified. No artefacts were identified in the spoil.

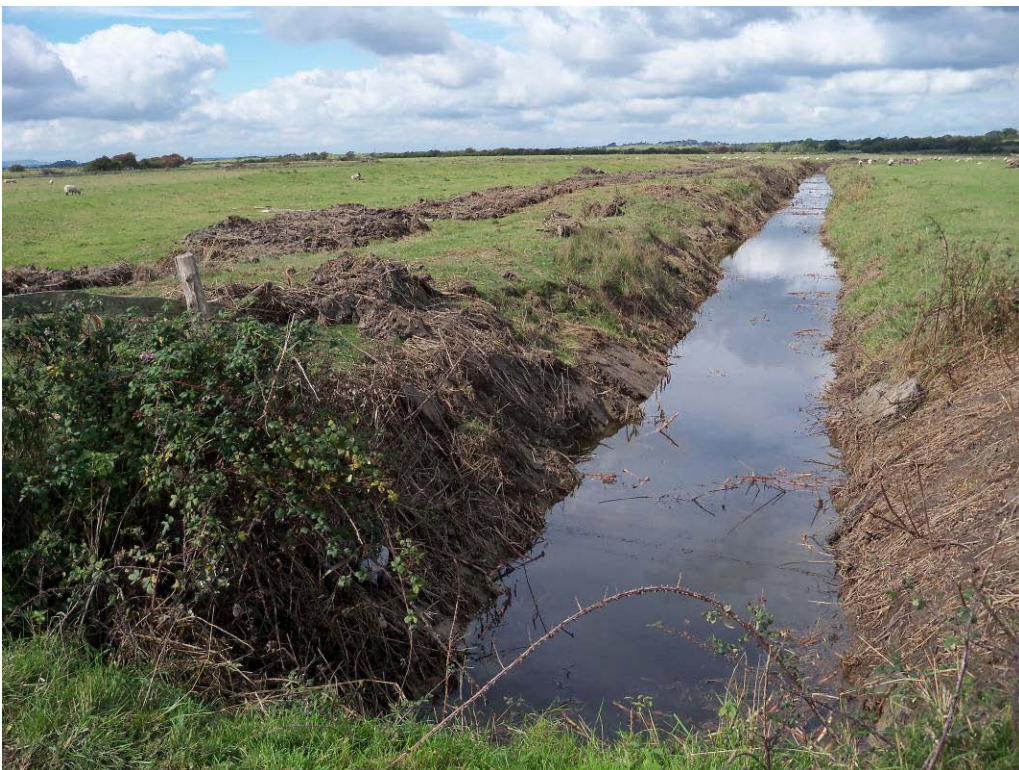
This stretch of ditch was located alongside the remains of the former sea defences. Between P.3 and P.4 the upstanding bank survives to a height of up to c.2m. No artefacts were identified in the spoil.

Plate 4: From P.4 Looking Northwest (sea defence bank in background)

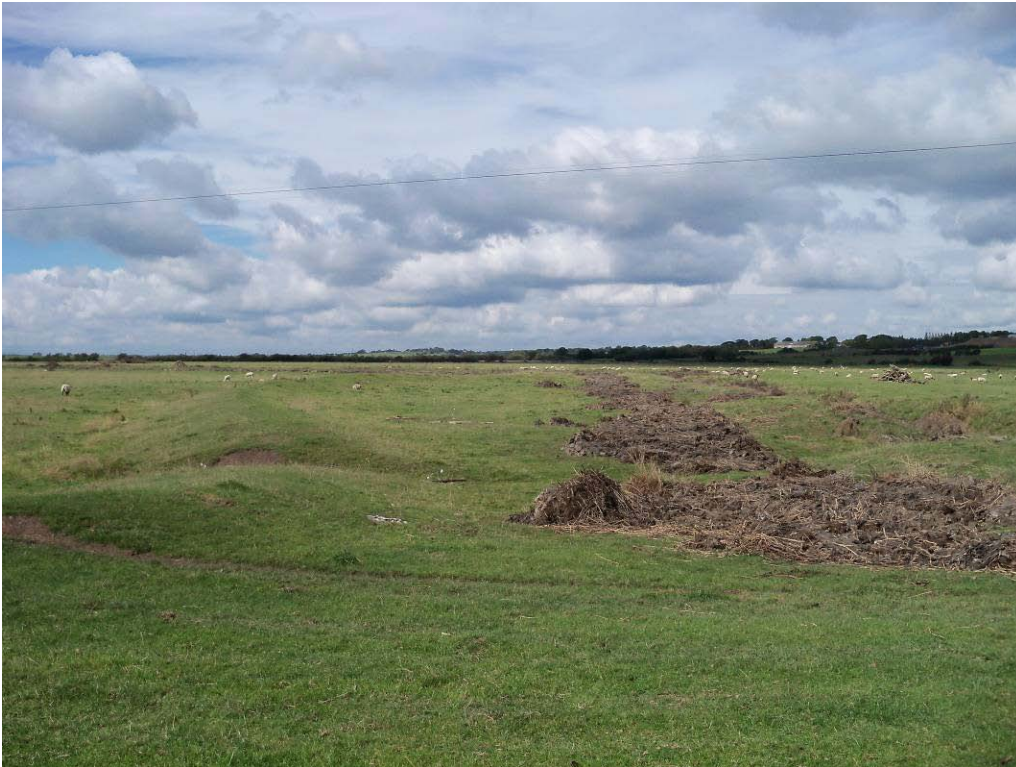
Plate 5: Looking NW towards P.4 - P.3 Including Up Cast Spoil & Sea Bank

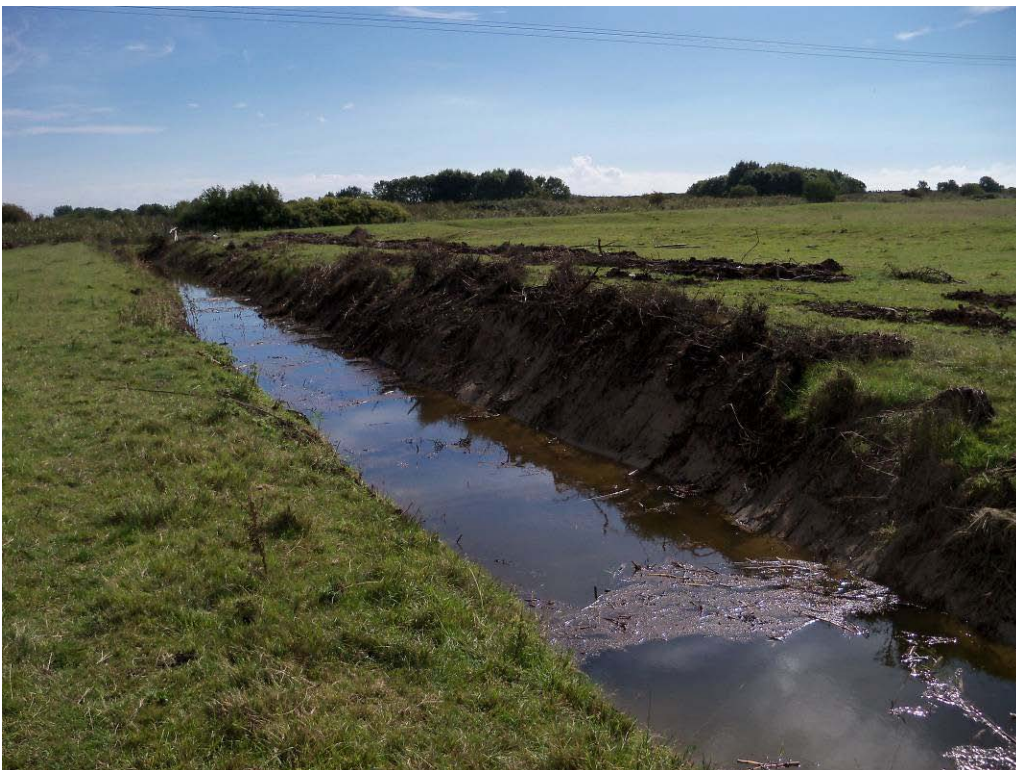
Between NGRs 569493 106830 and 569522 106803 a marked topographic rise was noted in the ground surface, which was most clearly visible in the northeast facing ditch section. The exposed section appeared to comprise a darker mixed matrix, although it was too obscured to draw any firm conclusions concerning archaeological deposits or cut features.

It was most likely this topographic anomaly related to the course of a former, disused channel. It seemed to be orientated perpendicular to the ditch, but did not extend as far or interface with the sea defence bank to the southwest. Likewise, its trajectory to the northeast was unclear

Plate 6: Looking at Topographic Rise in NE Facing Section (P.3 – P.4)
