**An Archaeological Standing Building
Recording and Monitoring
at Dowd's Farm, Hedge End,
Southampton.**

F/11/69881
SU 4884 1466

Project No. CBAS0276

February 2013

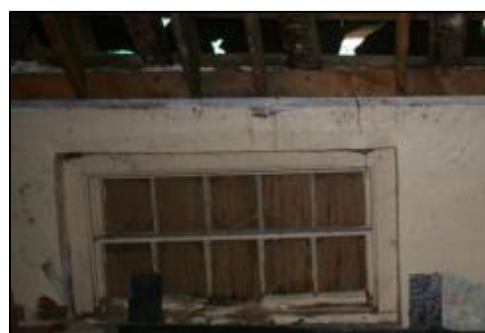
Plate 2: Example of first Floor Window

- 4.3 The southern elevation has four openings, with the first floor being lit by two wooden framed casement windows (**Plate 2**). These are positioned directly beneath the eaves. The western window is positioned with the dividing wall between Bays 1 and 2, and the eastern window lighting Bay 3. The windows lighting the ground floor are positioned in the centre of the southern wall of Bay 3 and 4.

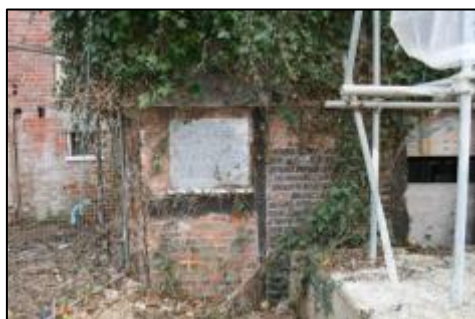
Plate 3: Framing in North end of West Wall

- 4.4** The western wall of the original building does have some timber framing still *in-situ*, at the northern end of this wall (**Plate 3**). This consists of the principal post A, with a wall stud to the south of the principal post. The principal post and wall stud are joined by horizontal beam which is mortised and pegged into both the post and the wall stud. Further south along the west wall there is the remains of a second wall stud on the northern side of the gap in the brickwork. This stud has an empty mortise on its southern face. To the south of the timber framing a large area of brickwork is missing, this revealing a length of the side girt (**Plate 4**). In the soffit of the side girt are two empty mortises with empty pegholes for walls studs. The upper part of the western wall was obscured by the plastic sheeting and ivy but appeared to be tile hung and devoid of features. The brickwork at the southern end of this wall was laid in stretcher bond, with the brick infill of the timber framing at the northern end being laid in a random bond. The brickwork at the southern end appeared to be a recent repair.

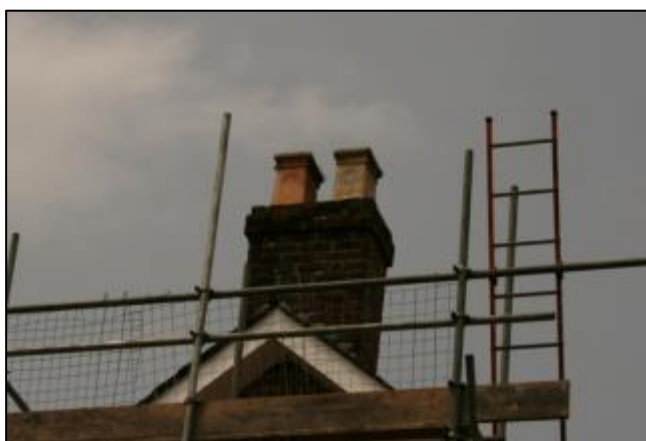
Plate 5: Chimney Pots on 19th Century Building

- 4.8 The extension to the north of the original building has a gabled end at both the eastern and western side. The roof covering is the same as that of the earliest part of the building, which is of artificial slate tiles. Located near to both the gable ends are two brick built chimney stacks, with two grey clay square chimney pots. The chimney pots having their lower part decorated with an inset panel on all four sides (**Plate 5**).

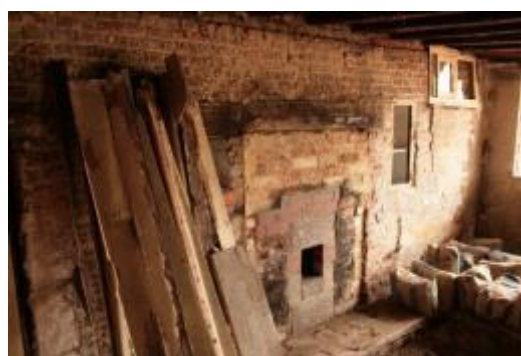
Plate 9: Second Cupboard with Area of Repair Below

5.3 Bay 3 is entered via a doorway at the western end of the small lobby to the north of the chimney stack; this entrance had no door fitted at the time of the survey, but there is a single strap hinge remaining near the top of the southern side of the door frame. The eastern wall has an inglenook fireplace that has had a later smaller fireplace inserted into the southern side of it (**Plate 8**). The later fireplace surround has been removed, revealing the brick construction of the chimney breast to the later fireplace. The original timber lintel of the inglenook fireplace is still apparent, and has been incorporated into the later chimney breast. To the south of the inglenook fire place is a small cupboard which was possibly a spice cupboard associated with the original fireplace. To the south of the spice cupboard there is a second high level cupboard. The wall to the south of the inglenook fireplace appears to have been re-built in brick, which sealed the alcove. Below this cupboard the wall showed signs of being repaired or possibly the cupboard was originally larger (**Plate 9**).

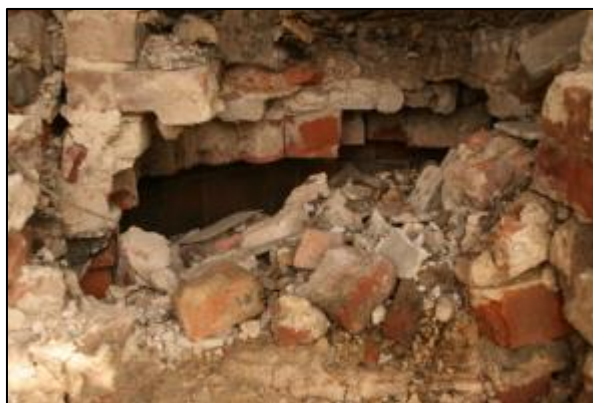
Plate 10: Structure to South of the Inglenook from Exterior

- 5.4 At the time of the second visit some of the brickwork had been removed on the exterior of the wall in this area which revealed a small section of a curved brick wall, possibly a bread oven. However, due to the small size of the gap in the wall it this was hard to interpret, it was also noted that there appeared to be no sign of burning or sooting (**Plate 10**).

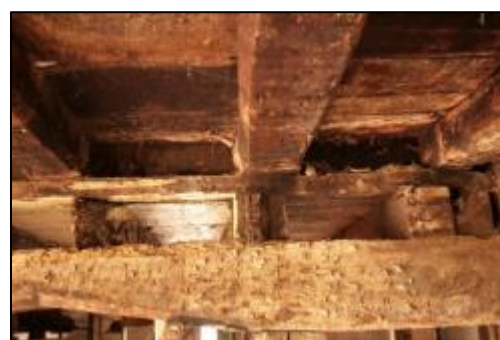
Plate 14: Joists of Bay 2 and Bay 3

- 5.6 In the northern wall the timber framing comprised two wall studs with a rail at approximately mid height running to the west from the western stud and the east from the eastern one. There is no visible timber framing in the centre of the northern wall (**Plate 13**). The ceiling in Bay 2 consists of eleven 17th century joists that have their lower corners chamfered and stopped at both ends, and measure 130mm wide with a depth of 100mm. The joists at the eastern end of Bay 3 rest on a beam running north south above the inglenook fireplace and on the western end rest on the floor boards of Bay 2. The floorboards of Bay 2 have their associated joists resting on the cross beam of the western wall of Bay 3 (**Plate 14**).

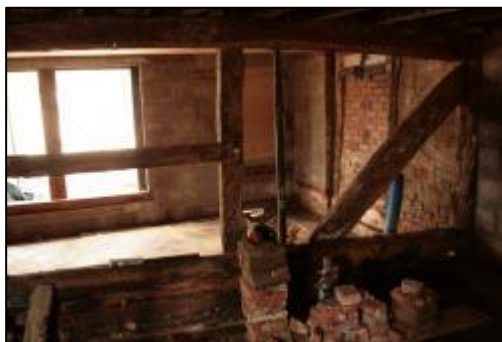
Plate 15: The Western Wall of Bay 2

crossbeam and the sole plate. All of these timbers appear to be the original 17th century fabric of the building (**Plate 15**). As in the western wall of Bay 3 the centre of the sole plate has had a chase cut into its upper surface to hold the wattle into the framing. The entrance to Bay 1 is located between the staircase and the southern wall stud. This appears to be a later doorway, as the frame is constructed of modern timber. The framing in the northern wall consists of a single stud at the western end of this wall; the rest of the wall is of brick.

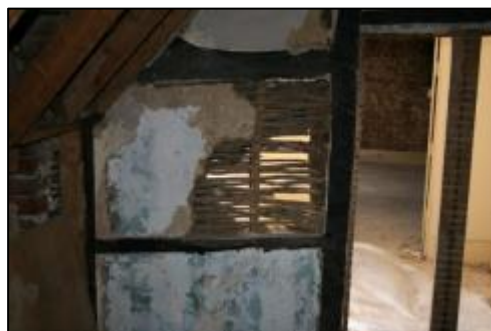
Plate 22: Area of Exposed Wattle Bay 3

been blocked at a later date. Above the opening of the fire place there was a wooden lintel. The lintel had a slightly arched lower edge, which had also been chamfered. Above the fireplace an area of the wall covering had been removed revealing four staves and a wall stud at either end. There was also a single length of the wattle *in-situ* above the lintel at the southern end. At the northern end of the eastern wall to Bay 3 an area of the wattle had been exposed (**Plate 22**).

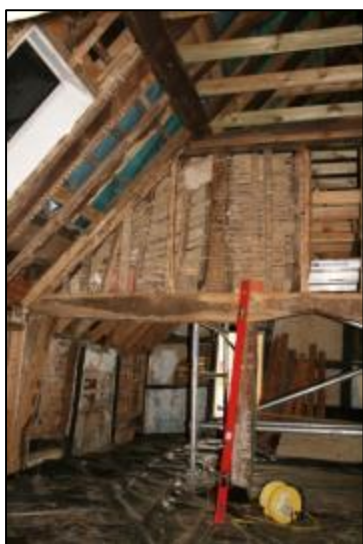
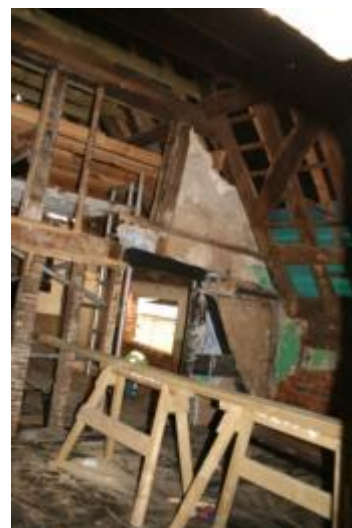
- 6.4** The west wall of Bay 2 had many of the original 17th century timbers and panels of wattle and daub *in-situ* (**Plates 25 & 26**). The original framing consisted of the tie beam (measuring 230mm deep by 160mm wide), which was supported on the northern side by principal post C, which also had the wall plate cut into the northern side. The southern principal post C-C was missing, most likely removed when the eastern wall was re-built in brick (Fig. 6). The principal post C was 200mm square and had a swelling jowl. Rising from the tie beam were three queen struts that were mortised and pegged into the tie beam and the high level collar. The collar was mortised and pegged into the principal rafter, which measured 140mm square. The principal post C originally had an upward brace rising to the tie beam, which is now missing but is evidenced by empty mortises in both the principal post and the tie beam. The upward brace on the southern side of the truss is in position but largely concealed by a covering of daub. Also apparent in the soffit of the tie beam are the empty mortises for missing wall studs. The northern wall is a mixture of brick, wattle and daub, and lathes and plaster, with two possible original wall studs *in-situ*.

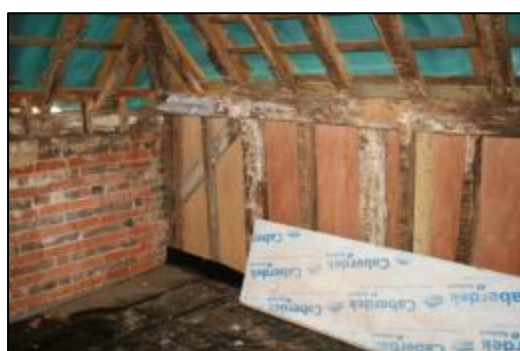
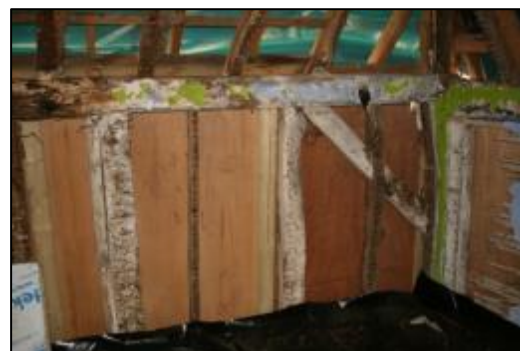
- 6.7** Bay 1 is located at the western end of the original 17th century building (Fig. 6). The western end wall (**Plates 28 & 29**) consisted of five original wall studs; with seven modern various sized timbers between them. Both the principal posts were *in-situ*. The principal post A had a swelling jowl which was noticeable smaller, with the overall shape being more angular, than the principal posts B and C in Bays 2 and 3. The top of the principal post A-A had no jowl with the end of the post being straight cut; it is possible that this principal post was a replacement. The tie beam was supported by the principal posts, and was higher than the wall plates of the northern and southern walls. Rising from both of the principal posts to the tie beam was an upward brace; these both measured 130mm deep by 70mm.

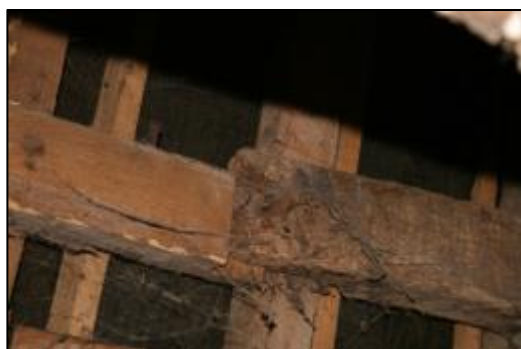
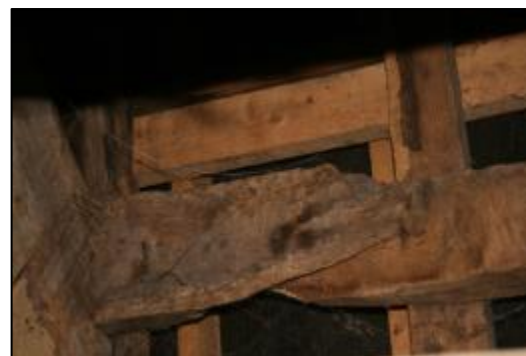
- 6.8** Both the northern and southern wall plates had been re-placed with new timbers just to the west of the junction between Bays 1 and 2. Both of these joints were rough scarf joints (**Plate 30 & 31**). It was also noted that both the northern and southern roof purlins had joints in a similar position (**Plate 32 & 33**). The northern wall is of modern

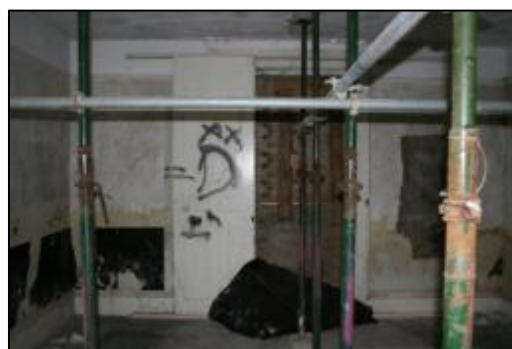
Plate 36: Example of Sliding Shutters

7.2 The main room on the ground floor has the internal measurements of 4.9m north-south by 6.8m east-west. All the walls are plastered and have a moulded wooden picture rail and wooden skirting boards with a moulded top. In the centre of the western wall there is the chimney breast with moulded wooden fire surround. Above the surround is a wooden shelf supported by a wooden corbel at the top of the two sides (**Plate 35**). The room is lit by full height windows in the eastern and northern walls; the eastern window only has the outside frame remaining. Both of the windows have sliding six panelled wooden doors fitted to the inside which act as shutters (**Plate 36**).
