A Standing Building survey of September Cottage Edburton, West Sussex

by
Chris Butler MIFA & Keith Butler AIFA

October 2009

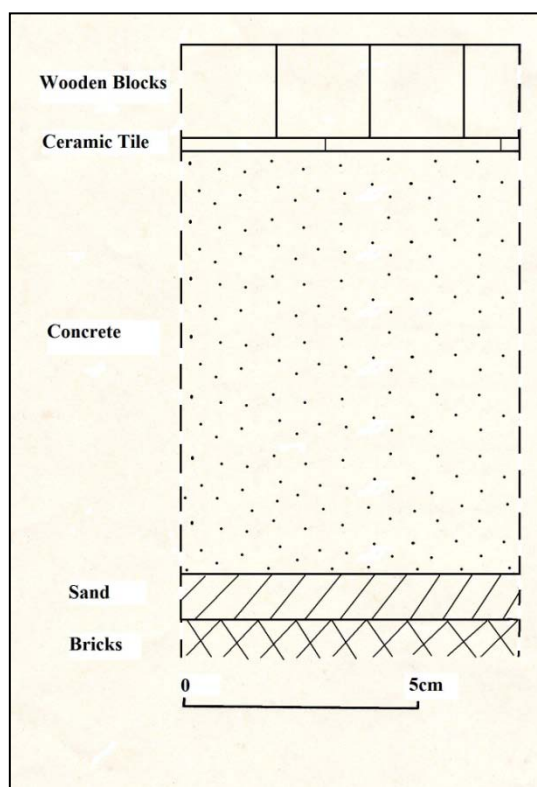
Fig. 1: Schematic section through Kitchen Floor

The raised floor here is currently covered with a herringbone pattern wooden tile floor (tiles are 220mm x 110mm x 20mm deep), above a layer of ceramic tiles (*c.*230mm square & 3mm deep). Below this was a 90mm deep layer of concrete, and below this was a 10mm thick layer of sand. The sand was sitting on a layer of bricks, however the hole was too small to be able to determine the dimensions of the bricks or their relationship to one another. Samples of the tile and brick were taken for analysis.

The ceramic tile can be dated to the mid 20th century, and was covered with a thin layer of bitumen. The brick fabric is typical of bricks made between the mid 18th century and into the 19th century. This would appear to suggest there is an in-situ brick floor of 18th/19th century date, which then been covered over and raised in height with the concrete, which in turn has been covered by the ceramic tiles and wooden blocks, perhaps during the 1960's work.

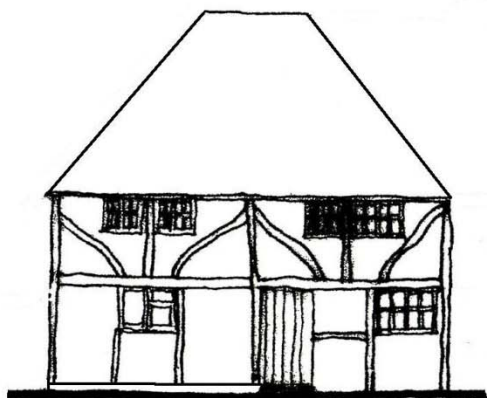
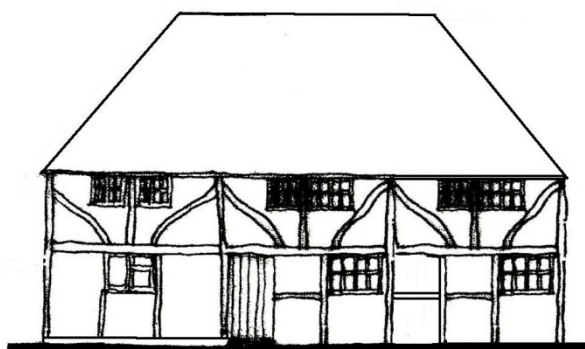
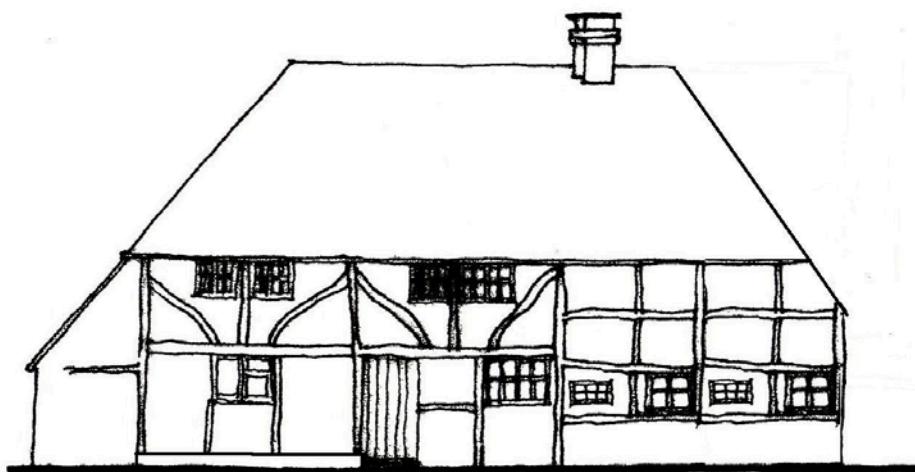
Fig. 3: September Cottage: Conjectural representations of the earlier cottage:
Top: two bay original; Centre: three bay original; bottom: after 17th century addition

In its original form September Cottage appears to have been a two- or three-bay box frame-construction house of possible 16th century date. Externally two bays of the original house currently survive at the eastern end of the Cottage; with four downward braces and central vertical studs showing on the upper storey of the north elevation. Vertical studs with horizontal midrails in the central panel can be seen on the lower storey of the north elevation. The panels have been infilled with regular courses of brick at a later date

At some stage in the 17th century either the 3rd (western bay) has been demolished and replaced, or a new bay has been added to the west end. This comprises a flint constructed dwarf wall upon which is placed a timber framed structure comprising six panels divided by horizontal midrails and vertical studs. A small window is located in the lower left panel, and may be in its original location; however the window in the bottom right panel has been inserted at a later date. The panels appear to be infilled with regular courses of bricks and some small stone blocks.
