**A Standing Building Survey
at Fishponds Barn, Hastings,
East Sussex.**

HS/LB/08/00145

Project No CBAS0270

June 2013

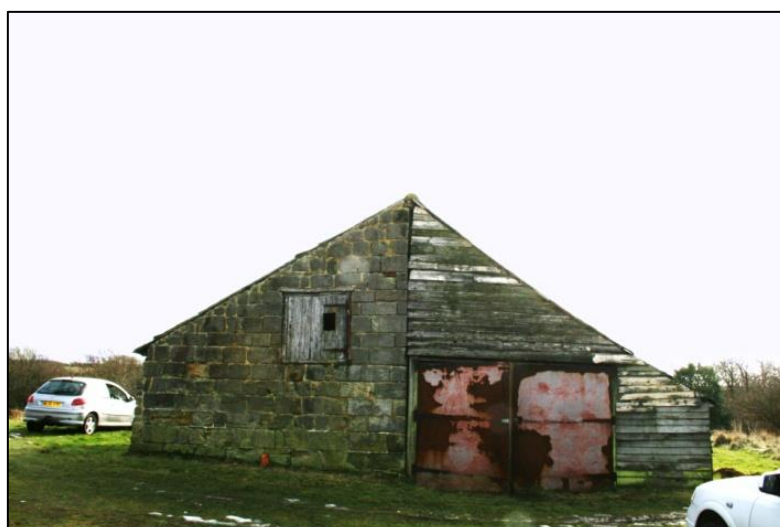
4.2 The northern elevation of the barn (**Plate 1**) consists of the eastern side (stable) and is constructed of coursed sandstone blocks which have been faced. The sandstone blocks are bonded with a sandy yellowish grey mortar. The western side (store) of this elevation is of horizontal weatherboarding planks, these appear to have been originally tarred. The stable on the eastern side of the barn has a high level opening comprising of a wooden frame fitted with a door, constructed of seven vertical planks. This opening was 1.8m above ground level, and was inset by 900mm from the western end of the sandstone part of the wall. The height of the wall from ground level to the apex of the roof was 4.75m. The door is fitted to the framework with two metal strap hinges on its western edge. Above the doorway there is a wooden lintel which has been bonded into the stonework. The only entrance to the store is located in this elevation, and located to the west of centre. The doorway is fitted with two wooden framed doors which are covered on their outer faces with metal sheets. Both of the doors are fitted with two strap hinges on their outer edges. There are no other openings in this elevation.

Plate 1: Northern Elevation of Barn

- 8.2** It was noted that the size and quality of the stone blocks used in the construction of the northern wall demonstrated a higher level of workmanship. The sandstone blocks were more regular in size, and greater care had been taken over the coursing of the stone blocks. This might suggest that this was the side of the building that could be seen by visitors approaching Fishponds Farm, and the use of good quality stone was to present a façade suggesting higher status. At both the joints between the north and east wall and the south and east wall, the walls were only butted up to one another which suggests that the eastern elevation was originally open. Alternatively, the current wall replaced an earlier one.

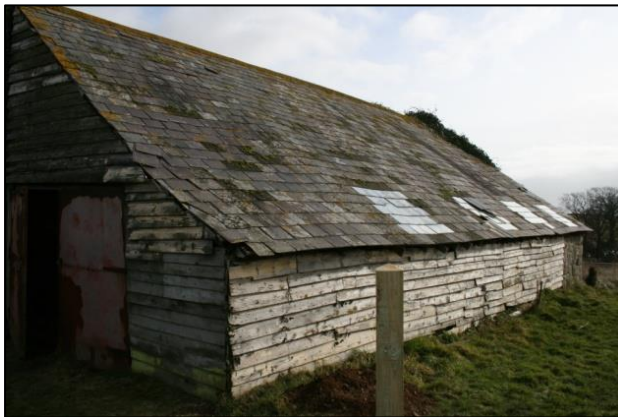
- 4.3** The western wall of the barn (**Plate 2**) is of mainly of the weatherboarding as noted on the western side of the northern elevation, and has a height of 1.9m. The weather boarding construction is apparent in the entire western wall except for a 2.4m long section of the sandstone blocks at the far southern end of this elevation (**Plate 3**). The sandstone blocks in this part of the structure are more randomly coursed than those seen in the construction of the northern wall of the barn. The eaves were visible at the bottom of the roof; there were no other features in this wall.

Plate 2: Western Elevation of the Barn

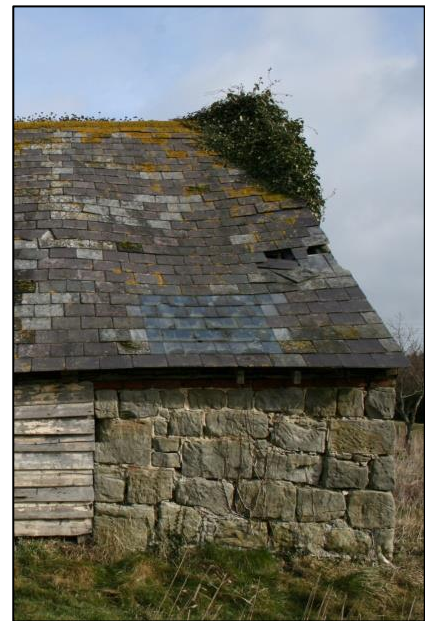
Plate 3: Sandstone Blocks at southern end of the West Wall

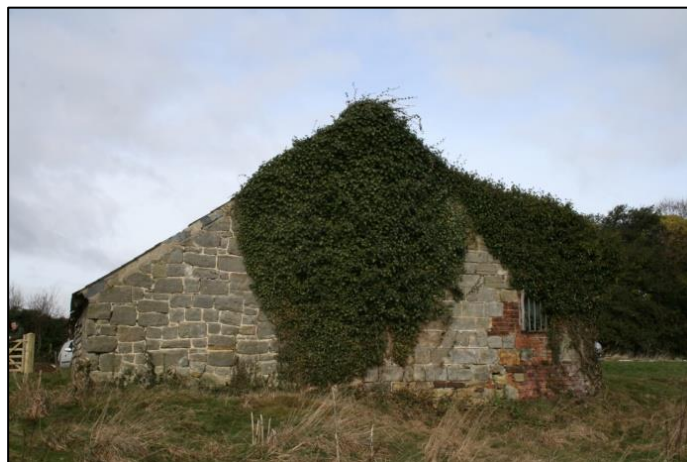
- 4.4** The southern wall of the barn (**Plate 4**) is constructed of the same roughly coursed sandstone blocks as seen at the southern end of the western wall. The exception to this is at the eastern end of the wall where the stone work is replaced with bricks. The brickwork is built around a second area of stone which is approximately 1m above the ground level, adjacent to its join with the eastern wall.

Plate 4: Southern Elevation of Barn

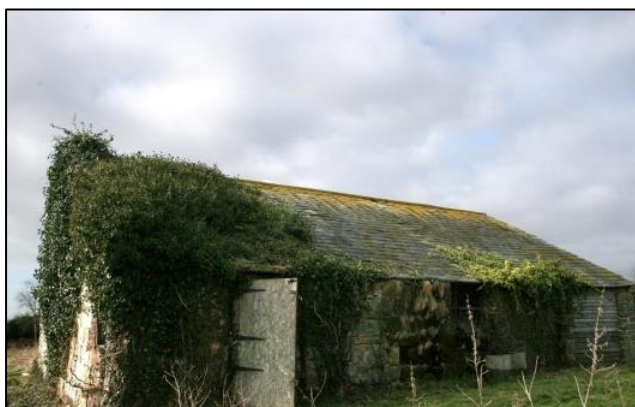
- 4.6** The eastern elevation is constructed from a mixture of building materials (**Plate 5**). The far northern end of the wall is constructed of the faced sandstone blocks. The sandstone blocks of the eastern wall run to the outside face of the blocks in the eastern end of the north wall and are only butted up to each other (**Plate 6**). To the south of this short length of sandstone blocks there is a blocked full height opening. The opening has been blocked using horizontal wooden planks which are nailed to an inner frame of studwork. This blocking looks to be of a recent date. To the south of the blocked entrance the wall is of brick construction. The bricks are laid in a random bond and bonded with a light yellowish grey sandy mortar. There are four sandstone blocks incorporated into the brickwork on the southern side of the blocked opening, which form the quoin on the southern side of the blocked entrance. These appear to be contemporary with the brick work which is apparent under the lowest sandstone block. The brickwork section of the wall has a length of 3m at which point the construction reverts back to the sandstone blocks. There are two openings in the sandstone section of the wall, at the southern end there is the only current entrance into the stable (eastern side of the building). The entrance is fitted with a door constructed of a chipboard sheet with three strap hinges on its southern edge. There is a window located on the south side at the point where the construction materials of the wall change. The window has a simple wooden frame and is unglazed. The wall is 1.9m high from ground level to the roof.

Plate 5: Eastern Elevation

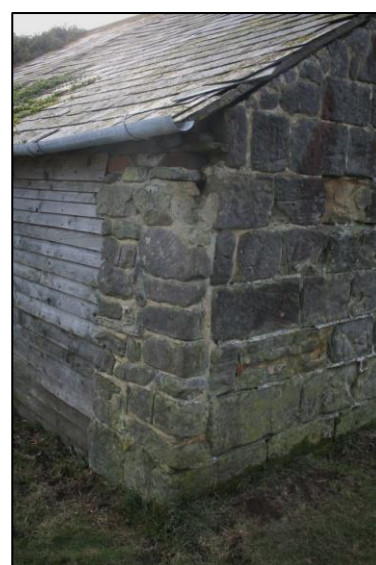
Plate 6: Joint of the East and west walls

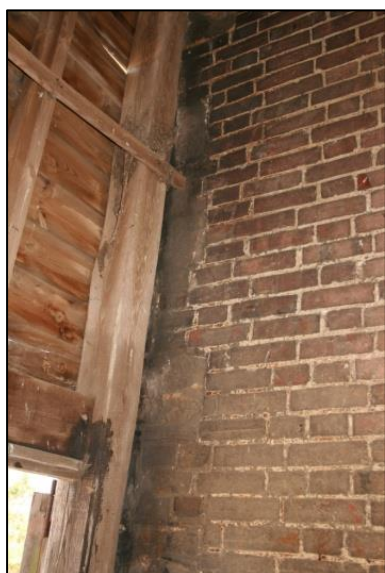
Plate 7: Northern End of dividing wall

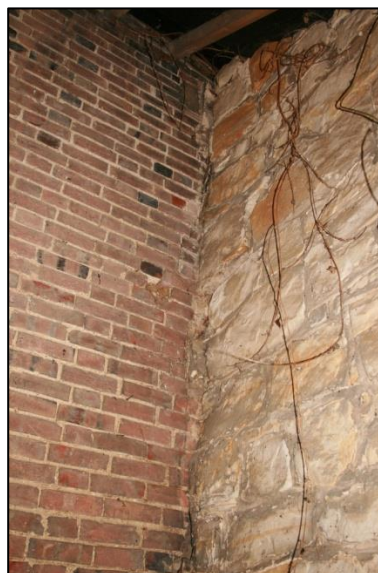
Plate 8: Southern End of Dividing wall

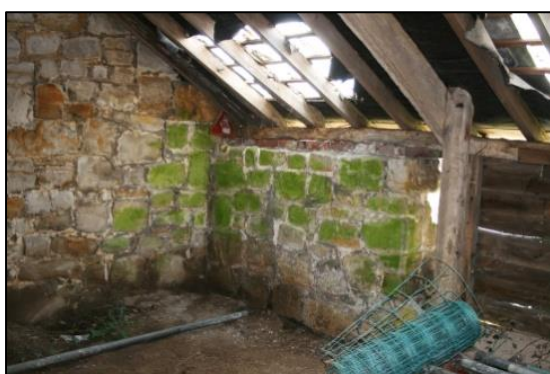
Plate 9: Southernmost Bay of Store

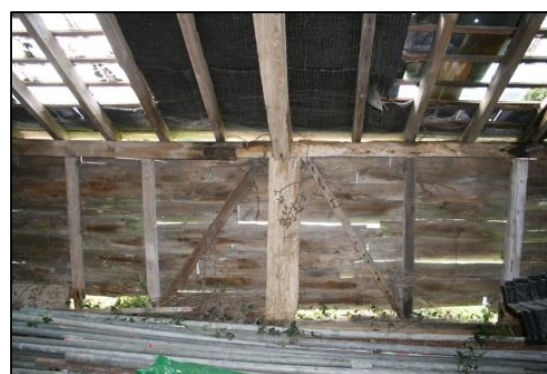
- 5.2** The western wall is of timber framing, consisting of four short posts measuring 220mm wide by 130mm deep and 1.1m high, which support a wall plate which measures 90mm wide by 150mm deep. These posts divide the store into five bays; the west wall of the fifth bay is constructed of sandstone blocks (**Plate 9**). Between the southernmost post and the next to the north the wall plate has been repaired with a modern length of timber which has been scarf jointed into the original timber. The studwork between the short posts of the western wall appears to be a modern replacement with the studs measuring 70mm square. The weathering of the low posts suggests that they are of a greater age (**Plate 10**). The western wall of the southernmost bay as mentioned above, the studwork and weatherboard construction is replaced by sandstone blocks. There is a single course of bricks laid between the upper course of the sandstone blocks, and the wall plate rests upon the bricks.

Plate 10: Low Posts and Studs of western wall

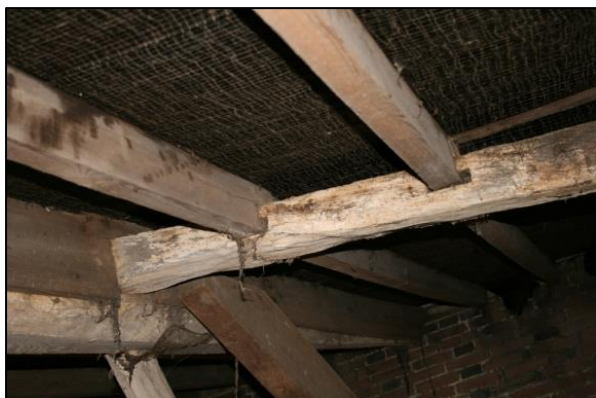
- 5.3** The roof of the store (western side of the building) appears to have a large amount of the original rafters replaced, however, the purlins, principal rafters and a few of the rafters appear to appertain to an earlier roof structure. The roof is of a staggered but purlin construction. A number of the lengths of stagger purlins have been repaired by fixing planks of wood to either one or both of their outer faces. Where the original timber of the purlin is visible earlier mortises have been cut into by later ones when the rafters were replaced (**Plate 11**). All of the ordinary rafters appear to be modern replacements measuring 100mm wide by 50mm deep, except for the rafters on the lower side of the purlin to the south of the fifth principal rafter. These appear to be original and are of un-prepared timbers (**Plate 12**).

Plate 11: Earlier Mortises in Purlin

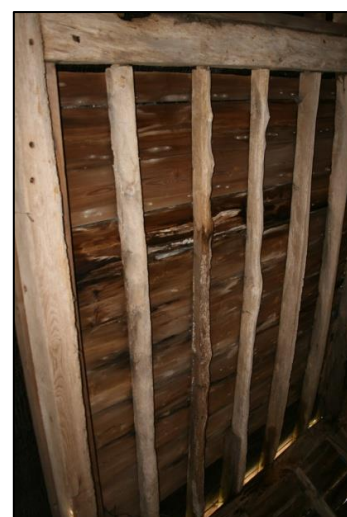
Plate 12: Original Rafters
(Un-worked Timbers)

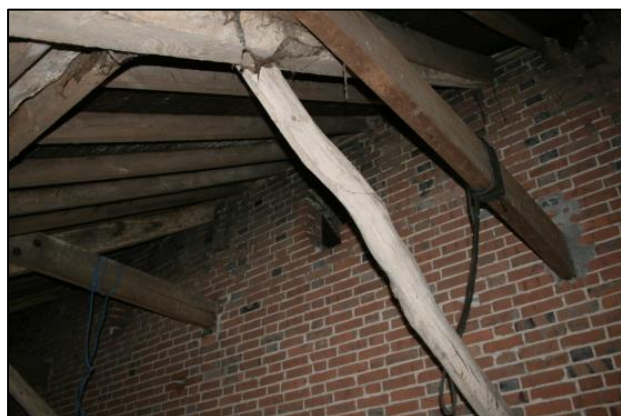
- 5.4** The five principal rafters measure 180mm wide by 120mm deep, some of these also showing signs of being repaired. The five principal rafters are also braced from the dividing wall by un-worked timbers that have been inserted into the brickwork of the dividing wall; these are only nailed to the principal rafters. Above these a second series of bracing is apparent (**Plate 13**), which appear to act as high collars and go through the dividing wall and bolt on to the roof over the stable (eastern side of the building). The roof also has a centre ridge beam but on the western side of the dividing wall this can only be seen at the apex of the gable of the northern elevation. The floor of the store is of bare earth.

Plate 13: Roof Braces in Roof
of Store

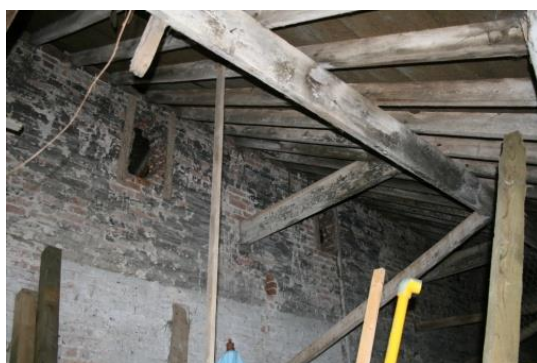
associated studwork at the northern end of this wall which appears to be a later blocking of an opening at that end of the building (**Plate 14**). Both the northern and southern walls are of sandstone block construction, with a small area at the eastern end of the southern wall repaired in brick as noted in the general exterior description. The apex of the gabled north end has also been repaired internally with brick. The small doorway in the northern wall of the stable appears to be a remnant of an earlier phase of the barn. The position of the doorway at mid height would suggest that there was possibly a floored area at this height but there is no surviving evidence for this on either the northern wall or the dividing wall.

Plate 14: Dividing Wall East Side

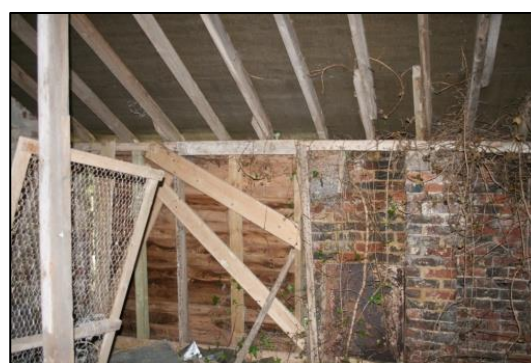
Plate 15: Blocked Opening in Eastern Wall

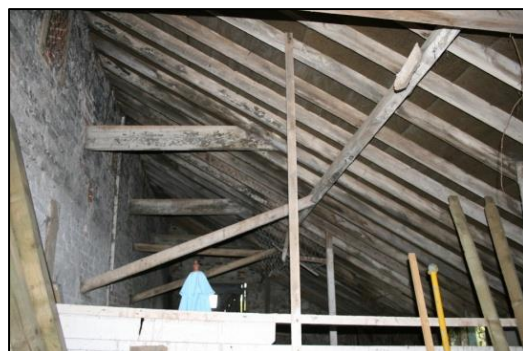
5.5 The roof of the stables (eastern side of the building) appears to be a modern replacement, which consists of single span of common rafters which are supported by a purlin mid way down the slope of the rafters. The rafters are of softwood and measure 100mm deep by 50mm wide, with the purlin measuring 175mm deep by 75mm wide. The purlin is supported originally on four braces which have been inserted into the brick dividing wall (**Plate 16**), the brace at the northern end of the building has been replaced with a post rising from the floor. There is a centre ridge beam visible at the top of the brick dividing wall to which the rafters are fixed, with the rafters resting on a wall plate at the top of the eastern wall. The floor of the stable has been floored in shallow frogged bricks, and incorporates a fall to a drainage channel (**Plate 17**).

Plate 16: Construction of Stable Roof

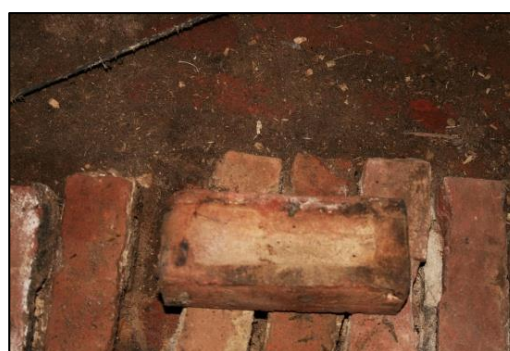
Plate 17: Brick from Stable Floor

- 8.3** The mixture of materials used in the construction of the barn, would imply that over the course of time a great number of alterations and repairs had taken place. This mixture of materials would suggest that the building was repaired using available materials. This would be consistent with the buildings use as a barn or storage building. However, the incorporation of a brick floor and drainage channel in the stable suggests that this side of the building was originally used as a stable or cowshed. The shallow frogged hand-made bricks used in the floor (Plate 17) suggest an early 19th century date¹⁶ for the floor.

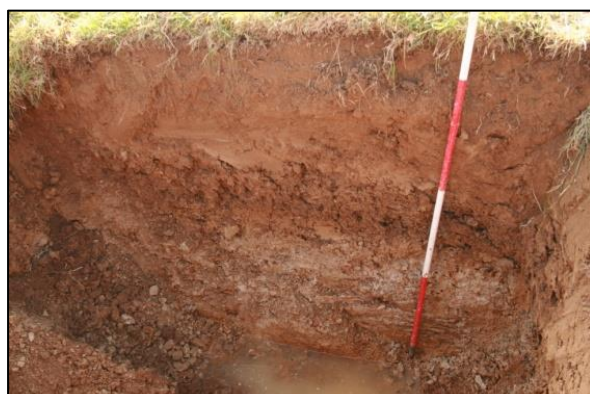
- 6.4** In the trench for the septic tank there were three deposits apparent (Fig. 8 and **Plate 18**). Context **4** was the topsoil and turf, a very dark brown silty clay loam with a loose consistence. This deposit was up to 100mm in depth with the only inclusions noted being of light rooting (2%). The deposit produced a number of sherds of pottery and ceramic building material (the latter was not retained).

Plate 18: West Facing Section of
Trench for Septic Tank
