**A Standing Building Survey of Two
Buildings at Warnham Brickworks,
(Site Ha)
Horsham, West Sussex**

Project No. CBAS 0382

by
Keith Butler PIfA

May 2013

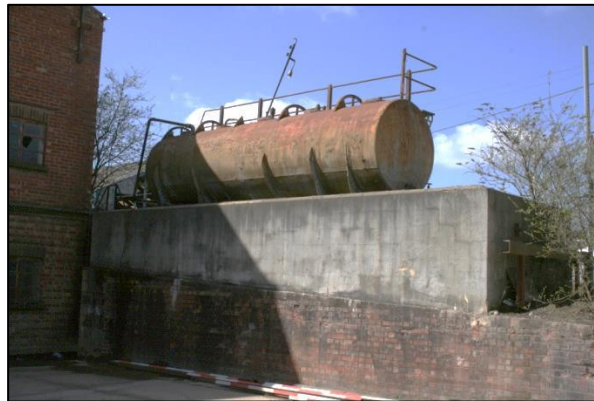
4.1 Building A is on a north to south alignment, and is rectangular in plan with a small projection located at the western end of the southern elevation. The building is built into a rise in the ground level which allows the northern end of the building to have a shallow basement level. In front of the north end of the building there is an area of hard standing with a metal cylindrical (fuel?) tank on the western side (Plate 1). The tank is supported on a large concrete plinth which in turn is supported by a brick built base.

Plate 1: Building A Cylindrical Tank

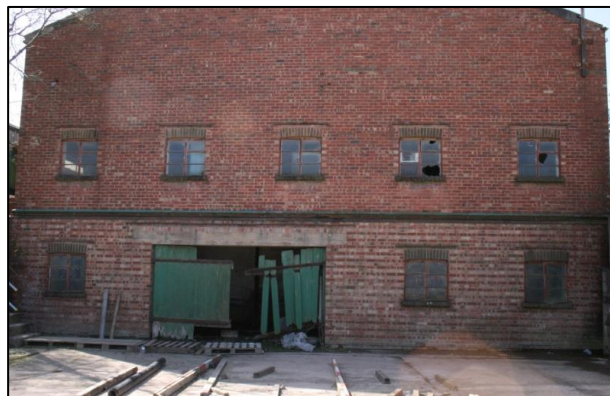
4.2 The northern elevation (Plate 2) consists of the gabled end of the main body of the building with a basement level. This elevation is of red brick construction with the lower part of the wall being laid in English bond (Alternating course of stretchers and headers), with the upper part of the wall laid in stretcher bond. The wall of the basement level slightly steps out to the north from the wall at ground level. The openings in the basement level consist of a large double door of vertical wooden plank construction, which is the only entrance to the basement level. There is a single window to the east of the double doors and two windows to the west of the doors. The main body of the building is lit by a row of five windows. All the windows on the northern elevation are of the same type, having metal frames with two columns of three lights. The windows on this elevation all having a slightly arched soldier course at their head and concrete sills.

Plate 2: Building A Northern Elevation

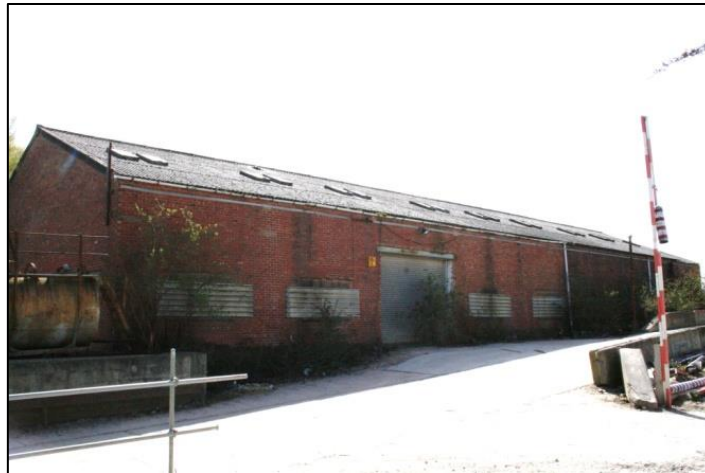
- 4.3 The western elevation (Plate 3) of Building A is constructed of bricks which are laid in stretcher bond. This elevation has two windows to the north of a metal roller shutter door, with a further six windows to the south of the door. All the windows were blocked over with corrugated metal sheets at the time of the survey, but the construction of the surviving frames was apparent on the inspection of the interior of the building, and these were of the same type as seen in the northern elevation. All the windows on this elevation have a decorative slightly arched soldier course at their heads and a slightly projecting brick built sill at their base.

Plate 3: Building A Western Elevation

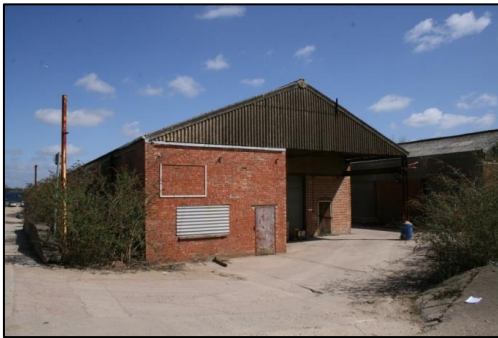
- 4.4 The elevation at the southern end (Plate 4) of the building has a projection from the building on its western end. The recess at the south eastern corner of the building is created by the western projection; this is under the main body of the roof. This part of the roof is supported by a vertical steel post which is 'H' shaped in section. The base of the steel post is set in concrete filled blue plastic barrel. Near the top of the vertical steel post there is a second horizontal steel girder running back into the building. The projecting part of the building on the western end of this elevation is of brick construction; the bricks have been laid in stretcher bond, whereas the southern wall of the main body of the building the bricks are laid in English bond. This projection is not shown on the 1961-2 OS map, so may be a later addition as it is shown on the 1976 OS map.

Plate 4: Building A Southern Elevation

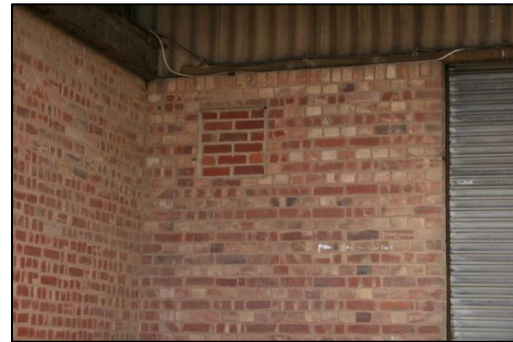
Plate 5: Building A Repair in Recessed Southern Wall

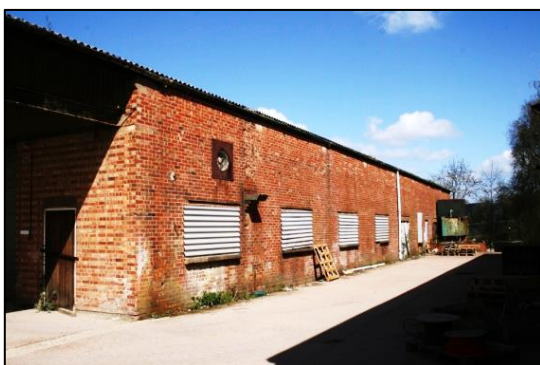
- 4.6** The eastern elevation is of bricks laid in stretcher bond. There are four windows which have been blocked with corrugated metal sheets at the southern end of this elevation, with a blocked door to the north of these. The four windows to the south have a flat soldier course at their heads with a projecting brick built sill at their base. To the north of these windows are two doorways; the southern one has been blocked with a corrugated metal sheet. The northern of the two doors is of vertical plank construction, and is the current access point to the interior of the building. Between the doors there is a smaller window that has been blocked with a corrugated metal sheet. To the north of the doorways there are two more windows, with metal frames of three columns of three lights. The windows at the southern end of this elevation are of the same type, but only visible from the interior of the building. Just to the north of the window at the southern end of this elevation there is a concrete corbel projecting from the wall. The concrete corbel is supported below by three courses of staggered bricks. Above the corbel there is a scar in the brickwork of the eastern wall. To the south of the corbel there is a ventilator with a metal plate surround. At the northern end of this elevation are two metal (fuel/oil) tanks supported on a brick built plinth at each end, and surrounded by a low brick wall forming an enclosure around the tanks (Plate 8).

Plate 6: Building A Eastern Elevation

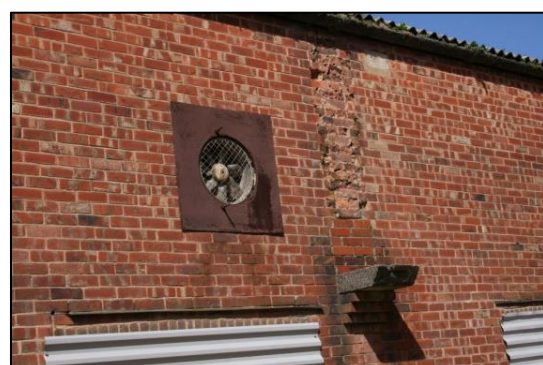
Plate 7: Building A Corbel and Ventilator

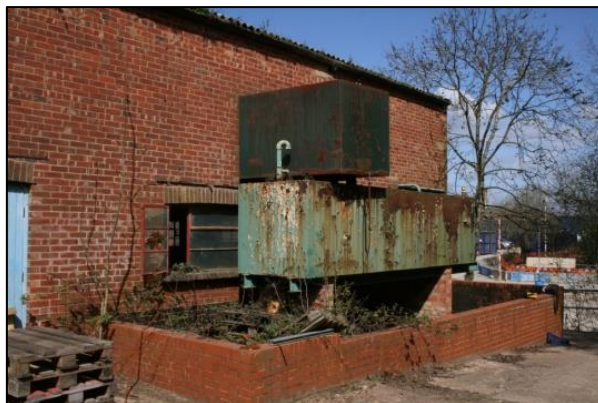
Plate 8: Building A Tanks Adjacent North
End of Eastern Elevation

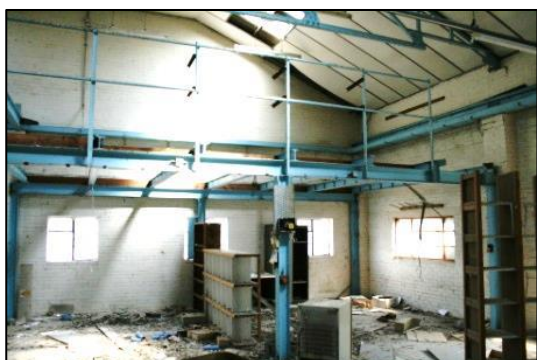
Plate 9: Building A Structure in
North-eastern Corner of Northern Section

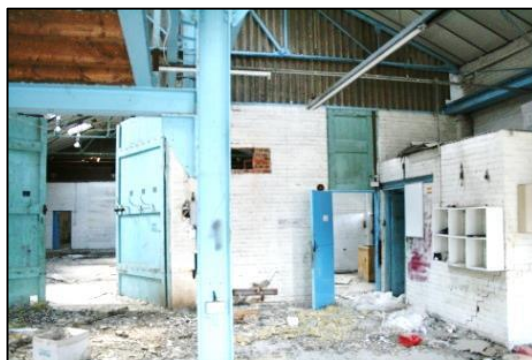
4.8 The interior of Building A is divided by brick built walls into three sections, with the southernmost section being further sub-divided by a central wall. The northern section has a concrete floor except for the far northern part which is above the basement; this is covered with thick wooden planks on a north to south alignment. In the south-western corner there is a small brick built office, with the entrance door at the southern end of the eastern wall. The entrance is fitted with a door constructed of vertical planks of wood. The north-western corner of this part of the building has a large structure of steel girders (Plate 9) which was possibly a second floor in this part of the building. Close to the top of the western and eastern walls there is a horizontal steel girder which is supported by a brick built piers on these walls. This appears to be the two outside tracks that the hoist in the centre section of the building runs on. In the centre of the southern wall of the northern section is the entrance to the central section, these doors are constructed of vertical planks of wood which are braced on the northern face. To the west of this doorway there is a second entrance which is also of full height but divided into two, similar to a stable door (Plate 10).

Plate 10: Building A Entrances to Central
Section

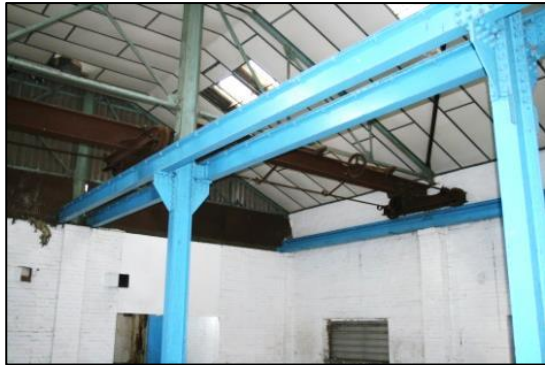
Plate 11: Building A Hoist

- 6.2** The most interesting feature in Building **A** is the hoist in the central section of the building. The hoist has four sets of bogies, each having two in-line wheels. The bogies run on four steel girders which act as rails, and extend for the whole length of the building. The hoist could only have operated in the centre section of this building as the rails are blocked by the internal dividing walls of the northern and southern sections, unless these partitions are a later addition. It was also noted that the north-south dividing wall of the southern section of the building separated the centre twin rails. No maker's name or model information could be seen during the survey.

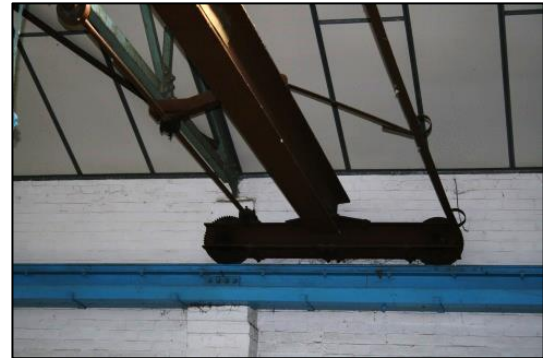
Plate 12: Building A Detail of Boogie

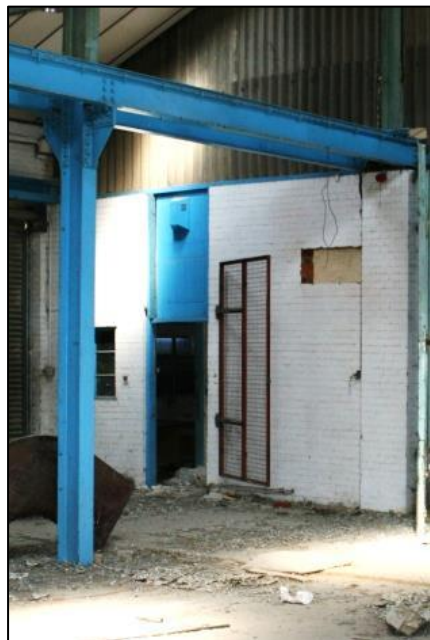
Plate 13: Building A Metal grille

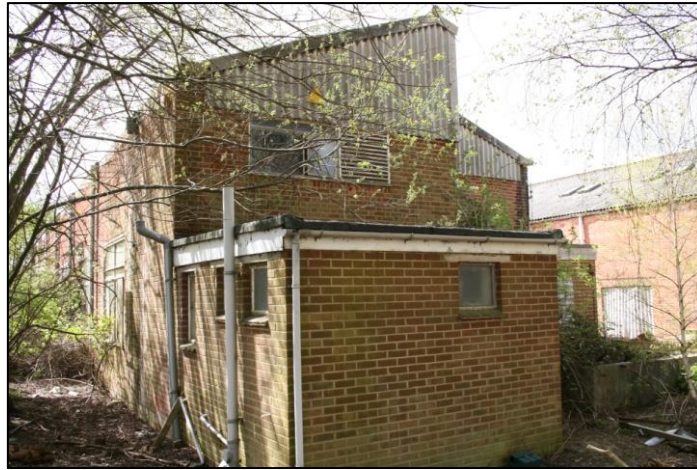
- 5.1** Building **B** was located to the east of Building **A** and was also rectangular in plan on a north south alignment, although smaller. The northern elevation has a projection on the eastern end of it (Plate 14). Attached to this is a single storey building, with a flat roof. This part of the building is constructed of brick laid in stretcher bond, and has a flat roof. There are three metal framed windows in the eastern wall with a single small metal framed window in the northern wall. The entrance to this part of the building is located at western end of the north wall, and is currently blocked with a corrugated metal sheet. This was a WC serving Building **B**. There is a second single storey part of the building located within the recess formed by the northern wall, and the western wall of the northern projection of the main body of the building. This is of brick construction but on this part of the building they are laid in English bond. The northern staggered gabled end wall of the main body of the building is of brick construction laid in English bond. The staggered gable is covered in the same corrugated asbestos sheeting as the roof. There is a single metal framed window in the eastern projection of the southern wall, with a square wooden slatted louver to the west of it.

Plate 14: Building B Northern Elevation

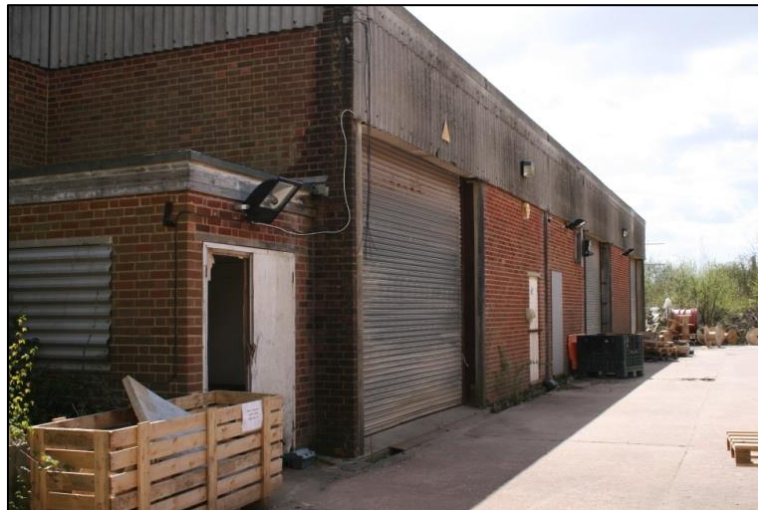
- 5.2** The western elevation (Plate 15) of Building B consists of three metal roller shutter doors with two doorways between the northern and centre roller shutter doors. The doorway to the north is fitted with a modern panelled door, while the southern door has been sealed over with a sheet of corrugated metal sheeting. The western wall is of brick construction laid in stretcher bond, with the upper part of the wall is covered in corrugated asbestos sheeting.

Plate 15: Building B Western Elevation

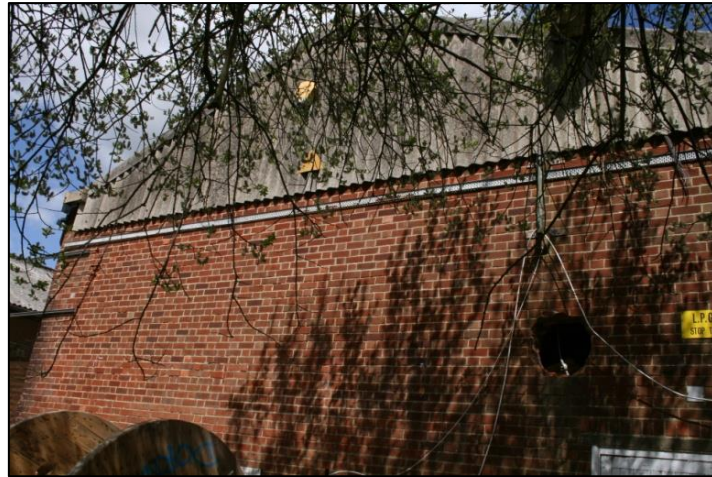
- 5.3** The southern elevation (Plate 16) is of brick construction laid in English bond with the gabled end covered with corrugated asbestos sheeting. There is a doorway at the eastern end of this wall, fitted with a door of vertical wooden plank construction. The doorway has a concrete lintel above. Above and to the west of the doorway a roughly circular hole has been knocked through the wall.

Plate 16: Building B Southern Elevation

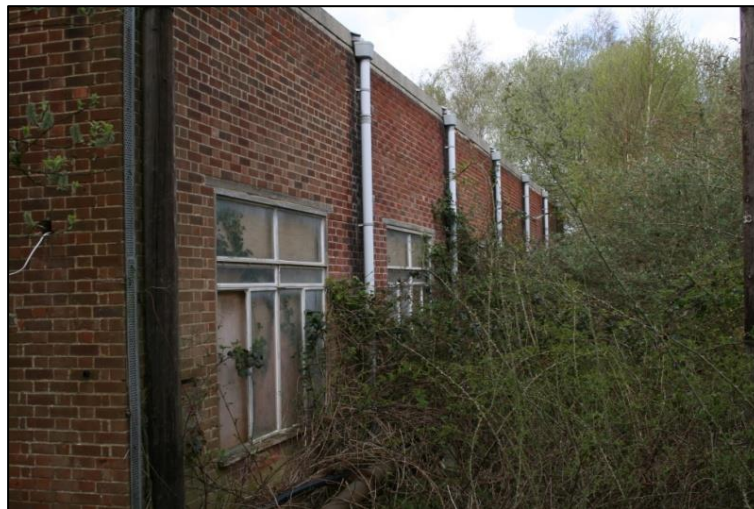
- 5.4** The eastern elevation of Building B is of brick construction and these are laid in English bond (Plate 17). During the survey the inspection of this elevation was hampered by the vegetation. There are six large metal framed windows with the glazing bars of the window forming eight lights. Between the windows are the down pipes from the guttering running adjacent to the eaves. The top of the wall is finished with a concrete band, with the windows each having a concrete lintel.

Plate 17: Building B Eastern Elevation

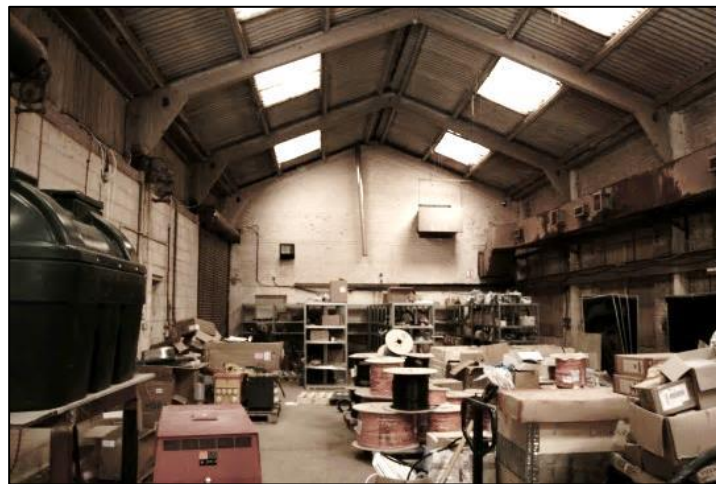
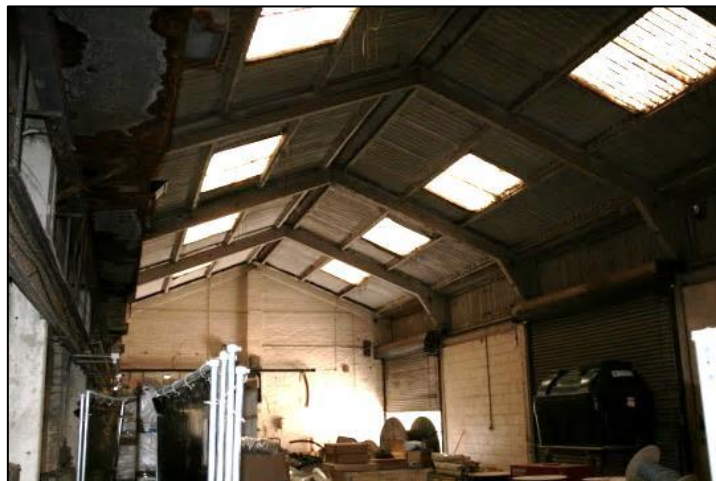
- 5.6** The interior of the main body of the building is of one large open space (Plates 18 & 19), and is largely devoid of features. The main body of the interior is accessed via a doorway at the eastern end of a corridor located within the single storey part of the building. The interior walls are painted bricks except for the western wall with the roller shutter doors, which is lined with breeze blocks. The framework of the roof is of steel girders which are supported by vertical steel posts adjacent to the eastern and western walls of the building. The southern end 'A' frame appears to be supported by a brick built plinth. High on the eastern wall there is the ventilation trunking running the entire length of the building.

Plate 18: Building B Interior North End

Plate 19: Building B Interior South End
