**A Standing Building Survey on  
the Buildings at Spells Yard,  
Worthing, West Sussex.**

Project No. CBAS0405

by  
Keith Butler PIfA

September 2013

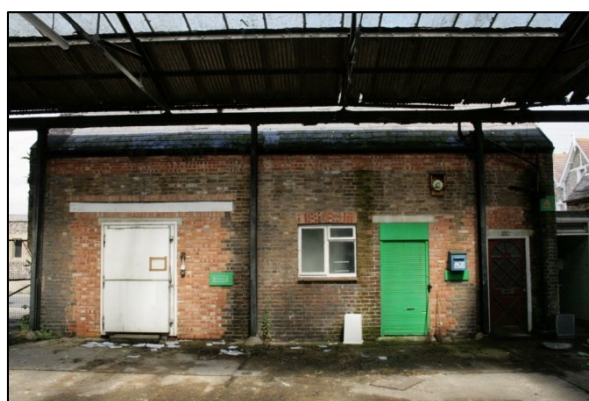
**Plate 1:** Southern Elevation of Building A

4.1 Building A is located at the northern side of the yard, and is on two storeys the first floor appearing to be built into the roof space, but unfortunately at the time of the survey the first floor had been sealed off due to health and safety concerns and could not be surveyed. The building is rectangular in plan, and on an east-west alignment. The southern elevation (**Plate 1**) of the building faces into the yard, and is of brick construction. The bricks in this elevation are laid in Sussex bond, with the majority being laid with three stretchers between each header. At the western end of the elevation there is a metal door, which, evidenced by the in-fill repairs to the brick work around the door, fills an earlier larger opening. There is also a wooden lintel inserted into the brickwork that overhangs both the eastern and western sides of the current metal door, which also suggests that the opening was originally larger. There are two doorways at the eastern end of this elevation. The entrance at the far eastern end of this elevation is the doorway to the first floor of Building A (this door was sealed at the time of the survey), and was fitted with a modern wooden door. The upper part of the door was glazed, with the glazing bars forming a latticework design with a fan light above. The lower part of the door had a single wooden panel with a St Andrews cross design. To the west of this entrance was the doorway to the middle room on the ground floor A2, and was fitted with a green coloured metal roller shutter door (F W GEBELER (HOVE) LTD). Above the door was a concrete lintel. The area between the two doors showed signs of being recently repaired, the bricks and mortar being very fresh and of a different colour. The top of the southern wall also showed signs of being recently repaired with newer bricks which were laid in a random bond. To the west of the metal roller shutter door was a wooden framed casement window, which was glazed with wired glass.

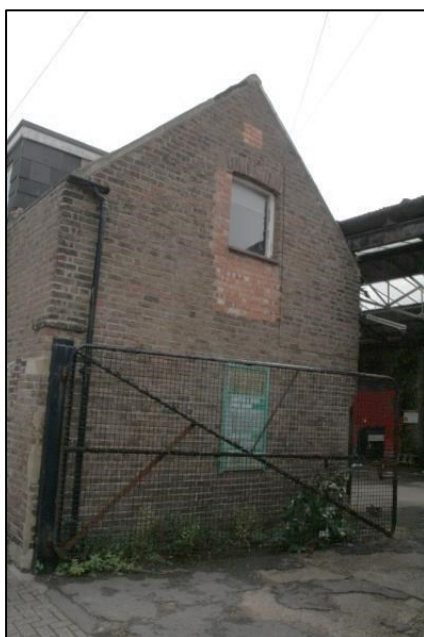
**Plate 2:** Western Elevation of  
Building A

4.2 The western elevation of Building A was of brick construction, and was gable ended. The bricks were laid in Sussex bond with three stretchers between each header. There was a single opening located in the centre of the first floor, consisting of a wooden framed un-opening window. The window had a slightly curved head of brick construction. To the north and below the window there was an area of repair,

apparent by the use of new bricks and fresh mortar. Above this window in a central position in the gabled end was a second area of repair using the same materials as in the repair around the window below. This area of repair described a regular square, which suggests that it is a blocked first floor opening. The lower part of the southern end of the western wall has been rounded, and cement rendered, which would appear to give better access to the yard, whose entrance is located to directly to the west of the southern end of this elevation.

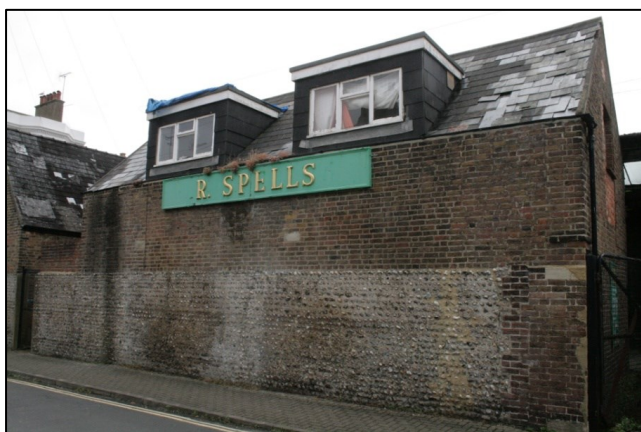
**Plate 3:** Northern Elevation of Building A

- 4.3** The northern elevation (**Plate 3**) of Building A faces onto Grafton Place and is constructed of flint below, with the upper part being of brick. The lower part of the northern wall incorporated the northern boundary wall of Spells Yard. The flint boundary wall making up the lower part of this elevation was coursed cobbles that had not been faced. The cobbled lower part had a height of 1.95m, after this the wall changed to brick. The bricks were laid in Sussex bond with three stretchers between each header. At the top of the brickwork just below the eaves in a central position was the sign 'R. SPELLS' in gold letters on a green painted wooden board. Below this in very faded paint could be seen the words 'BRIGHTON LTD'. At approximately 700mm from the base of the brick part of this wall the ends of two concrete beams could be seen incorporated into the brickwork. Two dormer windows were located in the northern slope of the roof, which were both with wooden framed dormer windows of three lights. The dormers had a flat roof above with slate clad sides. It was also noted that at the western end of the flint lower part of the wall there was a brick built quoin; this had been incorporated into a section of brickwork on its western side. This would suggest that the western side of the entrance to the yard had been reduced in width when this building was constructed.

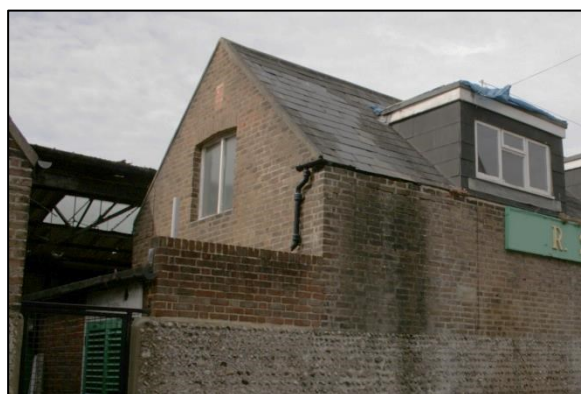
**Plate 5:** Eastern Elevation Building A

- 4.4 Only the upper part of the eastern elevation was visible due to the construction of a modern toilet block on the eastern end of Building A (**Plate 5**). The eastern wall was of brick built construction, with the bricks being laid in Sussex bond with three stretchers between each of the headers. There was a single wooden framed window of two lights on the first floor with a slightly curved head of brick. As noted on the western elevation there was a small square area of repair using modern bricks, suggesting that there was originally a small opening near the apex of the gable in this wall as well.

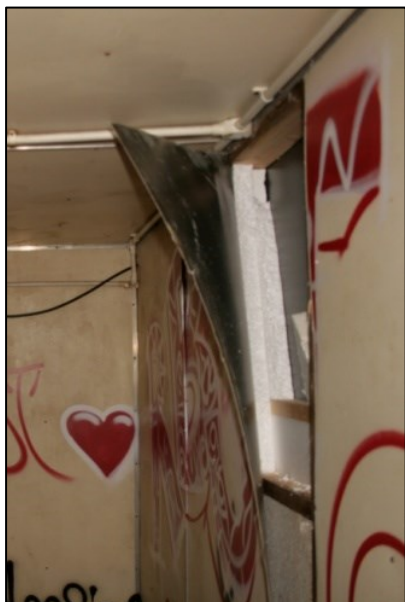
**Plate 6:** Wall Construction of **A1**

- 4.5 The roof of Building A was gabled at both ends and had a covering of slate. There were no chimneys stacks, with two dormer windows inset into the northern slope of the roof as mentioned above.
- 4.6 Only the two rooms on the ground floor were accessible, A1 was located at the western end of the building. Both the original walls and ceiling had been covered with metal sheeting which was fixed with wooden stud work. Between the original walls and ceiling and the outer covering of metal sheets there was a layer of

polystyrene sheets (**Plate 6**). Access to the room from the exterior of the building was located in the centre of the southern wall and was fitted with a metal door. The floor was of concrete that appeared to have been slightly raised. There was a doorway, which was fitted with a metal door, giving access to **A2** located at the southern end of the eastern wall. The polystyrene insulation of the walls and ceiling and the metal doors, would suggest that this room had been used as a cold store.

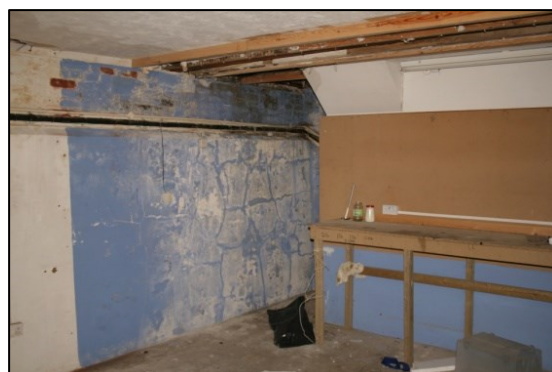
**Plate 7:** North and  
East Walls  
of **A2**

**4.7** **A2** was located to the east of **A2** and was accessed from **A1** by the metal door in the western wall. Access from the exterior of the building was via the metal roller door in the centre of the southern wall. The room was lit by a wooden casement window locate to the west of this doorway. The northern wall of the room was covered with plaster except for the top where there were seven courses of painted bricks visible. The southern wall was of painted bricks, with the western dividing wall between the two rooms being of the same metal sheeting over polystyrene as seen in **A1**. The eastern wall was made up of the underside of the staircase of the room to the east which projected into **A2**, and was boxed-in with plasterboard (**Plate 7**). The rest of the wall was of painted brick. Adjacent to this wall was a fixed wooden bench. The ceiling was of 'Artex' covered plasterboard which had been removed in places revealing the ceiling joists which were on a north-south alignment.

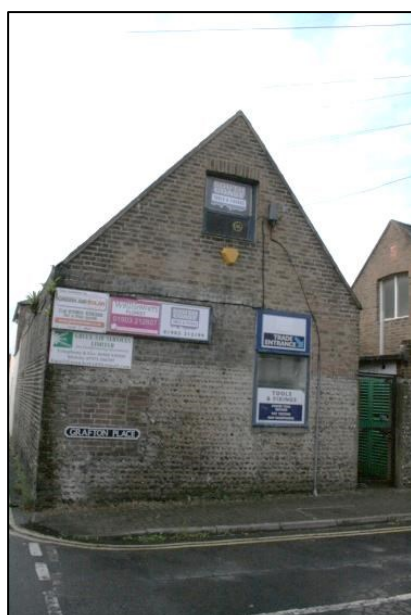
**Plate 11:** Northern Elevation  
Building B

- 5.2 The northern elevation of Building B fronted onto Grafton Place (**Plate 11**). The lower part of the wall to a height of 2.05m wall was of coursed flint cobble construction. The upper part of the wall was of brick construction, the bricks being laid in a random bond. The eastern end of this wall had a brick built quoin, but there was not a corresponding quoin at the western end. Directly to the west of the western end of the building an entrance to the yard had been created. This suggests that the southern wall of the building incorporated the earlier boundary wall. At the western end of the wall at ground floor level there was a wooden framed window, also in the wall at eastern end there was an area of brick repair suggesting a blocked window. The first floor was lit by a wooden framed window located in the centre of the gabled end of the building, with a flat head of a single course of bricks.

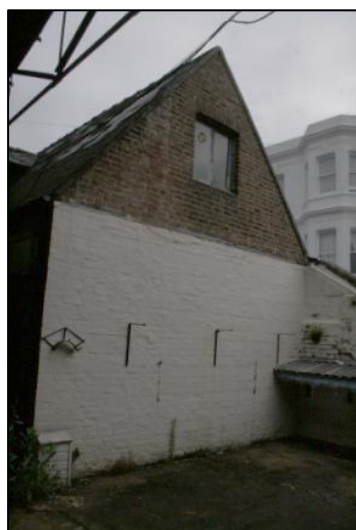
**Plate 14:** Southern Elevation of  
Building **B**

- 5.4** The southern elevation of Building **B** (**Plate 14**) was of brick construction laid in a random bond; the brickwork below the gable was painted white. There were two blocked openings suggested by two wooden lintels positioned level with the bottom of the gable. Both of these lintels had areas of repair below them, with the lintel at the eastern end of this wall being much longer. There was a single wooden framed window of two lights located in the centre of the gable in this elevation.

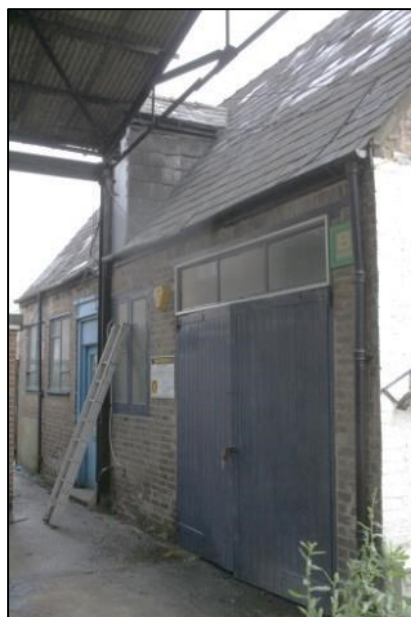
**Plate 15:** Projecting Structure on  
Roof Building **B**

- 5.5** The roof of Building **B** was gabled at both the northern and southern ends, and had a covering of slate. The only feature noted on the roof was a structure projecting from the western slope of the roof (**Plate 15**). This possibly housed a hoist but there was no evidence for this. The structure was located in the centre of the western slope of the roof, and had slate clad sides. The structure had a small roof which had a gabled western end, and was also covered in slate. The front of the structure had been boarded over.

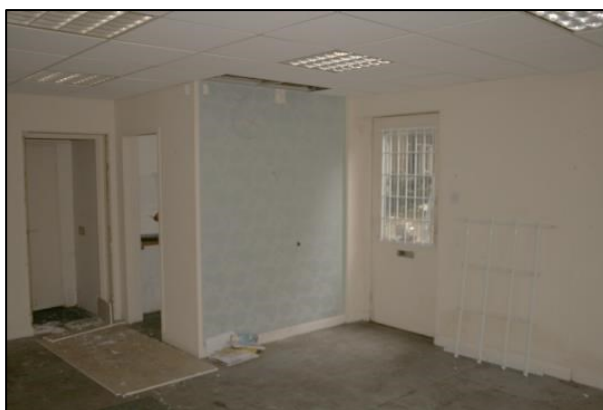
**Plate 16: B1 with Small Kitchen B2**

- 5.6** The ground floor of Building **B** comprised of four rooms. **B1** was located at the northern end of the building (**Plate 16**). The room was entered from the exterior of the building through a doorway located in the southern end of the western wall, and was fitted with a modern door with a glazed upper panel. All the walls had been panelled over with plasterboard sheets, which covered the two windows at the far northern end of the western wall. The suspended ceiling was of polystyrene tiles within a metal framework, with six lights which were protected by plastic grills. The floor covering was of square vinyl tiles. The south-western corner was partitioned-off to form a small kitchen (**B2**) (**Plate 16**). The partition walls to the north and east of the room were constructed of breeze blocks, with the south and west walls being of brick. There was a small modern sink unit located under the window in the western wall, with a worktop attached to the southern wall. Both of these having a ceramic tiled splash back. The ceiling was of plasterboard, and the floor covering was of vinyl tiles.

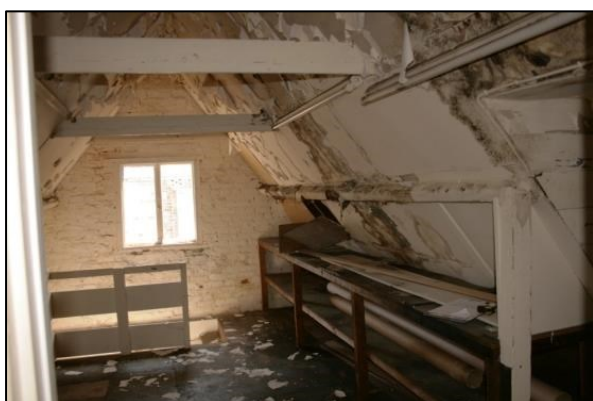
**Plate 18: Visible Roof Structure B5**

**5.9** The first floor consisted of two rooms, which were built into the roof space. **B5** was located at the southern end of the first floor of the building (**Plate 18**) and was accessed by the staircase in the south-eastern corner of the room. The staircase was protected by three posts and three horizontal planks on its eastern side. The southern brick-built gable served as the southern wall and had a wooden framed window of two lights in a central position. The northern wall was a plasterboard partition wall dividing this room from **B6**. The eastern and western walls of the room were the sides of the roof, which had been covered with hardboard leaving only the side purlins and two collars exposed. Located at the northern end of the western side of the roof the projecting gabled structure was apparent (**Plate 19**). This was of horizontal wooden plank construction on its north and south sides, with the opening on the western side being boarded over with chipboard panels. This structure most likely housed a hoist but as noted on the exterior examination of the building there was no evidence for this. The lower part of slope of the western side of the roof had a work bench of wooden construction with shelves fitted under. The floor had been covered with hardboard sheets.

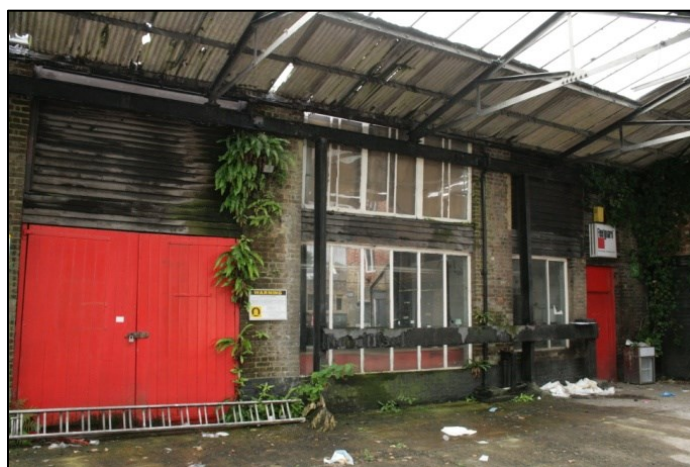
**Plate 20:** Northern Elevation Building C

- 6.2** The northern elevation of Building C (**Plate 20**) faces onto the yard, and is of mainly brick construction. The bricks have been laid in random bond. The brickwork forms four piers with the areas between being made up of doors, windows and areas of wooden vertical planks of weatherboarding. Starting from the eastern end of the building there is a double door of vertical plank construction on the ground floor level, above the doors the first floor is of horizontal weatherboarding. After a pier of brickwork there are large windows on both the ground and first floor. Both windows have wooden frames, with the window on the ground floor being divided into six lights by vertical glazing bars. The window at first floor level is divided into nine lights by vertical glazing bars. The lights are arranged with a narrower light between each pair of wider lights. To the west of the windows there is a second brick pier, with a window on the ground floor with an area of horizontal weatherboarding above, to the west of this pier. The window on the ground floor level is divided into three lights by vertical glazing bars. To the west of this window there is another brick built pier with a door and surround on the ground floor with an area of weatherboarding above. The weatherboarding above this door is deeper than that above the window to the east, and also conceals the top part of the brick pier. The door has a wide surround suggesting that this entrance was originally fitted with a larger door. To the west of this doorway up to its junction with Building D the wall reverts to brick construction.

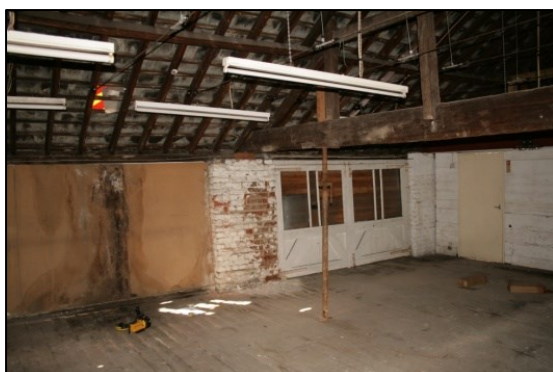
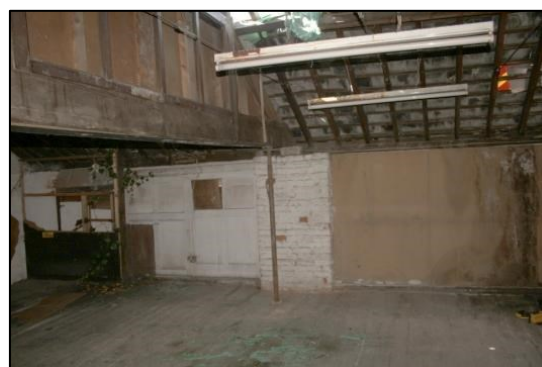
- 6.8 The north wall of C2 is of brick built piers with double doors located at the west and eastern end of it (Plates 27 & 28). Both of these sets of doors have been sealed over with the horizontal weatherboarding as seen on the outside of the building. Between the double doors at either end of this wall the window seen on the external inspection had been covered over with hardboard sheets.

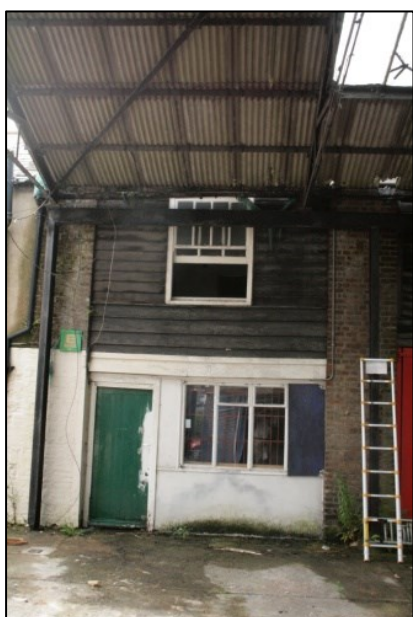
**Plate 33:** Northern Elevation  
Building E

- 7.1 Building E is located in between 89 Portland Street and Building C on the southern side of the yard, and appears to be an in-fill building. The northern elevation (**Plate 33**) is of a cement rendered ground floor, with a first floor of horizontal weatherboarding. The entrance to the ground floor is located at the eastern end of the building, and is fitted with a modern wooden door of vertical plank construction. To the west of this there is a modern metal framed casement window of four lights. The westernmost light has been boarded over with a sheet of wood. The first floor has a single wooden framed sash window located in the centre of it.

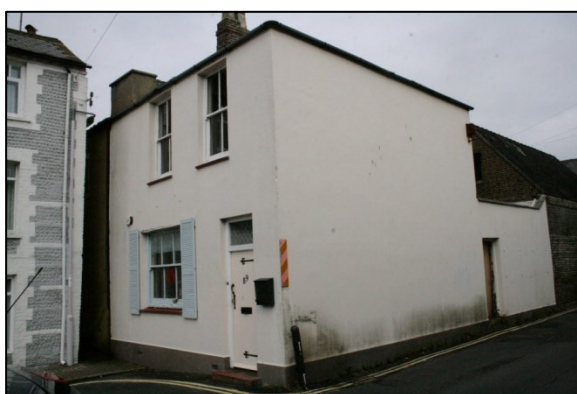
**Plate 40:** Eastern and Southern Elevations of 89

- 8.3** The southern elevation (**Plate 40**) of 89 Portland Road also faces on to Portland Road, and as with the eastern elevation is completely covered with white painted cement render. The front entrance to the building is located at the eastern end of the ground floor, and is fitted with a modern door of vertical wooden planks. The door has two decorative strap hinges on its eastern edge, and a rectangular light above the door glazed with diamond shaped leaded panes. To the west of the door on the ground floor there is a modern sash window of three lights in the lower and upper part of the window. Either side of this window there is a louvered shutter. The first floor is lit by two modern sash windows of two lights in the upper and lower part.

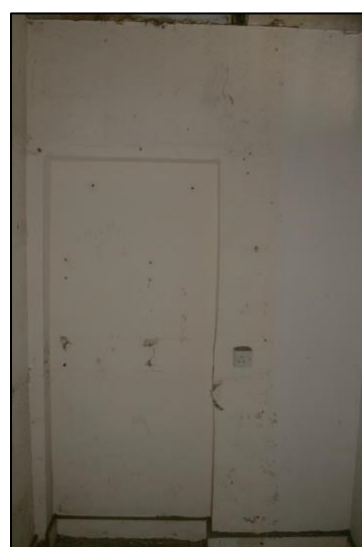
**Plate 46:** Sealed Doorway **P3**

- 8.10** The first floor of 89 Portland Road consisted of a landing, with a large room to the south of the landing, and a bathroom and a large airing cupboard to the north of the landing. The landing was in two parts with the area (**P2**) being located to the south of the staircase with the western end (**P3**) of the landing widening out to the north. The walls of **P2** and **P3** were all plastered except for the northern wall of **P3** which was a plasterboard partition wall. The area to the north of the partition wall was made up of **P4** and **P5**. The staircase was at the north-eastern end of **P2** and was protected by moulded balustrades, which were circular in section with square sectioned bottom and top blocks (**Plate 45**). The handrail and two newel posts were the same type as described in **P6**. These appeared to be of a 19<sup>th</sup> century date. In the centre of the western wall of **P3** there was a sealed doorway into the first floor of Building E (**Plate 46**).

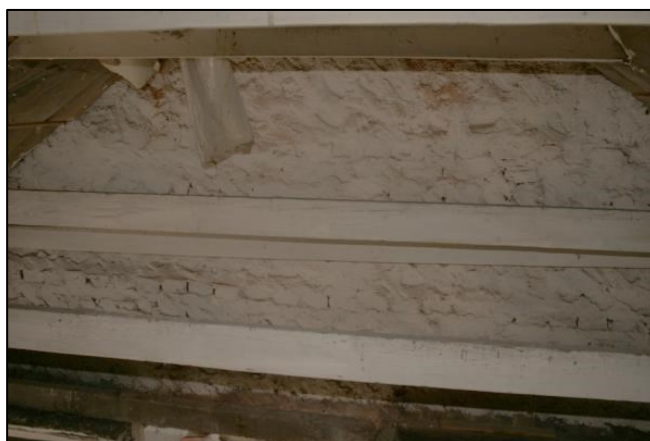
**Plate 49:** Gabled End West End

**8.13** With the ceiling covering removed in places it was possible to see the roof construction which was of common rafters with jack rafters of the hipped eastern end of the structure. The four pairs of rafters at the western end of the roof had high set collars. The common rafters had a ridge plate at their apex. The gable at the western end of the property was also visible, and although heavily painted appeared to be of brick construction, with some of the bricks being laid diagonally (Plate 49). Adjacent to the gable at the western end of the roof the chimney stack appeared to have been capped with a ceiling joist above the capping. This suggests that the roof had been repaired or replaced.
