A Survey of the Hydraulic System at Sheffield Park Gardens, Sheffield Park, East Sussex

by
Keith Butler PCIfA

July 2015

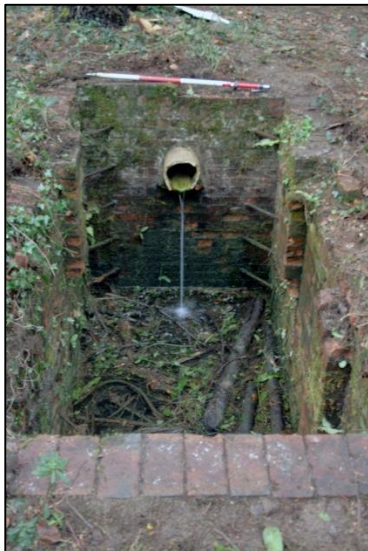
Plate 1: The Wheel Pit taken from the South (Context 1)

3.1 The Wheel Pit (Context 1) was rectangular in plan and had the external measurements of 4.07m north to south by 2m east to west, and internally 3.05m north to south and 1.53m east to west (**Plate 1** & Fig. 3). The full depth of the Wheel Pit was approximately 4.5m (ascertained by sounding rod) with only the upper 1.67m being visible above the water level. The water level remained at a constant level throughout the survey although there was a constant flow of water into it from the ceramic inlet pipe set in the northern wall of the structure (**Plate 2**), suggesting that there was a drain or outlet pipe below the current water level. The Wheel Pit was of redbrick construction with the bricks having shallow frogs and the dimensions of 230mm for the stretchers, 110mm for the headers and having a thickness of 65mm. The bricks were bonded with a hard light yellowish grey mortar with no apparent inclusions. The bricks were laid in English bond (alternating course of stretcher and headers).

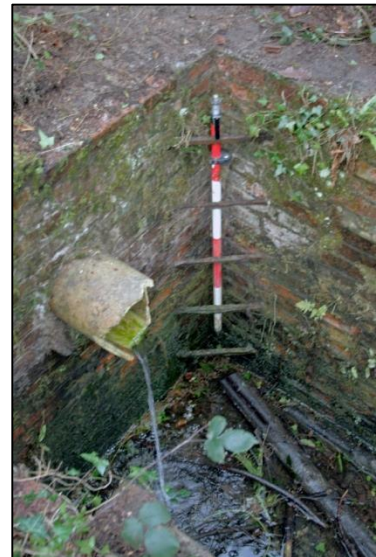
Plate 2: Water Inlet in North Centre of North Wall (Context 1)

Wheel Pit (**Plate 2**). Adjacent to the southern wall was a horizontal length of metal pipe with an external diameter of 50mm, which slopes downward at approximately 45° at its eastern end. The end of the pipe is built into the southern end of the western wall, with a second downward angled pipe joined to the main pipe 200mm in from the western wall (**Plate 5**). Although the full depth of these pipes was obscured by the water level and the debris in the wheel pit, the pipes were very firm suggesting that a pump may still be *in situ*.

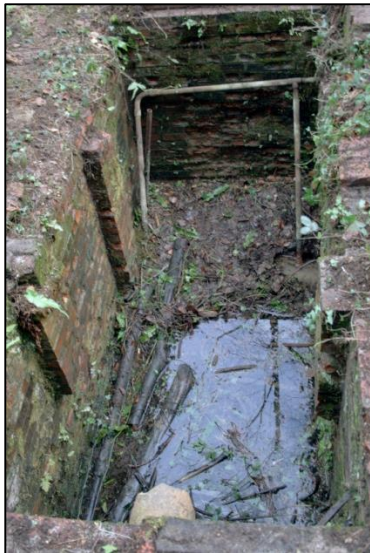
Plate 3: Brick Piers and Eroded Brickwork South Wall (Context 1)

3.2 There were two brick built piers built into the eastern wall of the Wheel Pit with the lower part of the northern pier appearing to have been removed. There was only a single pier built into the northern end of the western wall with its lower part removed (**Plate 3**). The pier at the southern end of this wall appearing to have been completely removed, but no scar was apparent due to the eroded state of the brickwork in this area. Both the lower part of the north wall and southern end of the western wall were highly eroded presumably by water movement (**Plates 3 & 4**). Set into the northern wall was the ceramic inlet pipe which had a 280mm external diameter, the southern end of this pipe was broken and would appear to have extended further into the wheel pit originally (**Plate 2**). The ceramic pipe was supported on its underside by two bricks projecting from the face of the wall and acting as corbels. In both the internal north-western and north-eastern corners of the pit there were five horizontal metal square sectioned iron rods fixed into the brickwork, which served as access ladders into the

- 4.1** The hydraulic system located in the woods to the north-east of Sheffield Park Gardens consists of two elements with the reservoir possibly being a third. The central structure is the Wheel Pit. The Wheel Pit (Context **1**) originally had two built-in piers on both the eastern and western walls. The northern pair of the piers has had the lower part removed, and the southern pier on the western side is missing completely. However, it was noted during the survey that there was a great deal of water erosion apparent on both the south and the southern end of the western walls of the Wheel Pit. This has removed any evidence for a pier to be located at the southern end of the western wall. It is thought that the damage done to the base of the northern pier on either side of the wheel pit is due to the removal of the water wheel

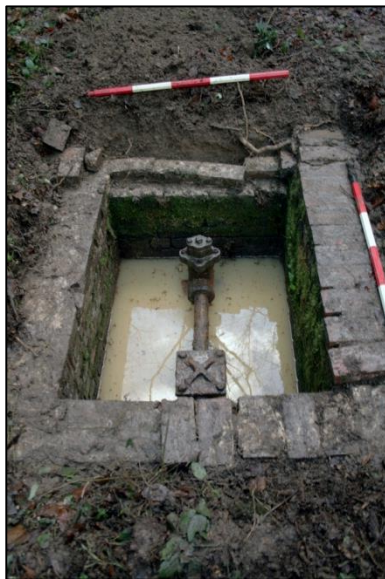
Plate 6: Valve Pit (Context 2)

3.3 Context 2 was a Valve Pit (**Plate 6** and Fig. 4) located to the west of the Wheel Pit (Context 2), (Fig. 2). The pit was rectangular in plan and had the external measurements of 1.3m north to south by 1.68m east to west and internal dimensions of 920mm north to south by 1.22m east to west, and was 820mm deep. The pit was of red brick construction laid in a random bond. The frogged bricks had the dimensions of 220mm for the stretchers, 110mm for the headers and having a thickness of 60mm, with a bonding material of a yellowish grey sandy mortar with no inclusions. Running through the centre of the pit on an east to west alignment was a metal pipe of external diameter of 75mm. This, although of a larger external diameter, lined up with the pipe inset into the western wall of the Wheel Pit. At the western end of the this pipe there was the Stop Valve for the flow of water from the Wheel Pit (**Plate 7**). At the eastern end of the pipe there was cast iron casing possibly containing a Non-Return Valve. This has a square cover plate bolted to the top of the casing with a two diagonal strengthening ribs on it (**Plate 8**). The pipe was supported on its underside on two bricks, which were laid directly onto the silty clay natural (**Context 3**). Context 3 was only apparent in the base of the Valve Pit and was an orange-brown colour. Although not excavated, the silty clay appeared to have no inclusions.

- 4.3** The valve pit was used to regulate the flow of water from the water pit to the estate, and comprised piping with a stop valve and non-return valve. This pit would have originally been covered.

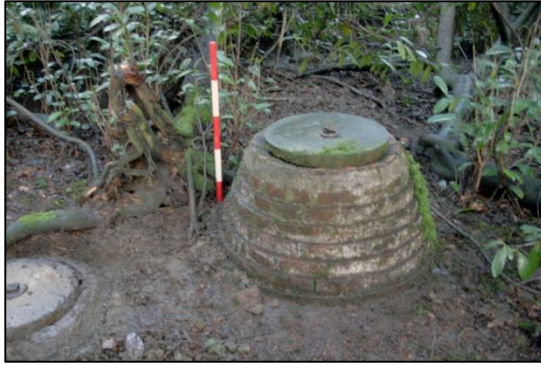
Plate 11: Southern Raised
Opening Context 5

3.5 Context **5** was a similar raised opening to the reservoir (**Plate 11**) as Context **4**, and was located 1.9m to the south of Context **4**. The southern raised opening had a height above ground level of 520mm and was circular in plan. The base of the feature was 720mm wide at its base and 680mm at the top. The southern raised opening was constructed of red bricks which had a variable stretcher length of between 240mm to 110mm and had curved outer surfaces. The brickwork stepped in six times, with the top course having a cement rendered finish. The inner surface of the opening was also cement render to form a collar for the stone cap. The cement render and bonding material for the brickwork was the same pinky grey mortar as used in the construction of Context **4**. The cap was of stone with a rounded outer face and a metal ring handle in its centre. The depth of the southern reservoir was measured by surveyor's staff at 3.9m.

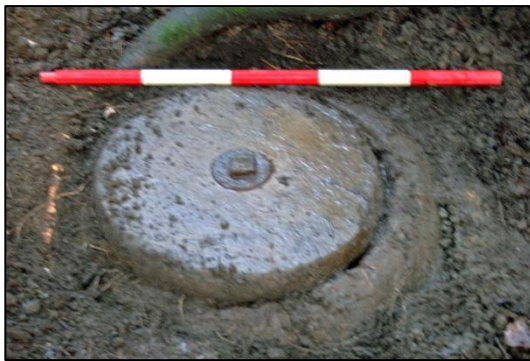
Plate 12: Reservoir Opening
Context 8

3.6 Context 8 is located between the raised openings to the reservoir Contexts 4 and 5, and is a third opening to the reservoir or reservoirs. This opening consists of a slightly raised collar of red brick construction with a cement render finish (**Plate 12**). The collar has an external diameter of 800mm and is fitted with a stone cap with an external diameter of 600mm. The cap covering the opening was fitted in a closed position by a large square headed bolt with a metal washer between the nut and the stone surface of the cap. No attempt was made to remove the stone cap.

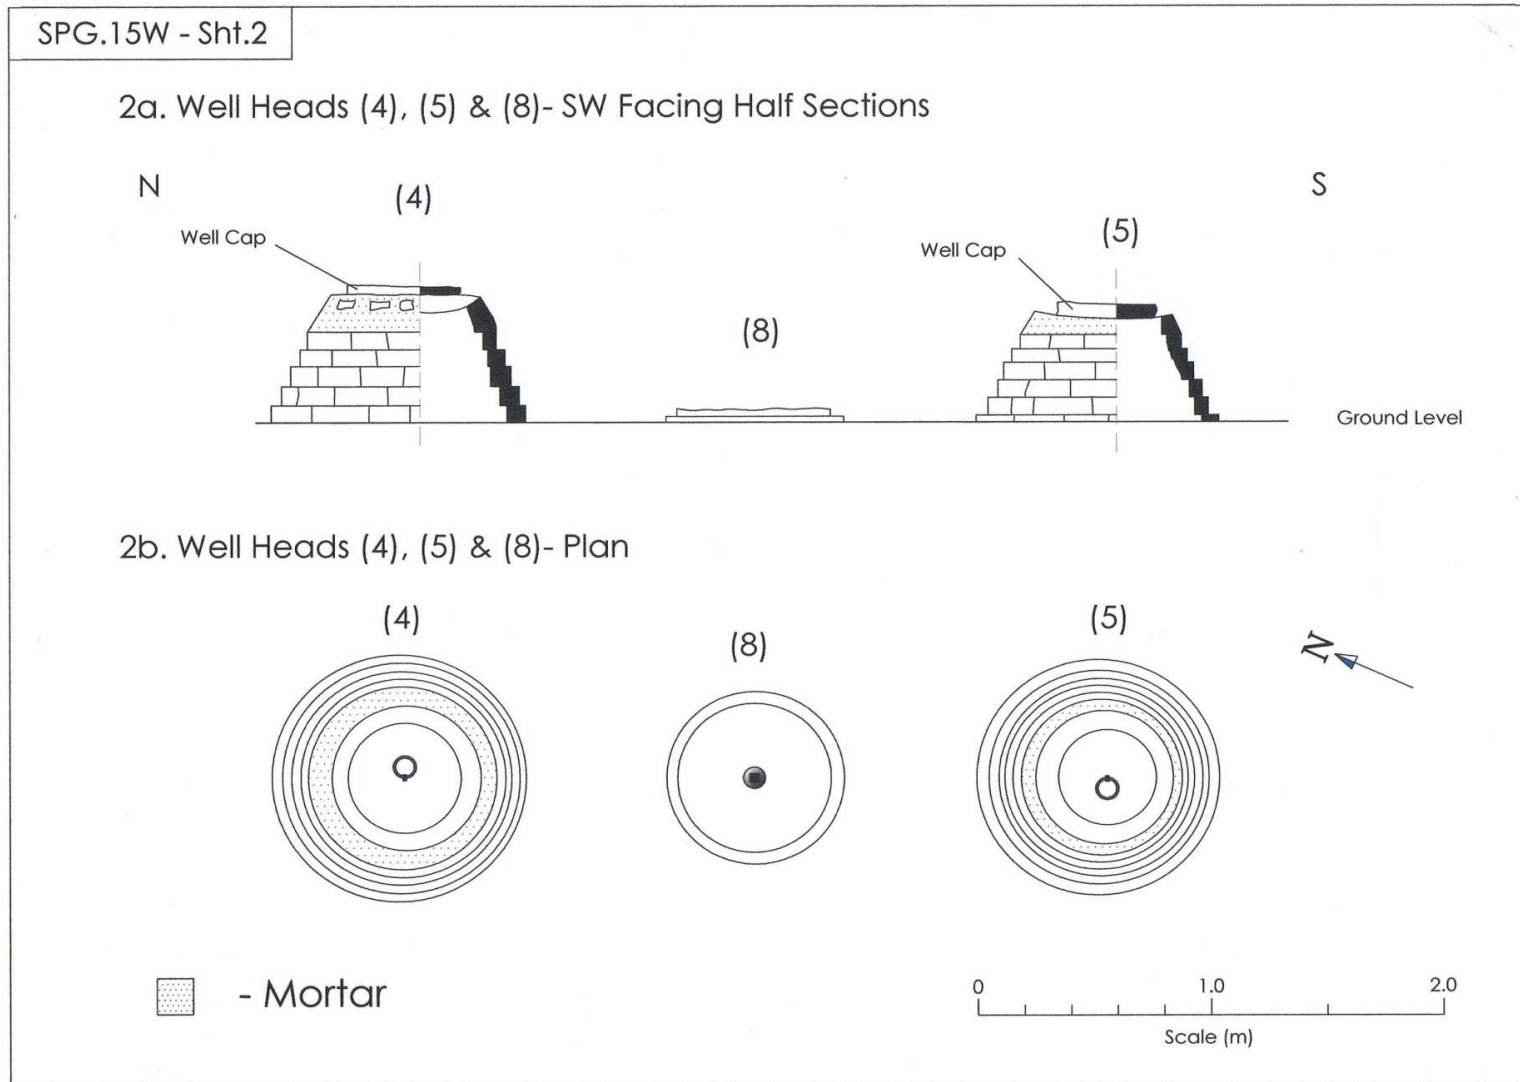
Fig. 5: Well Heads Plan and sections

3.4 To the east of the Wheel Pit (Fig. 2) was an underground reservoir, which appeared to be divided into three Chambers (Contexts **4**, **5** and **8**), Fig. 5. The Chambers could only be observed through the openings at Well Heads in the top, so it is impossible to discuss the interior features and number of reservoir Chambers (**Plate 9**). Context **4** was the opening to the northern Chamber which was raised above the ground level in a 'beehive' like structure (**Plate 10**). The structure was of red brick construction, the bricks having a curved shaped outer surface; with a stretcher length of between 225mm and 120mm. The brickwork stood to a height of 480mm above the ground surface and was circular in plan with an external diameter of 860mm at the visible base reducing to 710mm at the top of the structure. The opening at the top of the feature was 540mm, and had a collar of cement rendering around the opening which was angled in to the centre of the opening (**Plate 9**). The cement used for both the collar and the bonding of the bricks was a pinky grey mortar. The brickwork of the feature stepped-in five times, with the top two courses being cement rendered on their outer surface. The opening had a stone cap with a rounded outer edge and a metal ring handle in its centre. The depth of the reservoir below the northern opening was 4.9m, which was measured with a surveyor's staff.

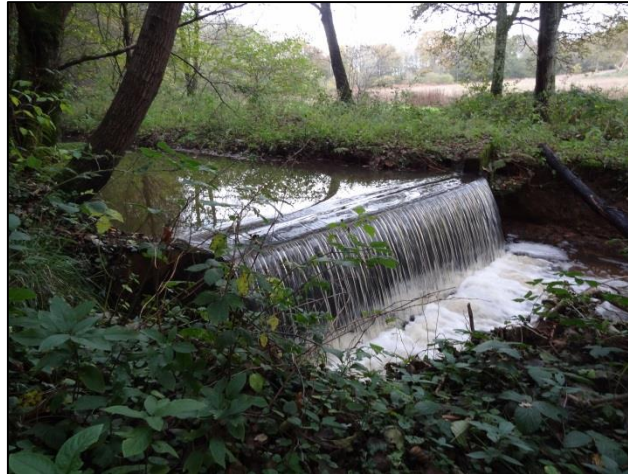
Plate 13: Weir Context 6

- 3.7** Context 6 was a weir (**Plate 13**) which was possibly connected with the hydraulic system or the maintenance of the water table. The weir comprised a 500mm thick concrete wall with cracked iron sheeting covering its southern face (downstream). The weir crosses the stream on an east to west alignment. Both the eastern and western ends of the weir are angled to the north at approximately 20°, with the eastern angled section retaining its sandstone or concrete block capping above the concrete and cranked iron wall.

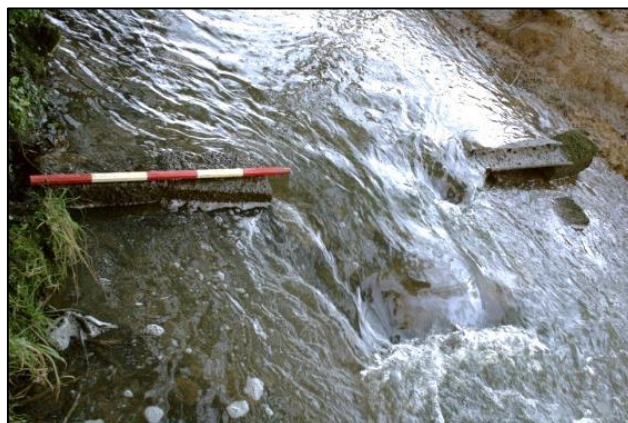
Plate 14: Earlier Weir Context 7

- 3.8** Context 7 appeared to be the remains of an earlier weir which was replaced by Context 6. The second weir was located 6.7m to the south (downstream) of the later weir (Context 6). Only a small amount of the structure can be seen above the water level but this weir appears to have been simply constructed of concrete blocks. The weir has been breached in the centre.
