**An Archaeological Watching Brief and  
Historic Building Survey at  
Rosehill Country Store, Isfield, East  
Sussex**

WD/2014/0882

Project No. CBAS0532

December 2015

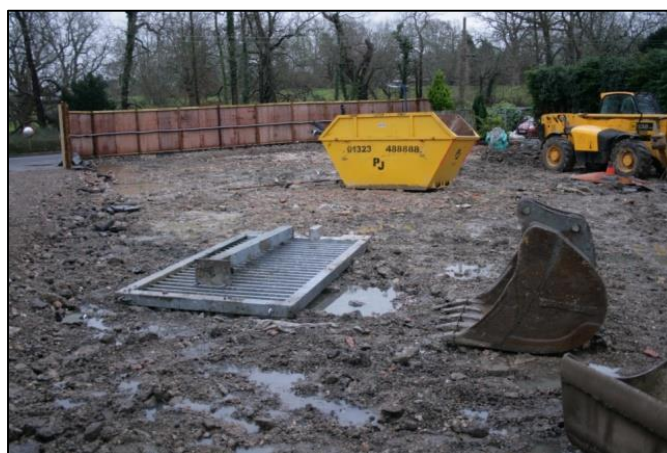
**Plate 1:** Site after Demolition of Buildings

- 3.4 After the demolition of the buildings on the site (**Plate 1**), a watching brief was maintained on the excavation of two irregular shaped trenches to locate and remove the redundant petrol tanks associated with the former garage at the site. The first trench was located over a vent pipe that was thought to be associated with the petrol tanks; however, no evidence for the tanks was discovered in this trench. A second trench was then excavated in the north-eastern corner of the site over an area of ground that appeared to be a darker colour. Two petrol tanks were discovered in this trench.

7.1 On the 17<sup>th</sup> December 2014 a watching brief was maintained during the excavation of two trenches to locate and remove the redundant petrol tanks to the former garage. At the time of this visit all the buildings on the site had been demolished and the ground level reduced to the natural silty clay (**Plate 1**).

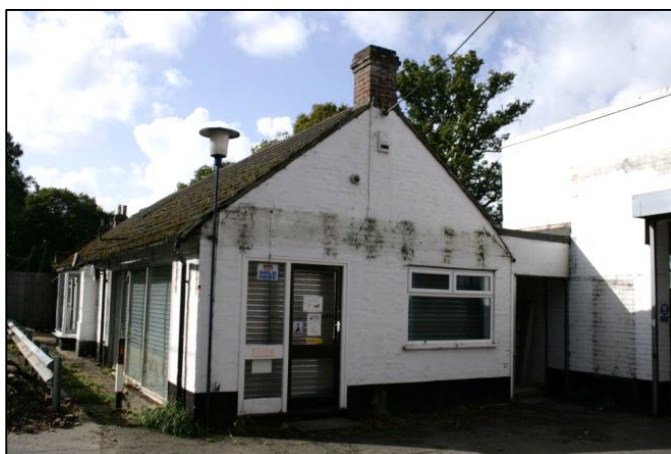
**Plate 2:** Northern Elevation  
taken from the North-East

4.2 The northern elevation of the Country Store is gabled (**Plate 2**), and brick construction. The brickwork is laid in a random bond with the majority of the bricks being laid in a stretcher bond. The brickwork has been painted white with a narrow band painted black at the base of the wall. There is a centrally positioned brick built chimney stack within the gable, which has four courses of over-sailing brickwork at the top, there are no chimney pots fitted. The main entrance to the interior of the building is located at the eastern side of this elevation, which is fitted with a two glazed panelled modern door. To the east of the doorway is a side window of two lights, divided by a horizontal timber housing the letter box. At the western end of the elevation there is a modern UPVC window with a single light below, and two opening lights above. The interior of the door and windows are fitted with metal security roller shutters.

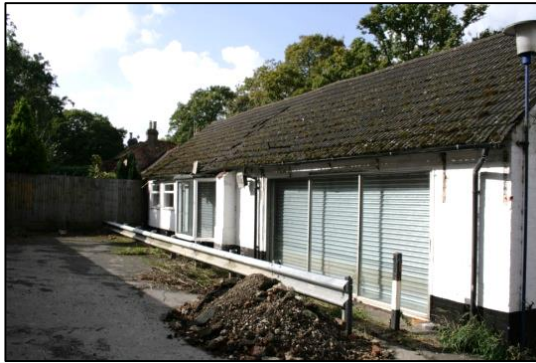
**Plate 3:** Western Elevation taken from the North-East

4.3 The eastern elevation is also of brick construction (**Plate 3**), which is laid in the random bond as noted on the northern elevation. At the northern end of this elevation is a modern metal sliding door of three elements. To the south of the metal sliding doors is what appears to be a small sealed chimney stack, the upper part of the chimney stack is sealed with clay tiles. To the south of this is a modern UPVC bay window, with two wooden framed windows of two lights with the upper part opening out from the base.

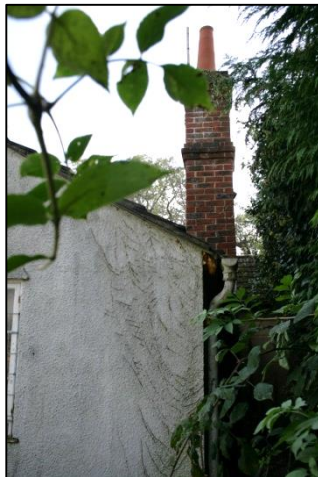
**Plate 5:** Chimney Stack Southern Elevation

- 4.4** The southern elevation of the property is located very close to the southern boundary of the site. The gabled southern elevation has a cement rendered finish with a central brick built chimney stack projecting from the wall. This chimney stack has four courses of oversailing bricks at the top, with a further three courses of bricks projecting from the stack creating a decorative band approximately 1.5m from the top of the chimney (**Plate 5**).

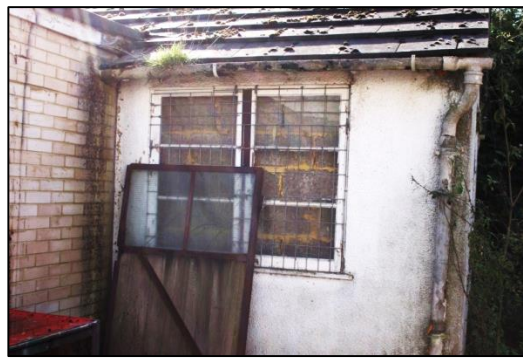
**Plate 8:** Window Sealed by Inserted Wall

- 4.5** The building has the garage block incorporated into the northern end of the western elevation (**Plate 6**) and the originally detached building at its southern end (**Plate 7**). The garage block is constructed of painted cement blocks. The later part of the building joining the main body of the building and the detached building at the southern end is constructed of hard fired white bricks which are laid in stretcher bond. The building that was originally detached has a rough mortared finish which has been painted white. The central part of this elevation has the rear doorway at the northern end, with a large window to the south of it. The window has a large glazed southern side with a small wooden framed casement at the northern side. The originally detached part of the building at the southern end of this elevation is lit by a window in the northern and western walls. These are only apparent on the exterior of the

property, as they have been sealed by an inserted inner wall constructed of breeze block (Plate 8).

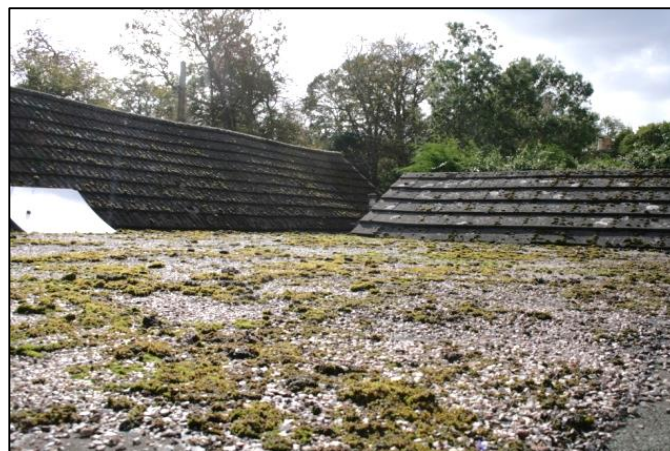
**Plate 9:** Flat and Gabled roofs

- 4.6** The roof of the main body of the building is gabled at both ends and has a covering of Redland type 49 interlocking concrete roof tiles. The originally detached part of the building is also gabled at both ends and has a covering of the same type of concrete tiles as on the main roof of the building. The two gabled roofs are joined by a flat roof with a felt and gravel covering (Plate 9).

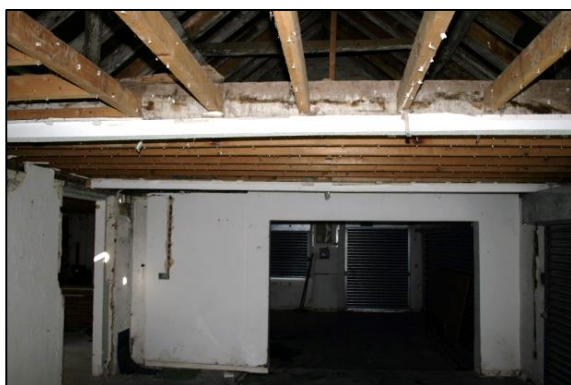
**Plate 13:** Exposed Joists in **G2**

- 5.3** **G2** was located to the south of **G1**, and measured 8.1m (26' 7") north to south by 4.9m (16' 0") east to west. The walls of the room had brick walls which had a white painted plaster finish. The room was lit by a modern UPVC bay window at the northern end of the eastern wall (metal roller blind fitted to interior of window), and two modern wooden framed windows at the southern end of the wall. As in **G1** the ceiling covering had been removed to reveal the construction of the roof. The joists in the northern half of the room were on an east to west alignment, whereas those of the southern end of the room were on a north to south alignment (**Plate 13**). There were two openings in the western wall. The larger southern opening had an RSJ acting as a lintel above, and was open to the short length of corridor **G5**. The northern smaller opening in the western wall of the room gave access to **G7**. The south-eastern corner of the room had been partitioned off with plasterboard walls to form a WC. The southern end of the eastern wall of the WC was missing, and a hot water tank was visible from **G2**.

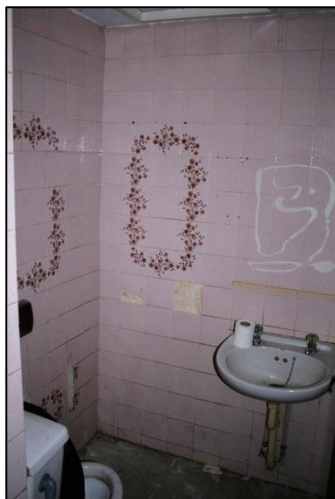
**Plate 14:** WC taken from Doorway  
in the Western Wall

- 5.4** The WC measured 2.2m (7' 2½") north south by 1.3m (4' 3") east west, and could only be accessed through an opening in the eastern wall of **G4** (**Plate 14**). The doorway was fitted with a modern flush door. The western and southern walls of the WC were of brick with a covering of modern ceramic tiles. The northern and eastern walls being of plasterboard, these also had a covering of ceramic tiles. The WC had a modern toilet with low level cistern to the north of the doorway in the western wall, and a wash hand basin adjacent to the centre of the eastern wall. In the south-eastern corner of the room there was a hot water tank, with the wall to the east of the tank having been removed. The floor was of concrete construction, with the ceiling having a plaster board covering, with a hatch to the roof space located in the north-eastern corner.

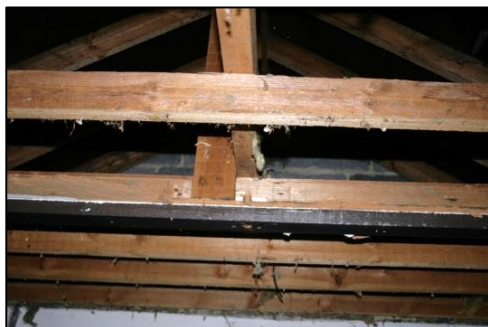
**Plate 23:** Roof Structure of the Originally Detached part of Building **G6**

- 5.10** The roof of the originally detached part of the building to the south-west of the main body of the building was visible in **G6 (Plate 23)**. This was of common rafters without side purlins, but with a central ridge plate. The original eastern gable of the detached part of the building had been incorporated into the roof structure, and was constructed from breeze blocks. This part of the roof had a covering of plain ceramic tiles.

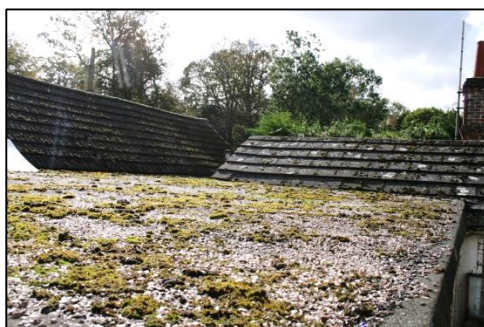
**Plate 24:** Flat Roof over Connecting Range

- 5.11** Between the main body of the store and the originally detached building to south-west, the connecting wing had a flat roof of roofing felt with a light covering of gravel (**Plate 24**).

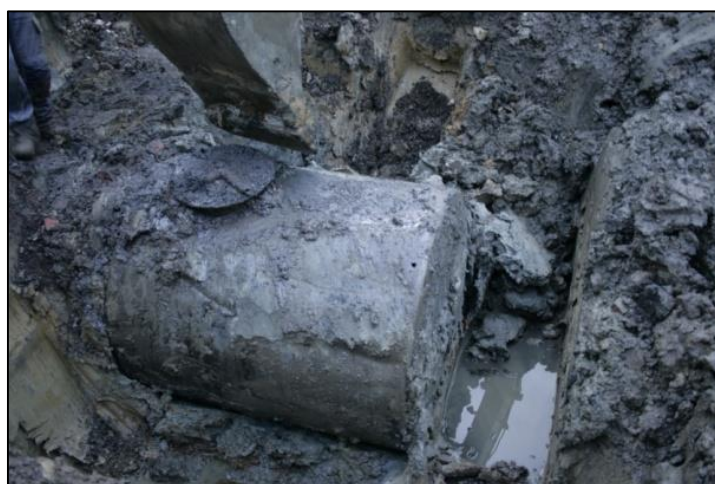
**Plate 27:** Petrol Tank in Trench 2

7.3 Trench 2 was located adjacent to the south-eastern boundary to site and 18.4m in from the south-western boundary (Fig. 8). This trench was irregularly shape and measured at it widest points 4.1m south-west north-east by 3.8m south-west north-east and had a depth of 2.9m in depth. There was only one deposit apparent in this trench Context 2, which had the same matrix but was slightly darker in colour with a looser consistence. This deposit was interpreted as the back fill for the petrol tanks which were discovered at a depth of 950mm depth (**Plate 27**). No inclusions were noted in this deposit and no artefacts recovered from it.

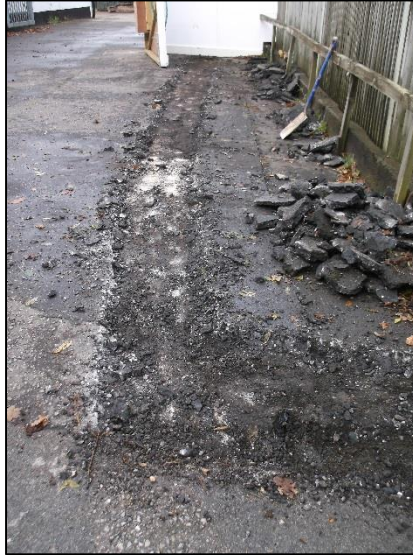
**Plate 28:** Abandoned service trench

- 7.5** The earlier monitoring visit on the 7<sup>th</sup> November to oversee the excavation of service trenches for a new electricity supply (Fig. 8) did not produce any results as the attempted excavation through the hardened surface was abandoned due to being unable to break through it (**Plate 28**). The electricity supply was subsequently arranged as an overhead supply.
