A watching brief
at
RYCOTEWOOD COLLEGE
THAME
OXFORDSHIRE

K A Rodwell
for
JOHN MOORE HERITAGE SERVICES

November 2007

REPORT ON A WATCHING BRIEF AT RYCOTEWOOD COLLEGE, THAME, OXFORDSHIRE

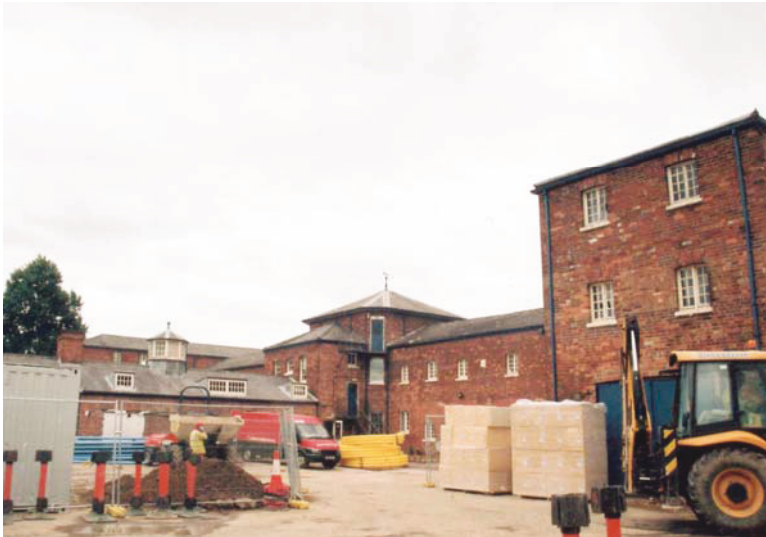
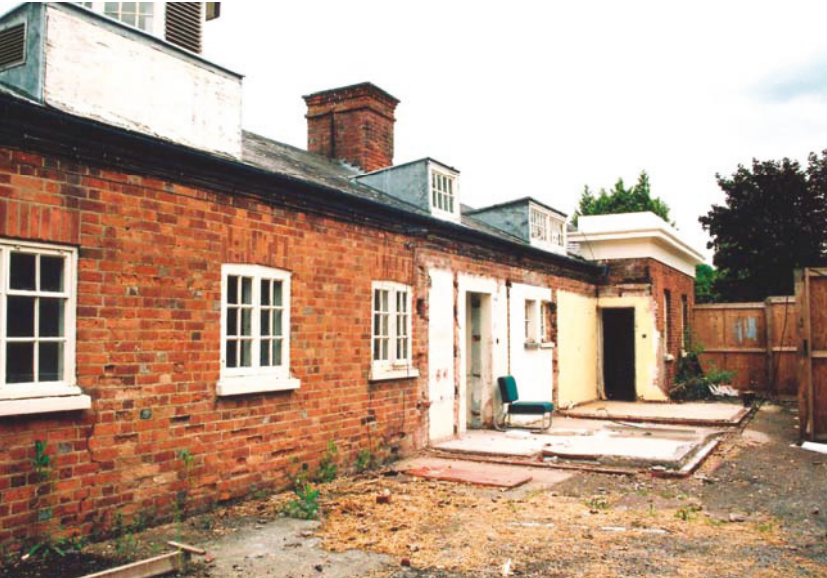
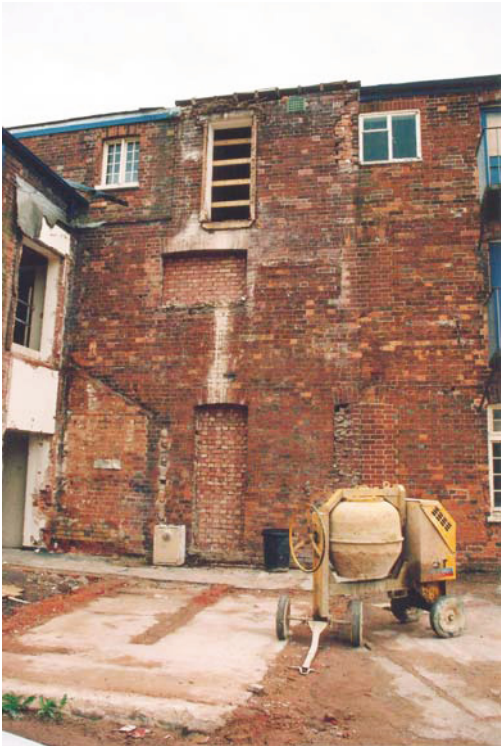
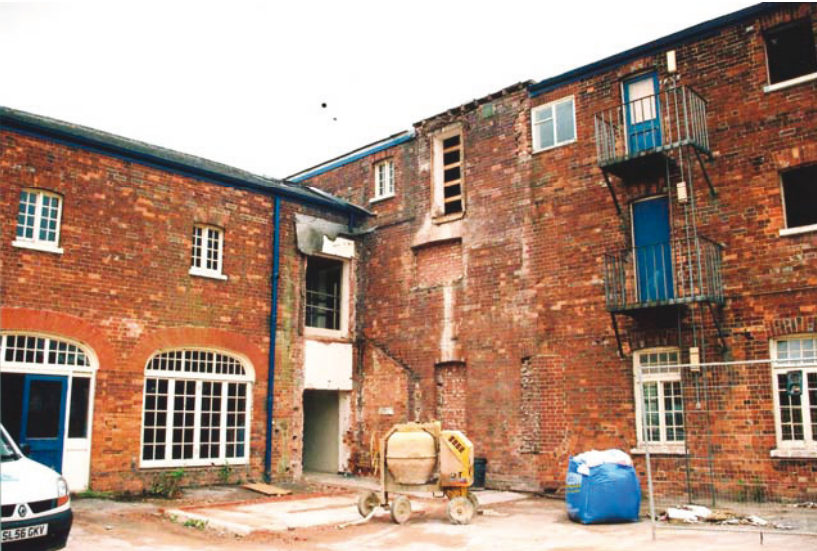
Rycotewood College
Fig 10

Exteriors – external elevations were discussed in detail in JMHS 2005. Demolition has revealed blocked windows in the west wall of the east range south of the spoke; Fig 10.45-48.

- 47) *Exterior* – junction of east spoke and east wing, SE corner showing blocked windows
- 48) *Exterior* – detail of 47
