SHARP'S HILL FARM
BICESTER ROAD
KINGSWOOD
BUCKINGHAMSHIRE
HP18 0RA
NGR SP 6845 1935

HISTORIC BUILDING RECORDING

By
IMOGEN GRUNDON

October 2011

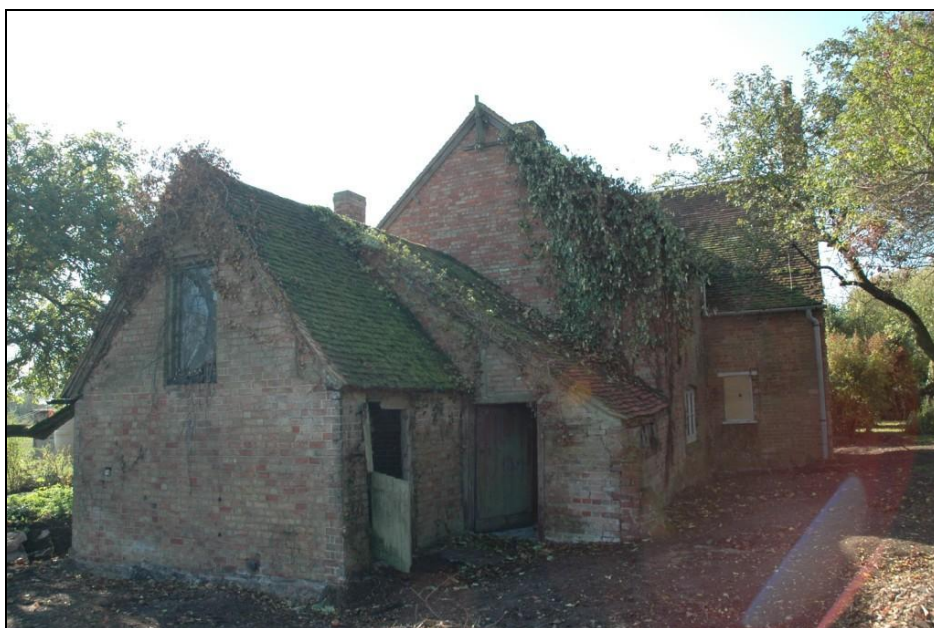
Fig 1. View of Sharp's Hil Farm from the north-west, showing the three phases in the two extensions in question in the foreground.

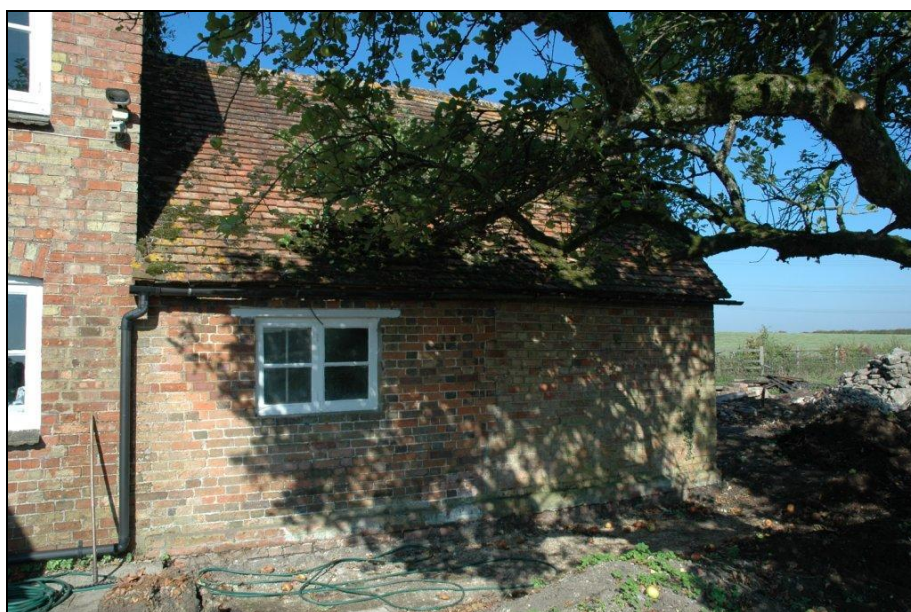
Fig 2. The east elevation of the two extensions, showing the block bonding of the two.

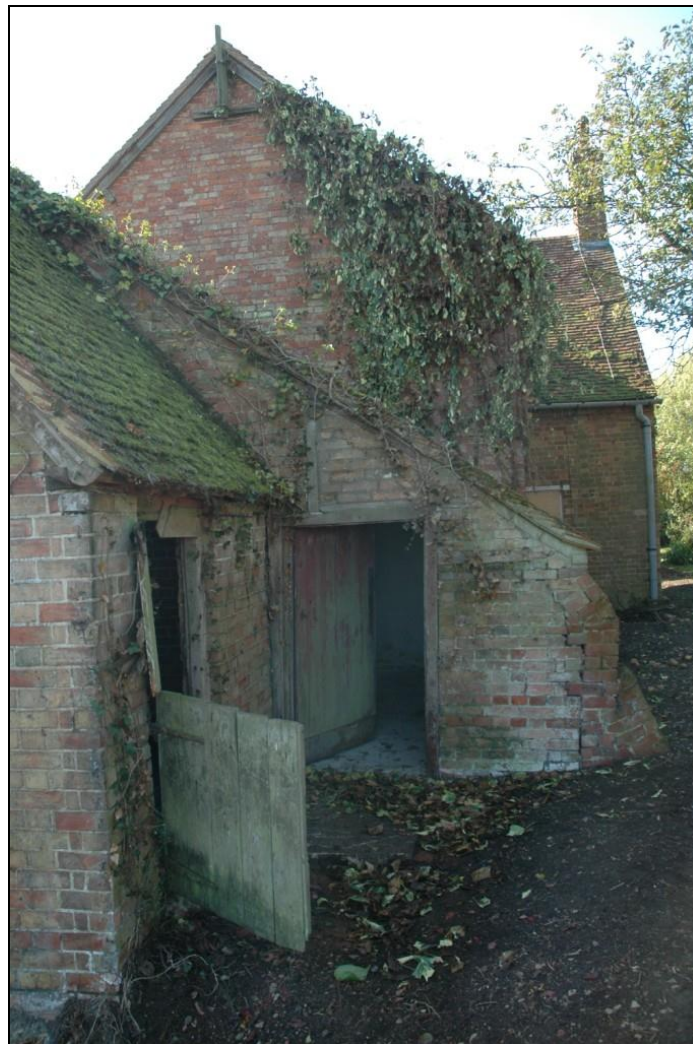
Although there are two extensions under investigation here, there are three phases of construction to the section to be demolished (Figs 1, 2, 3 & 9). The first phase is a two-storey pitch-roofed extension leading from the present farmhouse kitchen. This was then extended into a cat-slide lean-to on the west side in the second phase. The pitch of the roof was made shallower on this west side to accommodate the small additional room, but the west wall supporting the extended roof then needed an additional buttress to carry the load of the roof bearing down on it. This has been done with quite sophisticated tumbling of the brickwork, but nonetheless the buttress has begun to separate from the lean-to it was built to support (Fig 3).

Fig 3. View from the north-west, showing the split-leaf door to the stable (left) and inserted hayloft and the door to the larder (centre) leading on through to the 'Cold Store'.

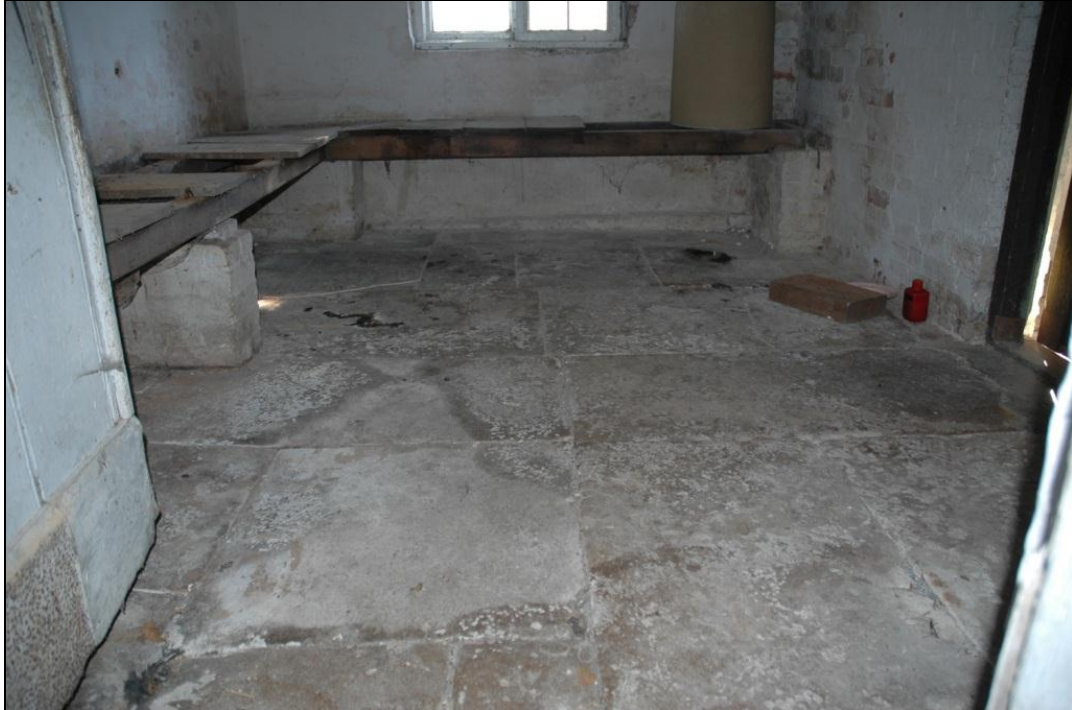
Fig 4. The 'Cold Store' flagstone floor and wooden benches on brick piers. Also showing is the door on the left hand side, repaired at its foot.

A door in the west wall leads into the second phase. The door leaf is panelled with three broad panels with horizontal battens on the rear and a small window opening (now boarded over Fig 6). The base of this door shows signs of repair which is another indication that the room was a wet room that needed frequent washing out, leading to the rotting of the door foot (Fig 4).

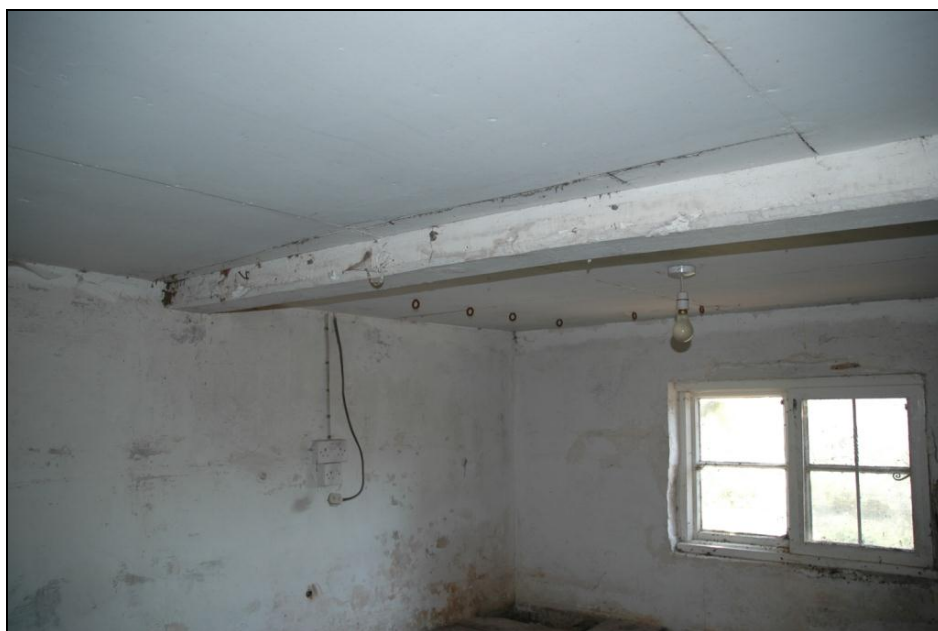
The plain ceiling has a single chamfered beam running north-south. The ceiling itself is ceiled with plasterboard. Hooks on this ceiling could suggest that this was an area for butchering and hanging carcasses and preparation of the meat (Fig 5).

Fig 5. The 'Cold Store' plasterboard ceiling, beam and hooks.

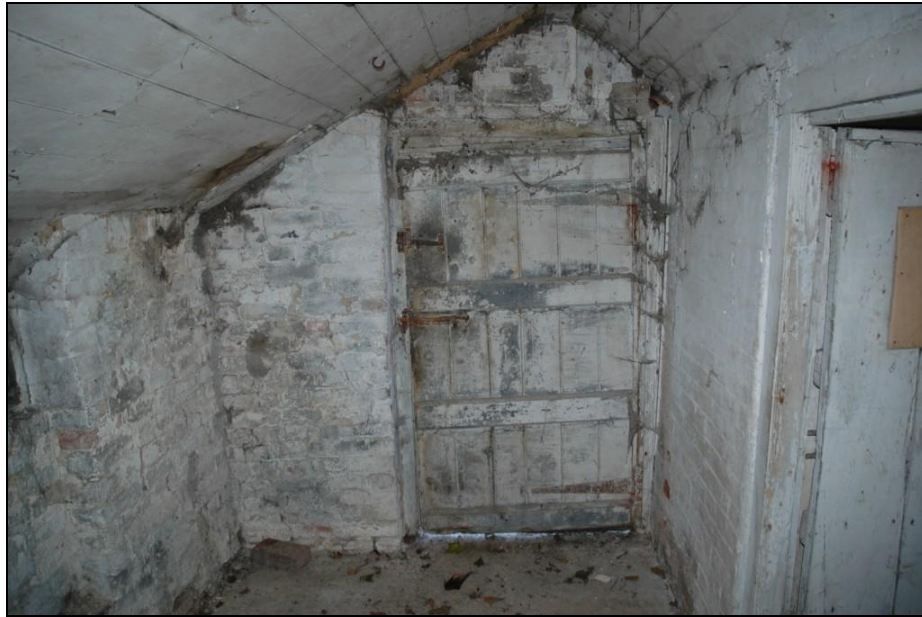
The small lean-to addition has a tongue-and-groove ceiling (Fig 6). This would appear to be a larder as the window is meshed over to exclude flies.

Fig 6. The lean-to representing the second phase of construction.

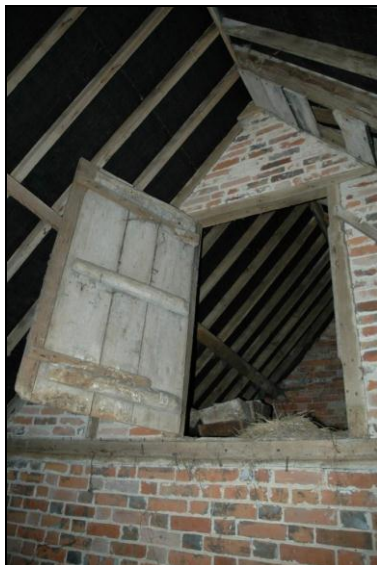
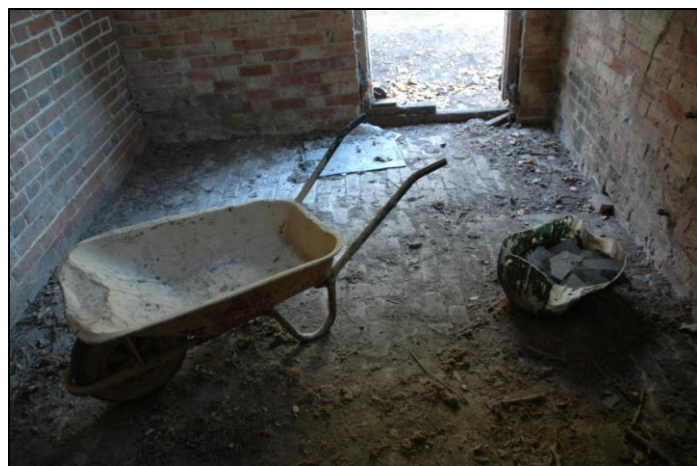
Figs 7 & 8. The single store stable with loft over the 'Cold Store'

The stable floor is paved in brick and while there is no sign of a drainage pattern in the brickwork there is a drain pipe at ground floor level beneath the north wall, but this has been inserted (Fig 8). Hearsay has it that this stable was last used for slaughtering animals, but there is no physical evidence to back this up. There is a window high up on the northern wall with an internally-opening wooden shutter. A hole has been cut out of the base of this shutter, presumably to allow access for barn owls.

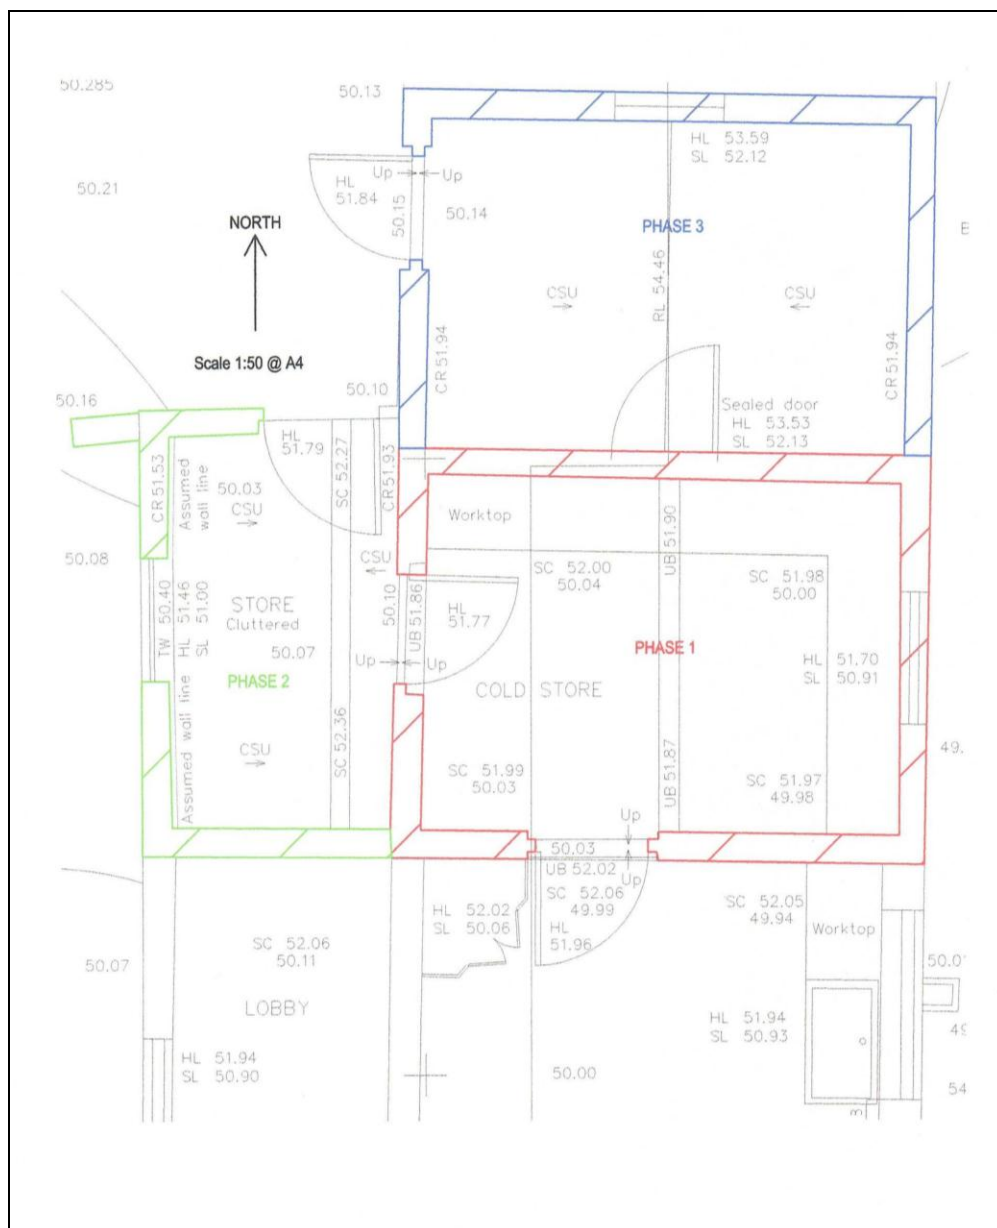
Fig 9. Plan showing the three phases of the two north extensions
