HERITAGE IMPACT ASSESSMENT

GARLANDS FARMHOUSE AND CHEESEROOMS,

WEST CHALLOW, WANTAGE

DECEMBER 2014

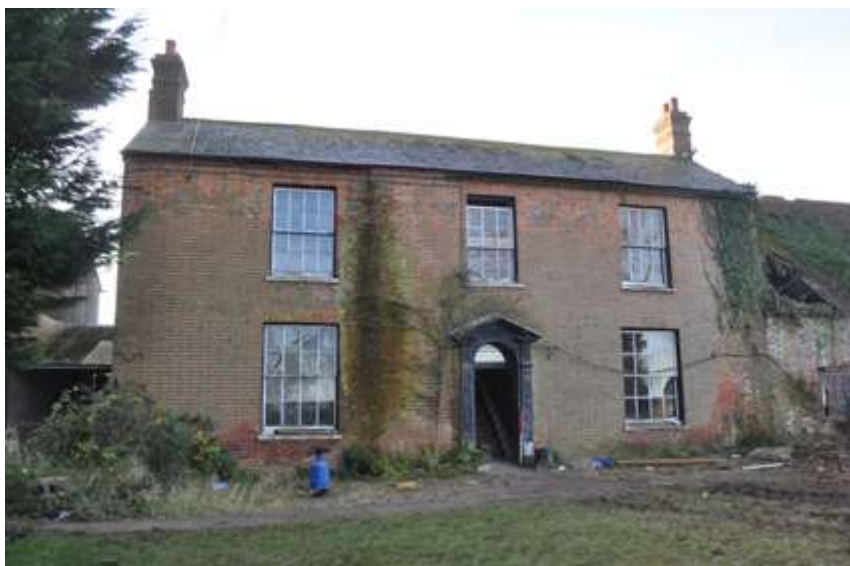
Plate 1: Front façade Farmhouse

The main part of the northeast or front façade contains a standard Georgian arrangement with three bays and is constructed with a chequered pattern in Flemish bond (Plate 1). The ground floor contains a six panelled door with fan light under a porch surround with broken pediment and constructed of wood. The flanking windows are square-headed sash windows with sills and soldiered lintels. On the right hand side there is a blocked doorway. The windows contain 16 panes. The three bays on the first floor are similar windows to those on the ground floor but are slightly smaller in their execution. A brick corbel exists under the eaves. The roof is of Welsh slate and there are two brick chimneys at each end with water tablatures.

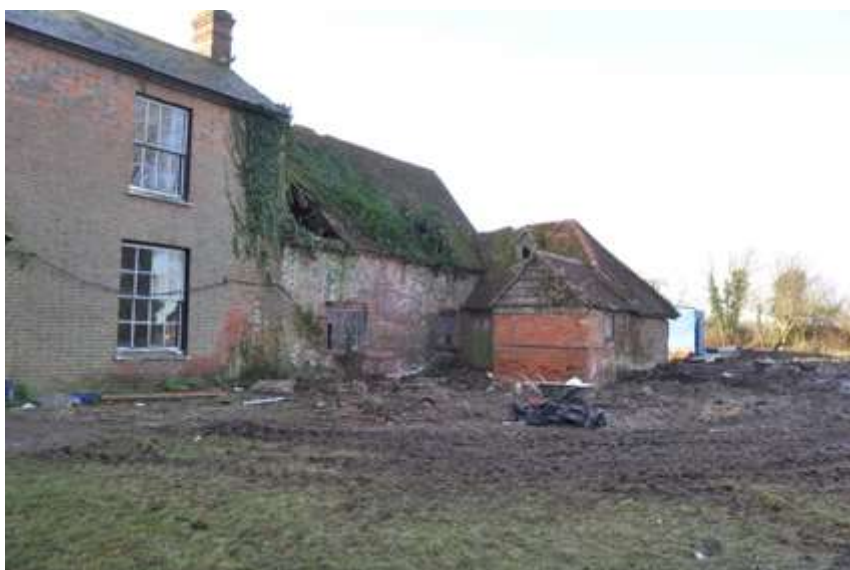
Plate 2: Front façade cheeserooms

The continuation of the façade on the northwest side is for the cheeseroom (Plate 2). This is also of brick and of a Flemish bond with a chequered pattern. On the ground floor there are two bays. The one on the right is a more complicated affair with a blocked earlier

aperture with a soldiered segmental arch. The secondary window is a double mullioned window with lead tracery and a flat soldiered lintel. The other ground floor window is a segmental arched mullion window with lead tracery and a soldiered segmental lintel. Above this is a brick corbel under the eaves and a more steeply pitched roof of red clay tiles. In the roof were two dormer windows one of which has collapsed.

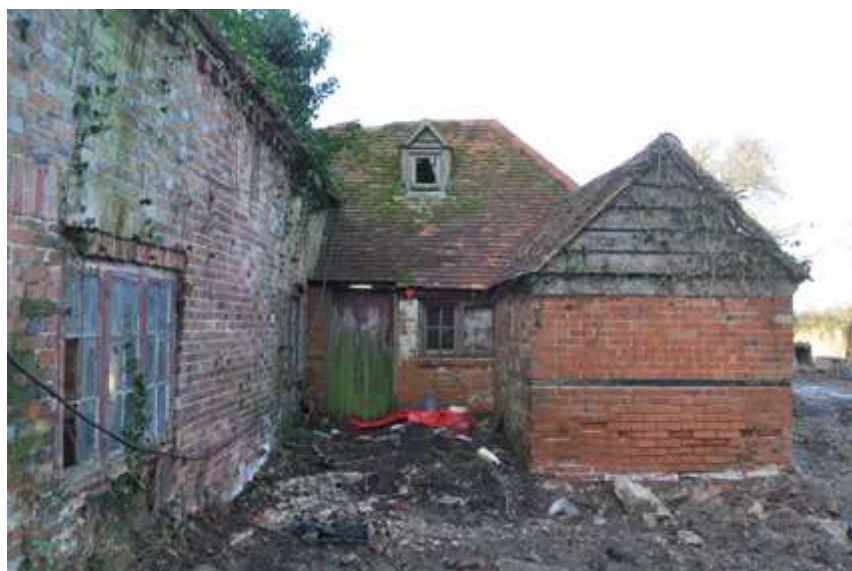
Plate 3: Southeast facing façade of cheeserooms

To the north of the line of the main northeast façade, the extensions on the north also contain part of the southeast façade (Plate 3). In the central recess there is a plank door on the left hand side and a mullioned window on the right hand side. Above this is a red tile roof with a small dormer window. To the northeast of this there is a gable end with a timber band. The gable contains weather boards.

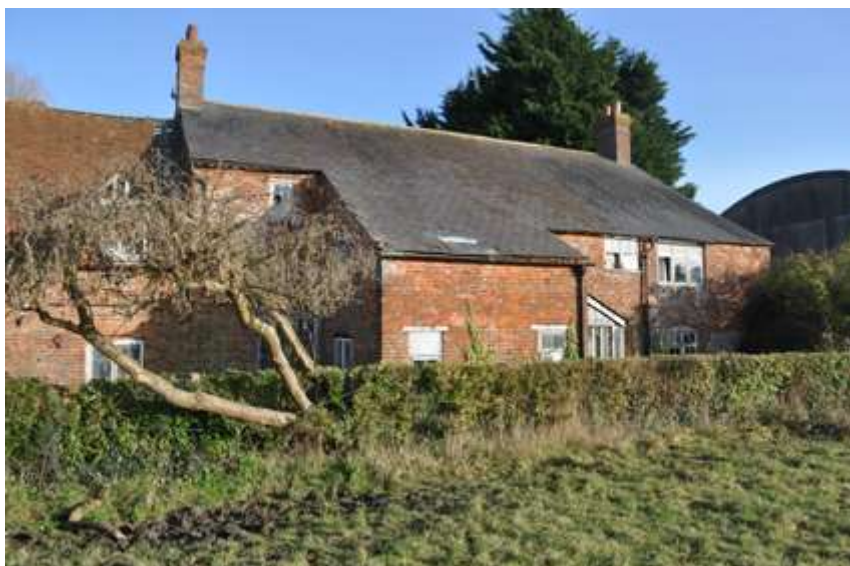
Plate 4: Rear façade of Farmhouse

The back façade can be divided into a number of units, three of which are on the staggered façade of the main farmhouse building (Plate 4). The right hand part of the façade has a lower wall built of limestone rubble with brick quoins, which is possibly part of an earlier structure. The right hand window is a mullioned feature with a segmental headed arch with a segmental soldiered lintel. On the left hand side there is a smaller square window with four panes. The first floor façade also contains two windows of differing sizes, on the right hand a double mullioned window with transom. On the left hand side there is a smaller square-headed mullioned window.

The central part of the façade contains two windows on the ground floor (Plate 4). These are transomed with timber lintels. There is a timber porch on the right hand side with door and half gable above.

The left hand part of the main façade contains a square-headed mullion window on the ground floor and a smaller square-headed window on the first floor (Plates 4-5). There appears to be no butt-joint between the cheeseroom building and this part of the back façade. This again implies that part of the back wall of the farmhouse may have been built on earlier walls.

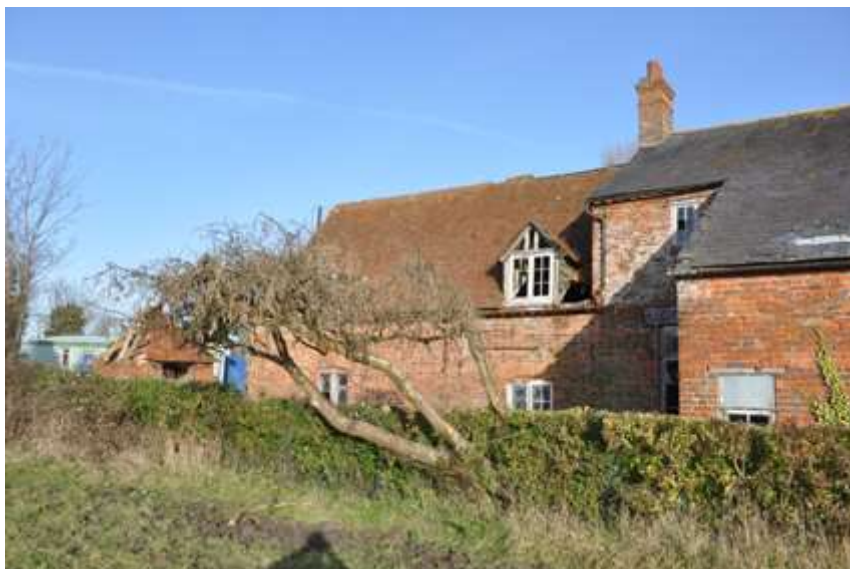
Plate 5: Rear façade of cheeserooms

The southwest façade of the cheeserooms contains two segmental arched mullioned windows of a different styles, sizes and heights (Plates 5). The wall was of a Flemish bond with a chequered pattern and brick corbel. The roof here is more steeply pitched with two dormer windows.

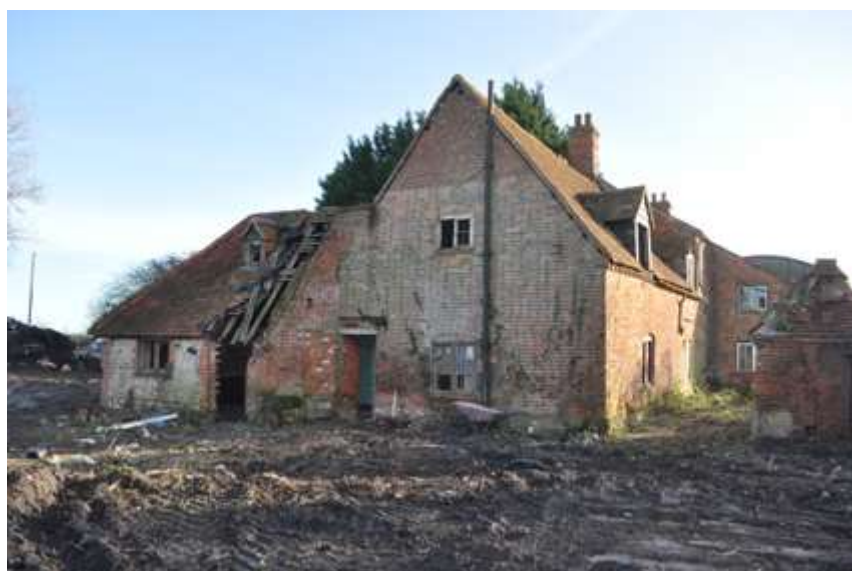
Plate 6: Northwest façade

The northwest façade of the building is dominated by the gable end of the cheeserooms. This shows the steep pitch of the roof, which is indicative of at least an early 18th century date if not before (Plate 6). On the ground floor there is a square-headed mullioned window with a segmental lintel arch. On the left hand side there is an opening for an earlier doorway.

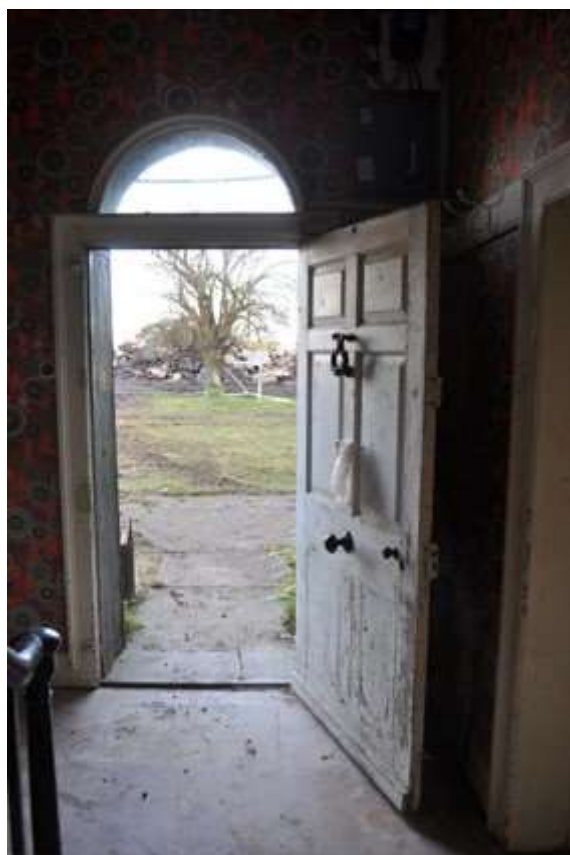
Plate 7: Front door G1

Room G1 is the central hall of the main part of the farmhouse. This is entered through the original white panelled door with fanlight above (Plate 7). Internally there is still original moulding surviving around this feature. The main feature here is a dog-legged stairwell with staggered landing that is probably an original feature or, if later, made in a style to fit. At the base of the stairs there is a panelled door with a moulded surround. Opposite this is the southeast wall where there is a further panelled door with moulded surround. Under the stairs there is a further original panelled door that leads into a corridor (G2) that is an extension to the hall (Plate 8). In this back passage there is a door in the southeast wall and two in the northwest wall. At the far end of the passage there is a panelled door with upper glass panels that lead out into the small timber and glass porch (G2a). This contains an opposing panelled door with glass in its upper panels.

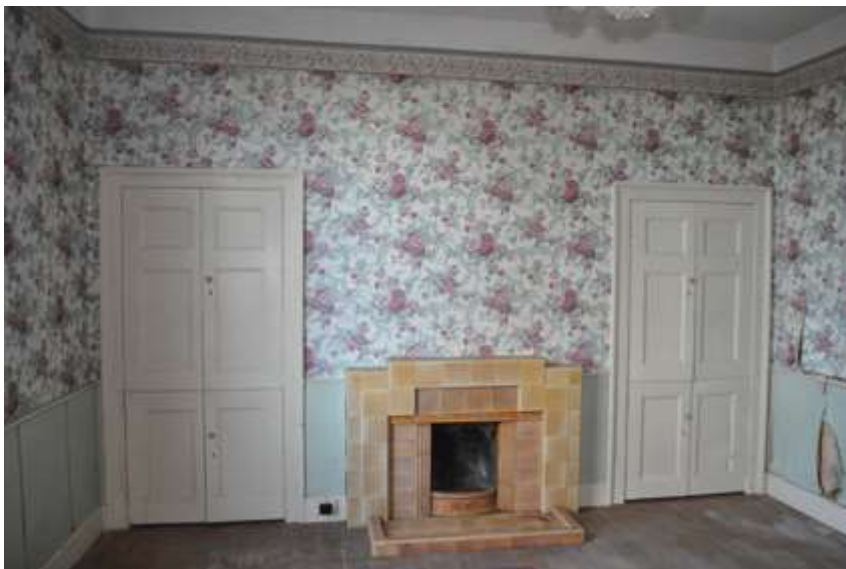
Plate 9: Room G3

The panel door on the southeast side of the hall leads into room G3 (Plate 9), this doorway also has original moulded surround on this side. The room contains a dado line. The skirting board is not elaborate. In the northwest window there is a sash window with 16 panes and some original moulded surround but the pelmet is probably new. In the southeast wall there is a fireplace of a 1960s style which is flanked by two alcove cupboards that use a 18th to early 19th century design pattern. In the southwest wall there is a door, a probable modern insert.

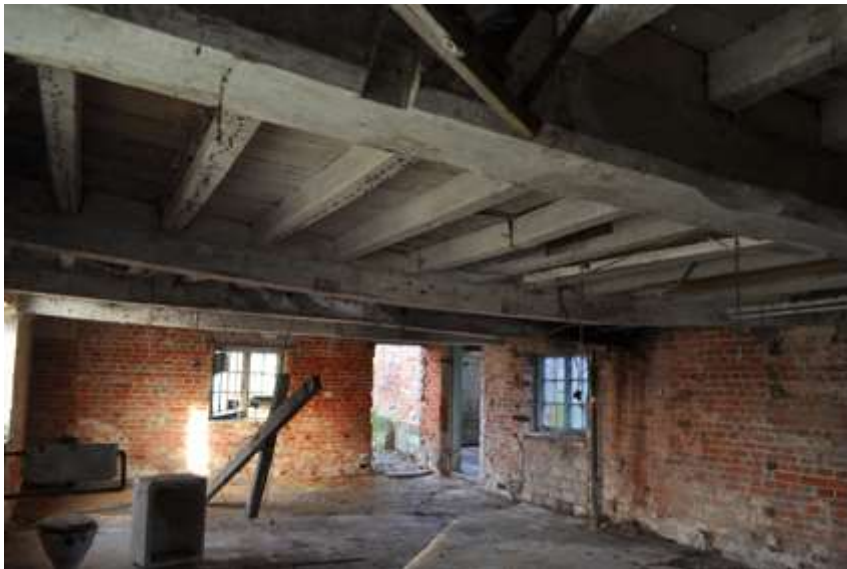
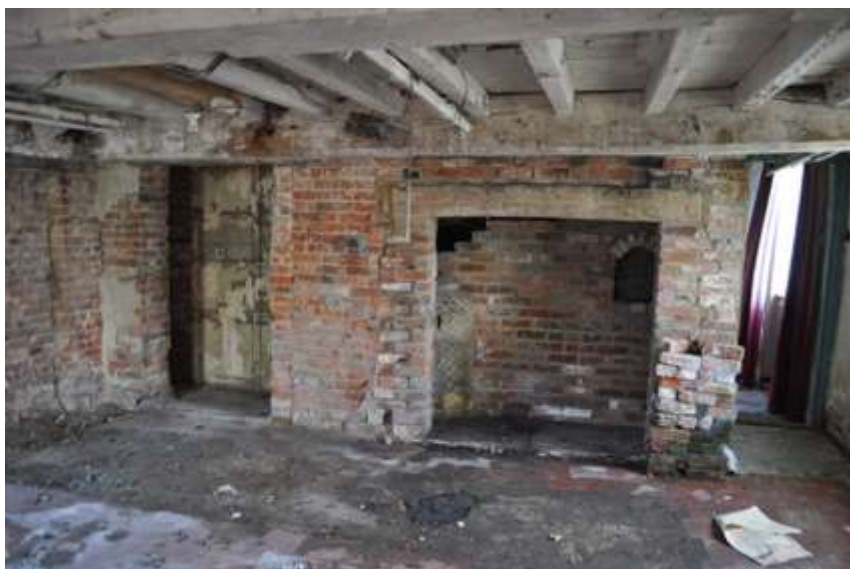
The panelled door in room G6 leads into the ground floor of the building with the cheeserooms (G7, Plates 12-13). The floor contains paving stones and an isolated toilet suggesting that some later internal walls had already been removed. This revealed a large rectangular space with four transverse beams possibly reused. There are no chamfers on the underside but evidence for further timber fittings. In the northwest wall there is a single mullioned window, in the southwest wall there are two single mullioned windows, and in the northwest wall there is a single mullioned window and a double mullioned window. Some of these windows show internal evidence of reworking and resetting. In the southeast wall there is a fireplace with lintel, but the chimneybreast shows much evidence of reworking. There is a small oven in the back of the fireplace. To the left of the fireplace there is an alcove. In the northwest wall there is an opening of an external door, and in the northwest wall there is a doorway.

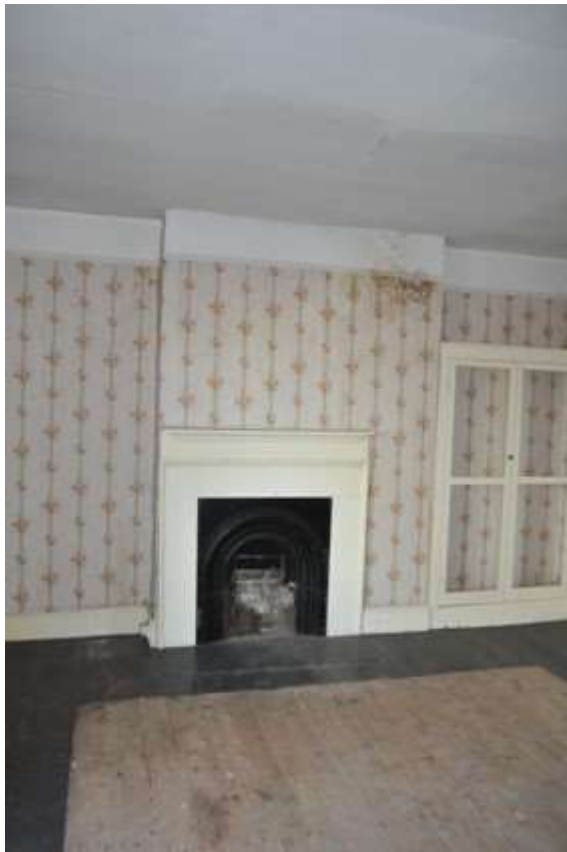
Plate 16: Room F5

The southeast panelled door on the upper part of the landing leads into room F5 (Plate 16). This has a square-headed sash window in the northwest wall and an original fireplace in the southeast wall. There is a cupboard in the alcove to the right.

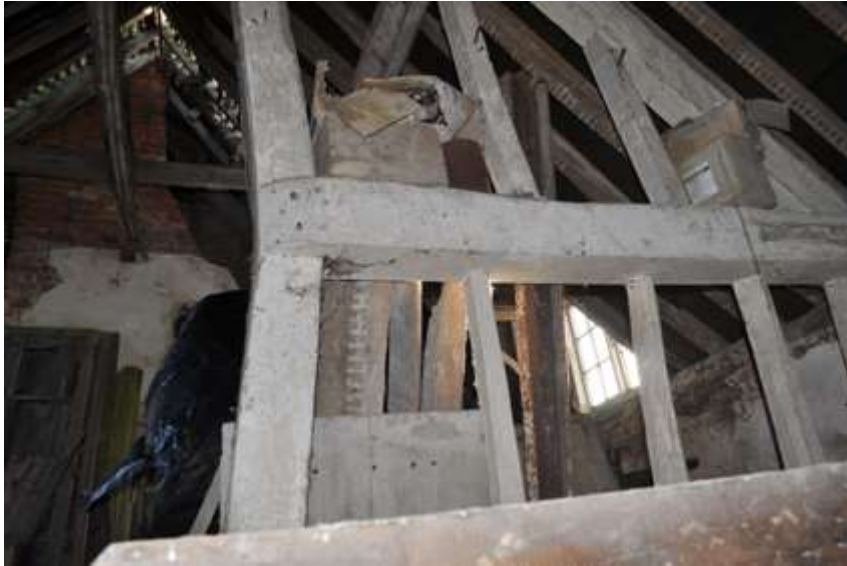
Plate 18: Truss in cheeseroom loft

The loft space of the cheeserooms extension has one truss (Plate 18). This truss is based on a queen strut with a collar beam and hammer beams, and extra princess struts. The queen struts are larger and form a central opening. There are struts above the collar beam. This truss divides the area into room F7 and F8. In the southeast wall of F7 there is a

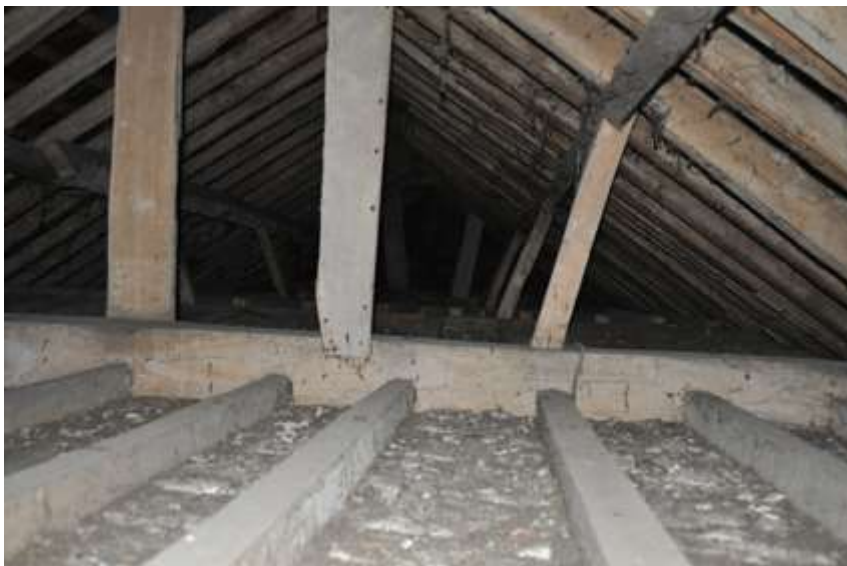
Plate 19: Attic

The attic space contained a number of strut trusses (Plate 19).

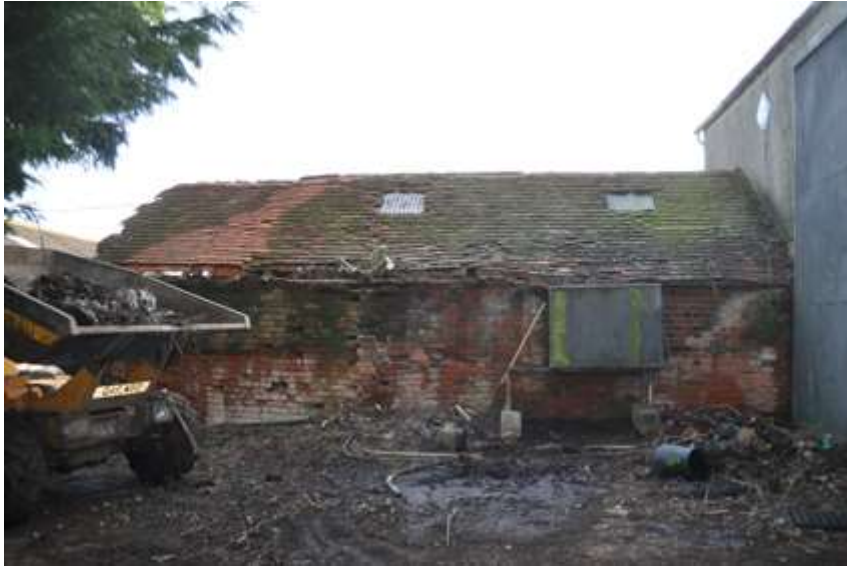
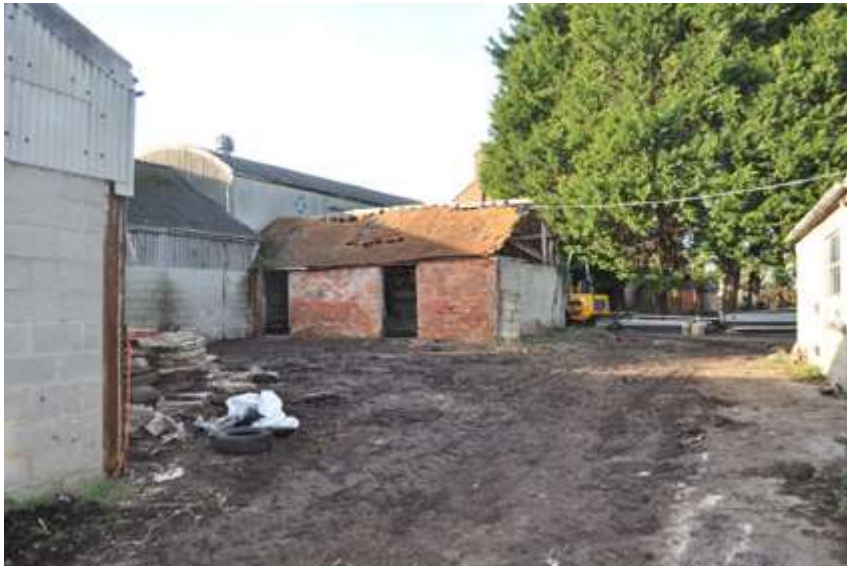
At right-angles to this earlier range there is part of the cowshed. This has two walls of brick on the northwest and southeast side. The northwest wall is blank (Plate 20) and the southeast wall has two doorways in it (Plate 21). The southwest wall has gone, as it butts up to the Dutch barn. The northeast wall has also gone and has been filled in by a breezeblock wall. A further breezeblock wall has been inserted internally. In the roof space there are three strut trusses (Plate 22). The roof is of slate.

The Cowshed or Milk Shed is in a poor state of repair and it is proposed to demolish this building.

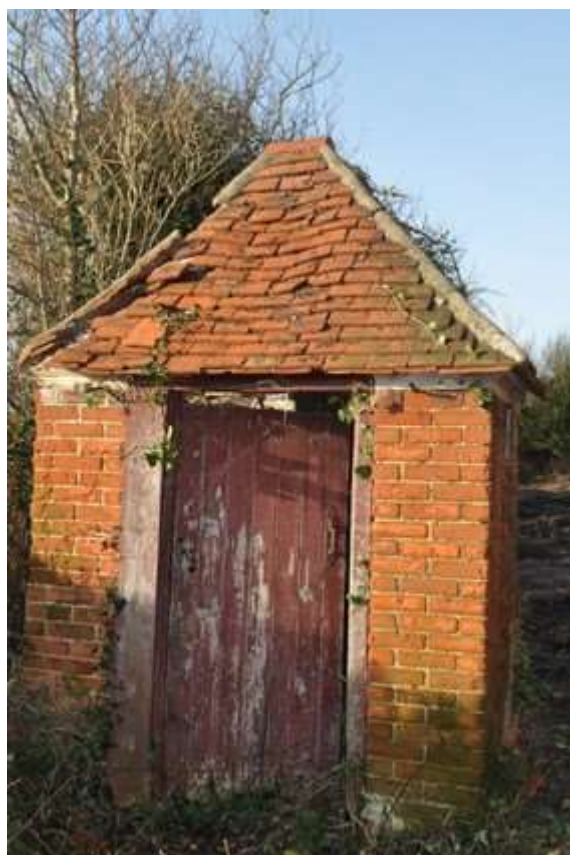
Plate 23: Privy

The detached privy is a small square structure of brick with no chequered pattern. There is a plank door in the southeast wall (Plate 23). The roof is of red clay tile. Internally the walls are planked and there are the remains of a wooden seat with pot indicating a previous use as a privy.
