JOHN MOORE HERITAGE SERVICES

## **BUILDING ASSESSMENT**

# **10A CLARENCE ROAD,**

# WINDSOR, BERKSHIRE

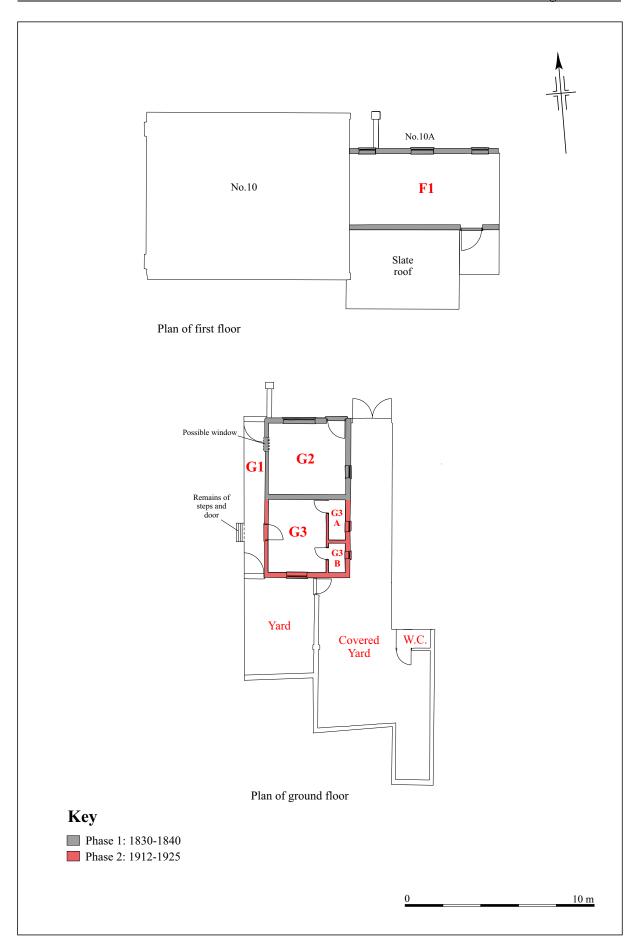
Figure 11: Ground floor and first floor plans

The listed building originated as a commercial property probably in conjunction with 10 Clarence Street, to which there is a blocked up entrance from passage G1 (see plan). The original commercial use is unknown.

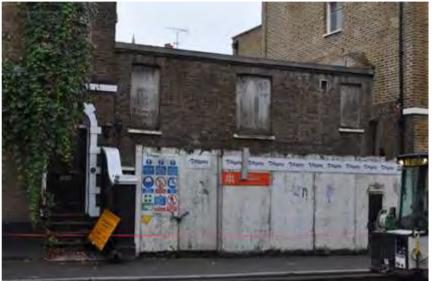
Plate 1: Front façade

The north or front façade has two storeys with a staggered window and door arrangement (plates 1-2). On the left hand side of the ground floor nestling up to the wall of 8 Clarence Road is a double door of a cart access. Alongside this to the right is a single panelled door with a segmental arch with soldiers. There is a similar door and lintel with a similar design located on the right hand side of the ground floor nestling up to 10 Clarence Road. Between these two single doors there is a large window. The upper floor has a series of three bays but the windows all appear to be of different sizes. There is a parapet above with a simple band. It is evident that this wall is butted up to the buildings 8 and 10 and that this structure represents infill along the line of the street.

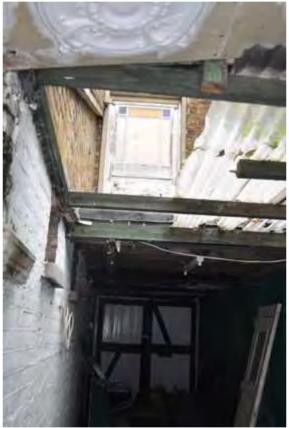
In the cart way there is a double door and in the side wall two small windows and a large opening, possibly originally a window (plates 3-4).

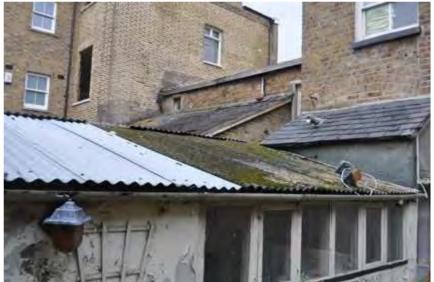
Plate 5: Rear façade

The rear elevation of the historical part of the building shows a ground floor with a door on the left or west side with a sash window alongside it. There is a lean-to slate roof above, which does not run the whole length of the building. In the first floor elevation there is a door set adjacent and to the right of the roof (plate 3). In the wall between the first floor lean-to roof and the upper roof there is a small window (plate 5).

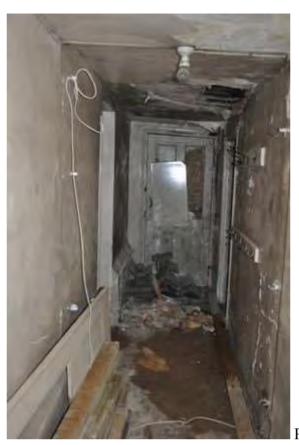
Plate 6: Passage G1 looking north

Entering the building via the single door on the left hand side of the north façade, one enters a long narrow passage that runs the length of the building (plates 6-7). There is a door at the far end of the passage, which opens up into a yard, and a door located in the west wall that would lead directly into 10 Clarence Road. On the east side of the passage there is a door and a further opening. The opening enters into room G2 and the door into room G3.

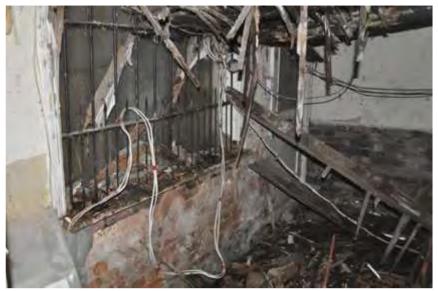
Plate 8: Room G2 north wall

Room G2 was viewed from an opening in its west wall from the passage. In the north wall there was a large window with bars and an adjacent door. There is a further opening in the

east wall. The ceiling timbers and first floor have subsequently collapsed into this front room.

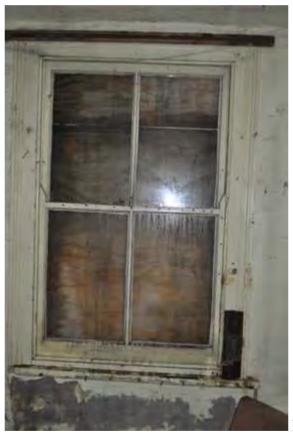
Plate 9: Sash window room G3

The other east door (plate 11) from the passage G1 leads into room G3. There is a sash window in the south wall (plate 9) and formerly there were two doors in the east wall both plank doors (plate 10) that lead into two small cupboards (G3a and G3b). Part of G3b cupboard had been removed at the time of viewing.
