JOHN MOORE HERITAGE SERVICES

HISTORIC BUILDING ASSESSMENT

LOGG FARM

ODDINGTON, OXFORDSHIRE

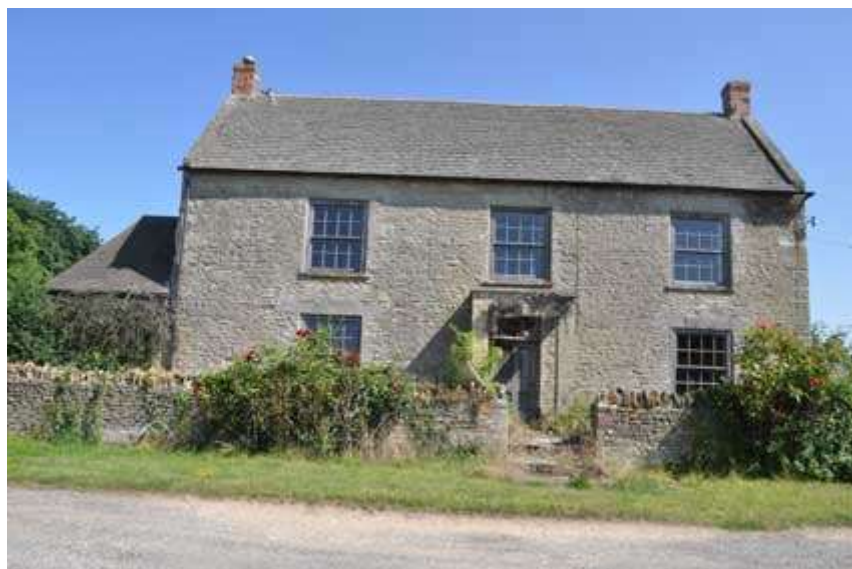
Plate 1 Front façade

The front façade contains a main range with three bays (Fig. 15, E3; plate 1). The central bay contains a door on the ground floor, which is an original panel door with window light above in a square headed arch. On the first floor there is a sash window with 16 lights in a square-headed arch. The square-headed arches all contain soldiered lintels. In-front of the door there is a porch with collapsed roof. The porch appears to have a more modern appearance, constructed of reconstituted blocks. Above this is a limestone slate roof with a steep pitch. At the end of each gable there is evidence of a parapet wall with capping stones. There are small brick chimneystacks located at either end of the roof.

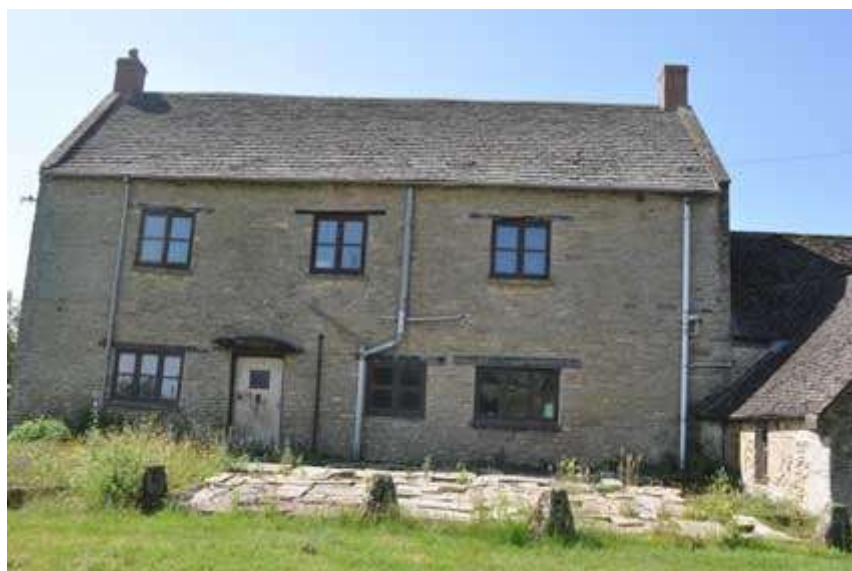
Plate 2 Rear façade

The rear façade contains the main block of the two storey house on the left hand side (Fig. 14, E1; plate 2). This contains an irregular arrangement of bays. On the ground floor there is a plank door to the left of centre, with a glass panel. To the left of this there is a window with six lights. On the right-hand side of the door there is a four light window set centrally and to the right of this there is a six light window. The first floor contains three windows in a more uniform arrangement with the windows of the front of the house. These windows contain four lights. The door and all of the windows are square-headed with timber lintels. Most if not all of the window casements look new. There are variations in the material used to make the sills, which include engineering bricks and stone.

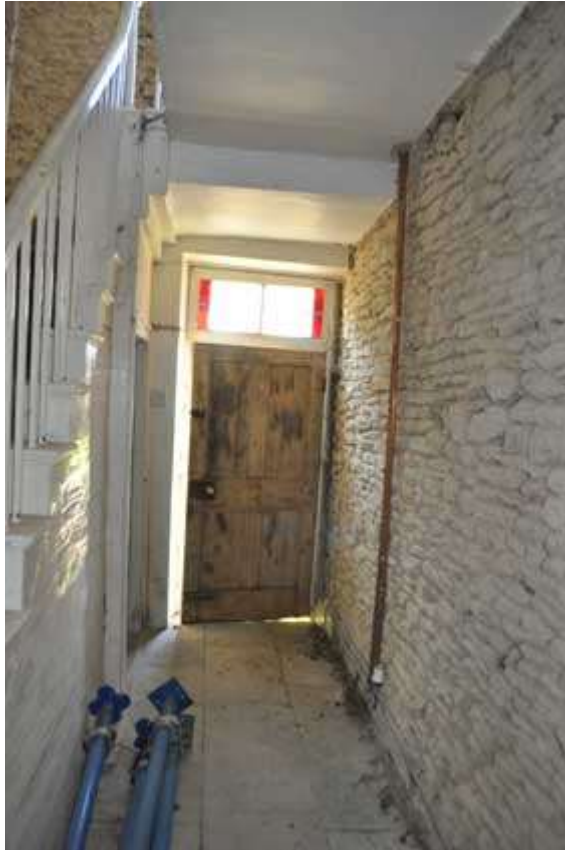
Plate 3 Internal view of front door

The panelled front door leads into an entrance hall (G1), (plate 3). Adjacent to it in the west wall of the hall there is evidence of a butt joint. There is a panel door in the west wall, and a further door in the north and east walls. The staircase has ramped handrail and turned balusters. The floor contains flagstones of various sizes, and the walls have been largely stripped of their plaster. Under the staircase there is a further plank door that gives access to a stone staircase. This leads into a room with stone floor and walls. There is a window in the east wall. The ceiling contains a transverse timber beam that is a partially chamfered timber trunk.

The following alterations will be made to the ground floor. In room G1, the entrance hall, this sees the replacement of the existing original door and window lights. This is an original feature and will have an impact on the heritage asset, both internally and externally. The staircase is to be refurbished. The plaster has already been removed from this room and the stonework is to be re-pointed.

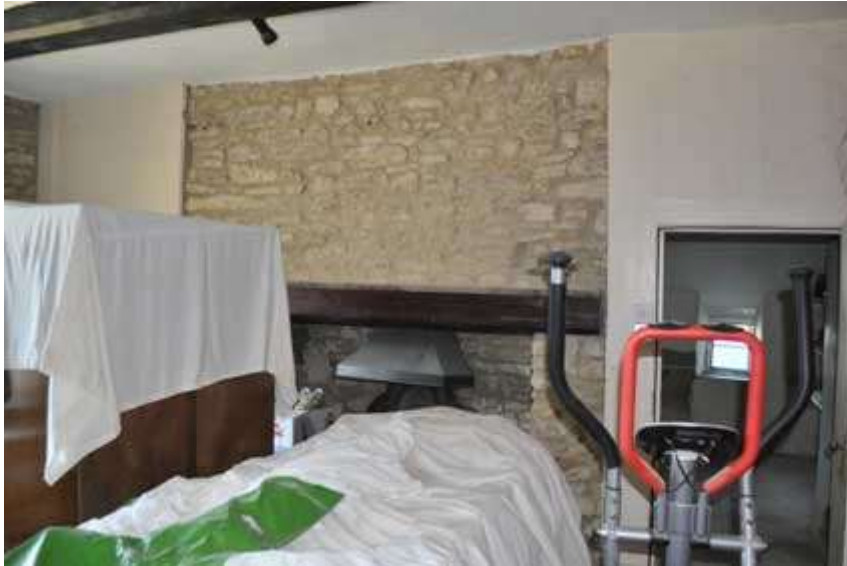
Plate 4 Panelled cupboards either side of fireplace (G3)

burner and a new timber lintel inserted (plate 4). Either side set in the alcoves are matching panelling with central doors. On the left-hand side of the fireplace the door is panelled and has a glazed upper section, it is possible that this door is a later replacement. The door on the right-hand side is panelled and with no glazing, it is probable that this one is original. There are two transverse beams in the ceiling, both of which are chamfered and with straight cut stops.

be retained. The alcove panelling is a common 18th century feature, so the basis of this feature is part of the heritage asset; however, the glass panel door is a probable 19th century addition. The existing sash window is to be refurbished. The lime plaster has already been removed from three of the four walls, where the stone is exposed this will be re-pointed with lime mortar, on the other internal wall the lime plaster is to be retained. The flagstone floor is to be raised and relaid with under floor heating. The ceiling is to be repaired. In the fireplace a liner is to be installed and a new wood burner. The lintel on the fireplace is to be replaced, which is a large chamfered beam, but one that is highly worked and varnished and is not original. As a non original feature this will not have an effect on the heritage asset.

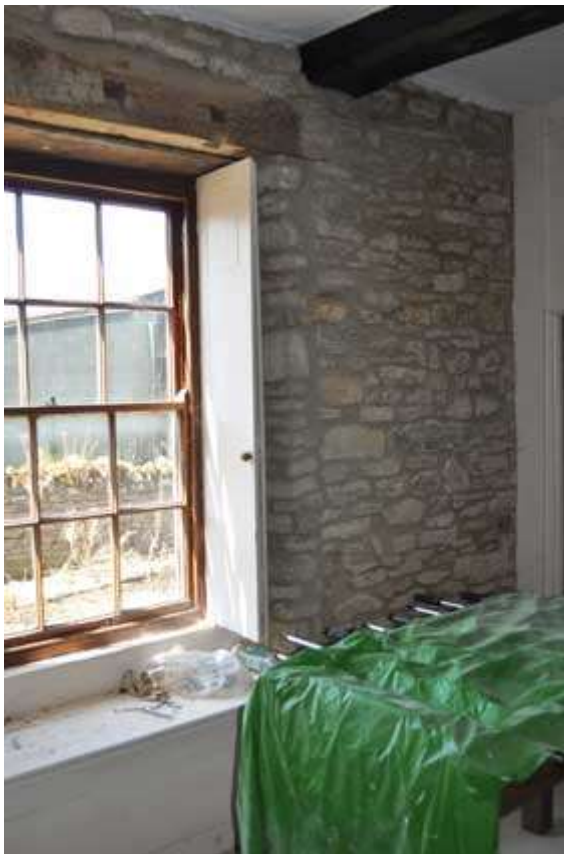
Plate 5 Window (G3)

The west panel door from the hall with original surround leads into a larger sitting room (G3) to the west of the hall. The north wall has surviving plaster, skirting and cornice rail, however, the other walls have been stripped of plaster and there are limestone flags on the floor. In the north wall there is a glass panelled door of a recent origin. In the south wall there is a sash window with wooden shutters. There are butt joints either side that appear to indicate that the window has possibly been reset or enlarged. The lintel above has either been reset or is indicative of their previously being a lower ceiling with common joist settings (plate 5). At the west end of the room there is a central fireplace with a cast-iron

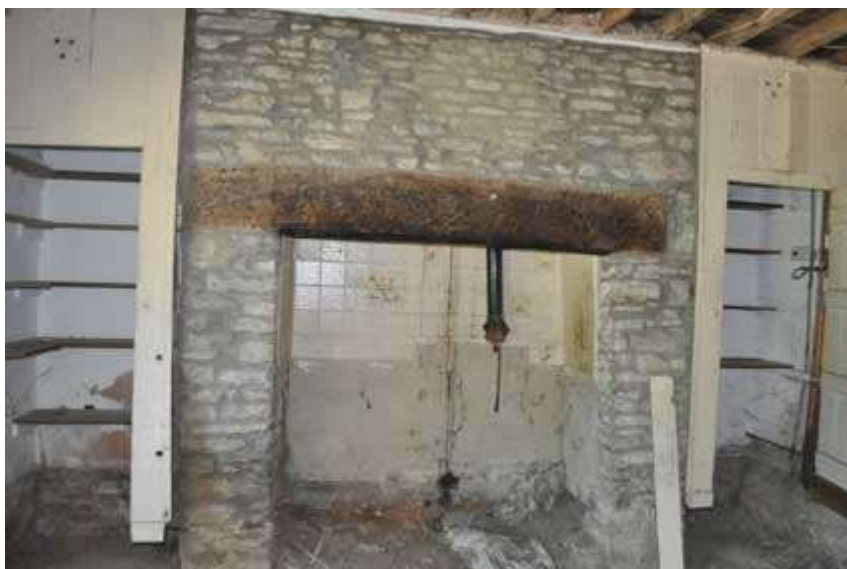
The north panel door from the entrance hall (G1) leads into the kitchen (G6). This is a rectangular room, almost square in design. In the east wall there is a large fireplace with a timber lintel with adze or axe marks, a steep chamfer and stop at its left-hand side. There was no stop on the right-hand side, but there were three dowel holes in the timber which were off-set to the right and may indicate that the lintel had been reduced in size with the removal of the right end. The fireplace is flanked by two areas of panelling that turn the alcoves either sides into cupboards (plate 6); both contain a plank door with internal shelving. In the north wall there is a window on the right-hand side and a door on the right. The door is one of a plank construction with a glass panel. In the ceiling there is a chamfered transverse beam. Adjacent to the west wall and located in the south wall there is the remains of a setting for a timber beam similar to the other. The beam has presumably been replaced by the insertion of the wall at a later date, as the wall contains butt joints at both ends.

Plate 6 Cupboard fittings either side of fireplace (G6)

The kitchen (G6) is to see the following alterations. The existing alcove cupboards are proposed to be replaced. These are matching alcove features which are features associated with 18th century structures; their loss is thus the loss of an original feature in this heritage asset. The external door with a lowered threshold is to be replaced. This again represents the loss of a probable original plank door, which will have an impact on the heritage asset. The chimney is to be cleaned and relined. Any lime plaster in this room has already been removed; the exposed stonework is to be re-pointed. The existing doors to rooms F1 and F7 are to be retained. Localised repairs to the transverse beam in the ceiling. The dirt floor to a large extent has already been partially removed, which is to be replaced by a limecrete feature with under floor heating. The removal of the floor has exposed part of an under floor hypocaust associated with the original construction. Thus this activity may have a further impact on the heritage asset.

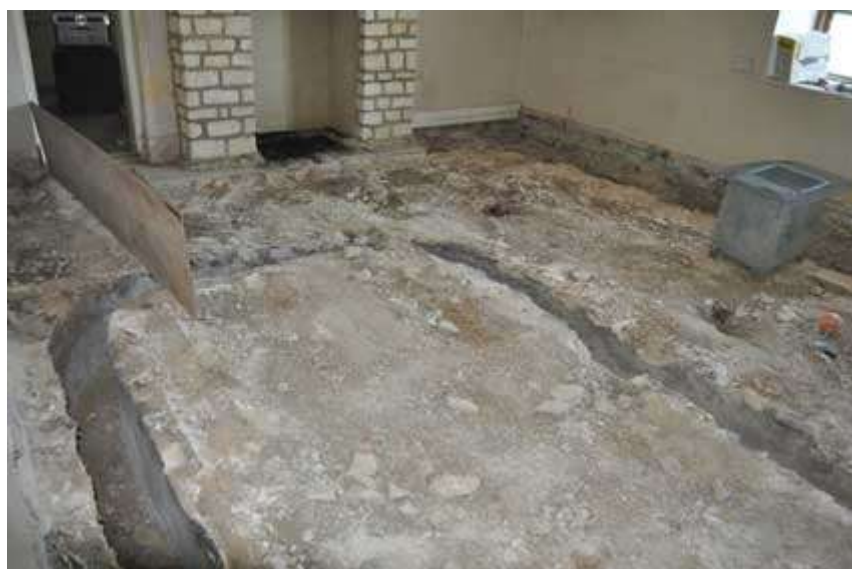
The panel door in the west wall of the kitchen (G6) leads into the Dairy (G7). This room has a fireplace in its west wall. The fireplace was smaller than all of the others in the building and the chimneybreast narrower. There has been a modern addition on the front with a new bowed lintel, this covers up an earlier lintel. A doorway is located to the left-hand side of the chimneybreast. There are two windows in the north wall, one with four lights and the other with six; both look as if they are newer replacements. In the ceiling there are two transverse beams, the west one has stops at both ends, while the east one of the two has stops only at its north end. A door in the south wall is a modern glass panel door, which leads into the sitting room. The floor was constructed of limestone flagstones, under which there are the remains of a hypocaust channel with plastered side walls (plate 7).

Plate 7 Hypocaust under floor of the dairy (G7)

The dairy (G7) will see structural repairs to the ceiling. The existing windows, which are not original, probably 20th century, are to be retained. The flagstone floor has already been removed; it is to be relaid with under floor heating. The door to room G6 will be retained, the new door to G3 will be replaced, and the door into room G8 will be replaced. The door into room G8 is if not original an early narrow depth door of the period. A new wood burner is to be inserted into the fireplace.

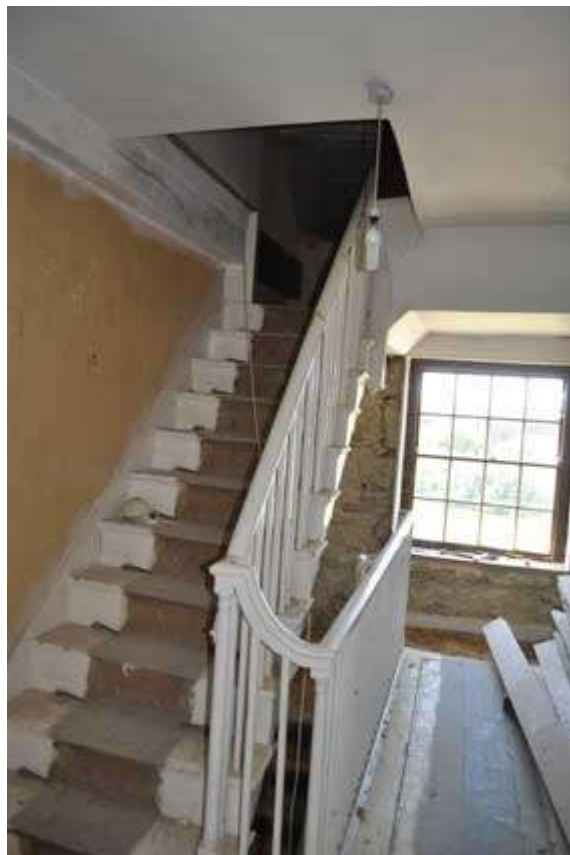
Plate 8 Stairs on landing (F1)

The stairs in the Entrance Hall (G1) ascend to the First Floor Landing (F1). Either side of the stairs the walls have been stripped to reveal timber framed walls that would have contained a lathe and plaster finish. The timbers are evidently sawn. There are panelled doors in the east and west walls and a sash window with 12 panes. In the north wall there is an opening through a stone wall. This opens up into an east west passage with a door at either end. There is a door facing in the north wall, which has been partially removed to uncover a timber framed wall. There is a transverse beam, which may be a replacement as the timber framing has been cut to incorporate the new beam. The doors are predominantly panelled and contain L-shaped hinges, which are seen as a 17th century characteristic.

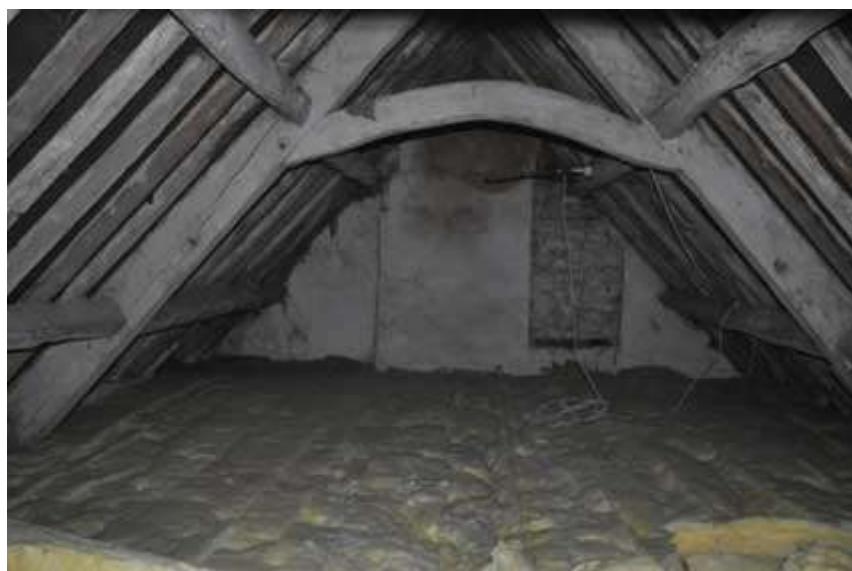
Plate 10 Bowed cross beam (A5)

The final attic room (A5) is the largest of the spaces of the landing. Floorboards do exist but have been covered with insulation. In the west wall there is evidence of a chimneybreast and alongside it on the right-hand side the remains of a blocked window. This window was blocked so that the chimney from the 19th century addition could be
