HISTORIC BUILDING ASSESSMENT

AND WATCHING BRIEF

THE THREE HORSESHOES,

OLD MARSTON, OXFORD

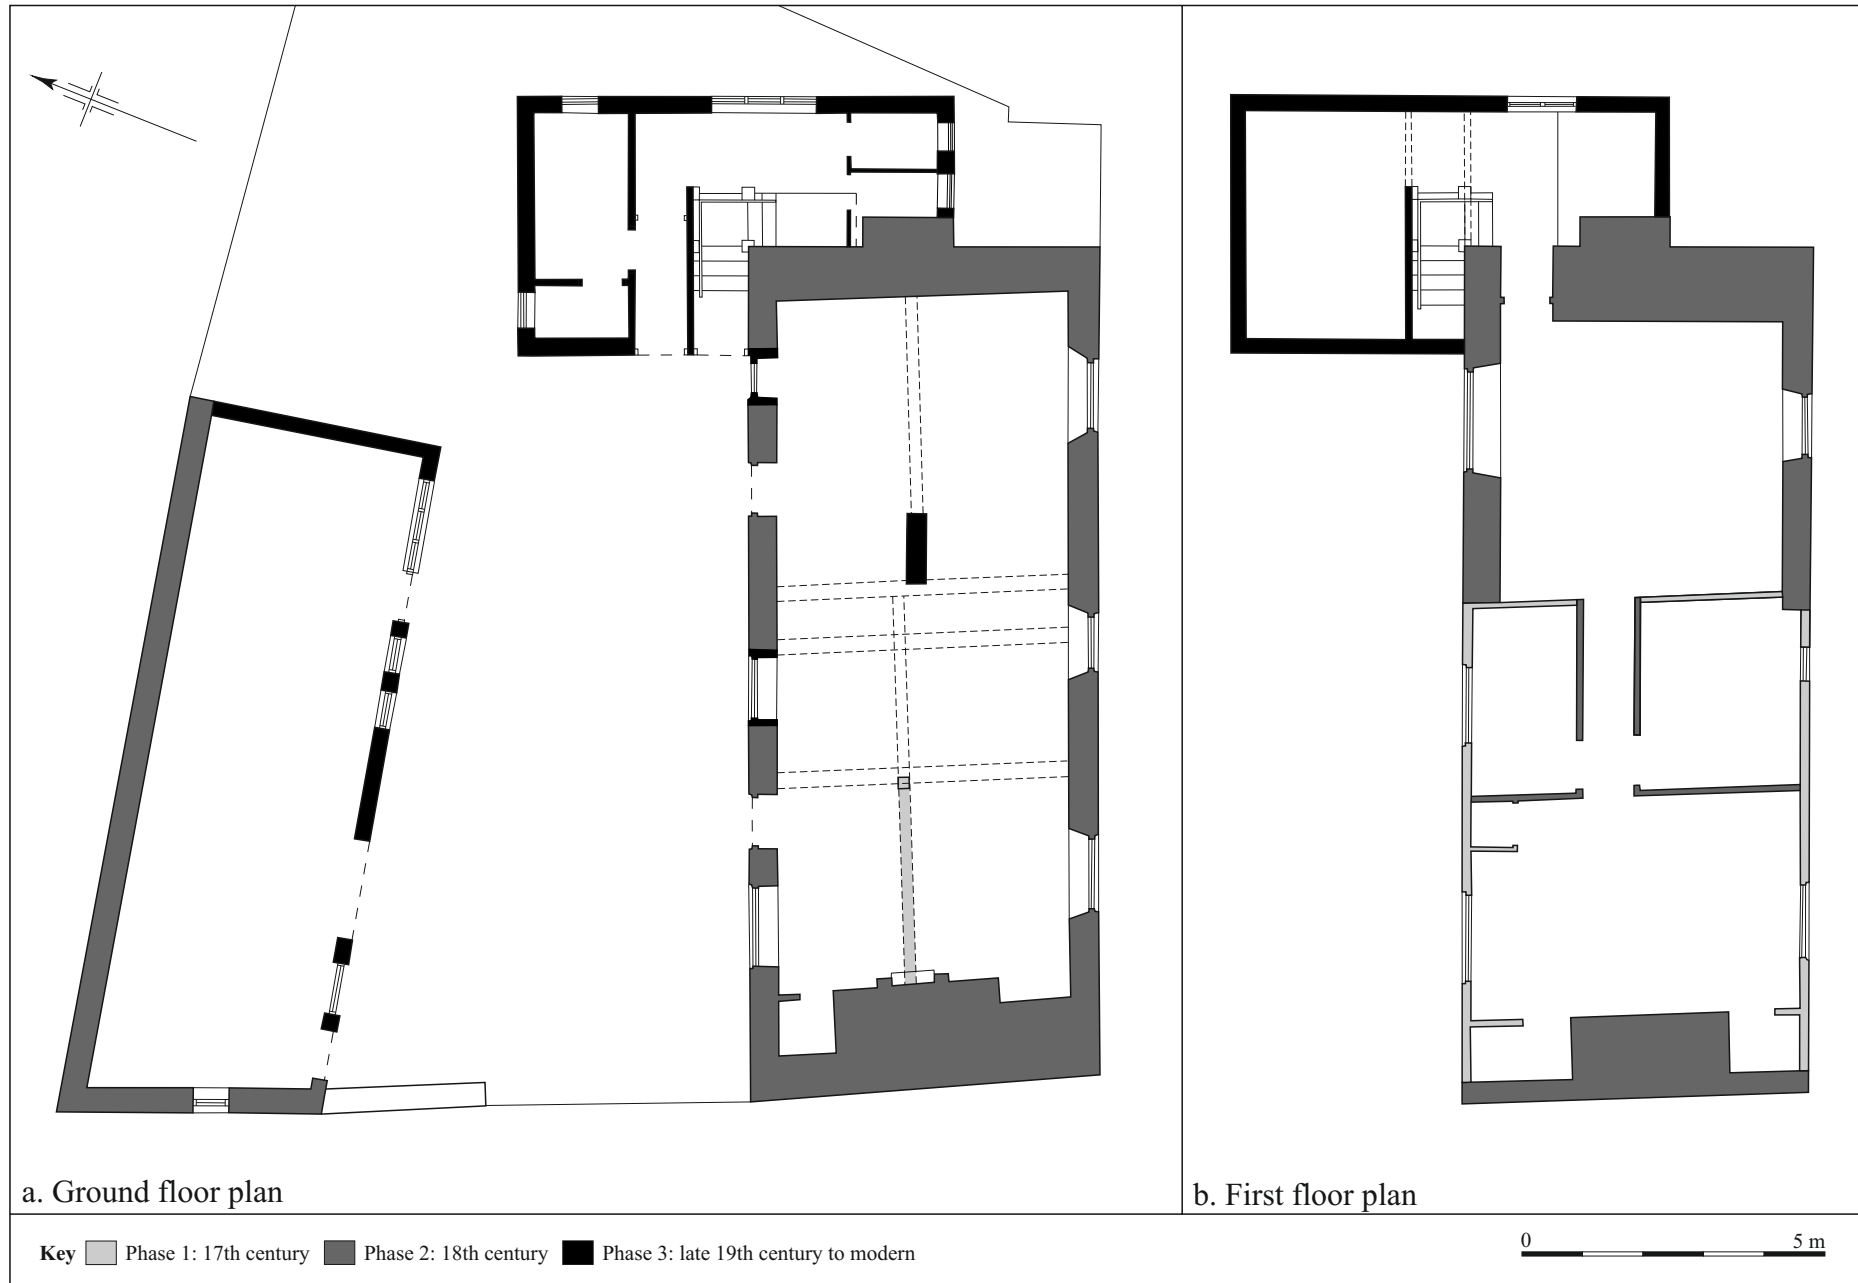
Figure 3. Phased building plans

The Three Horseshoe public house consists of two buildings; the larger is the house, while the other is an outbuilding (fig. 3). The old building is essentially a three celled unit, with a modern extension at the east end. The outbuilding is a lean to against some old boundary walls.

Phase 2 is probably represented by a replacement of the timber framing on the ground floor and on the gables, and on the northeast unit on the first floor. There are stylistic features that may be of this date such as the sash window on the ground floor on the southwest unit northwest wall. Some of the windows indicate that this process of refurbishment and replacement of a timber frame and replacement of windows continued into the 19th century. Some of the timbers in the central unit on the ground floor may be 17th century in origin, but some show saw marks and are replacements of the 18th and 19th centuries.

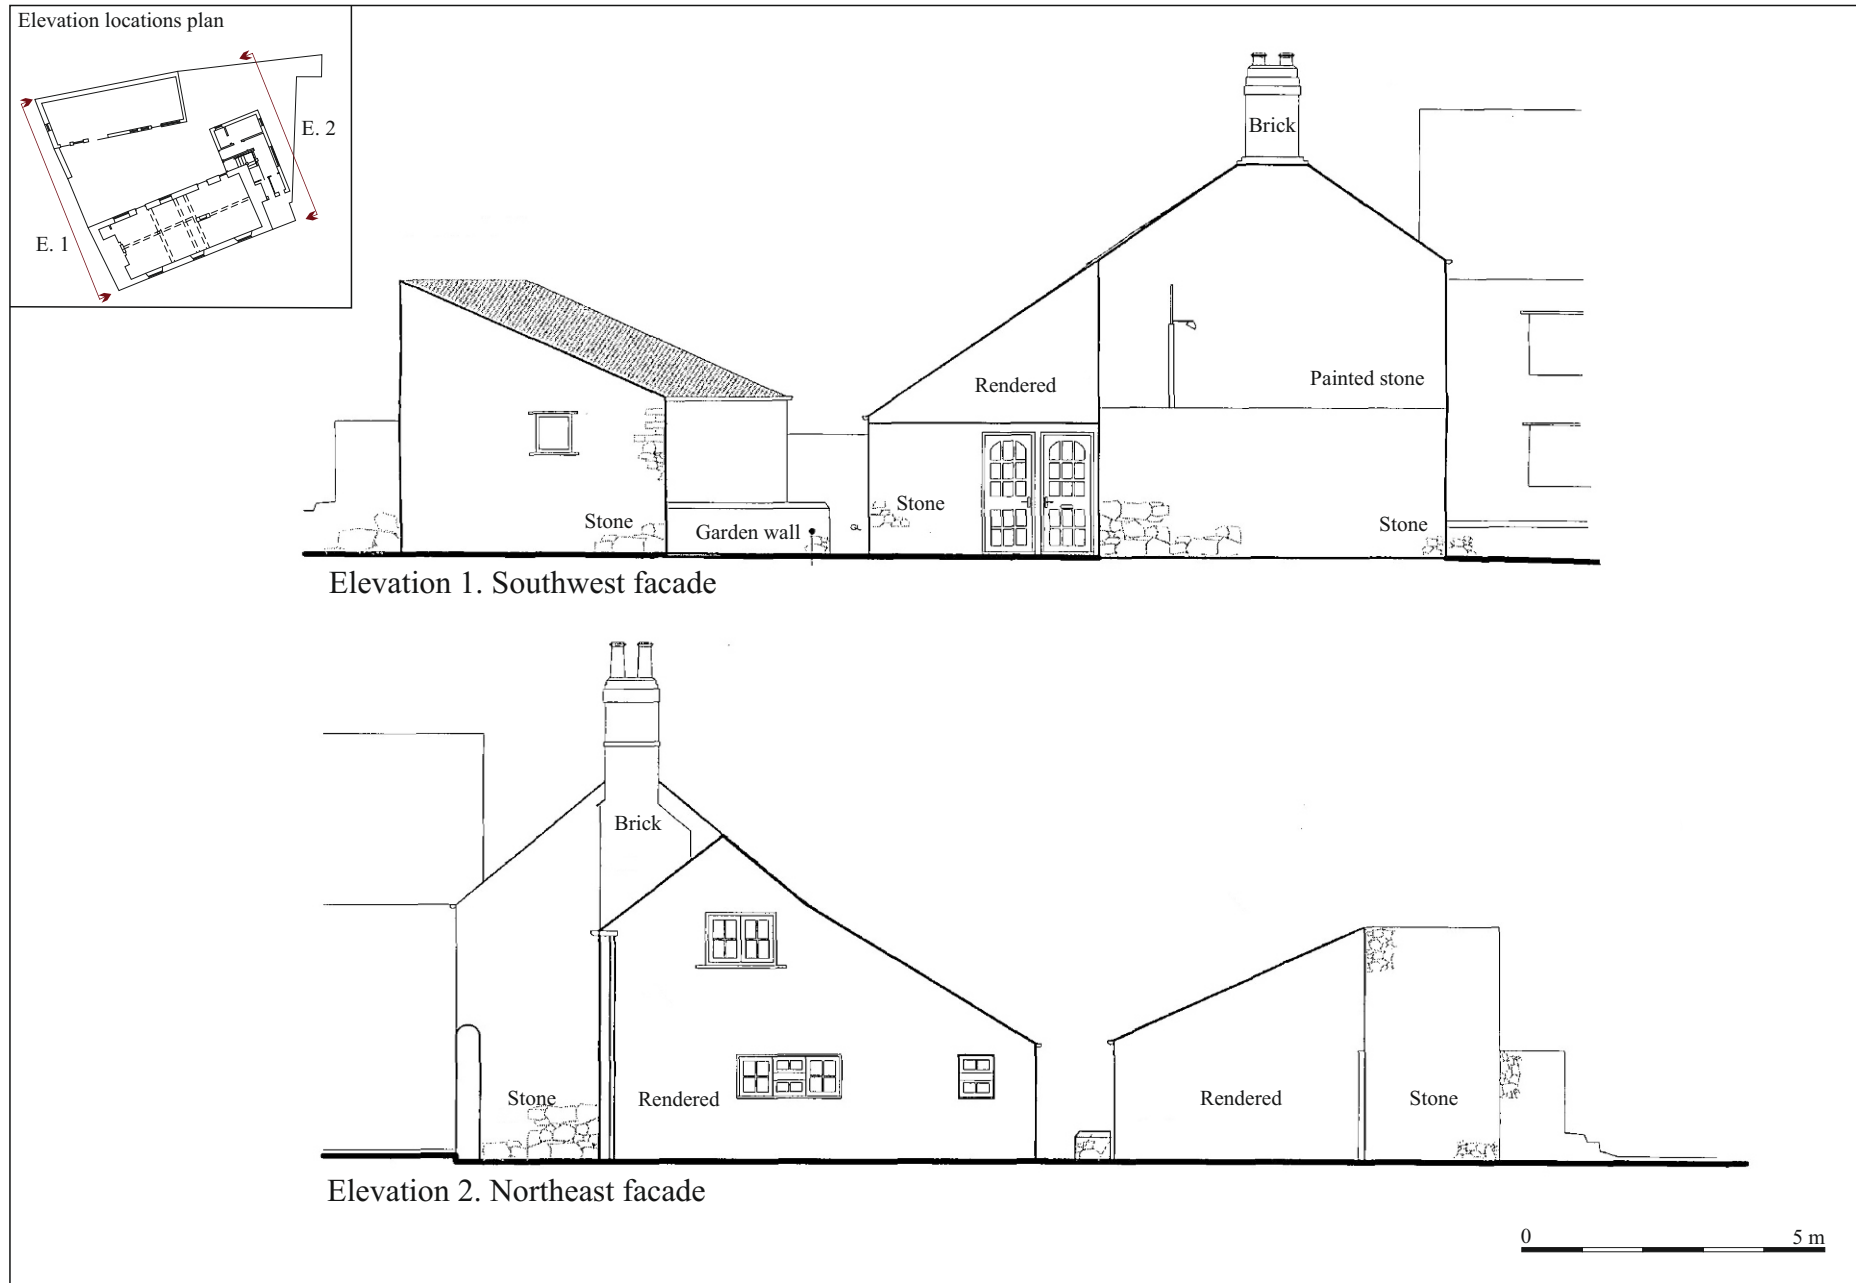
Figure 4. Southwest and northeast elevations

The northeast elevation contains both old and new components (Fig. 4). The old gable contains a large external chimneybreast with a brick upper stack with upper and lower water tablets and two chimneypots. The modern extension has two windows on the ground and one on the first floor.

The southwest elevation (Fig. 4, plate 1), facing the street, contains the remains of a limestone rubble gable. The upper part of the wall is painted or whitewashed stone rather than render. This is surmounted by a brick chimney with upper water tablet. The chimney would appear to have been rebuilt at some time in the near past. The modern eastern extension also has a southwest elevation, which contain two modern doors, one to the customer's toilet facilities, the other to the public house living quarters.

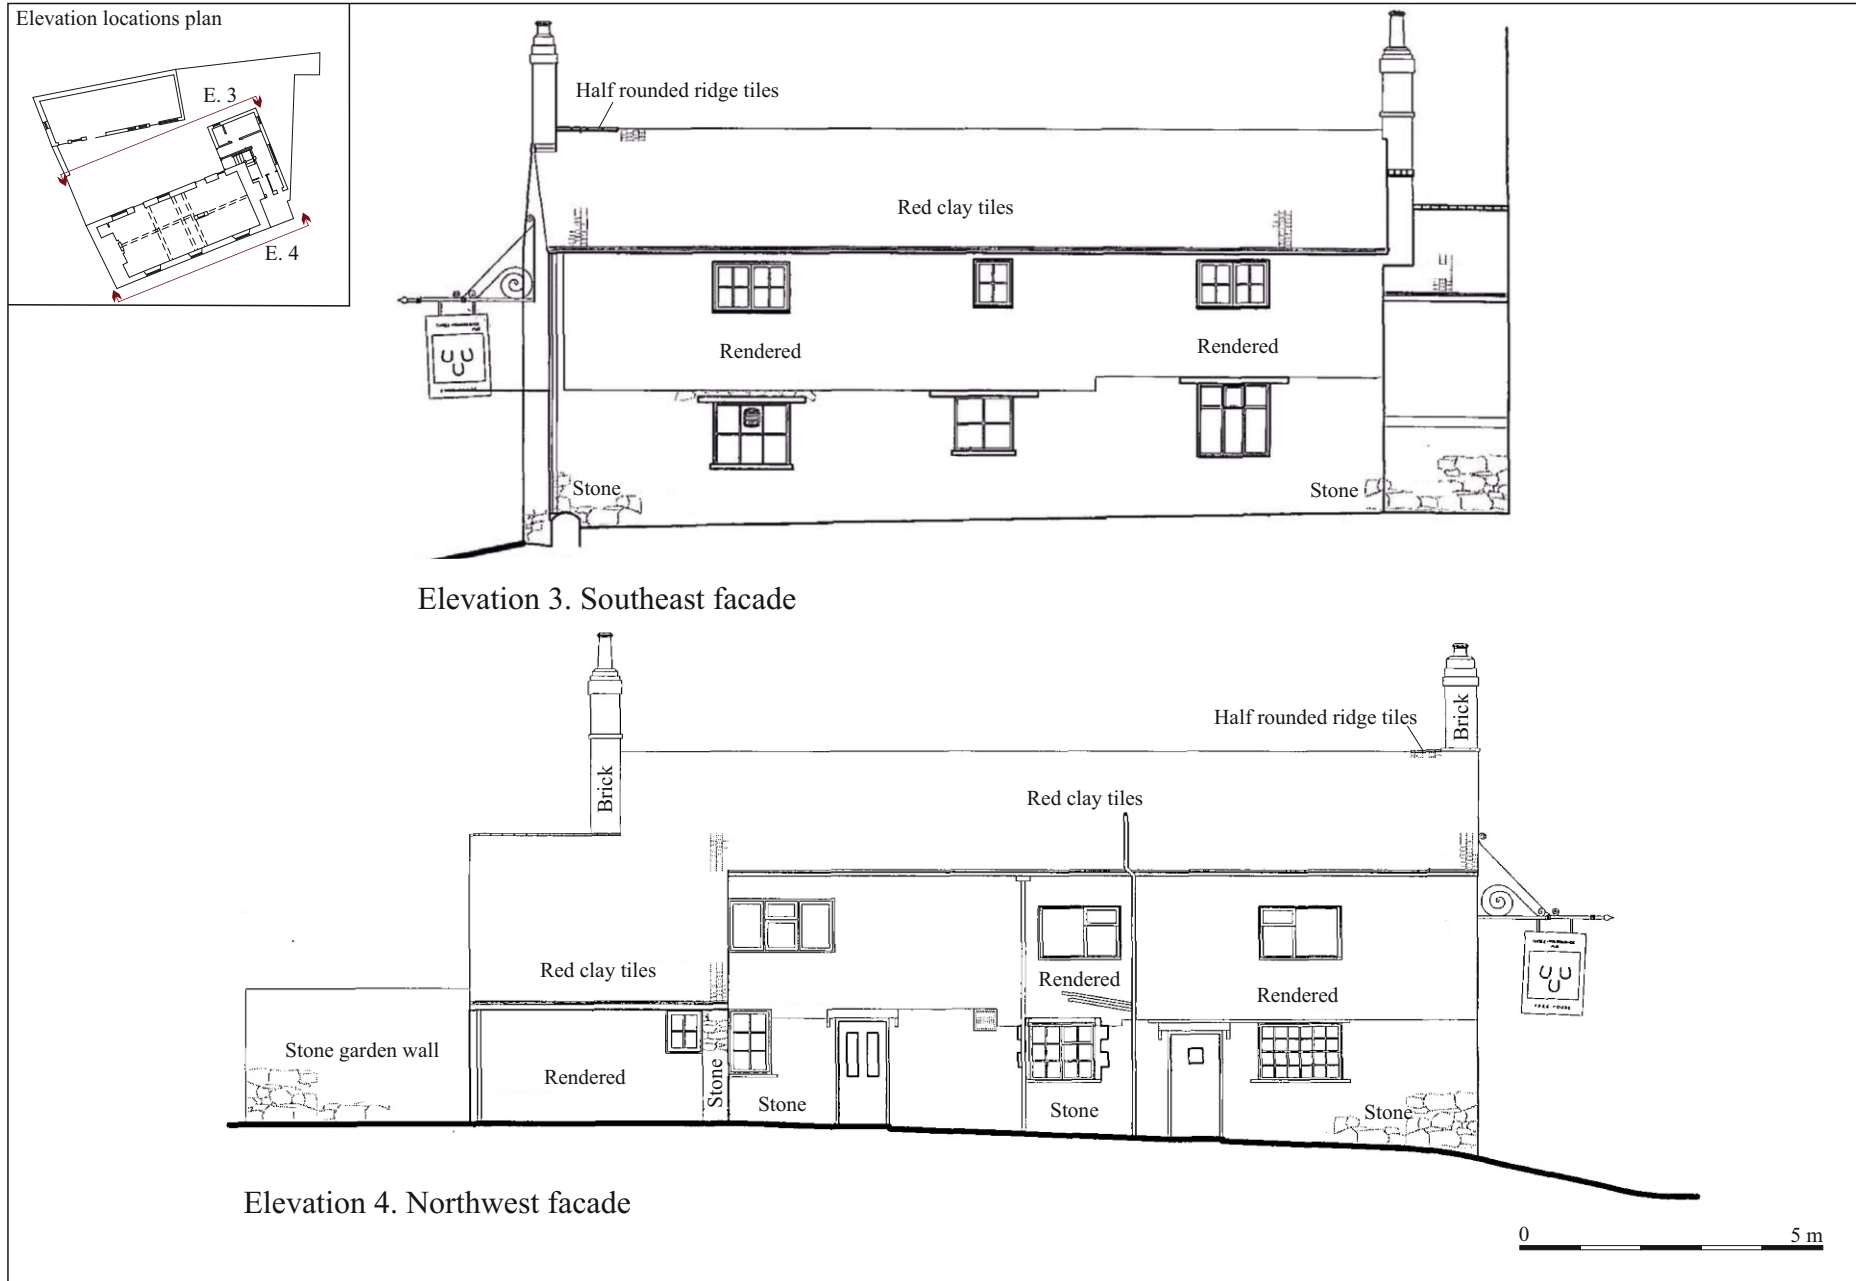
Figure 5. Southeast and northwest elevations

The front elevation of the main building is located on the northwest side of the structure (Fig. 5, plate 1). The old part of the façade contains a ground floor with a lower rubble limestone wall. The upper floor is rendered, which may contain timber framing. In the ground floor elevations there are three windows, the most westerly a sash window with 6 x 4 lights. This window may be early but is suspected not to be original. The central window contains 4 x 3

The southeast elevation like that of the north elevation contains lower rubble wall and an upper rubble wall (Fig. 5, plate 2). Part of the first floor render may conceal timber framing. The

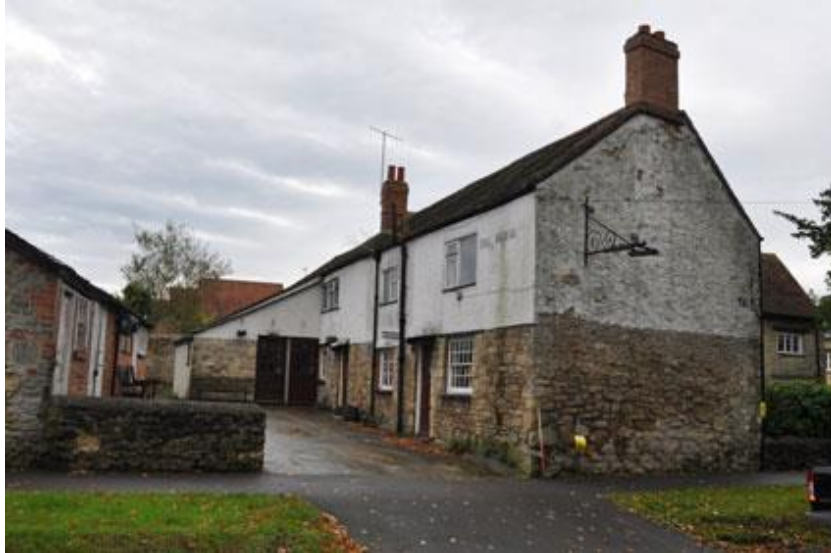
Plate 1. Northwest and Southwest Elevations

lights, there is a modern brick quoin work thus indicating a recent insertion. The east window is the smallest with 2 x 3 lights. The sill is made of blue engineering bricks and is indicative of a date in the later 19th or early 20th century, although the size may be nearer to the original. Between each of the windows are doors, the locations may be old but the doors are modern. The first floor consists of three bays, each of which contains a modern and probably enlarged window fitting. On the east end there is a modern extension.

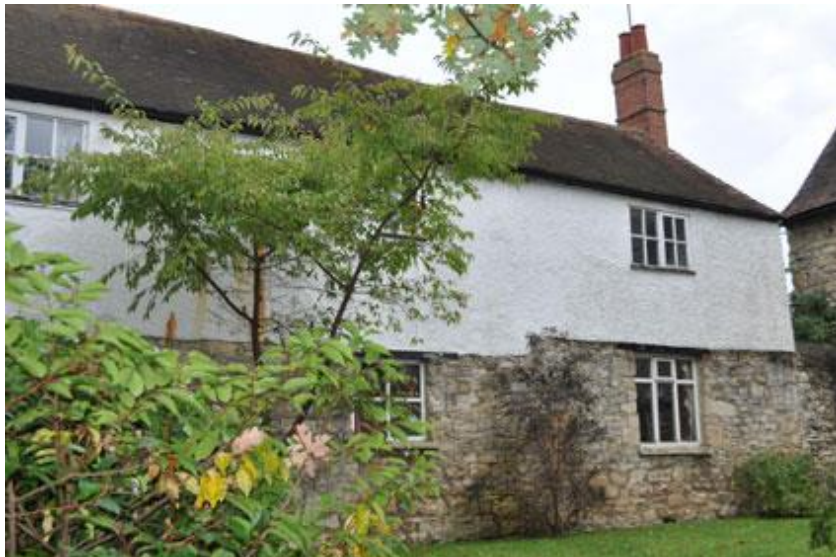
Plate 2. Southeast Elevation

south elevation contains three bays. The windows are smaller here, especially on the first floor, and some of these may reflect the original smaller windows that would once have existed on the building. All of the casements are probably, potentially of a later date.

The central window on the southeast side first floor is to have its width reduced. These windows are amongst the smallest in the old building; though the size may be original the casements are later.

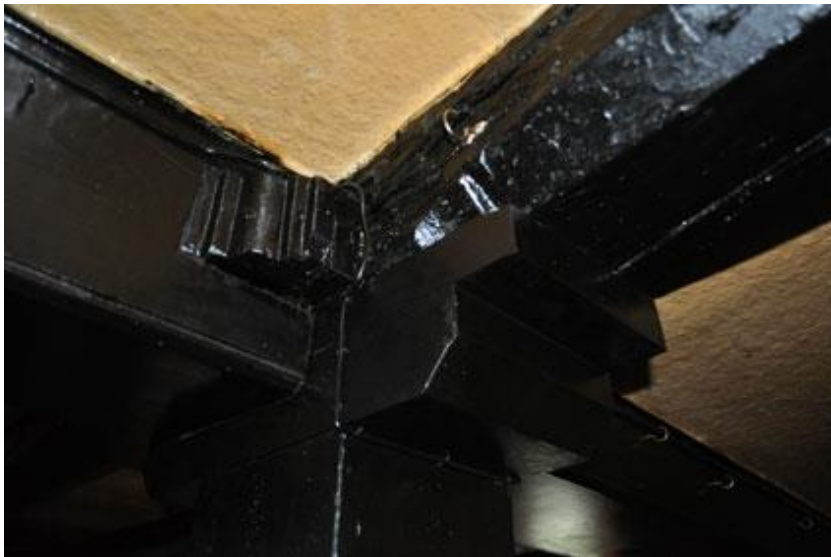
Plate 3. Stop on chamfered beam west unit ground floor

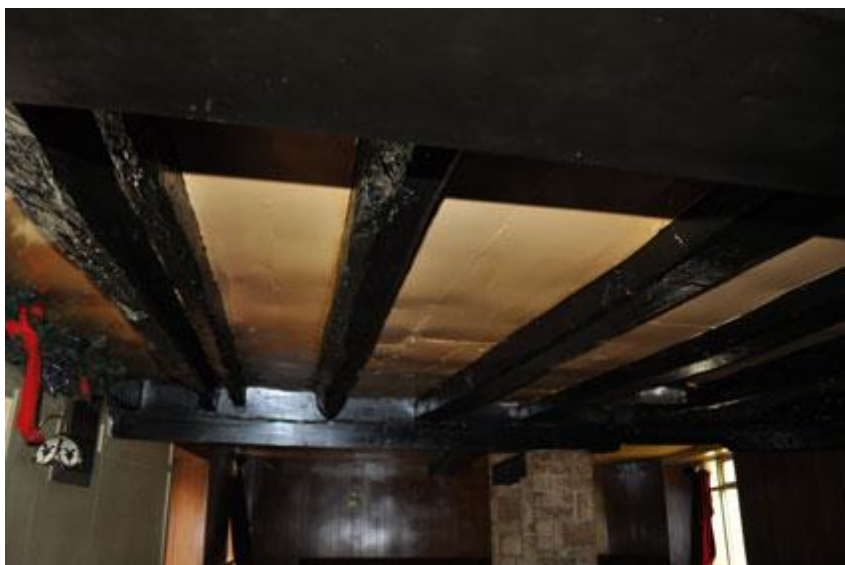
wood. This was an axial beam (similar to that in the western part of the building. In the central part of the ground floor a timber beam running transversely was uncovered between the west and central unit. The timber was decaying but still retained the bored holes for the hazel uprights of the wattle and daub.

Plate 4. Timbers in central unit ground floor

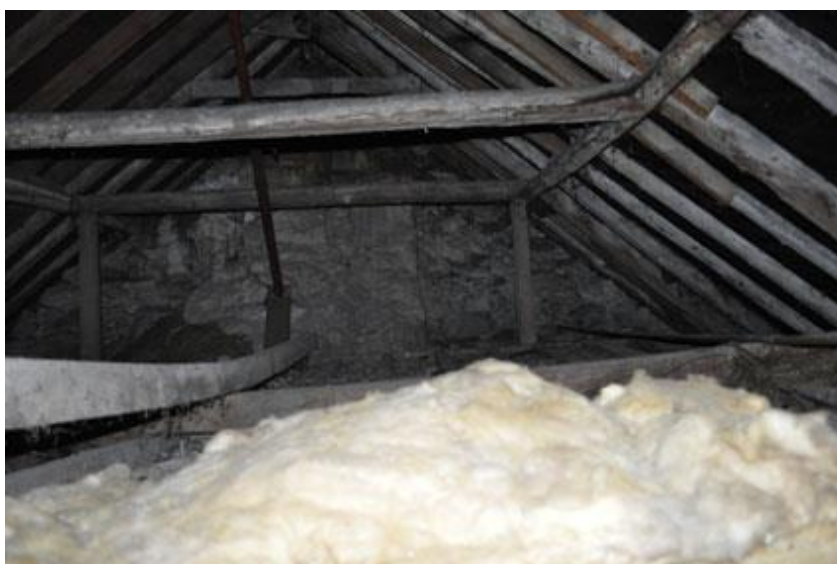
Plate 5. Roof timbers

The roof space is unconventional with partially formed trusses. The purlins are supported on struts, but with no collar beam, while in other places collar beams create A-frames to tie the roof structure together (plate 5).

Three conservation roof-lighting were added to the southeast side of the old roof, which will require the cutting of old roof timbers for their insertion.

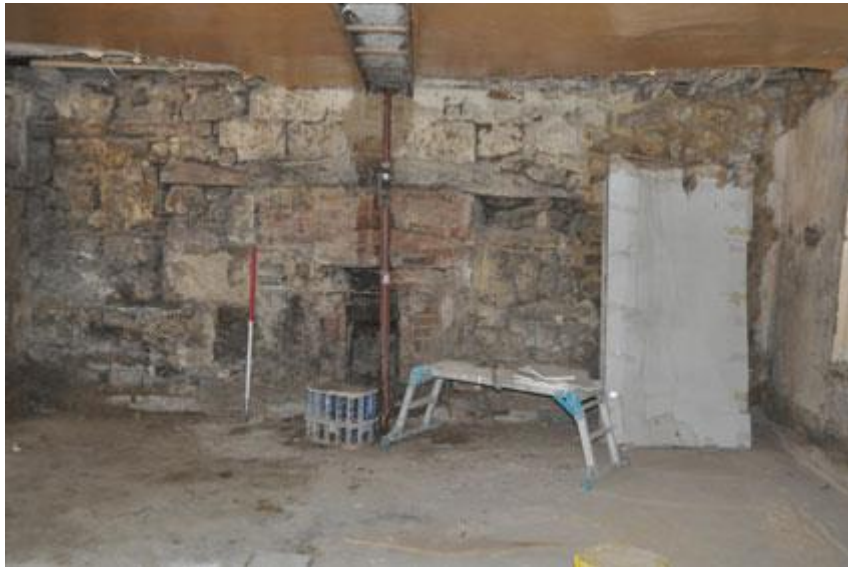
A number of observations were made during the internal stripping of the structure on the ground floor. A large fireplace with timber lintel was uncovered in the east wall of the stone structure (plate 6). The chamfered timber lintel was exposed which had previously been clad in

Plate 6. Uncovered fireplace east unit ground floor

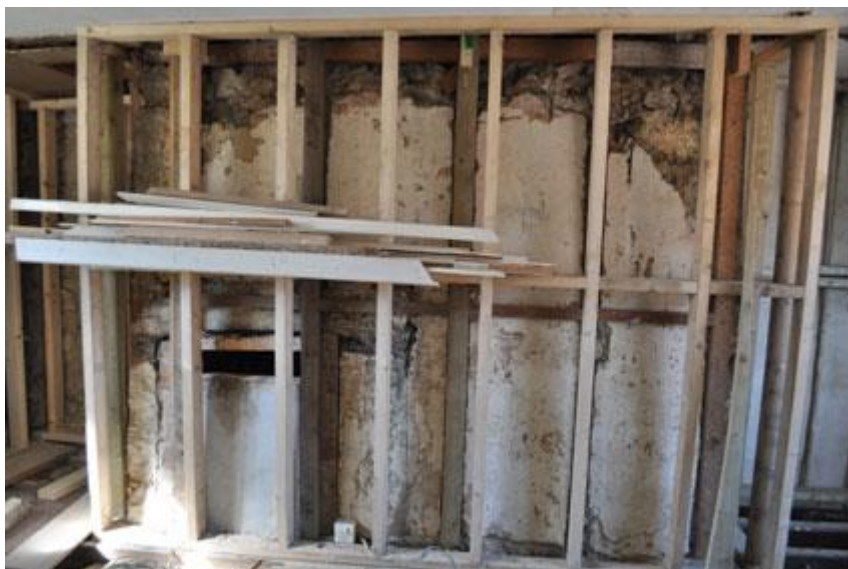
with plank doors. The walling between the two cupboards and the room are timber framed. The fireplace was uncovered during renovation (plate 7).

Plate 7. Uncovered fireplace and chimney breast, west unit first floor

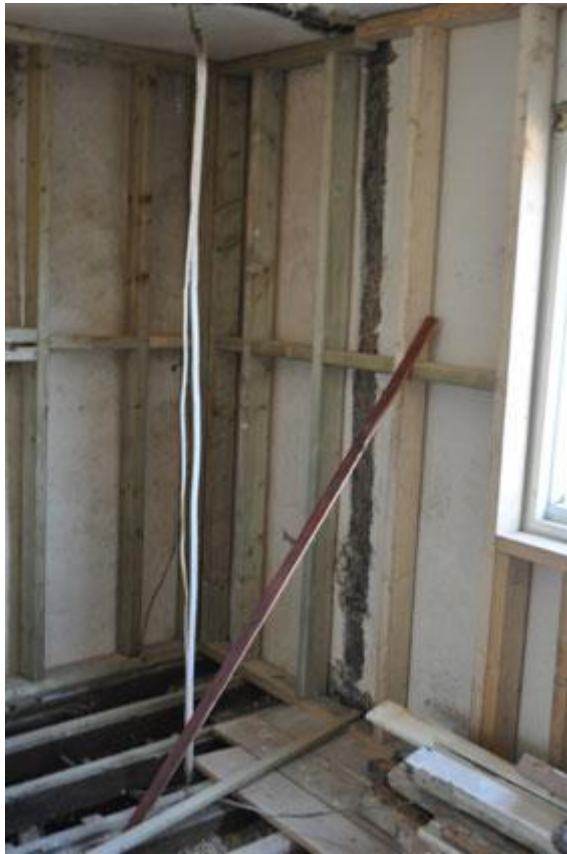
Observations were also made on the first floor that confirmed that part of the southeast and northwest walls were a thin timber framed structure.

Plate 8. External timber framing seen below framing for dry walling

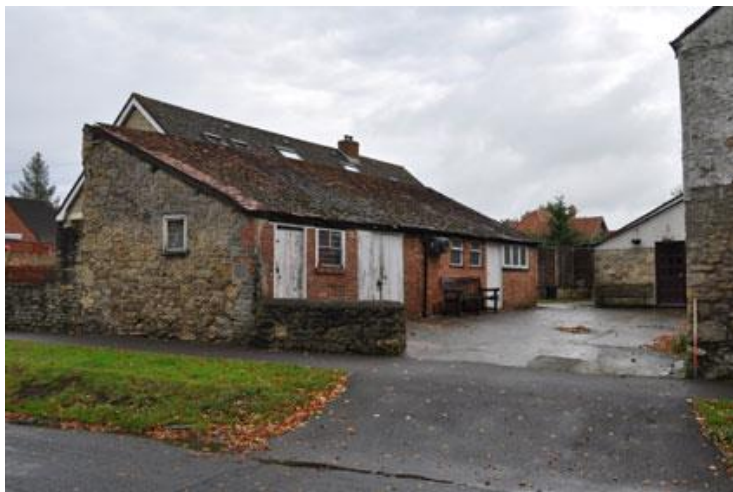
Plate 9. Outbuilding

The outbuilding is a lean-to structure built against a garden boundary wall (Fig. 4). The large garden wall is on the north and is constructed of limestone. There is evidence of a building previously constructed against this. The west wall is also on the boundary of the property and is constructed of rubble stone, with later brick quoins and a window inserted. The east wall is blank and rendered. The south wall is of brick and from west to east contains the following features; a

plank door alongside which is a window, to the east of this is a double door, then two windows, a further door and another window.

The outbuilding consists of two old walls, which have probably been in existence from at least the 18th century (Phase 2), though without precise dating details it is difficult to know to what extent it has had later rebuilds. The brick walls and internal breeze block walls are of a late 19th and 20th century date, although some of the brickwork looks as if it has been rebuilt.

The external walls of the outbuilding were retained on the north, east and west, but the southern façade was completely revamped. It is probable that this represents an original 19th century construction that has seen rebuilding in the 20th century. This externally had the largest visual impact, however, it is the three celled structure that is listed and not the outbuilding of which the architectural merits are poor. A photographic record of this part of the building should suffice as mitigation.

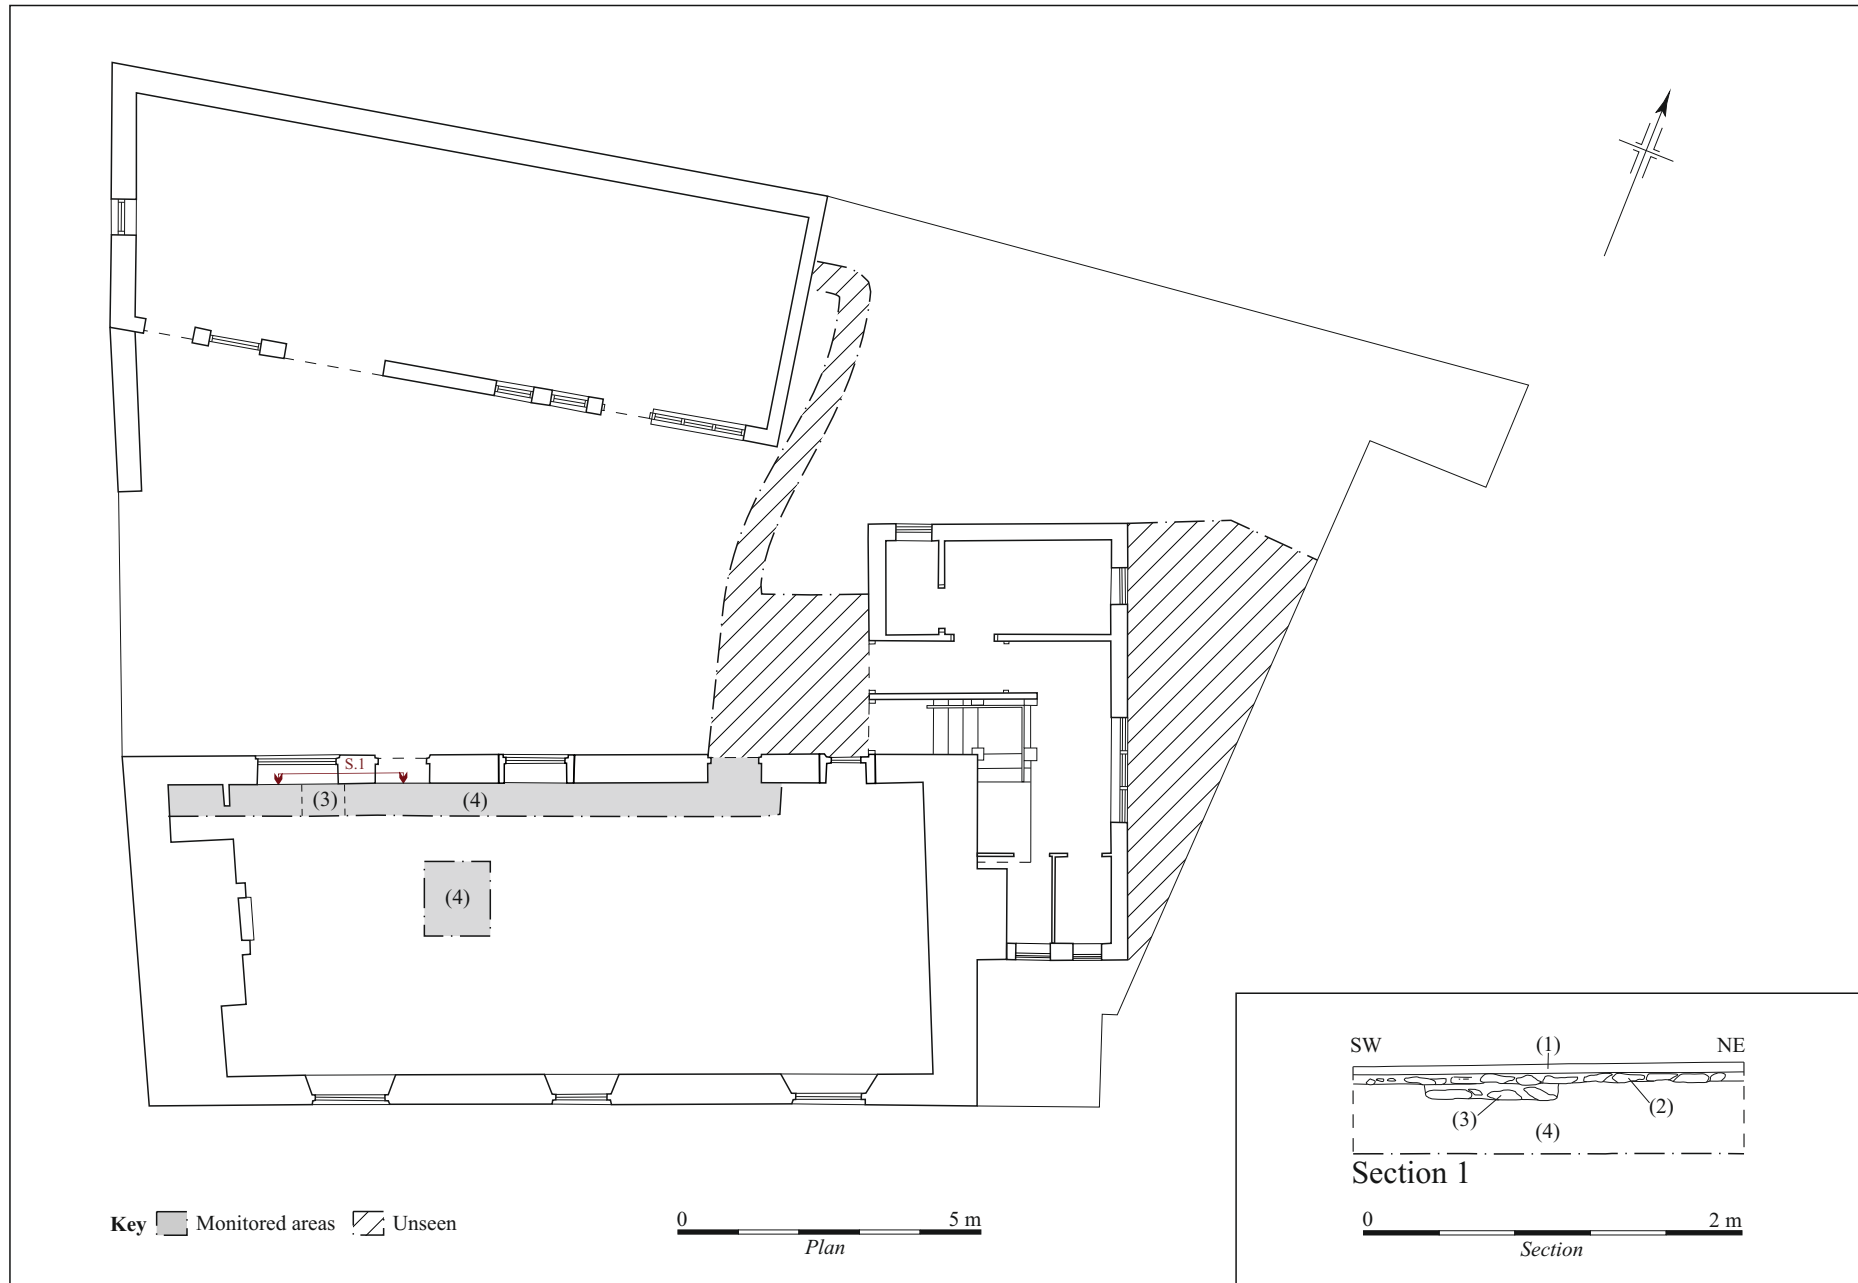
Figure 6. Plan and section of excavated areas

Not all of the areas uncovered were observed (which are marked in Fig. 6). The natural ground (4) was a highly compact yellow blue/green clay. The foundation cut of the Three Horseshoes Public House was 0.15m deep. The rubble stone wall was set into this. Lying in or on layer (4) was deposit (3) a grey blue clay with stone inclusions. This context though noted separately could have been a separate series of laid rubble stones as part of a wall, or could also have been the lower part of layer (2) a mortar skim rammed with stones, which could either be part of an earlier floor surface or could have been part of a rough bedding layer. Too little of context (3) was observed. Sealing deposit (2) was a concrete skim 0.05m deep.

The watching brief observations cannot be described totally as negative, but context (3) was ambiguous.
