SPEEN MANOR
BATH ROAD
SPEEN
BERKSHIRE
(NGR SU 4571 6809)

HISTORIC BUILDING RECORDING OF THE GARDEN WALL

October 2011

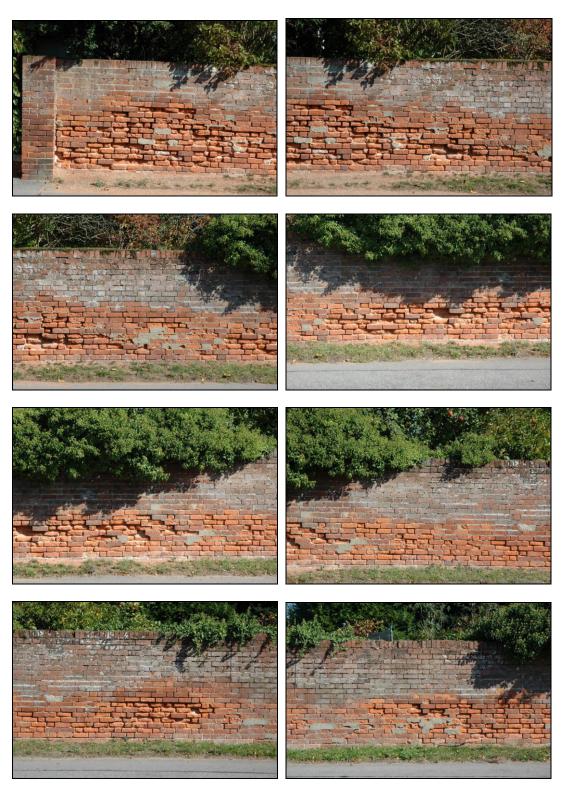
The Manor at Speen is situated on the north side of the A4 Bath Road and consequently the red brick wall that forms the manor's present southern boundary has suffered greatly from salt damage from the passing traffic and salt treatment of this road during periods of freezing. The wall has deteriorated in places beyond repair. Efforts have been made to repair it with a cement-based mortar which has greatly exacerbated the deterioration of the brickwork by directing moisture into the heart of the wall. In places it is worn through to such an extent that it is possible to see right through the formerly mortared joints. As this is all on the lower half of the wall, the structure is being seriously undermined.

Figs 1-8. Speen Manor Garden Wall on the A4 Bath Road, from west to east

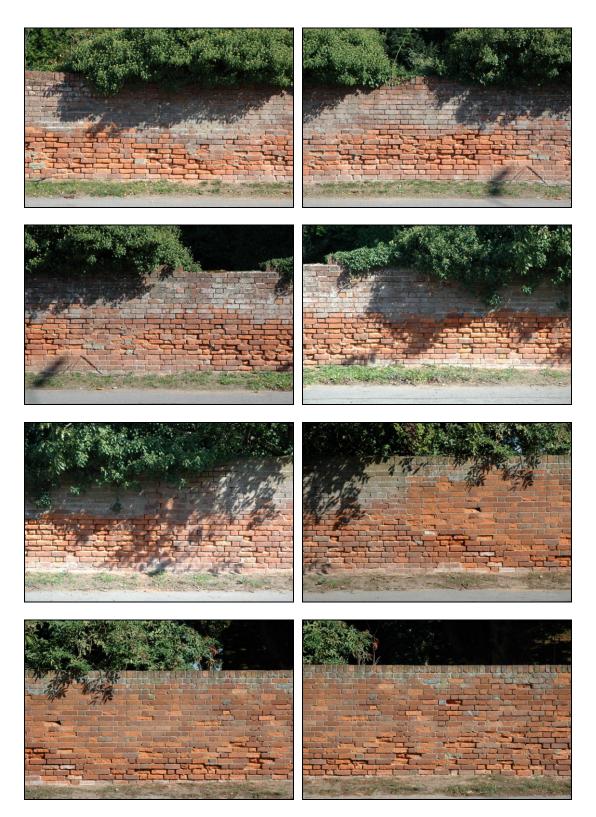
Figs 9-16. Garden wall continuing from west to east.

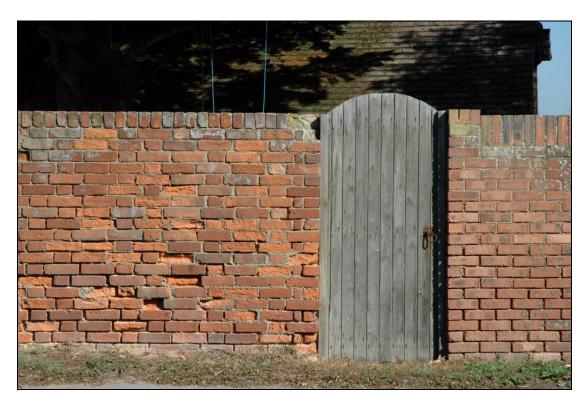
The final image (Fig 17) shows the boundary wall of Speen Manor up to an original garden gate opening, which now forms the limit of the property. Beyond this there is marked difference between the original wall and a modern replacement in stretcher bond where the manor's original land was sold off for redevelopment. As can be seen, the mortar of this modern wall is already succumbing to a similar fate.

Fig 17. The junction at an original gateway between the Speen Manor garden wall and the recent replacement of a section of it where the land has been sold off.
