JOHN MOORE HERITAGE SERVICES

HISTORIC BUILDING RECORDING

MALTINGS FARM OUTBUILDINGS, SOUTH STREET,

CASTLETHORPE

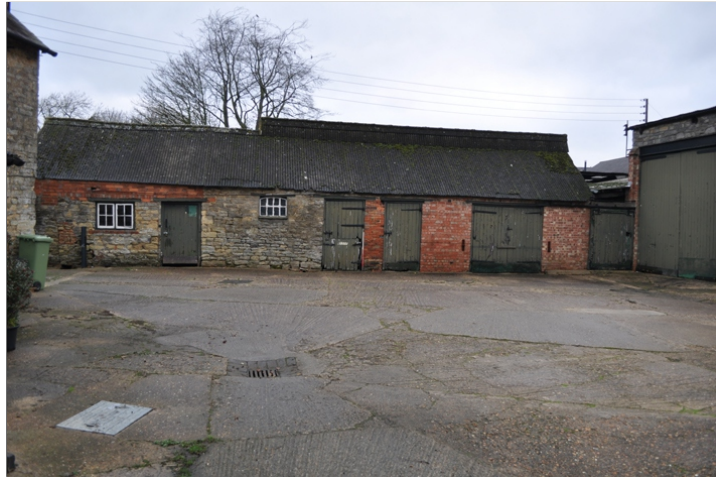
Plate 1. Building 1, south facade

The main façade is the south façade (Fig.3 E1.1), which fronts onto the farmyard behind the Maltings Farm house. The west end contains a structure built predominantly of stone. There is a central low door, to the left is a two casement window with four panes in each, and a wooden lintel (Plate 1). To the right is an eight paned window with segmental arch under a straight timber lintel. The upper part of this part of the structure is raised to roof level in brick. The east end contains three doors with modern brick walling between. The left door is a stable door, while the right door is a double door.

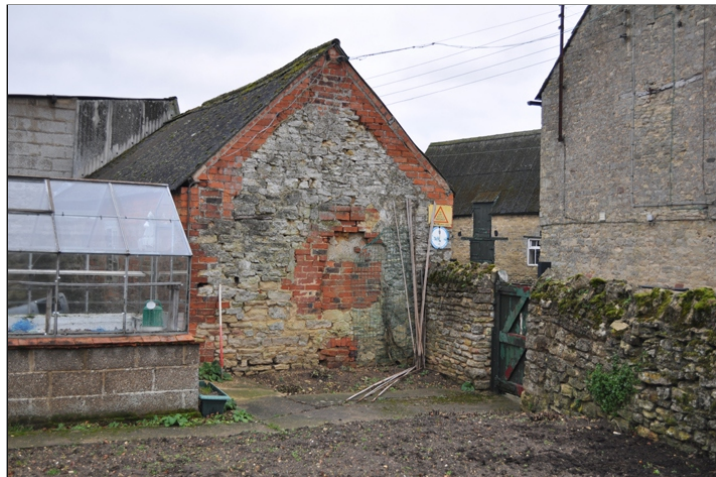
Plate 2. Building 1, east facade

The east wall (Fig.3 E1.4) is of stone rubble with some brickwork on the south side (Plate 2).

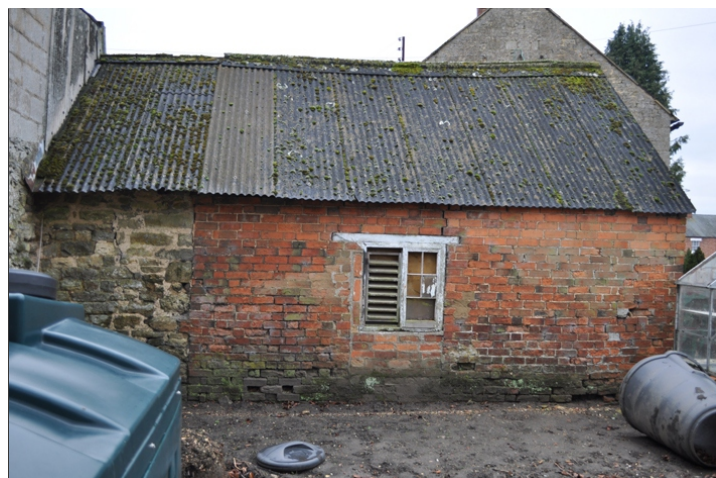
Plate 3. Building 1, north facade

The north wall (Fig.3 E1.2) has had a large modern cowshed built alongside it on the northeast side. The wall is predominantly of rubble limestone, which is dominant in the eastern part of the structure. The western part of this wall has been rebuilt in brick and has a two light window frame, in part of which are louver timbers (Plate 3). The window is a replacement for an earlier door.

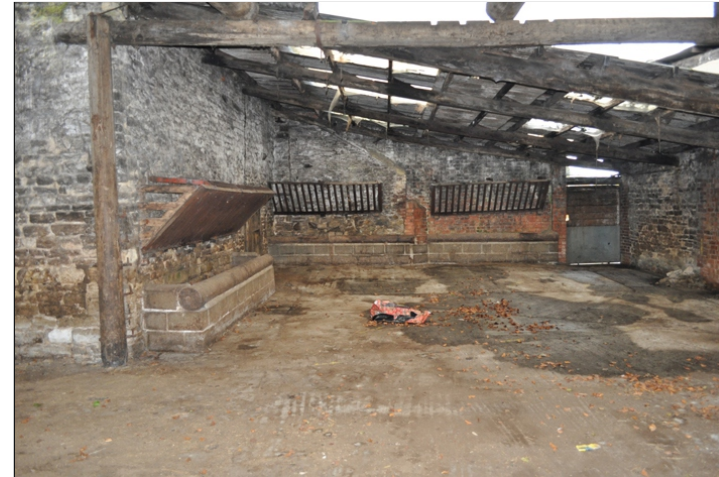
Plate 5. Building 2, north facade

The north wall (Fig.4 E2.4) of Component A is a limestone wall forming a gable end (Plate 5).

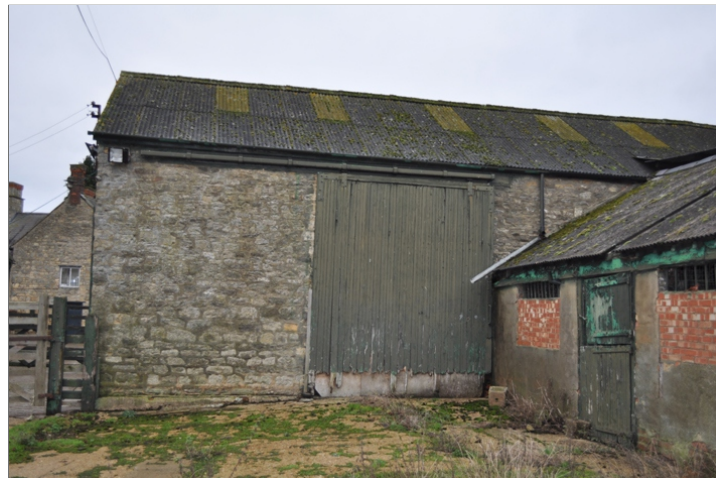
Plate 6. Building 2, east facade

The east façade of Component B is also of limestone blocks and has the remains of a large sliding door located centrally (Fig.4 E2.2, Plate 6). Component C joins this structure on the north side, it may have originally butted the larger component of the barn (Component B), but this was dismantled and rebuilt in the latter part of the 20th century.

The south wall (Fig.4 E2.3) of Component C is of brick but with grey render finish and contains a central stable door with two partially blocked windows either side. Iron grids are fitted into the surviving part of the opening and a fascia board is fitted to the eaves (Plate 6).

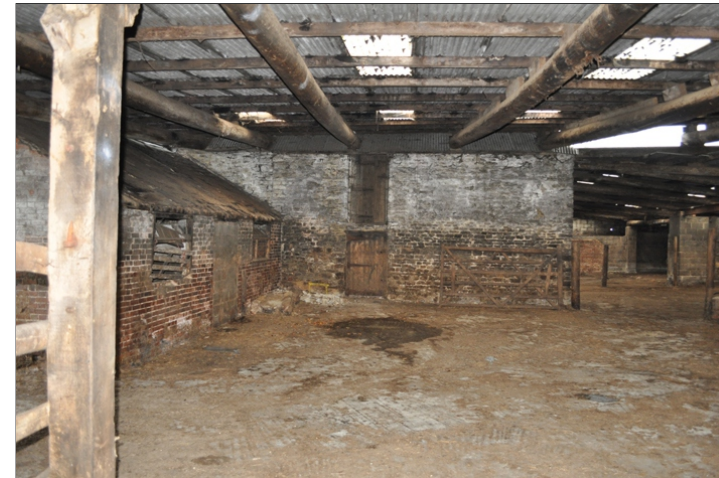
Plate 7. Building 2, east facade

The east wall (Fig.4 E2.2, Plate 7) of Component A is a limestone wall with a ground floor door and a hayloft door above. The lower storey looks as if it is a different build to that of the upper storey.

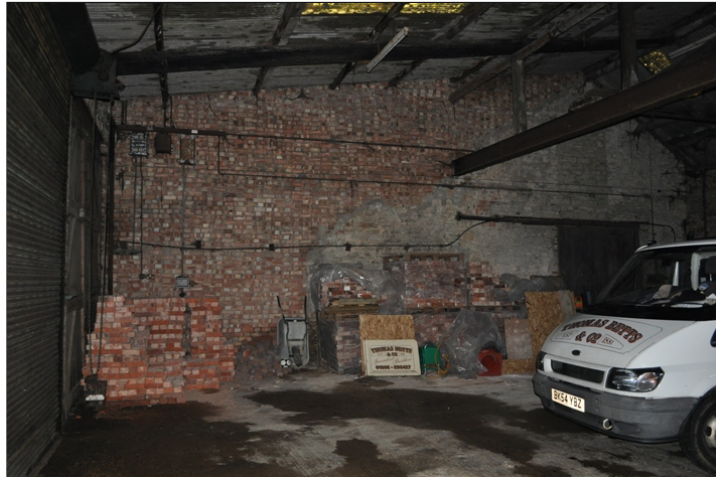
Plate 8. Building 2, Component B internal

Internally Component B is an open expanse with mainly brick internal walls (Plate 8), three large doors to the west and one large door to the east. The surviving stone walls can be seen on the north wall. In this there is a lower door and a blocked upper door. There are four windows set in the south wall and a single door into component A in the east part of the north wall. The roof is supported by RSJs.

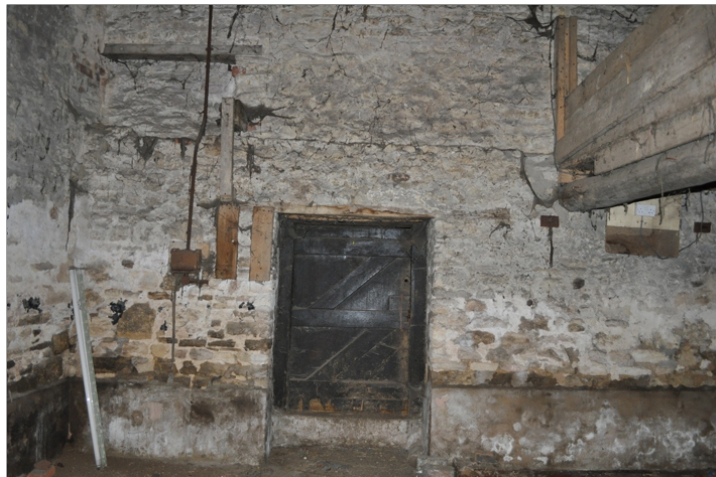
Plate 9. Building 2, Component A internal

Internally Component A has limestone walls which still contain whitewash (Plate 9). There is a concrete or mortar plinth around the lower part of the wall on the west, north and east walls. There is a single ground floor door in the west wall, two doors in the east wall, one ground floor and the other what would have been first floor. The stone wall of the west wall has two different widths suggesting the upper story is a later addition. There is a door in the south wall at ground level, this has brick quoining and looks like a later insertion. Above is a blocked doorway. A central timber (reused telegraph pole) supports a transverse beam that forms part of the hayloft at the north end of the building. None of this can be confirmed as being old. Above this is a roof truss which is formed by a king strut post. Though the design may be part of a traditional roof structure, the timbers have a newer appearance and may be replacements, either 19th century or even perhaps for the revamp of the barn in the 20th century (Plate 10).

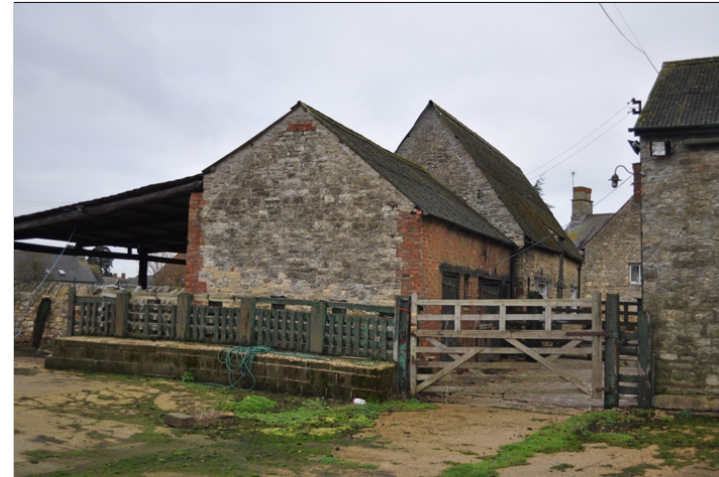
Plate 12. Building 4, north and east facade

The east gable is visible above the eastern Component; it contains signs of an earlier roof line (Fig.5 E4.3, Plate 12).

The south wall of the eastern Component was described above, but the other walls were not. The east wall (Fig.5 E4.3) is of limestone rubble but with brick quoining. The gable is not as steep as the western Component (Plate 12).

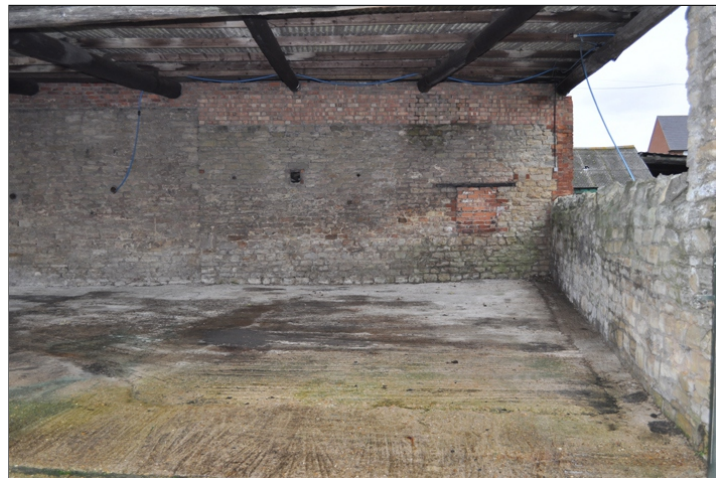
Plate 13. Building 4, south facade

The south facades of both the eastern and western Components are of limestone rubble (Fig.5 E4.2, Plate 13). There is a butt joint presumably where the eastern Component is added to the western Component. The eastern Component has a bricked up window and brick quoining. The upper part of the wall has been raised by brick coursings all the way along so that a modern lean-to structure using telegraph poles can be added.

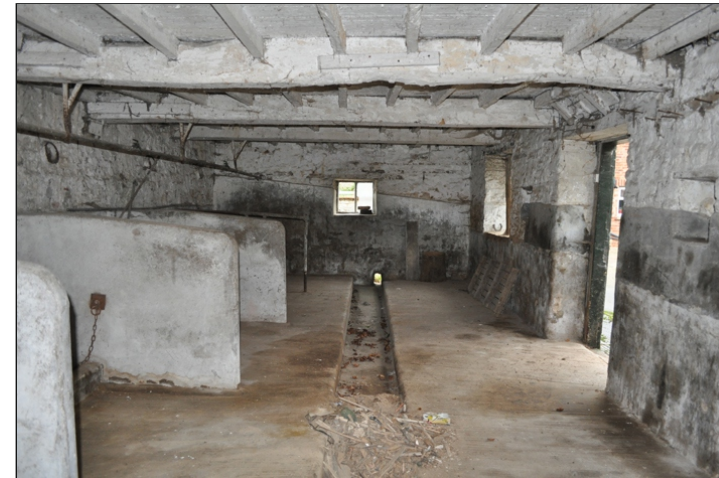
Plate 14. Building 4, west component ground floor

The ground floor of the western Component internally has a concrete/cement floor with central drainage channel and low partitions (Plate 14). The outlet on the drainage channel contained the remains of blue engineering bricks which indicates the internal features are post 1850, possibly as late as the 20th century. The lower part of the wall is rendered and the upper part lime washed. Some of the ceiling beams contain evidence of chamfering and of being cut from irregular sized timbers, the joists appear square cut with no chamfering, but have no sign of sawing. They could be contemporary.

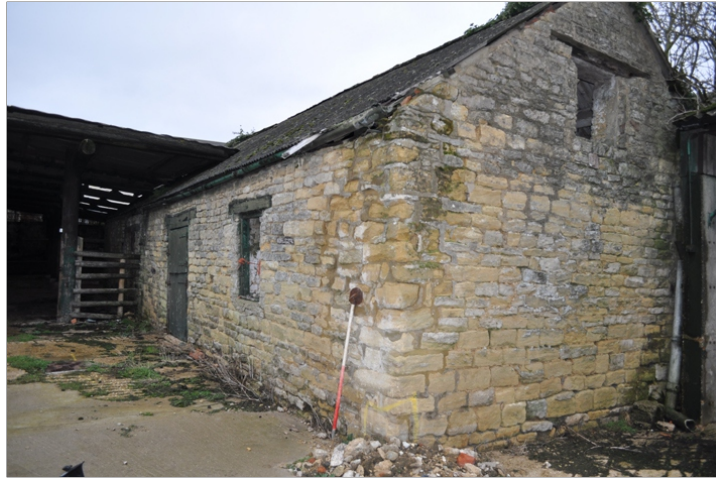
Plate 19. Building 3, south and west facade

Building 3 is a linear rectangular building constructed of limestone. The south façade is a gable wall with a small opening with lintel in the gable (Fig.6 E3.4, Plate 19).

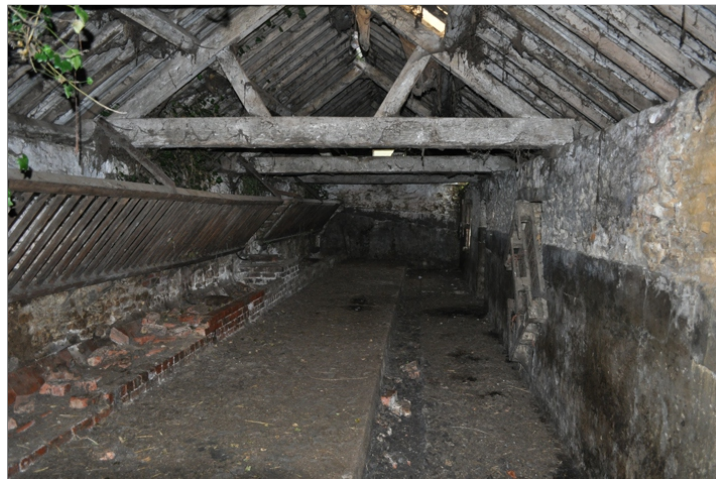
Plate 20. Building 3, internal

Internally the east wall contains feeding stalls with brick bases (Plate 20). The floor has been concreted or cemented, and this has been extended half way up the walls. The roof contains three original timber principle rafter trusses with raking strut.
