**BUILDING RECORDING**  
**AT**  
**HILLSIDE COTTAGE,**  
**CHURCH HILL, FOREST HILL**  
**NGR SP 58202 07451**

**AUGUST 2010**

**JMHS Project No:** 2293

### *Building Recording*

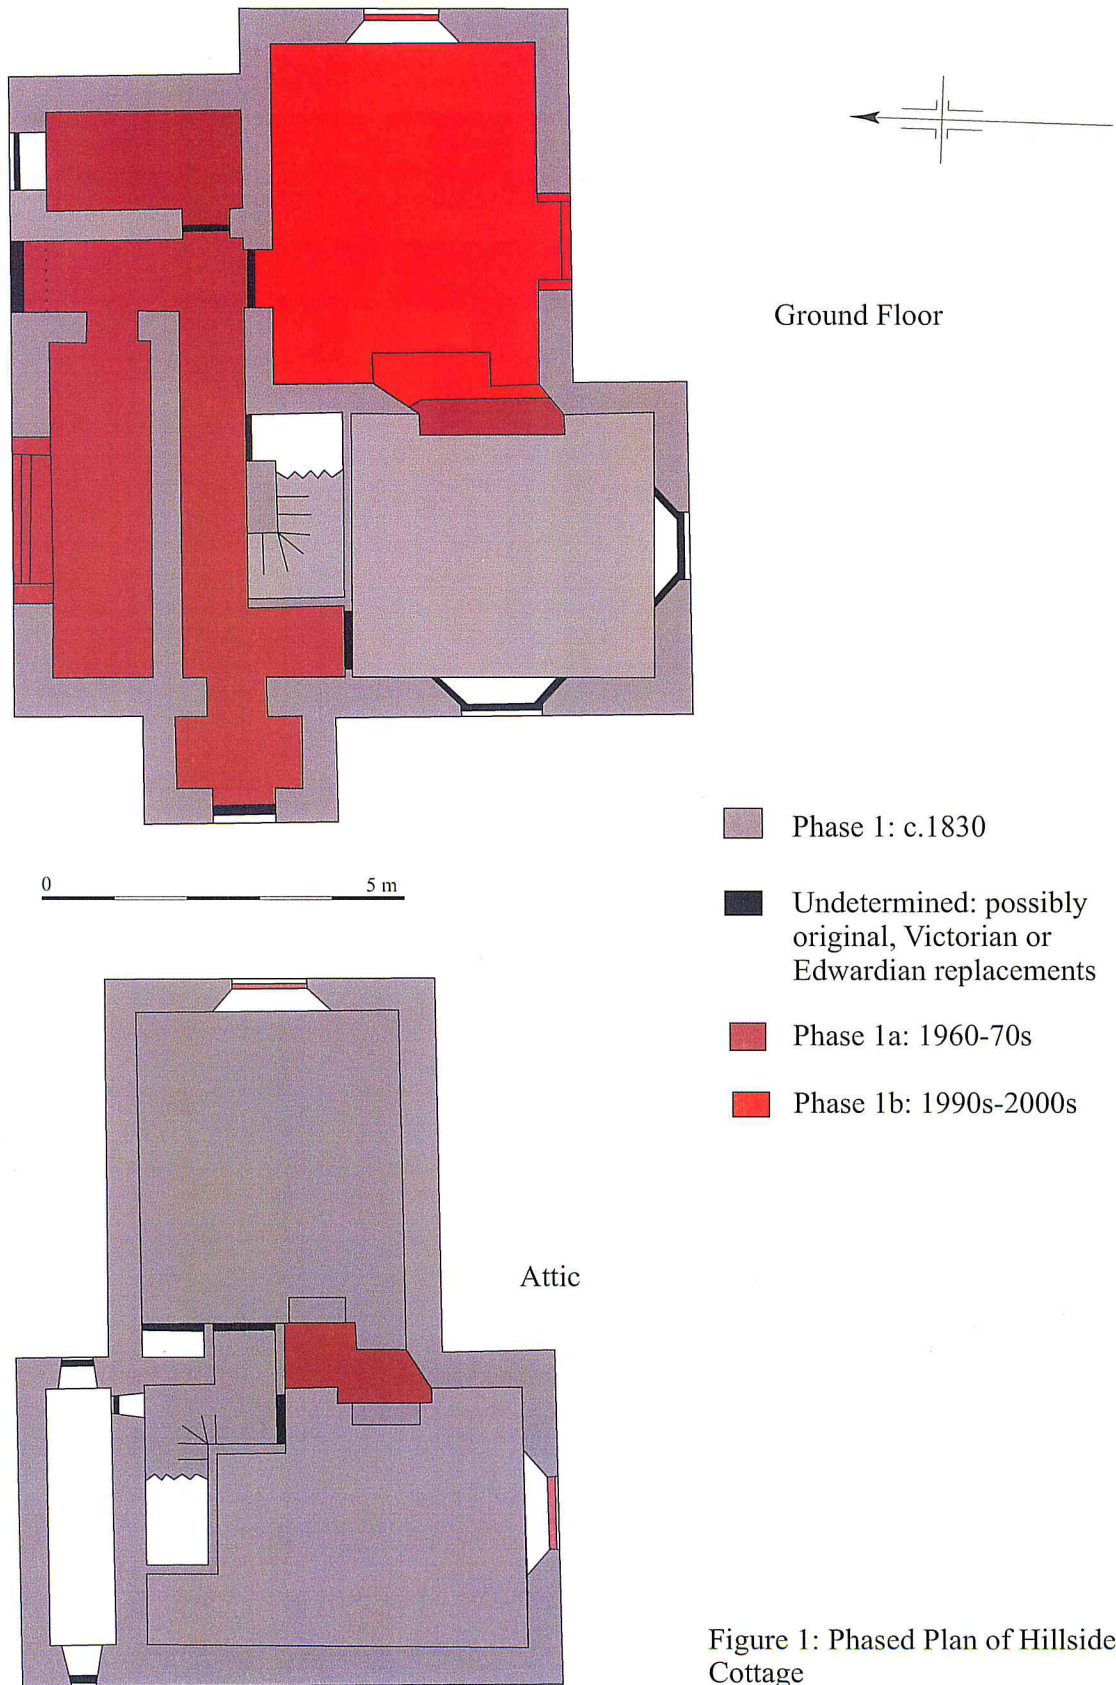
Figure 1: Phased Plan of Hillside Cottage

- 4.1.1 The building has one major phase with numerous sub-phases (see figure 1). The recognisable sub-phases are principally two, which probably took place in the 1960s-1970s, and the other in the 1990s-2000s. There were probably some alterations prior to this but they are more in keeping with the original building.

- 4.1.3 Phase 1a saw the insertion of windows in the 1960s-70s, which included the bedroom windows, the kitchen window, and presumably the concrete flooring in the kitchen bathroom and hall. The bathroom and kitchen were probably refurbished at this time.

- 4.1.4 Phase 1b covers the alterations from the 1990s-2000s, which saw the insertion of the PVC windows in the back sitting room and the general refurbishment of this room including the fireplace and lighting, presumably the concrete floor at this time.

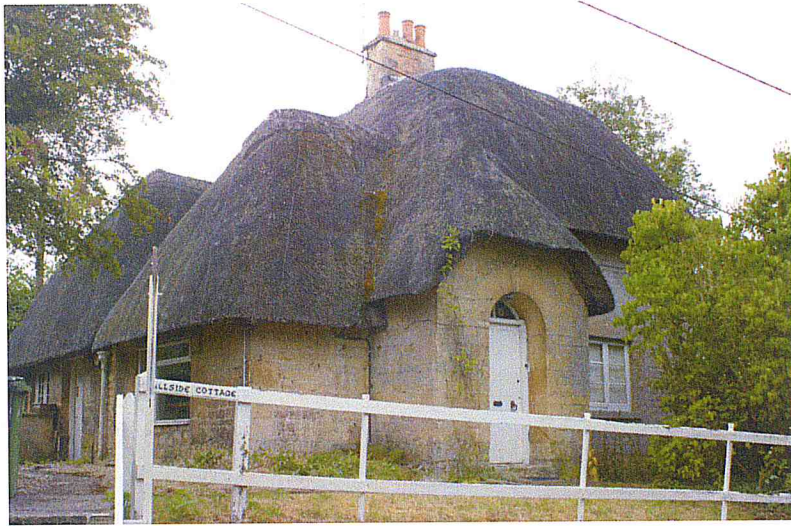
- 3.1.1 The building faces west and is constructed of squared limestone blocks with ashlar dressing. The rooves are thatched.
- 3.1.2 The north façade (see plate 1) shows a single storey structure with an attic to the west with a single window on the ground floor with a stone lintel and sill. The whole south part of this façade stands on a plinth or stylobate. To the right is a porch with a round arch. This has a round-arched doorway containing a 4-panel door with an over light. There is a window in the south side of the porch. The roof is thatched with a half hipped design above the door. A window is located in the south side of the porch. None of these have been described as being re-cased.

Plate 1: The north elevation of Hillside Cottage.

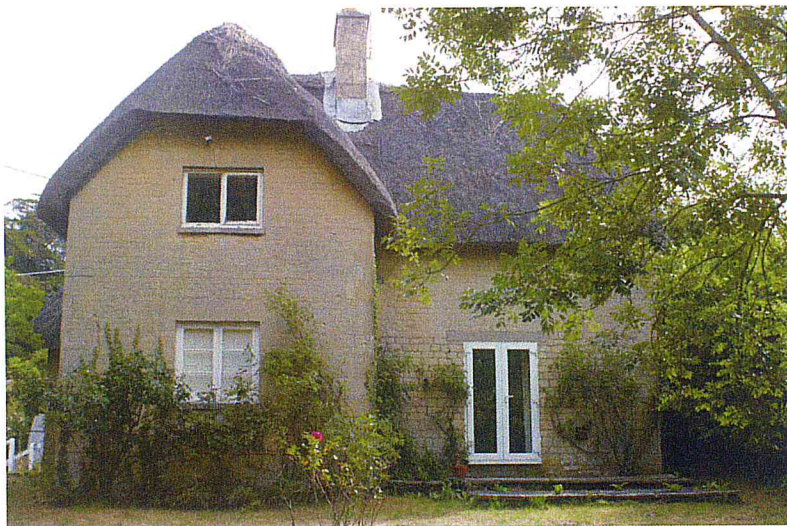
- 3.1.3 The west elevation (see plate 2) contains a gable end on its west side with half hipped roof and two windows that have (according to English Heritage) been re-cased under original flat stone lintels and stone sills. The upper is certainly re-cased the bottom is less certain without further research. The plinth or stylobate continues around this part of the building. The wall on the east side of the south elevation has a patio door inserted on the ground floor with a side attic wall above. The patio doors are PVC with a concrete lintel, the walls either side are re-pointed, and some parts re-built.

Plate 2: The west elevation of Hillside Cottage.

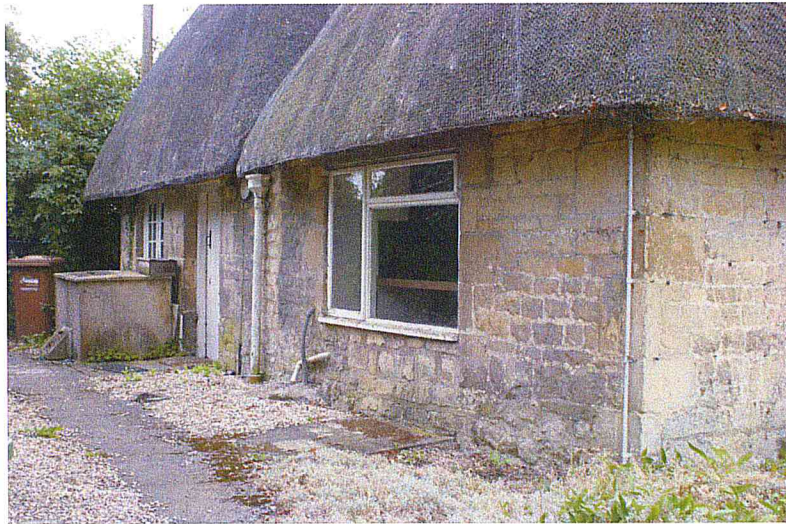
- 3.1.5 The east façade (see plates 3, 5, and 6) of the building is single story. The window on the west side (kitchen) has been enlarged and reset and is not original. The door is in an original location as is the window to its east (both may be original but the window is ether re-pointed around or reset). The door is a planked door with ledge or batten. The roof on the single storey is constructed of two hipped gables. The wall behind the drainage has either been rebuilt or more likely re-pointed.

Plate 3: The east elevation of Hillside Cottage.

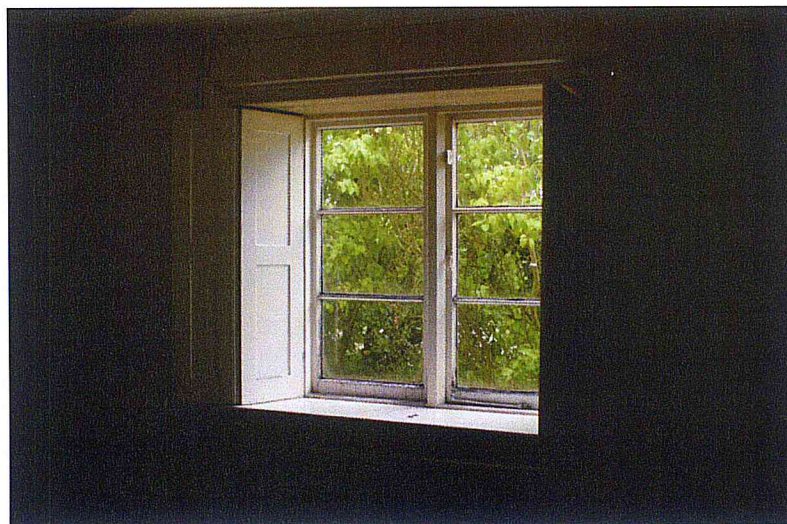
Plate 4: The north window, front sitting room, showing wooden shutters.

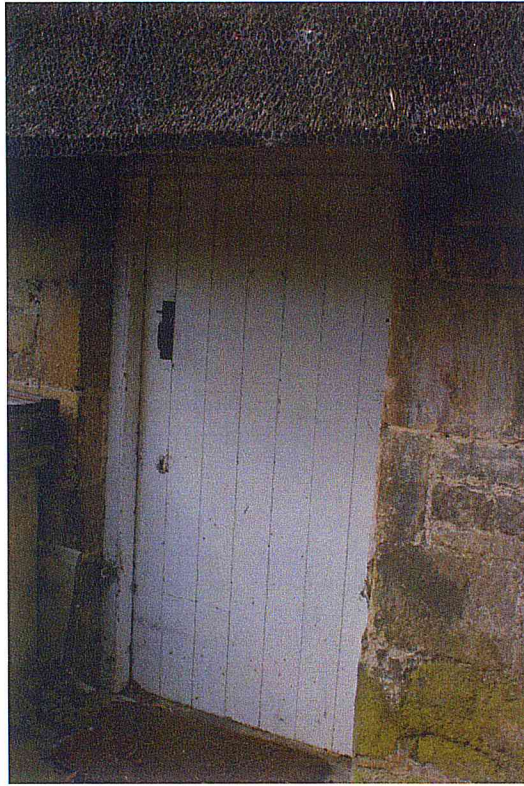
Plate 5: The plank and batten back door with Suffolk Latch

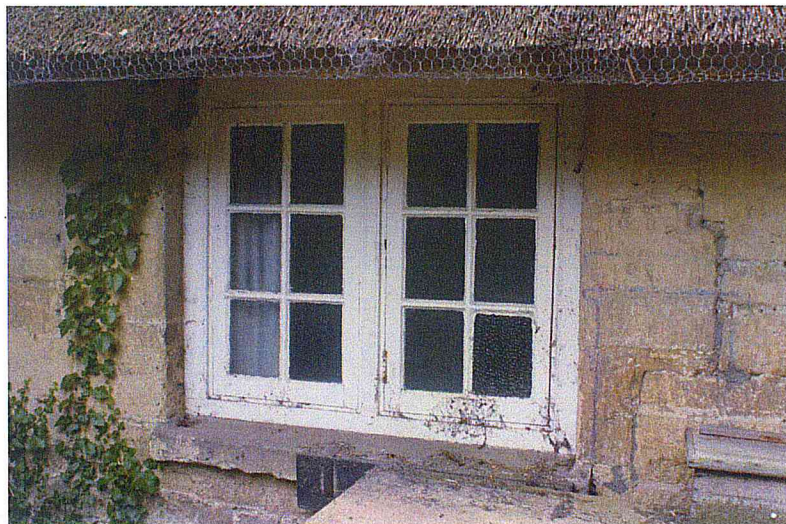
Plate 6: The bathroom window which has possibly been reset.
