# JOHN MOORE HERITAGE SERVICES

# RYCOTE WOOD COLLEGE,

HISTORIC BUILDING RECORD

**OCTOBER 2004**

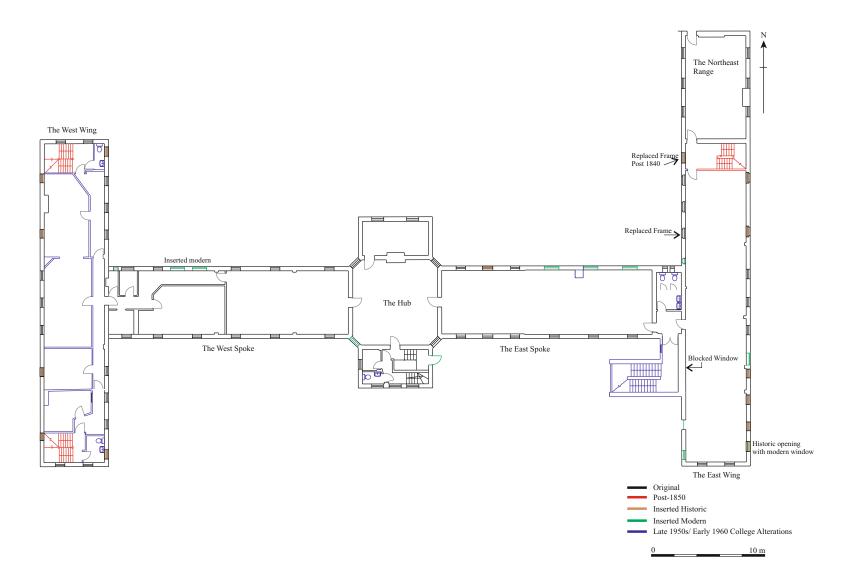
On the eastern elevation at first floor level there is an inserted window (Fig. 9). The window is on an odd alignment above the doorway (Plate 35) and has been inserted into an opening cut through the brick building fabric: there are cement rendered sides and odd sized bricks where regular closers are usually found. The three remaining windows on this elevation are original and *in situ* Type 2 windows.
