JOHN MOORE HERITAGE SERVICES

BUILDING ASSESSMENT

THE PERCH,

BINSEY, OXFORD

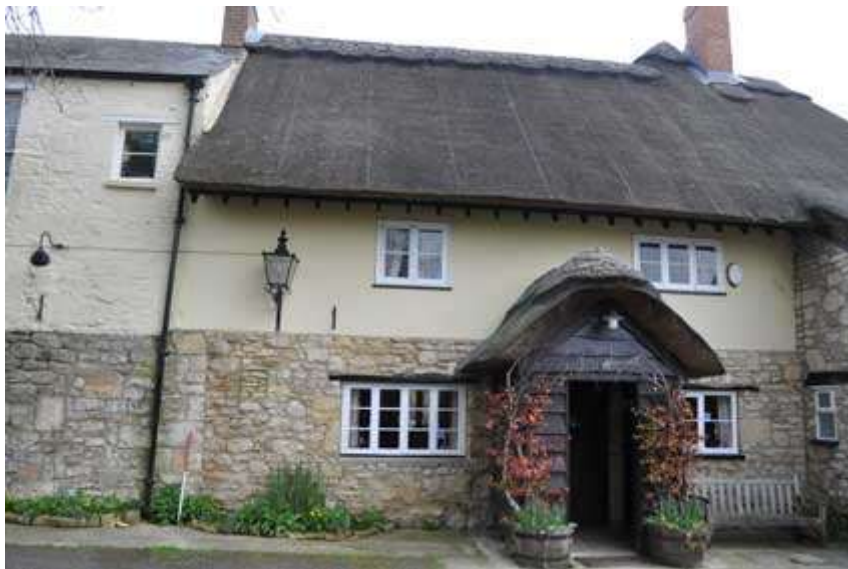
Plate 1 Old southwest façade

The main façade is the southwest one (Fig. 9 E1), which has at its centre a two story unit with central door with timber porch clad in weatherboard, flanked by windows in the ground floor and the first floor (plate 1). The ground floor wall is of limestone rubble, while the upper wall is rendered and coated in pale yellow wash. The main door is a panel door of a more recent origin. The window to the left of the door has

three mullions creating with four lights divided into three. The window above this has one mullion with each window divided into two. Both windows on the left hand side of the door have two mullions with each of the windows divided in two. The roof above this façade is of thatch. On the north side of this central arrangement there is evidence of a staggered butt joint and an adjacent small square infilled with limestone rubble.

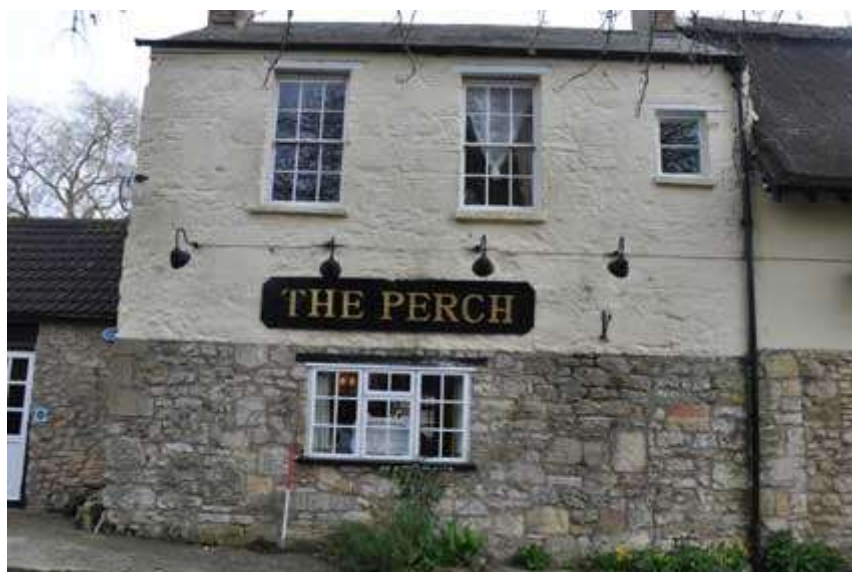
Plate 2 Northern extension southwest façade

On the northern part of the elevation, the elevation is higher (plate 2). The ground floor wall is also made of limestone rubble, while the upper wall is made of limestone and brick infill. The ground floor contains one window with a timber lintel. The window on the ground floor has two mullions in its casement. The first floor has a higher wall elevation than that adjacent, and has three windows; the central and northern windows are sash windows with timber lintels. The southern window is smaller with two lights, and timber lintel, but has been rebuilt around in brick, suggestive of the window size being reduced. The roof above is of slate and shallowly pitched. There are brick chimneys at either end. To the north of this is a single storey extension with a central patio door and a tile roof.

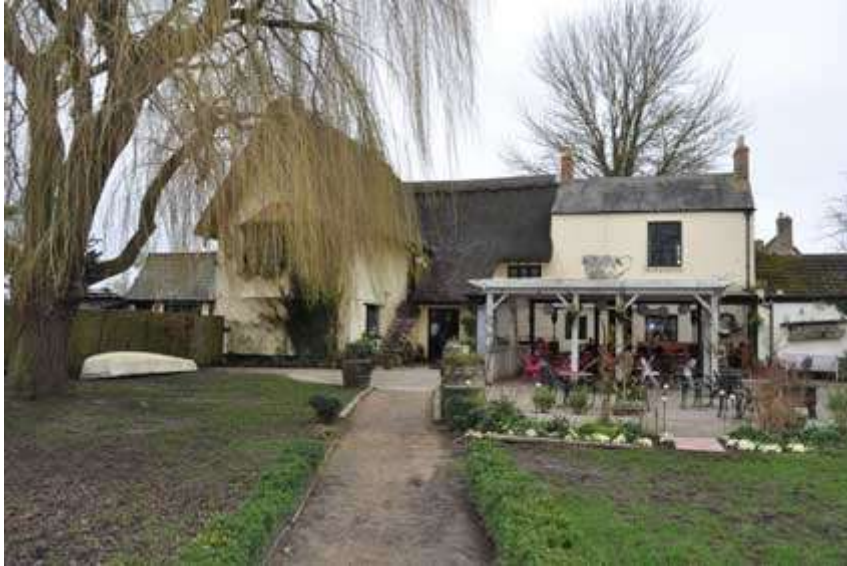
Plate 3 Rear or northeast side of the Perch

The northeast façade of the main range has a double door under the thatch of a lean-to porch, with a stairs to the left (Fig. 10 E3, plate 3). The wall to the north is mainly of brick, although some rubble limestone walling is evident. It has a central door with glass panels, and windows either side. The one on the right has a central mullion, and there is a sash window above also with a timber lintel. Above the window to the left of the door there is an offset window with two mullions set under the lower thatched eaves. The roof above the sash window is a slate roof with a gentler pitch.

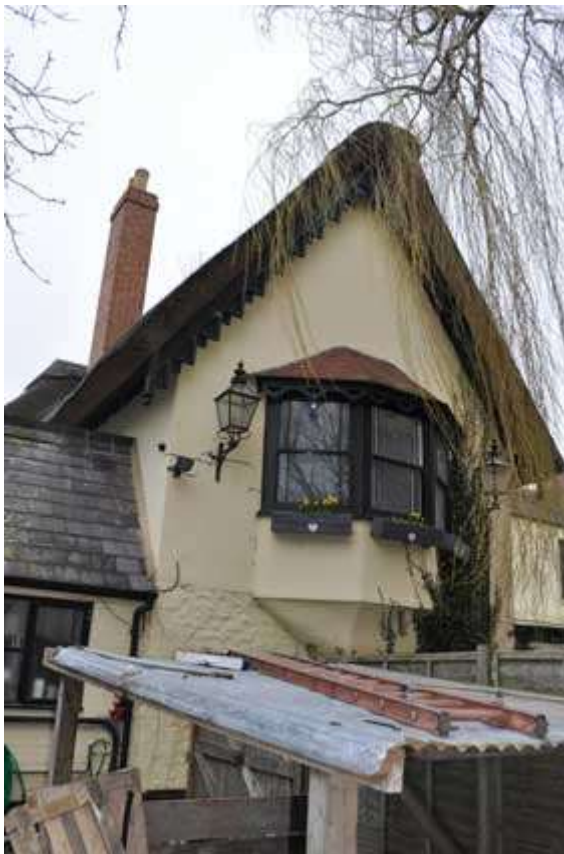
Plate 4 Oriole window

The south part of the northeast elevation consists of a gable end with a ground floor rubble limestone wall, which has been washed (plate 4). Above this the walls are rendered. The wall is dominated by an oriole bay window with sash windows, and the gable has a decorative fascia with step type pattern and a steep pitch, perhaps imitating a Swiss chalet style. There is an extension on the south side of this gable with a steeply pitched slate roof. The wall is of brick and has a glass panel door on the left and a window with two mullions on the right.

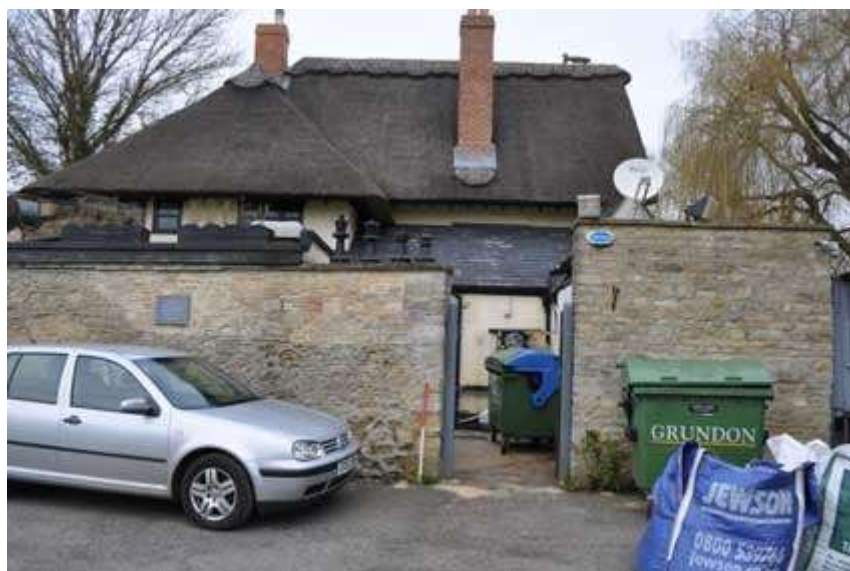
Plate 5 Southeast facade

The east part of the southeast façade has a rubble limestone wall below the main elevation in which there is a gate, which leads into a small courtyard (Fig. 10 E4, plate 5). On the north side of the courtyard there is a brick structure with a slate roof, and window below. The west wall of the courtyard is breezeblock and contains a modern panel door. On the east side is a refrigeration unit that is set under a small brick gable. The wall above the lean-to is blank, the roof above this is thatched and there is a lateral chimney. There is a fish shape created as a decoration on the ridge of the thatch, presumably supposed to represent the perch. The remains of a hipped and thatched gable can be identified on the west side, which contains three windows, a larger two mullioned window on the east side and two smaller identical windows on the west side. To the west of the rubble limestone walls and thatched hipped gable there is a rubble limestone lean-to.

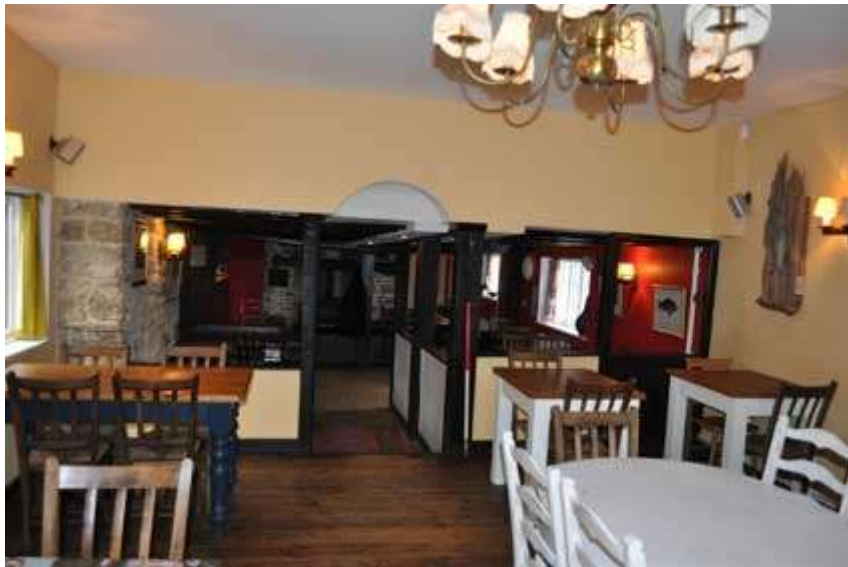
Plate 6 G1-G2 the removed wall

The front door, with a weatherboard porch, enters into a long room (Fig. 7, G1-2) which has been created with the removal of a wall and fireplace (plate 6). The room has two different levels with the north end being approached by steps. The lower southern part is larger (G1). The walls above must now be supported by RSJs. Timber framing has been inserted into the gap; presumably this is of a new date. There is a large fireplace with timber lintel at the south end, which contains a wood burner (plate 7). There is a central support running axially to the building, what is underneath part of this is not known, but presumably there was originally a timber here; part of a timber survives with cut for headroom and there is a central timber support (plate 8). The joists are roughly chamfered and may be early. The floor is of limestone slabs. In the

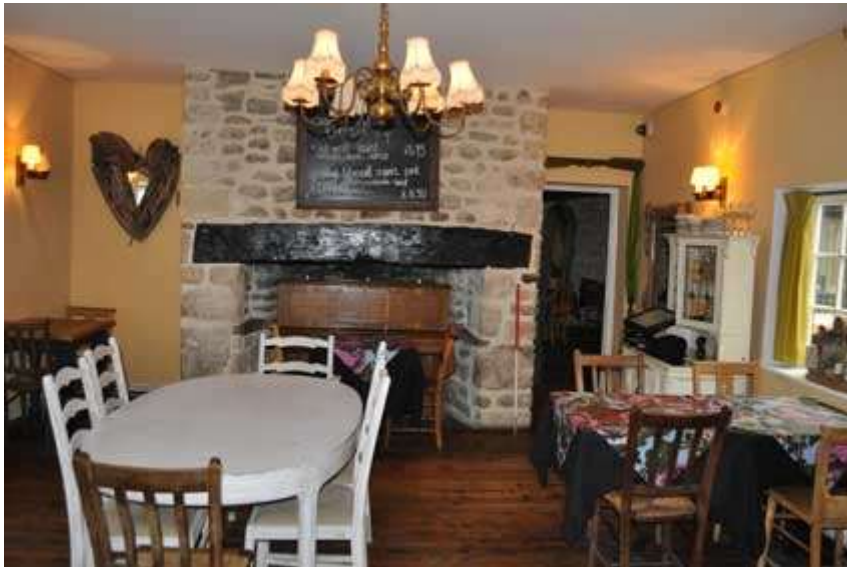
Plate 9 G2 fireplace

The raised area to the north (G2) has a timber floor and a fireplace in north wall (plate 9). In the west wall there is a single window with a timber lintel, and in the east wall a glass panel door with windows flanking to the left and right. There is a door to the right side of the fireplace.

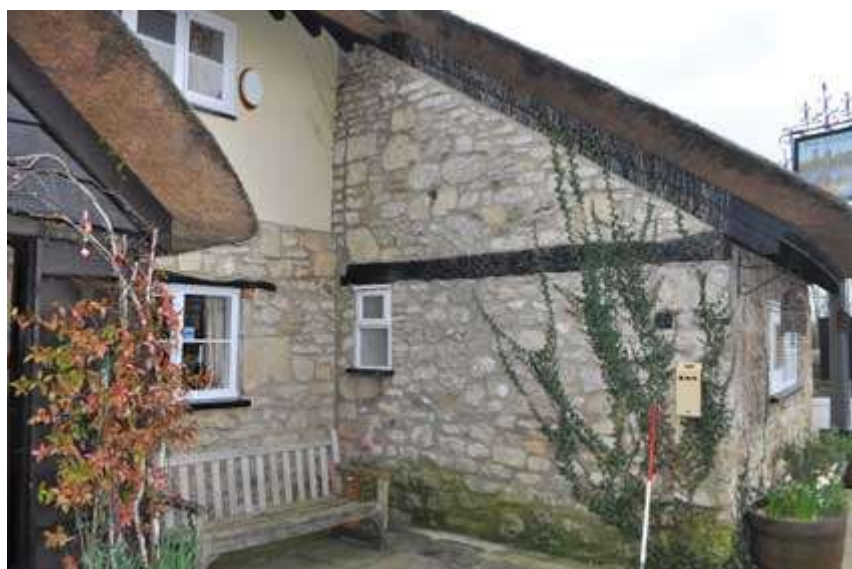
Plate 12 Butt joints of Phase 3

The next addition (phases 3a and 3b) saw the rebuilding in stone rubble of the southern unit which was capped by the hipped gable (plate 12). In the front of the building there is the remains of a butt joint in the wall that runs in height to roughly midway up the first floor windows in the old central range. Though it is not overly clear it is likely that the lower rubble walls of the south extension were rebuilt with the butt joint probably marking the height of the original eaves of the structure. The butt joints position implies that the old three cell structure once had eye lid dormer windows. The rubble lower walls of the wing were added at some unknown date, at present this is being added as part of phase 3a, due to the fact that we have no better knowledge. It can be noted that the walls of these structures lie at slightly different alignments, perhaps implying that there are two clear phases here. The addition of the lean-to on the southwest was also probably added as phase 3b, also probably in the 17th century. Other country public houses of this date and plan can be recognised in Gloucestershire (pers. knowledge).

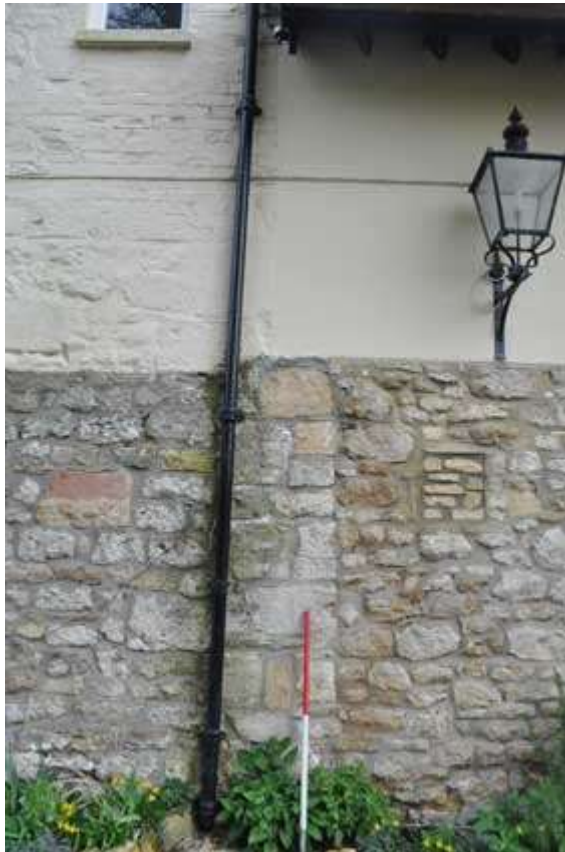
Plate 13 Butt joint for north extension

Phase 4 of the structure can be identified in some of the butt joints (plate 13). A stone extension was added on the north side (possibly single storey), which must have initially included the insertion of a chimney, or its partial rebuild, on the north side of

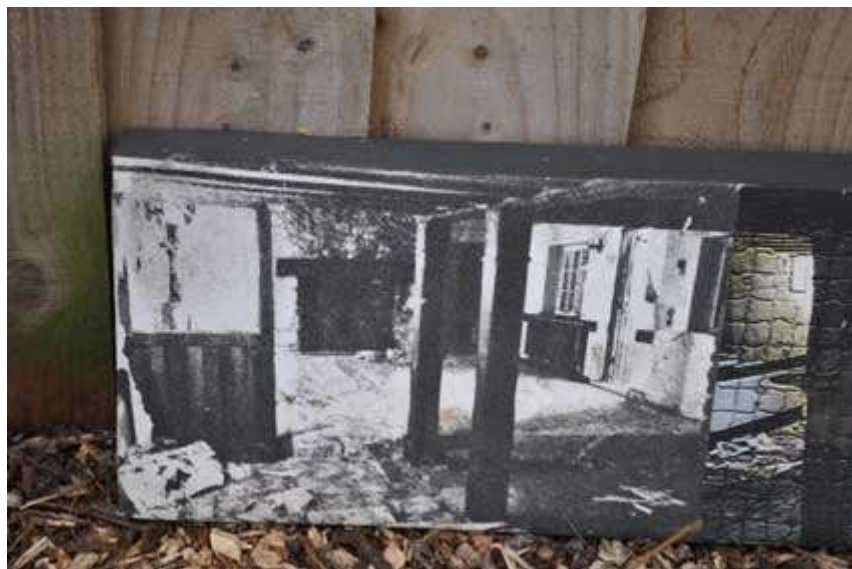
Plate 14 Picture of bar shown at same level or possibly a low step

The bar is to be re-located at a place where there is a split in the current floor levels. A wall has previously been removed here (pre-1977) that probably contained a fireplace

and other features. Any old timbers in this area have thus been moved and relocated. A photograph that survives showing the building after one of the fires at the public house, possibly 1977, shows that the floor layer in the rooms did continue through the bar area at one level or that there was previously only a slight step. It can, therefore, be shown that from the current proposal none or very little ancient fabric of the structure will be damaged. If the conservation officer believes this should be monitored and the uncovered features recorded, then this may need monitoring.
