HISTORIC BUILDING RECORDING

LOGG FARM

ODDINGTON, OXFORDSHIRE

JMHS Project No: 3311

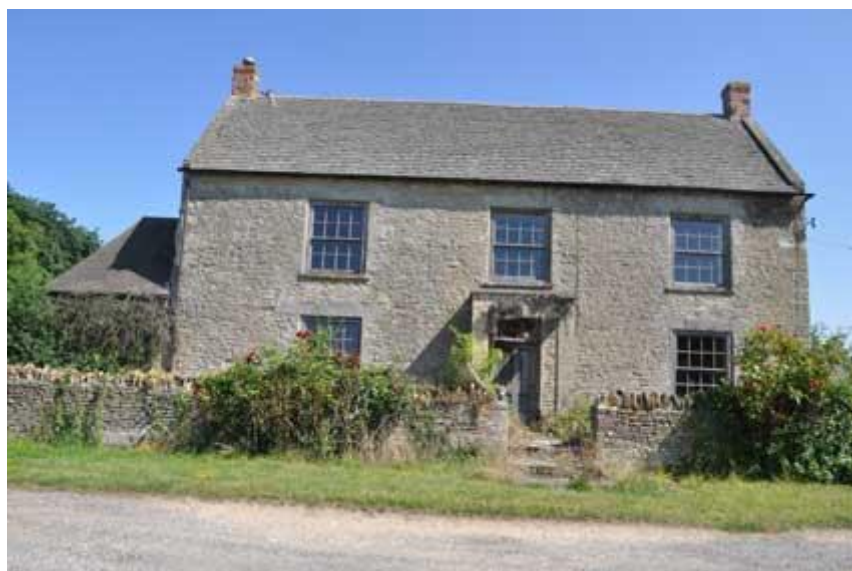
Plate 1 Front façade

The front façade contains a main range with three bays (Fig. 15, E3; plate 1). The central bay contains a door on the ground floor, which is an original panel door with window light above in a square headed arch. On the first floor there is a sash window with 16 lights in a square-headed arch. The square-headed arches all contain soldiered lintels. In-front of the door there is a porch with collapsed roof. The porch appears to have a more modern appearance, constructed of reconstituted blocks. Above this is a limestone slate roof with a steep pitch. At the end of each gable there is evidence of a parapet wall with capping stones. There are small brick chimneystacks located at either end of the roof.

To the left of the main part of the façade there is a ground floor extension, which is also constructed of rubble limestone. There is a bay window at the end and a hipped and steeply pitched roof above. Seen extending beyond this is a rear extension, which contains a rubble limestone wall with a panel door under a timber lintel on the ground floor. The roof has a gable end with a capped parapet wall.

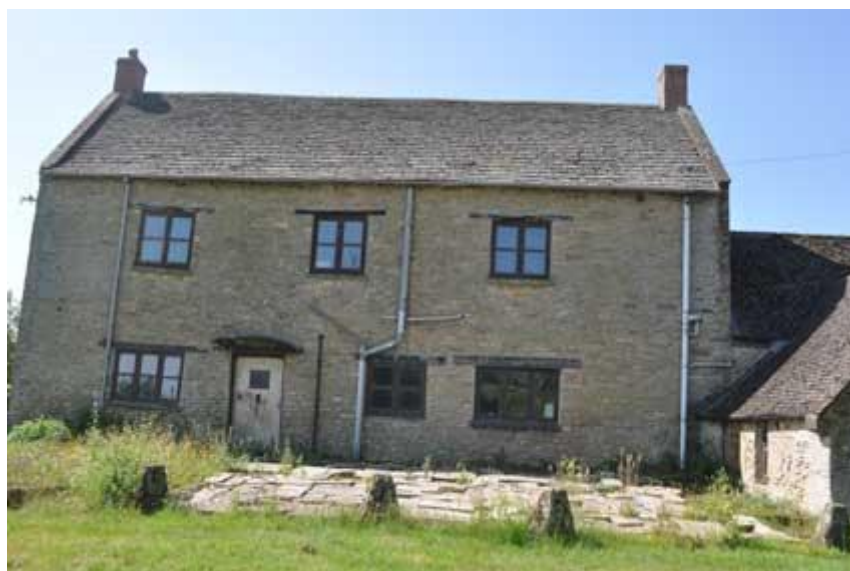
Plate 2 Rear façade

The rear façade contains the main block of the two storey house on the left hand side (Fig. 14, E1; plate 2). This contains an irregular arrangement of bays. On the ground floor there is a plank door to the left of centre, with a glass panel. To the left of this there is a window with six lights. On the right-hand side of the door there is a four light window set centrally and to the right of this there is a six light window. The first floor contains three windows in a more uniform arrangement with the windows of the front of the house. These windows contain four lights. The door and all of the windows are square-headed with timber lintels. Most if not all of the window casements look new. There are variations in the material used to make the sills, which include engineering bricks and stone.

On the right-hand side there is a ground floor extension with a parapet walled gable. Extending from this there is a further extension with a limestone rubble gable end with a parapet wall.

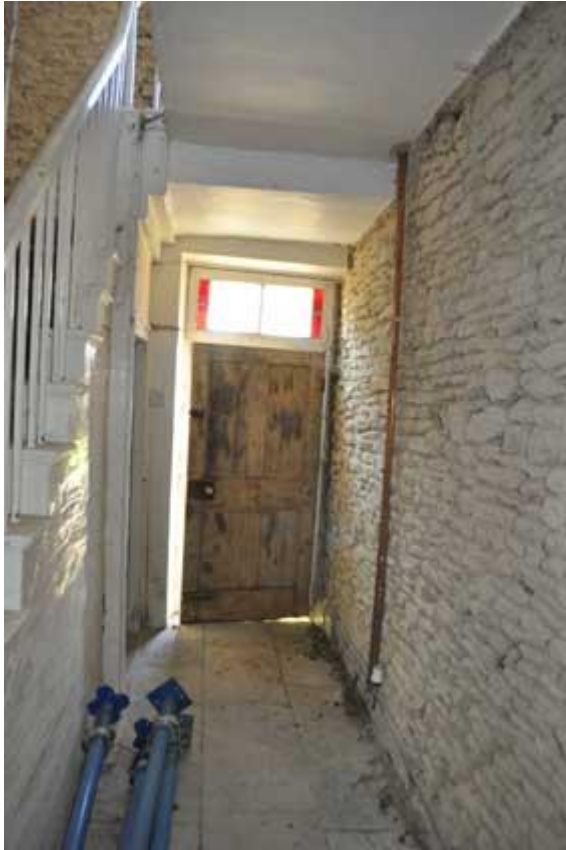
Plate 3 Internal view of front door

The panelled front door leads into an entrance hall (G1), (plate 3). Adjacent to it in the west wall of the hall there is evidence of a butt joint. There is a panel door in the west wall, and a further door in the north and east walls. The staircase has ramped handrail and turned balusters. The floor contains flagstones of various sizes, and the walls have been largely stripped of their plaster. Under the staircase there is a further plank door that gives access to a stone staircase. This leads into a room with stone floor and walls. There is a window in the east wall. The ceiling contains a transverse timber beam that is a partially chamfered timber trunk.

The following alterations will be made to the ground floor. In room G1, the entrance hall, this sees the replacement of the existing original door and window lights. This is an original feature and will have an impact on the heritage asset, both internally and externally. The staircase is to be refurbished. The plaster has already been removed from this room and the stonework is to be re-pointed.

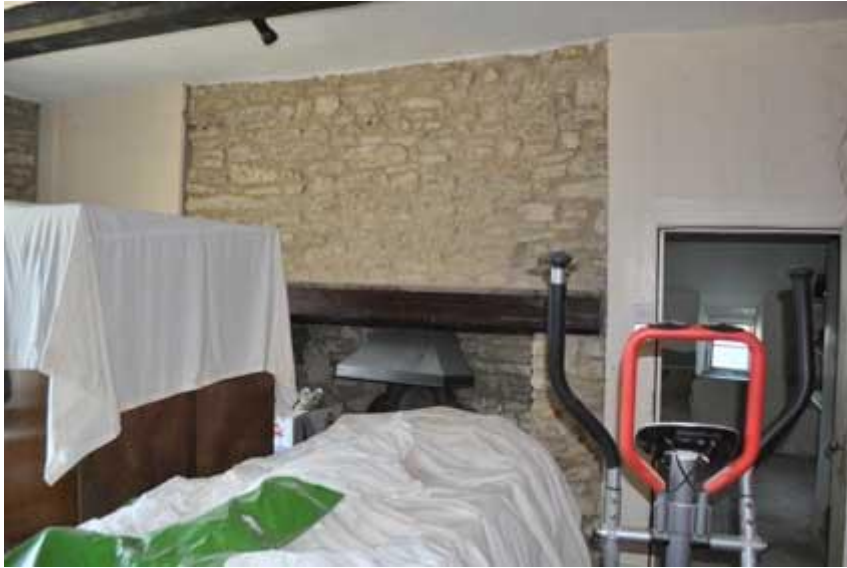
Plate 4 Panelled cupboards either side of fireplace (G3)

burner and a new timber lintel inserted (plate 4). Either side set in the alcoves are matching panelling with central doors. On the left-hand side of the fireplace the door is panelled and has a glazed upper section, it is possible that this door is a later replacement. The door on the right-hand side is panelled and with no glazing, it is probable that this one is original. There are two transverse beams in the ceiling, both of which are chamfered and with straight cut stops.

The sitting room (G3) is to see the original panel door into room G1 retained. The new door into room G7 is to be replaced. The existing panelling and doors in the alcove are to be retained. The alcove panelling is a common 18th century feature, so the basis of this

feature is part of the heritage asset; however, the glass panel door is a probable 19th century addition. The existing sash window is to be refurbished. The lime plaster has already been removed from three of the four walls, where the stone is exposed this will be re-pointed with lime mortar, on the other internal wall the lime plaster is to be retained. The flagstone floor is to be raised and relaid with under floor heating. The ceiling is to be repaired. In the fireplace a liner is to be installed and a new wood burner. The lintel on the fireplace is to be replaced, which is a large chamfered beam, but one that is highly worked and varnished and is not original. As a non original feature this will not have an effect on the heritage asset.

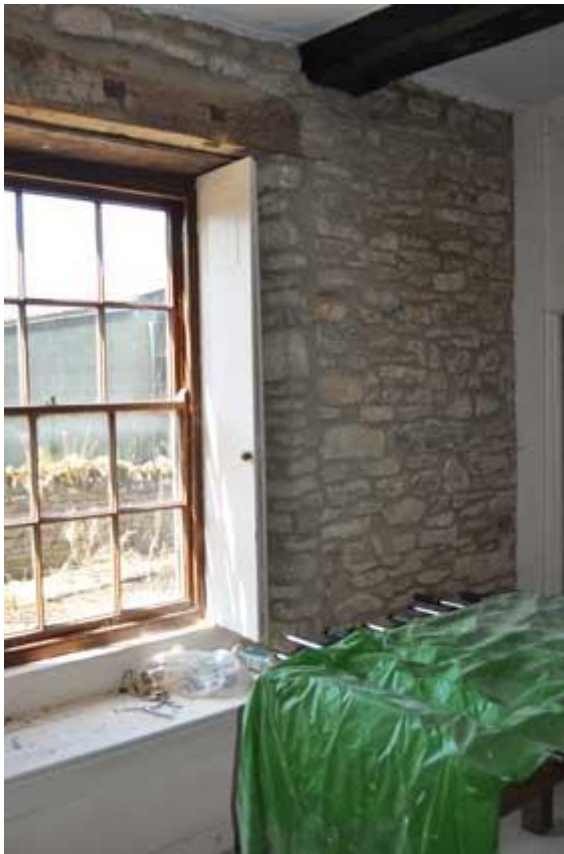
Plate 5 Window (G3)

The west panel door from the hall with original surround leads into a larger sitting room (G3) to the west of the hall. The north wall has surviving plaster, skirting and cornice rail, however, the other walls have been stripped of plaster and there are limestone flags on the floor. In the north wall there is a glass panelled door of a recent origin. In the south wall there is a sash window with wooden shutters. There are butt joints either side that appear to indicate that the window has possibly been reset or enlarged. The lintel above has either been reset or is indicative of their previously being a lower ceiling with common joist settings (plate 5). At the west end of the room there is a central fireplace with a cast-iron

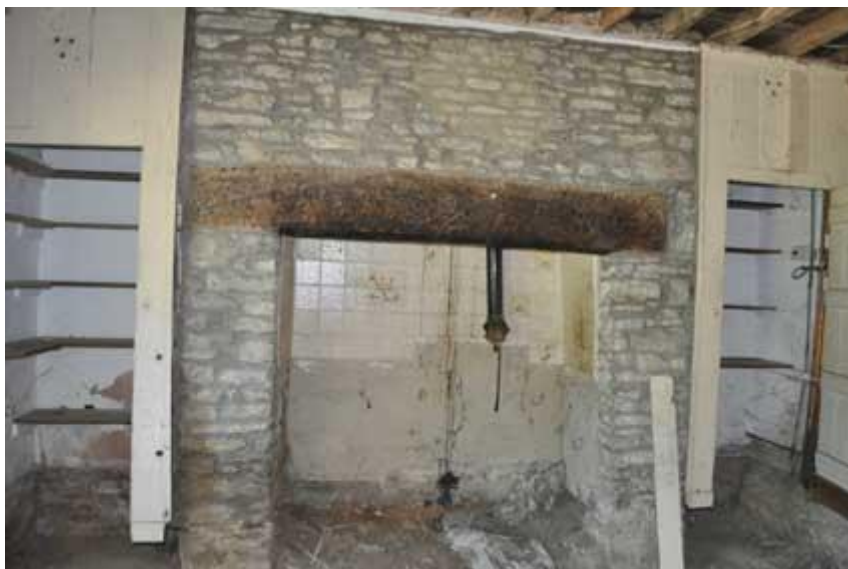
The north panel door from the entrance hall (G1) leads into the kitchen (G6). This is a rectangular room, almost square in design. In the east wall there is a large fireplace with a timber lintel with adze or axe marks, a steep chamfer and stop at its left-hand side. There was no stop on the right-hand side, but there were three dowel holes in the timber which were off-set to the right and may indicate that the lintel had been reduced in size with the removal of the right end. The fireplace is flanked by two areas of panelling that turn the alcoves either sides into cupboards (plate 6); both contain a plank door with internal shelving. In the north wall there is a window on the right-hand side and a door on the right. The door is one of a plank construction with a glass panel. In the ceiling there is a chamfered transverse beam. Adjacent to the west wall and located in the south wall there is the remains of a setting for a timber beam similar to the other. The beam has presumably been replaced by the insertion of the wall at a later date, as the wall contains butt joints at both ends.

Plate 6 Cupboard fittings either side of fireplace (G6)

The kitchen (G6) is to see the following alterations. The existing alcove cupboards are proposed to be replaced. These are matching alcove features which are features associated with 18th century structures; their loss is thus the loss of an original feature in this heritage asset. The external door with a lowered threshold is to be replaced. This again represents the loss of a probable original plank door, which will have an impact on the heritage asset. The chimney is to be cleaned and relined. Any lime plaster in this room has already been removed; the exposed stonework is to be re-pointed. The existing doors to rooms F1 and F7 are to be retained. Localised repairs to the transverse beam in the ceiling. The dirt floor to a large extent has already been partially removed, which is to be replaced by a limecrete feature with under floor heating. The removal of the floor has exposed part of an under floor hypocaust associated with the original construction. Thus this activity may have a further impact on the heritage asset.

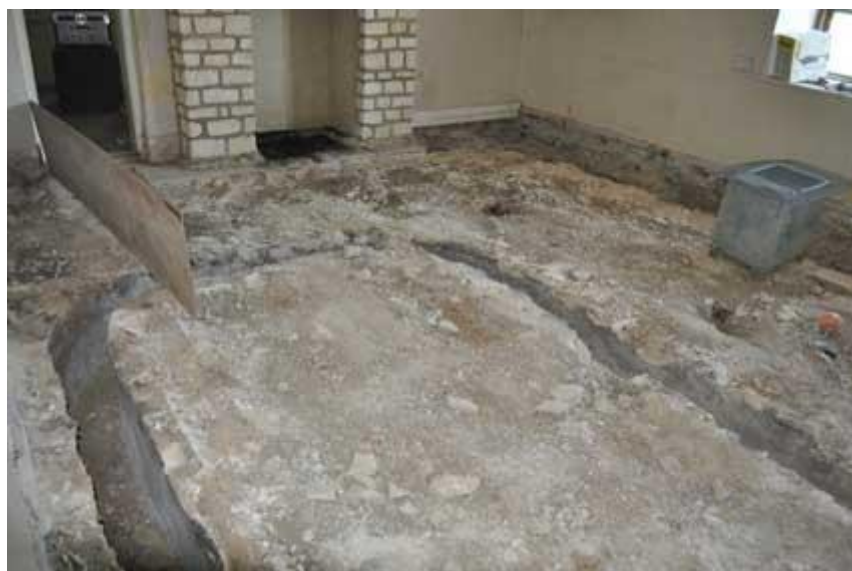
The panel door in the west wall of the kitchen (G6) leads into the Dairy (G7). This room has a fireplace in its west wall. The fireplace was smaller than all of the others in the building and the chimneybreast narrower. There has been a modern addition on the front with a new bowed lintel, this covers up an earlier lintel. A doorway is located to the left-hand side of the chimneybreast. There are two windows in the north wall, one with four lights and the other with six; both look as if they are newer replacements. In the ceiling there are two transverse beams, the west one has stops at both ends, while the east one of the two has stops only at its north end. A door in the south wall is a modern glass panel door, which leads into the sitting room. The floor was constructed of limestone flagstones, under which there are the remains of a hypocaust channel with plastered side walls (plate 7).

Plate 7 Hypocaust under floor of the dairy (G7)

The dairy (G7) will see structural repairs to the ceiling. The existing windows, which are not original, probably 20th century, are to be retained. The flagstone floor has already been removed; it is to be relaid with under floor heating. The door to room G6 will be retained, the new door to G3 will be replaced, and the door into room G8 will be replaced. The door into room G8 is if not original an early narrow depth door of the period. A new wood burner is to be inserted into the fireplace.

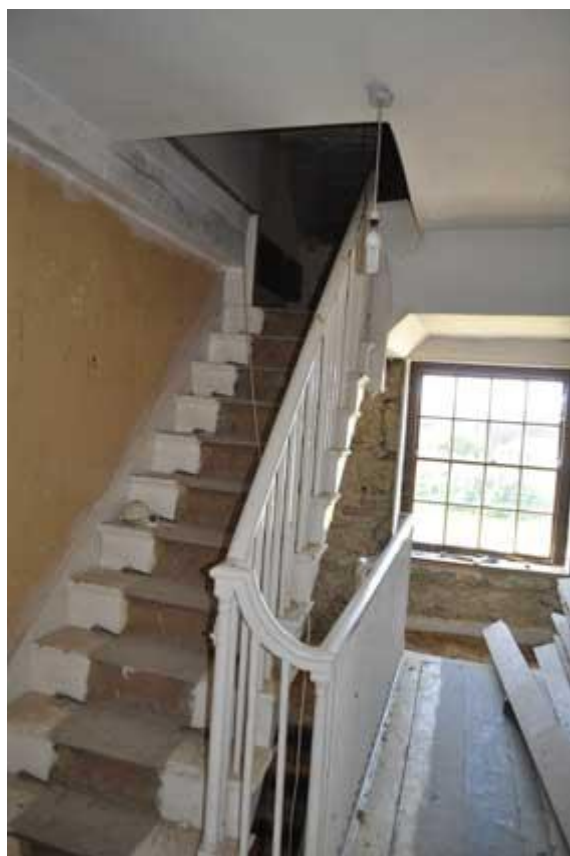
Plate 8 Stairs on landing (F1)

The stairs in the Entrance Hall (G1) ascend to the First Floor Landing (F1). Either side of the stairs the walls have been stripped to reveal timber framed walls that would have contained a lathe and plaster finish. The timbers are evidently sawn. There are panelled doors in the east and west walls and a sash window with 12 panes. In the north wall there is an opening through a stone wall. This opens up into an east west passage with a door at either end. There is a door facing in the north wall, which has been partially removed to uncover a timber framed wall. There is a transverse beam, which may be a replacement as the timber framing has been cut to incorporate the new beam. The doors are predominantly panelled and contain L-shaped hinges, which are seen as a 17th century characteristic.

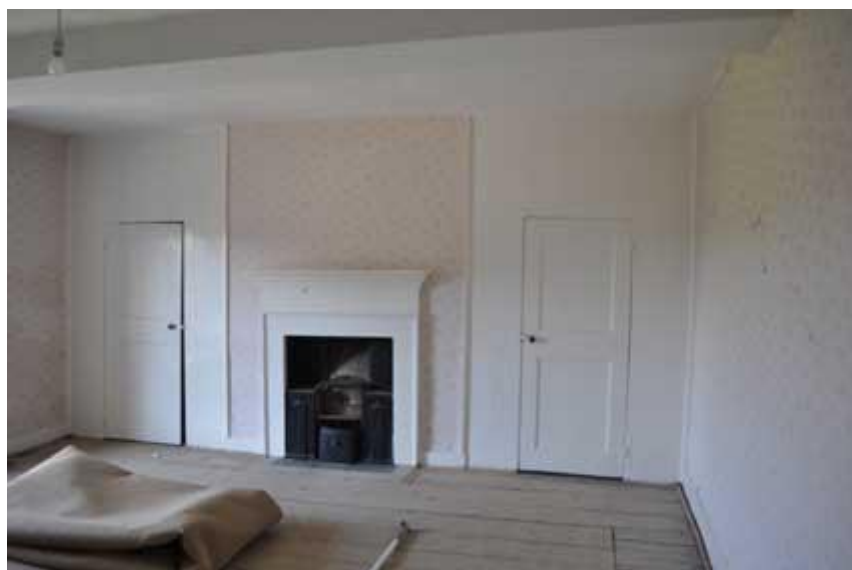
Plate 9 Room (F7) fireplace and cupboards

Alterations that will impact on bedroom (F7) include the removal of part of the wall between this room and F5 as previously mentioned. Repairs are to be made to cupboard or wardrobe doors set in the alcoves either side of the fireplace. A new downpipe is to be inserted, hidden in one of the cupboards. The window is to be refurbished.

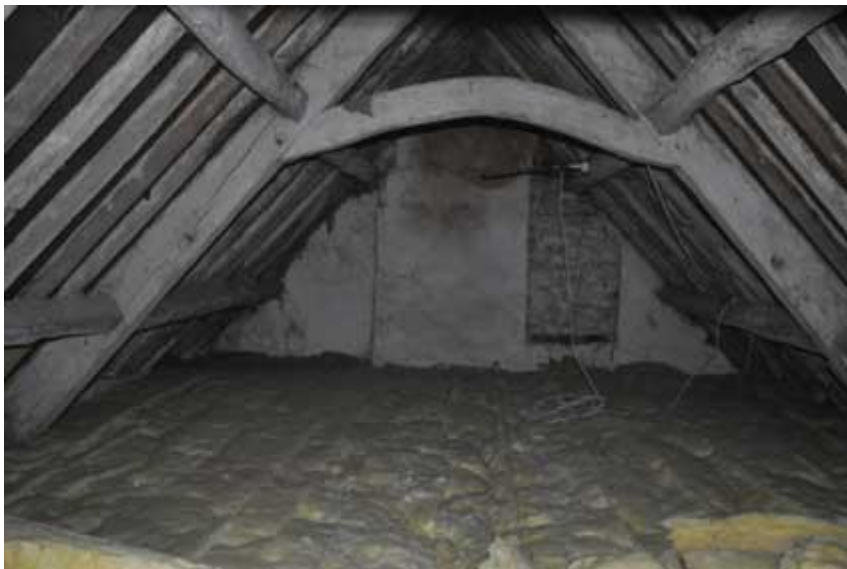
Plate 10 Bowed cross beam (A5)

The final attic room (A5) is the largest of the spaces of the landing. Floorboards do exist but have been covered with insulation. In the west wall there is evidence of a chimneybreast and alongside it on the right-hand side the remains of a blocked window. This window was blocked so that the chimney from the 19th century addition could be

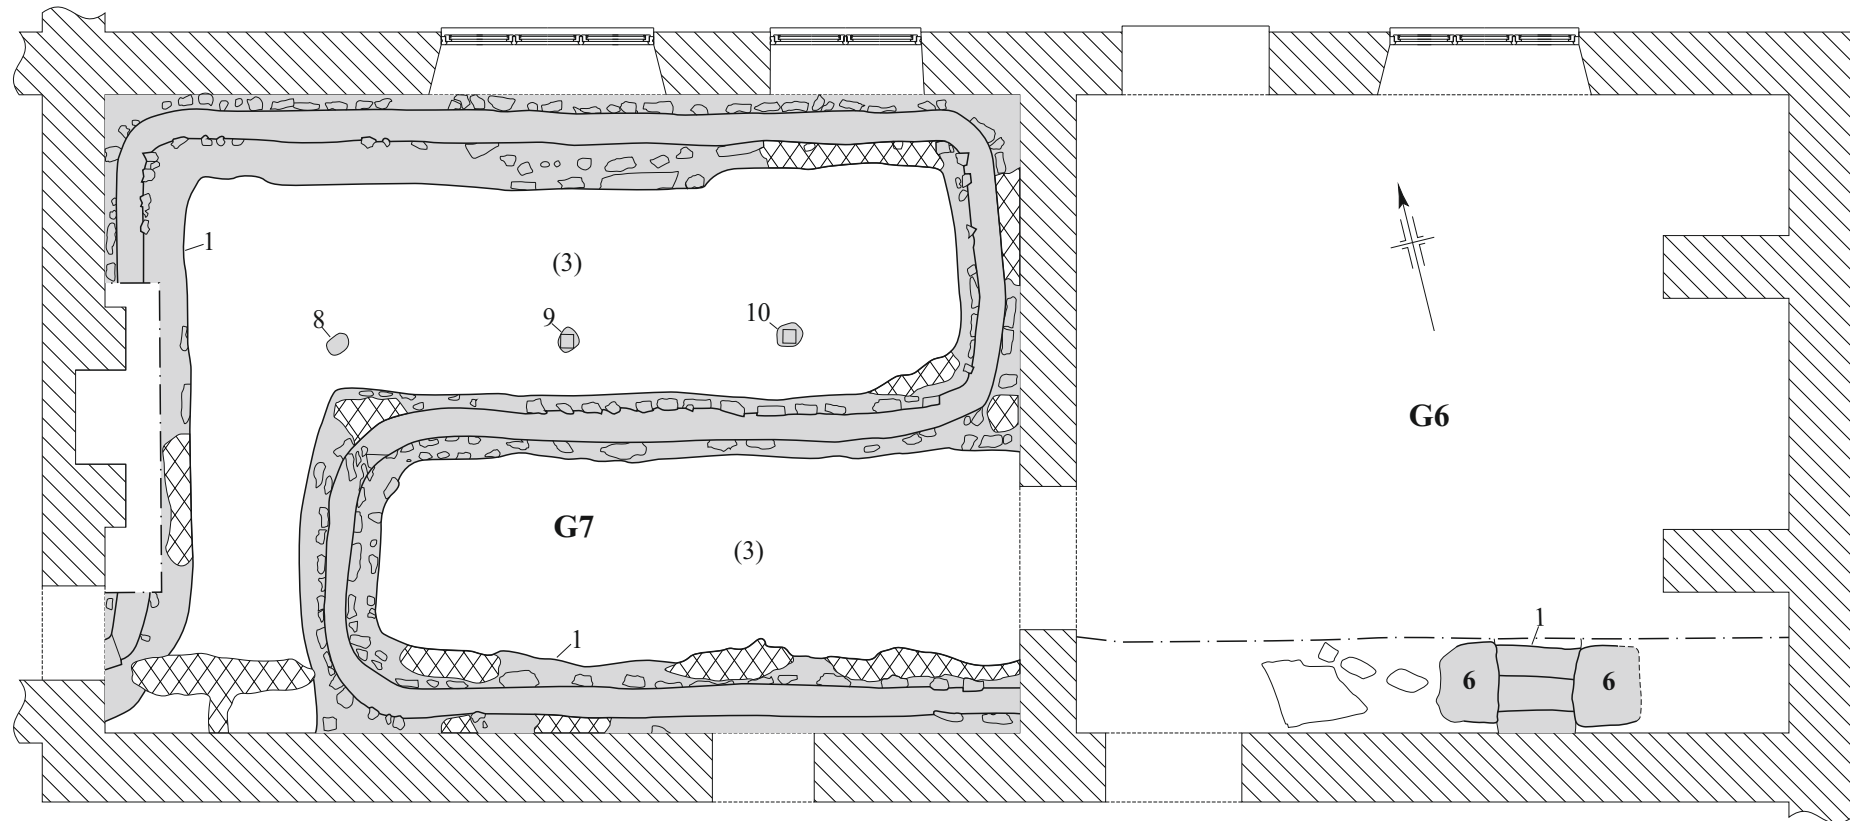
Figure 16: Monitored area at rooms G6 and G7

The construction of the house with excavation of the foundations appeared to create a loose and mixed deposit (3) which was made of lenses and patches of red sand gravel and grey brown silt sand. This covered an area some 6.4m by 4.18m approximately in the dairy. This deposit appears to be cut by the later cut features of the hypocaust (air) or culvert (liquid) structure constructed in the floor of the dairy. As the floor in the hypocaust went up and down, which would have caused pooling with a liquid, it is considered that the feature was probably for air flow.

The hypocaust cut 1 was a linear looping feature and may be interconnected with part of the foundation cut of Logg Farm. The width of the cut varied from 0.77-0.8m. The cut had vertical sides and a presumably flat base. In the base of the hypocaust there was a context 7 which was created from bedding lumps of limestone in a hard black cement stained deposit. This had a width of 0.2-0.25m across. The two walls of the hypocaust or culvert 2 were constructed of limestone, with the stones being variable in size measuring about 200mm by 100mm by 50mm. The walls were bonded by a brown yellow sand and rendered internally with a hard white grey substance internally.

There were three other features that were evident as being cut into the top of deposit (3), which were postholes 8, 9 and 10. Circular/oval cut 8 was 0.15m across with vertical sides and a rounded base. The fill (11) was a loose brown silt sand and had the remains of a piece of decaying timber. Circular/oval cut 9 was 0.17m across and had vertical sides and a rounded base. The fill (12) was a loose brown silt sand and had the remains of a piece of decaying timber. Circular/oval cut 10 was 0.14m across and had vertical sides and a rounded base. The fill (13) was a loose brown silt sand and had the remains of a piece of decaying timber. There was a hard or highly compact brown yellow sand mortar (4) that was the bedding for the floor cover and the roof of the hypocaust system. The floor was originally covered by limestone flagstones, but these had already been removed. The postholes had previously supported a table, and there had been a further group of postholes to support this feature on the other side. These other postholes, however, were not evident in the remaining features, or when the surface was cleaned back.

In the kitchen the cap stones 6 were large limestone slabs of variable size, one of which measured 520mm by 620mm. The slabs in the kitchen were covered with a deposit (5) that was a moderately compact brown grey silt sand. This was part of what remained of an earth floor in the kitchen.

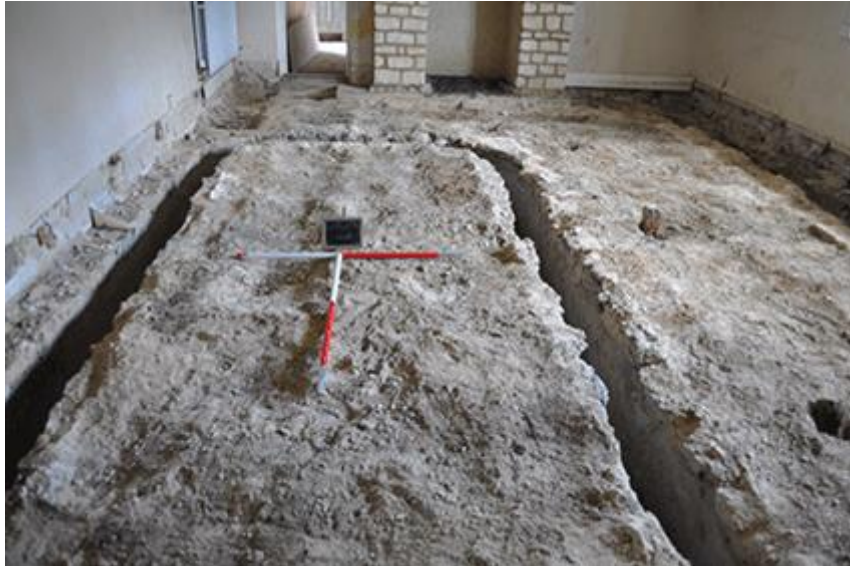
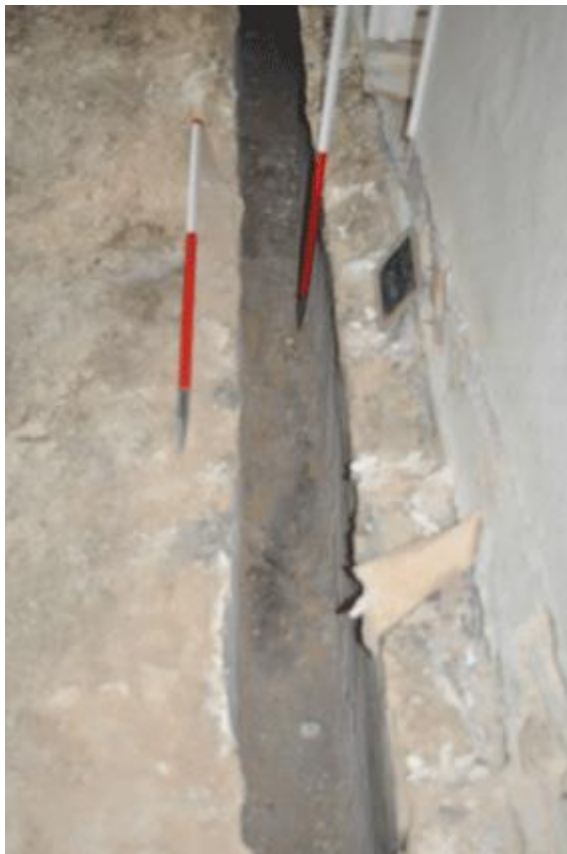
Plates 11: Hypocaust system room G7

Plate 12: Hypocaust system room G7

The area of the kitchen and the upper and lower dairy appear to have a hypocaust system extending across all three rooms. The feature is considered more likely to be a hypocaust than a culvert, as there is no consistent fall that would allow the run off of liquids. No hypocaust system has been reported from any other dairy rooms, and none was noted in the cheese room at Garland's Farm near Wantage when a study was carried out of that building by the author (Yeates 2014). Until the 19th century heating of milk and butter was not part of the process of production. However, in cheese production the processes of scalding the curds is noted, and even storing the curds at a standard room temperature is. This would imply that the dairy may be associated with cheese production and that the hypocaust was inserted to maintain temperatures in the room.
